Maryland Inventory of Historic Properties number: BA-2866

Name: MD 147 over HAYSTACK BRANCH

Maryland Inventory of Historic Properties
Historic Bridge Inventory
Maryland State Highway Administration
Maryland Historical Trust

SHA Bridge No. 3091 Name: MD 147 over Haystack Branch

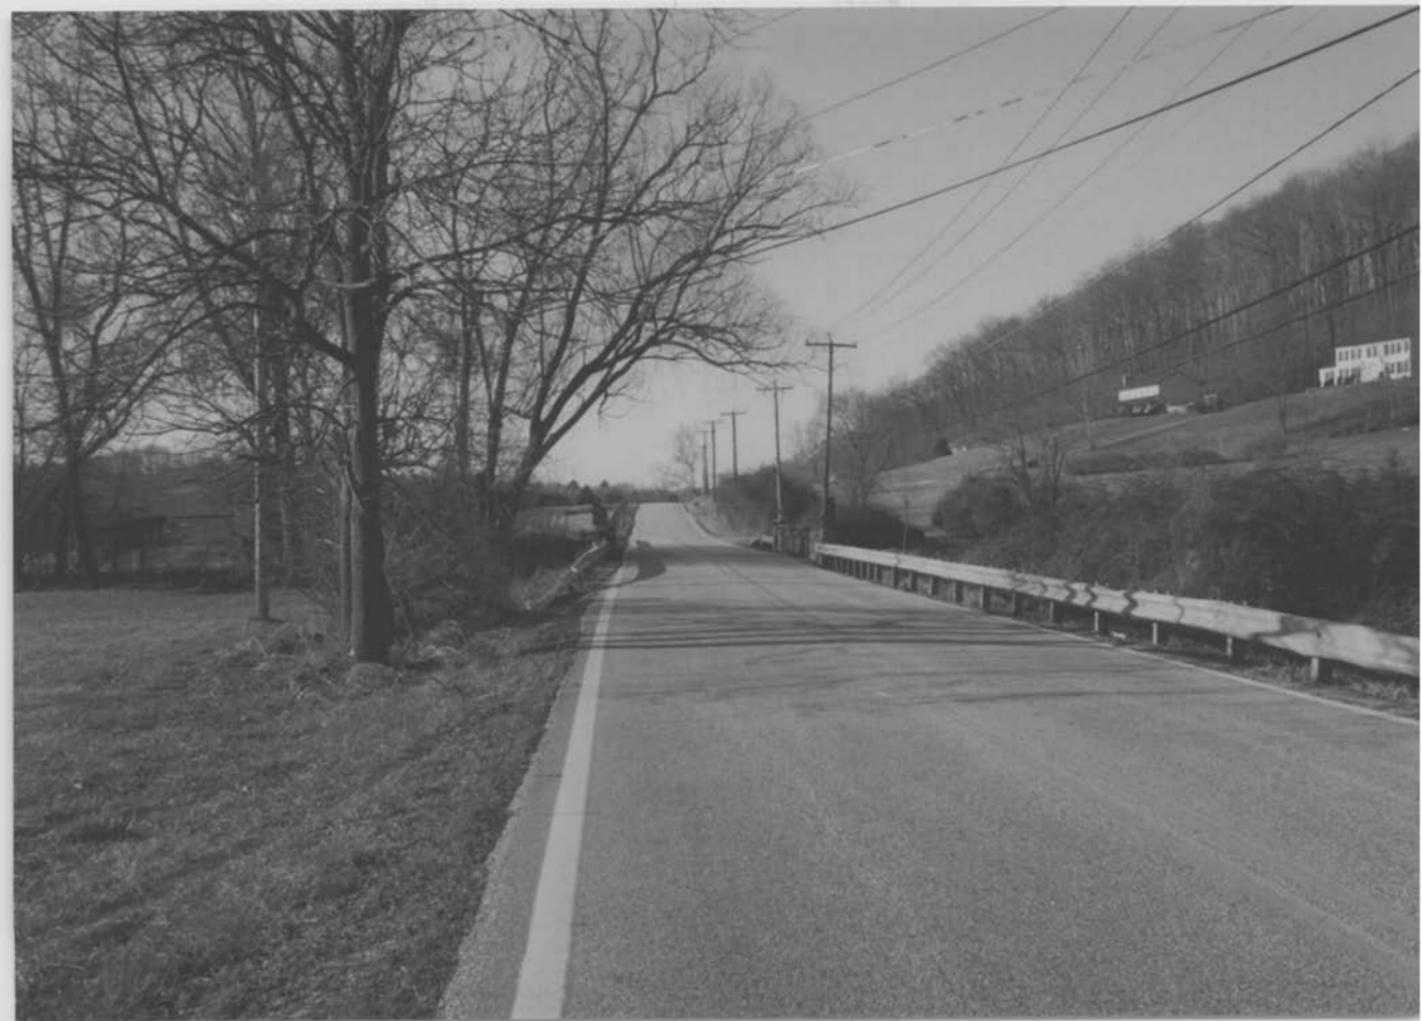
Number # 1 of 4

Description NORTH APPROACH LOOKING

SOUTH

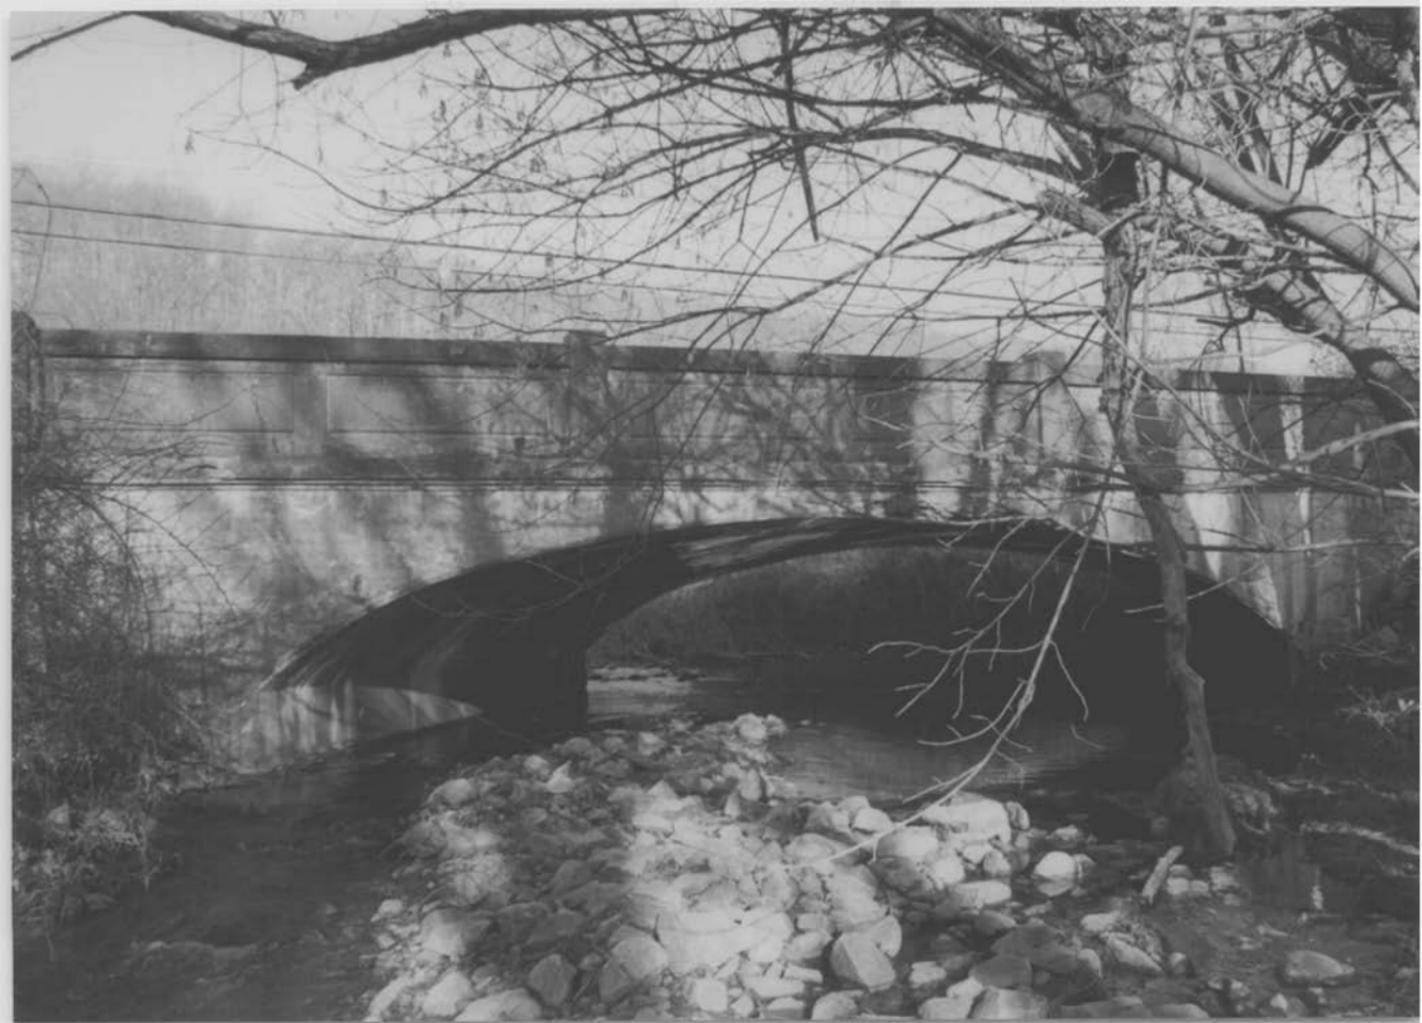
Number 2 of 4

The spandrel walls have heavy spalling with exposed reinforcement bars, and efflorescence on the eastern side of the bridge. On the western side of the bridge the spalling extends 4 inches along the southeast edge, exposing aggregate. This side of the bridge also has surface spalling, surface erosion and random cracking with efflorescence.

Description EAST ELEVATION LOOKING
WEST

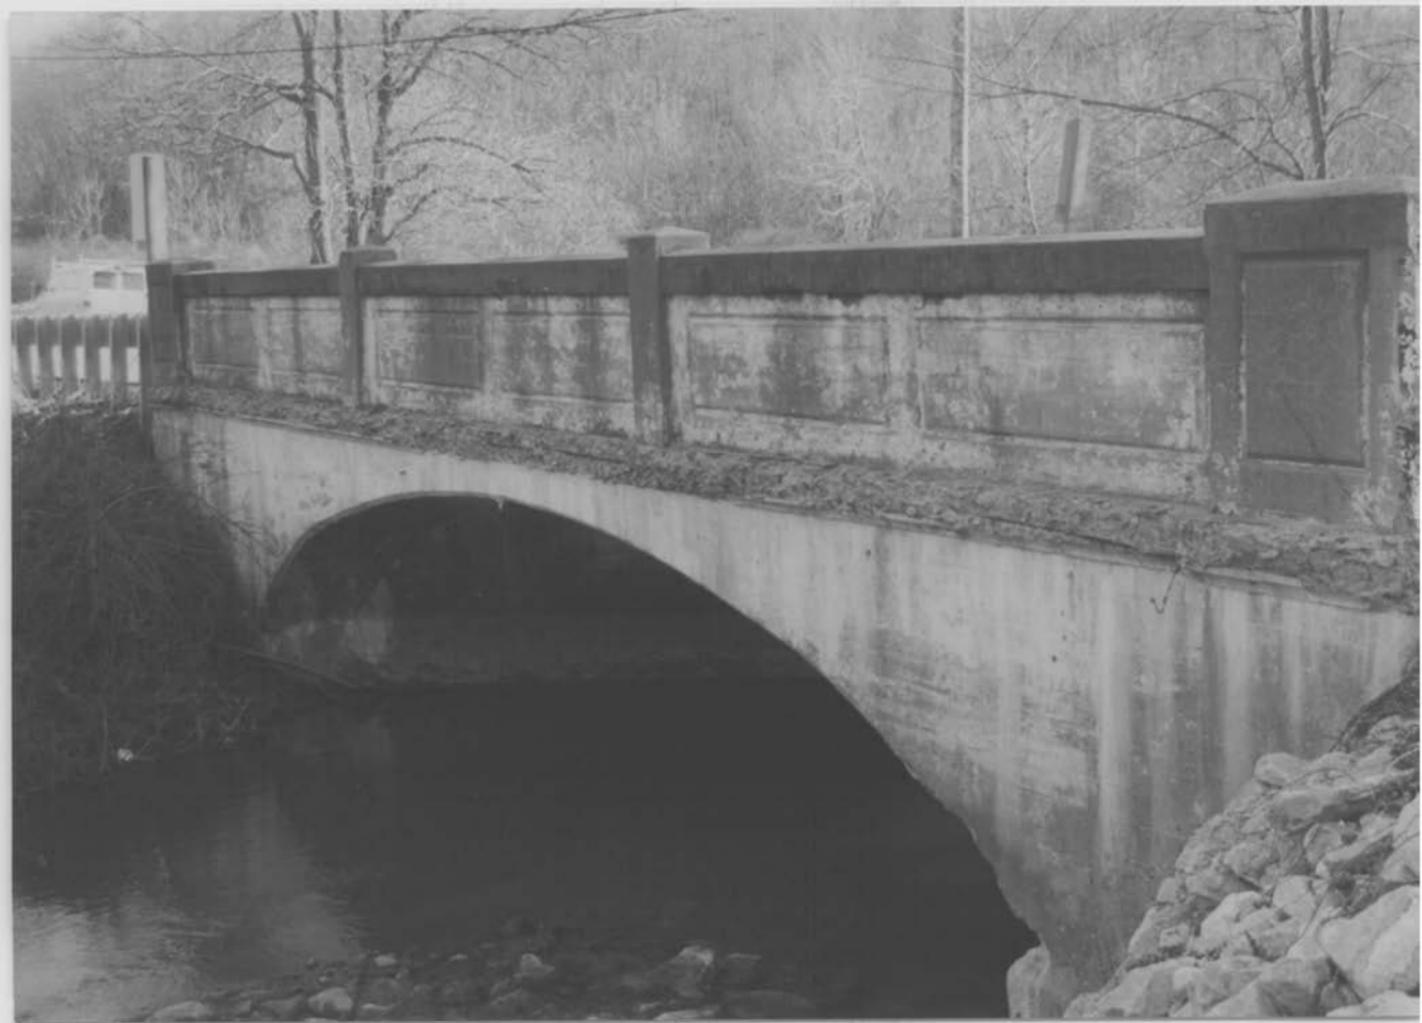
Number # 3 OF 4

Description WEST ELEVATION LOOKING

NORTHEAST

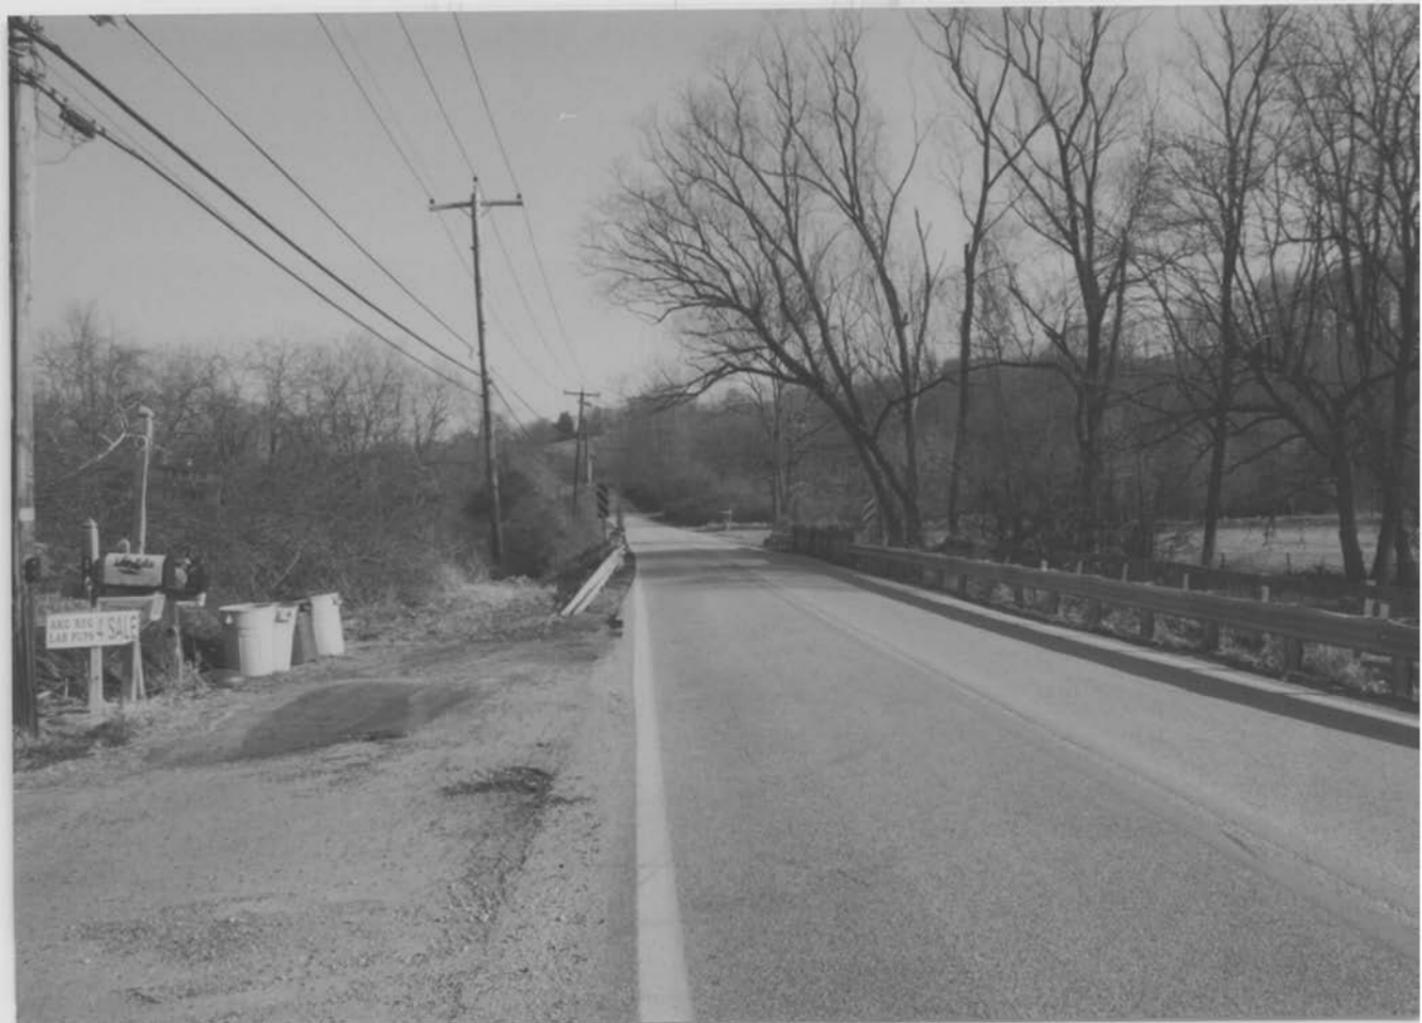
Number # 4 of 4

Description SOUTH APPROACH LOOKING
NORTH
