1. STATE **Maryland**
 COUNTY **Baltimore**
 TOWN **Lutherville** VICINITY
 STREET NO. **300 W. Seminary Ave.**

HISTORIC AMERICAN BUILDINGS SURVEY
INVENTORY

2. NAME **College Manor**

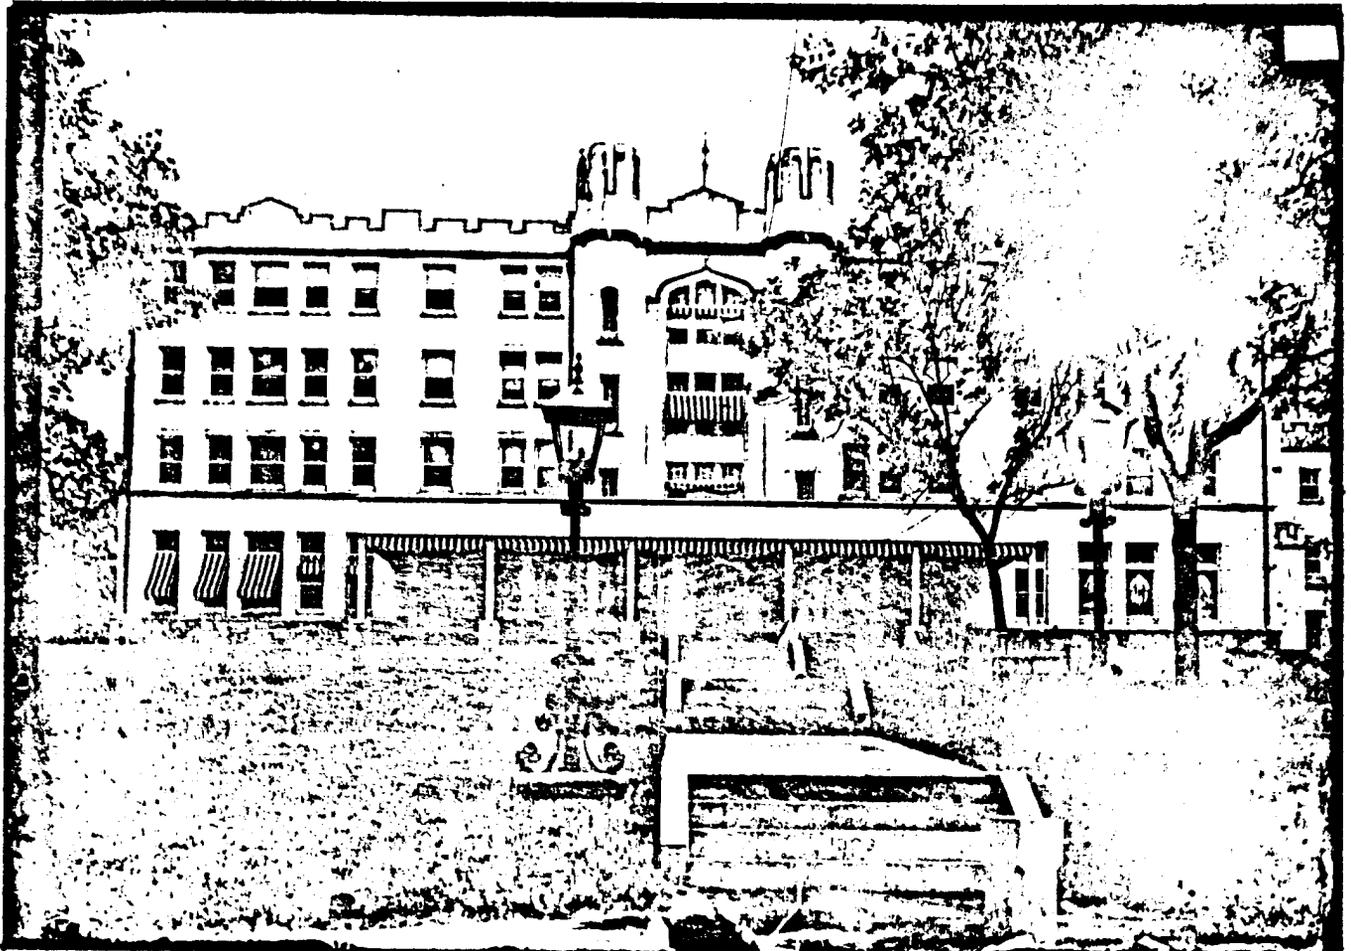
An early view of the post-1911 college building.

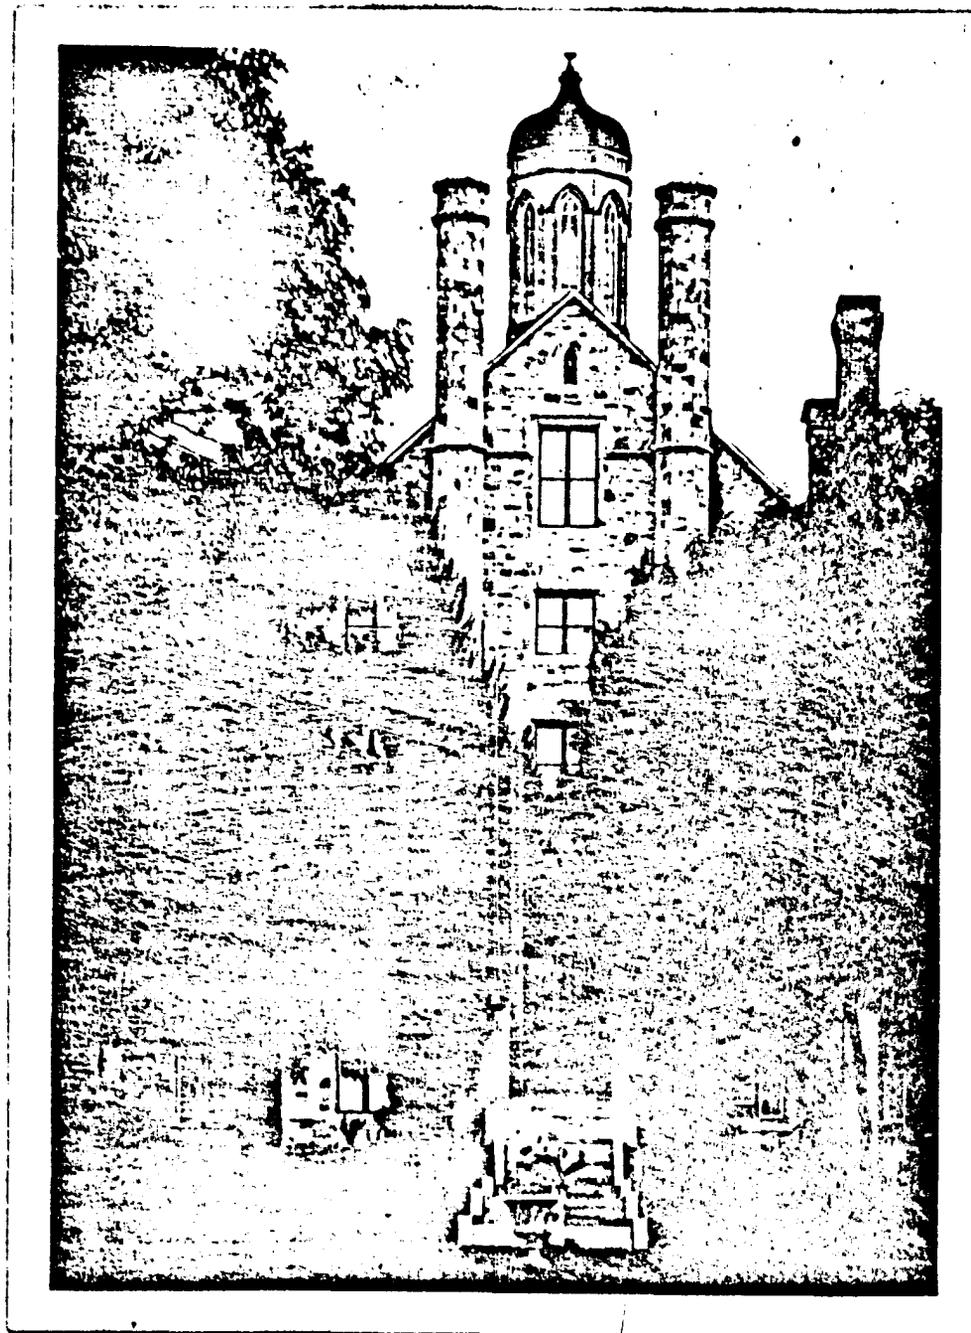
College Manor, Sheet 4.

An early view of the original Lutherville Female Seminary Building before the 1911 fire.
