FRAME TOBACCO BARN ON CALVERT CLIFFS  
(Visitors Center)

Report on a Preliminary Inspection

Garry Wheeler Stone  
Archaeologist  
St. Mary's City Commission

24 January 1978

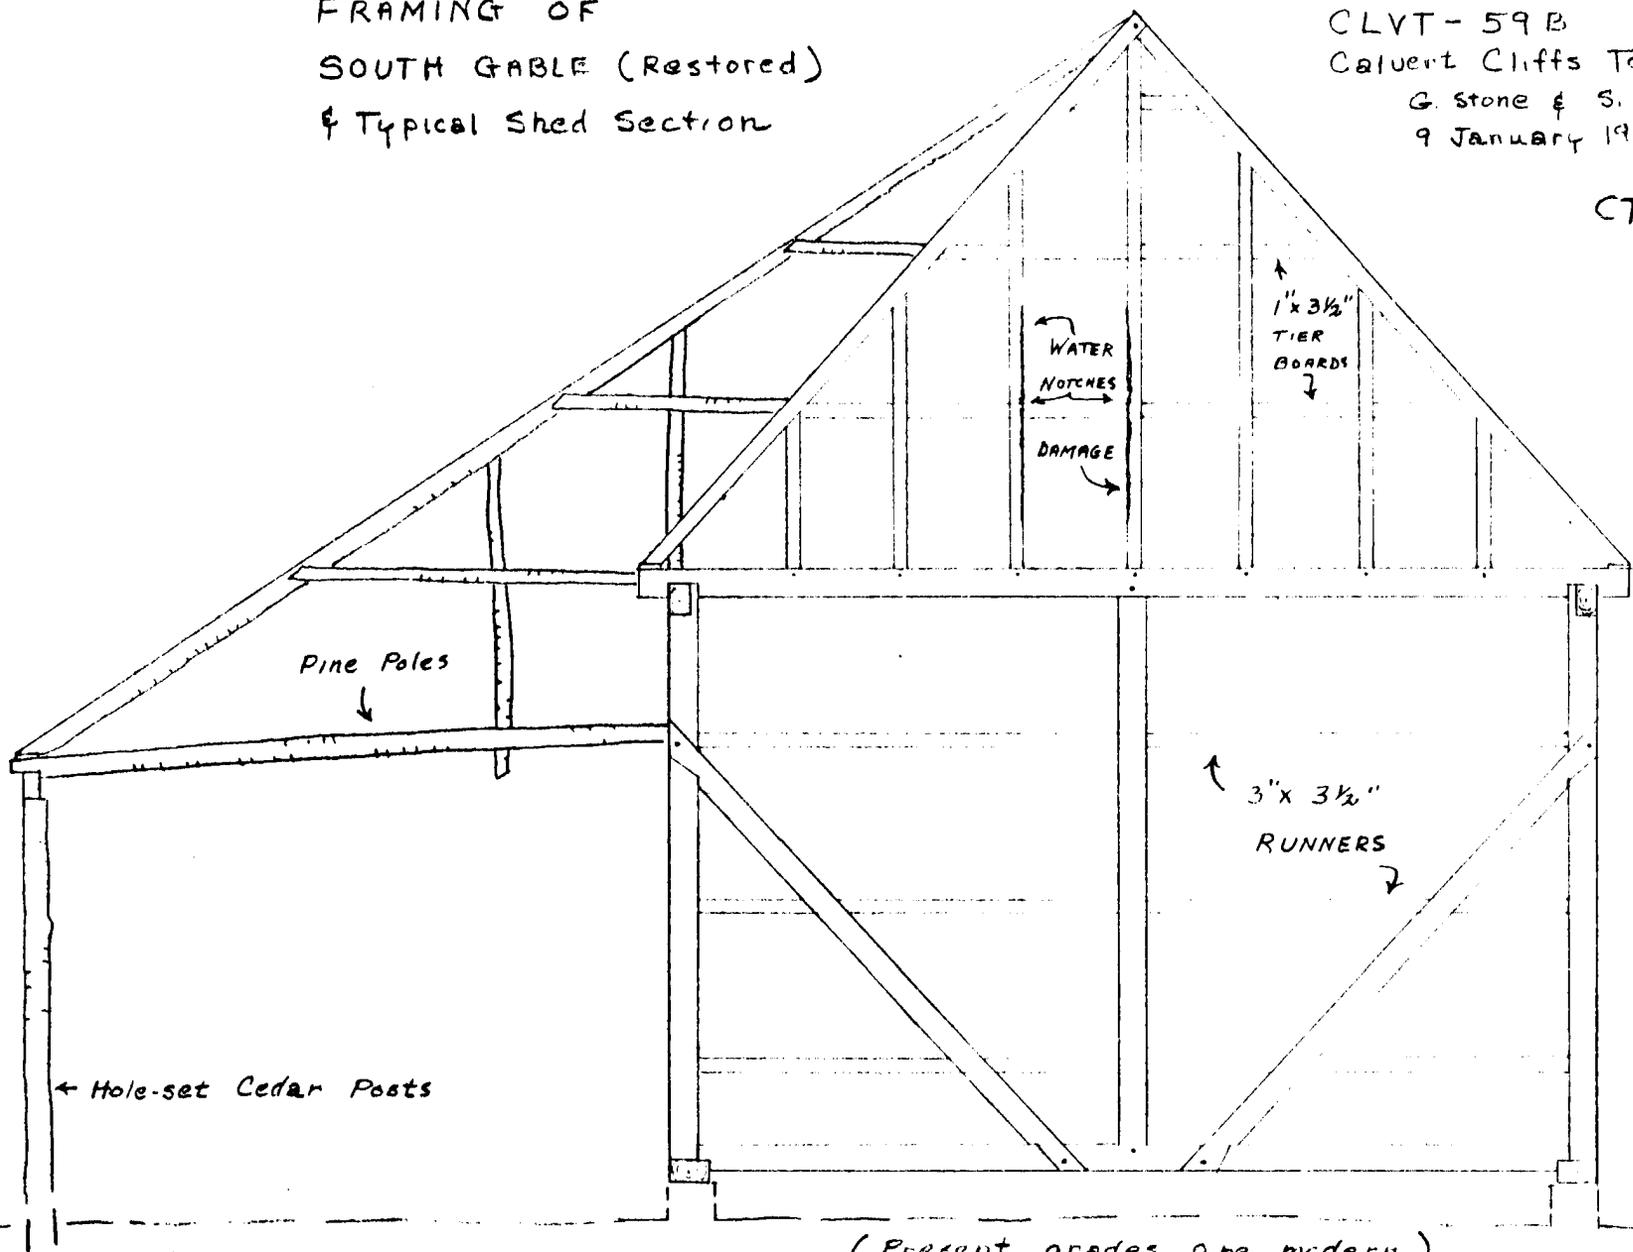
FRAMING OF  
SOUTH GABLE (Restored)  
& Typical Shed Section

Probable evidence for gable ventilation windows was observed. It consisted of areas of obvious water damage to the studding (in similar locations in both gables) and possible sill notches in the south gable [13, 14].

The shed extension of the barn is also of interest. It is constructed completely\* of second growth, "old field" timber (pine and cedar) [18]. The wall frame consists of formerly hole-set cedar posts, tenoned to the plate [15]. The posts are not hewn. They were flattened only with an axe where the runners join, so that the runners would butt securely. (They are toe-nailed to the posts.) No diagonal bracing is present. The wall is now underpinned with a sill [16]. The eaves' framing is very poor. The board false plate carries the rafter toes only an inch or two beyond the wall. The roof frame consists of pine poles [19]. Even some of the shingle lath are small poles (hewn on their upper sides only [27]).
