**MARYLAND HISTORICAL TRUST
DETERMINATION OF ELIGIBILITY FORM**

Property Name: Adams Tenant Farm Inventory Number: D-823
 Address: 4919 Bucktown Road City: Cambridge (vicinity) Zip Code: 21673-3761
 County: Dorchester USGS Topographic Map: Cambridge
 Owner: Roger F. Adams Is the property being evaluated a district? yes
 Tax Parcel Number: 001 Tax Map Number: 53 Tax Account ID Number: 13 000026
 Project: OneEnergy Cambridge Solar, LLC Agency: CPCN/PSC
 Site visit by MHT Staff: no yes Name: _____ Date: _____
 Is the property located within a historic district? yes no

MARYLAND HISTORICAL TRUST
NR-ELIBILITY REVIEW FORM

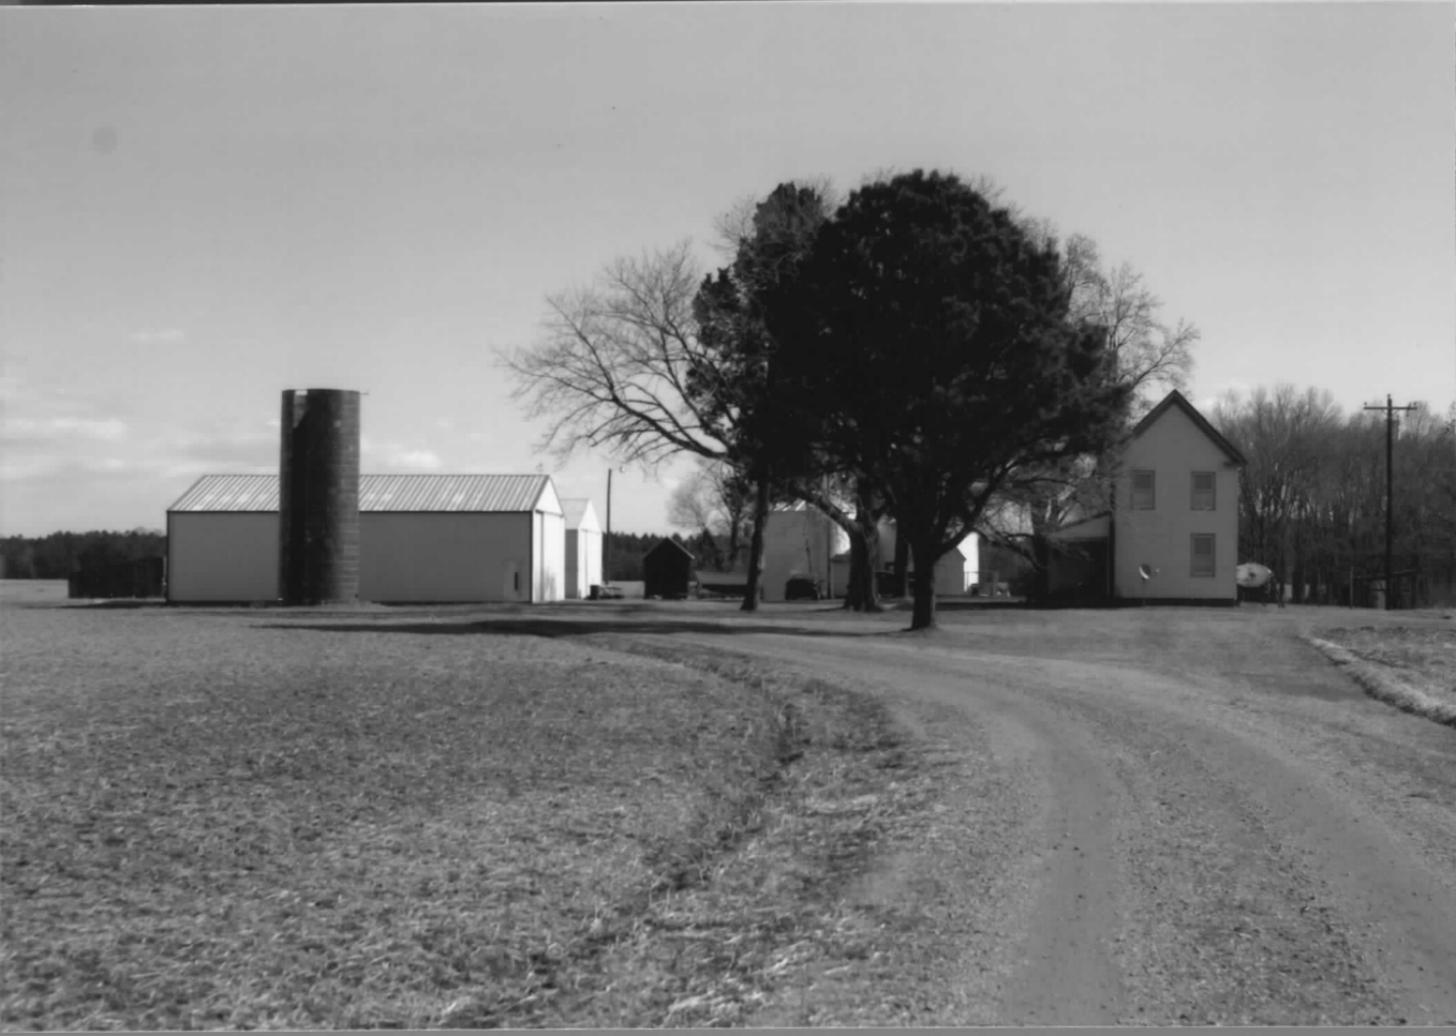
1 of 12

CAMERA facing East

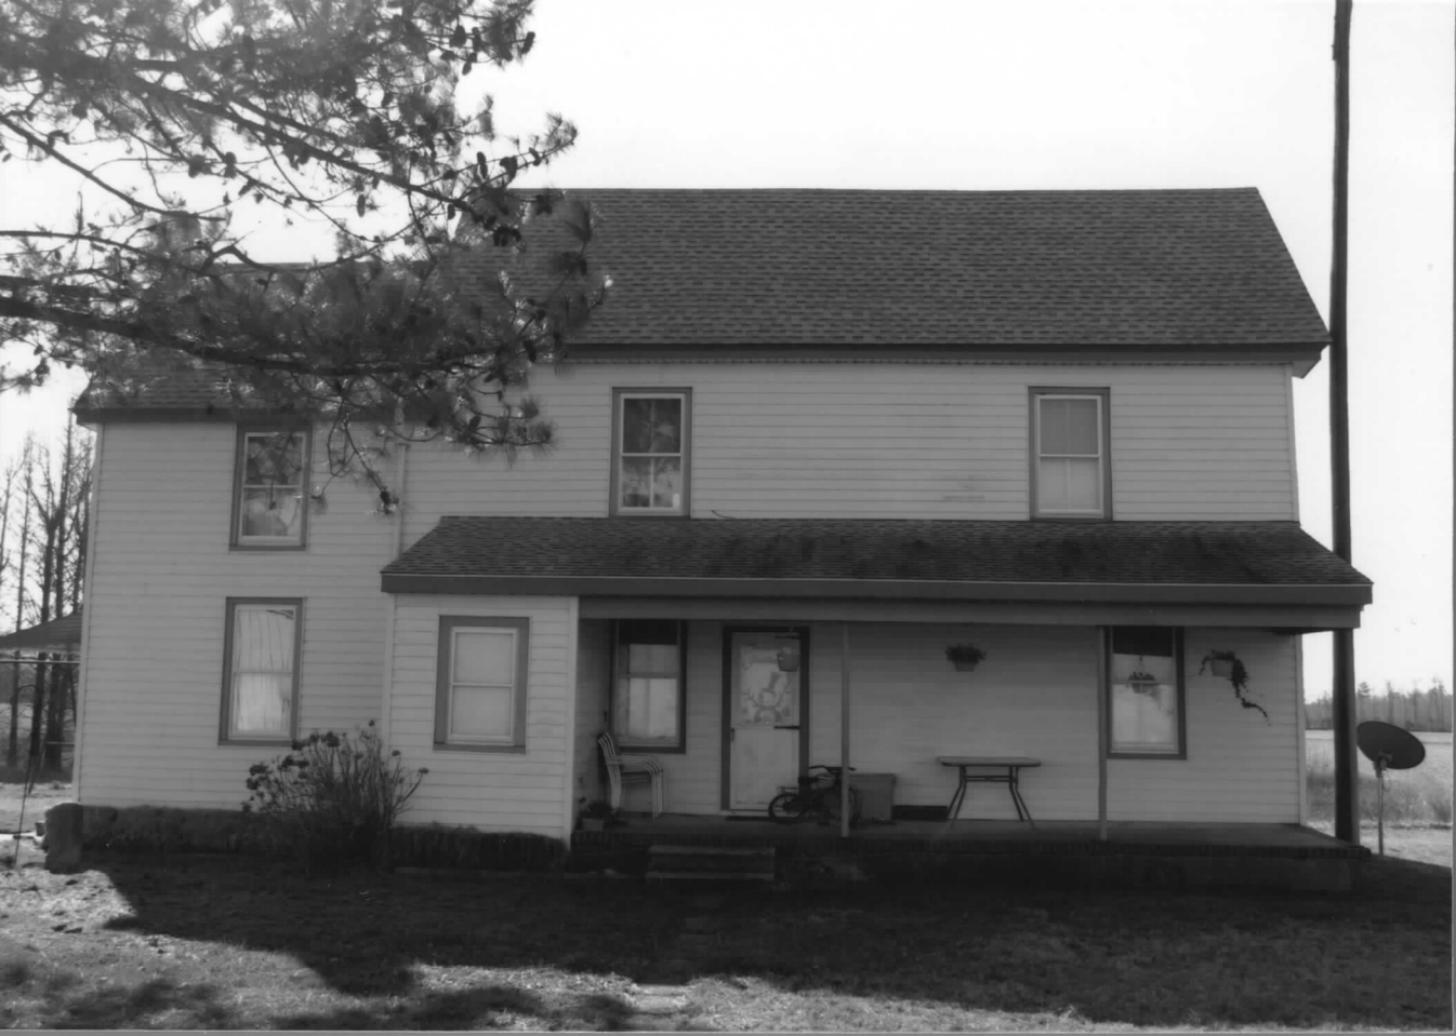
2 of 12

This plain, two-story, asymmetrical, side-gable, single-pile-plan, frame dwelling consists of a 40 ft. long main block and a 15 ft. telescoping kitchen wing. Both sections are 16 ft. deep. Walls are sheathed in aluminum siding. A shed-roofed front porch projects from the façade an additional 8 ft. The tubular metal supports and poured concrete floor clearly indicate this is not an original porch. In addition to being rebuilt, part of the porch has been enclosed to accommodate a bathroom.

The house faces north, which is not typical for old rural houses that relied heavily on natural light and ventilation. The façade's asymmetrical fenestration pattern is also unexpected. A classic center-hall-plan is much more typical in this agricultural context. These facts, combined with the rebuilt porch, may indicate that the house originally faced south. Countering this theory, however, is the lack of visible evidence for a south-side doorway or south side driveway.

As with the exterior walls, windows, cornice and soffits are also encased in metal. The composition shingle roof is of recent date. Original, two-over-two, double-hung, wood-sash windows (fitted with storm windows) are employed in all but one opening. Two doorways are present. The front opening is fitted with a relatively new door, while the glazed-and-panel door that leads into the kitchen appears to date to about the third quarter of the 20th century. Other notable features include the narrow, exterior, brick stove chimney that bisects the gable end of the kitchen wing.

A low, brick pier foundation, later infilled by concrete blocks, supports both sections of the house. The spacing and quality of the bricks supporting the wing is the same as that used under the main section. This identical treatment suggests that the two parts of the house were built at the same time.

Dwelling. camera facing South

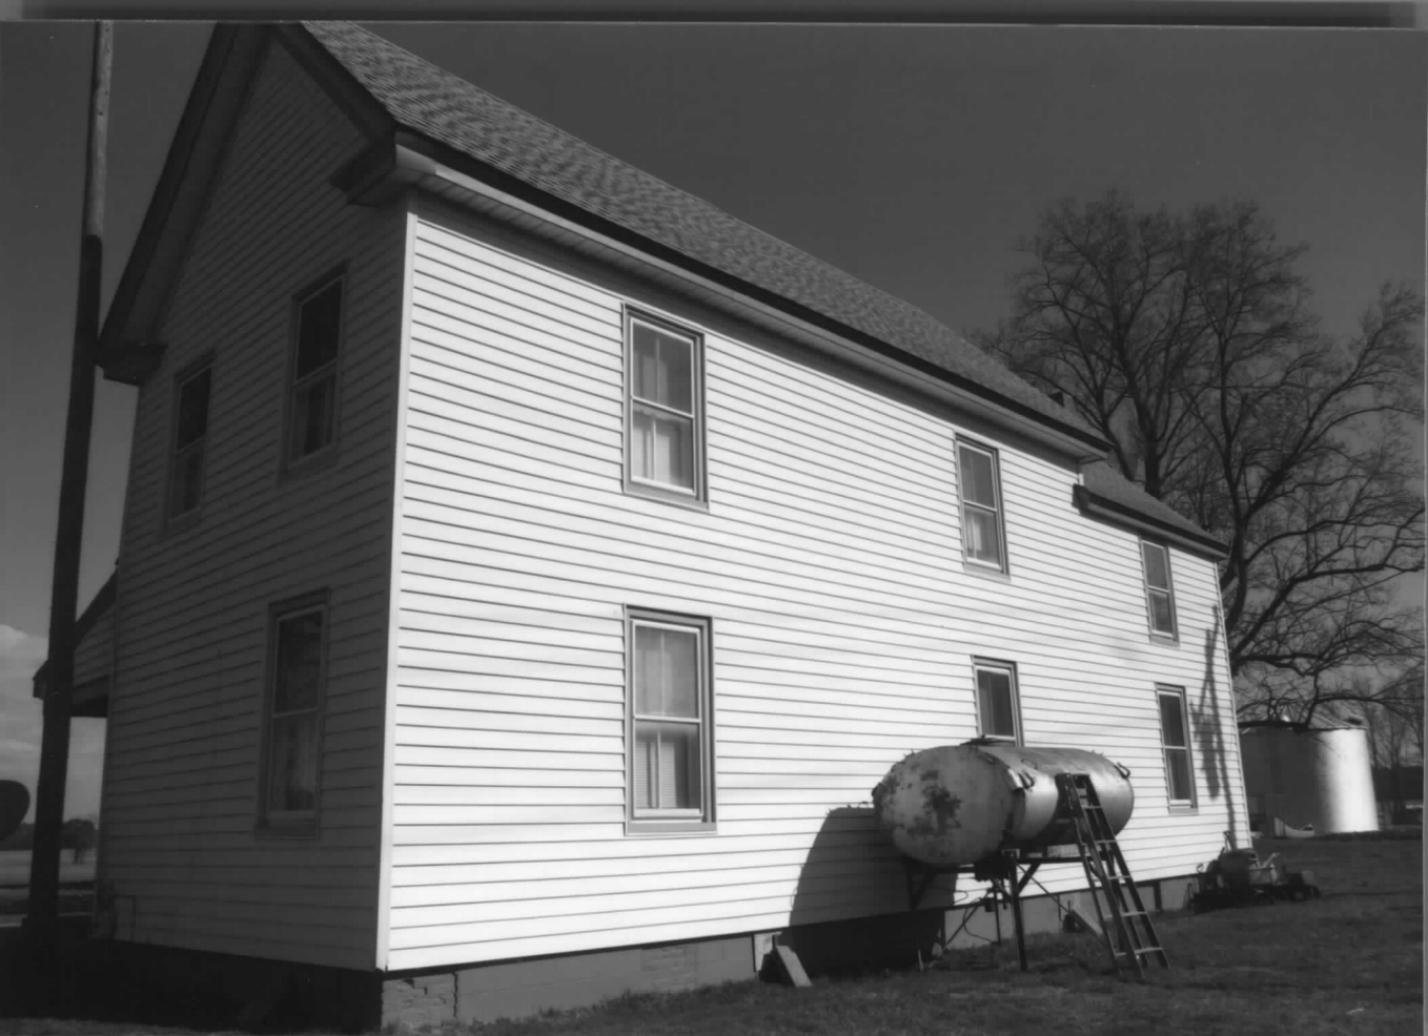
3 of 12

Dwelling, CAMERA facing NE

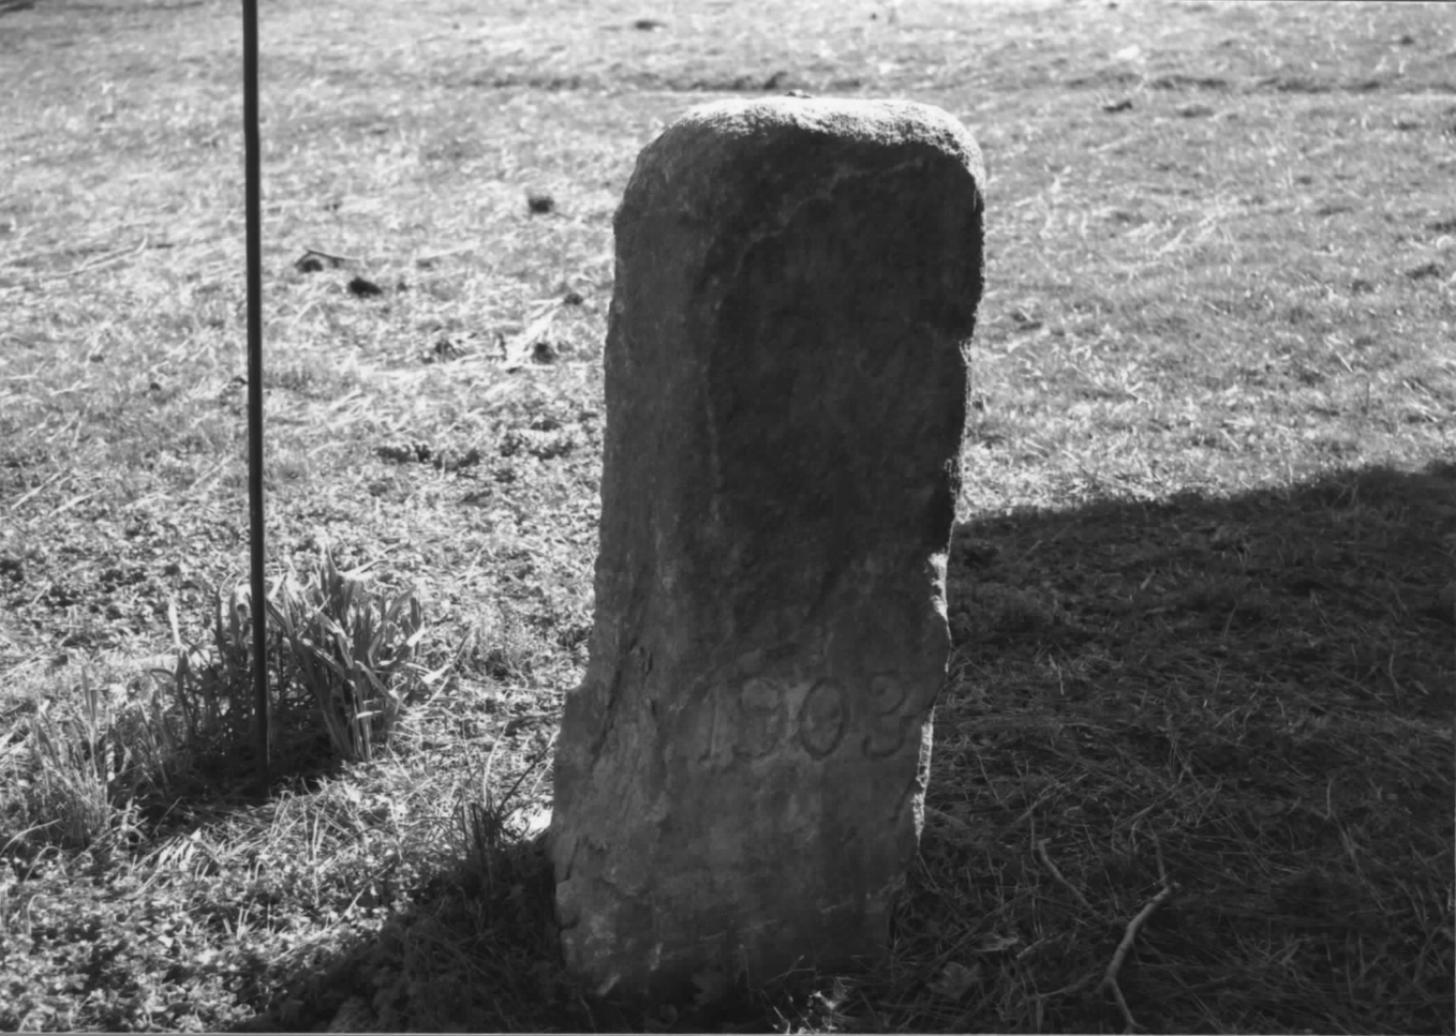
4 of 12

Five feet north of the kitchen wing's northeast corner stands a stone marker dated "1903." The stone measures two feet in height and is approximately six inches square at the base. Its purpose is unclear. It is, perhaps, a survey marker, or a date stone associated with the construction of the house. A metal ring has been inserted into the top of the stone. Roger Adams, whose father acquired the farm in 1951, said that the stone was used to tether horses.

"1903" Date stone

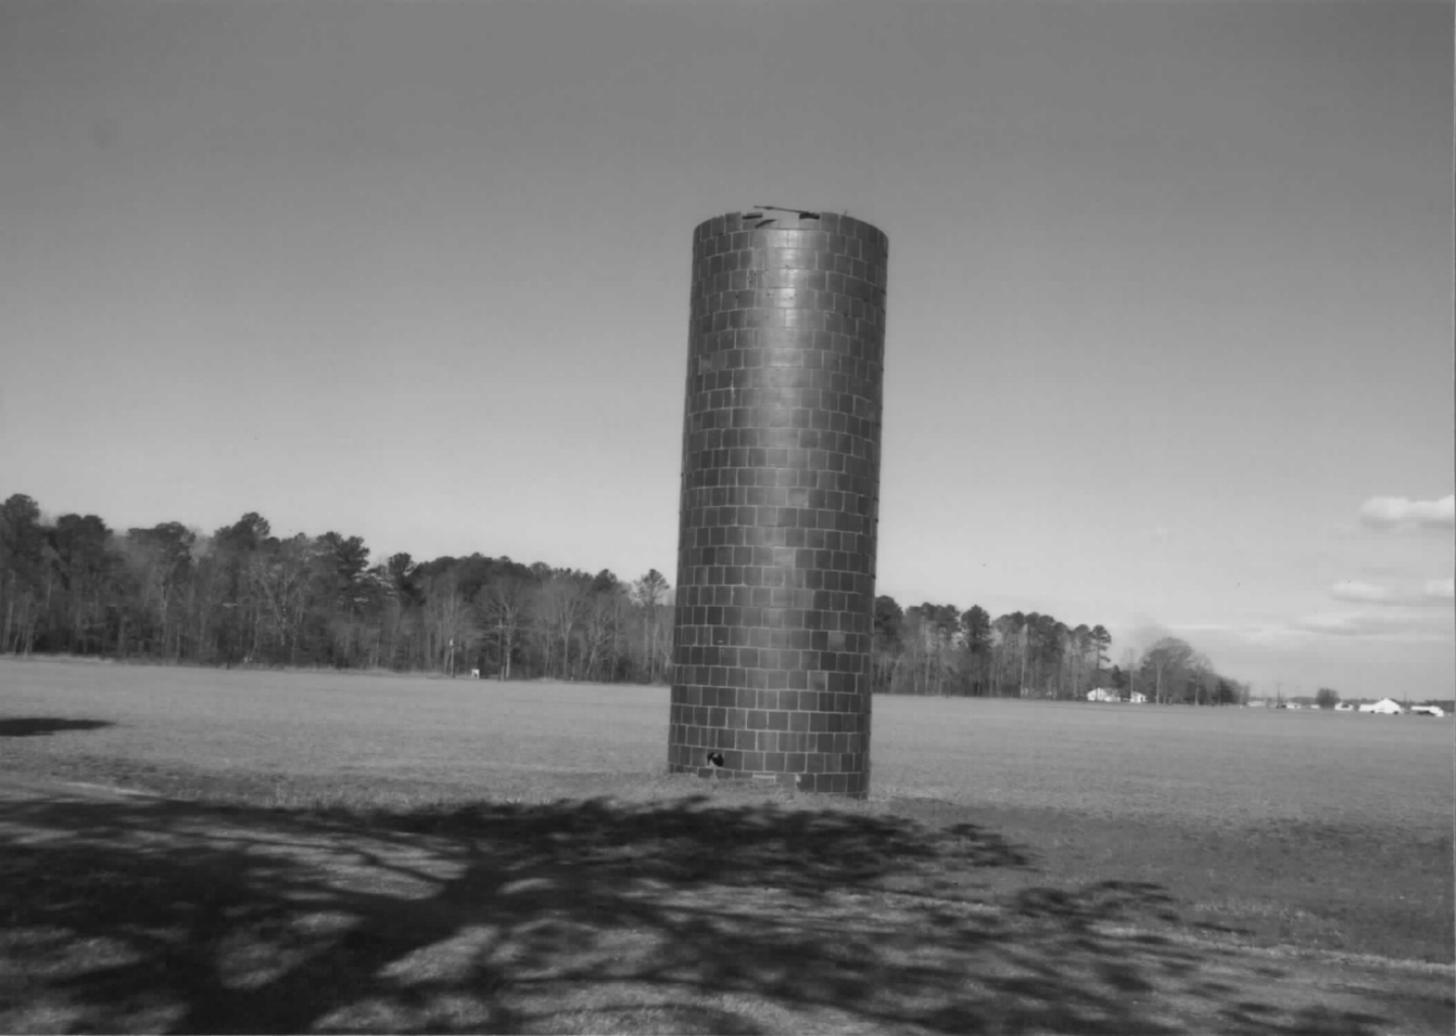
5 of 12

This structure is located on the north side of the farm drive. If common practice was observed, it was most likely built in close proximity to a now-demolished barn. This approximately 40 ft.-tall round structure is built of vitrified hollow clay tiles, and has an internal diameter of 10 ft. The roof is missing and the top rows of tiles are damaged. A metal plaque identifies the structure as a "Natco Imperishable Silo." It was manufactured by the National Fireproofing Company of Pittsburg, Pennsylvania.

Silo

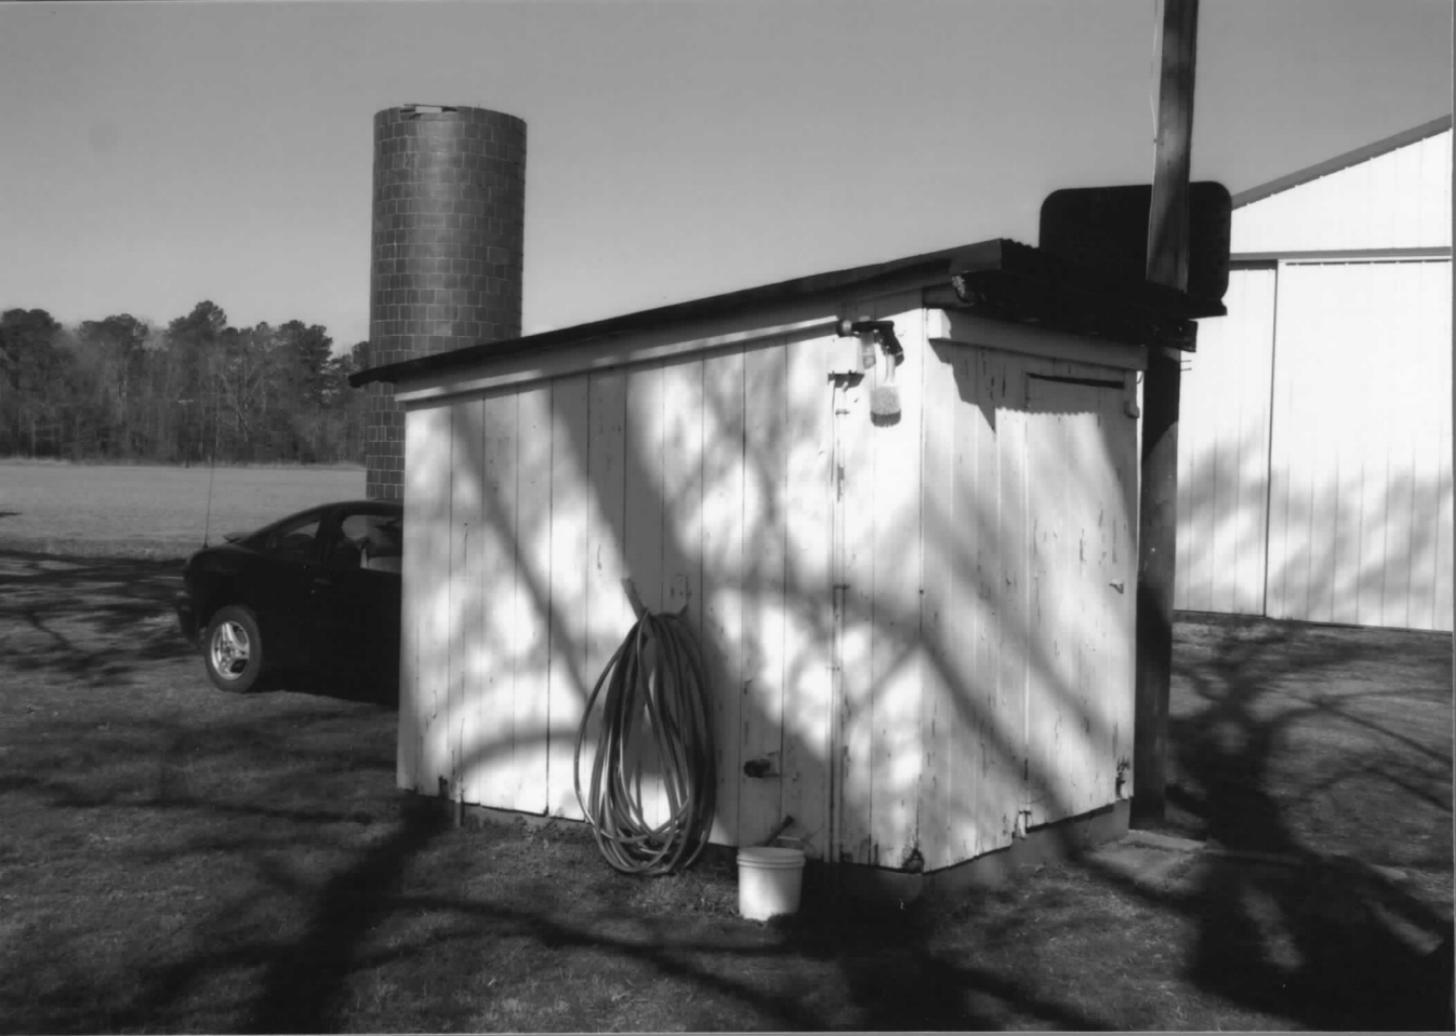
6 of 12

This 6 ft.-3 in x 8 ft. -3 in., shed-roofed, frame structure rests on a 6 in. poured concrete foundation. The vertical siding measures 6 in. x 1 in. The roof joists overhang at the front in a manner designed to protect the doorway. Materials were fashioned with a circular saw and are held together with wire nails. As its name indicates, it houses the farms electric water pump.

Pump House

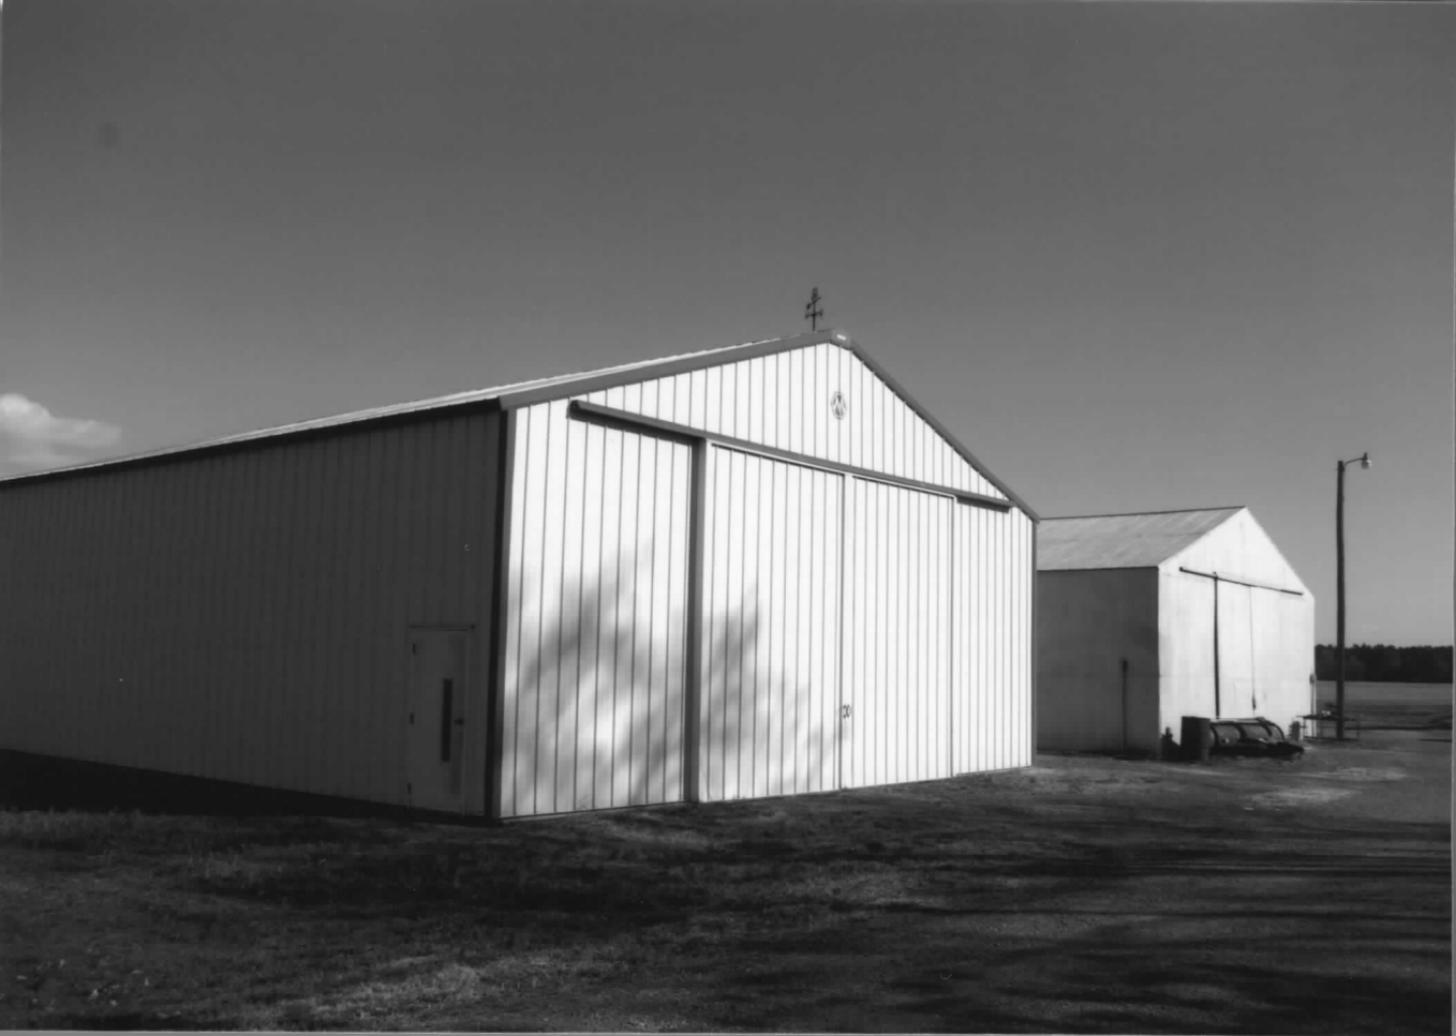
7 of 12
<ILFORD... True SOL... 83/84/13

These two large prefabricated corrugated metal buildings house farm equipment. They measure 50 ft. x 150 ft. and rest on a poured concrete pad. Track doors are located in the front gable end, with an additional pedestrian entrance located in a side wall.

Digital MASTER at MHT
Equipment STORAGE Bldgs

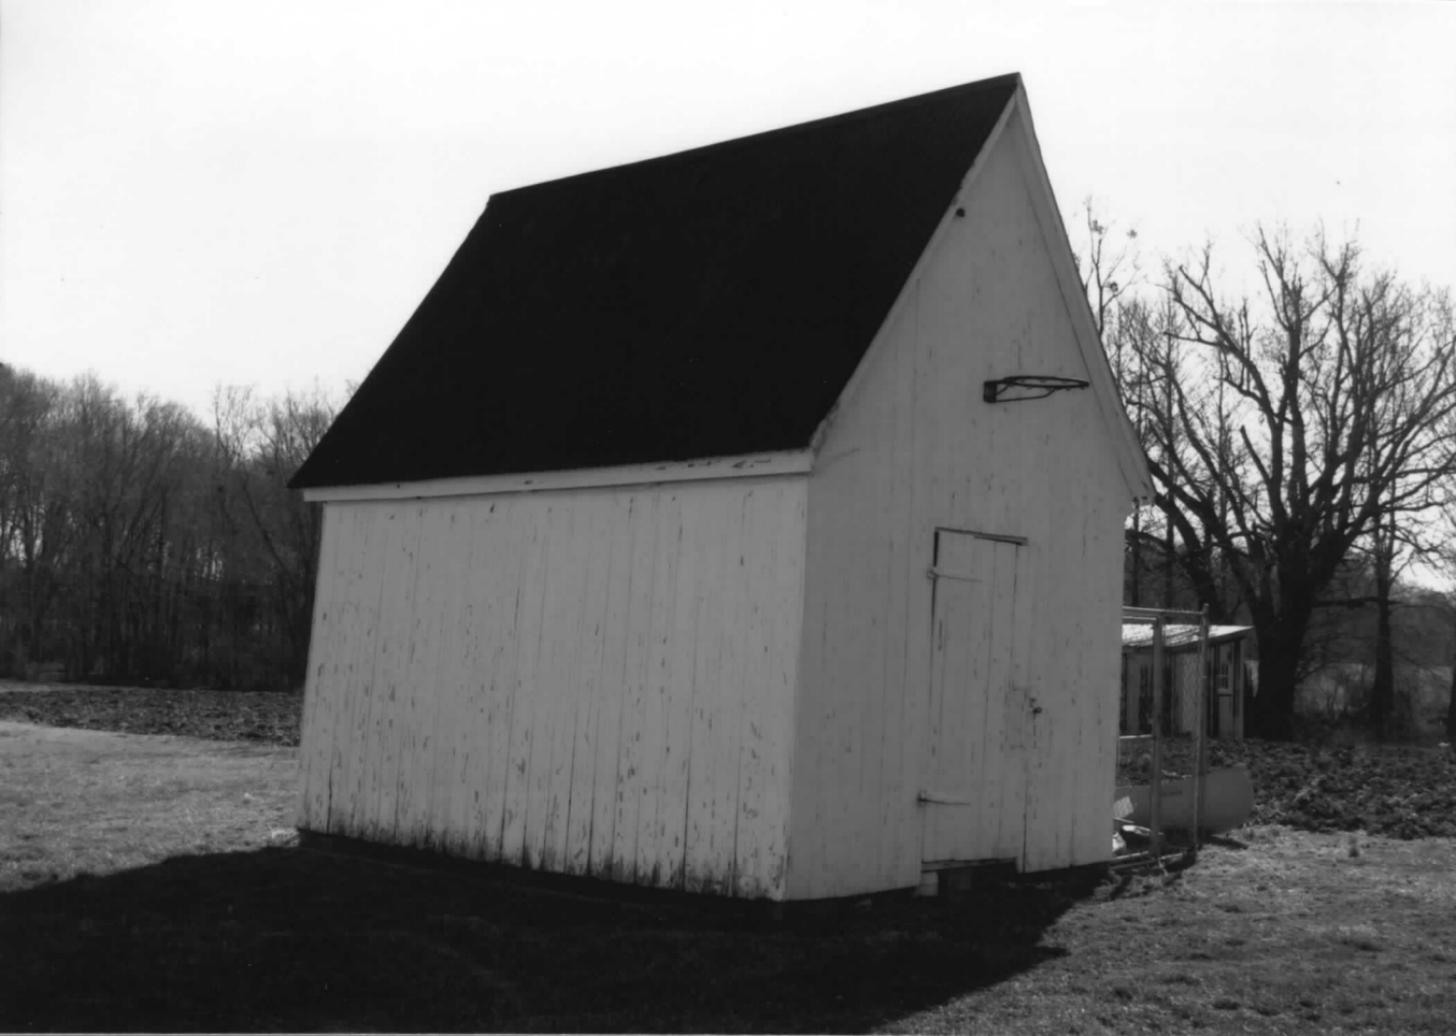
8 of 12

This 10 ft.-5 in. x 14 ft. -3 in. gable roof structure has slightly overhanging eaves with exposed joist ends. The exterior siding is very similar to that displayed by the pump house. Walls rest on low, poured concrete piers. Most roof and wall members are fashioned with a circular saw and wire nails. However, the plate and floor boards are wider and older than the majority of the structural components, and are likely recycled from an older structure. The reason for the extreme pitch of the roof is not apparent. The area above the plate is now used for storage. The interior is whitewashed and provides no apparent evidence as to original purpose. It is located adjacent to a small vegetable garden plot.

SHED (ILFORD), (From: True BSLD, 03/04/13)

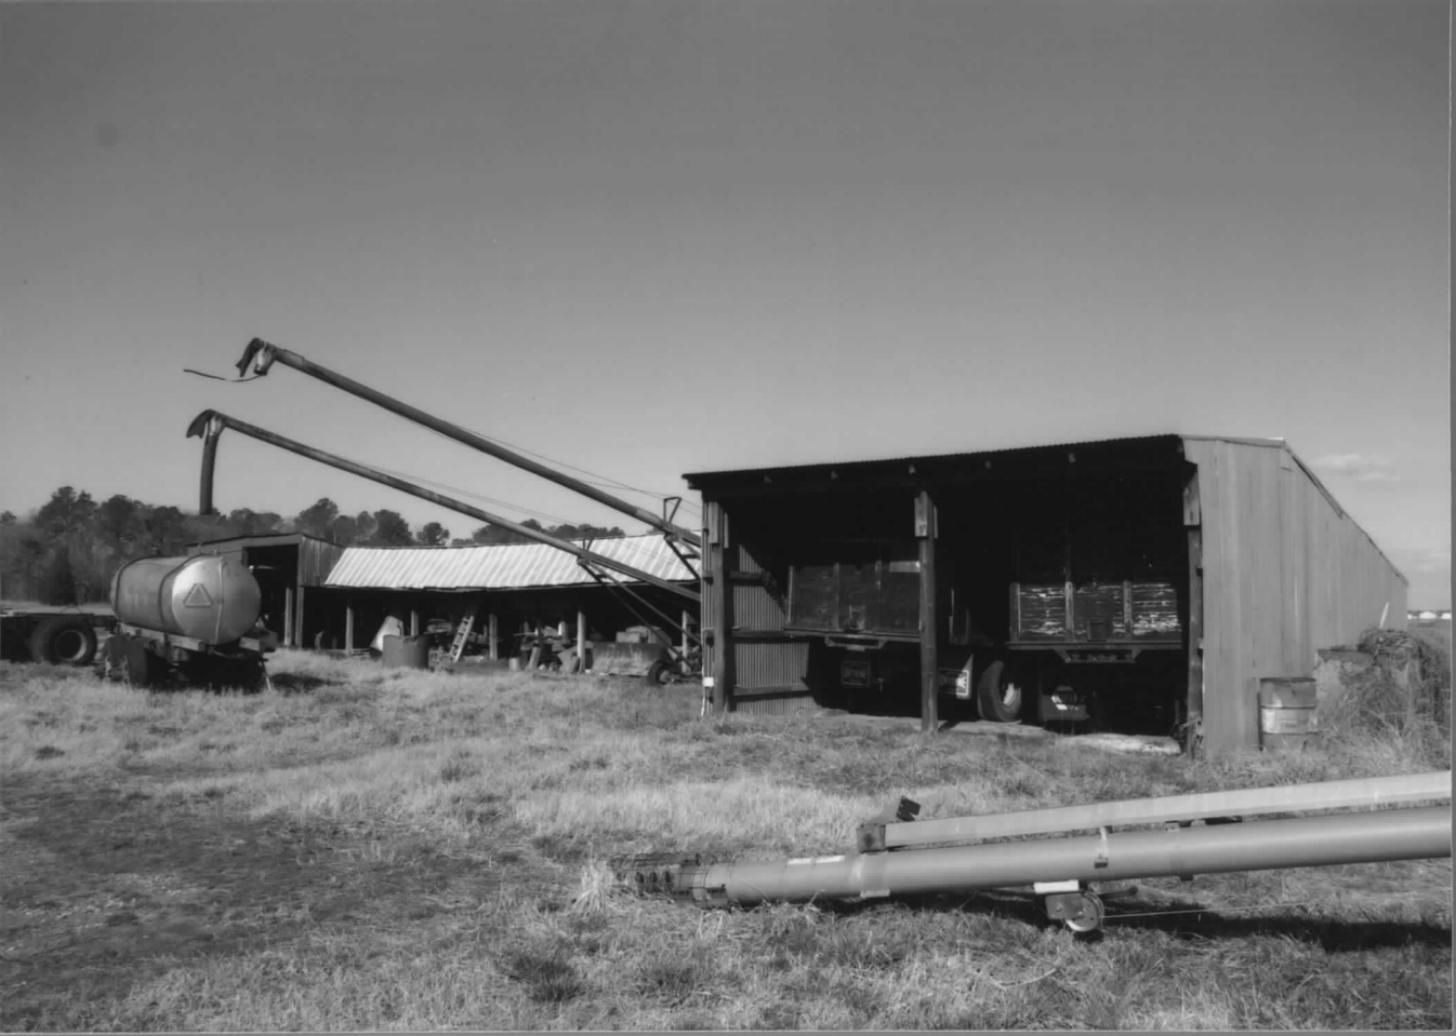
9 of 12

This three-part structure collectively measures nearly 150 ft. in length. The center section appears to be the most well-built section, and utilizes the least recycled material. The wooden sided, two-bay, west section has a poured concrete floor. The two-bay east section is the largest and most recently constructed. Utility poles on grade serve as structural supports. This somewhat decrepit structure is used to store equally decrepit farm equipment.

CART Shed

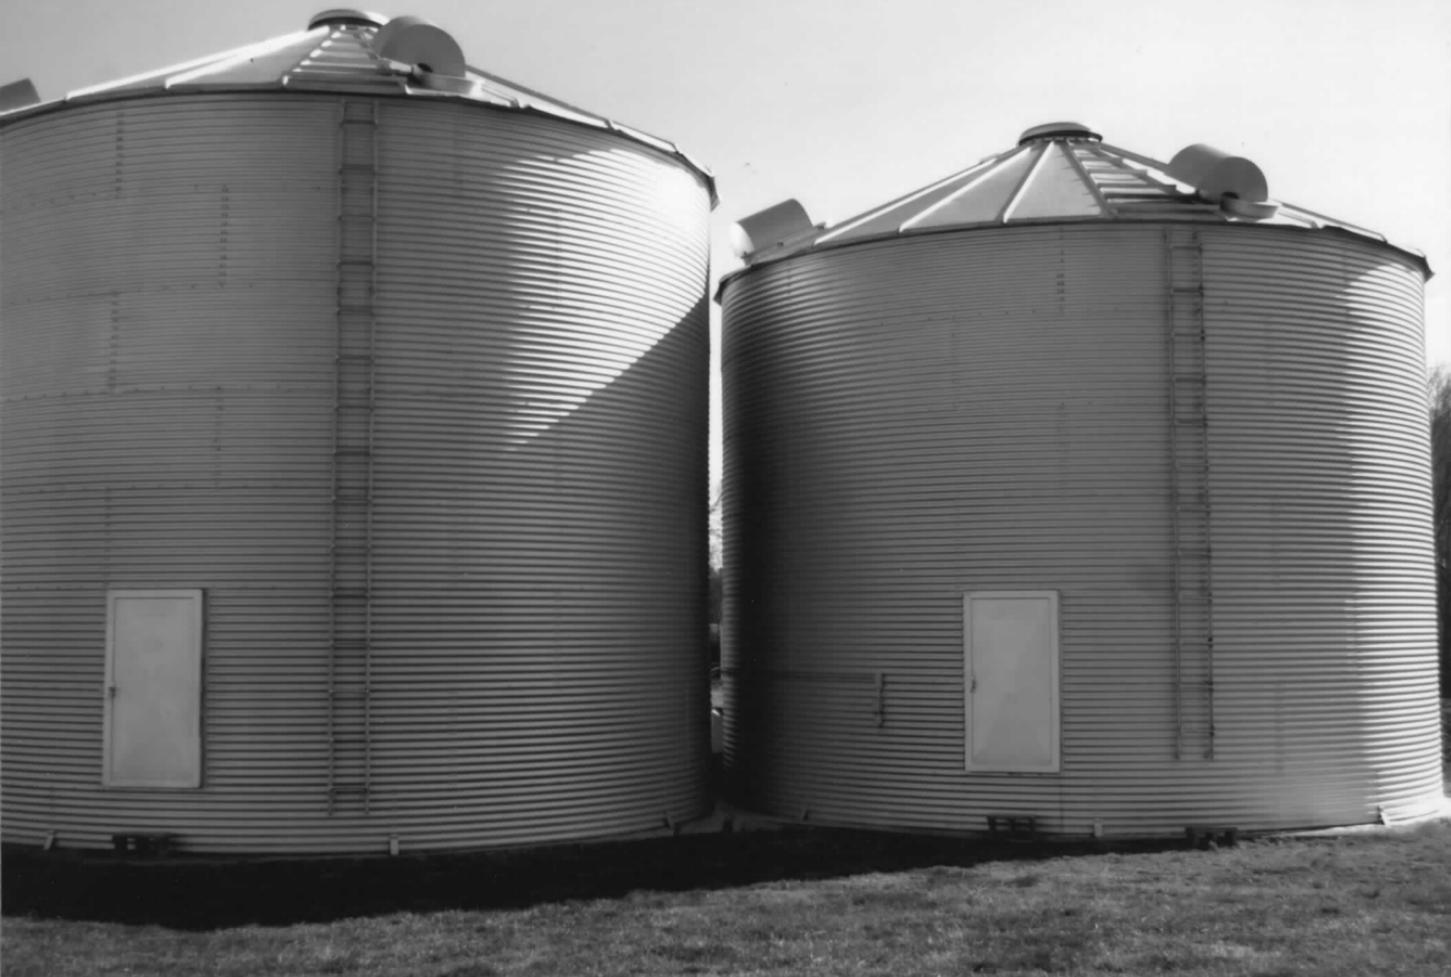
90 of 12

These two, prefabricated, corrugated metal circular grain bins are used to store dry grain. The largest is formed up from eight rings, while the companion shed is built with seven rings. They measure about 50 ft. and 40 ft. respectively, and have a 30 ft. diameter. Both rest on a poured concrete pad.

GRAIN BINS

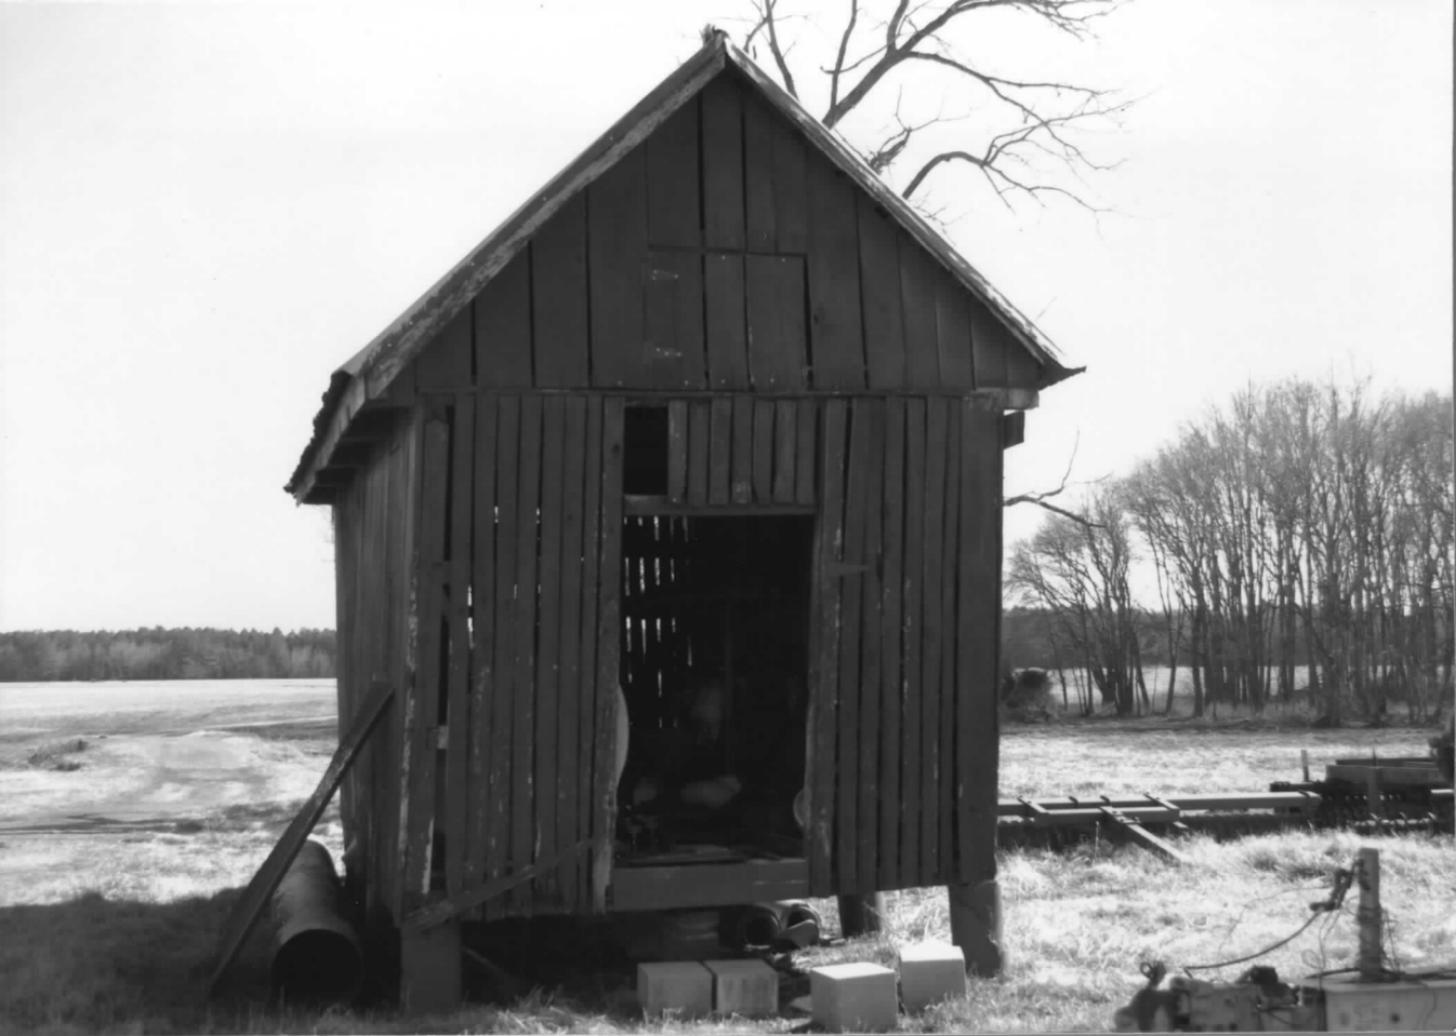
91 of 12

This light-dimensioned frame structure measures 10 ft. x 20 ft. Lower walls are sheathed in 4 in. vertical siding, spaced 1 in. apart, to allow for ventilation. The upper part of the gable is enclosed with 10 in. vertical boards. Structural members and siding are attached with wire nails. Walls rest on a poured concrete pier foundation. Now used for storage, the structure has been neglected for some time; the front door is missing. Despite condition problems, this is a classic example of an early 20th-century Delmarva corn crib. This type of small obsolete structure is rapidly disappearing from the landscape.

CORN CRIB

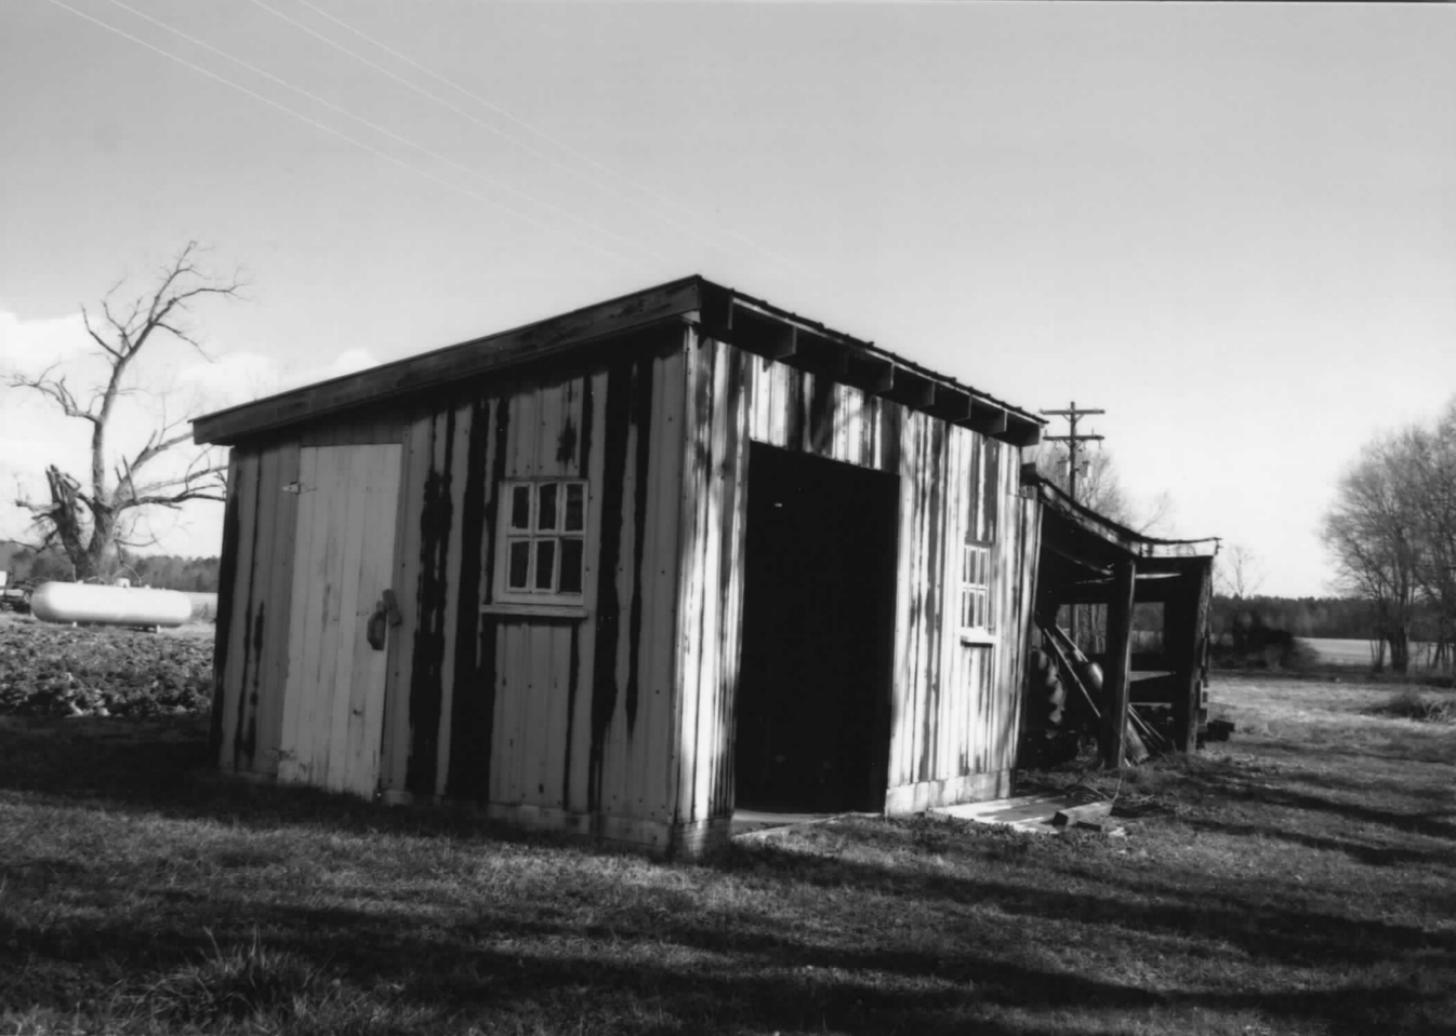
12 OF 12

This two-part, shed-roofed, frame structure measures 15 ft. x 40 ft. The west section is partially enclosed in rusted metal siding. Two recycled fixed-sash windows are present. A pedestrian door is located in the west side wall. The floor is dirt and the wooden foundation rests directly on the ground. The interior indicates the building was once used as a stable. The nearly collapsed and older east section is formed up from utility poles. The horizontal wooden siding has mostly fallen off. The front (south) wall has been opened up to use for storage. The windows and wire suggest this section was previously used as a poultry house.

STABLE / Poultry House
