Maryland Inventory of Historic Properties number: HA-1873

Name: Nova Scotia Rd over James Run

Maryland Historic Highway Bridges  
Bridge Type Metal Girder  
Map B-14 Aberdeen  
County Harford  
Bridge # and name H 11/Nova Scotia  
Road over James Run  
Maryland Historic Highway Bridges

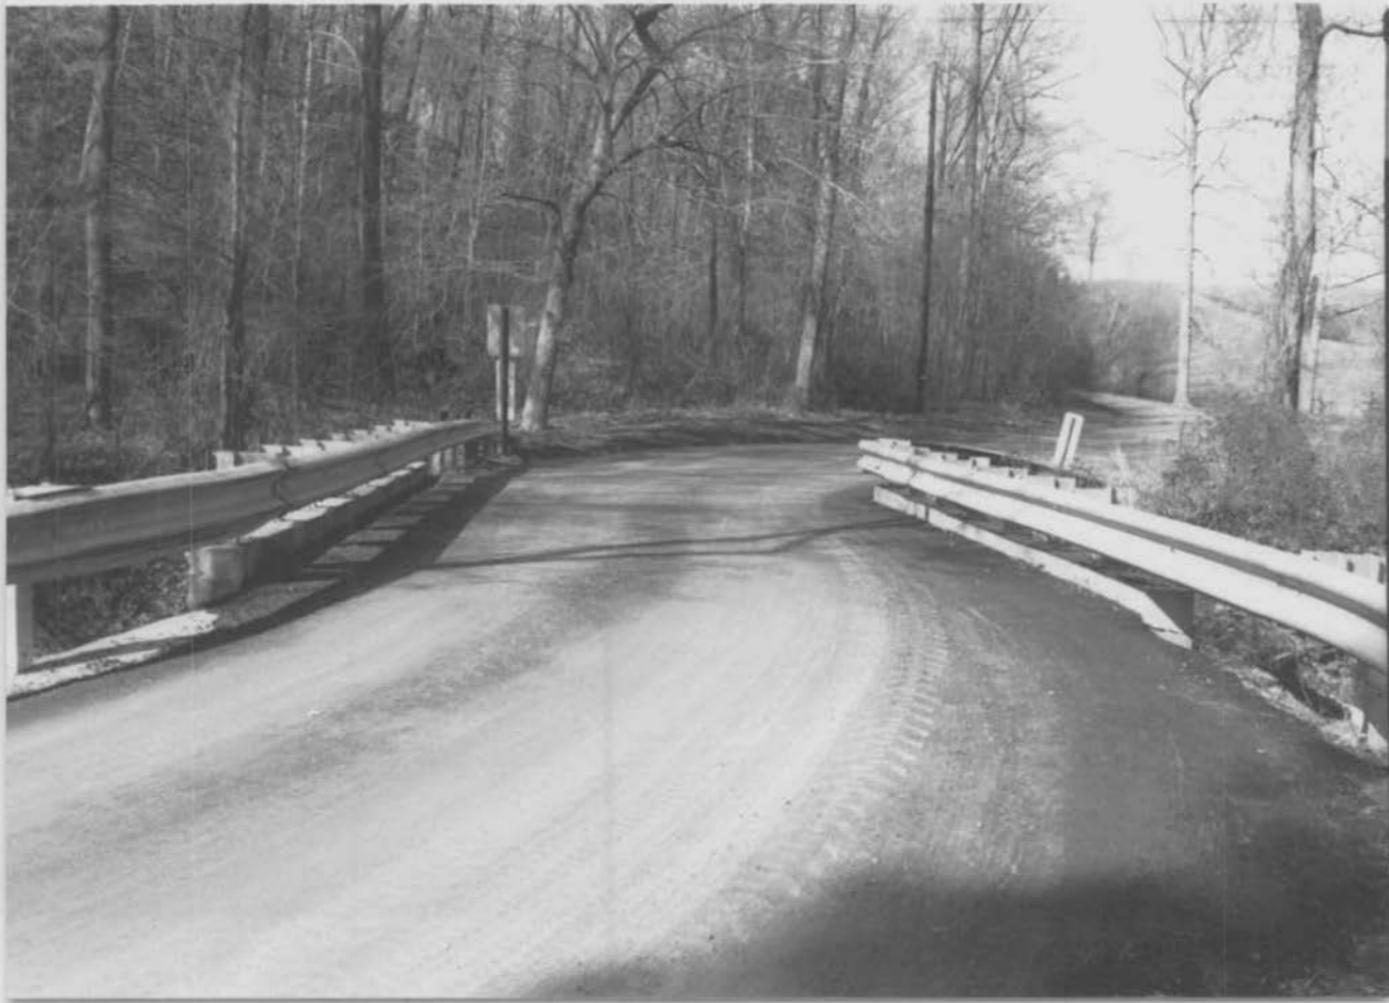
1/4

- BRIDGE NO. 111 OVER JAMES RUN
- VIEW LOOKING NORTH ON  
NOVIA SCOTIA RD

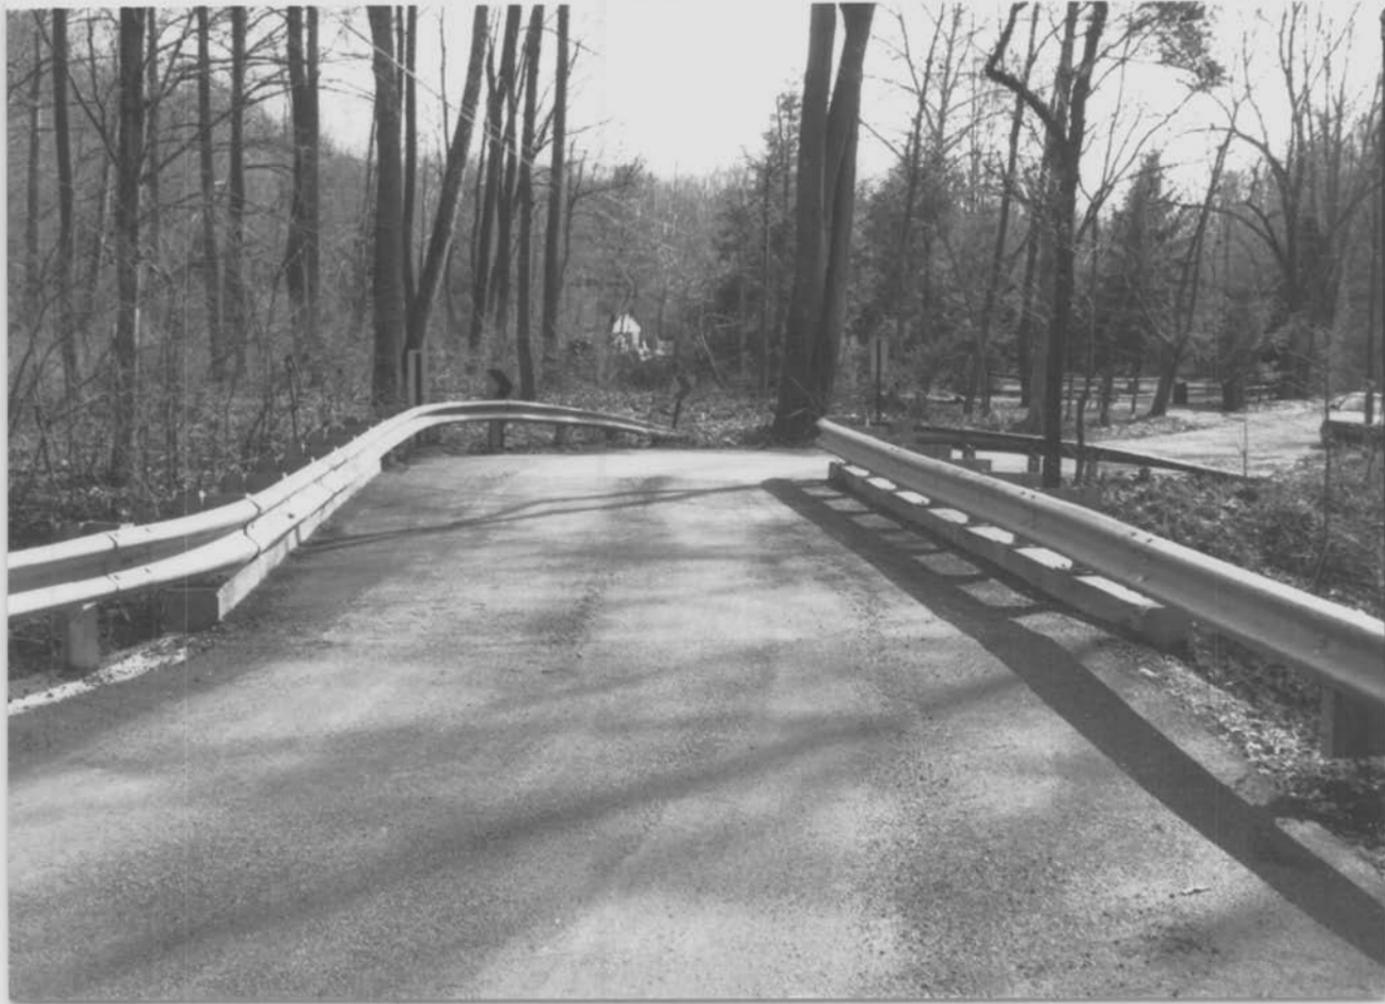
2/4

- BRIDGE NO. 111 OVER JAMES RUN
- VIEW LOOKING SOUTH ON  
NOVIA SCOTIA RD

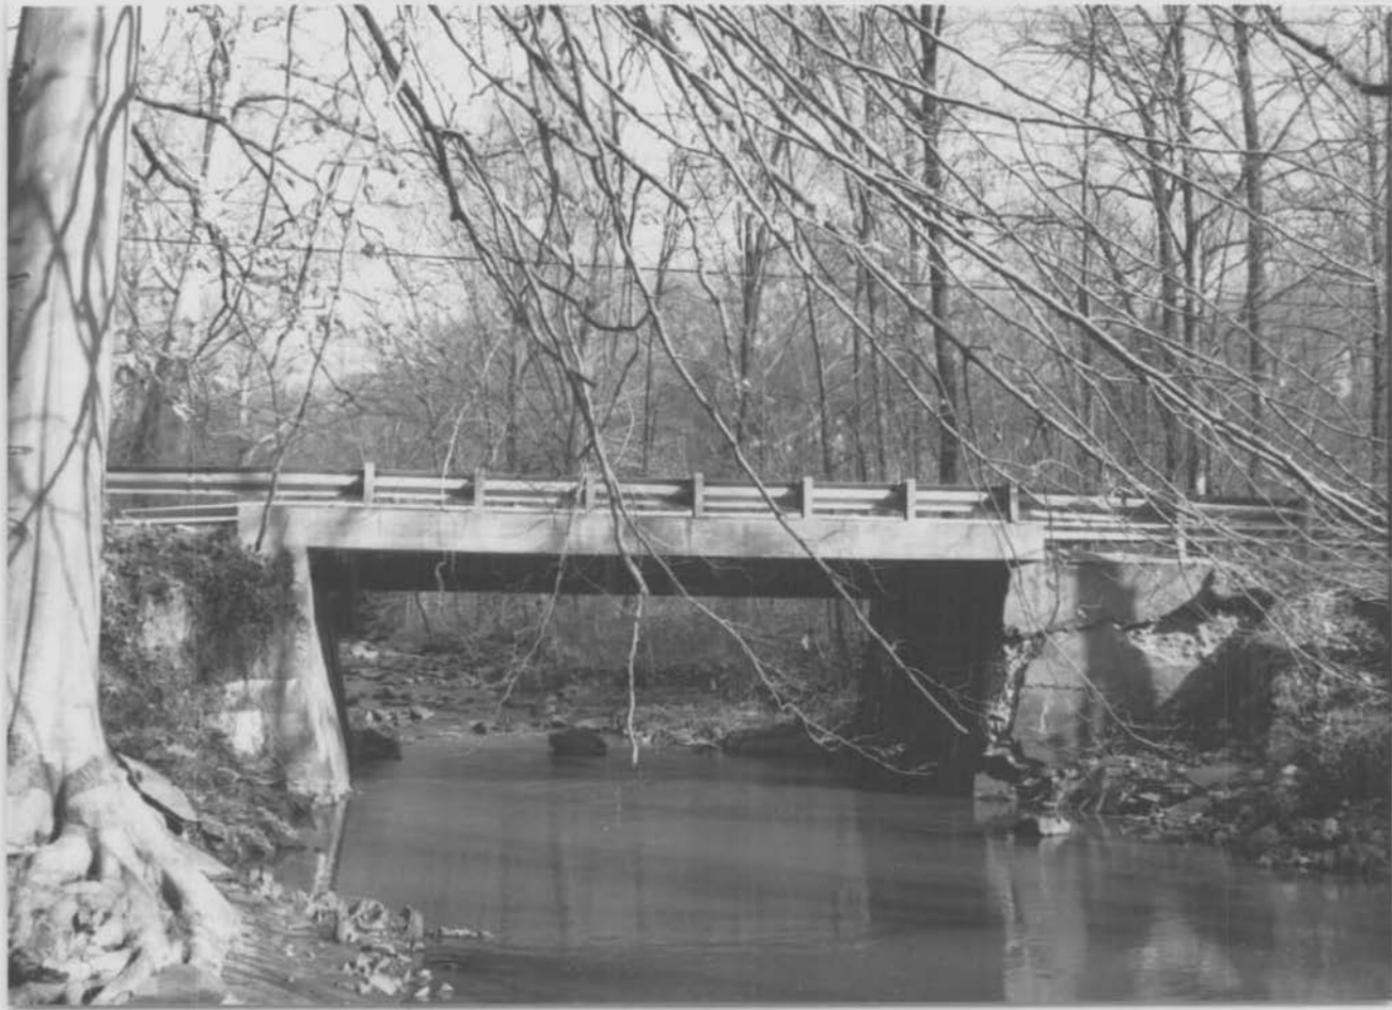
3/4

- BRIDGE NO. H11 OVER JAMES RUN
- VIEW LOOKING EAST

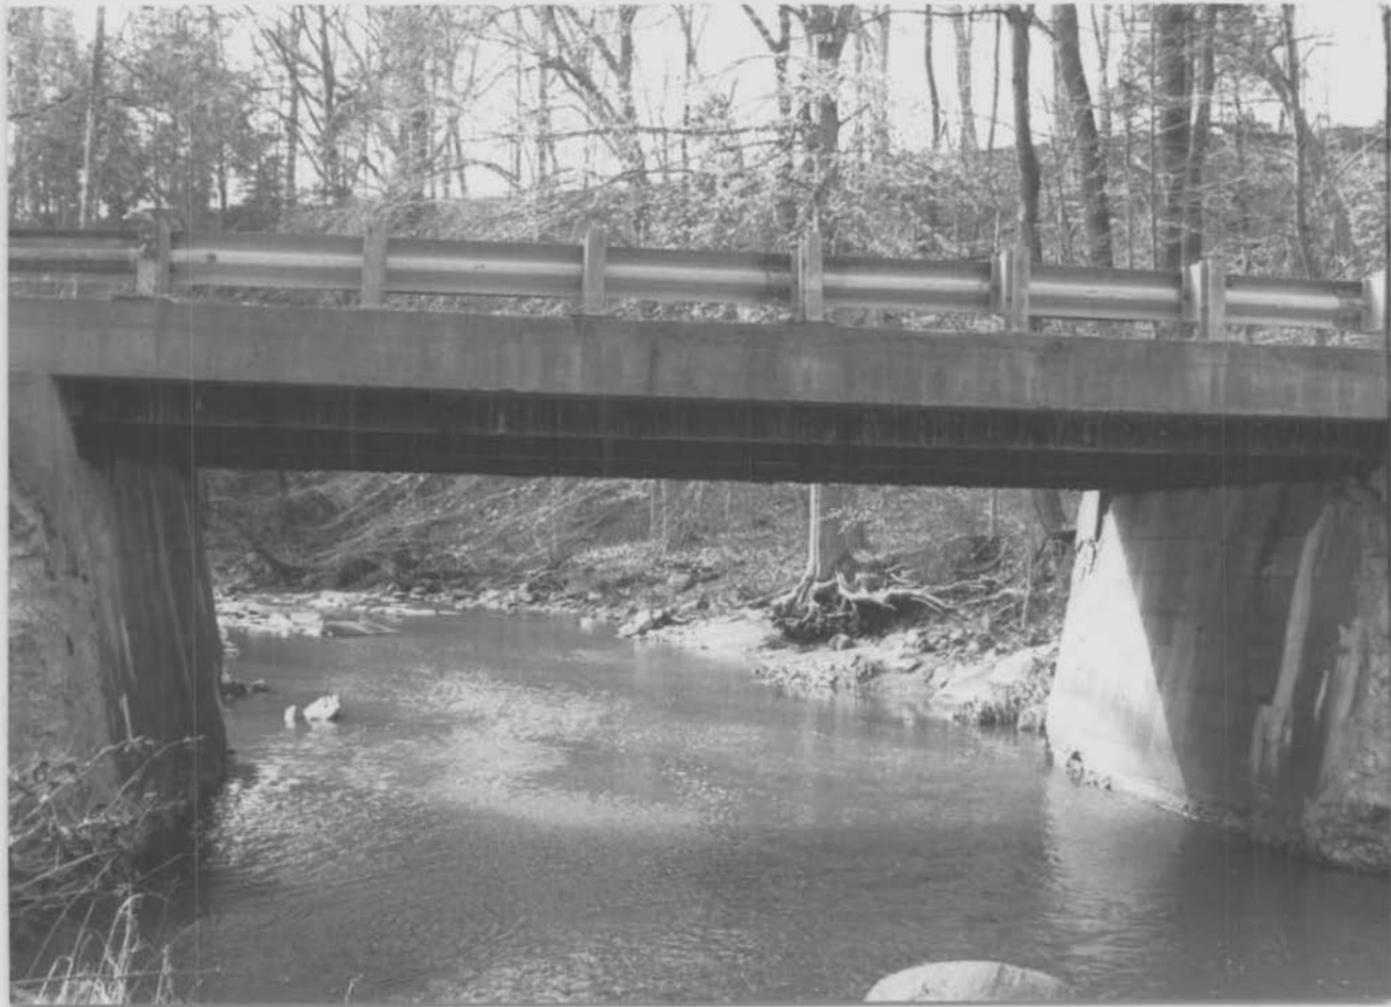
4/4

- BRIDGE NO. 111 OVER JAMES RUN
- VIEW LOOKING WEST
