Maryland Historical Trust

Maryland Inventory of Historic Properties number: HO-670

Name: SANDY RD. OVER BR. OF MIDDLE PATENT

Describe Setting: Bridge HO108 carries Sanner Road over a branch of the Middle Patuxent River in Howard County, Maryland. Sanner Road runs in a generally north-south direction at this location; the branch of the Middle Patuxent runs generally east-west. The bridge is located in a semi-wooded rural area. There is one twentieth century domestic structure in view from the bridge.

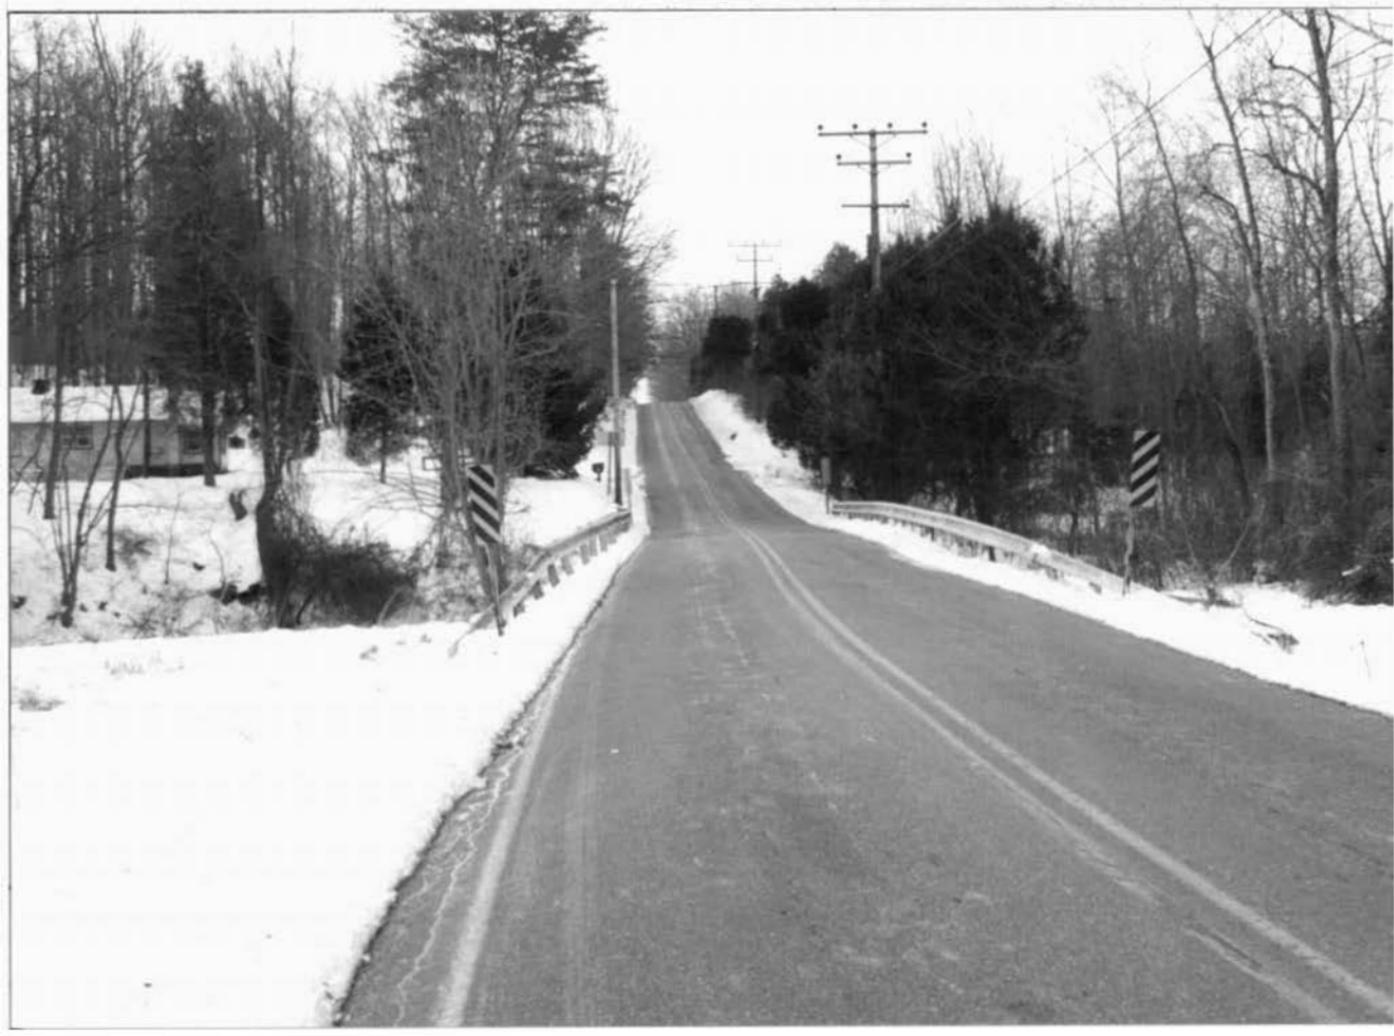
Number 1 of 4
B of 1/2

Description NORTH APPROACH LOOKING SOUTH

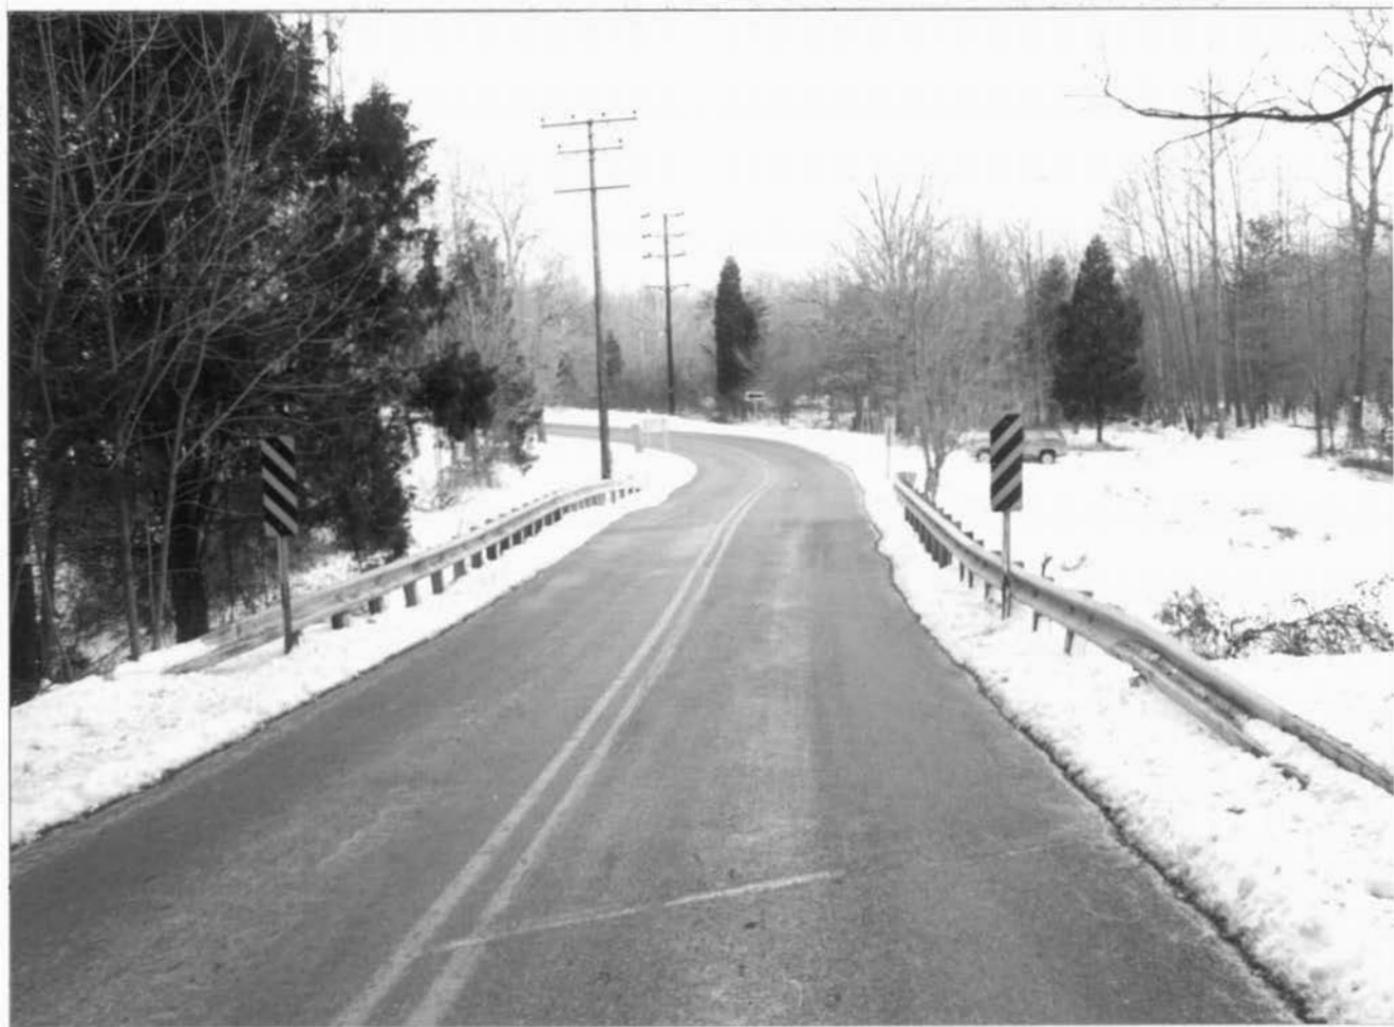
Number 2 of 4
~~1~~ ~~3~~

Description SOUTH APPROACH LOOKING NORTH

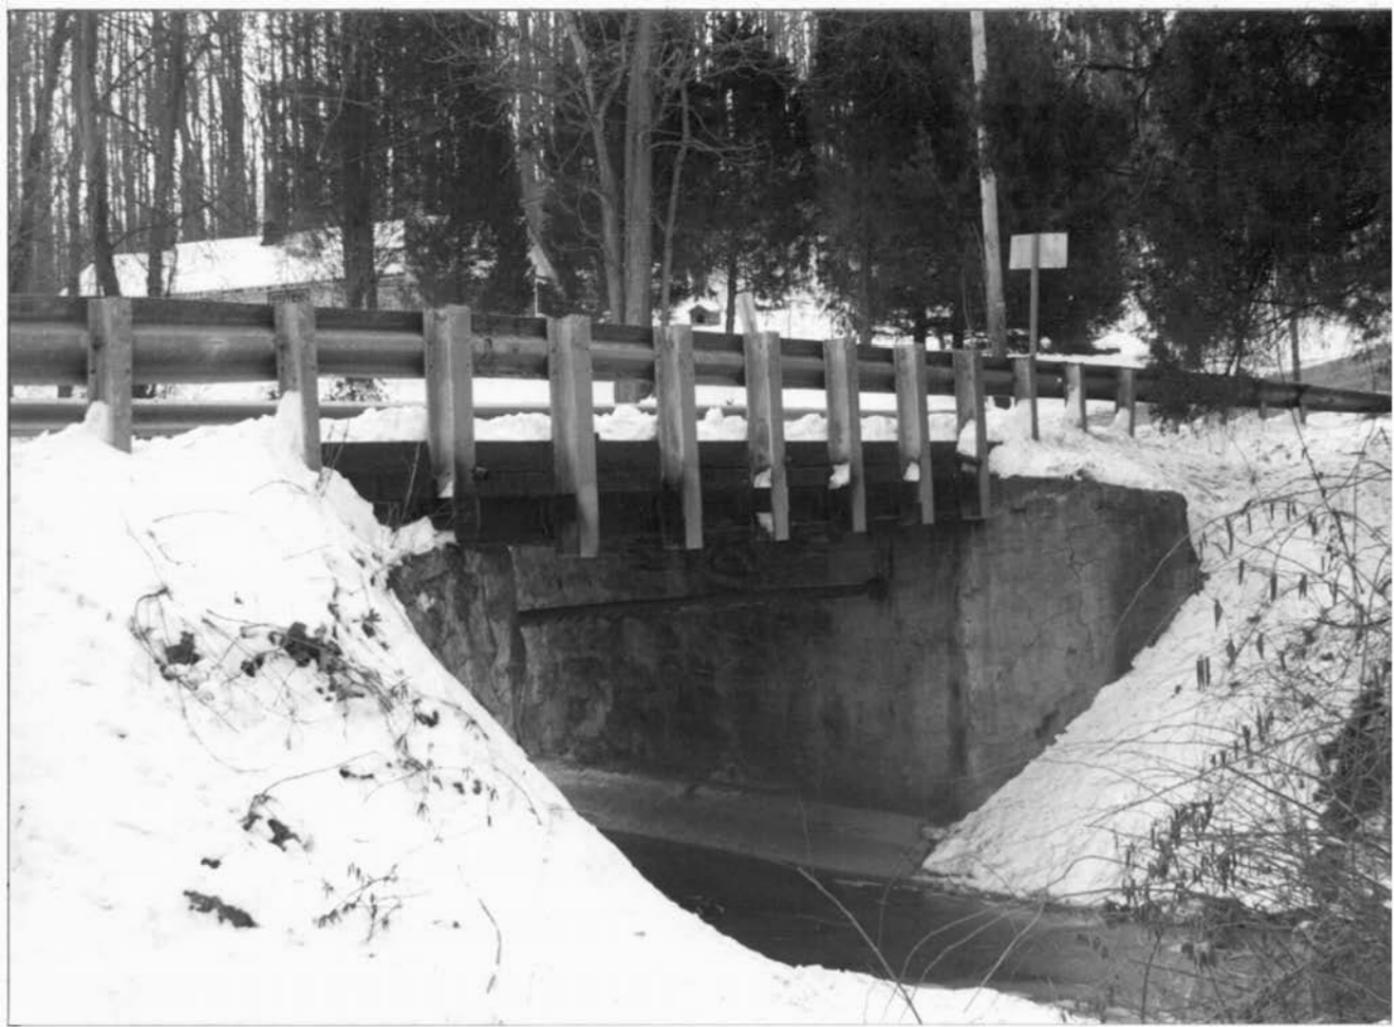
Number 3 / 4 of 32

Description WEST ELEVATION LOOKING

SOUTHEAST

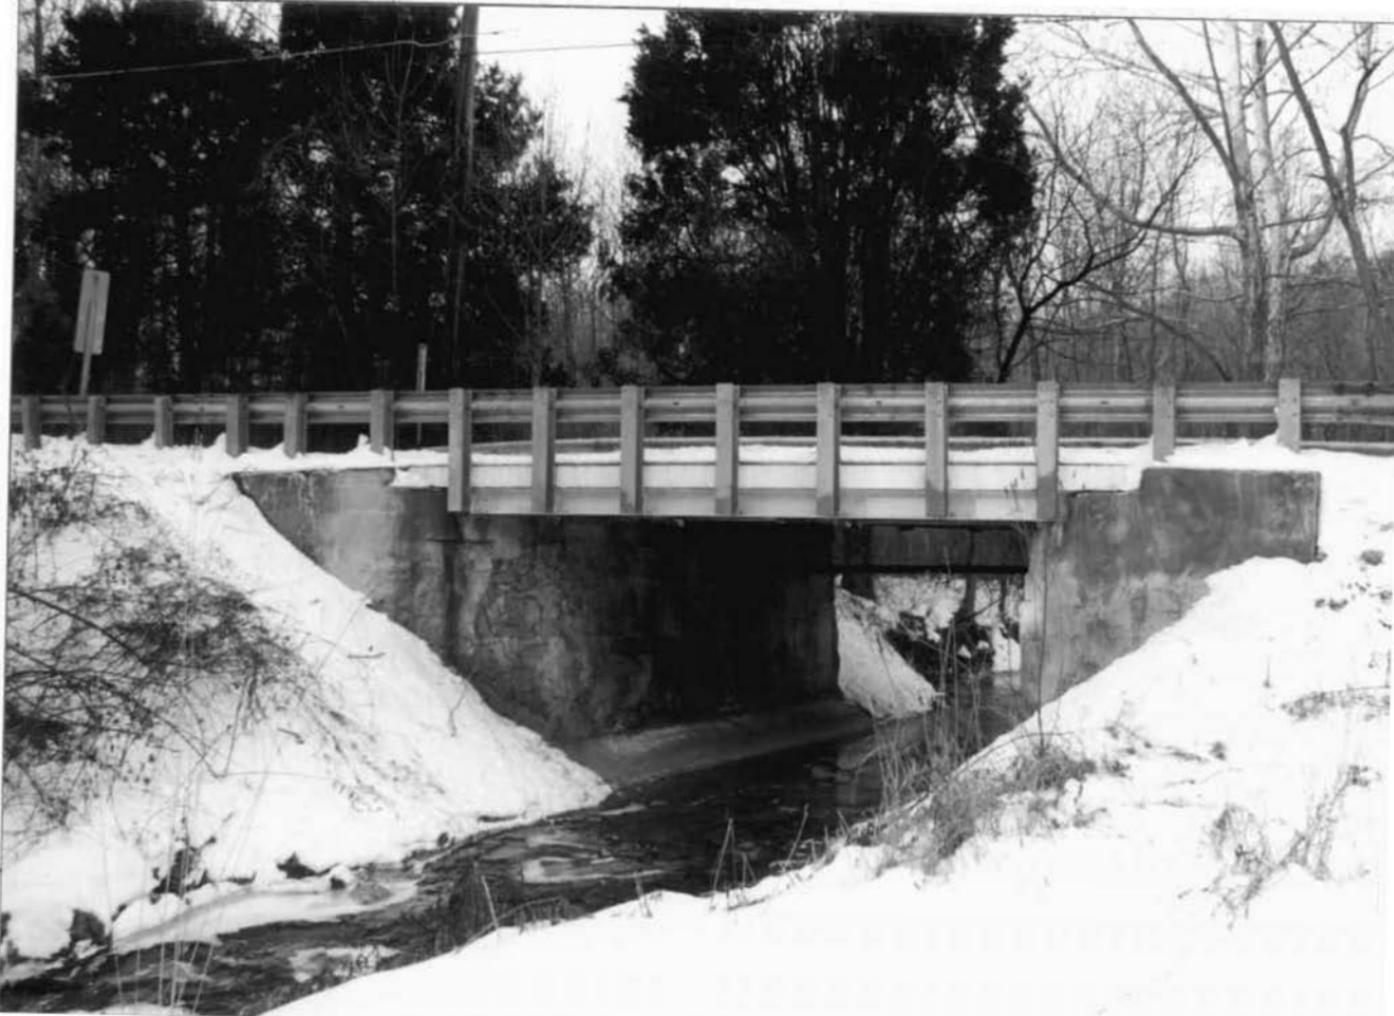
Number ~~10~~ ⁴ of ⁴ 32

Description EAST ELEVATION LOOKING

WEST
