McDANOLDS FARM
Still Pond, Maryland
(late 18th century)

K-217

INVENTORY FORM FOR STATE HISTORIC SITES SURVEY

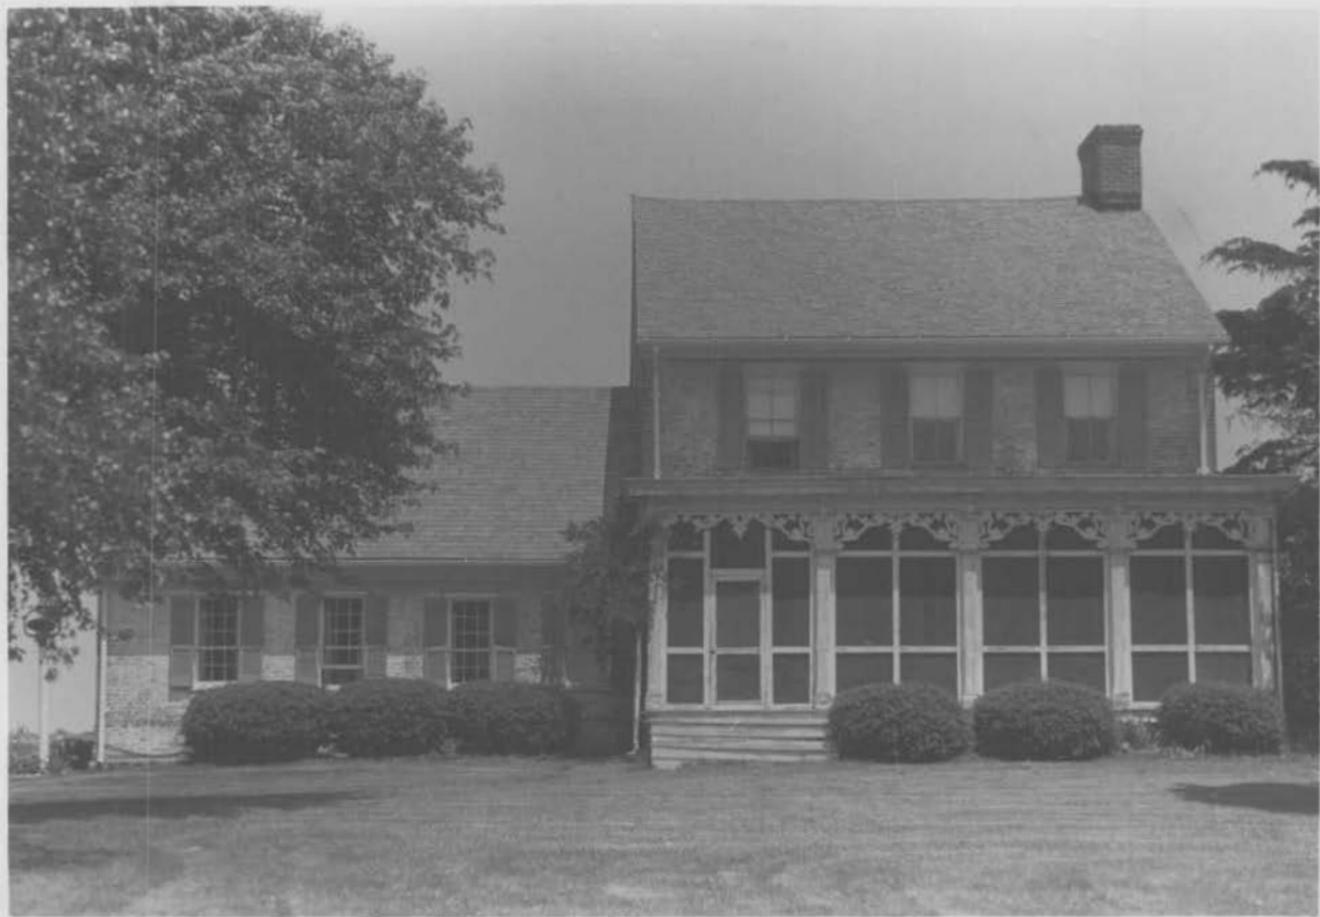
K-217

McDonalds Farm

view to North

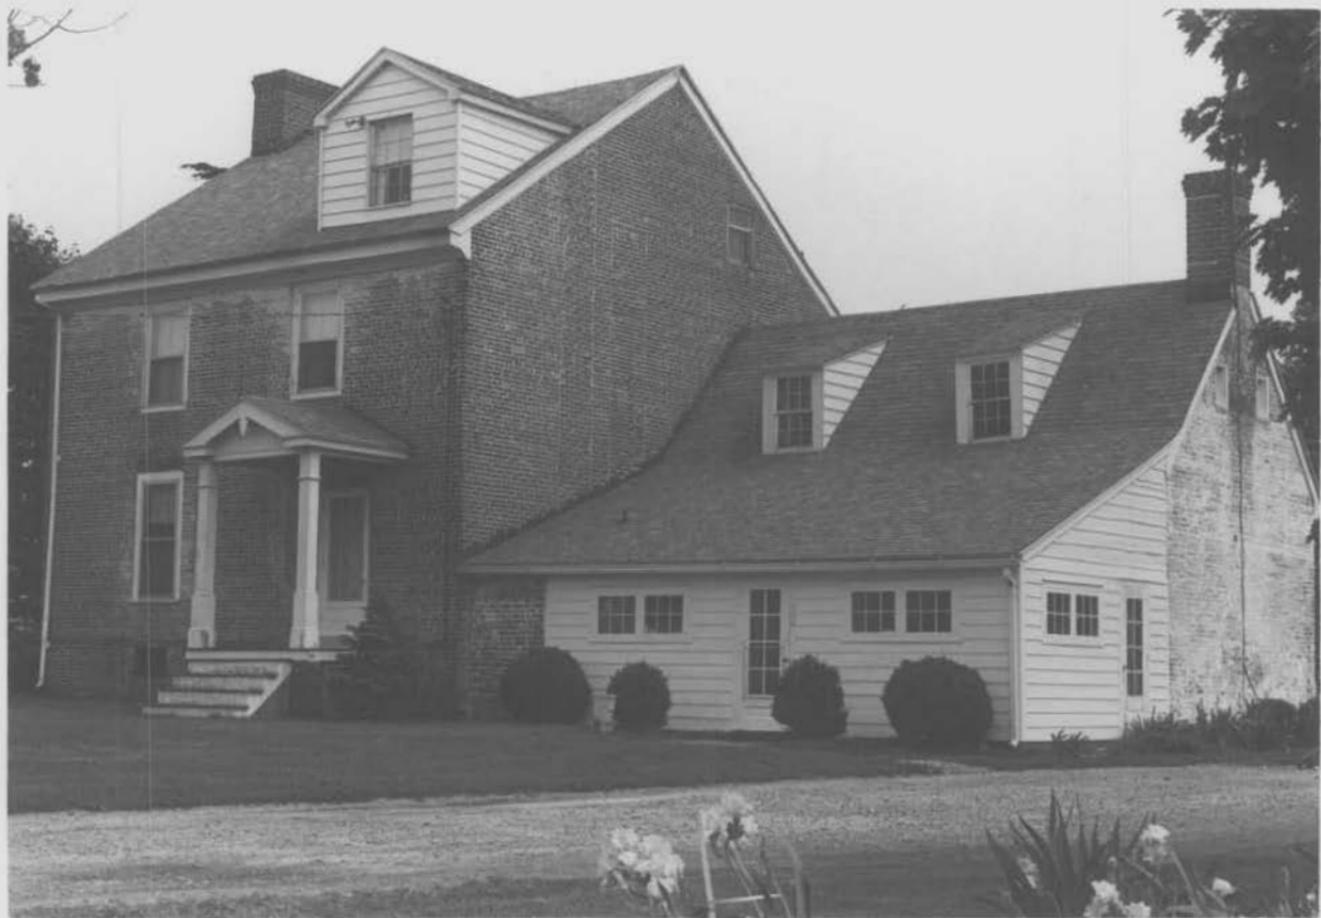
K-217

Mc Daniels Farm
View to Southeast
