**MARYLAND HISTORICAL TRUST
DETERMINATION OF ELIGIBILITY FORM**

Property Name: SHA Bridge No. 1606100, MD 382 over Charles Branch Inventory Number: PG:82B-39
 Address: Croom Road (MD 382) Historic district: yes no
 City: Croom Zip Code: 20772 County: Prince Georges
 USGS Quadrangle(s): Upper Marlboro
 Property Owner: State Highway Administration Tax Account ID Number: _____
 Tax Map Parcel Number(s): _____ Tax Map Number: _____
 Project: Reevaluation of Highway Bridges Statewide Agency: FHWA/MD SHA
 Agency Prepared By: KCI Technologies, Inc.
 Preparer's Name: Kim Sebestyen Date Prepared: 10/16/2009

MIHP No. PG;82B-39
SHA Bridge No. 1606100
MD 382 over Charles Branch
Prince George's County, Maryland

Photograph Log

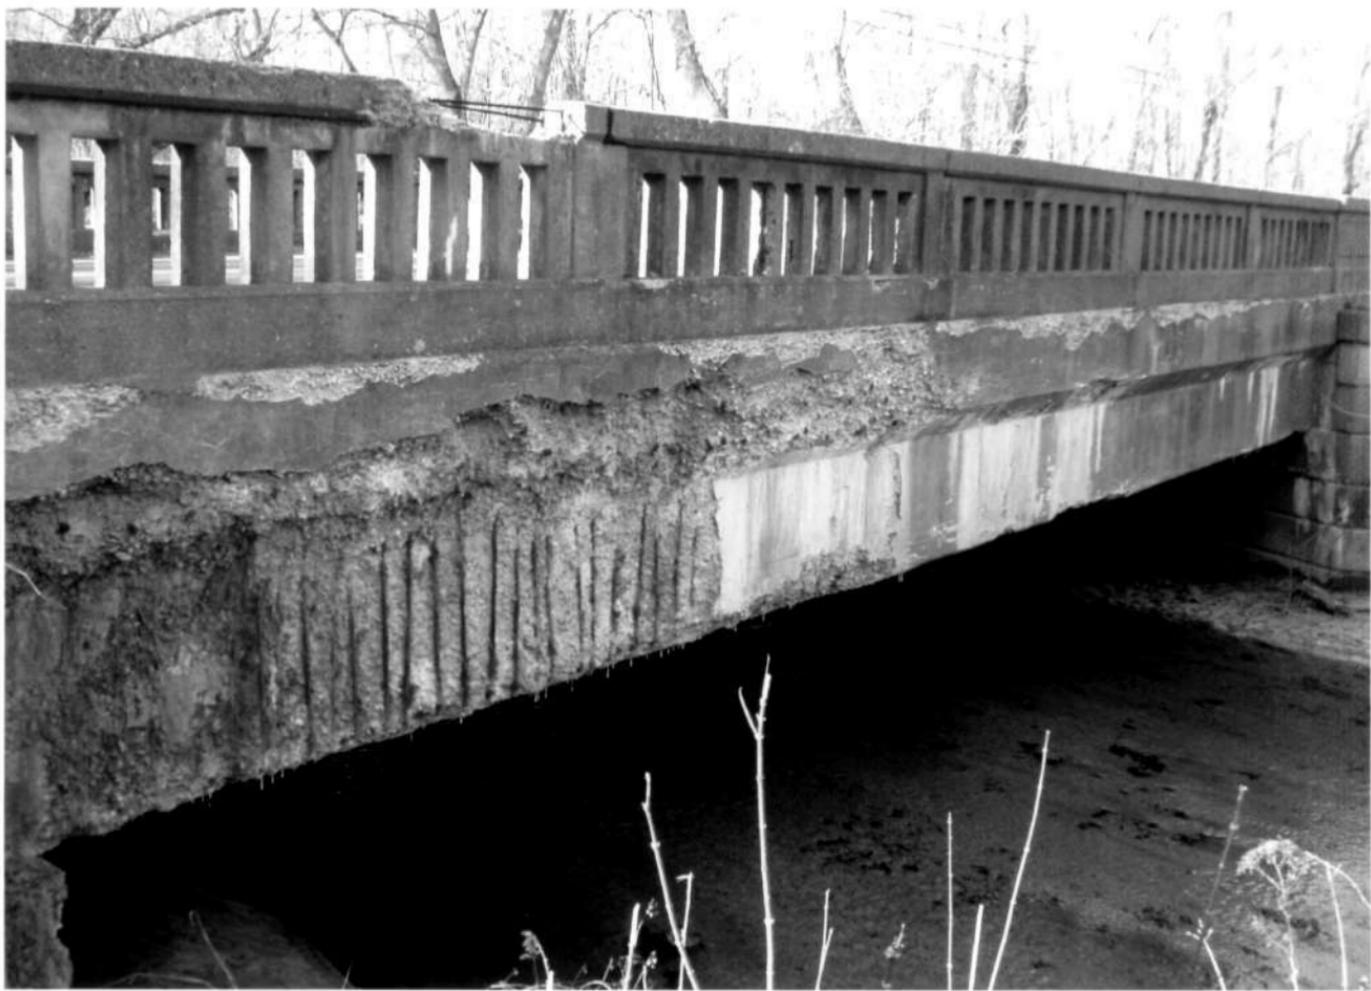
1/6

Determination on No elev., facing SW

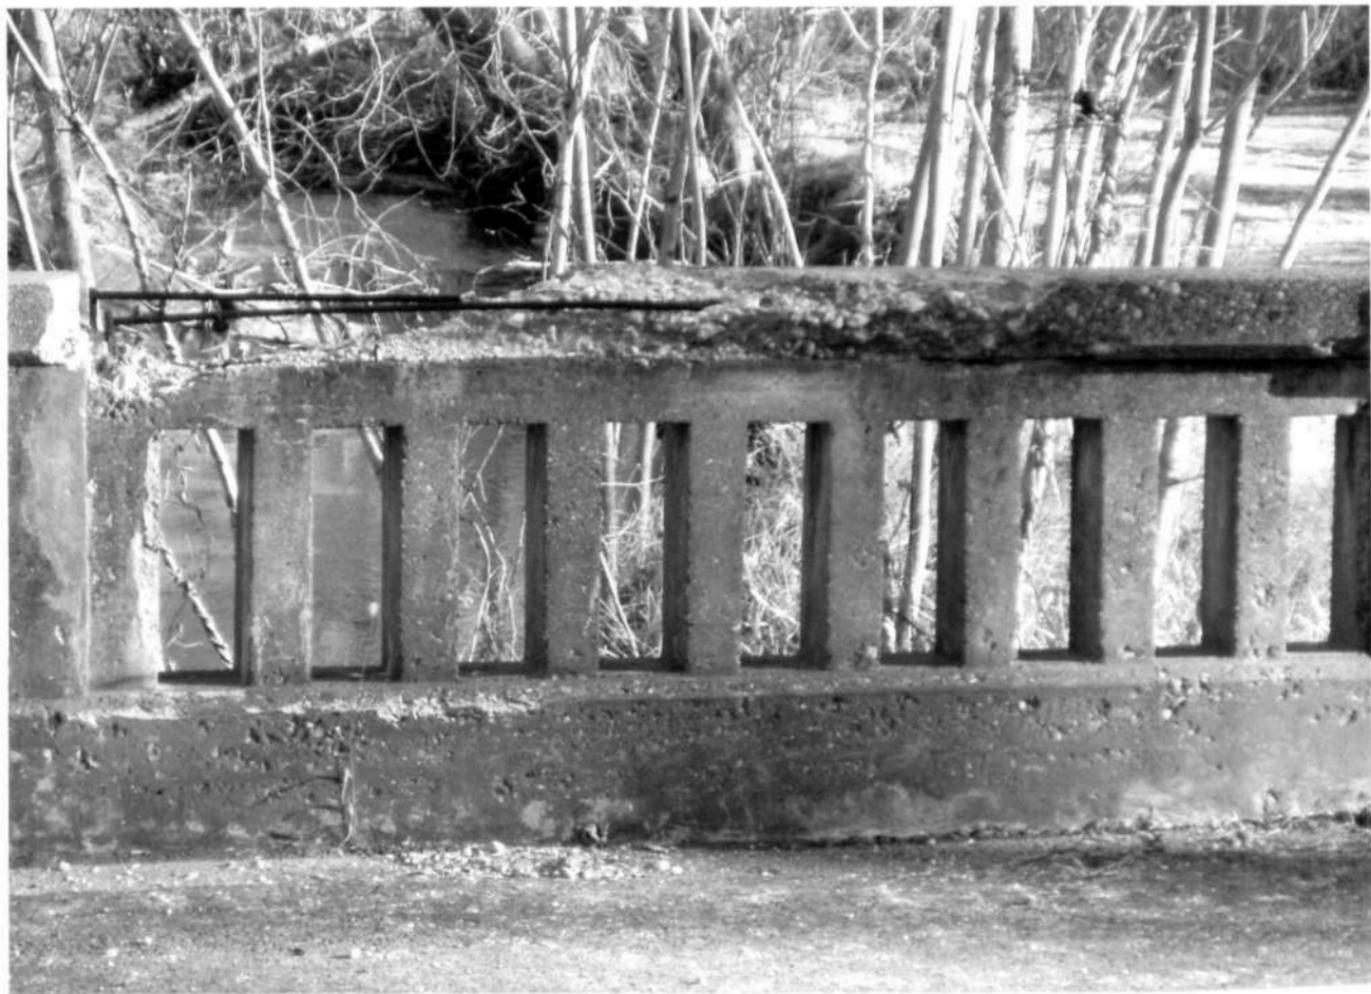
4/6

N. wall railing, facing N.

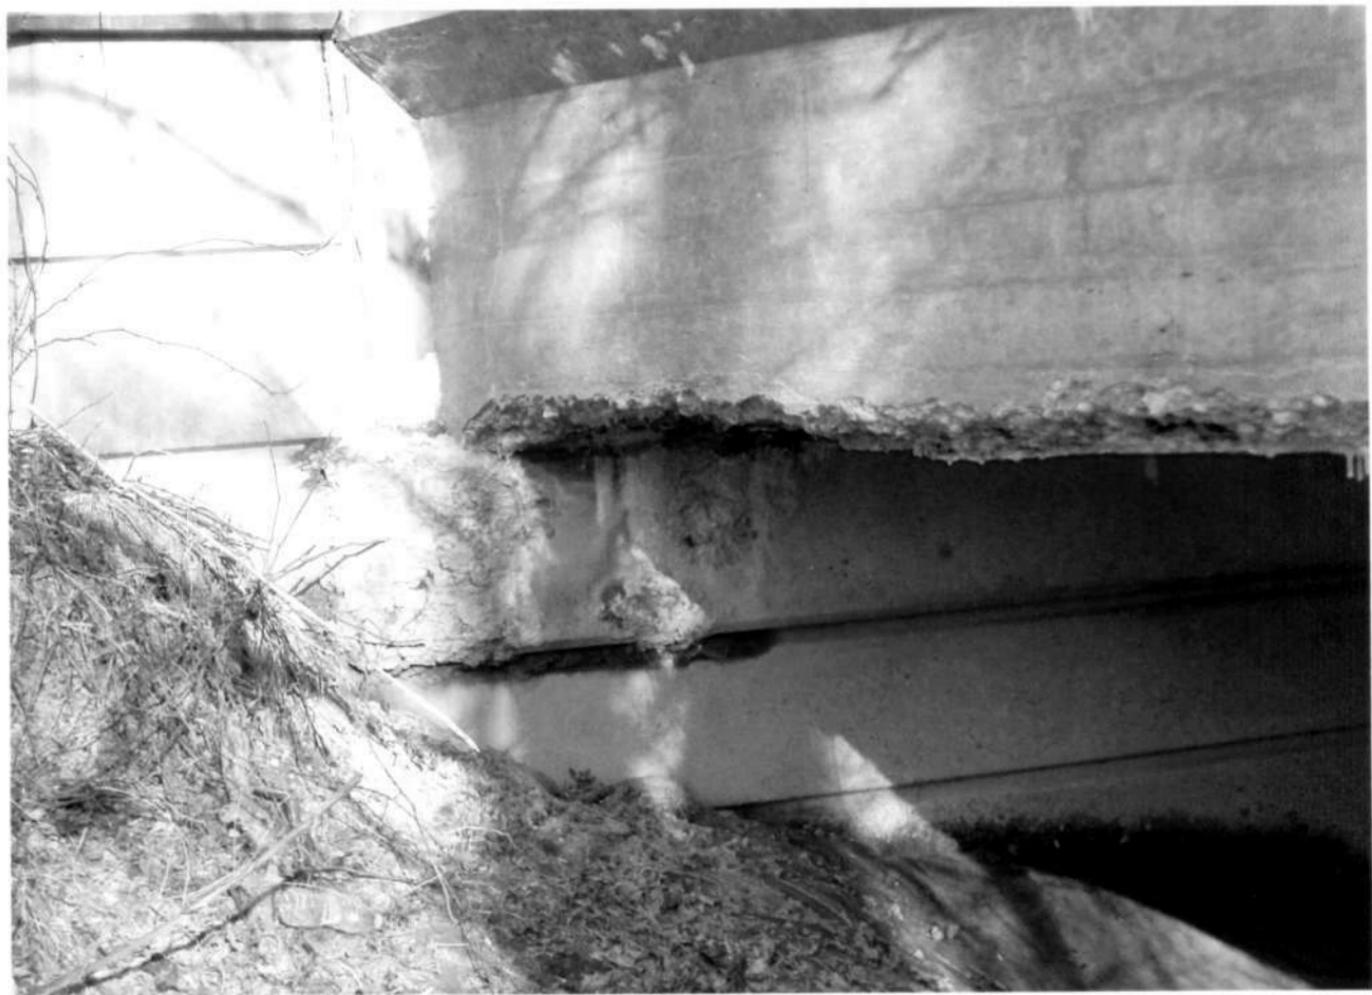
5/6

The substructure was given a rating of 6 in the 2008 BIR; this rating has remained the same since 1996. The 2009 field survey noted that both abutment walls are in generally good condition with minor cracking, efflorescence, and some scour with visible aggregate at the waterline. Three wingwalls have efflorescence at the junction with the abutments and the northeast wingwall has large buildup of minerals or efflorescence from the decaying concrete girder above. The southeast wingwall has minor cracking, efflorescence, and scaling.

W. abutment + scaled girder, facing NW

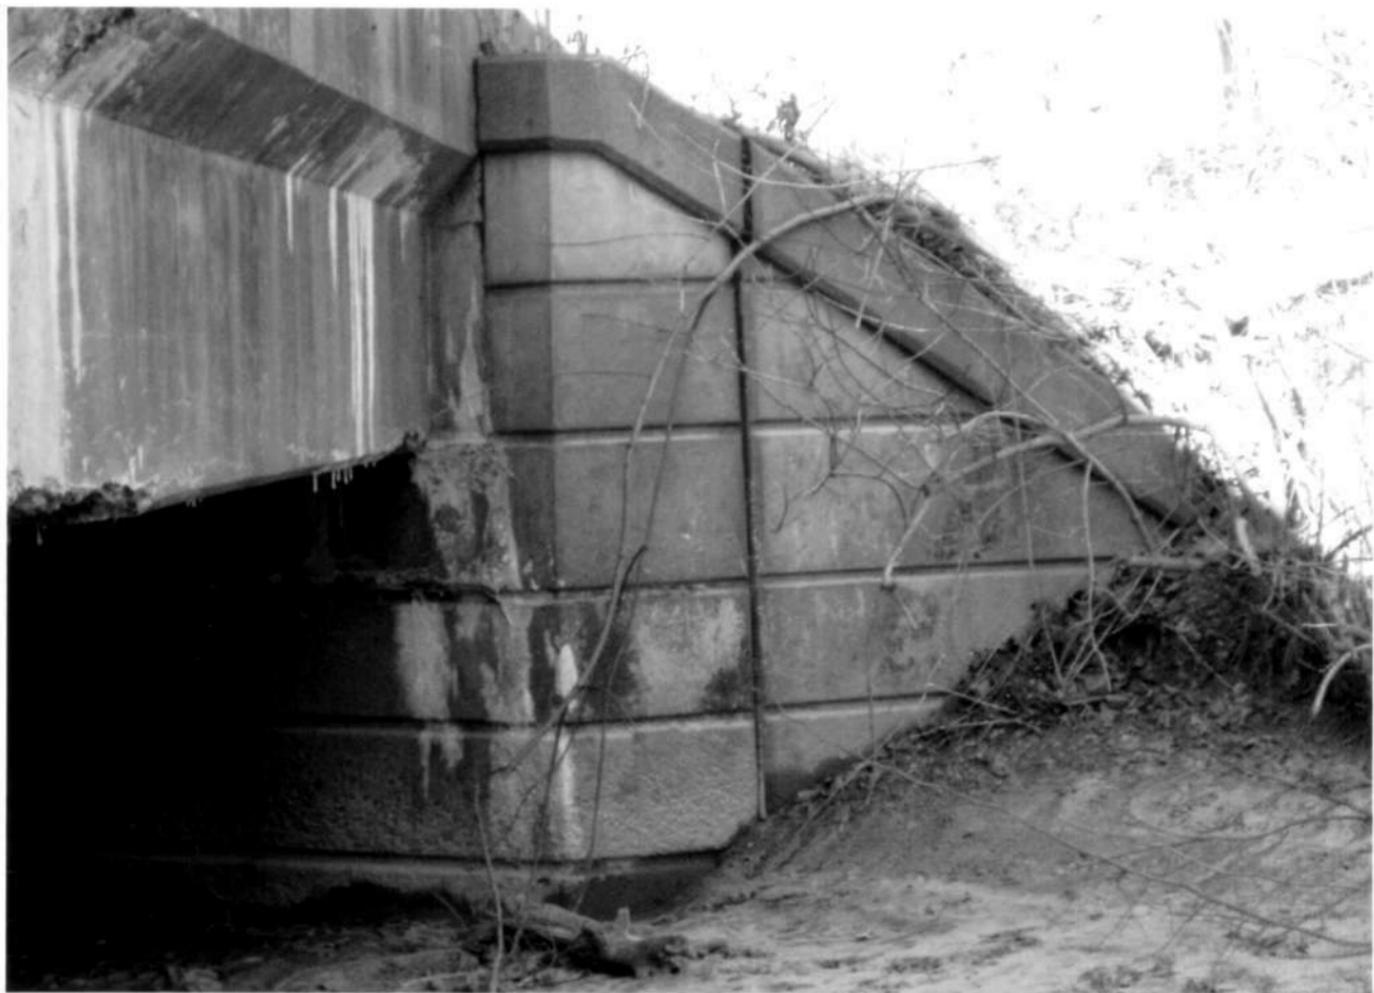
6/6

NW abutment ← wing wall, facing SW
