STMA-201162
UNDERWOOD
Charlotte Hall
Private

"UNDERWOOD"

A Restoration and Modernization
By John A. Chappellear

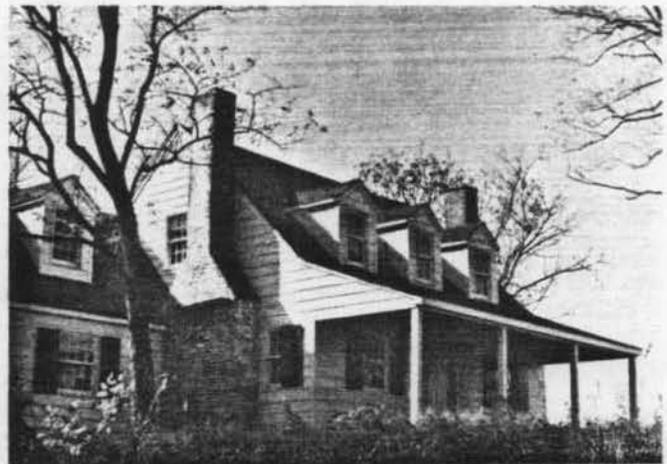
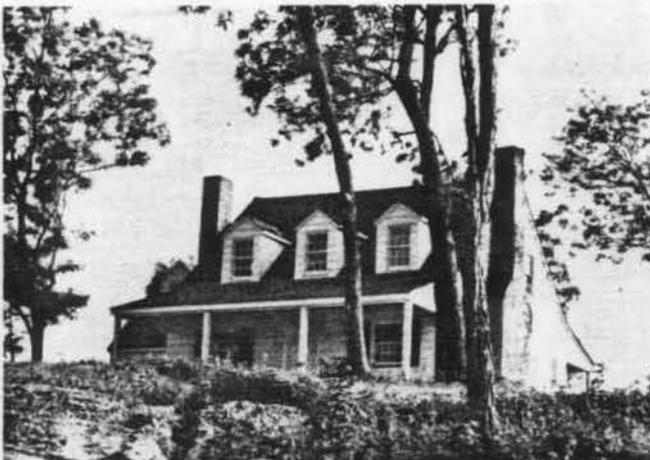
AFTER RESTORATION

The porches front and rear were replaced using new material but following the original pattern. The kitchen was replaced using new material. It was necessary to enlarge the kitchen slightly in order that space might be provided for a first floor bathroom and furnace room. A third chimney was added to accommodate the modern furnace. This was laid with old brick and in the position indicated by the outline of the sills as having been the location of one of the missing chimneys. As now constructed this chimney has no fireplace although one could be added later.

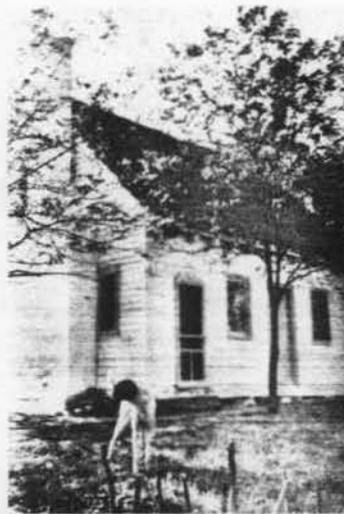
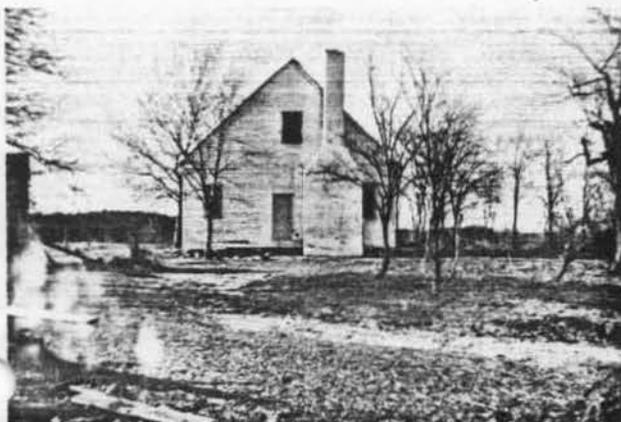
BEFORE RESTORATION

"Underwood" at one time appeared to be, and in many respects was, in an advanced stage of dilapidation. Its main roof was in fair condition, but the porches and kitchen had partially collapsed. They were removed and discarded as beyond salvage. Much of the woodwork exposed to the elements was also in bad repair, however, the basic structure was for the most part sound.

The softness of the oyster shell mortar over a long period of time had allowed the stone foundation to crumble and the sills to settle. The first step was to level the outside sills and rebuild the foundations. The interior sills were then leveled and new boxing of stone and concrete installed to contain the hearths of the two existing fireplaces. Bracing members were added to strengthen and stabilize the first floor joists. New sub-flooring was installed and the hearths were relaid using the original brick. Minor repairs were made to the fireplaces themselves and dampers were installed in the chimneys to prevent the loss of heat. The dampers were placed well up in the chimneys and so arranged that no part of their operating mechanisms are visible.

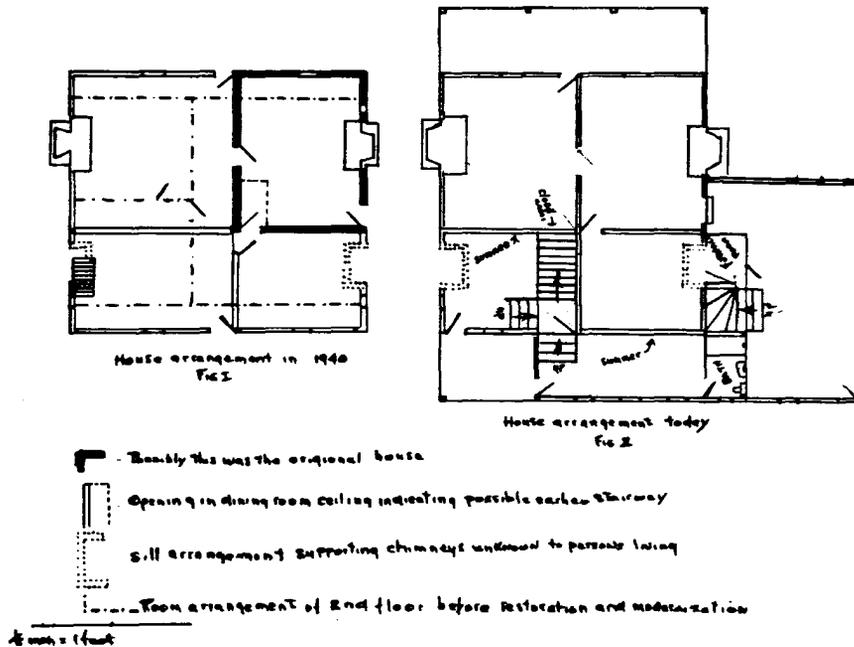
Fig III

The figures below reflect the original arrangement and the reconstructed interior.

Broken line indicates possible original house

was necessary to change the room arrangement on the second floor to accommodate this new bath and to provide a more appropriate means of access to the second floor. The ladder stairway was removed and a new stairway provided.
