Maryland Inventory of Historic Properties number: SM-506
Name: MD 244 over Poplar Hill Creek

MARYLAND INVENTORY OF HISTORIC BRIDGES
HISTORIC BRIDGE INVENTORY
MARYLAND STATE HIGHWAY ADMINISTRATION/
MARYLAND HISTORICAL TRUST

SHA Bridge No. 18024 Bridge name MD 244 over Poplar Hill Creek

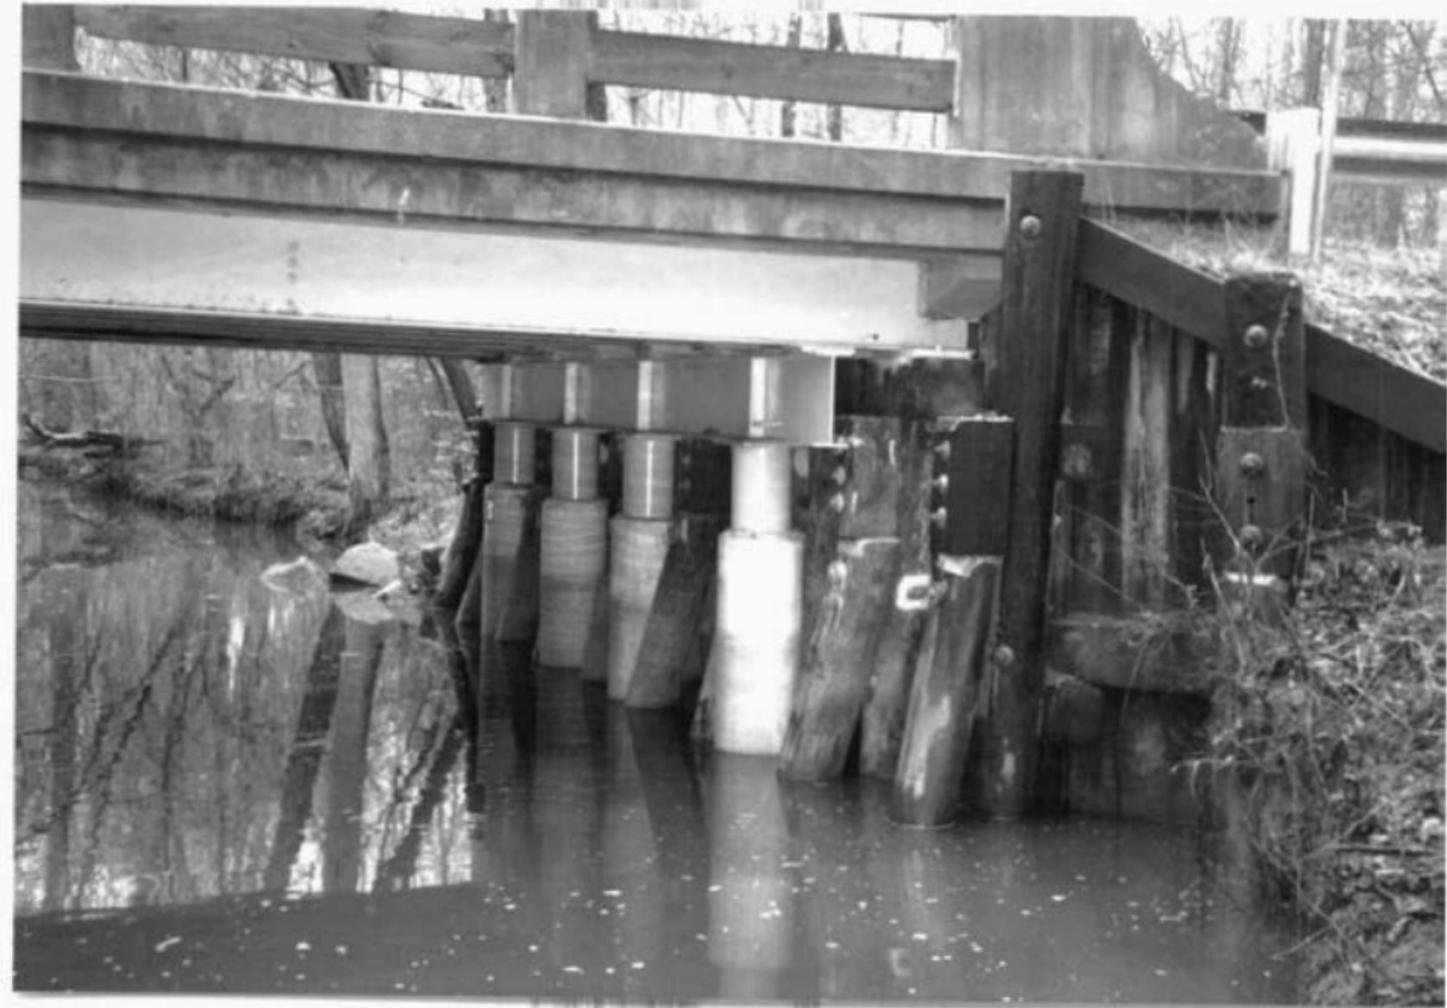
7. Detail of west abutment

According to the 1996 inspection report, this structure was in satisfactory condition. The deck has a new overlay of asphalt with no visible cracks or defects. The girders have light to moderate rusting and spots of efflorescence. The timber abutments have areas of soft wood with cracks and splits. The new piles are supporting the bridge, while the timber abutments are holding the fill for the approach roadways. The timber wing walls are rotting and decaying with soft wood and fungus.
