**MARYLAND HISTORICAL TRUST  
DETERMINATION OF ELIGIBILITY FORM**

Property Name: 19794 Point Lookout Road (Eliff Farm) Inventory Number: SM-745  
 Address: 19794 Point lookout Road Lexington Park (Great Mills) City: vicinity Zip 20653-3114  
 County: Saint Mary's USGS Topographic Map: Saint Mary's City  
 Owner: Robert R. Eliff Jr. et al Is the property being evaluated a district?  yes  
 Tax Parcel Number: 51 Tax Map Number: 14 Tax Account ID Number: 1908009139  
 Project: St. Mary's County Public Schools Agency: \_\_\_\_\_  
 Site visit by MHT Staff:  no  yes Name: \_\_\_\_\_ Date: \_\_\_\_\_  
 Is the property located within a historic district?  yes  no

MARYLAND HISTORICAL TRUST  
NR-ELIBILITY REVIEW FORM

MIHP No: SM-745

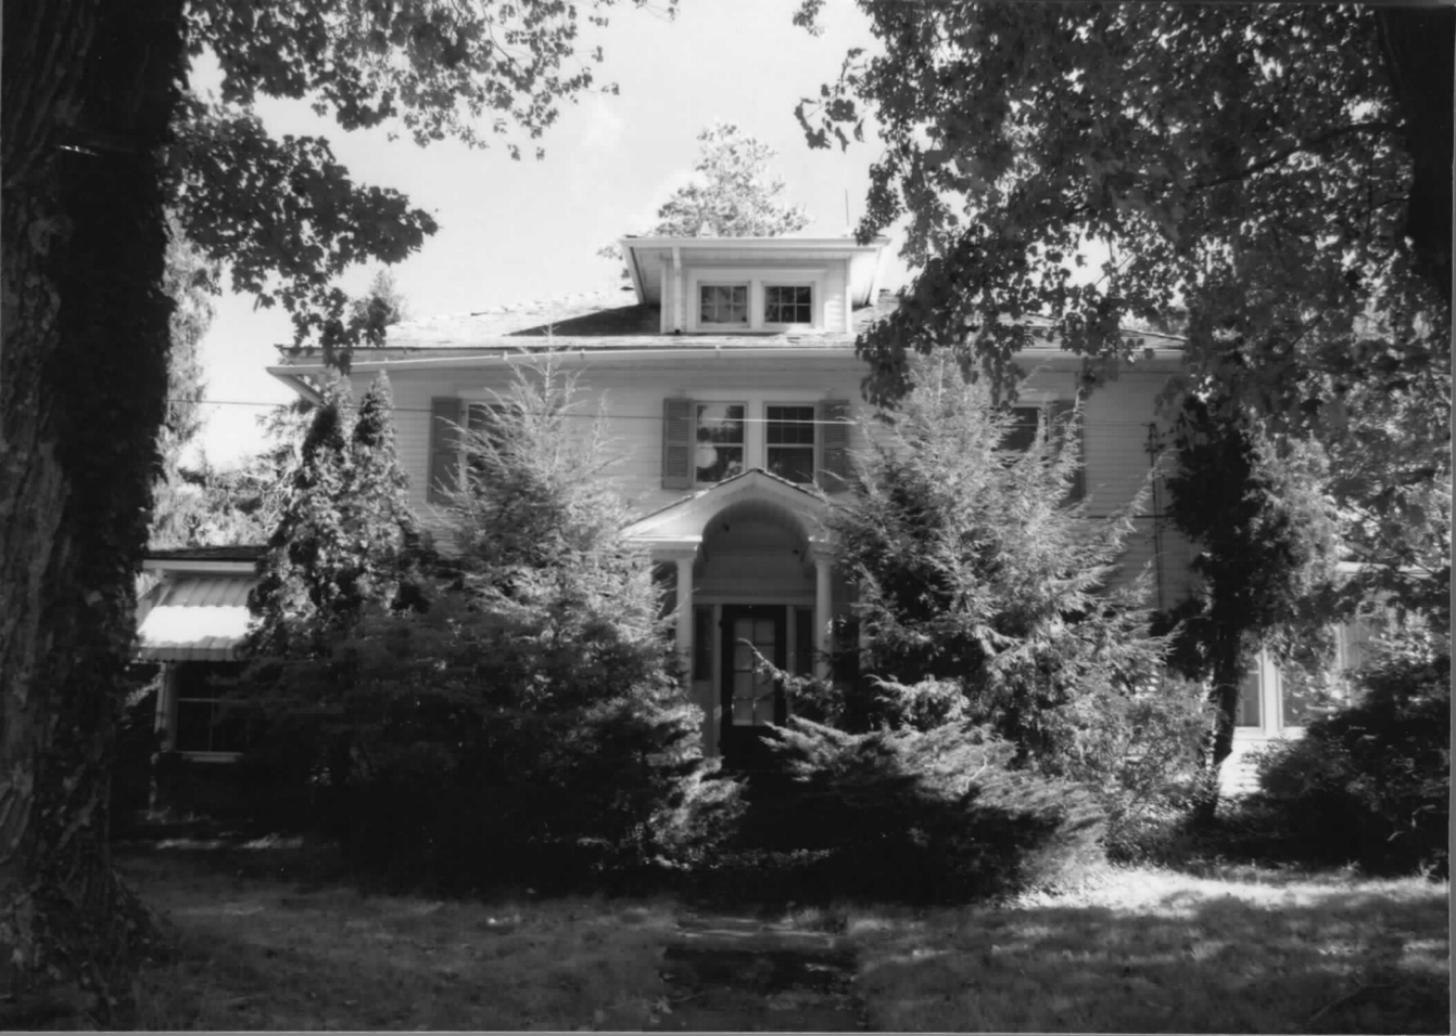
photo 1 of 47

1940 Dwelling, Camera facing North

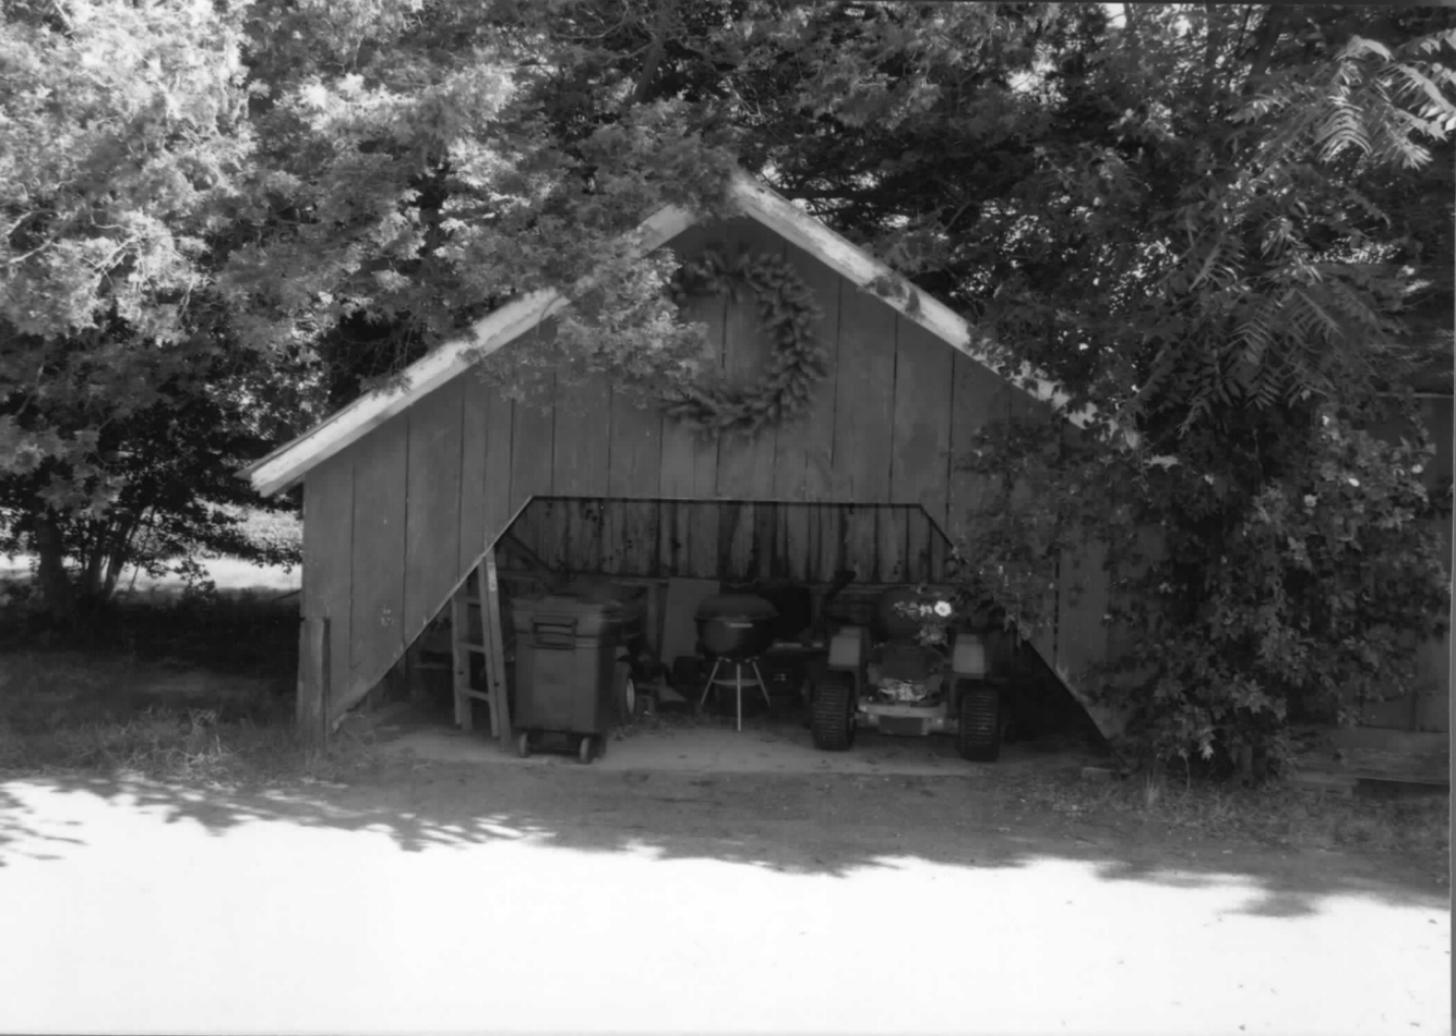
13 of 47

**2. Wood Shed** (c. 1925) Walls of this 16 ft. x 12 ft. frame gable-front structure sit on 4 in. x 6 in. rotten sills, placed on a poured-concrete-slab floor. Walls are covered with vertical boards that average 1.5 ft. in width, and are separated by a .5 in. ventilation gap. Interior access is through a low trapezoidal-shaped opening cut into the front (south) wall. The low-pitch roof has overhanging eaves and exposed rafter ends. The tenant says originally served as a wood shed.

wood shed, camera facing North

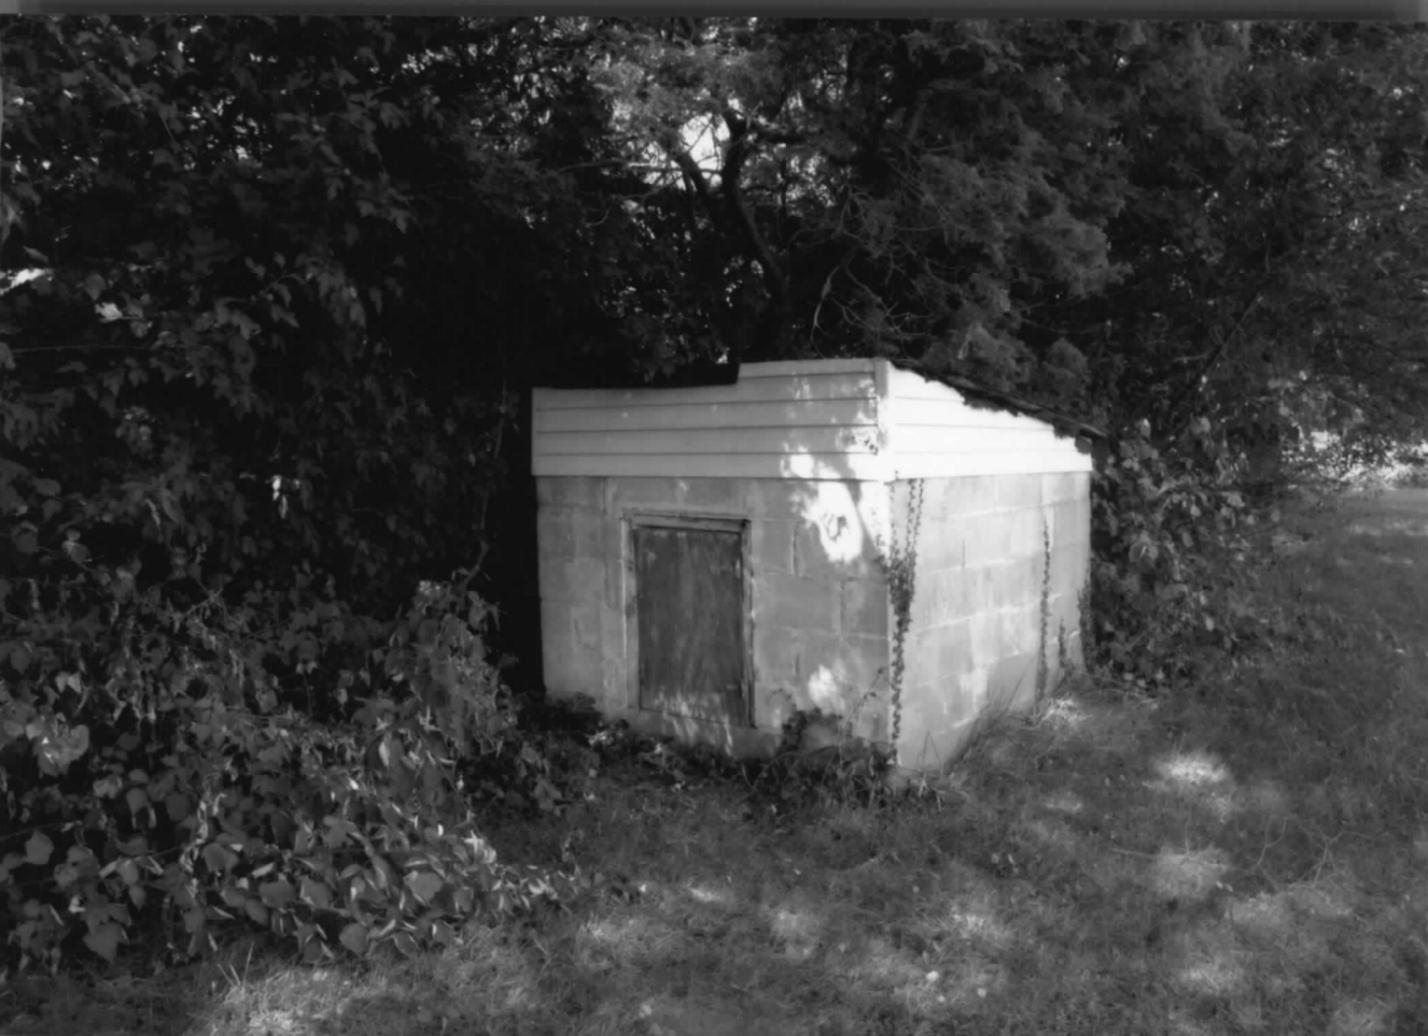
16 of 47

**4. Well and Pump House** (c. 3<sup>rd</sup> quarter of the 20<sup>th</sup> century) An asphalt-covered plywood board forms the shed roof of this 5 ft. x 5 ft. concrete block structure, which measures 5.5 ft. in height at the front and 4.5 ft. at back. A small plywood door serves as the only opening.

Well AND Pump House, Camera  
facing SW

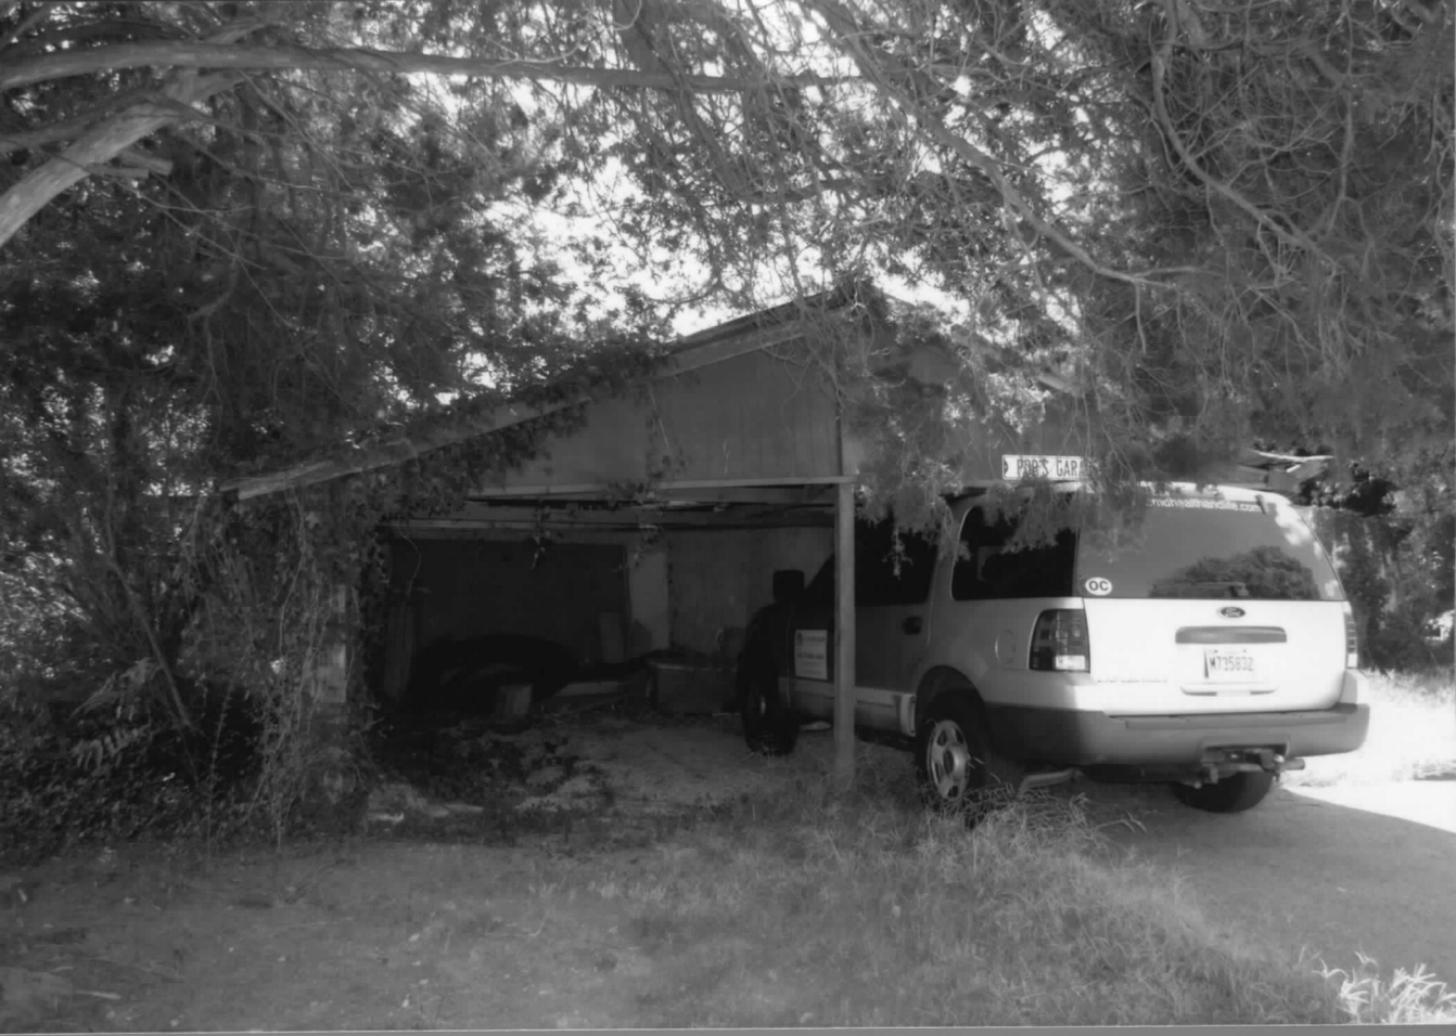
17 of 47

**5. Two Bay Garage** (c. 1925 with late-20<sup>th</sup> century modifications). Recent alterations undermine the structural integrity of this 22 ft. x 18 ft. building, located at the end of the paved driveway, 55 ft. east of the house. Vertical siding boards on the north wall and, exposed rafter ends date the original structure to c. 1925, but the south and east walls' T1-11 siding, and the removal of the west wall to create a two-bay garage occurred more recently. Sills rest directly on the gravel and dirt floor surface. The ceiling joists sag and the rafters splay from insufficient vertical support. A mid-20<sup>th</sup> century pedestrian door (and a much later window) in the south wall may indicate this building had a previous function.

TWO BAY GARAGE, facing east

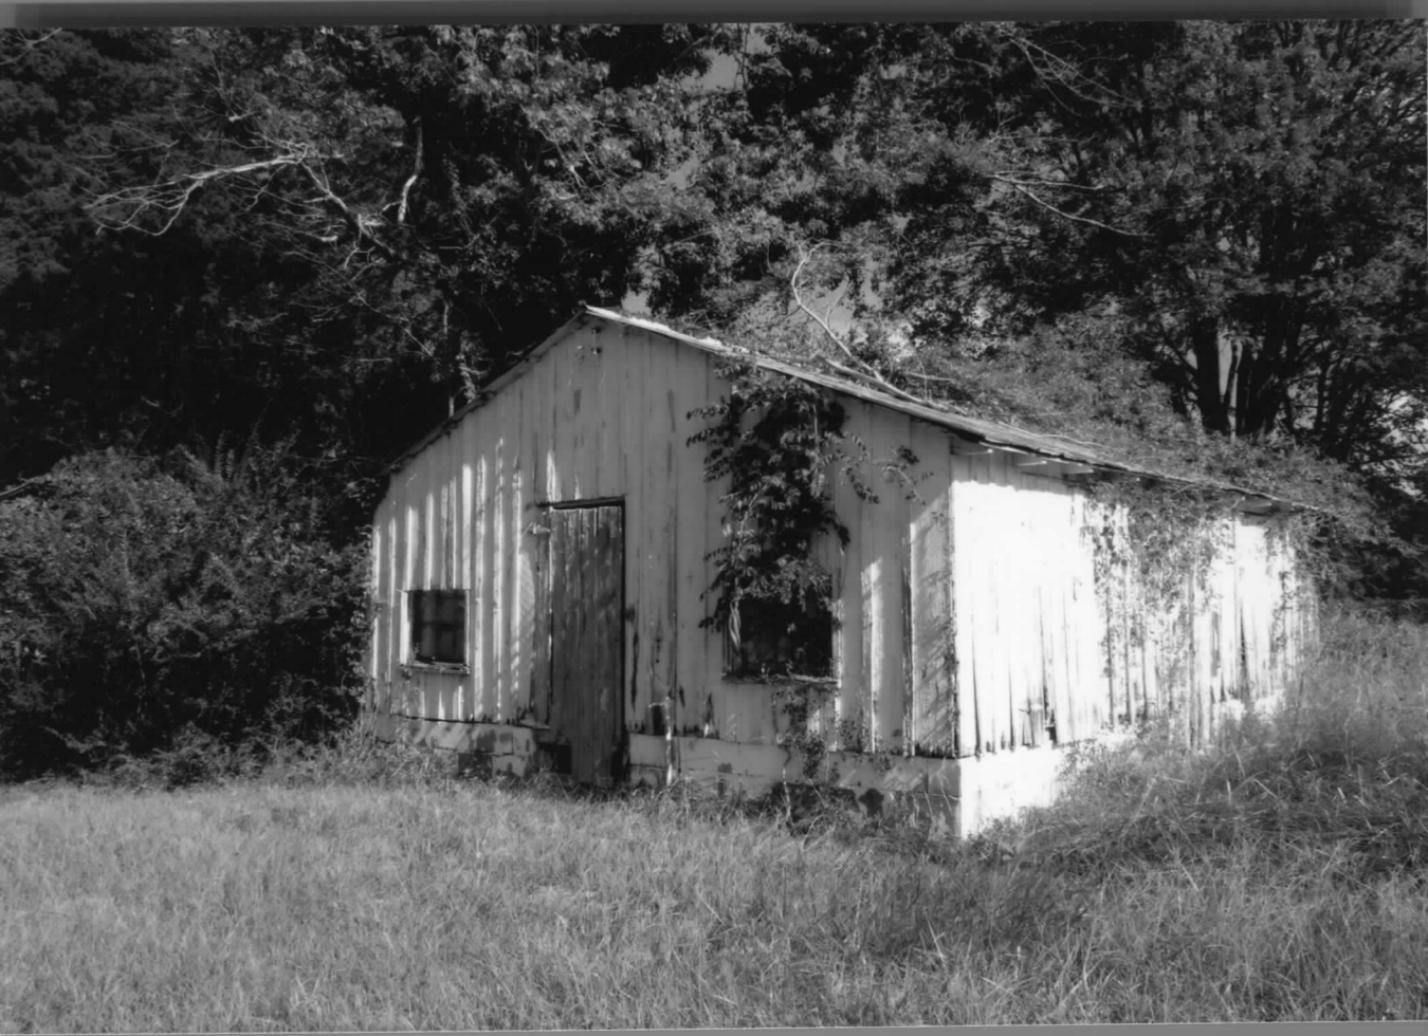
19 of 47

**6. Poultry House** (c. 1925) This 17.5 ft. x 23.5 ft., gable-front, board-and-batten sided building stands 25 ft. east of the Two Bay Garage. It is the survivor of a pair of two identical, commercial poultry houses (Clark 2015). It shares many similarities with other farm buildings, with the notable difference being the 2.5 ft.-tall, terra-cotta-block foundation. (This feature kept predators out and chickens in.) Gable-end openings are the same, with a 6-light, fixed-sash window on either side of a board-and-brace door. Narrow, board-and-brace jib doors in the sidewalls open for ventilation

Poultry House, CAMERA facing NW

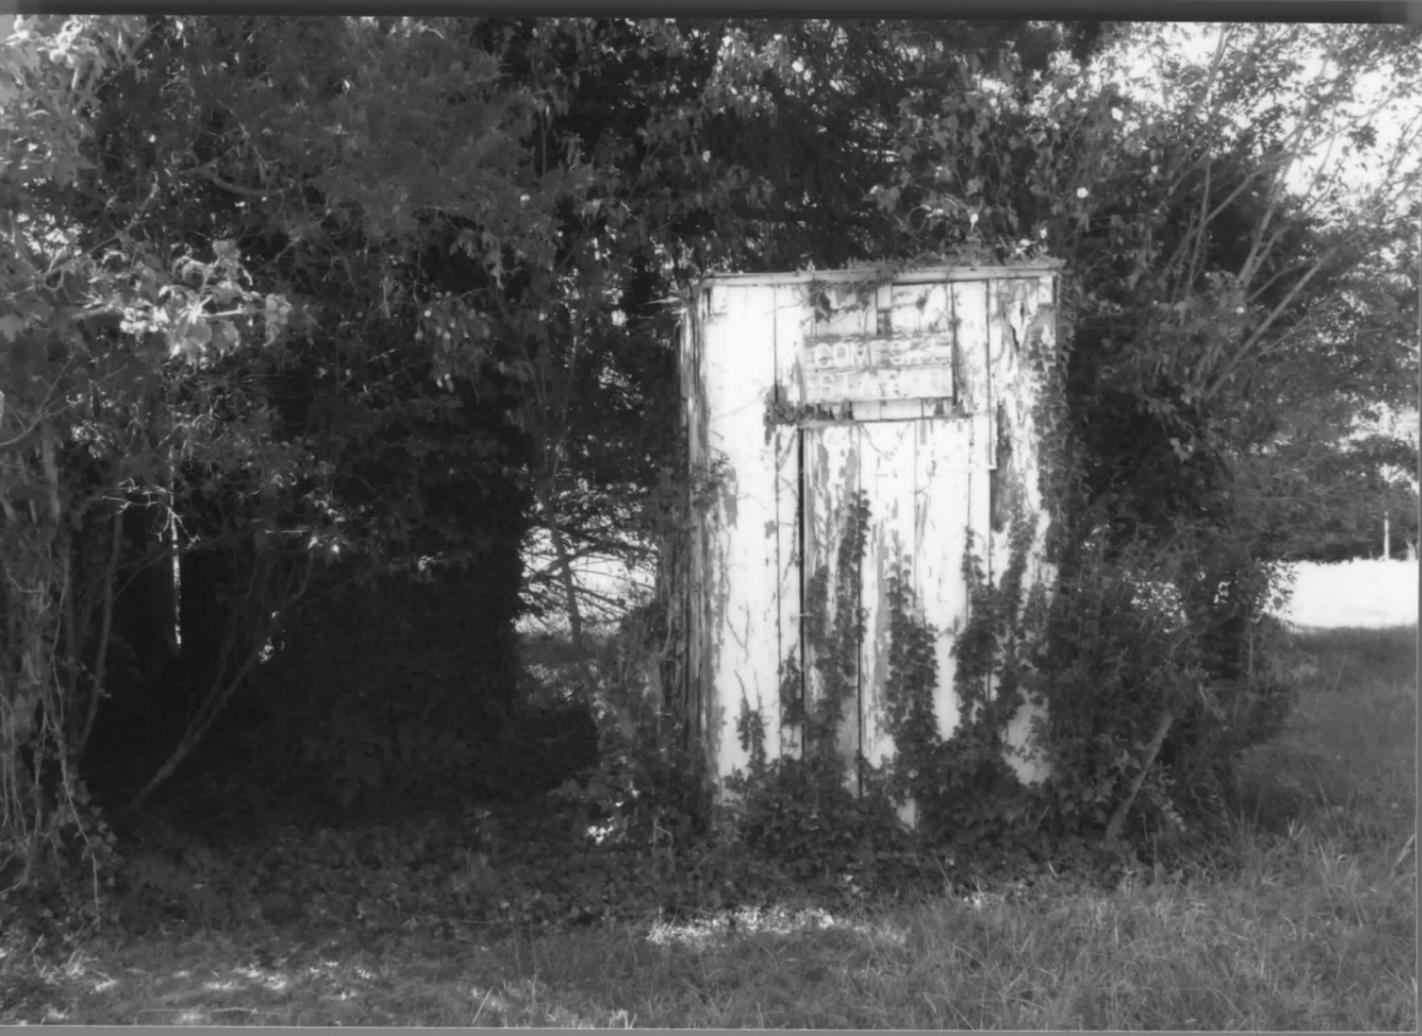
20 of 47

**7. Privy** (c. 1925) This two-seat frame privy measures 4 ft. x 5 ft. Vertical siding covers the walls. Badly deteriorated 4 in. x 4 in. sills lay directly on the ground. The over-hanging roof and exposed rafter ends are cut back to a point nearly flush with the front wall.

PRIVY, CAMERA facing south

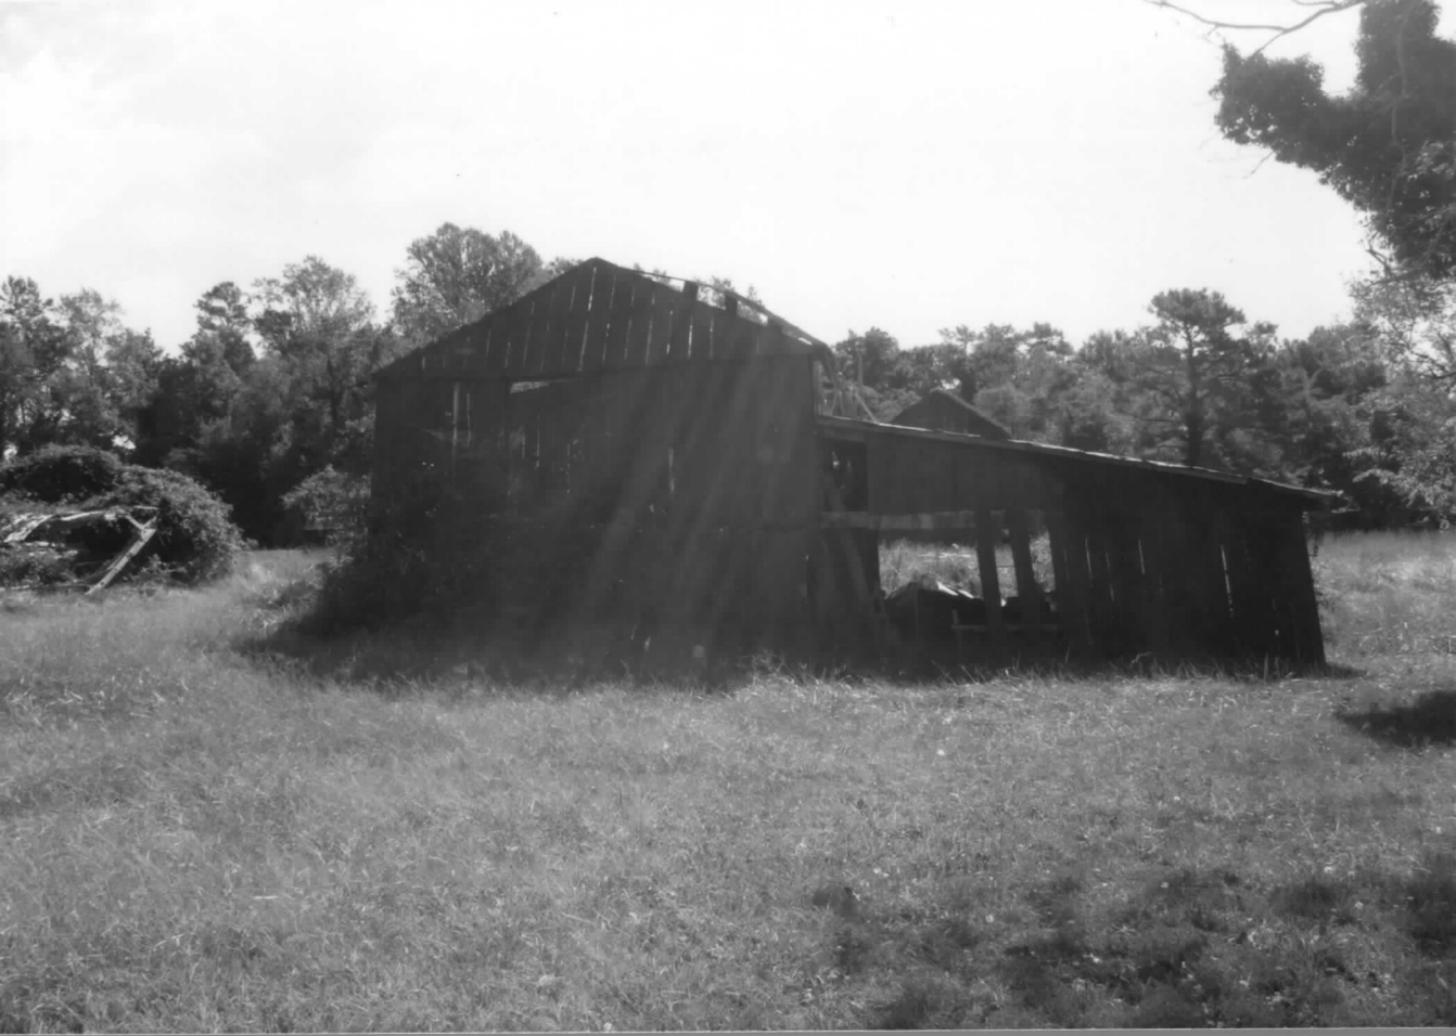
Photo 23 of 47

**9. Large Animal Barn Ruins** (c. 1925) Only the west walls of the barn and attached shed remain standing. The two parts of this structure were built at about the same time. The gable-roof animal barn measured 30 ft. x 50 ft., and the attached shed 36 ft. x 30 ft.

LARGE ANIMAL BARN, CAMERA FACING east  
SMALL HORSE BARN Ruins AT left

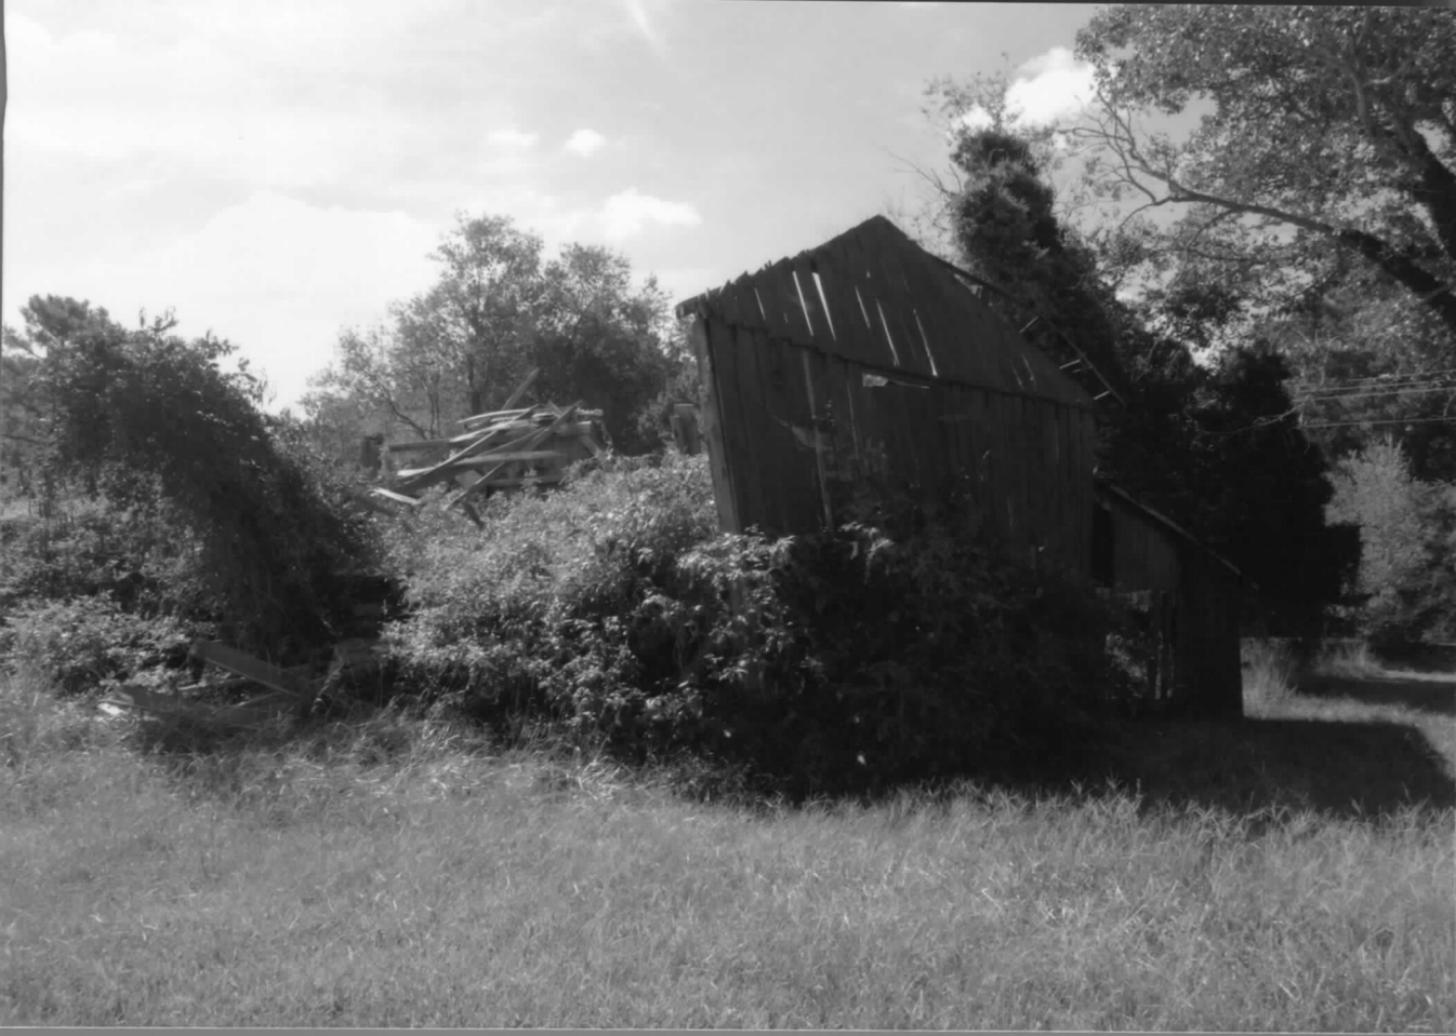
Photo 24 of 47

**10. Small Horse Barn Ruins** (c. 1925) John Clark identified the building debris located on the north side of the Large Animal Barn Ruins as a former horse barn. Clark recalls a covered breezeway once connected the two structures.

HORSE BARN Ruins, CAMERA facing North

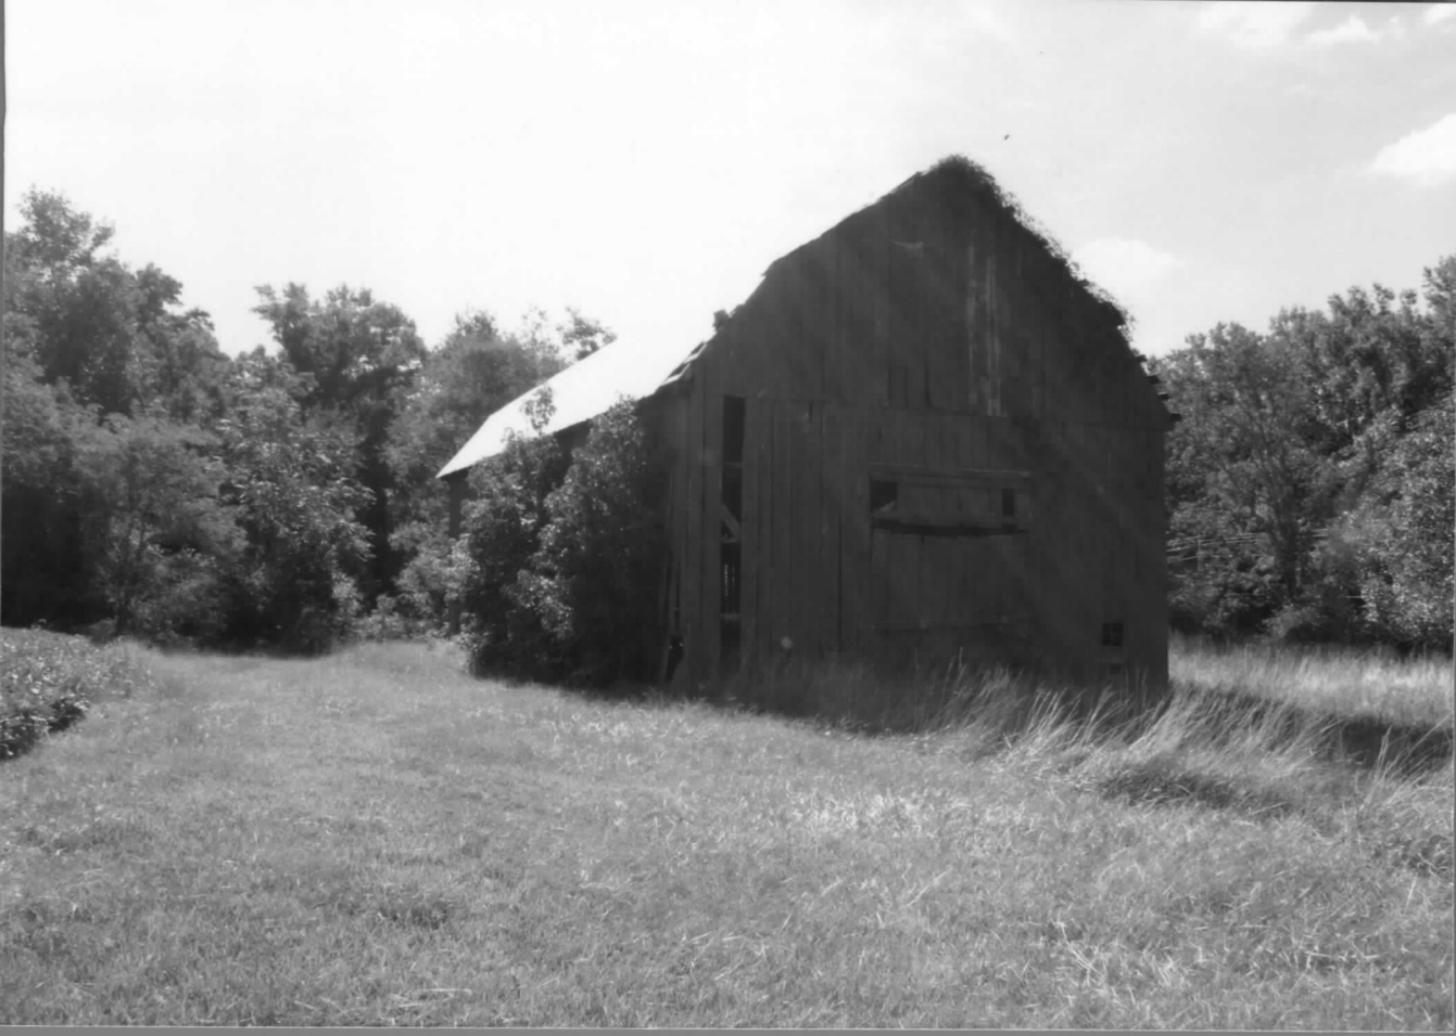
Photo 26 of 47

**12. Tobacco Barn** (1950s) This neglected but well-built and structurally sound, gambrel-roofed structure stands at the property's edge, about 330 ft. east of the dwelling and 125 ft. north of Point Lookout Road. It measures 30 ft. in width and 60 ft. in length, with 10 ft.-wide, paired door openings in the narrow end walls. The ridgeline of the gambrel roof runs roughly east to west. A small section of standing-seam metal cover is missing and other sections are unsecure.

Detracting integrity issues include the loss of some metal roofing and subsequent encroachment by vines and minor water damage. The double doors have partially fallen from their hinges. The stripping room's windows are broken, and some sash damaged. Other problems include damaged and missing siding boards, and borrowing animals that are undermining the foundation.

Tobacco Burn, CAMERA FACING EAST/Southeast

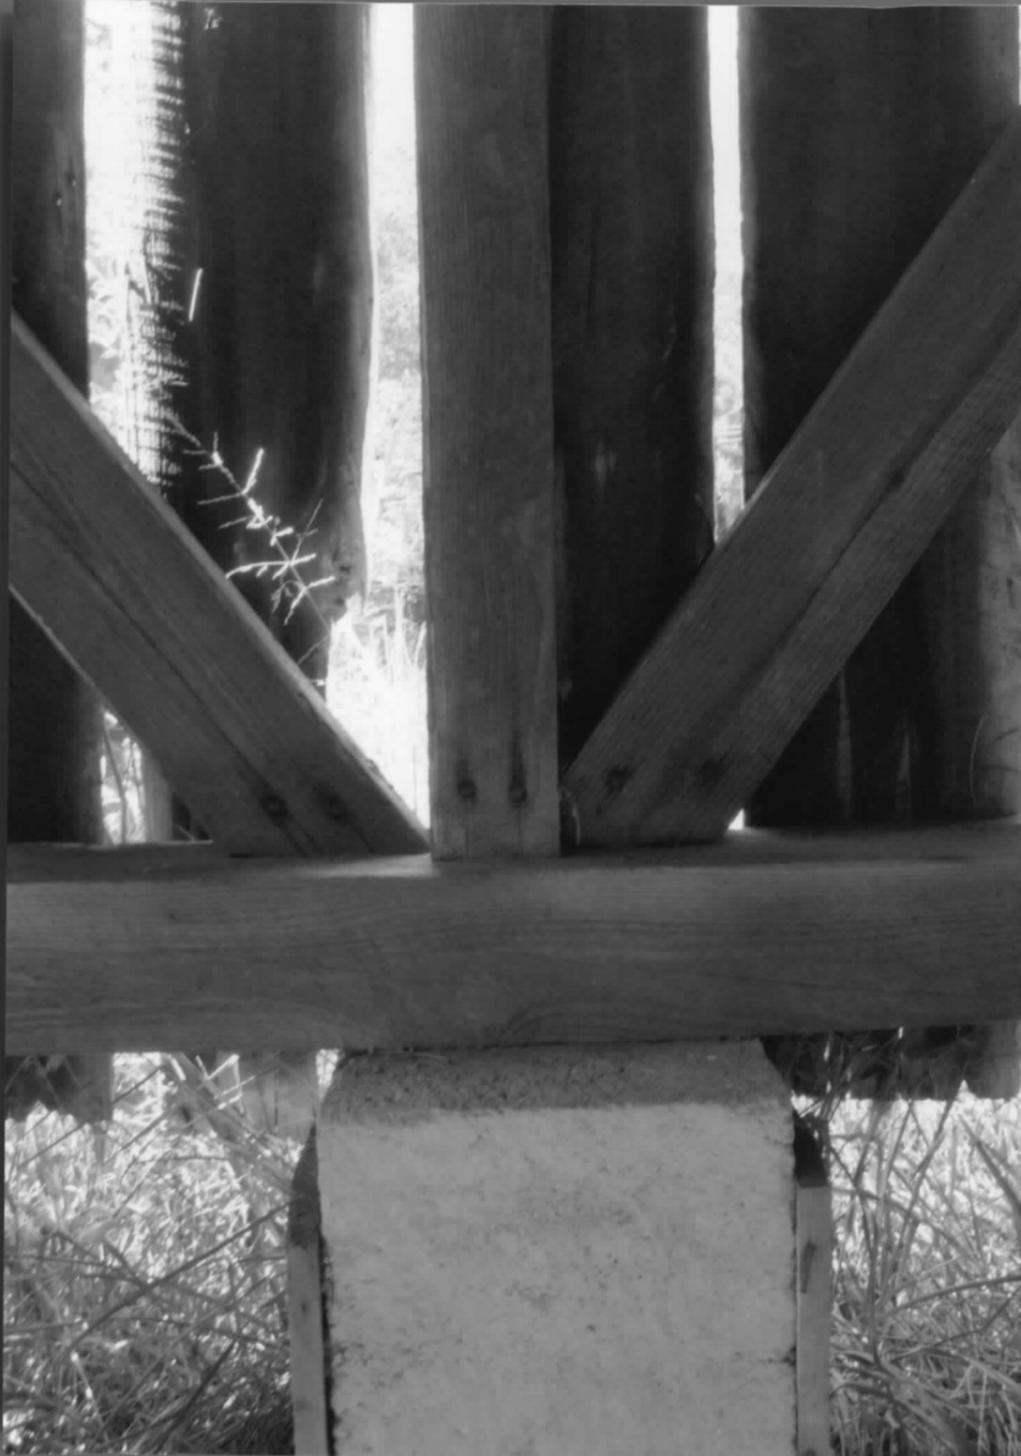
Photo 34 of 47

The vertically hung siding averages between 10 in. and 1ft. in width, with a .5 in. ventilation gap separating boards. Several pieces are missing and others show rot. The walls rest on a variable height concrete pier foundation. Parts of three, of an original group of six, 6-light, fixed-sash windows remain in the southwest corner, and correspond with an interior stripping room.

Sill and Foundation FRAMING Detail

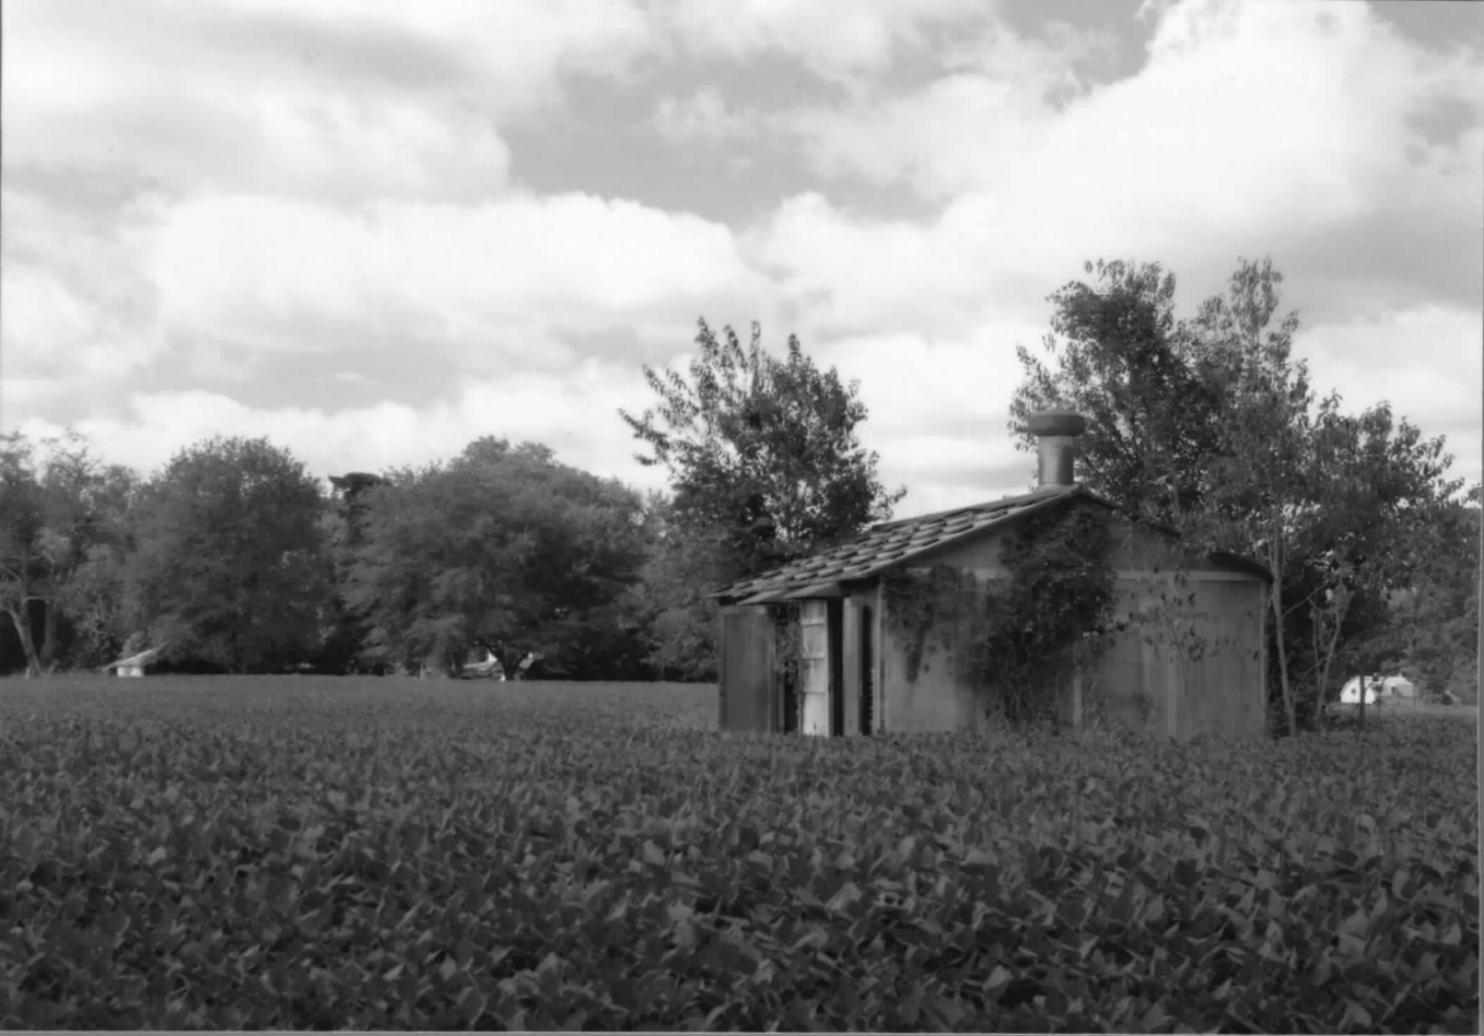
photo 350 of 47

In the field, approximately 525 ft. north of the tobacco barn, sits this incongruous one-story, gable-roof, two-room building. The 20 ft. x 15 ft., structural metal frame bolts to 4 ft. x 8 ft. wall panels that sit on a poured, concrete slab. Panels appear asbestos based and, without exception, all exhibit some degree of damage. Inside, pervasive mold, as well as animal waste and carcasses create additional biohazards.

The roof is missing, walls deteriorated and metal components rusted. Purpose-defining equipment has been removed. Asbestos and mold make it a health and safety risk. The 2.26-acre environmental setting (representing the Navy's leased area) has reverted to farm field. Of the seven aspects of integrity, only location remains intact.

Instrument Landing System support shack  
facing south toward FARM Buildings

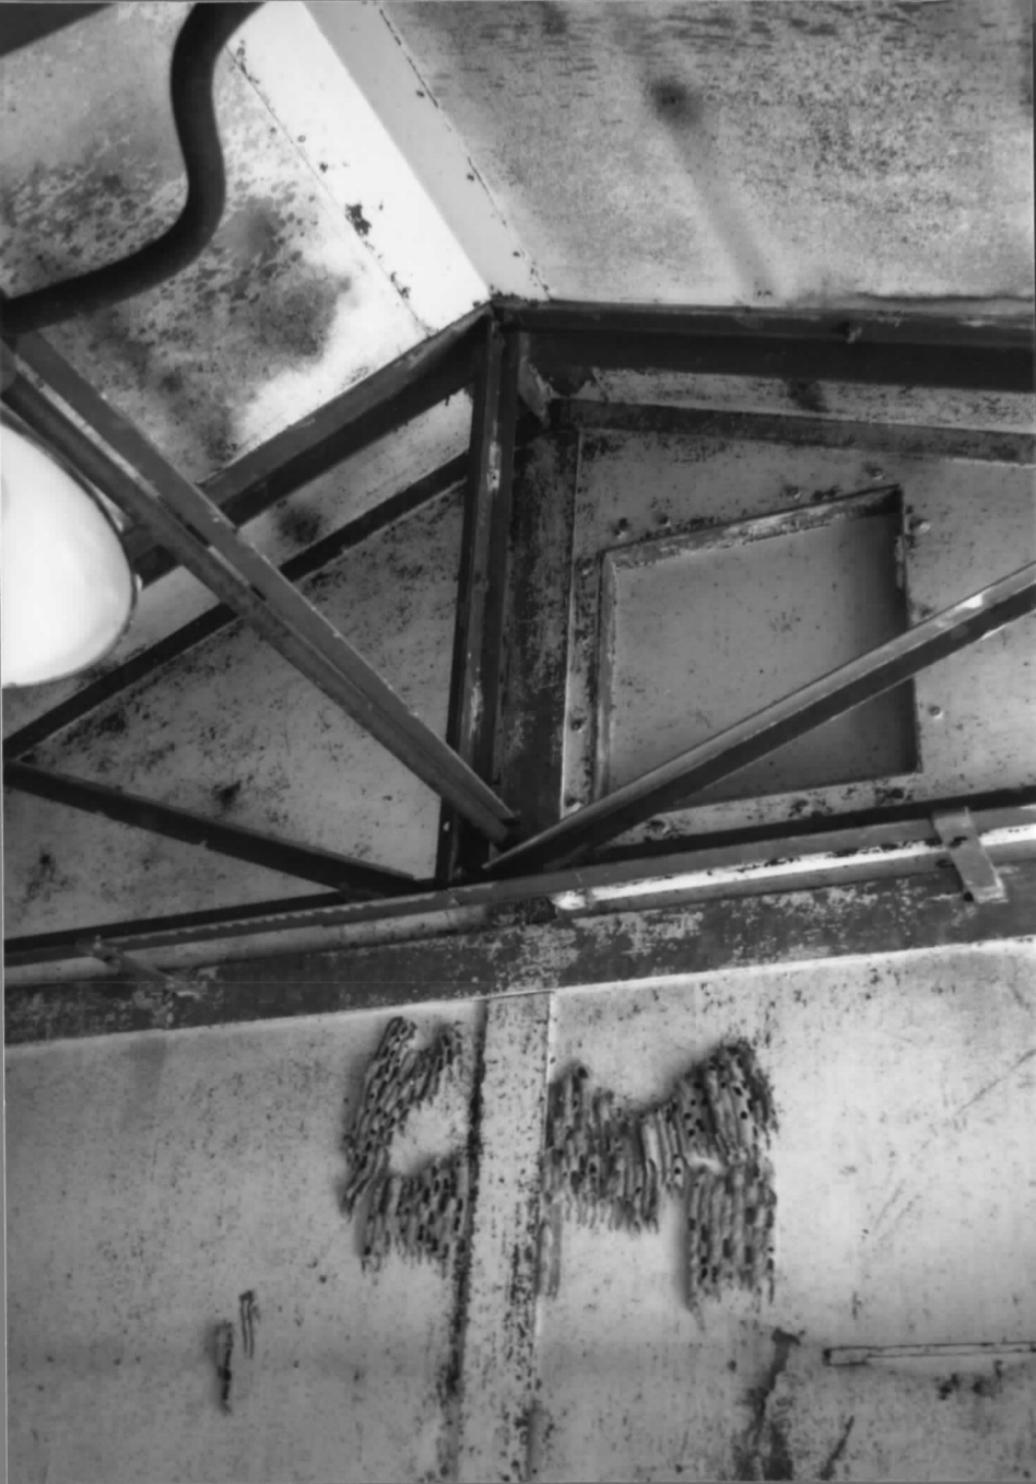
Photo 46 of 47

An approximately 4 ft.-tall ventilator shaft projects from the top of the building at the ridgeline. The roof is sheathed with nothing. Roofing material is cut away, leaving the horizontal metal rafters and interior ceiling material exposed. Inside these are supported by prefabricated, metal, king-post trusses. Front wall openings consist of two metal doors in the east wall. Windows are limited to the 12-light, fixed-sash, metal units in the south and west walls of the west room.

Support Shack, truss detail

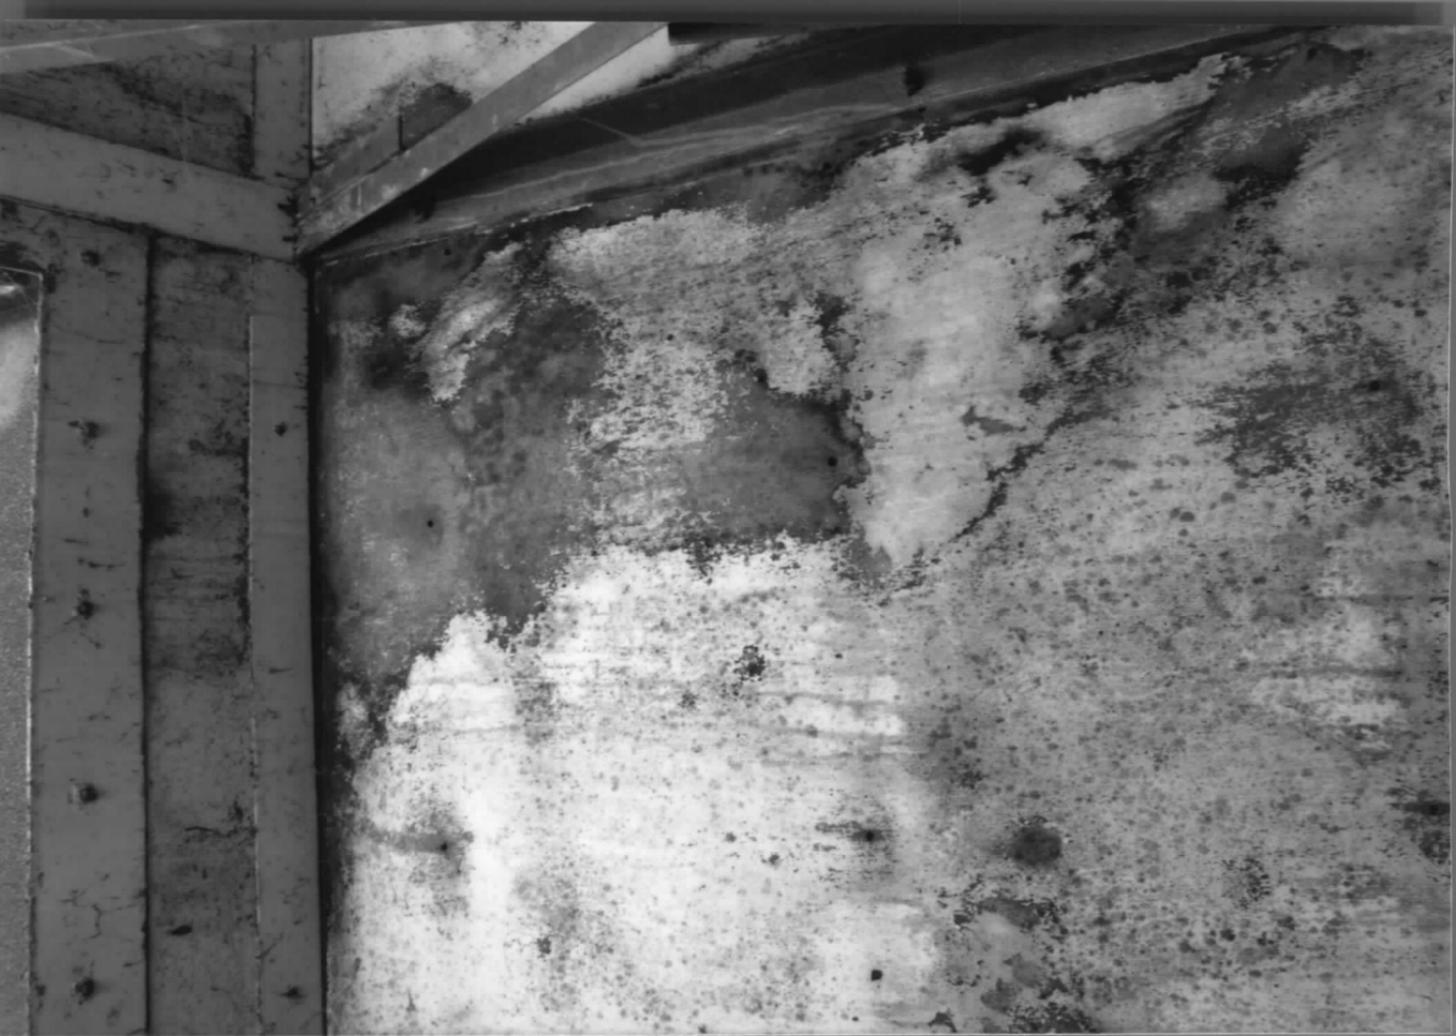
Wall panel Deterioration
