Name: Strausburg Residence

MARYLAND INVENTORY OF  
HISTORIC PROPERTIES

Survey No. T-1132

and/or common Strausburg Residence

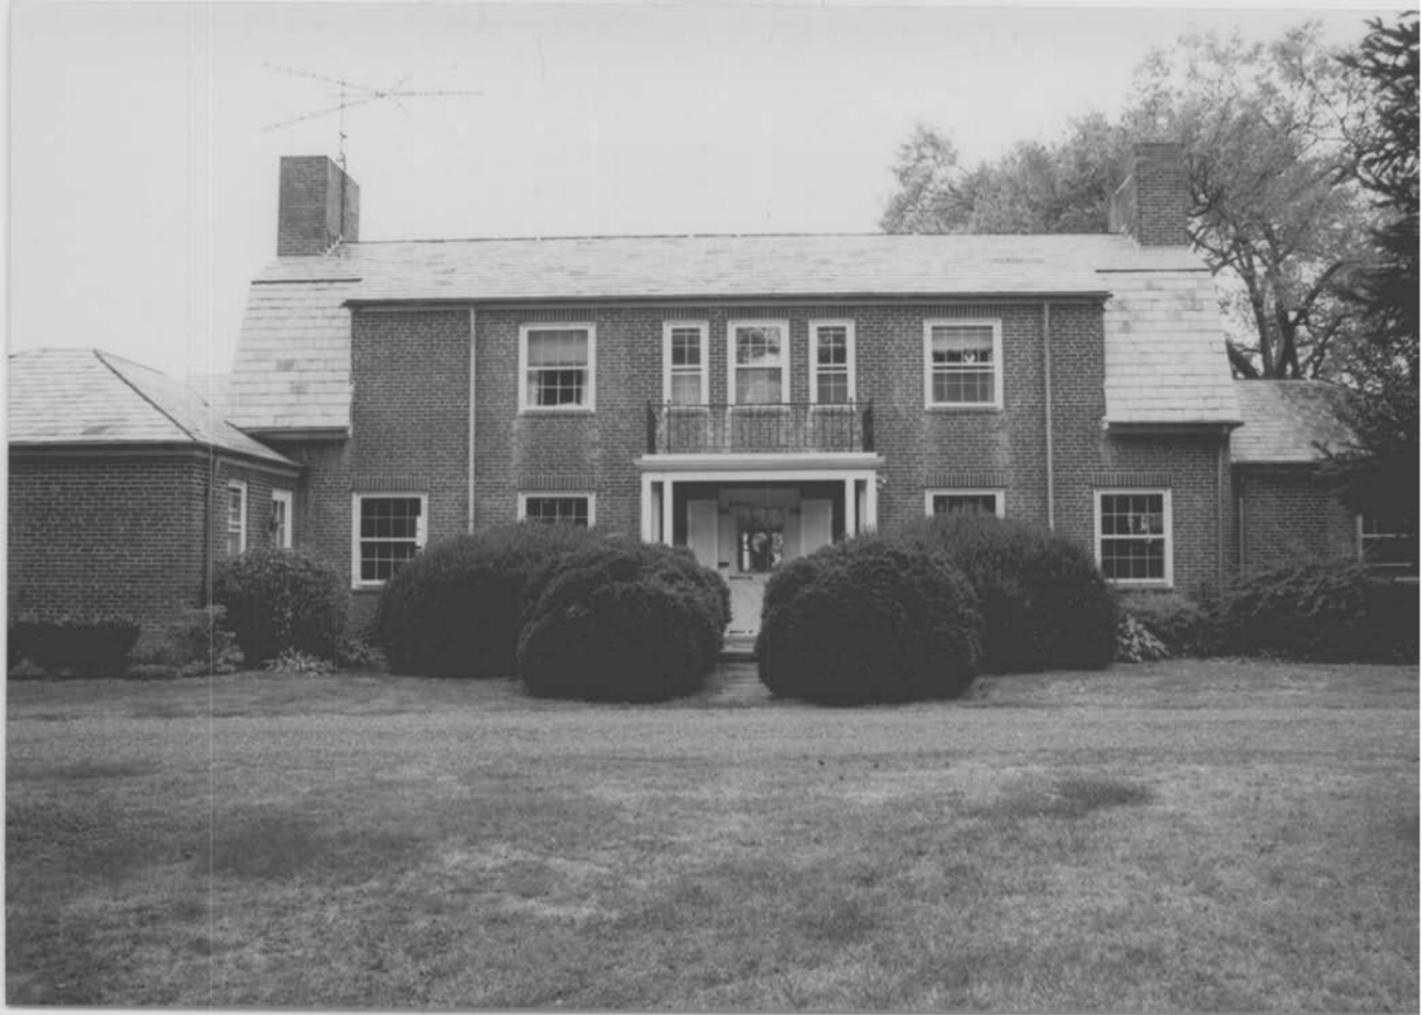
1 of 21

Main House, East Facade

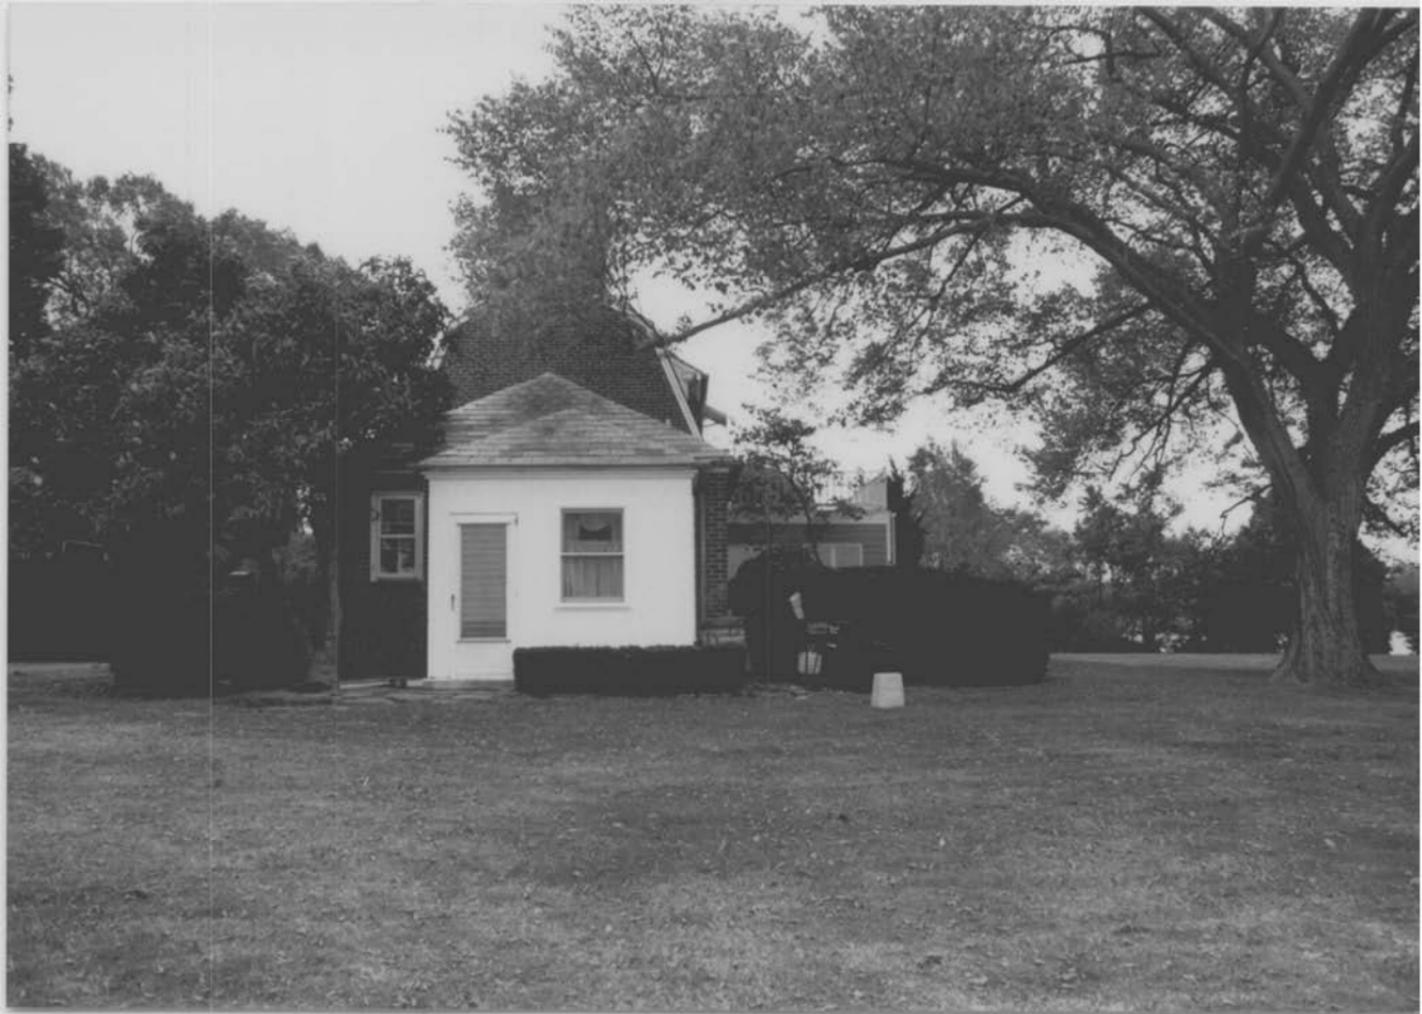
2 of 21

Main house, north elevation

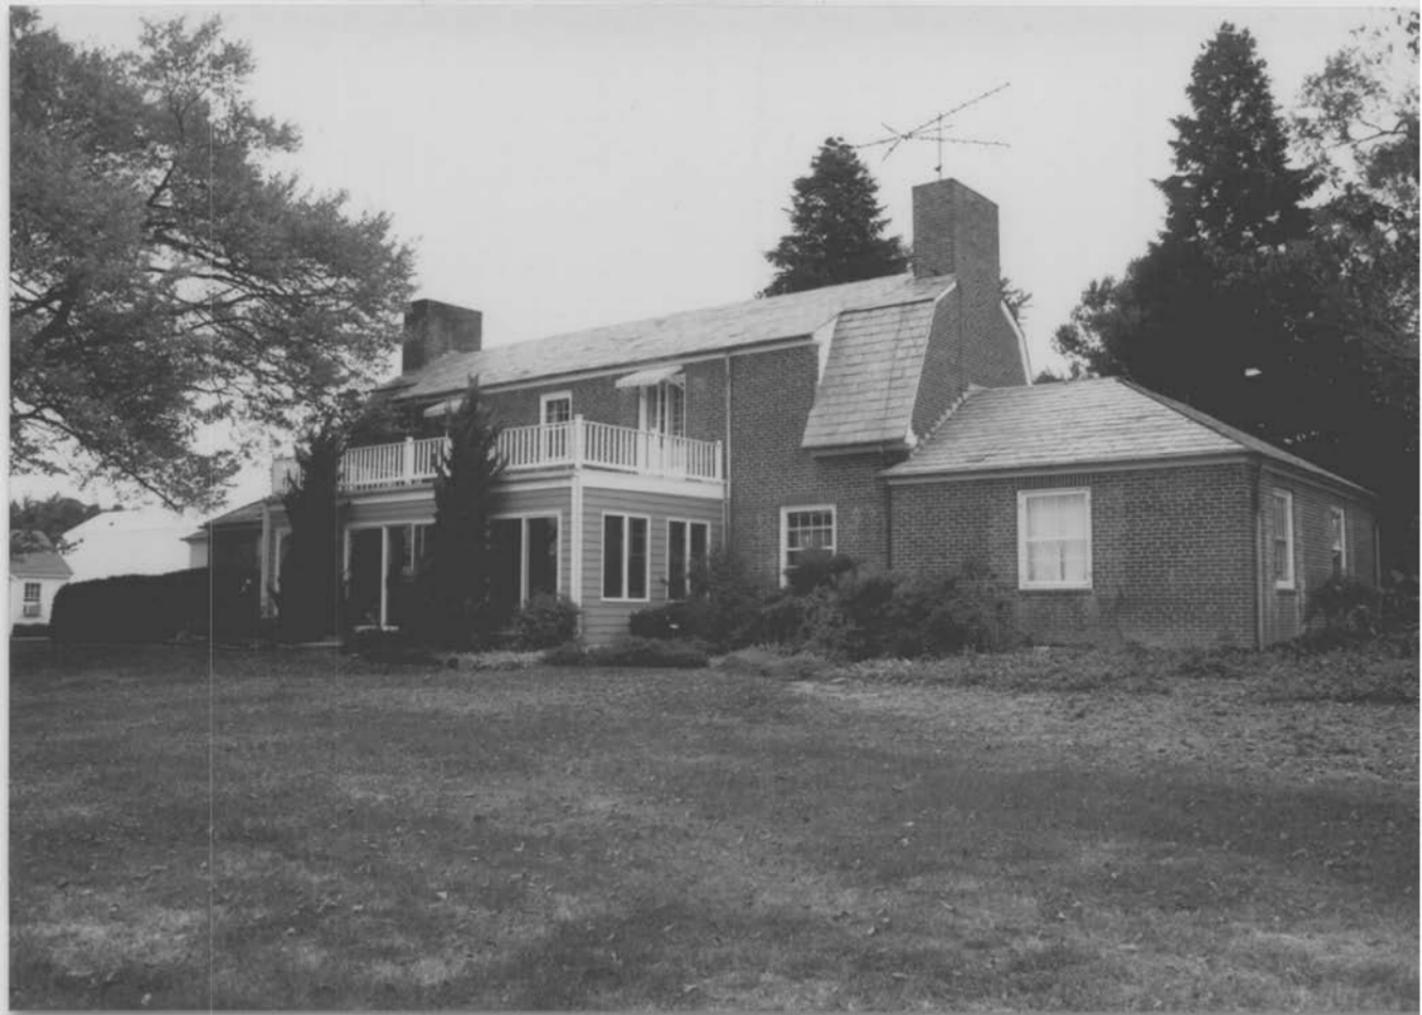
3 of 21

Main house, west elevation

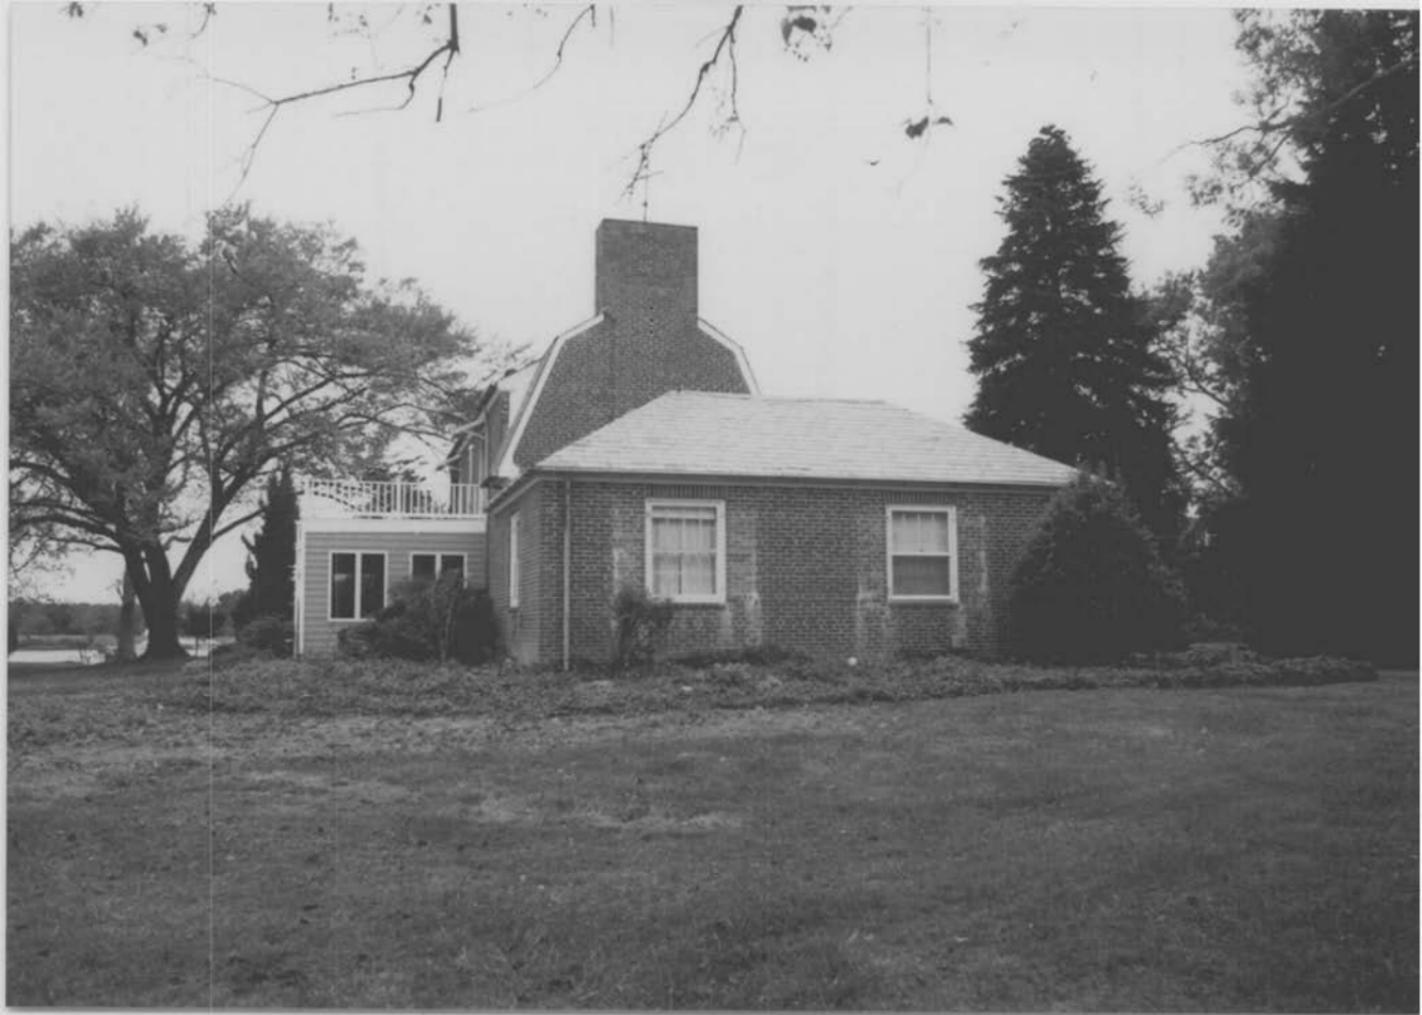
4 of 21

Main house, south elevation

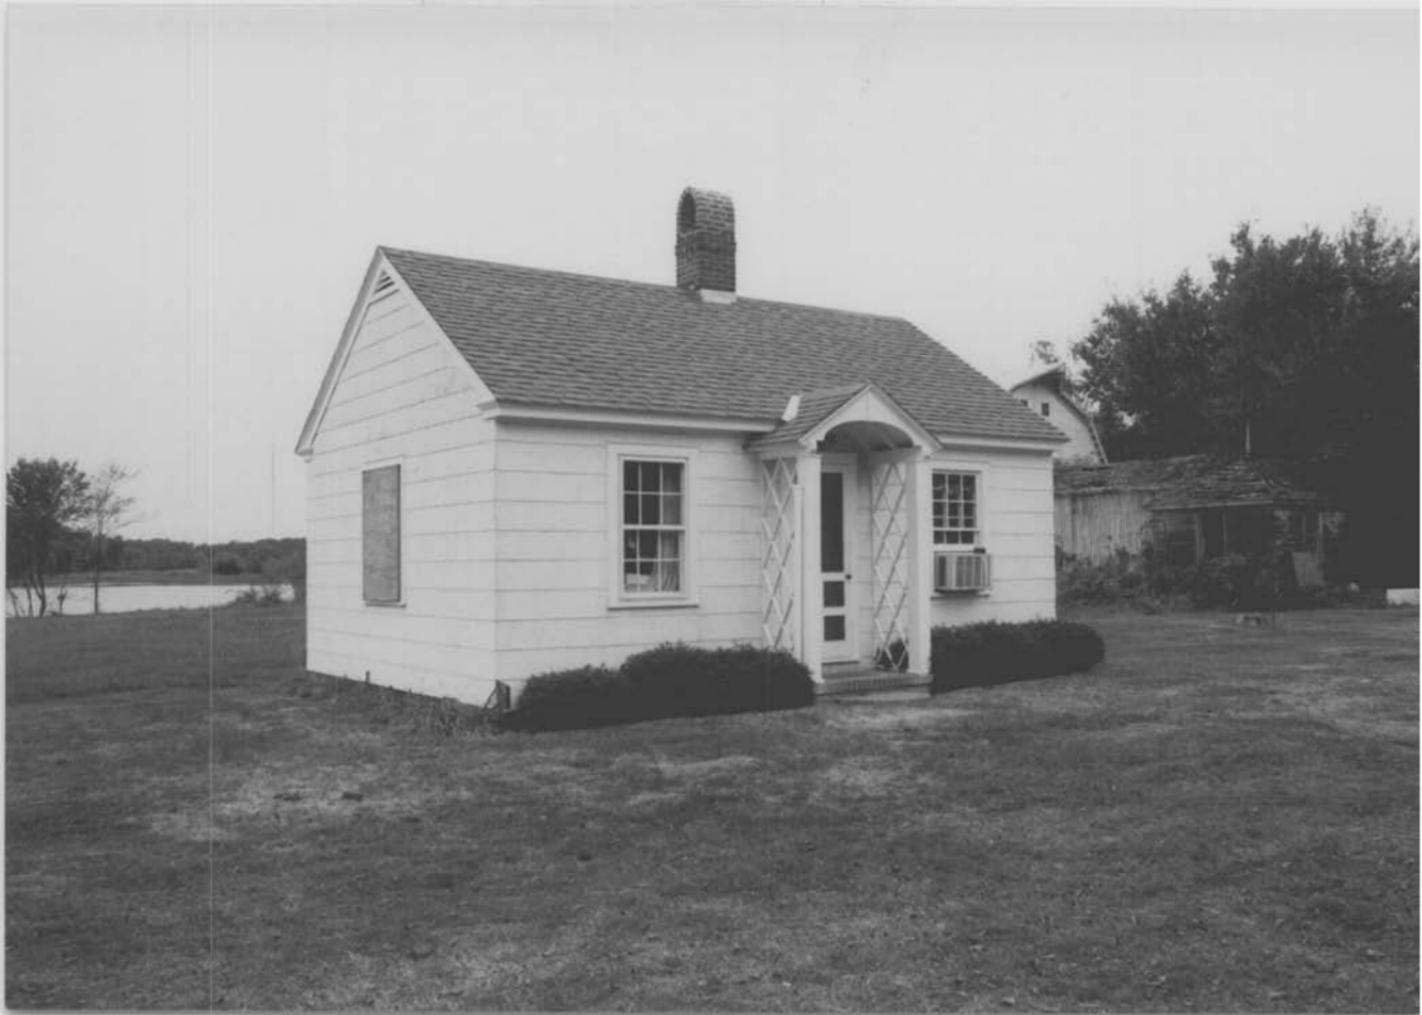
5 of 21

An in-ground swimming pool is located northwest of the main house. A small, uninhabited, guesthouse is located north of the main house. The single-story guesthouse has a lateral gabled roof with an interior chimney, offset slightly to the east. The roof is covered in asphalt shingles. The gabled central entrance on the south facade is flanked by six-over-six double hung windows. A second entrance and bulkhead are located on the east elevation. A single six pane casement window is on the north elevation. A window opening on the west elevation is boarded over. The building rests on a concrete block foundation and is clad in asbestos shingles.

Guesthouse, looking NE.

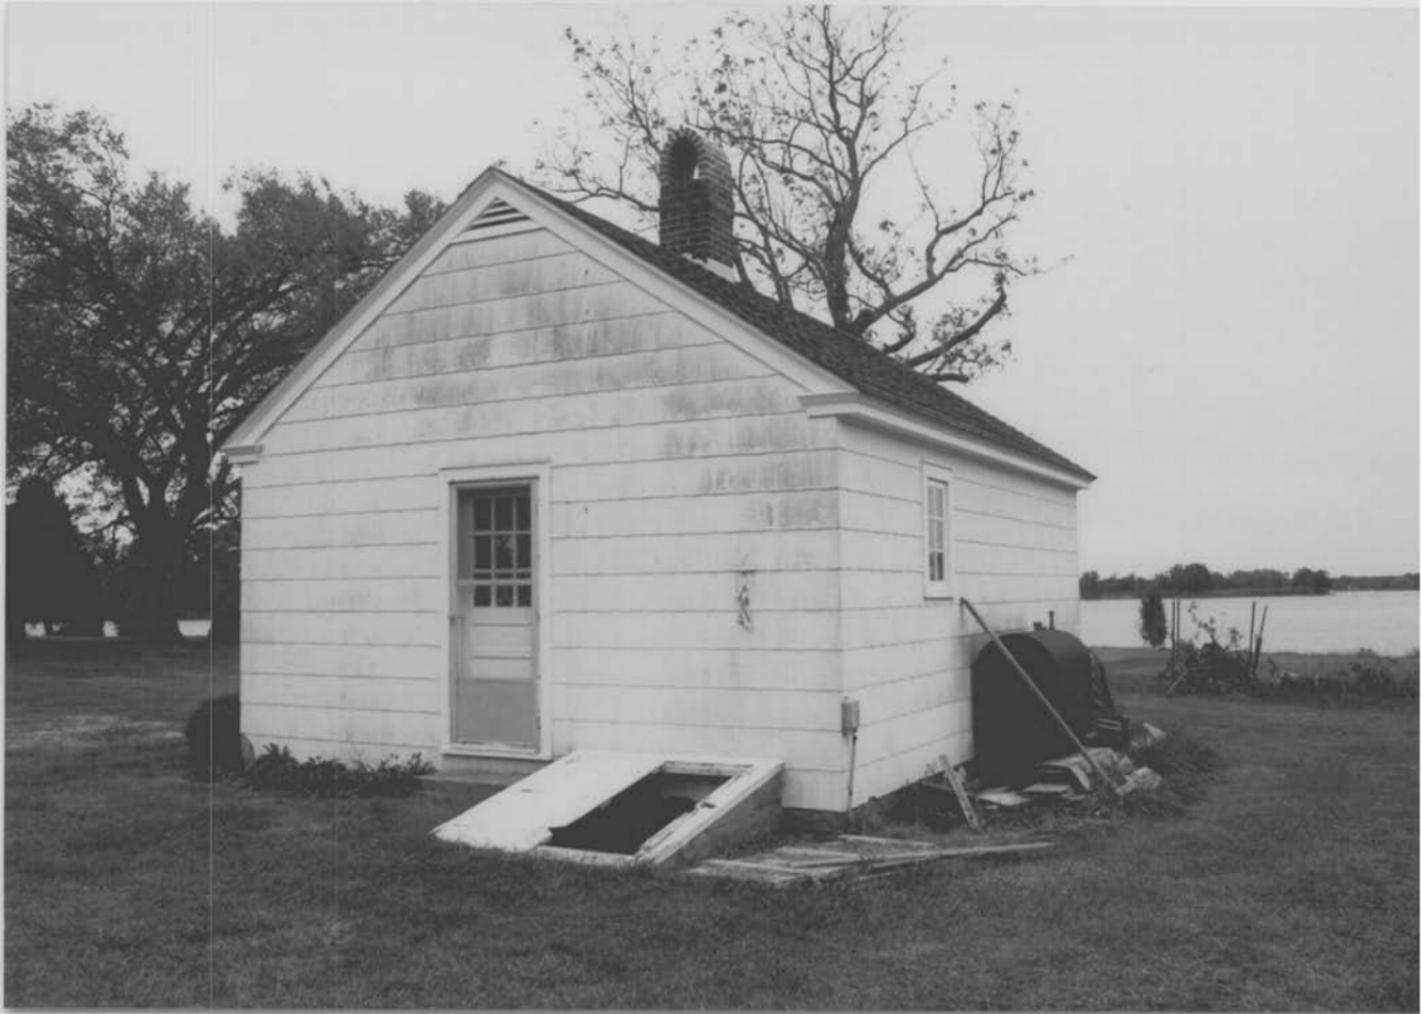
6 of 21

Guesthouse, looking SW

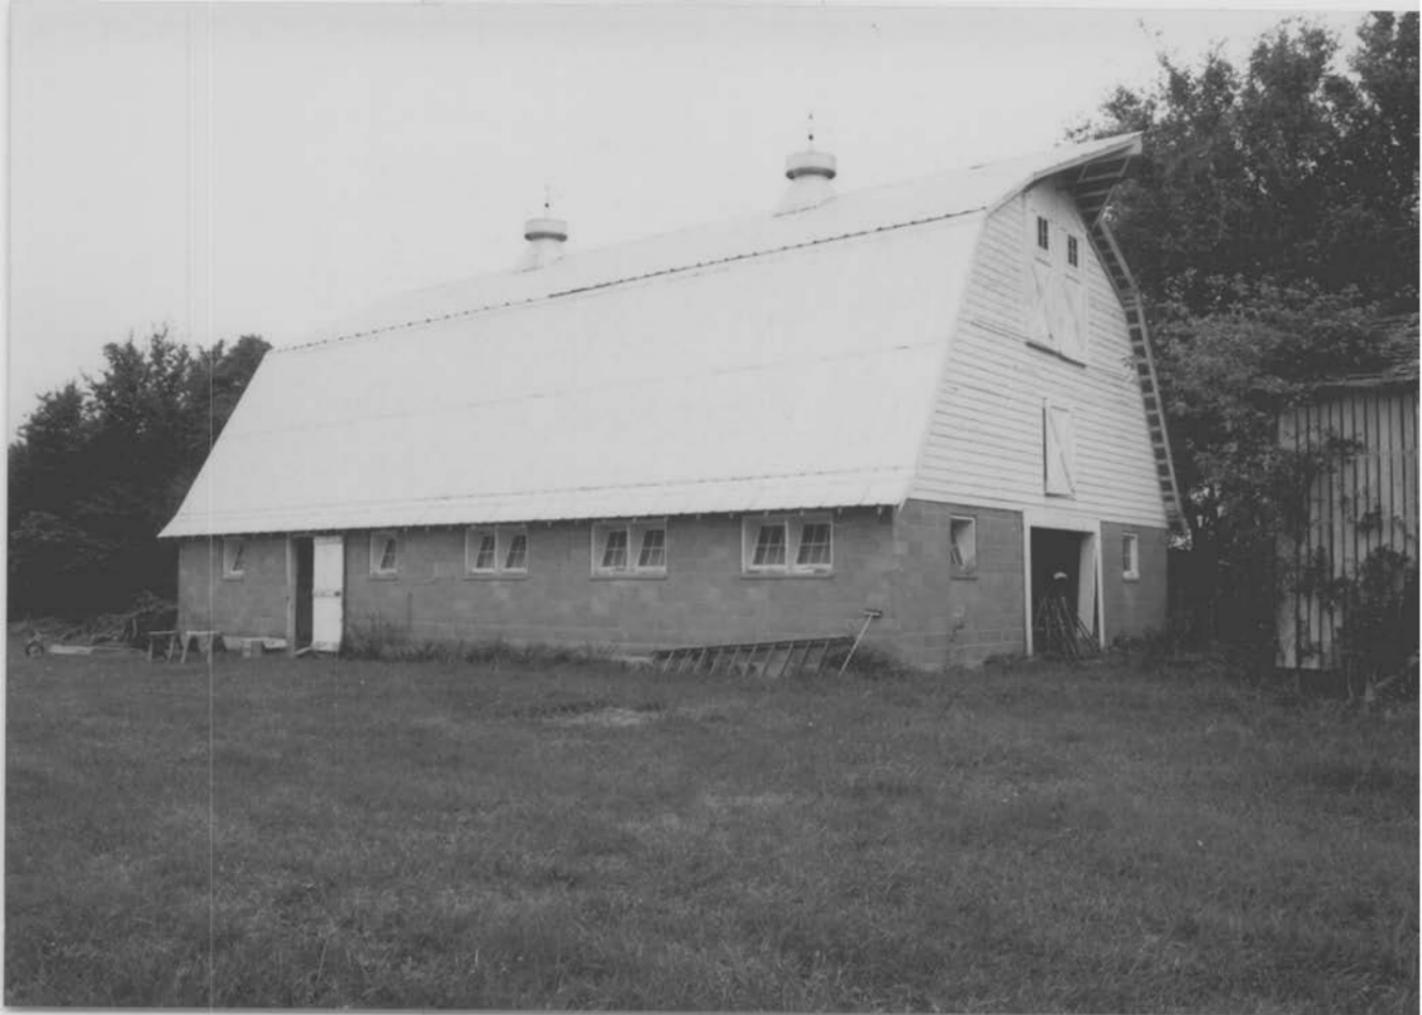
7 of 21

A large three-story gambrel roofed barn is located north of the corncrib. The foundation of the barn is poured concrete, and the first floor walls are concrete block. Hopper-like windows line the first floor of the east and west elevations. The windows are slanted inward and are hinged at the bottom. Central entrances are located on the north and south elevations. Hay doors are located over the central entrances. A third floor hay door and hood are located on the south elevation. Two metal ventilators top the corrugated metal roof. Wood clapboards cover the gambrel ends of the north and south elevations. Two unidentified collapsed outbuildings are located south and east of the barn.

Barn, looking NE

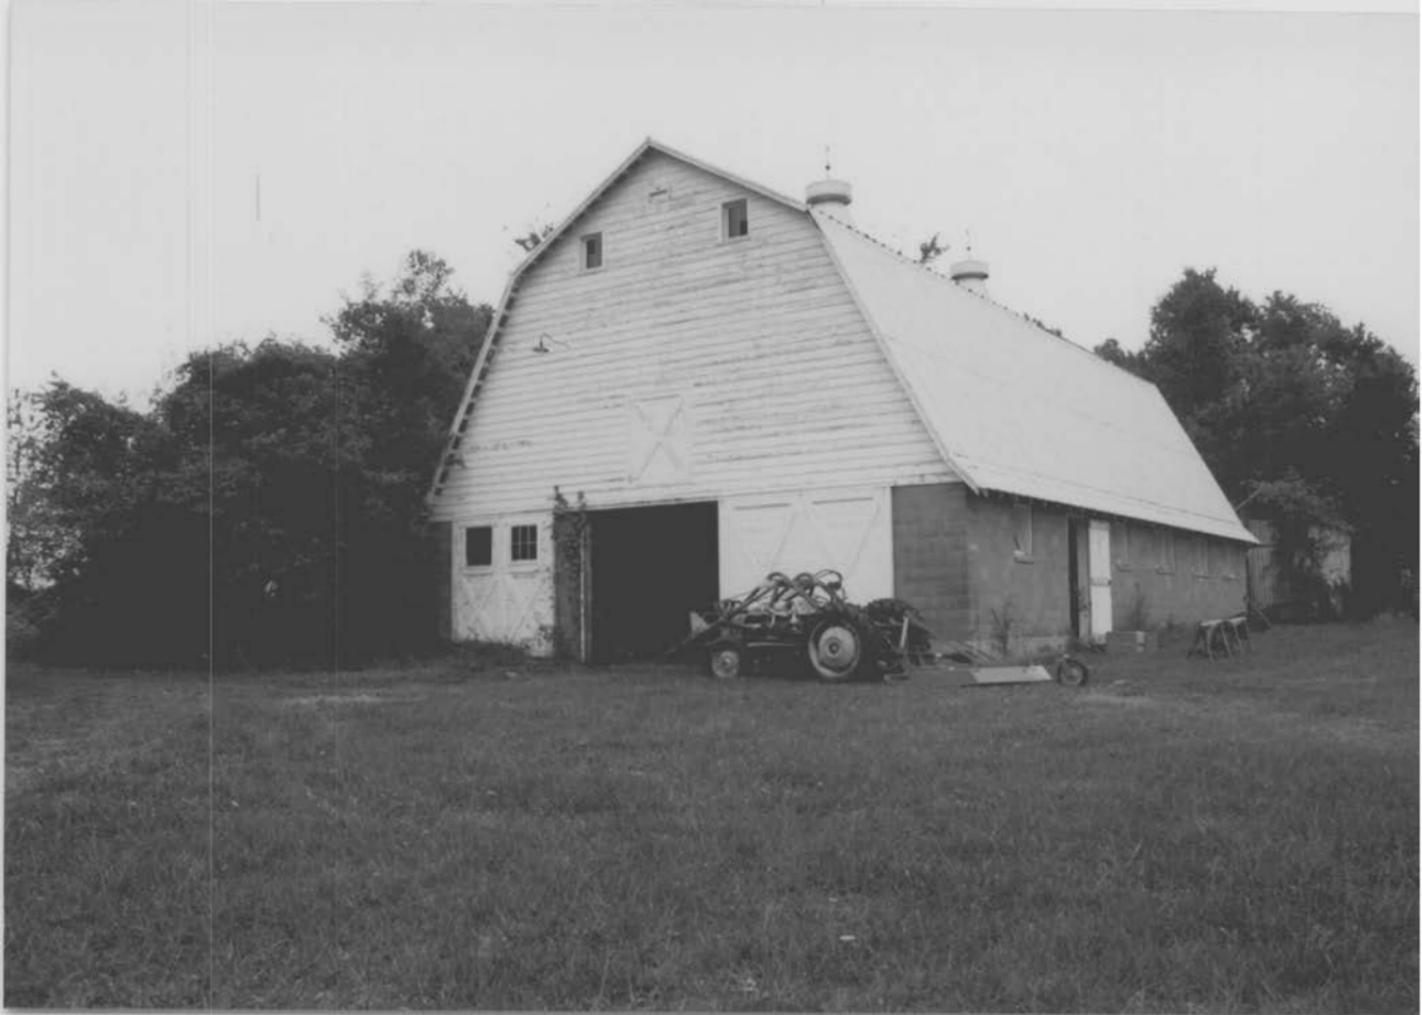
Barn looking SE  
8 of 21

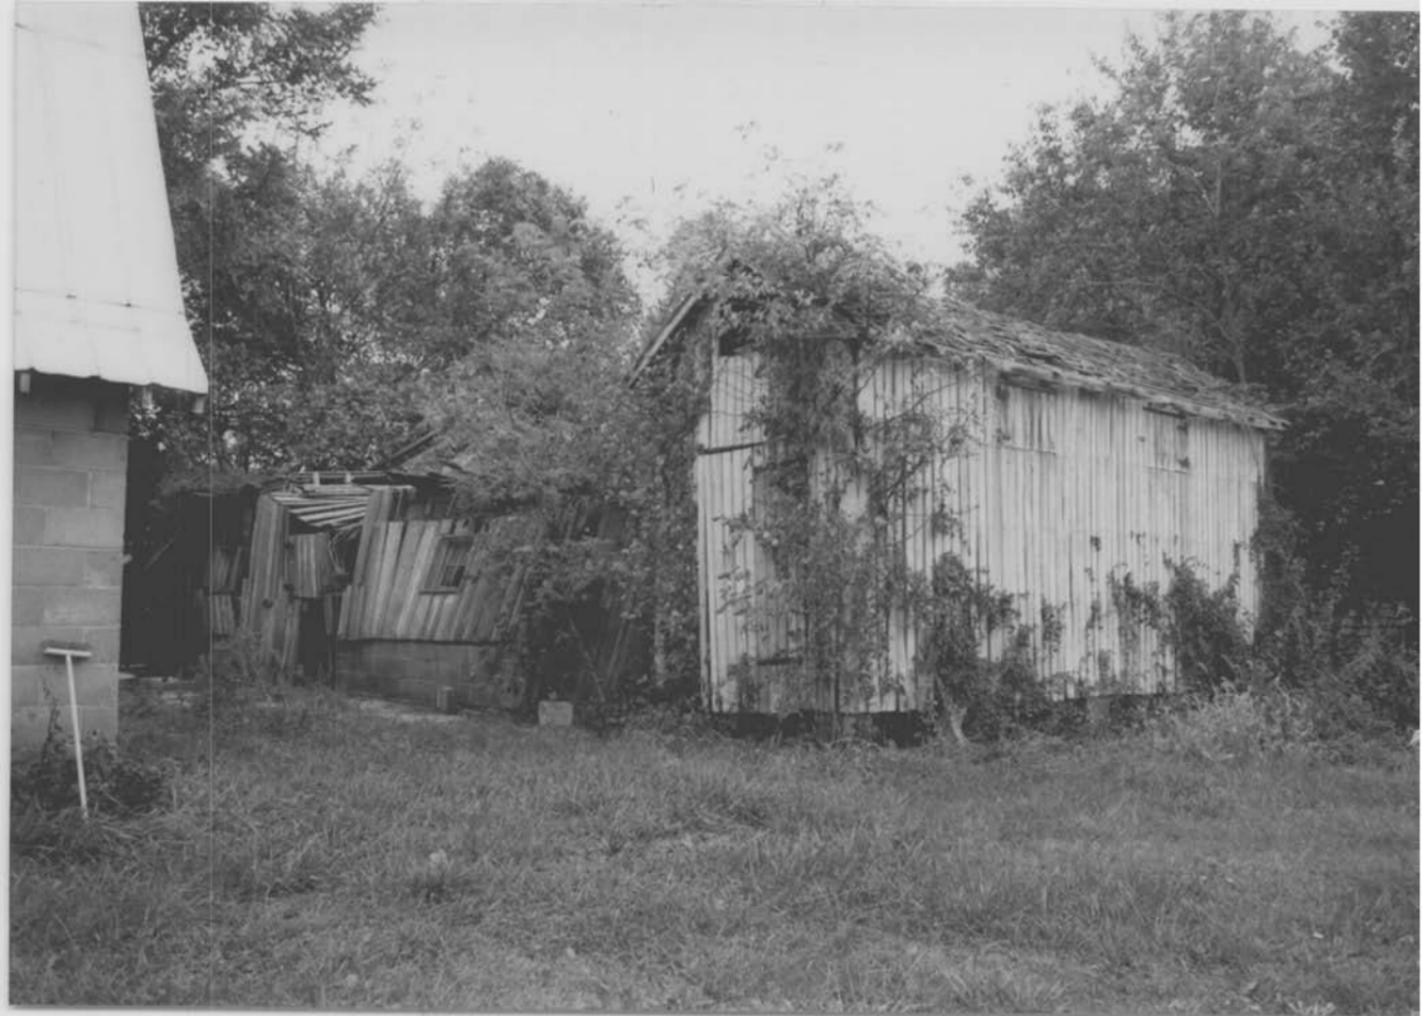
9 of 21

Northwest of the garage is a gabled corncrib. The building is roofed with wood shingles and has horizontal slats. An entry door is on the north elevation. Two small loading doors are located under the eave on the east elevation.

Corn Crib, looking SE

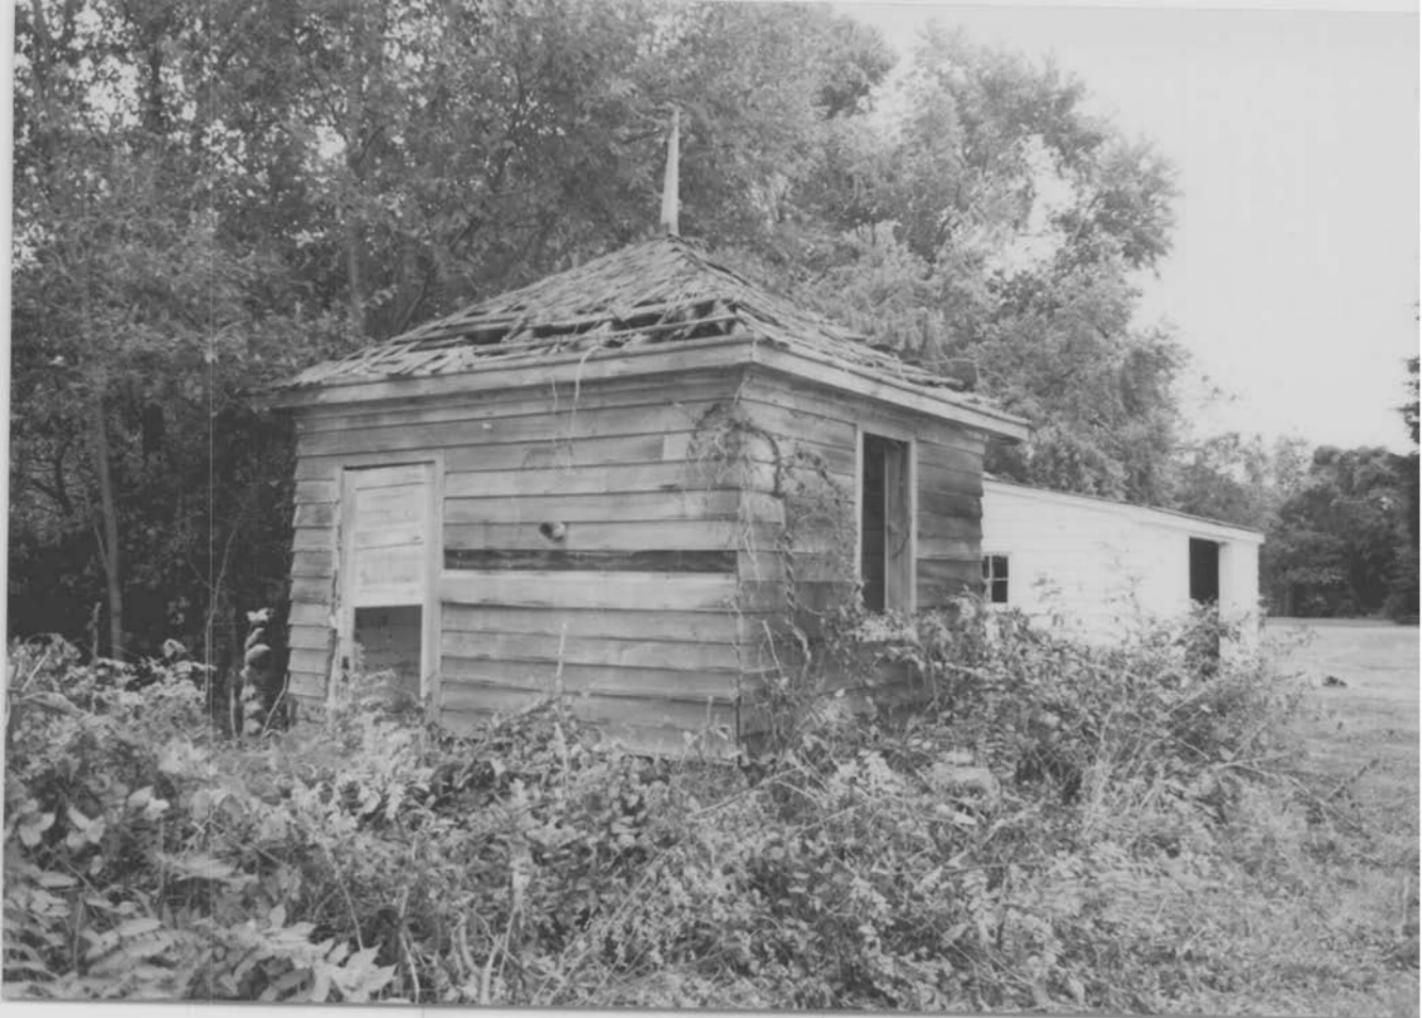
10 of 21

Outbuilding, looking SE

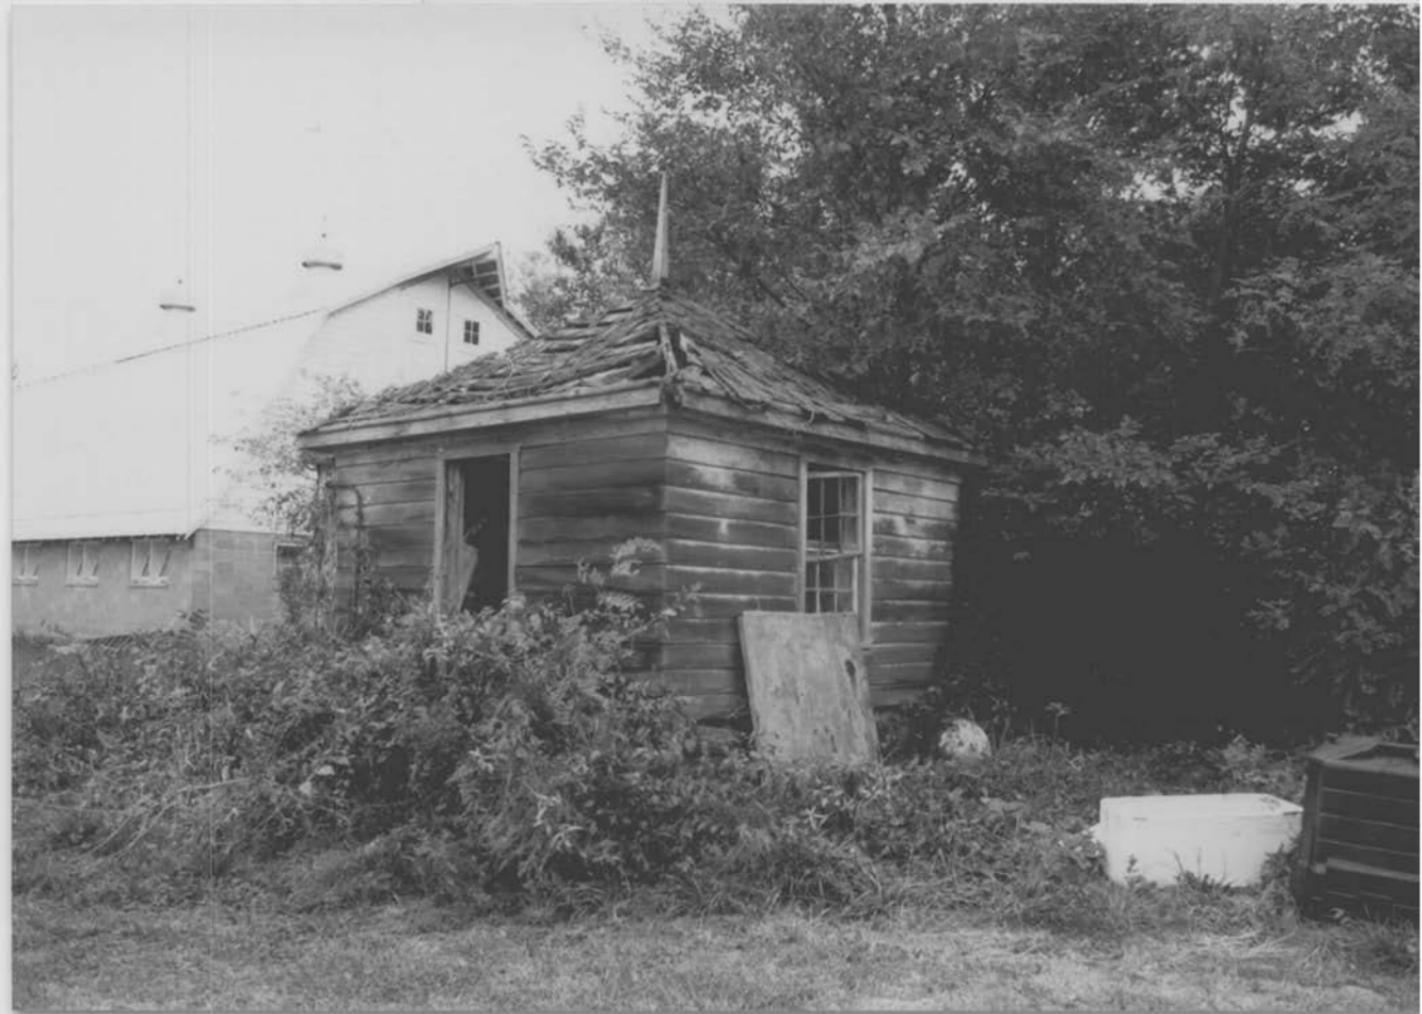
11 of 21

Outbuilding, looking NE

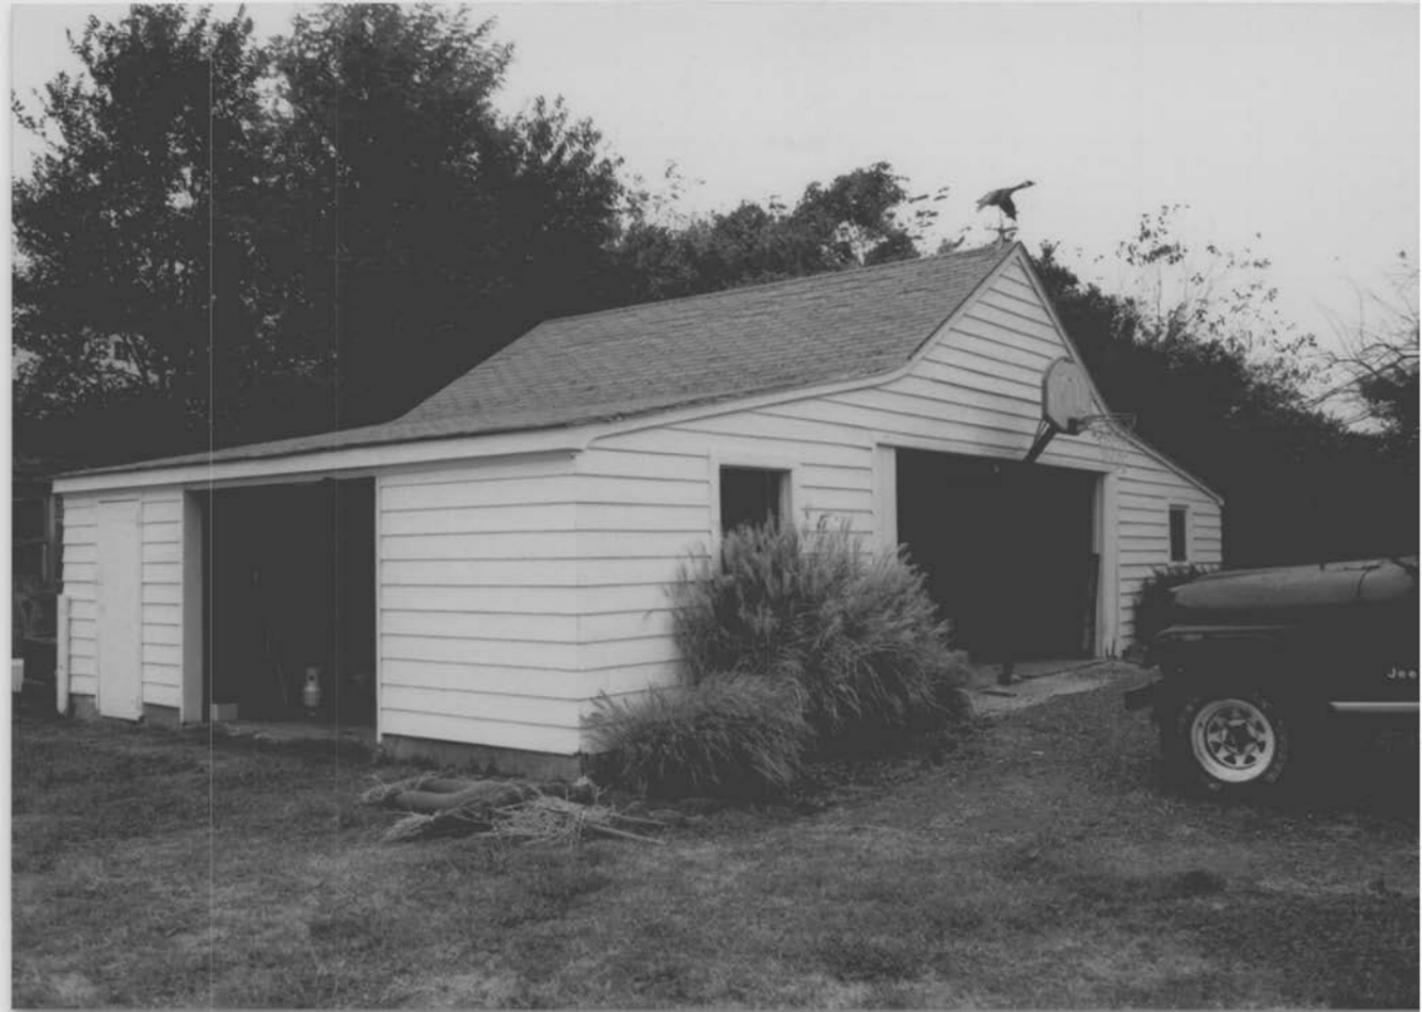
12 of 21

A three bay front-gabled garage is southeast of the pyramidal roof outbuilding. On the south elevation of the garage is a large opening for automobiles, supported by a metal post. Shed roof additions are on the east and west elevations. The building is covered in German siding and is roofed in asphalt shingles.

Garage, looking NE

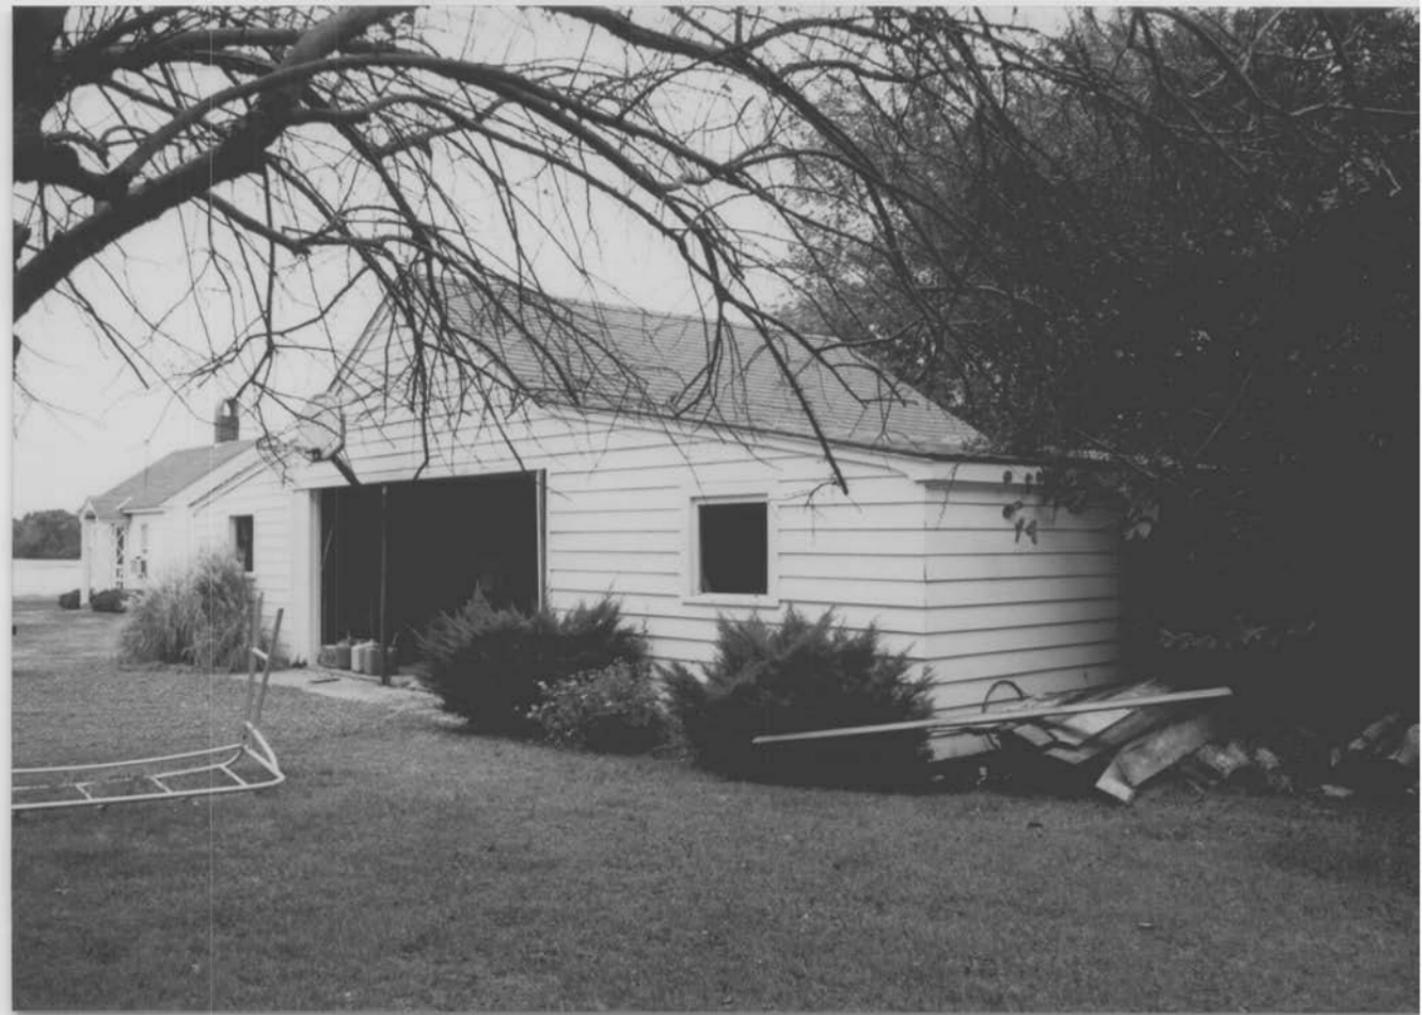
13 of 21

Garage, looking NW

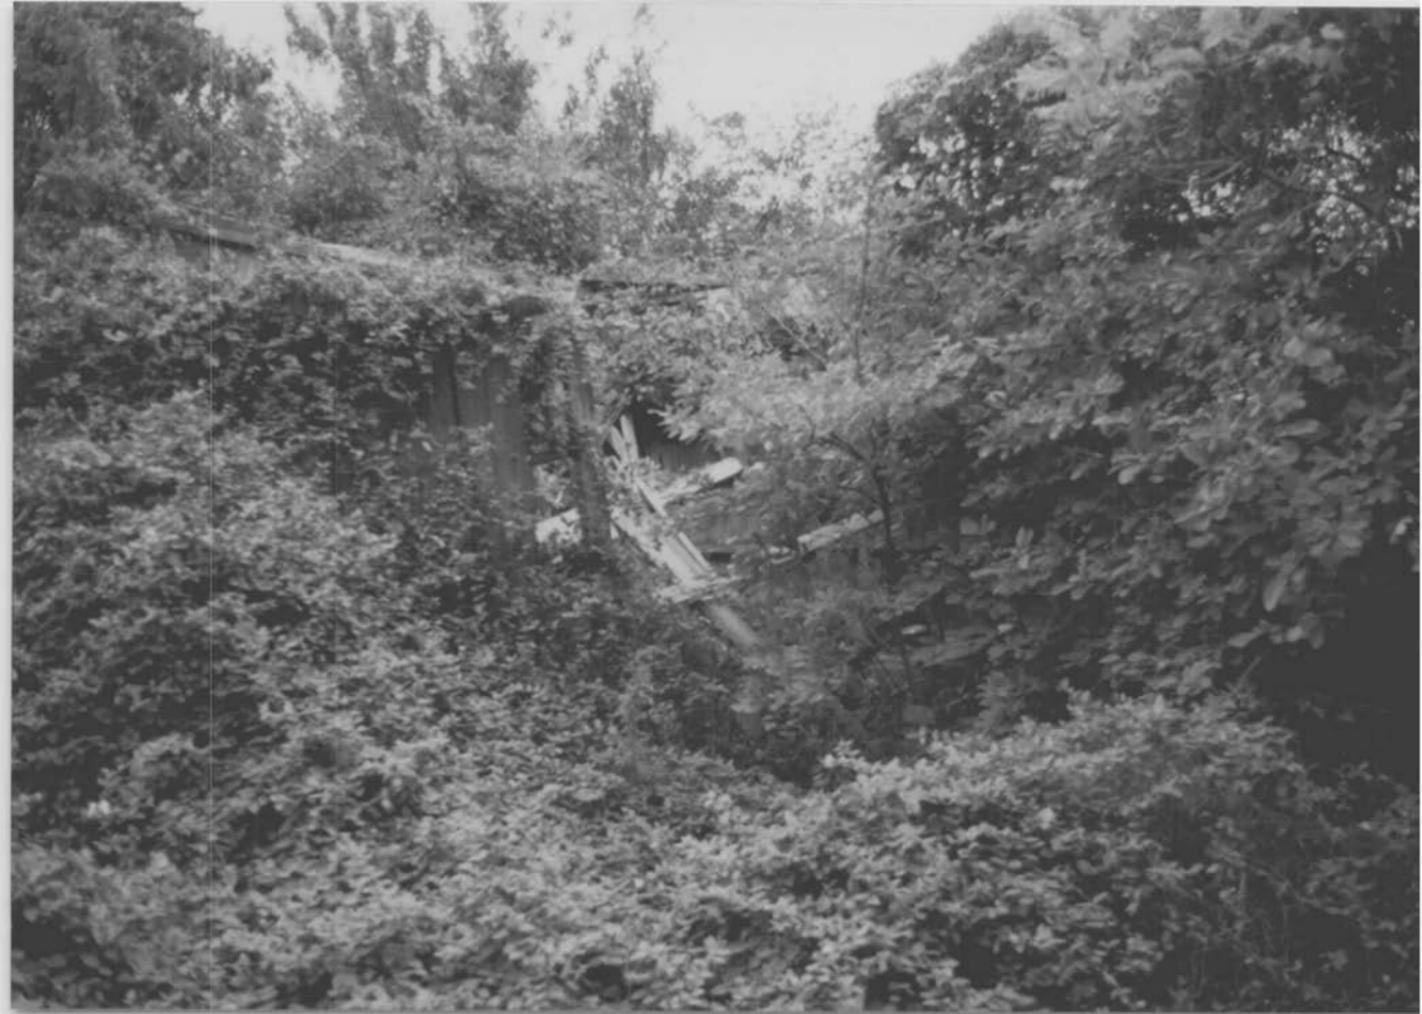
14 of 21

Collapsed outbuilding, looking south

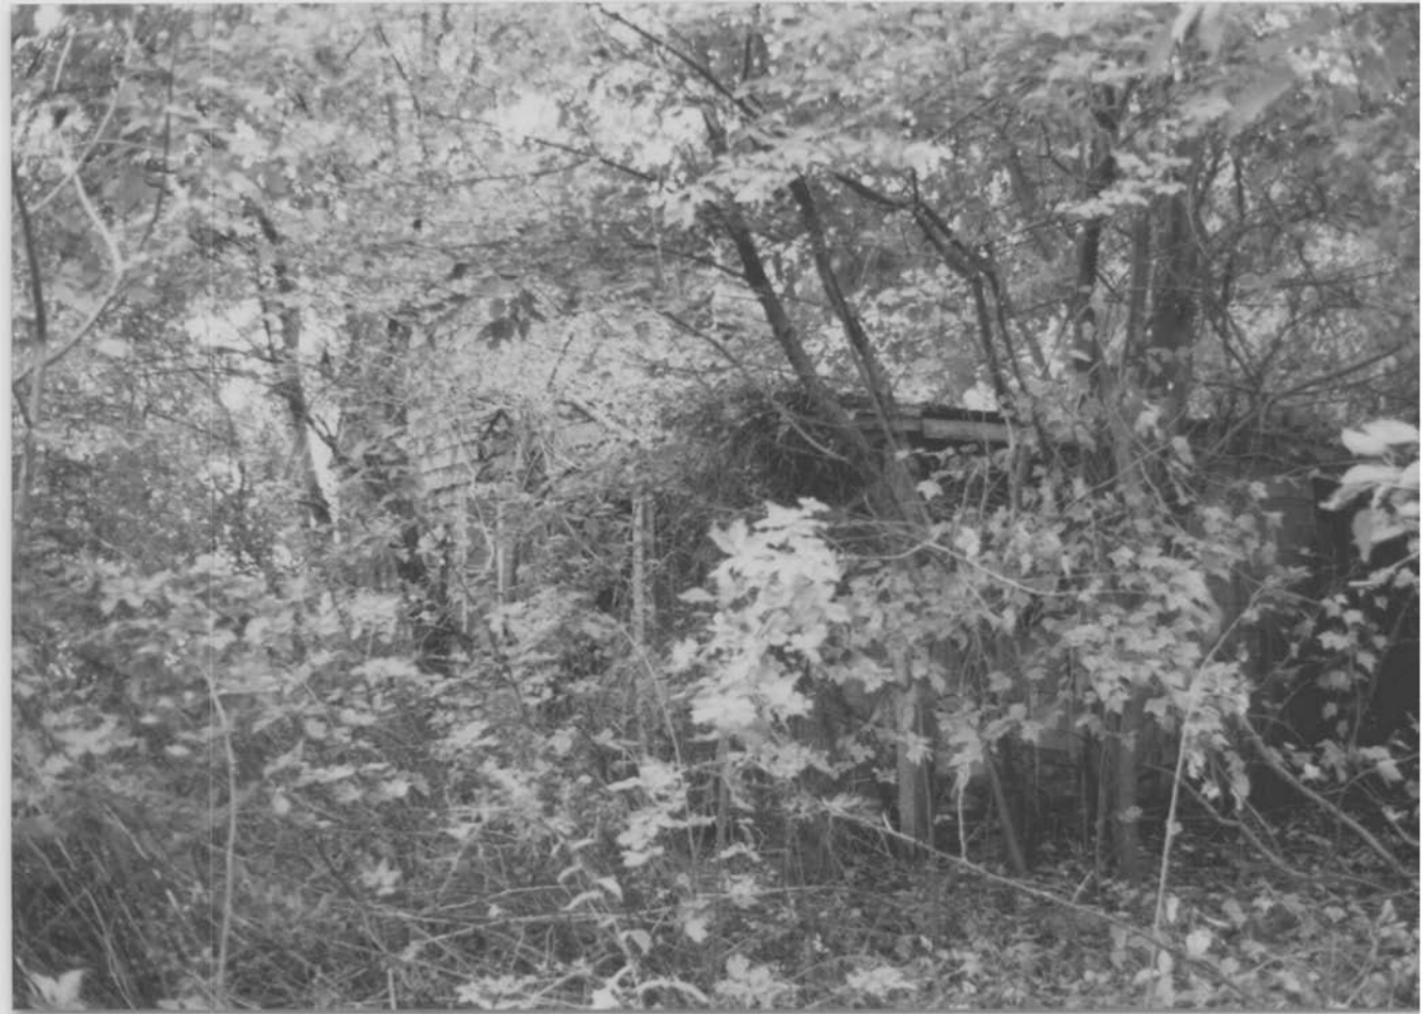
16 of 21

An abandoned house located north of the barn was reported by the owner to have been a "slave house," moved from the nearby Rolles Range Farm. Unless the building was extensively renovated, this seems unlikely. The one-and-one-half story lateral gabled, wood framed structure has a rear shed roofed addition and rests on concrete block piers with parged bricks in-between the piers. Paired gabled dormers with six-over-six double hung windows are located on the east and west roof lines. There is a central chimney on the main block, and an exterior chimney on the east elevation of the shed addition. The house is clad in wood shingles and is covered in asphalt shingles.

"slave house" looking NW
