Name: Strausburg Residence

MARYLAND INVENTORY OF  
HISTORIC PROPERTIES

Survey No. T-1132

and/or common Strausburg Residence

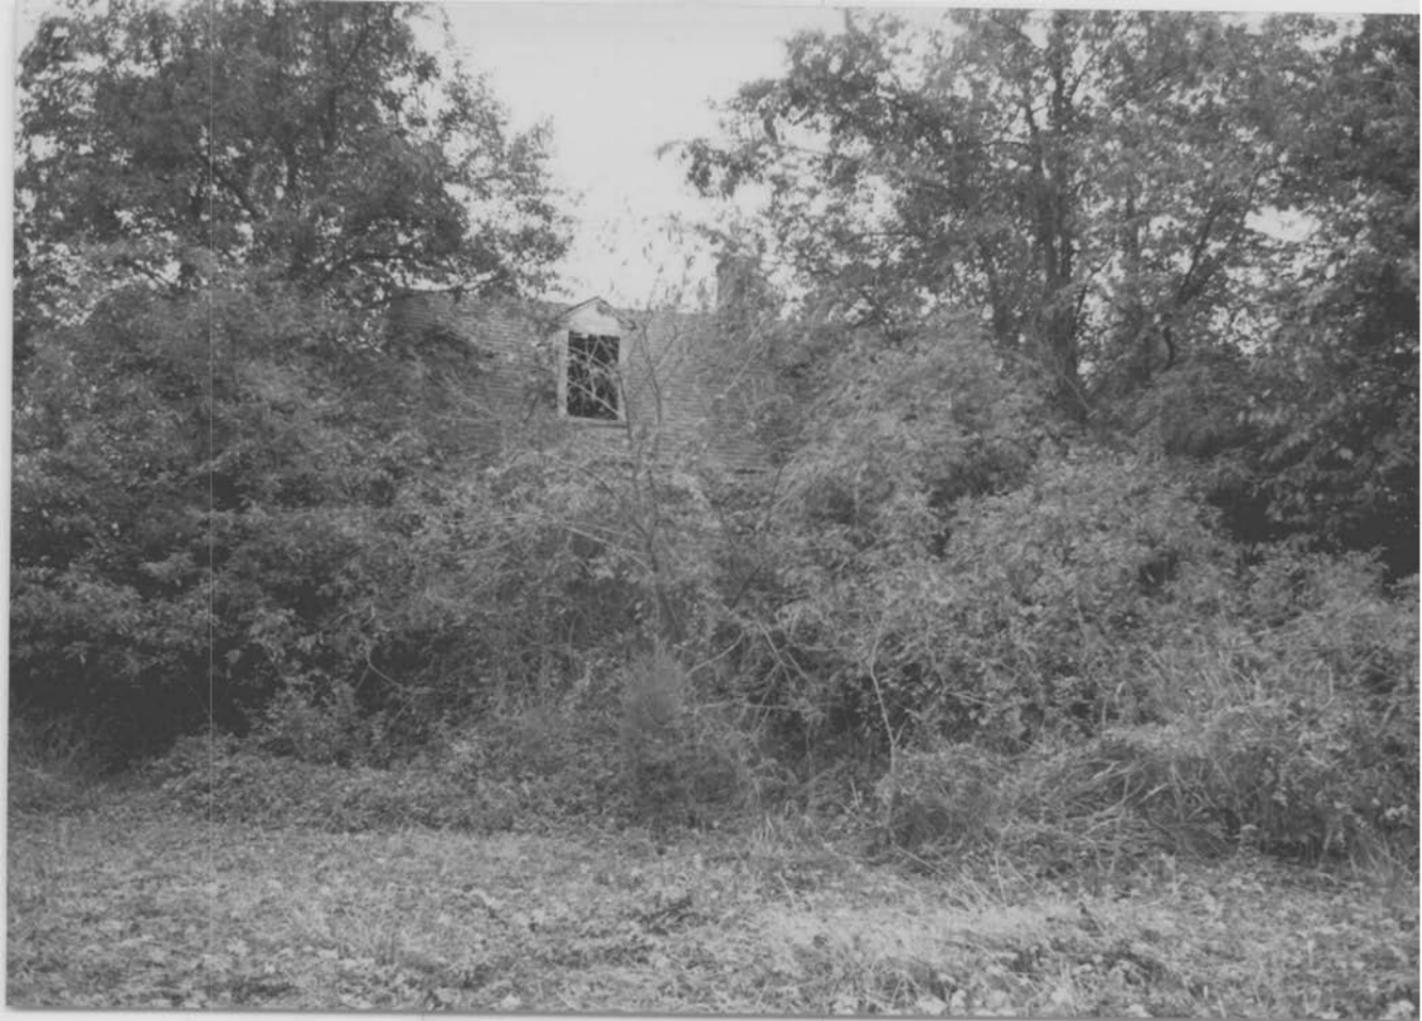
17 of 21

An abandoned house located north of the barn was reported by the owner to have been a "slave house," moved from the nearby Rolles Range Farm. Unless the building was extensively renovated, this seems unlikely. The one-and-one-half story lateral gabled, wood framed structure has a rear shed roofed addition and rests on concrete block piers with parged bricks in-between the piers. Paired gabled dormers with six-over-six double hung windows are located on the east and west roof lines. There is a central chimney on the main block, and an exterior chimney on the east elevation of the shed addition. The house is clad in wood shingles and is covered in asphalt shingles.

"slave house", looking east

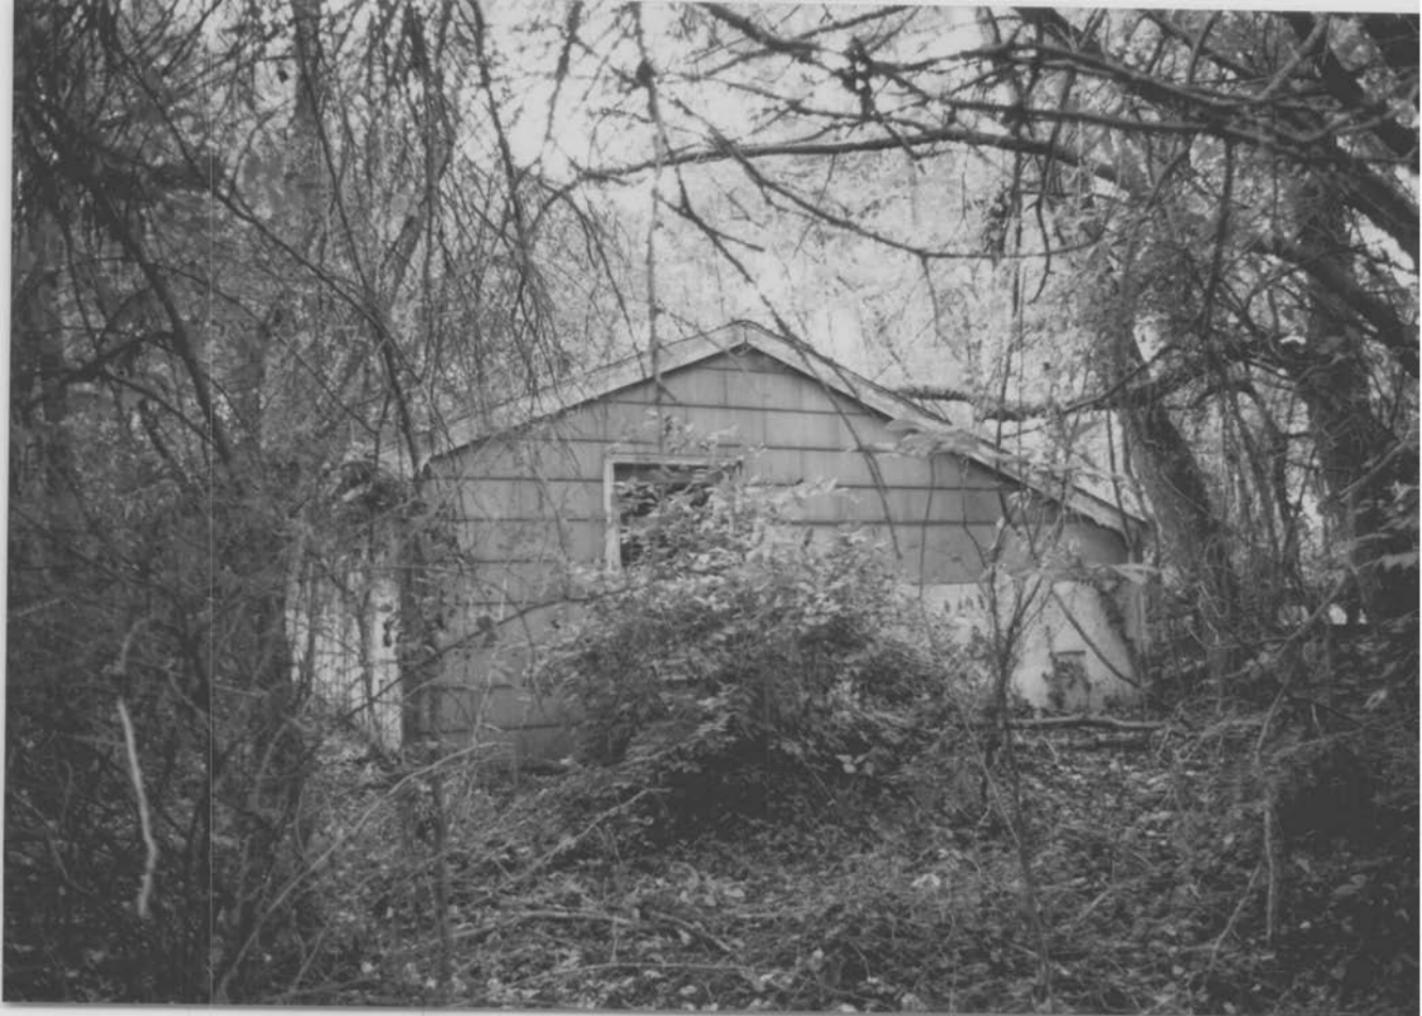
18 of 21

Outbuilding, looking west

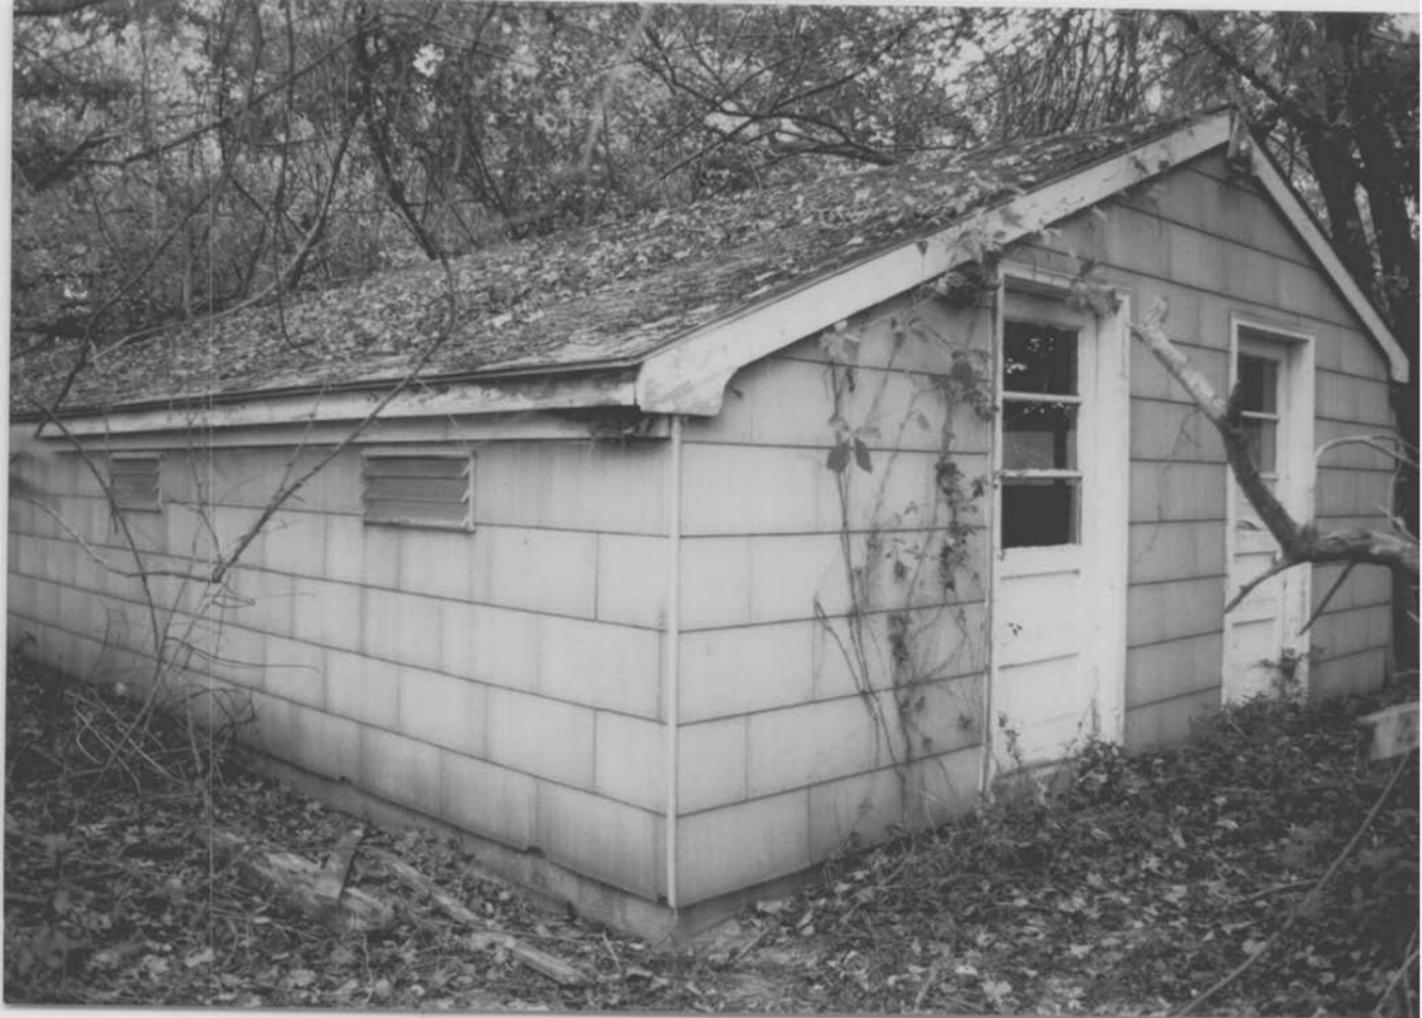
19 of 21

Outbuilding, looking SE

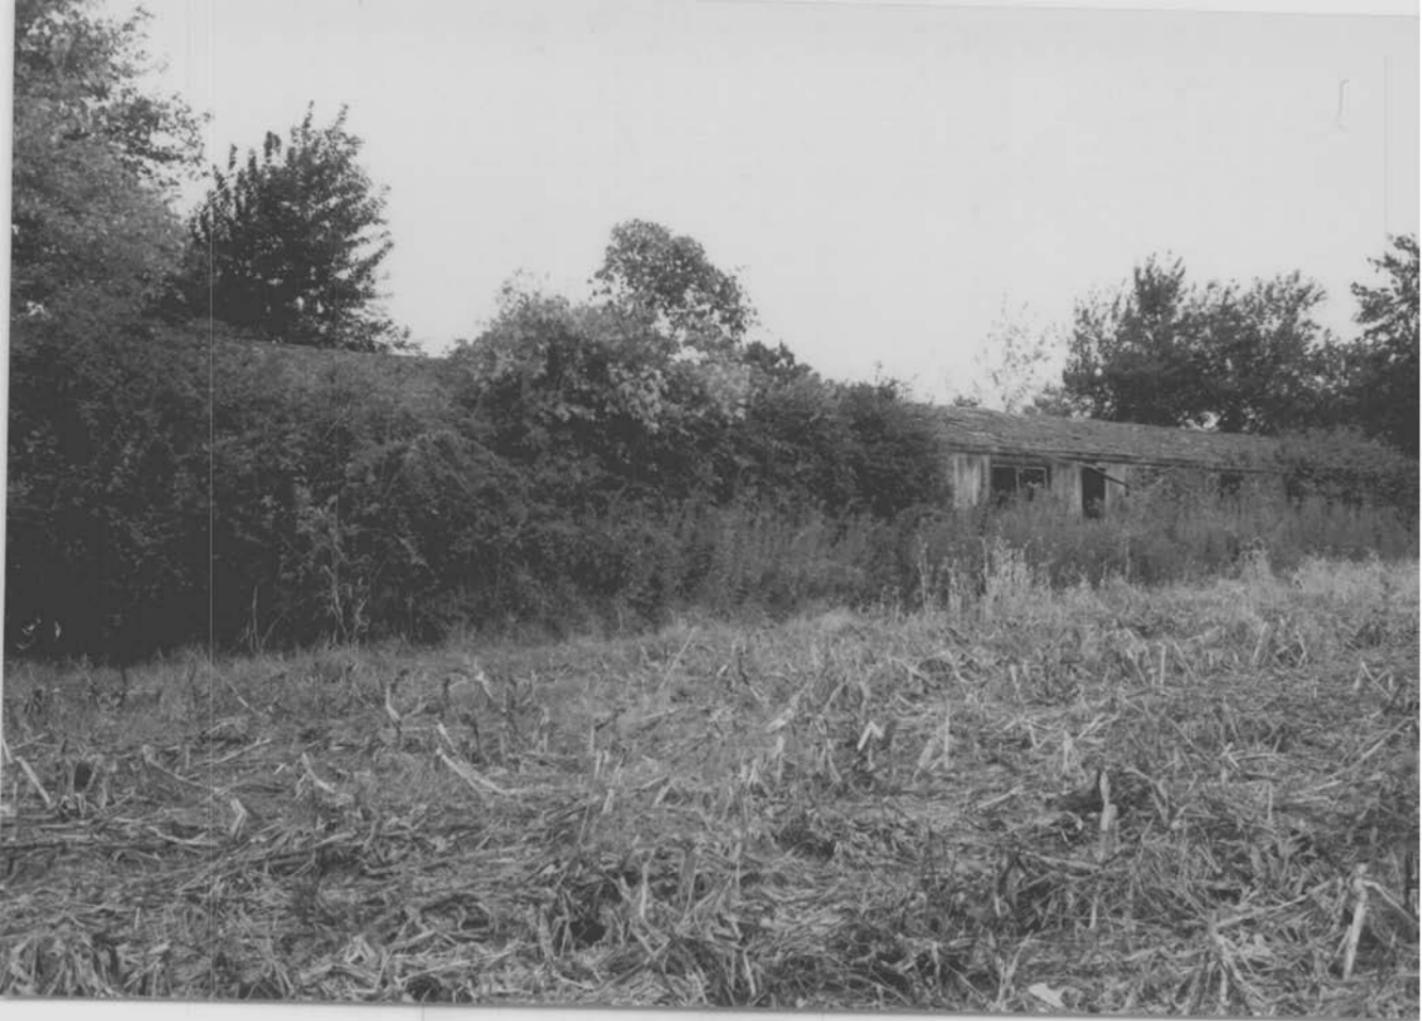
20 of 21

Processing? outbuilding, looking NE

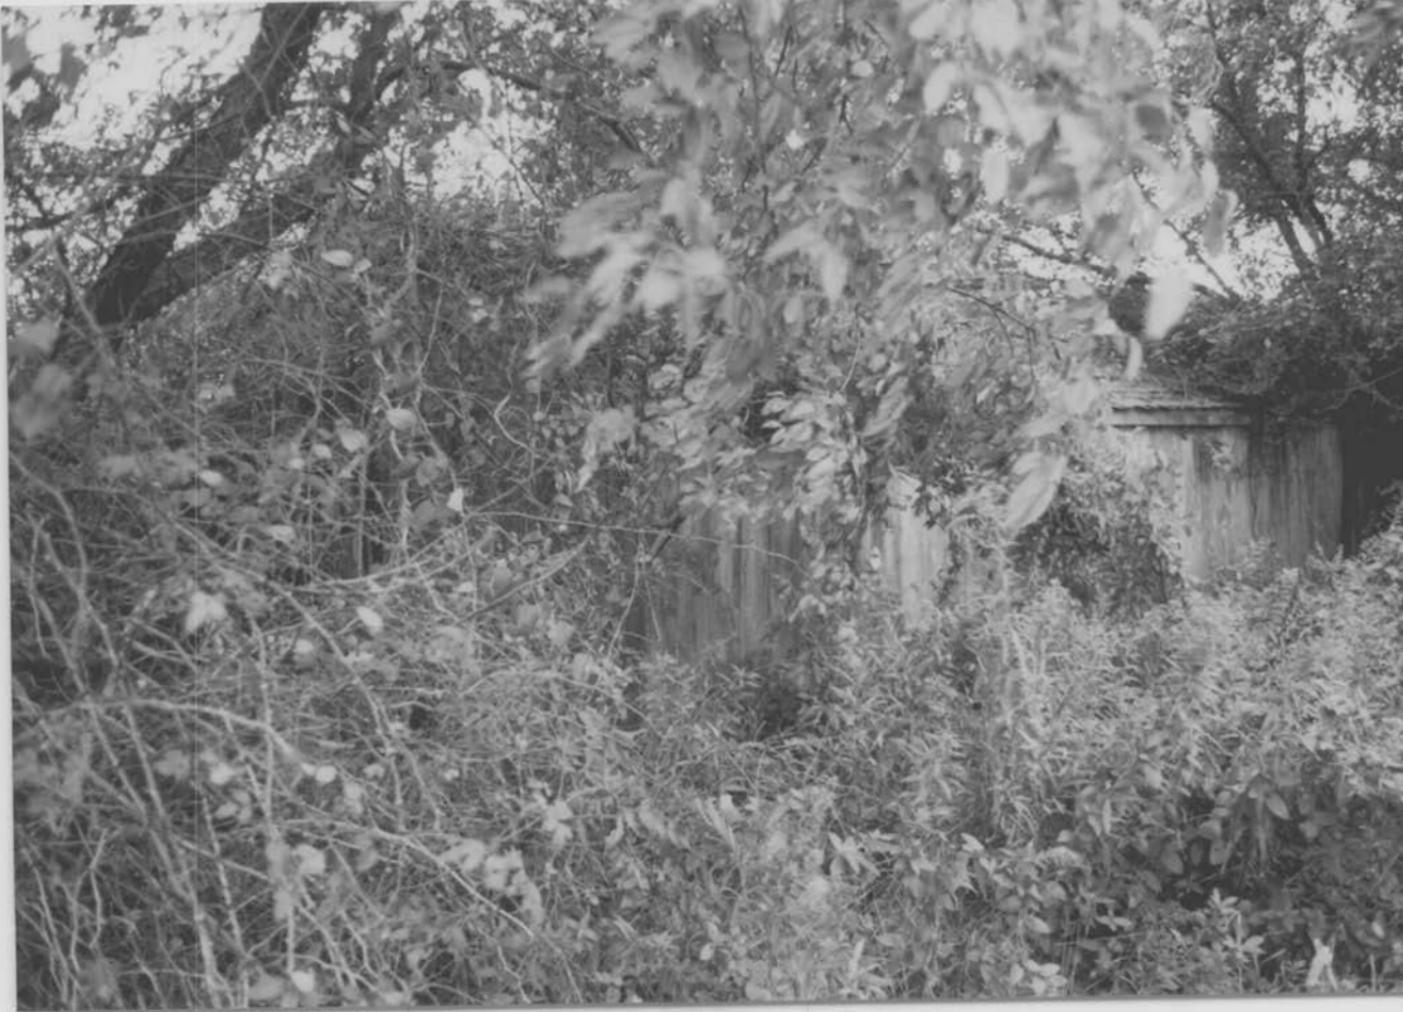
21 of 21

Processing? outbuilding, looking w
