# HAMMOND - HARWOOD HOUSE

## CULTURAL LANDSCAPE REPORT

PREPARED BY:  
HAMMOND-HARWOOD HOUSE ASSOCIATION INC.

2021

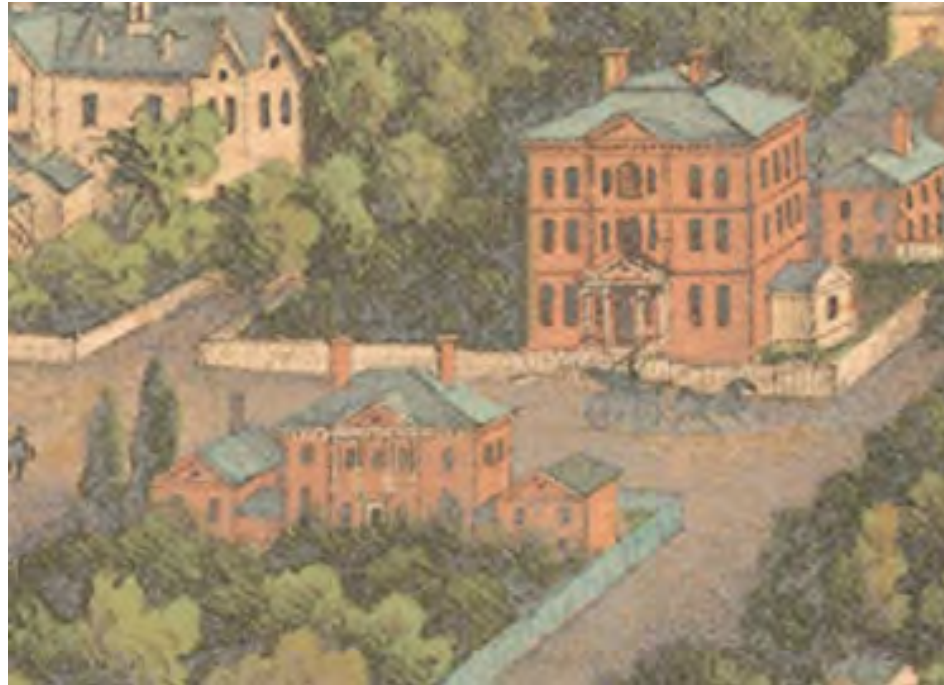
1858. Detail of the Annapolis bird's-eye view by Edward Sachse.

This detail of the 1858 view by Edward Sachse shows the property as it appeared from the east. One hesitates to place much faith in the color of the rear enclosure, but the draftsmanship seems astonishingly accurate where it can be evaluated against surviving features -- although the wings are shown as single stories, when they are actually two stories. A notable feature is the enclosure that stood along King George Street at what is now the outer edge of the present sidewalk. Most importantly, this enclosure turned 90 degrees at the corner, and continued some distance along Maryland Avenue, possibly crossing in the front of the house. Close to Maryland Avenue, it appears that the artist intended to depict vertical pales in the fence. Perhaps this enclosure was an antebellum addition. Whatever the date, a barrier taking in what are now sidewalks would equate today with a fence at the curb. Whether at the curb, or at the inner edge of the present walk, this fence would have obscured a house that was made to present itself to the street. Perhaps it bowed back toward the front of the house, as across the street at the Chase-Lloyd House? If so the fence of what had become the Harwood property would not have been as successful as *that* across the street, where the house sits much higher, allowing the deeper, higher steps to pour out over and beyond the barrier.

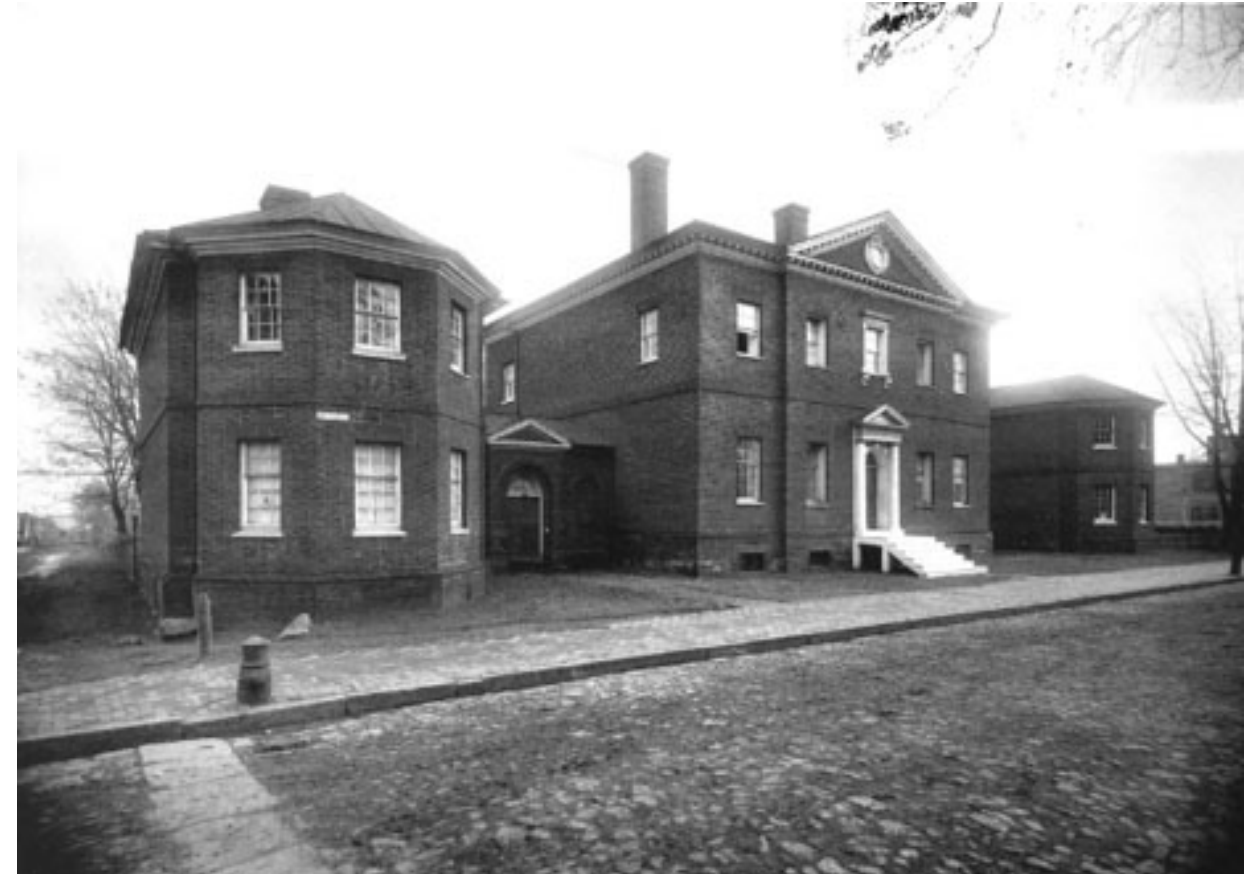
Image #1 - 1892 or before.

A large stone at the outer corner of the wing may have served as a splash block, standing under a truncated rain leader. Nearby, a bollard delimits what was presumably the northern boundary of the property, just at the foundation of the wing. At the stone curb of the Maryland Avenue sidewalk, a cast-iron hydrant aligns with the flank of the wing. By this time, there appears to have been a brick walk along King George Street as well as Maryland Avenue.

The photo seems to have been taken in the spring. The image is credited to the Heliotype Printing Company of Boston. Sanborn fire insurance maps for this area of town show that lots behind the Hammond-Harwood House remained vacant until 1891 at least. That would seem to be the condition reflected here, as the fencing along King George Street appears continuous.

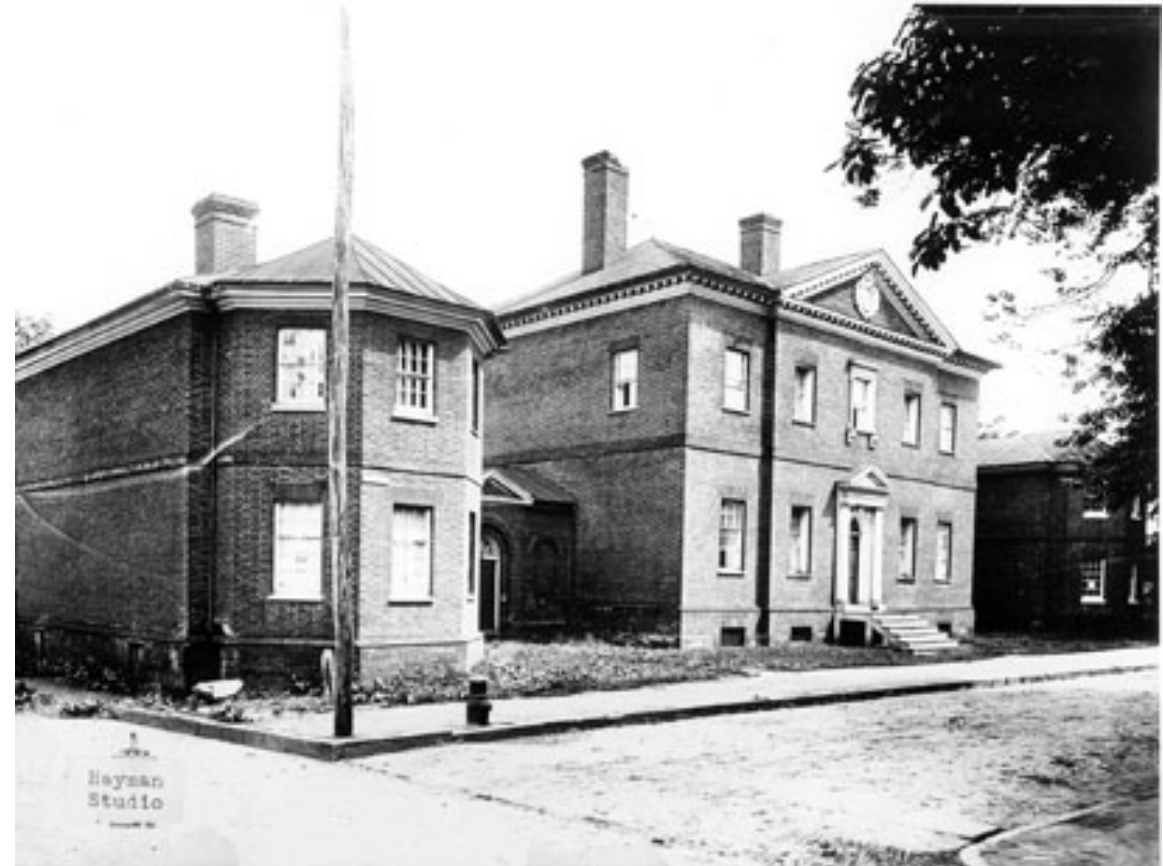
Image #2 - Probably 1892-1895. From a glass plate negative.  
The Hayman Studio

The photo marked “Hayman Studio” seems to have been a glass plate negative originally, judging from what appear to be cracks at the left margin.

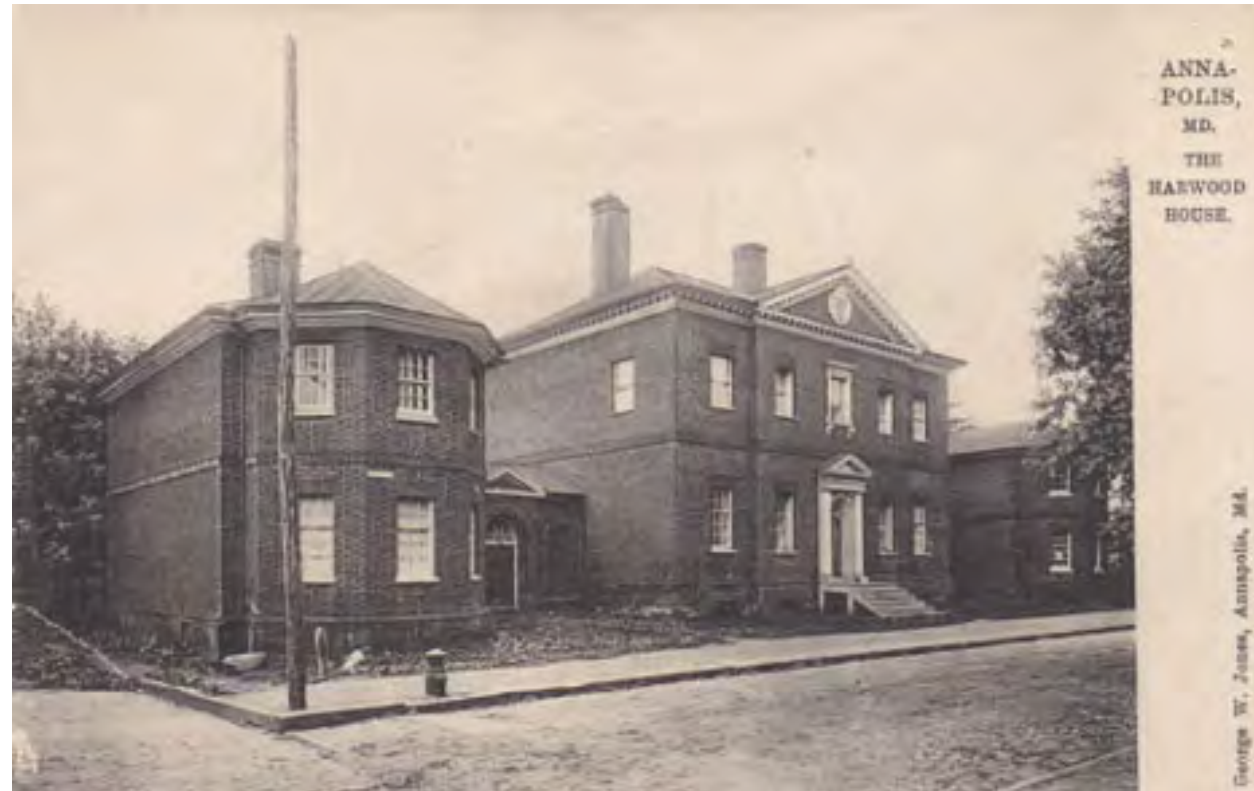
Image #3 - Probably 1892-1895. Photo by George W. Jones, appearing here on a later, unused postcard.

Initially, this photo appears contemporaneous with the one preceding. Seemingly, little had changed since the previous photo, but this one was taken from a slightly different angle, and probably on a different day than the preceding image. In both cases, shadows indicate that the sun was in the west, well up in the sky, all indicative of summer, which is confirmed by the trees in full foliage. Despite being taken about the same time of day, the two images reflect very different lighting conditions (sunny and clear *versus* overcast), and the steps seem to have slumped just a bit more in this photo, and they had become just a bit dirtier.

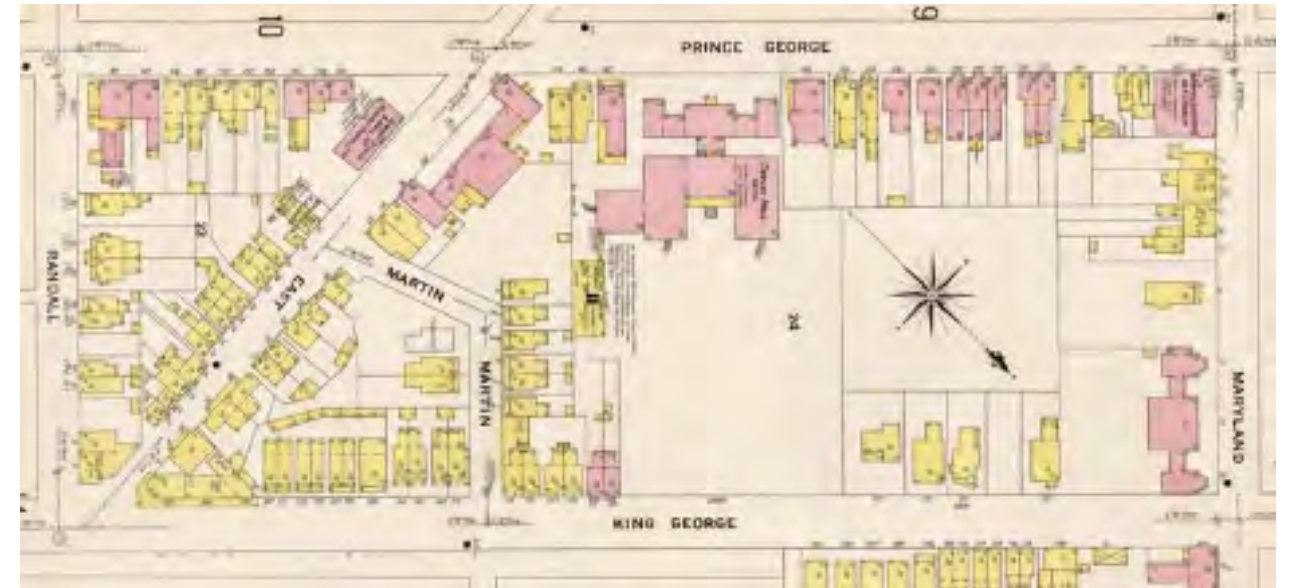
Image #4 - 1897. Sanborn Fire Insurance Plan.  
Library of Congress

The black dot at the corner of Maryland Avenue and King George Street represents the cast iron hydrant seen in the 1892 photo. The 1885 Sanborn survey for this area indicates that hydrants and water mains were already in place by that date. This hydrant in front of Hammond-Harwood House stood beyond the property line, which coincided with the inner edge of the sidewalk. Thus, the fence seen behind the house in the 1892 photo stood on the Harwood property line.

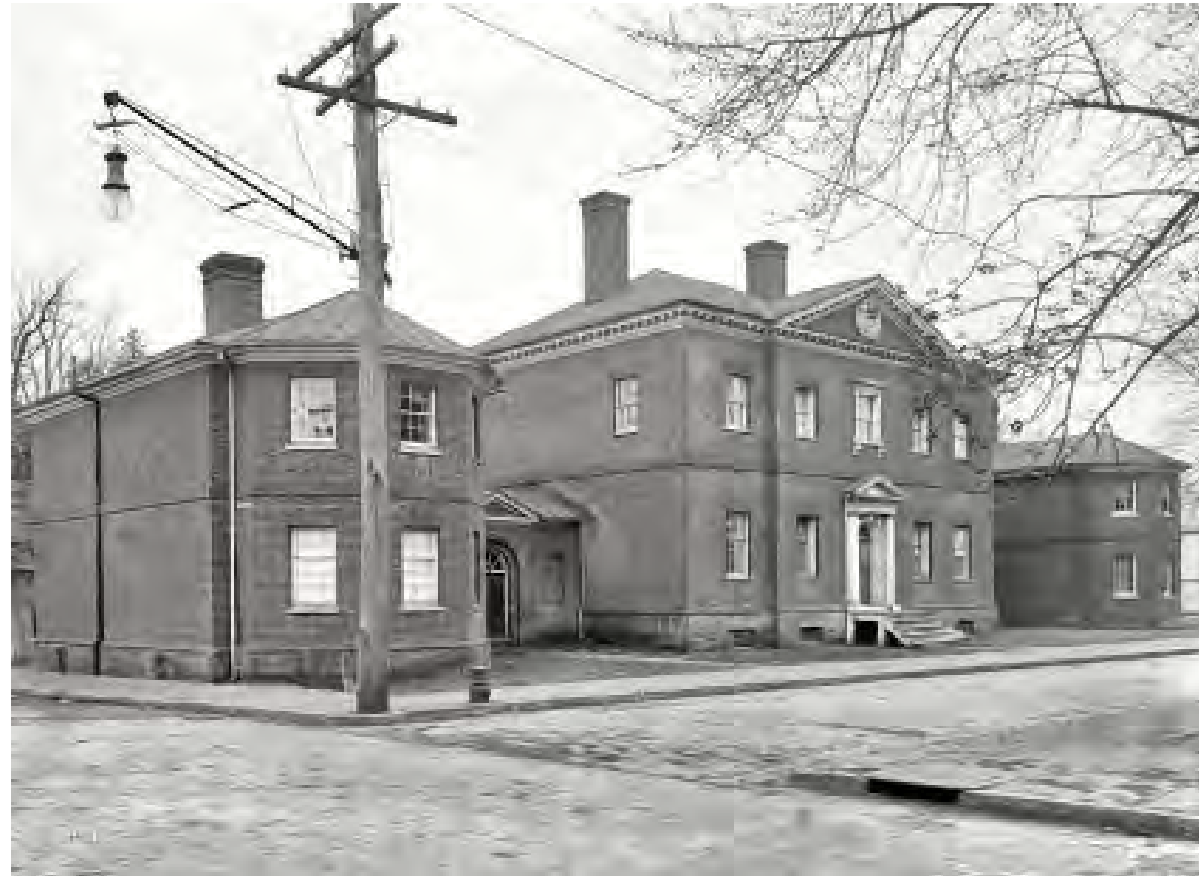
Image #5 - c. 1905?

This photo, supposedly dating to c. 1905, documents the addition of a cast-iron vent stack on the side of the wing since the previous photo. Street lighting had been introduced, so that a large electric fixture and many utility lines now hung from a robust new post. The decline of the house was increasingly evident as the steps continue to sag and accumulate dirt. The visible flank of the main house had been darkened by splash-back above the hyphen roof, probably a consequence of clogged gutters above. Perhaps this explains the bright new rain leaders at the front corner of the wing, and at the junction of hyphen and main house. Above the main roof, a missing corner of the north chimney had been repaired, and the stone curbing had been reconfigured to make a rounded transition between the adjacent streets.

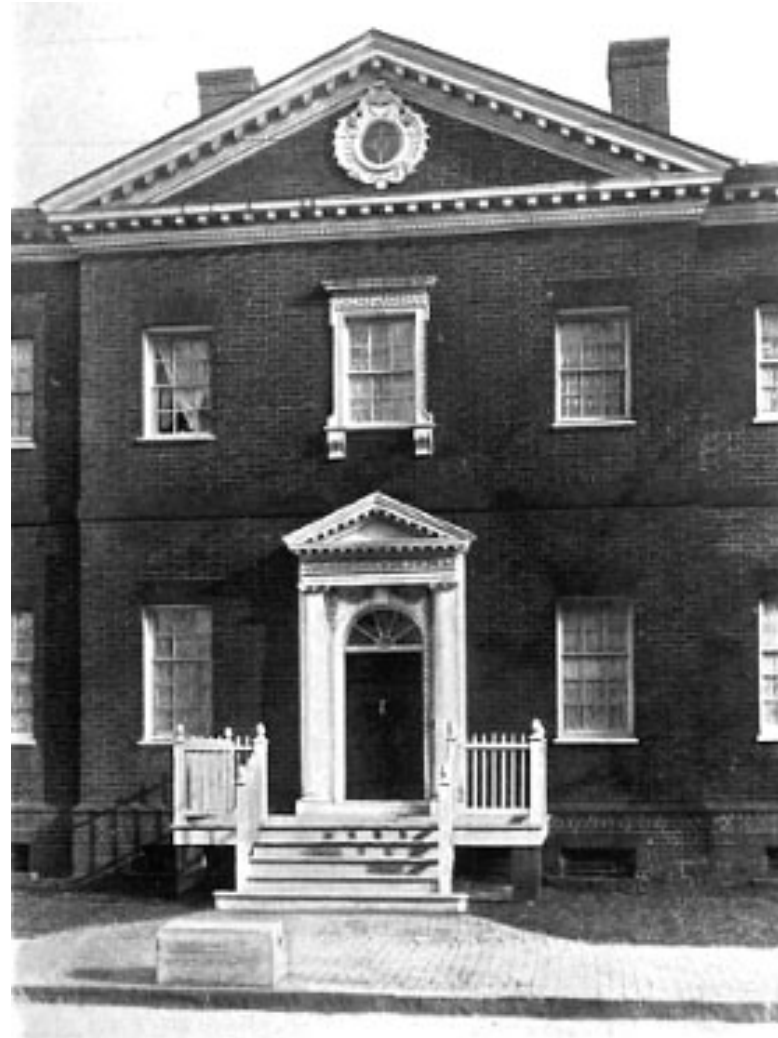
Image #7 - Before 1914.  
Hammond, *Colonial Mansions of Maryland and Delaware*, 1914.

This image, published in 1914, may be the first to show the Colonial Revival porch and wooden balustrade that succeeded the wooden stoop. The details of the balustrade may have been inspired by those at the Chase-Lloyd house across the street. The brick walk appears to have been reworked to accommodate the new steps. As yet, there were no boxwoods and no chain fence at the walk, and it looks as if all ivy had disappeared. A stone mounting block[?] appears at the curb.

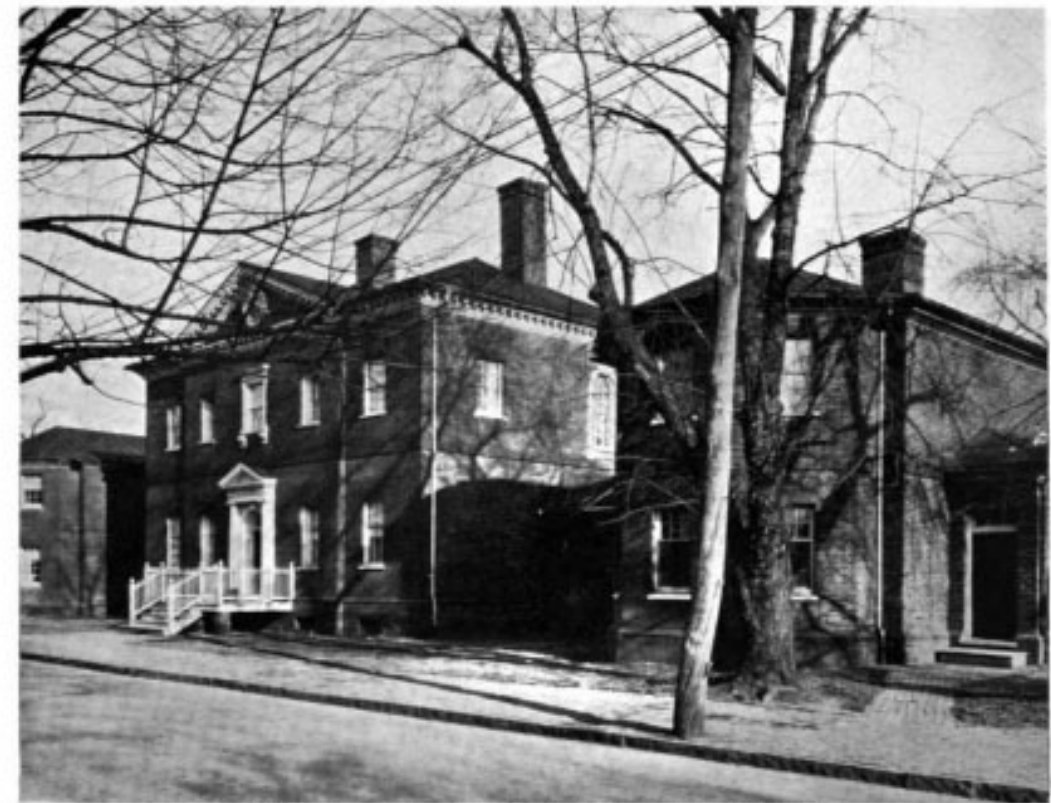
Image #8 - Before 1922. The Harwood House  
*The Architectural Forum*, October 1922, p. 160.

GENERAL STREET VIEW. PORCH AT EXTREME RIGHT IS MODERN WORK.

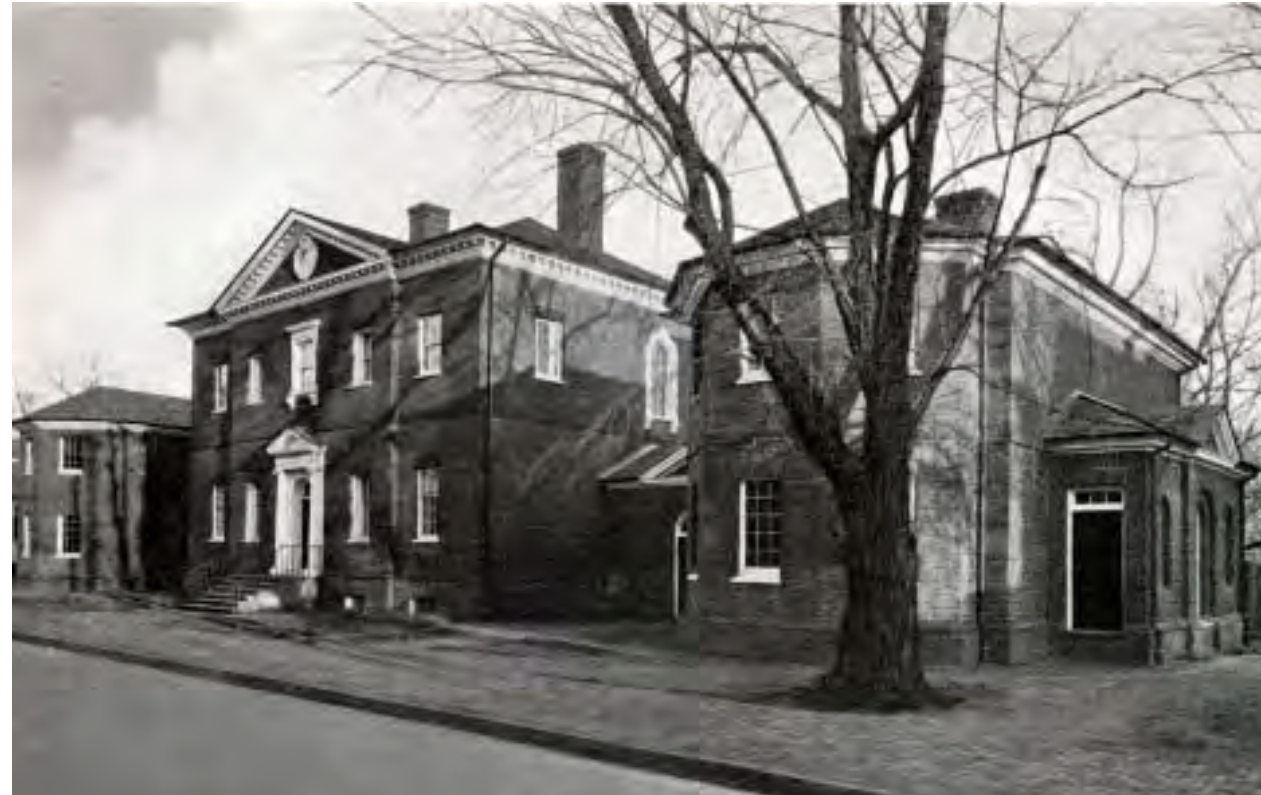
Image #8 - c. 1928  
*Historic Houses for St. John's.*

This photo was taken from a nearly identical vantage point as that preceding, but at a later time. Stone steps and iron railings had since appeared at the front doorway, but no boxwood or ivy. The unsightly utility pole and the single exterior step of the wing's eastern appendage had disappeared. Owing perhaps to the ownership of St. John's College, the property presented a neater appearance, including what appears to have been a recent re-painting. The brochure cited in the caption bears no publication date, but one antiquarian book dealer places its publication around 1928. St. John's College had acquired the property in 1926. It appears that a slate roof had since been installed.

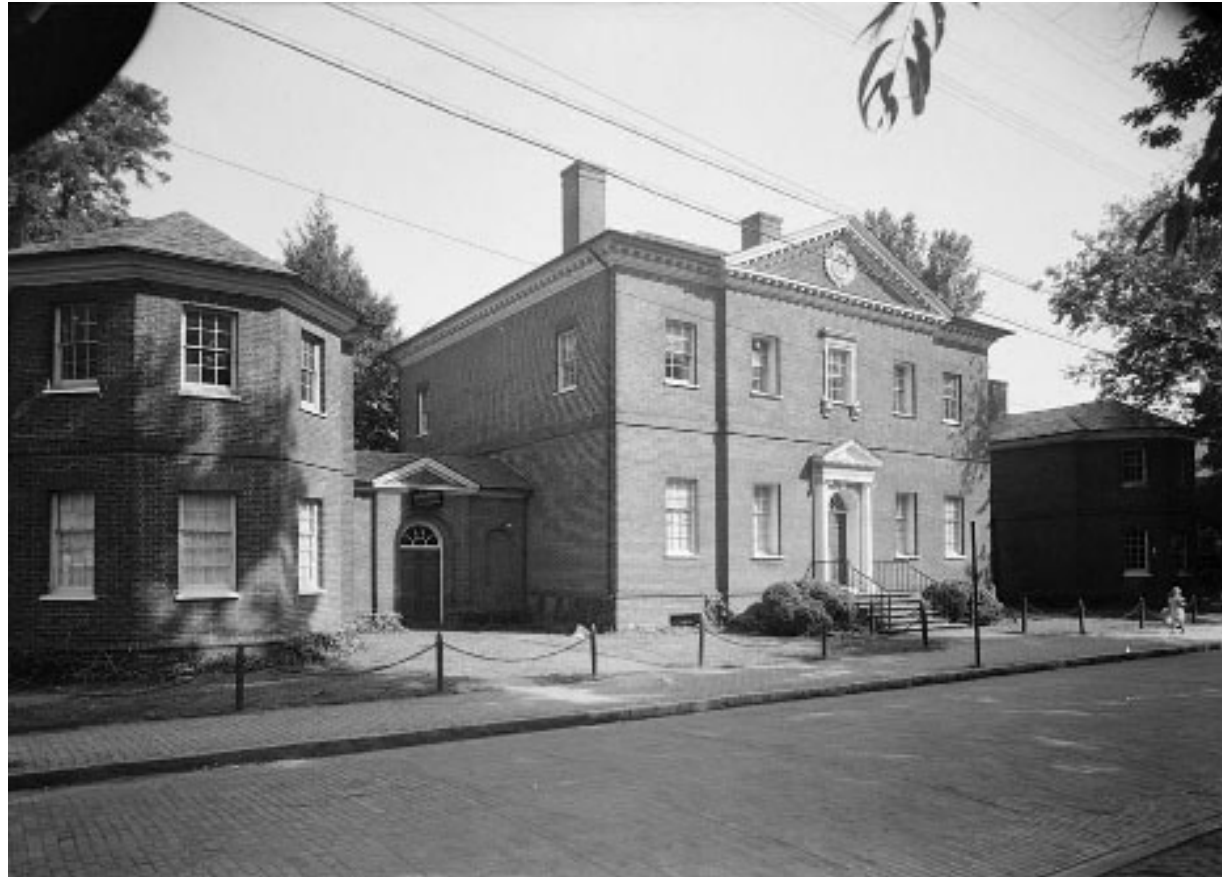
Image #10 - 1936. This view was taken for the Historic American Buildings Survey in June of 1936. E. H. Pickering, a local photographer, was mentioned among the contributors. Perhaps he produced this image. American Buildings Survey, Library of Congress.

By the time of this photo, the Colonial Revival porch had been present for nearly a decade, and so was enfolded in small boxwoods and ivy. The lawn was now cordoned off by a suspended chain fence, with short, pointed posts painted in some dark hue. The street was handsomely paved.

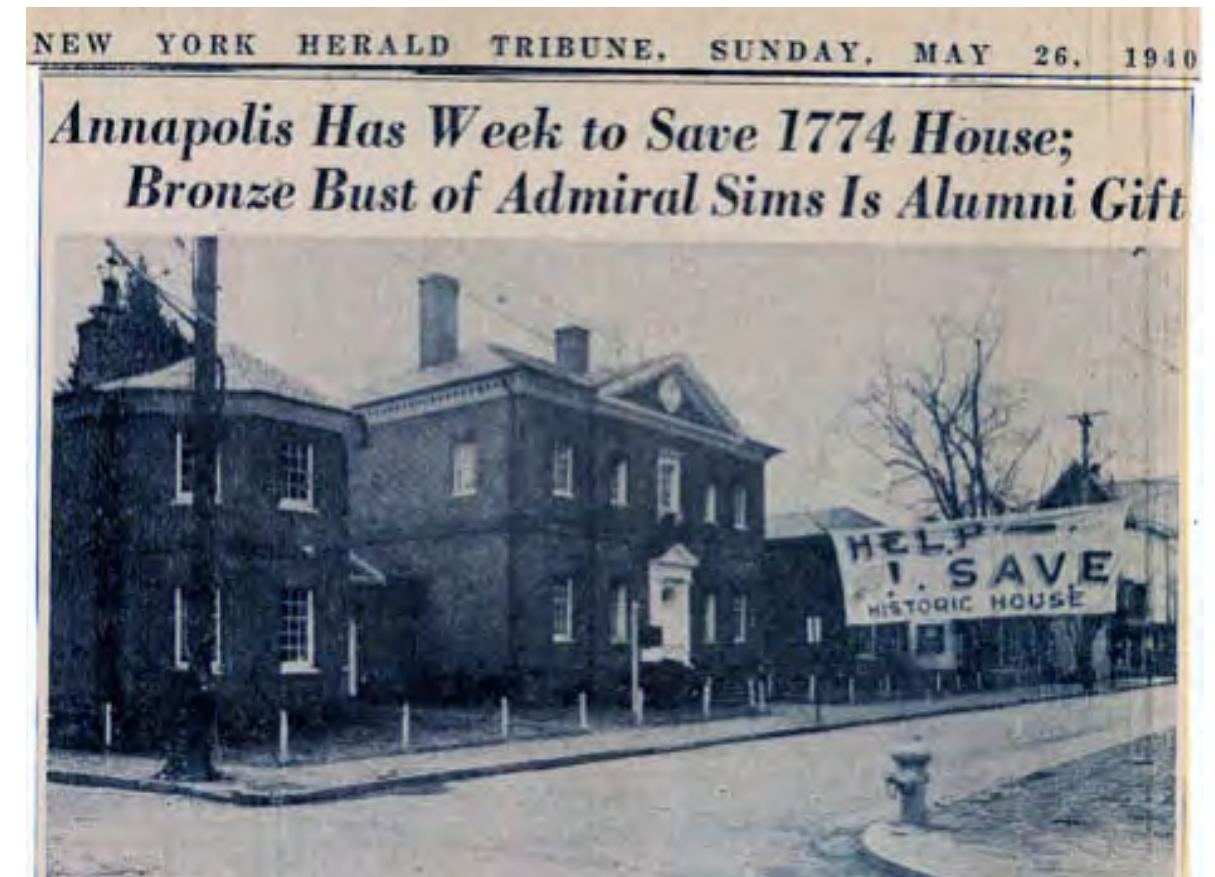
1940. "Annapolis Has Week to Save 1774 House..."  
New York Herald Tribune, May 26, 1940.

By 1940, the utility pole at King George Street had moved back from the corner, the posts of the suspended chain fence had been painted white, and a new fire hydrant had appeared on the corner by the Chase-Lloyd House.

Financial necessity compelled St. John's College to sell its historic house properties in 1940. The painted banner proclaims the availability of the Hammond-Harwood House.

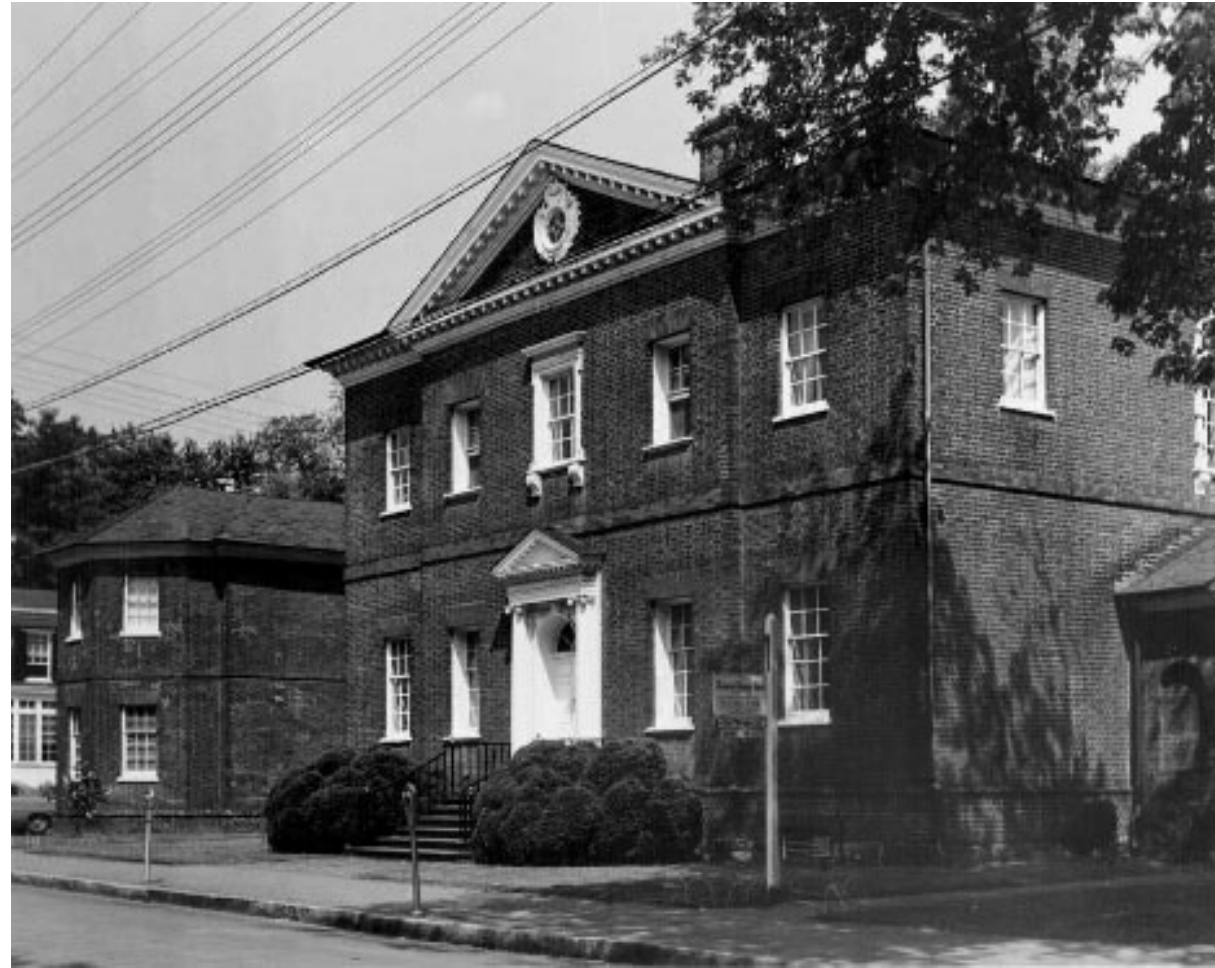
1966. Looking east.  
National Register of Historic Places.

After the 1940 sale, the Hammond-Harwood House continued to function as a museum, as indicated by the sign. By 1966, parking meters had appeared, and small metal wickets served to keep pedestrians off the lawn as they turned to approach the visitors' entry. The boxwoods flanking the main entry had grown plump over the space of a quarter century. In the meantime, efforts to beautify the yard continued with the addition of small boxwoods by the front entries of the hyphens. Perhaps the wooden posts of the chain fence had rotted and failed; at any rate the fence was gone. A small magnolia tree stood in front of the far wing. In the future, this tree, or one of its progeny would assume a more imposing aspect. A paired magnolia may have been planted at the same time in front of the south wing—it is not shown in this photo, however.

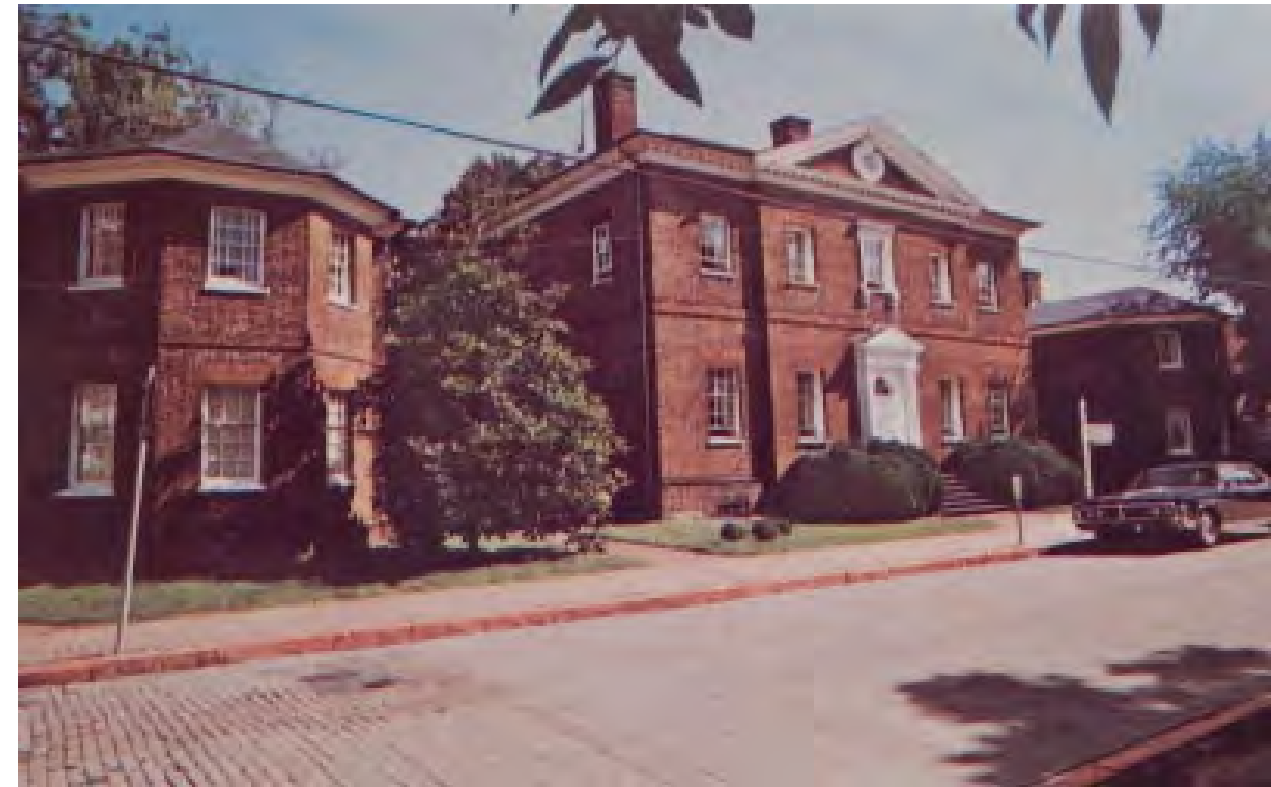
After 1969. Looking south.

A 1969 Buick stands before the front of the mansion in this color photograph. Since the previous photo, boxwood shrubs had billowed out to enclose the front steps completely, extending clear across the main dwelling's central pavilion. In the meantime, a mature magnolia had occupied the yard in front of the wing. Metal wickets and the intersections of the walks had disappeared, but small boxwood bushes planted at the corners took over their function of protecting the lawn at its most vulnerable points. The curb now painted red to warn away motorists who thought of parking in front of the mansion or too close to the corner. The museum sign present in the 1966 photo seems to have moved closer to the walk for the main entrance.

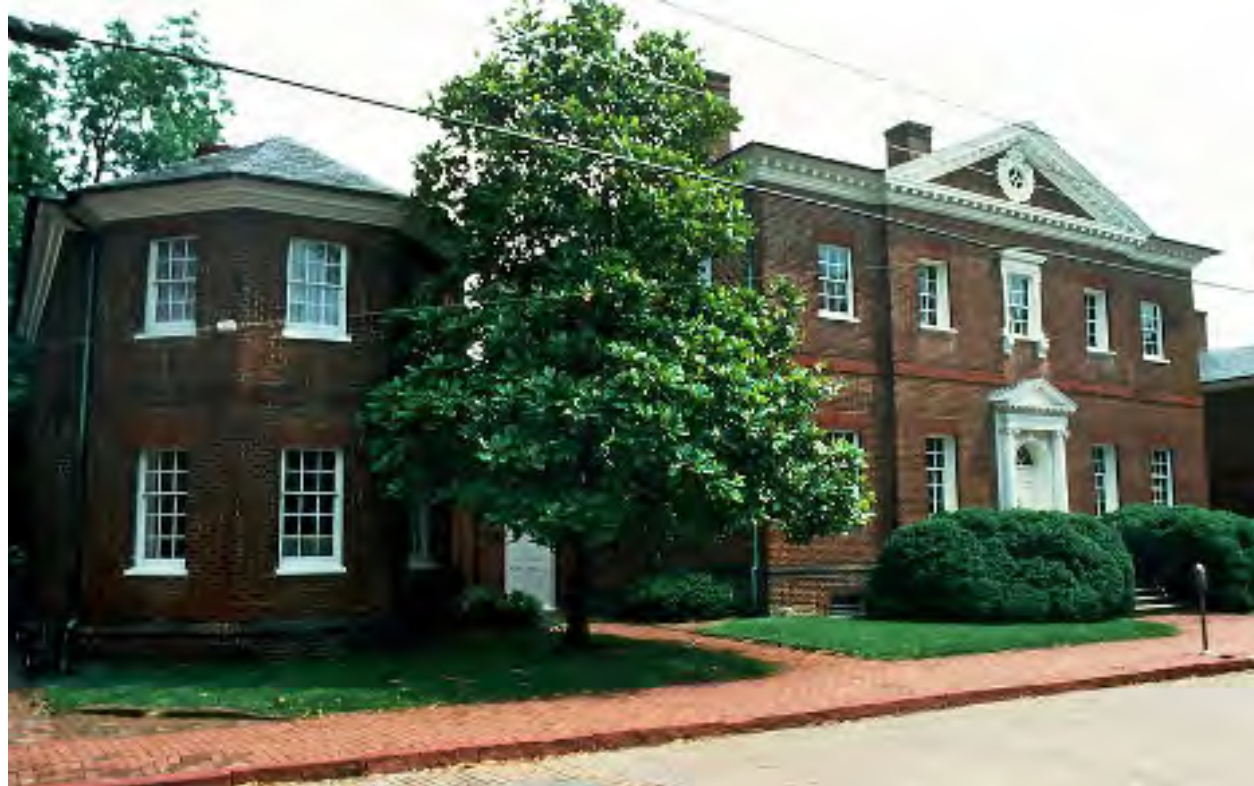
Reportedly 1985. Looking south.

By the time this photo was taken, the boxwoods had grown to embrace everything between the basement windows. The small boxwoods near the main walk had not survived, but those at the north hyphen doorway had grown to occupy most of the available space. The magnolia tree was now as tall as the wing. The red paint remained on the curb, but the parking sign was gone.

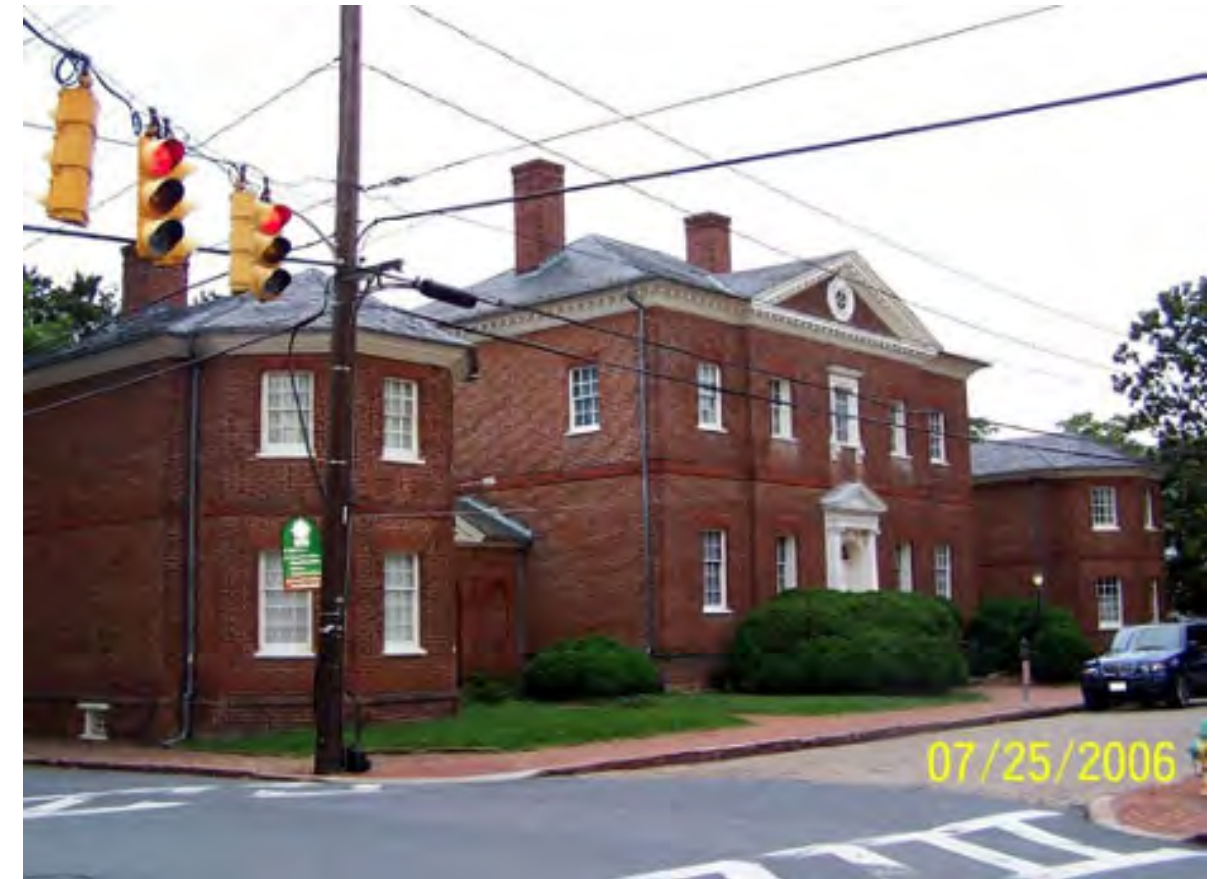
July 25, 2006. Looking southeast.

Twenty years after the preceding image, the great boxwoods were moving to envelope the basement windows, while those at the hyphen door were beginning to creep over the sidewalk. On both sides of Maryland Avenue, ADA compliant crossing points had removed the curb stones at the intersection with King George Street. That thoroughfare had been paved with asphalt, while an unsightly utility pole carried larger and more numerous cables while holding a collection of traffic signals aloft. The remaining curbstones retained their coat of red paint.

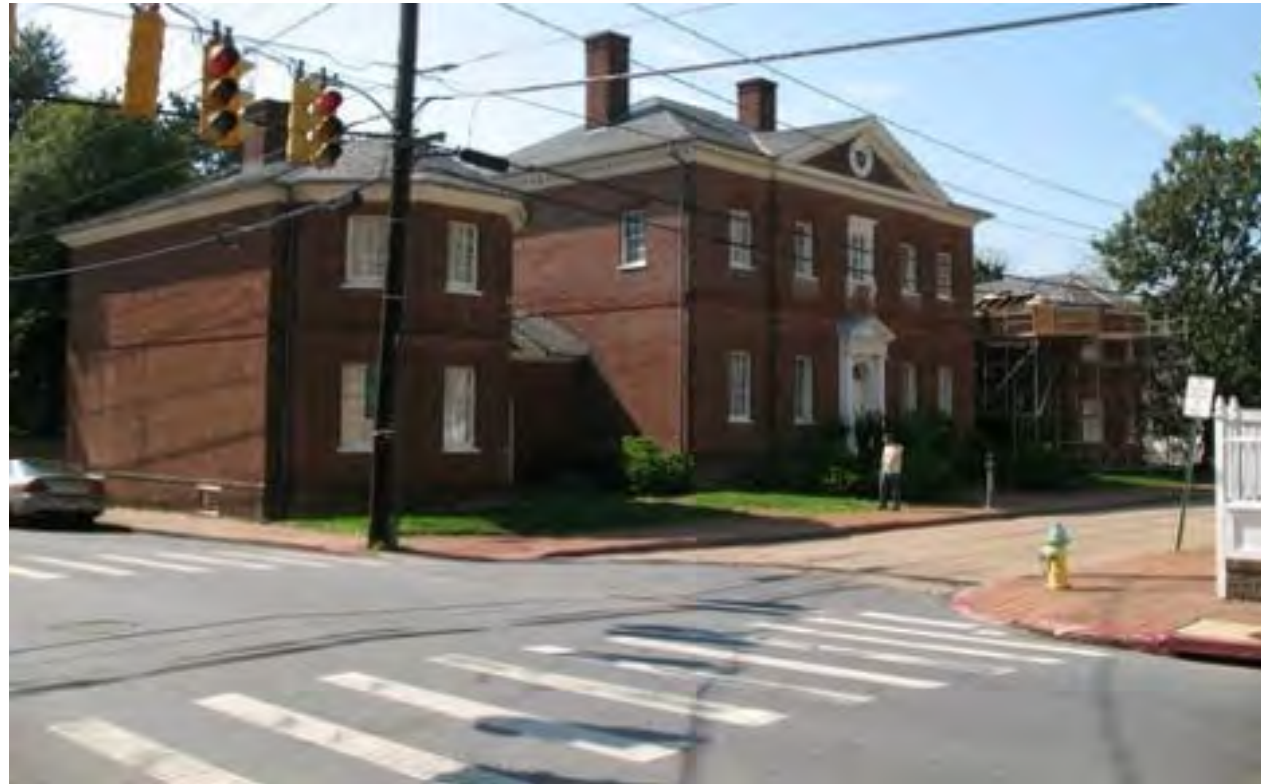
2011. Looking southeast.

At the time of this photo the slate roof of the far wing was being replaced. The boxwoods at the entry have been broken down and those by the hyphen doorway were getting out of control.

Meanwhile, the hardscape remained little changed.

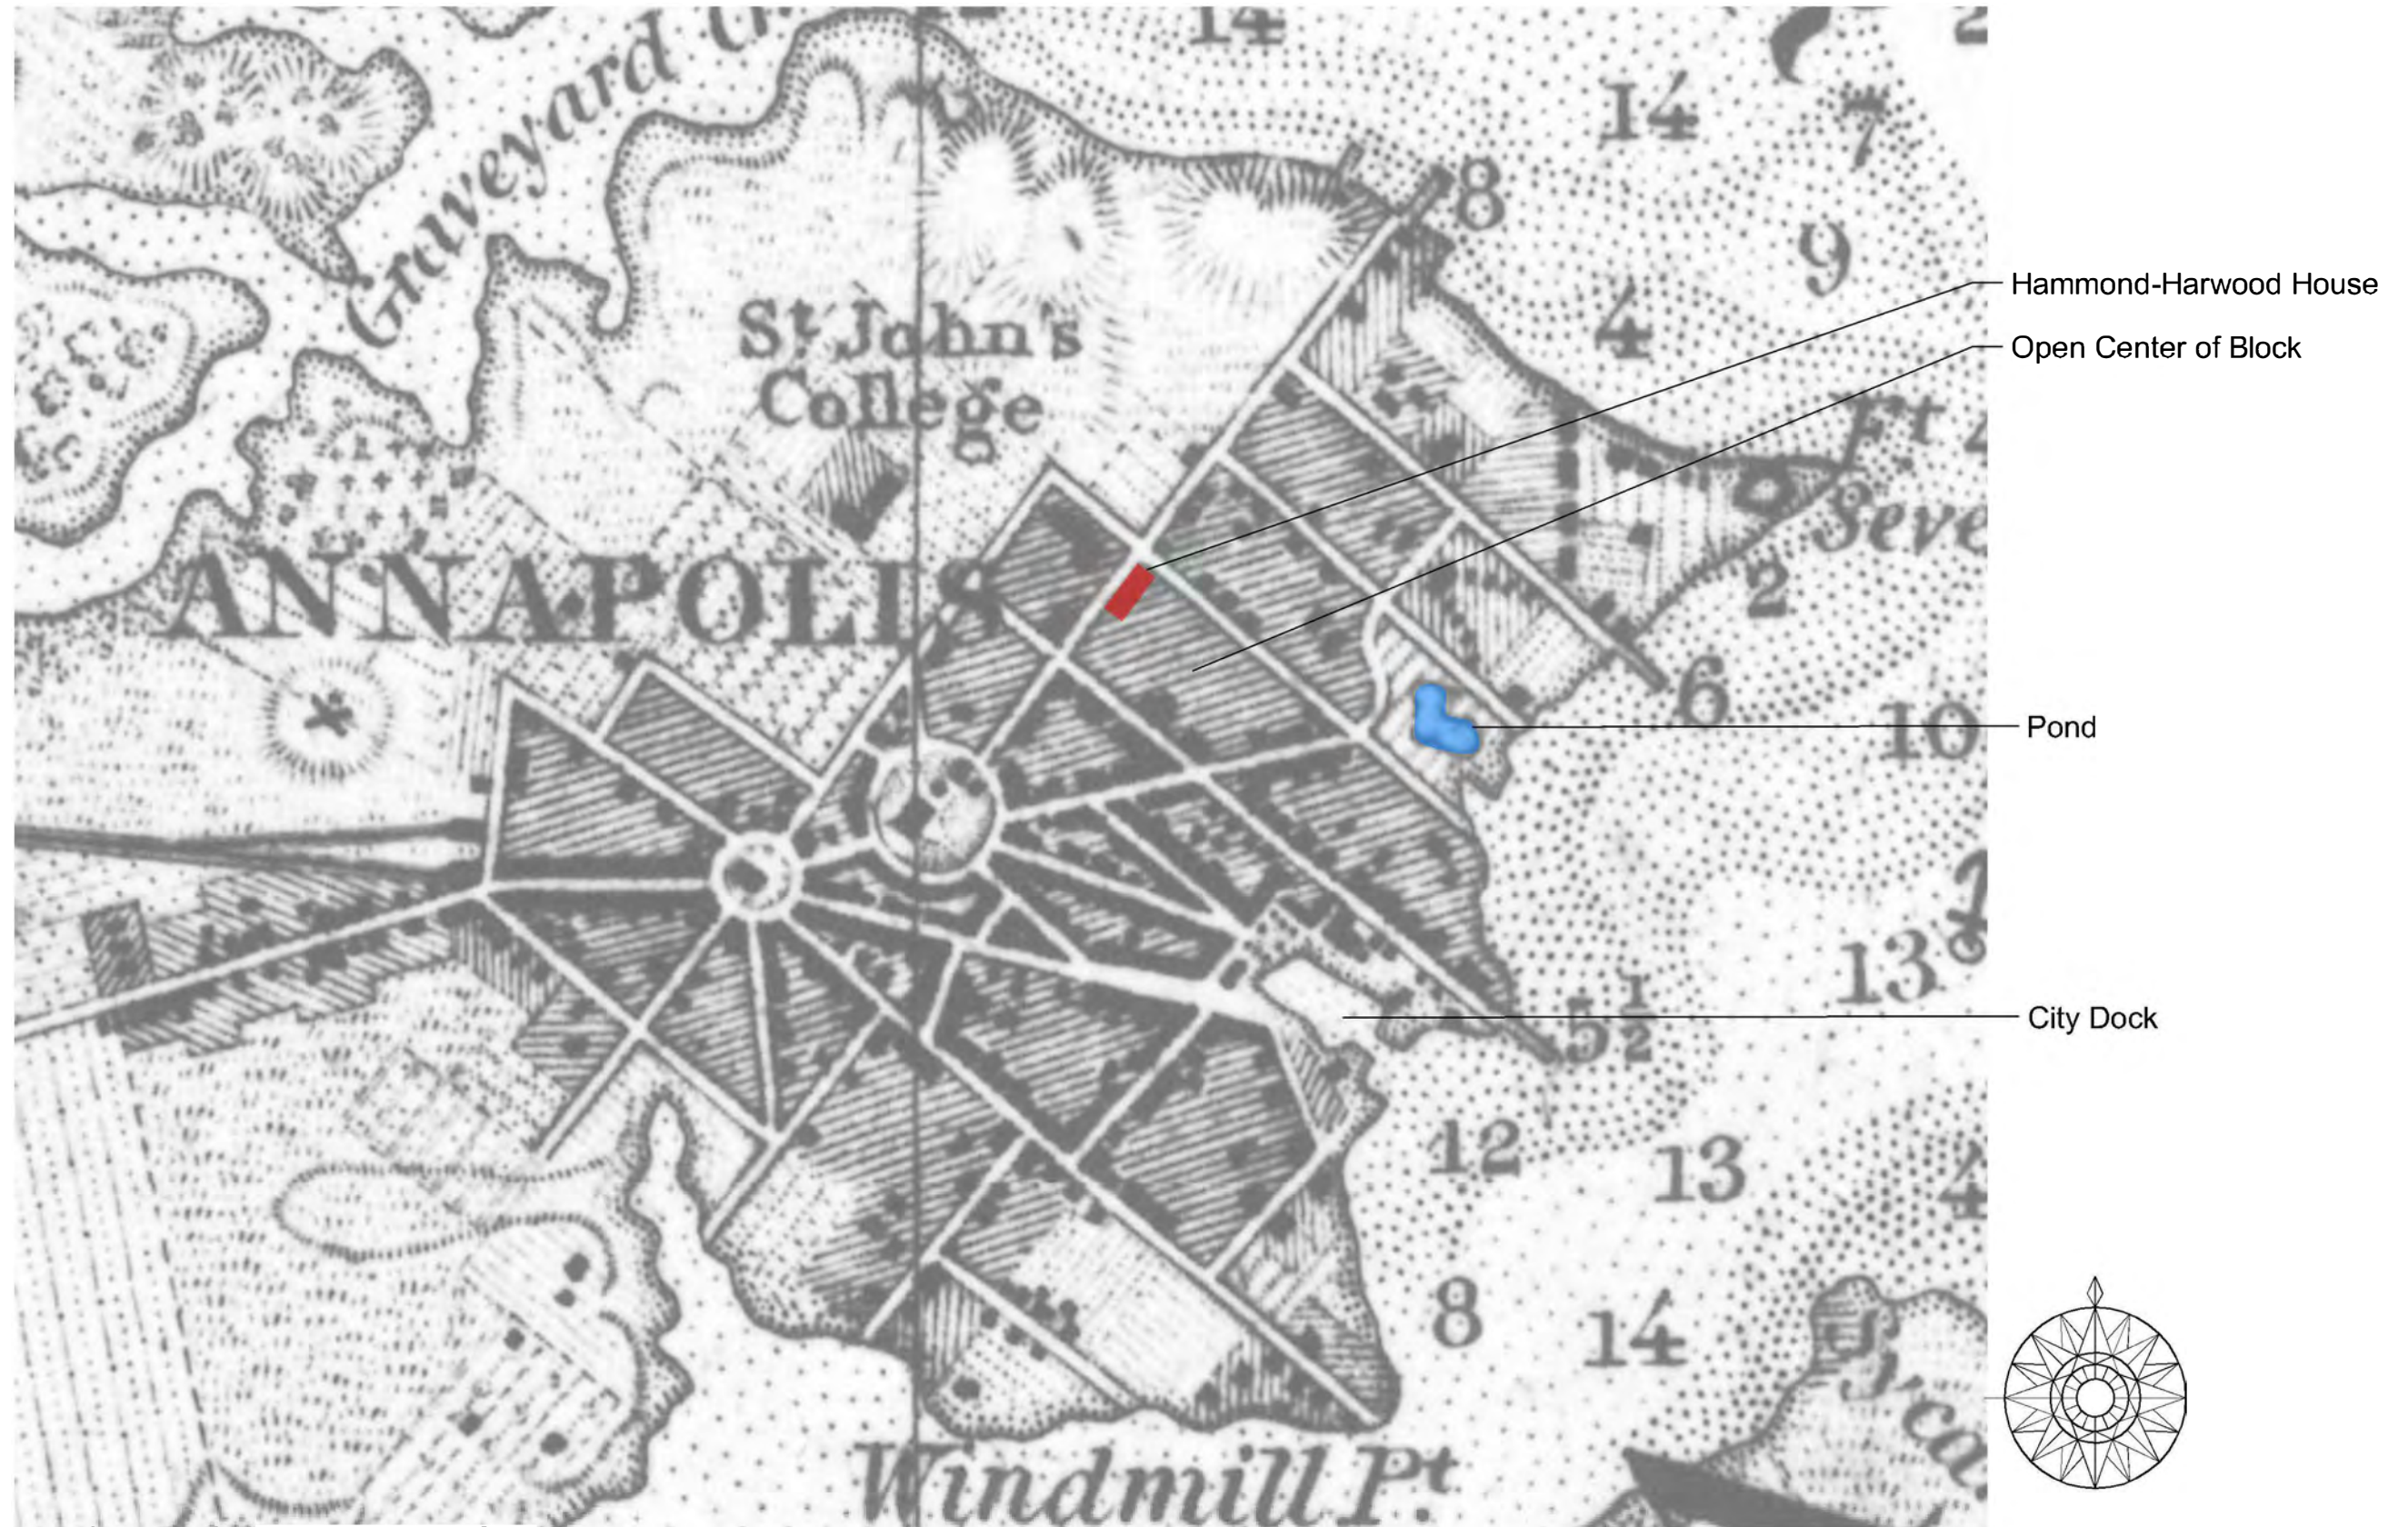
Detail from George M. Bache and F. H. Gerdes, *The Harbor of Annapolis*, 1846, Peabody Library Collection of the Johns Hopkins University, MdHR G 1213-486.

The city dock area is larger and more naturally shaped than today. There is a pond identified on fill land where the Naval Academy Field House stands now. Also apparent is the infill from ongoing construction in the city. Hammond-Harwood House is still located away from most of the building—almost in the country—and along with Chase Lloyd House across Maryland Avenue, heralds the approaching edge of urban growth.
