# HAMMOND - HARWOOD HOUSE

## CULTURAL LANDSCAPE REPORT

PREPARED BY:  
HAMMOND-HARWOOD HOUSE ASSOCIATION INC.

2021

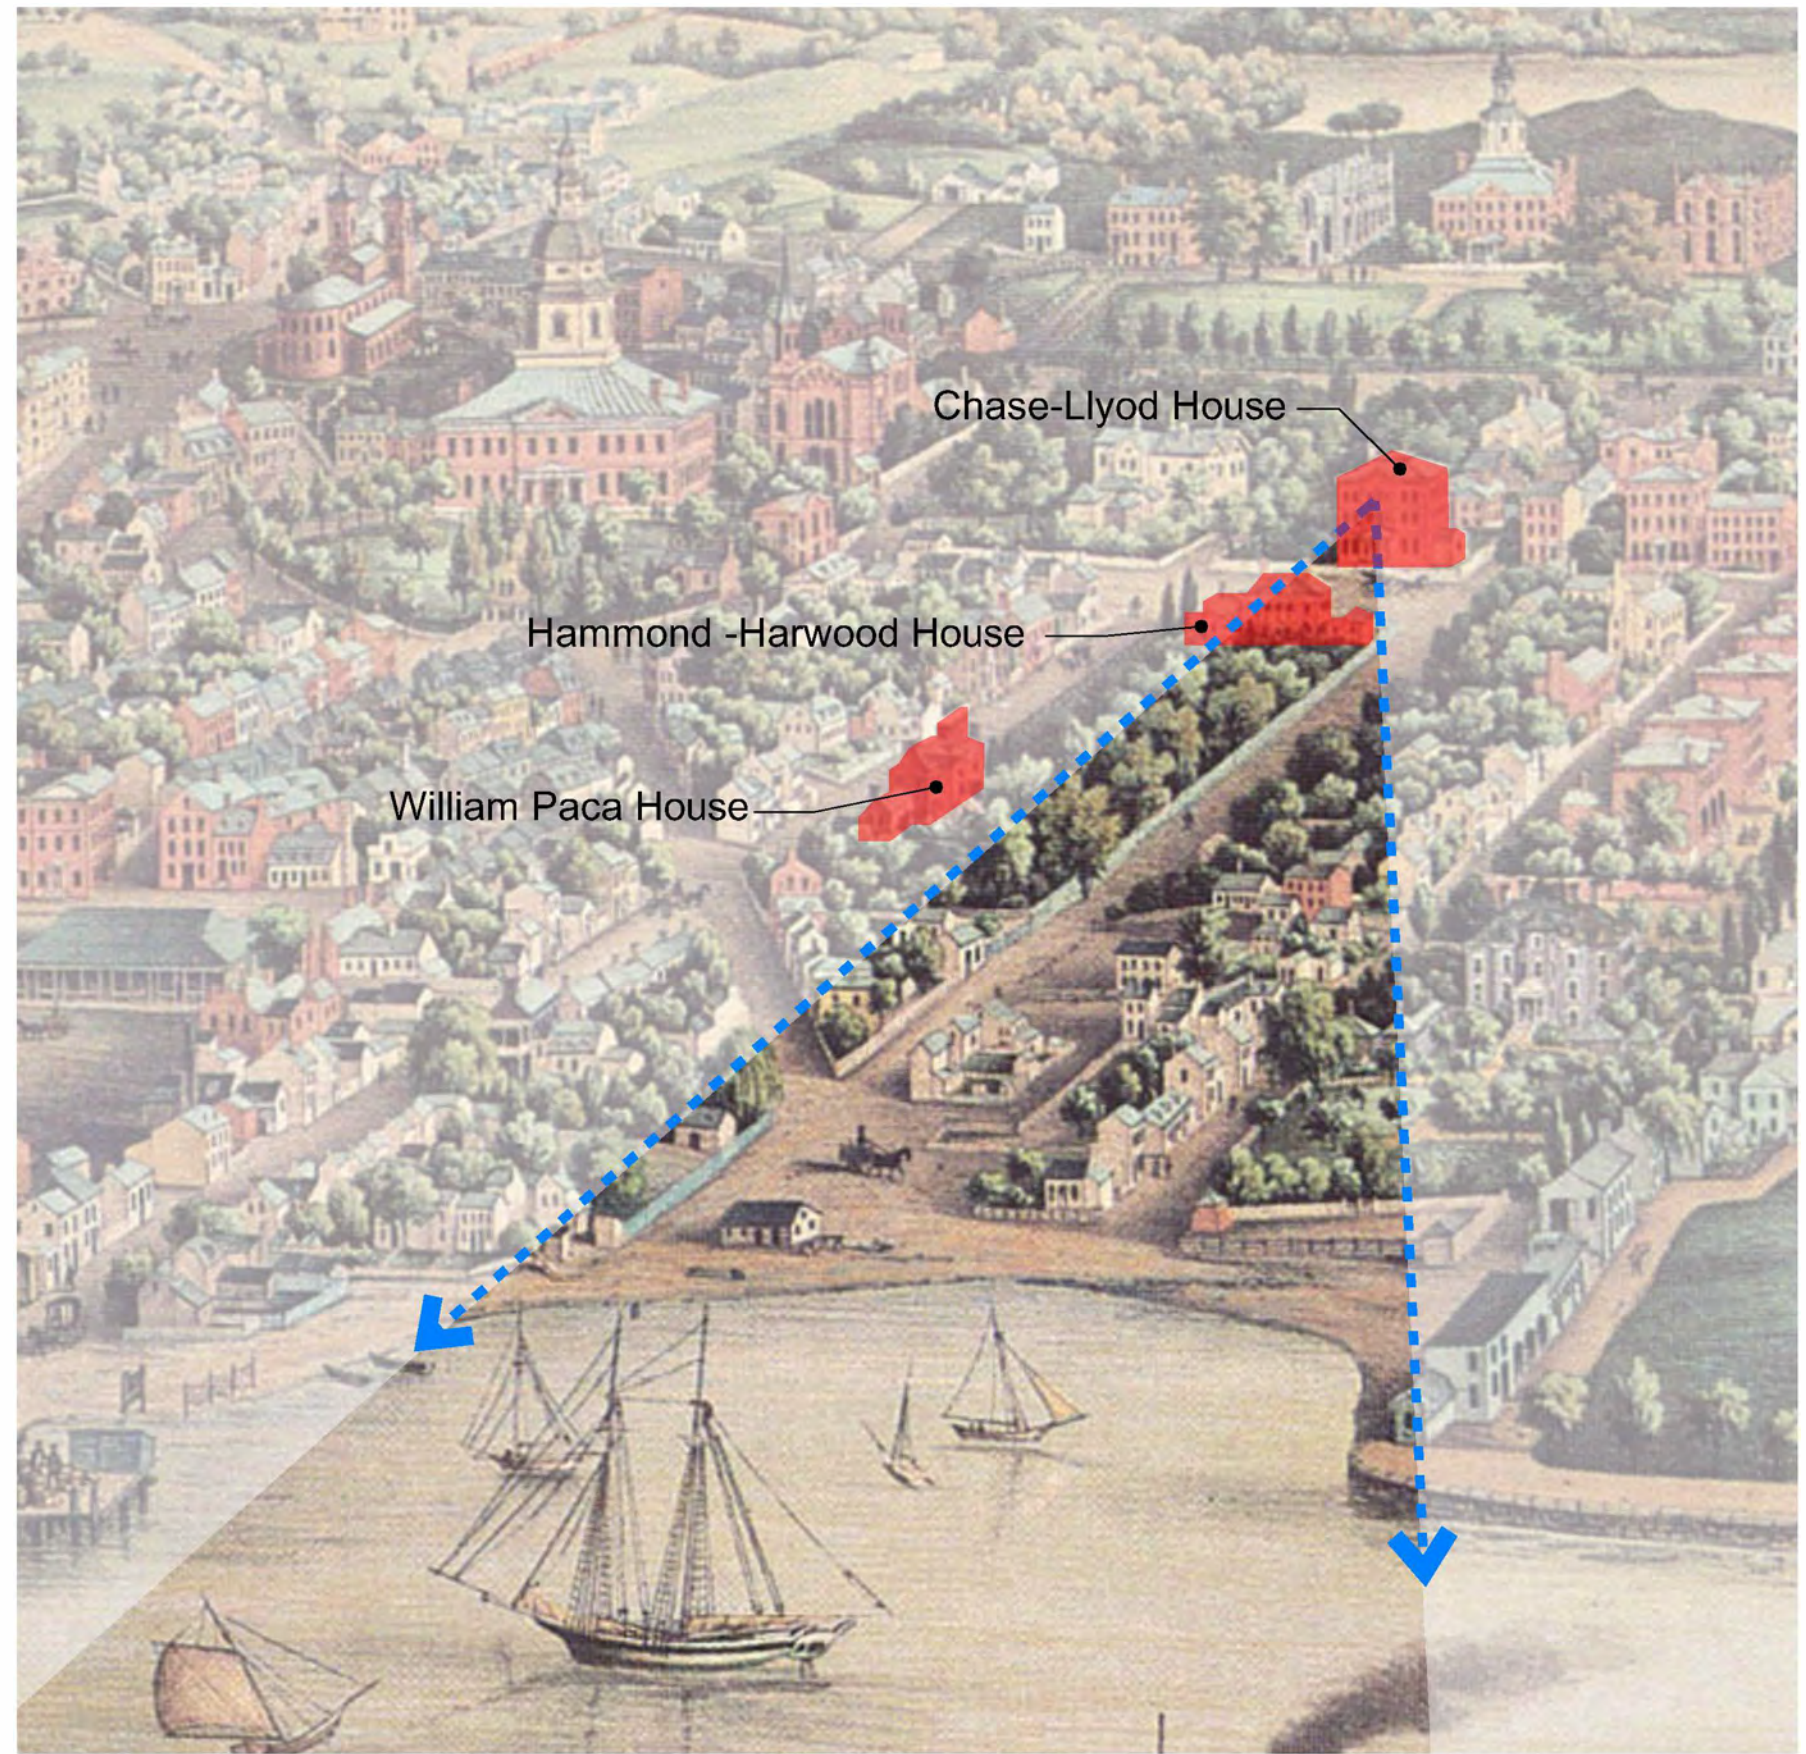
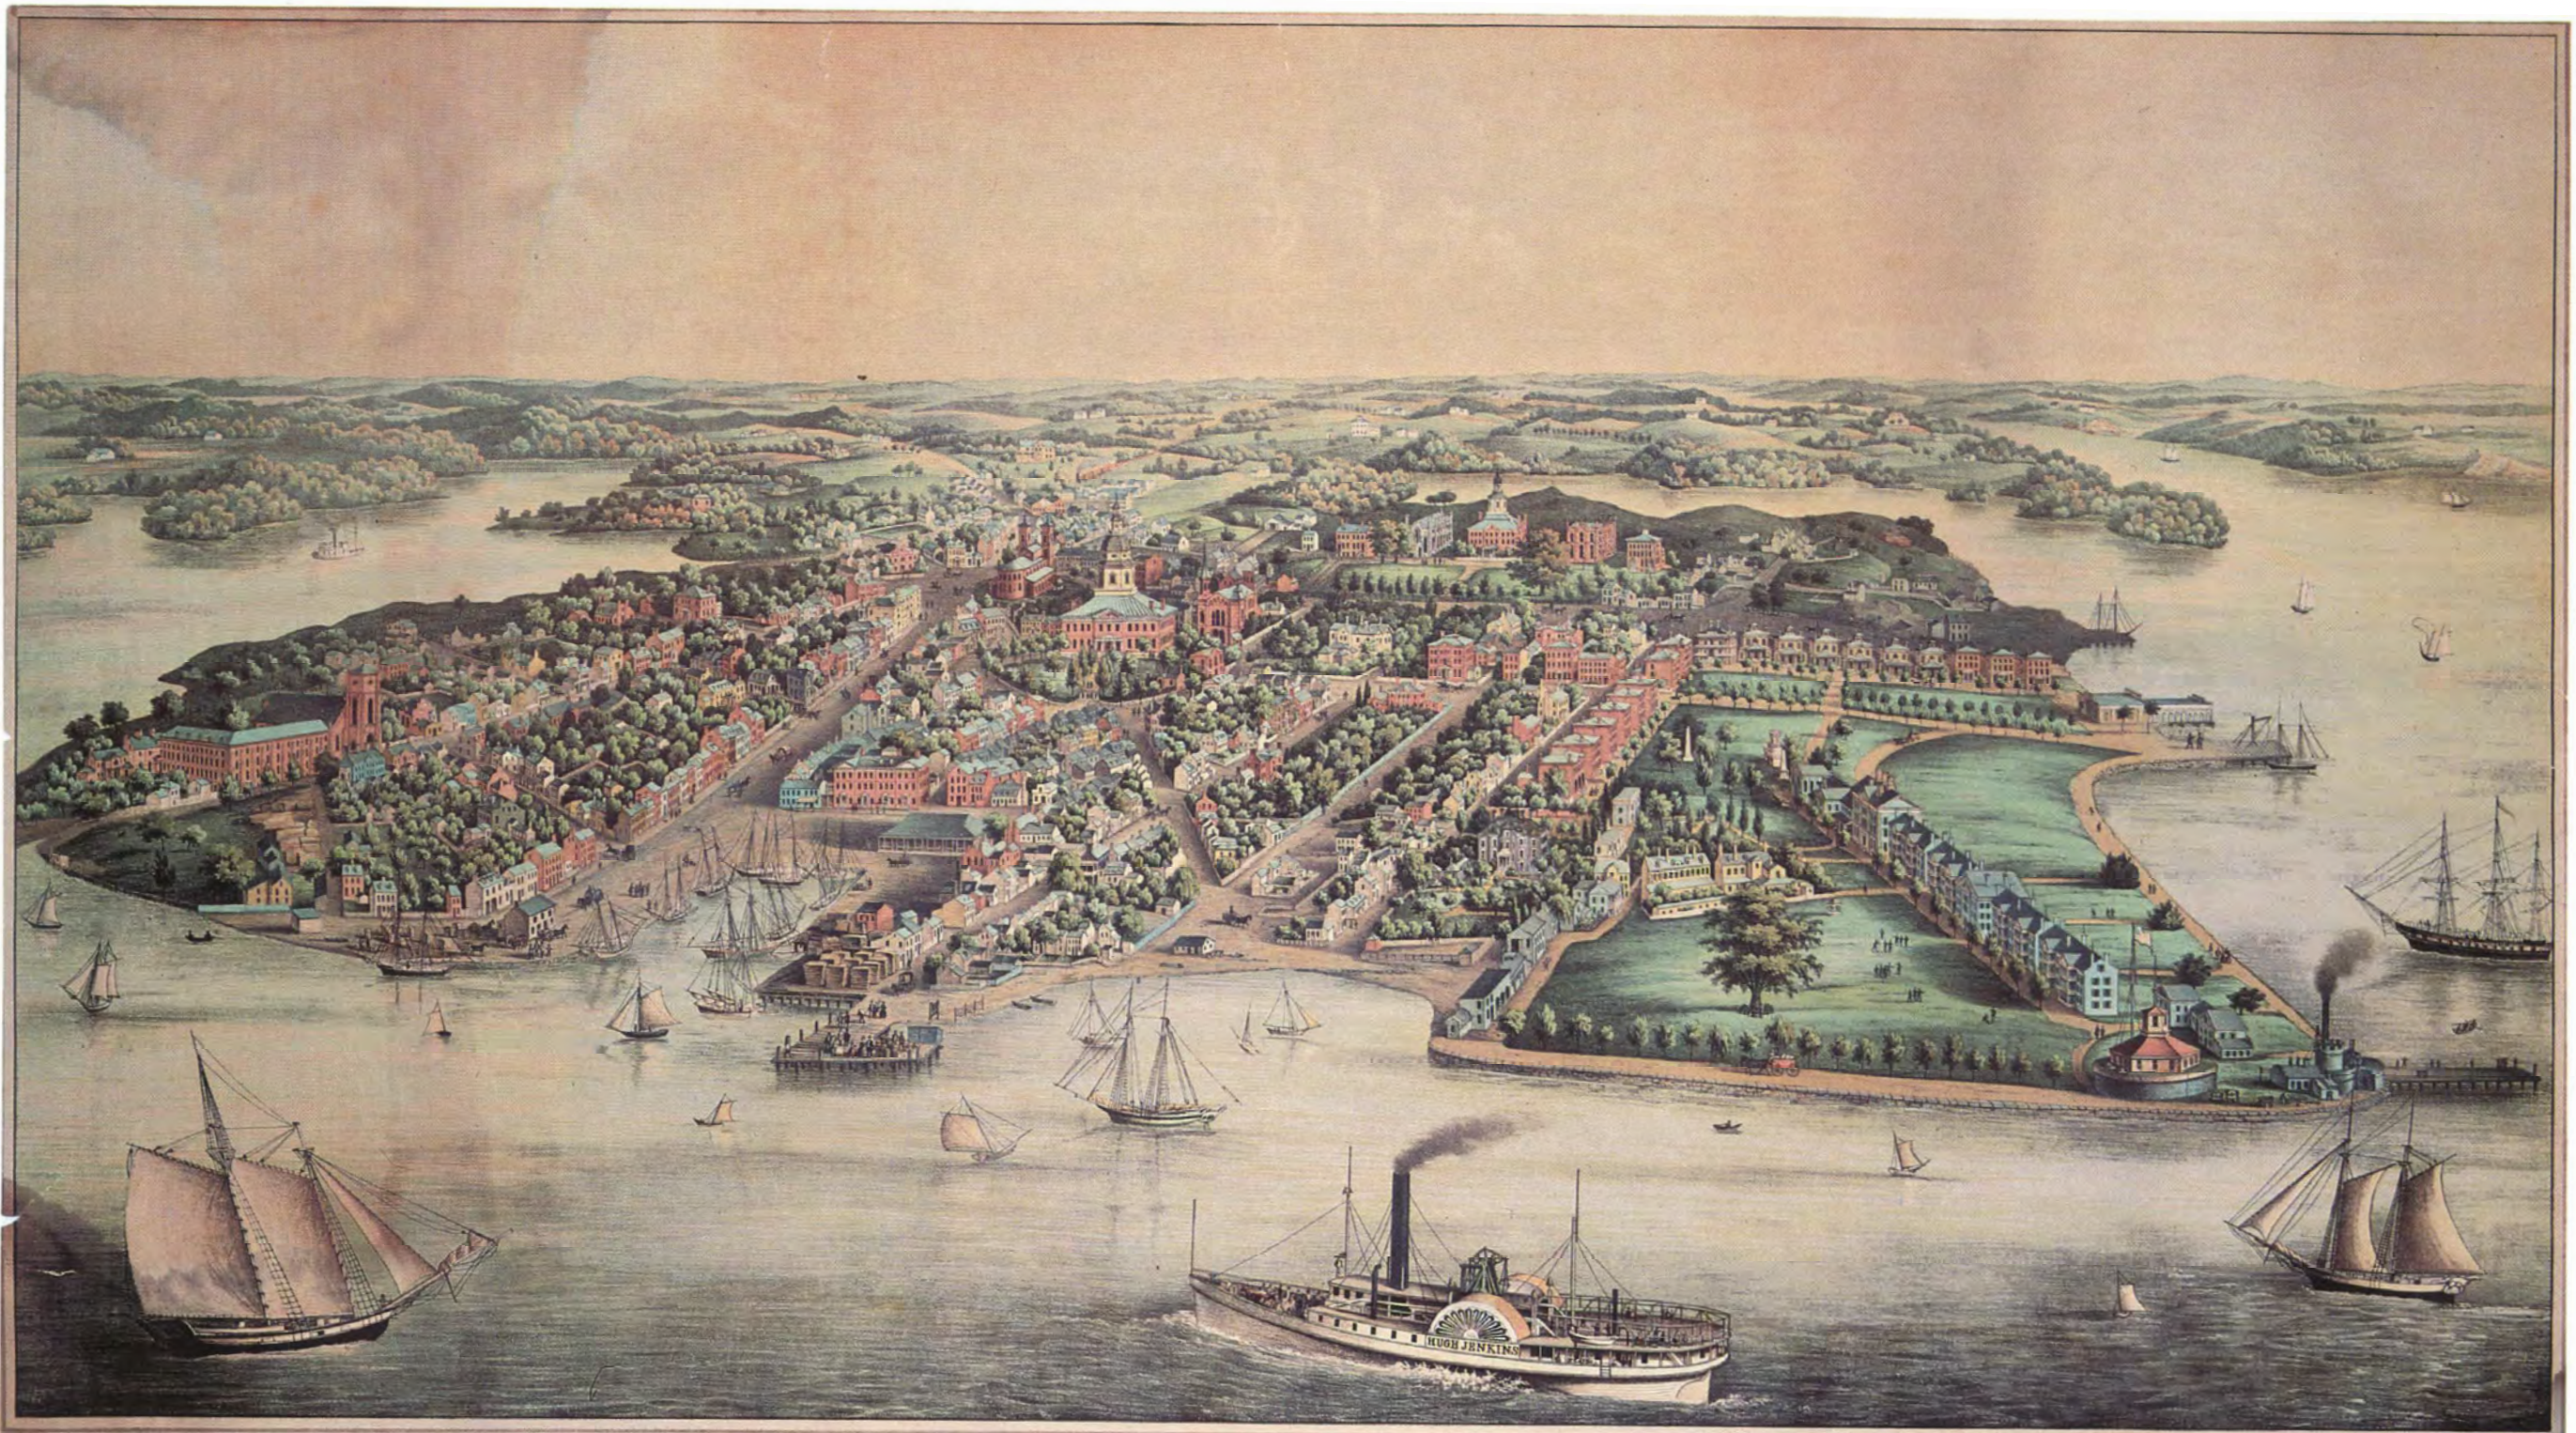
### Sachse Bird's Eye View of Annapolis - 1858

This detail from the Sachse print highlights the naturalistic wooded back garden of Hammond-Harwood House, and the views toward the Severn River from it and from the Chase Lloyd house across Maryland Avenue. Also visible is a fence—likely wooden—along the King George Street side of the property.

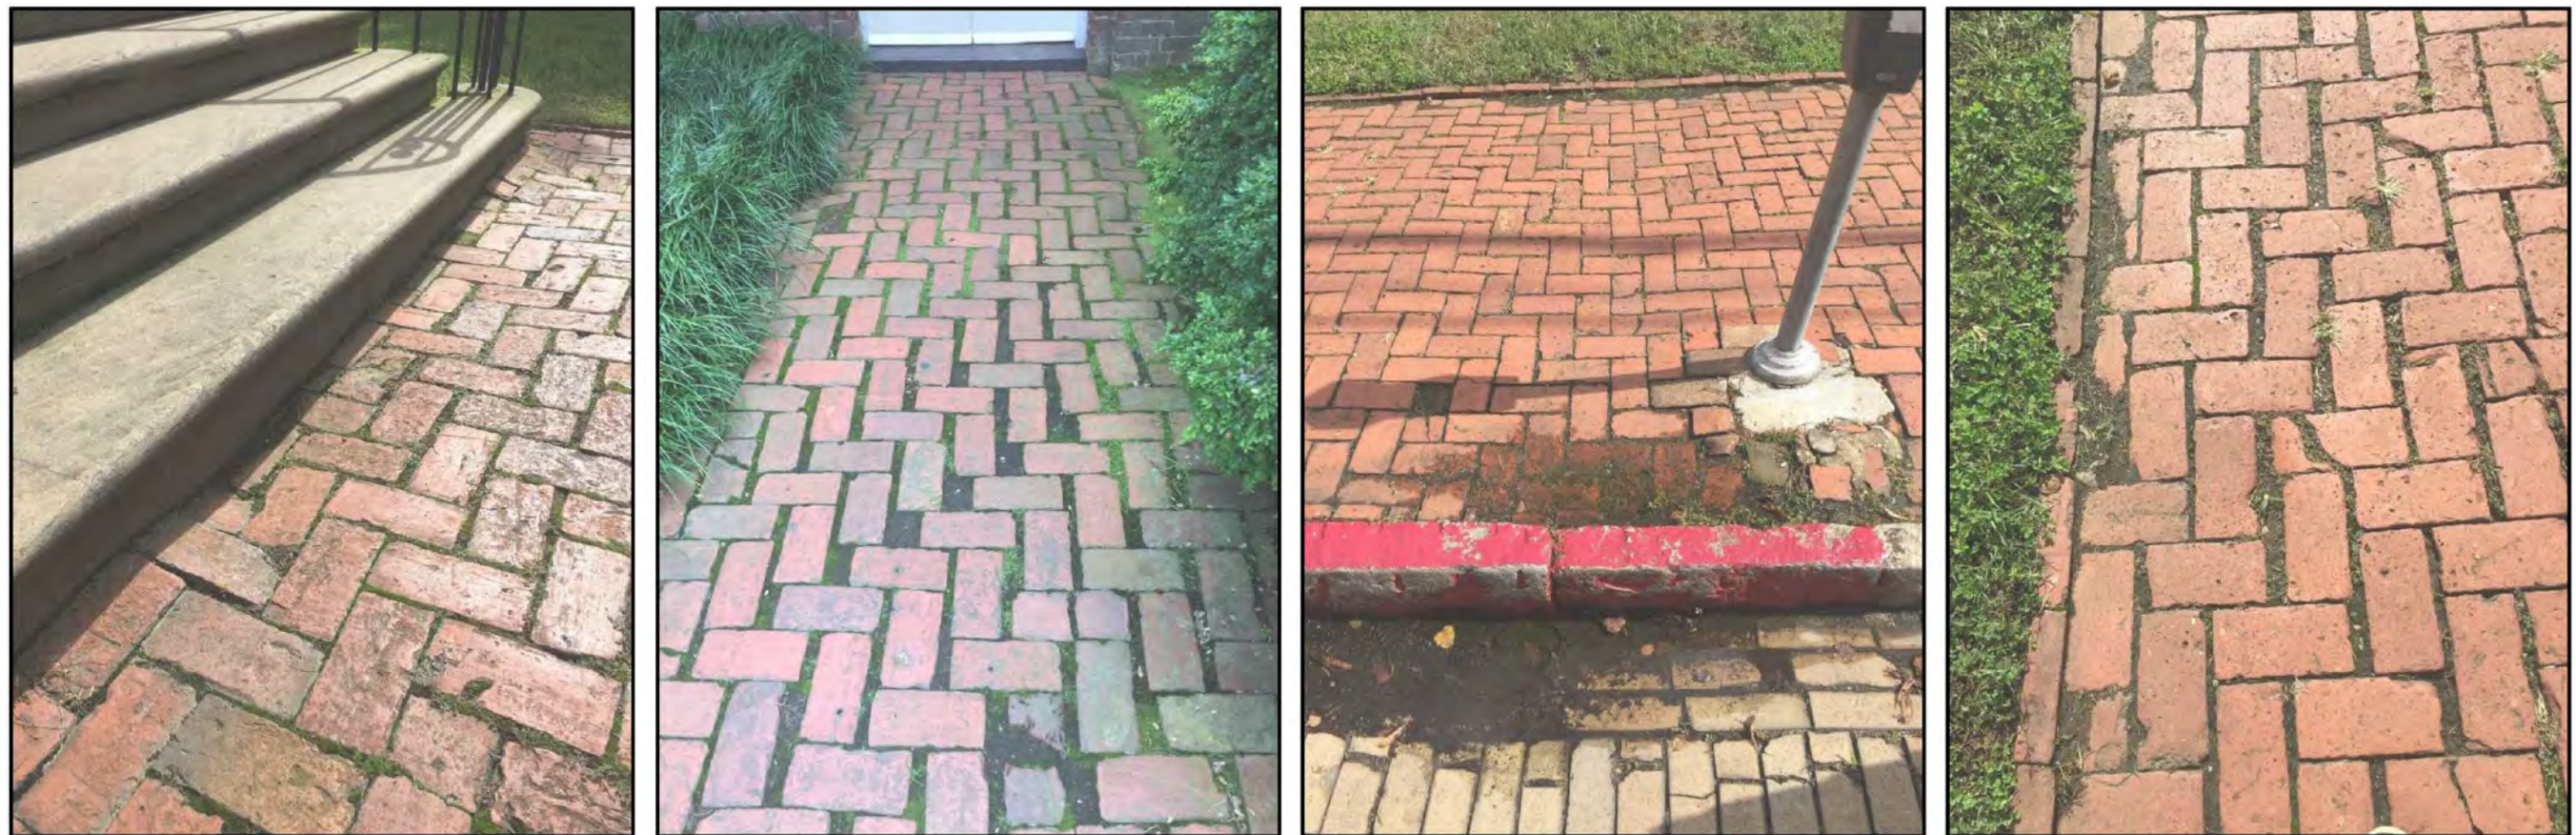
The condition of the brick sidewalk in the front of the Hammond-Harwood House needs attention. The brick is of mixed quality with a large percentage of the brick appearing to be hand-molded and consistent with many other historic sidewalks in Annapolis: beige clay marbling mixed with a majority of redder clay. Patches of wire-cut brick stand out as patchwork since the finish on the newer brick reflects light while the hand-molded brick tends to absorb light. The sidewalk on Maryland Avenue is out of level with gaps between the bricks that create trip hazards. After rain or snow, water collects on the brick paving in front of the hyphen entrances. The roots of the large magnolia tree have encroached on the paths to the kitchen annex entrance causing the bricks to heave up.

**Recommendation:** A brick salvage survey should be conducted to quantify the salvageable character-defining brick. The historic brick with beige clay marbling mixed with a majority of redder clay should be carefully removed, culled for reusable brick, stacked or stored, and reset according to a plan that prioritizes historic brick reuse. Some like-kind infill brick will have to be selected to replace brick that has been lost due to attrition. When the brick is reset, an appropriate base technical section will need to be designed that provides a rigid foundation for the brick; this will remedy the unevenness that can cause tripping hazards as the brick moves over time. In order to level and straighten the pathways to the kitchen annex, the magnolia and its root system will need to be removed.

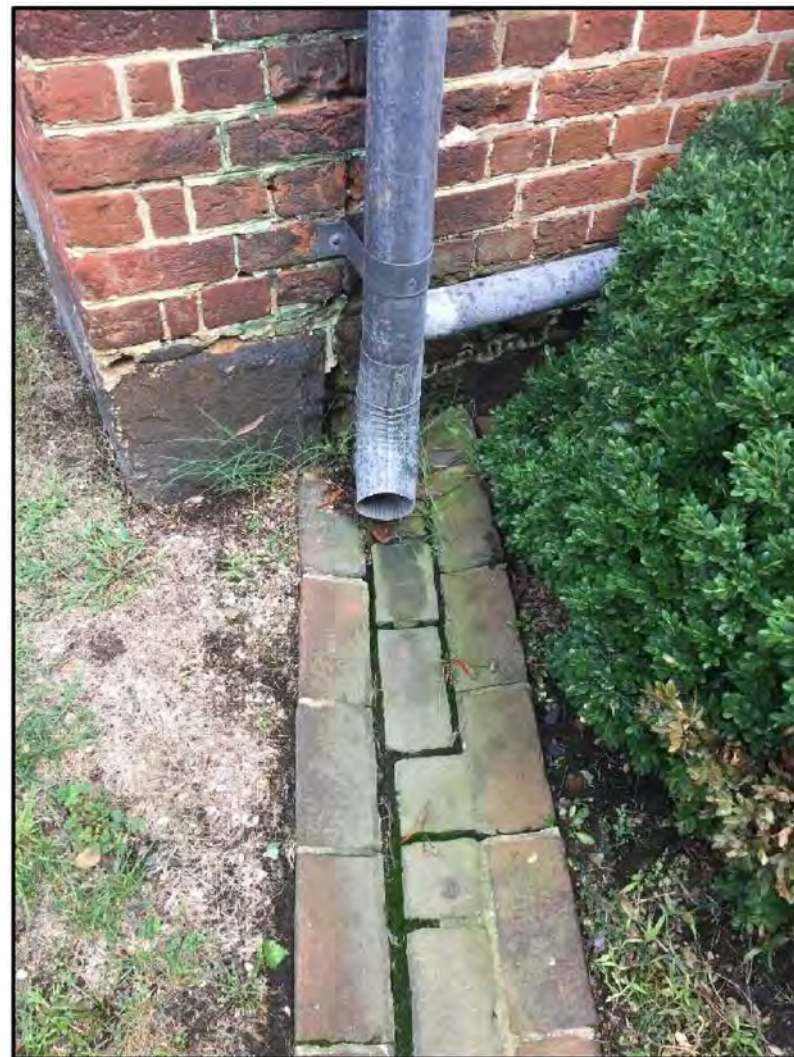
## 2 Stormwater Management

Currently the stormwater management on the street side of the house is inadequate. No engineered-site features are in place specifically to treat the quality of stormwater runoff and/or to reduce the quantity of runoff. Stormwater including that discharged from the building roof gutters flows towards lower ground over land to the street in the front.

The concentration of roof gutters and downspouts dominates the visual environment at the key building entrances at both hyphens. The gutters themselves in combination with the extensions, both in the form of pipes on the surface of the ground and ground-level brick spillways connecting to the main pathways, are dysfunctional. The confluence of runoff in the area near the building entrances at both

hyphens creates a microclimate resulting in a concentration of moss colonizing the brick walking surfaces. This saturated condition is damaging to the building structure because moisture can be a contributing factor to the loss of mortar integrity.

**Recommendation:** The area between the gutter outfalls and the Maryland Avenue curb is close to level, which is the primary reason that there is a lack of positive drainage and or overland flow away from the building. A combination of drainage systems is the best means to solving this problem. However, a possible combination of surface microretention, below grade cisterns, and a possible mechanical connection to a curb outfall would be difficult to put into place (and to obtain permits for), considering the historic nature of the street, the sidewalk, and the house grounds.

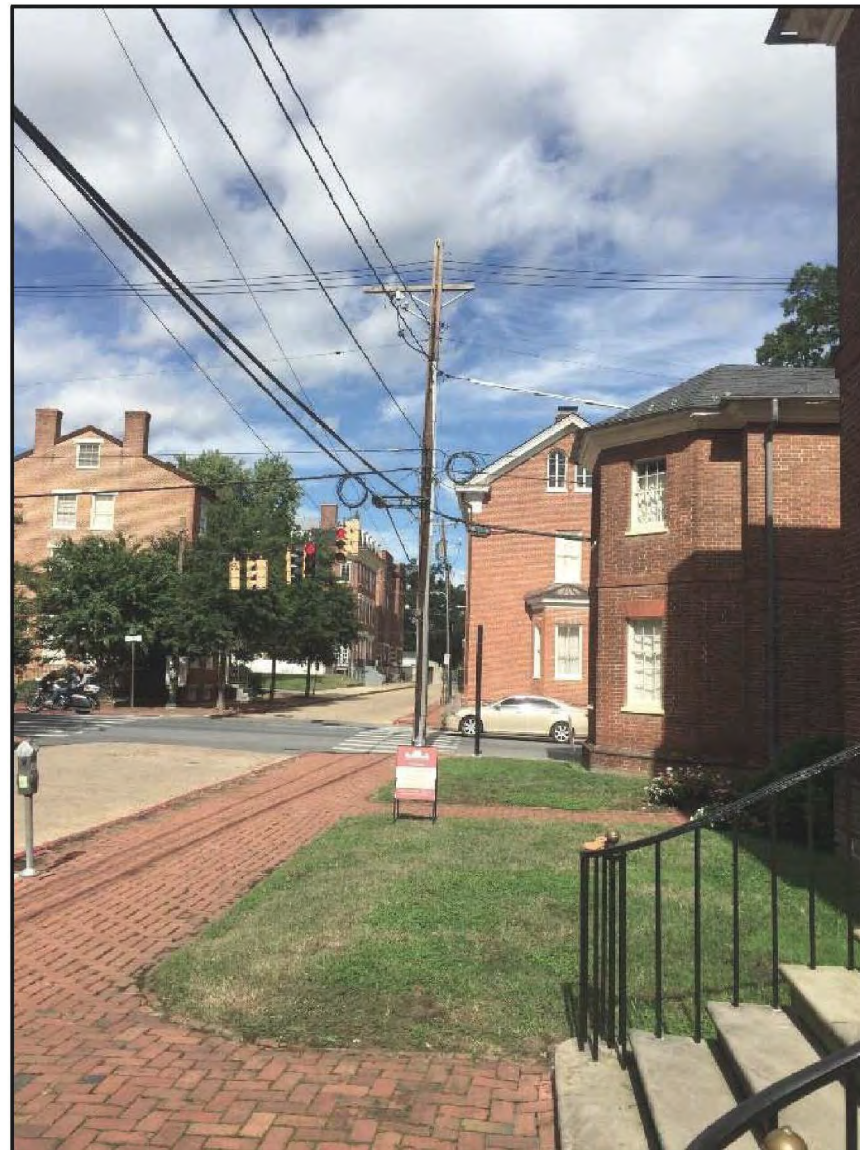
### 4 Shrubs and Foundation Planting

Overgrown shrubs and foundation plantings are unsightly and do not contribute to the quality of the front landscape. Boxwoods by the hyphen entrances screen the water table of the building from view. Additionally, these boxwoods have lost their ideal form and natural habit.

**Recommendation:** Where foundation shrubs have obscured the view of the building and the brick water table they should be removed. Liriope on the north side of the front are unkempt and should be cared for or replaced.
