The Architecture of Domestic Support Structures in Southern Maryland

Prepared by:
Willie Graham, Principal Investigator
Scott M. Strickland
Julia A. King

Prepared for:
The Maryland Historical Trust
Crownsville, Maryland

2020

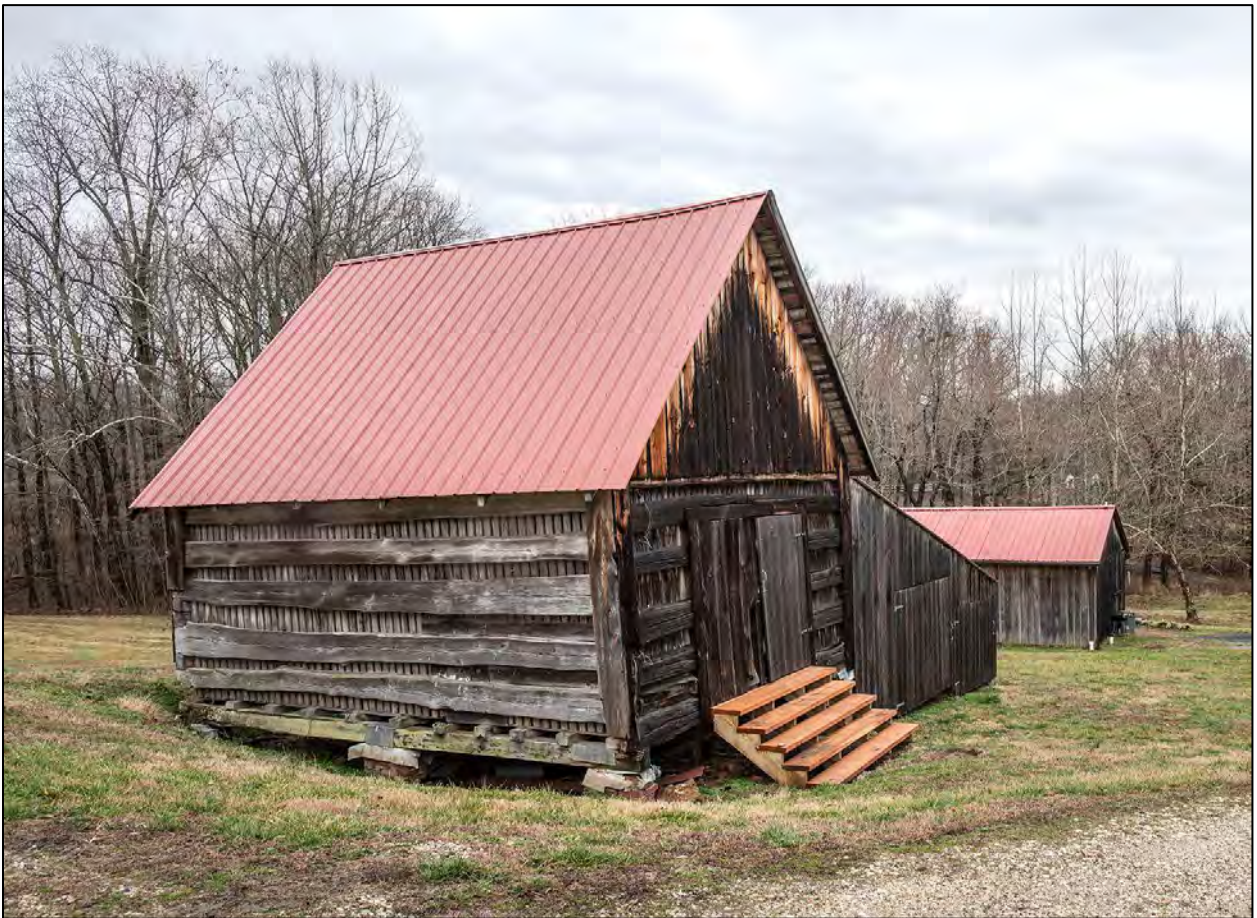
Figure 4. Corn crib, Cedar Hill (Willie Graham).

The carpenter who built the Cedar Hill corn crib (Figure 4) at the end of the 19th century created an unusual building by combining common building methods and materials in a novel way. Corn cribs need to sit high off the ground for good airflow and protection against rodents. The grain they store also requires shelter from rain. Much of this was accomplished in the Cedar Hill corn crib in time-honored ways. Brick piers seated the building off the ground, making it difficult for rodents to climb in. Long overhanging rafters protected the sides of the building, while deep projections of the roof at the front and back combined with vertical sheathing in the upper gables worked to keep the contents dry. These details had evolved as standard treatment for corn cribs over the previous two centuries.

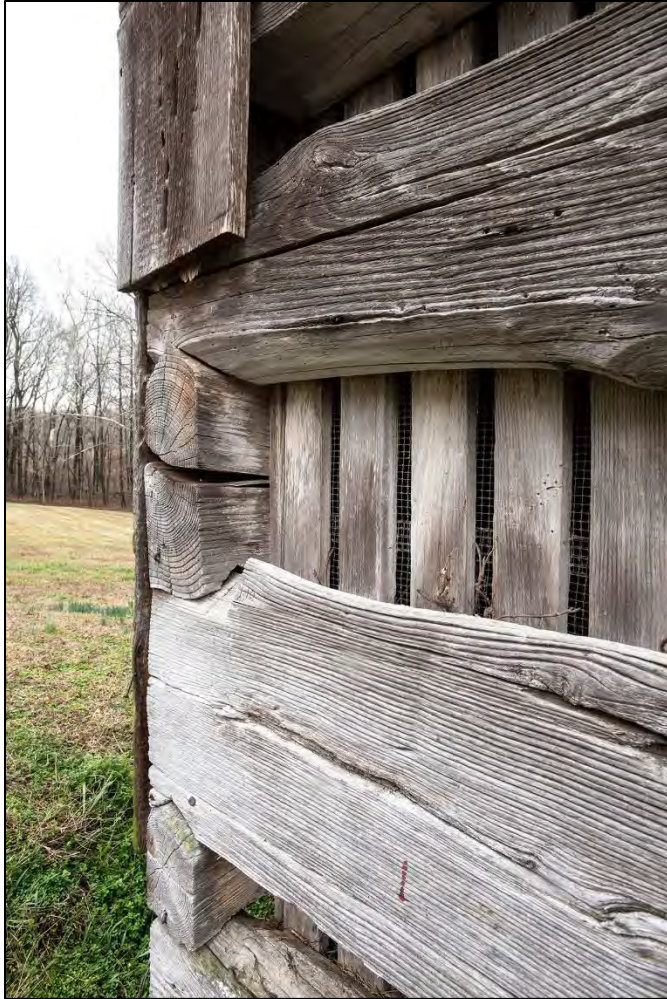
Figure 5. Cedar Hill corn crib, vented walls (Willie Graham).

The carpenter's cleverness was in how he vented the walls. First, he built them of V-notched logs with unusually wide interstices (Figure 5). Logs held an advantage over frame in

measuring about 4-in by 5½-in, lie across the sills and summers to carry flooring in the crib. The first five joists (from the front gable) run the full width of the crib.

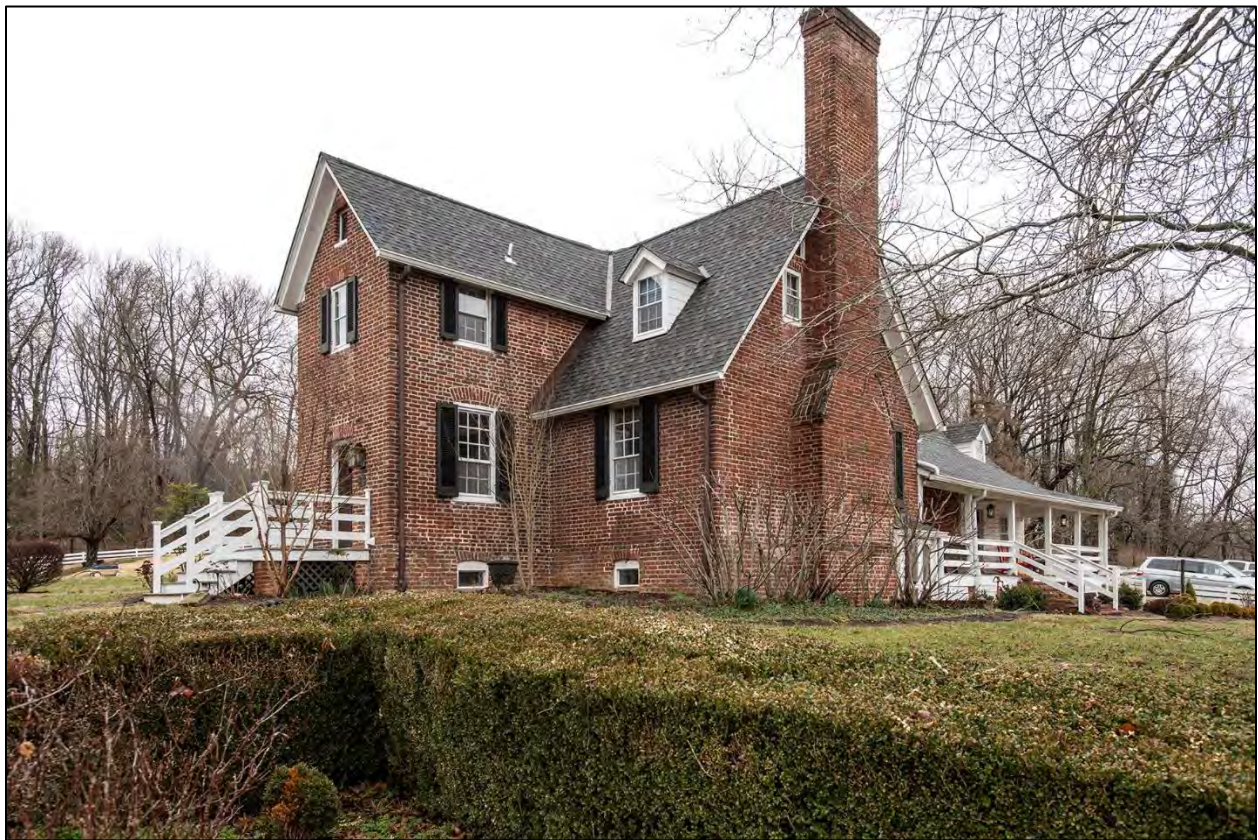
Figure 6. Cedar Hill (Willie Graham).

Cedar Hill makes up a portion of a larger, impressive farmstead assembled during the 17th and 18th centuries. Sometime during the first half of the 18th century, a grand brick dwelling was constructed (Figure 6). A 1745 probate inventory of Major Thomas Crompton's estate, which appears to describe the current house, serves as a likely *terminus ante quem* for the dwelling's

construction. Crompton lived in a single-story, T-plan house, which included an enclosed two-story porch tower on the front, a rear wing conceivably used as a kitchen, a cellar under the front block, and an accessible garret over the whole. Along with later additions it remains the sole surviving house of this form in southern Maryland.

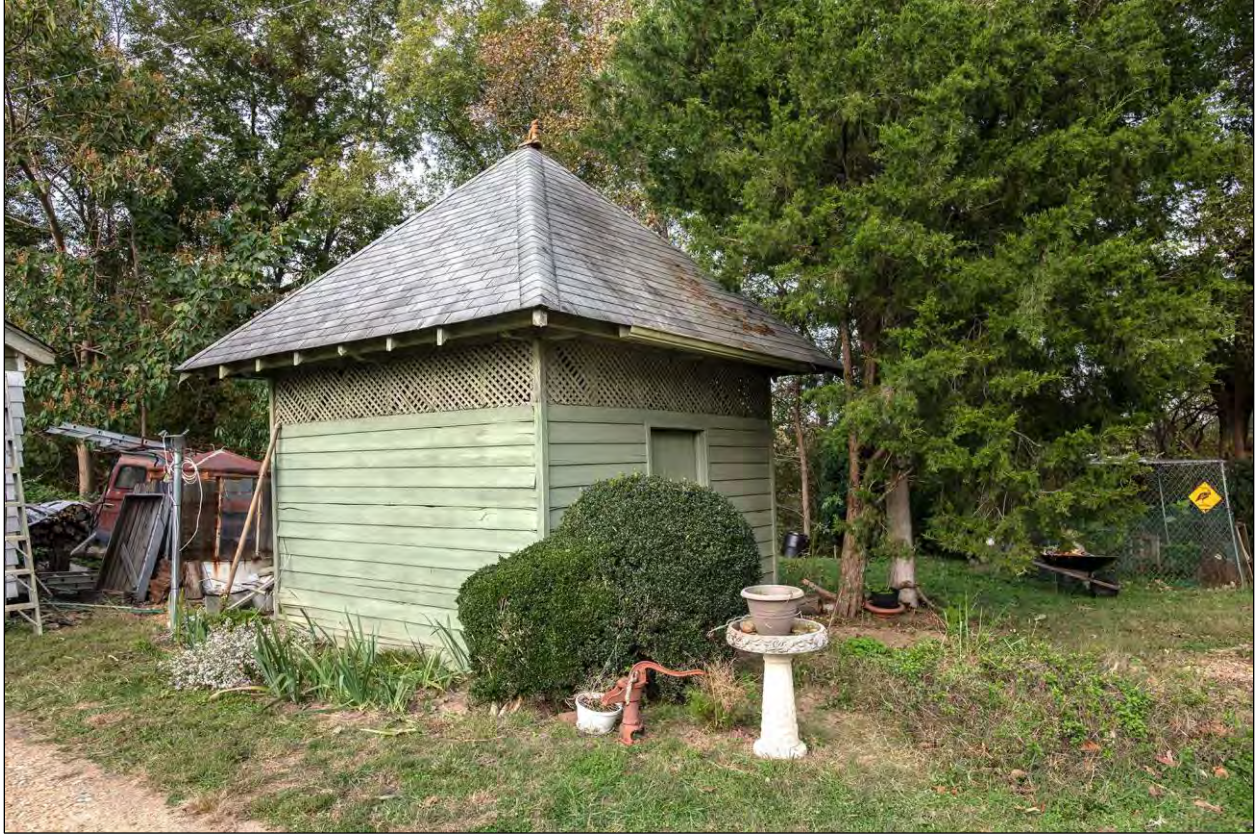
Figure 9. The dairy at Araby (Willie Graham).

While the posts, studs and braces join to a continuous sill, how that sill was seated and its relationship to the floor is obscured. The current owner uses the dairy for storage and it is packed with belongings, making portions of the interior hard to examine. For instance, the sill does sit on a very shallow brick foundation. However, it is difficult to determine whether that foundation is original or replaced a lower layer of “ground-laid” sills. Also, the extant sills are conceivably original and what little of them is observable do not show evidence of floor joists. Nonetheless, they deserve a closer examination to affirm that, until the addition of concrete in the 20th century, the dairy had a dirt floor.

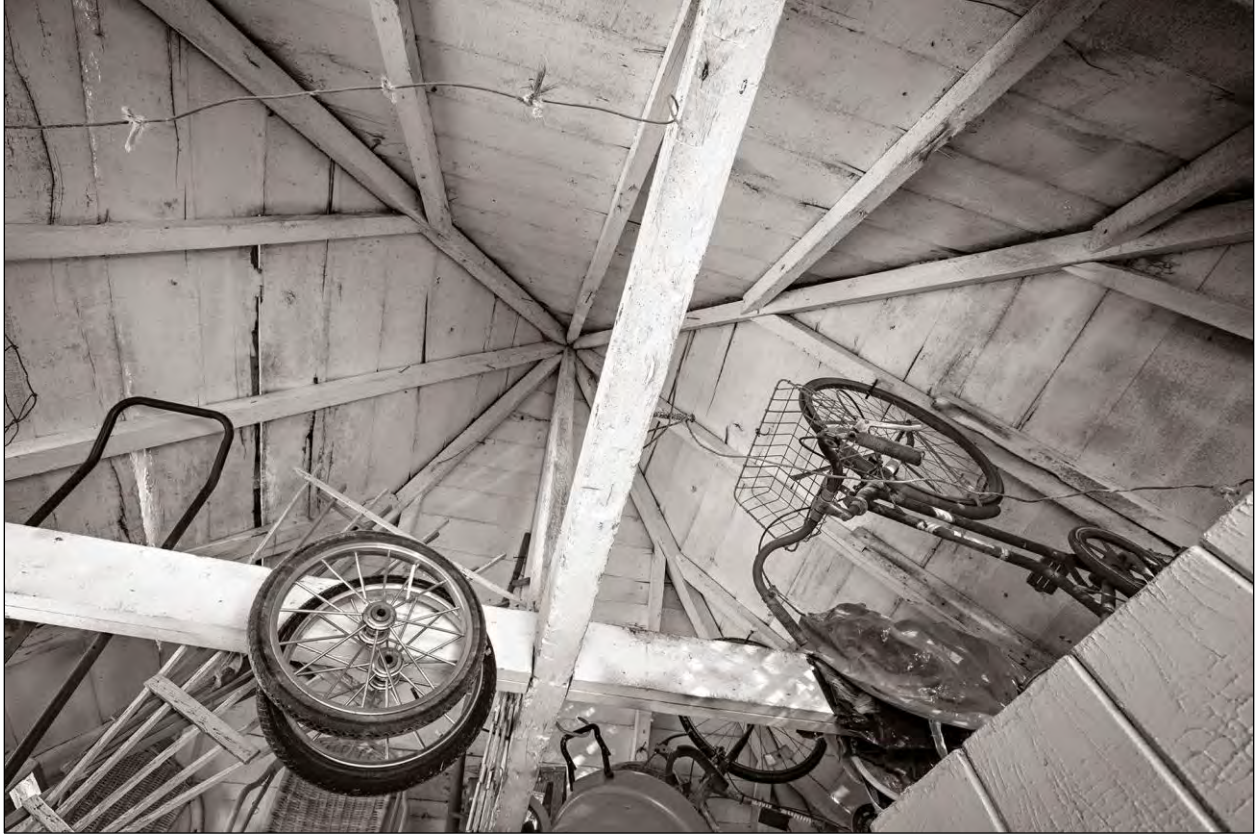
Figure 10. Interior view of the dairy roof, Araby (Willie Graham).

While the upper roof structure was wholly rebuilt in the 20th century, evidence indicates that the building always had some form of roof covering. First, the weatherboarded covering of the lower roof is not sufficiently weathertight to have worked on its own and there is no evidence it simply served as a base for shingles. More importantly, though, the plate and tie-beam overhang on the four sides was created to carry the feet of that second covering. Unfortunately, a 20th-century remodeler replaced the outer plate when she or he replaced the rafters, destroying the evidence of their connection. Nonetheless, the tenons on the ends of the plates and tie beams ensures that the outer plate (and thus the upper roof) was intended from the outset.

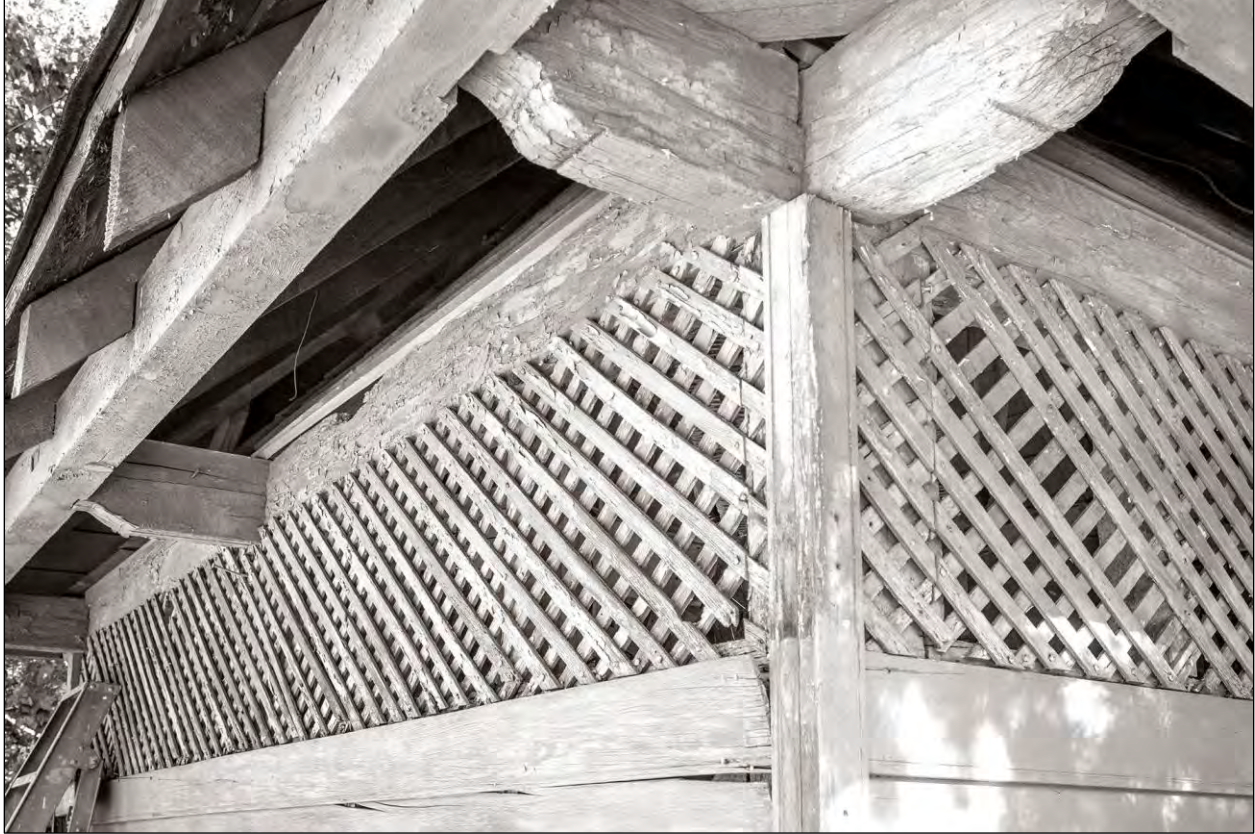
Figure 11. Lattice ventilation, Araby (Willie Graham).

The front door retains its head, which shows that the framed opening measured about 3 ft 8-in wide and 5 ft 10-in tall, if the sill originally ran through the opening. The door was replaced in the 20th century when the sill was cut out. The windows are more intact. They are latticed with

1-in by ¼-in pine strips that are smoothly planed and set on a crisscrossed diagonal (although not precisely 45 degrees) to form a vented opening that surrounds all four sides of the building, including over the doorway. Although the corner boards are now replaced, repairs at the four corners within the latticed opening indicate that they originally were quite wide. Based on surviving dairies, latticed vents are the common treatment of window openings in Maryland dairies, especially those in the southern portion of the state. The Araby dairy serves as an especially large, early, and intact example.

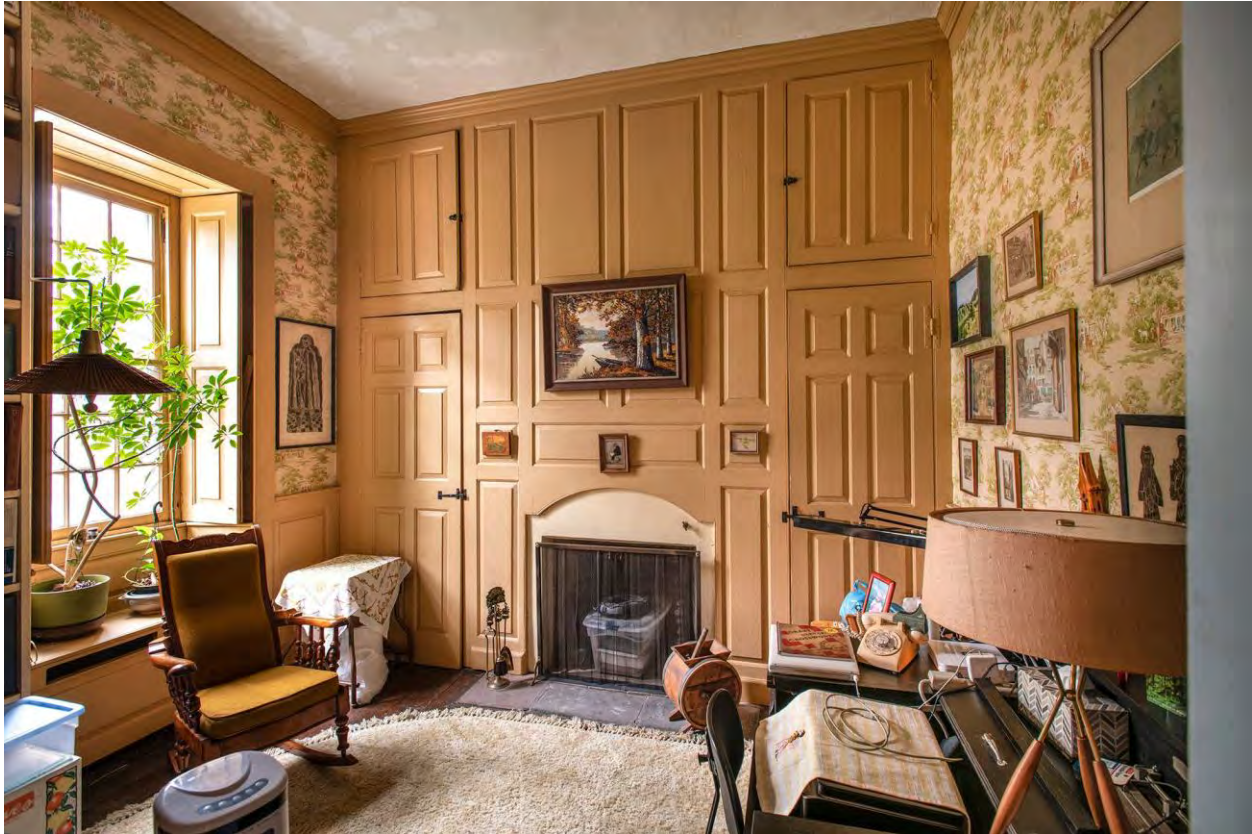
Figure 12. Interior paneling, first floor rear chamber (behind the hall), Araby (Willie Graham).

These rooms were elaborately finished, with fully paneled fronts on the chimneys (Figure 12). Initially, the paneling simply trimmed out the fireplaces without the benefit of additional mantels (a treatment that the chamber behind the dining room still retains). The dining room had closets flanking its fireplace (with that to the left serving as a passageway to the exterior). Those closets were removed possibly in the 19th century. The room cornice and wainscoting were patched when the closet fronts were removed. A built-in “beaufat” was fitted to the right of the parlor fireplace, and a closet was located on its left. The chamber was finished with two closets. The hall was treated as the most elaborate room in the house. It was paneled floor to ceiling and included a pair of cove-headed beaufats on either side of the fireplace.

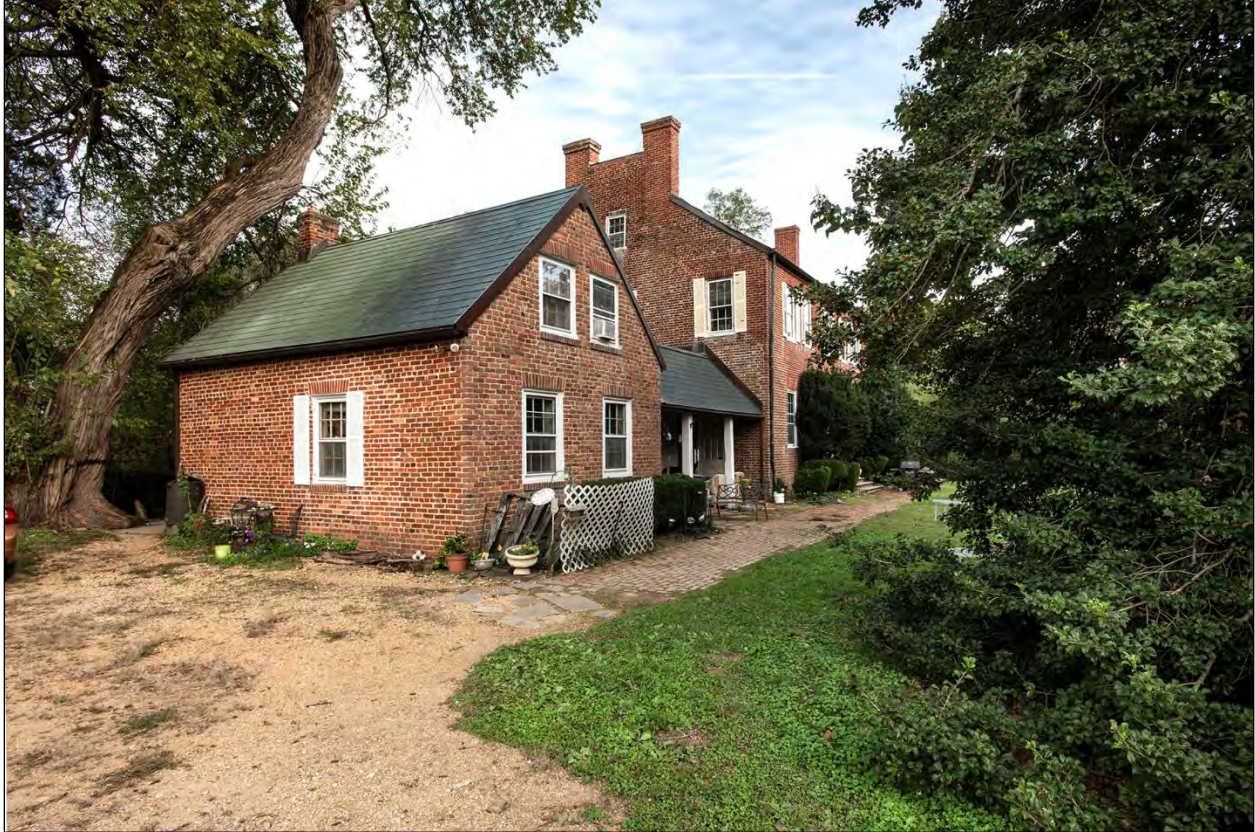
Figure 13. Kitchen addition to Araby (Willie Graham).

A brick kitchen that is now connected to the main house by a frame connector might date to the late 19th or early 20th century. It is built of brick laid in five-to-one bond and has a stove chimney stack at one end (Figure 13). The Clines remodeled it in the last quarter of the 20th century and it was perhaps earlier remodeled by the Fletchers, who bought the farm in the 1930s.

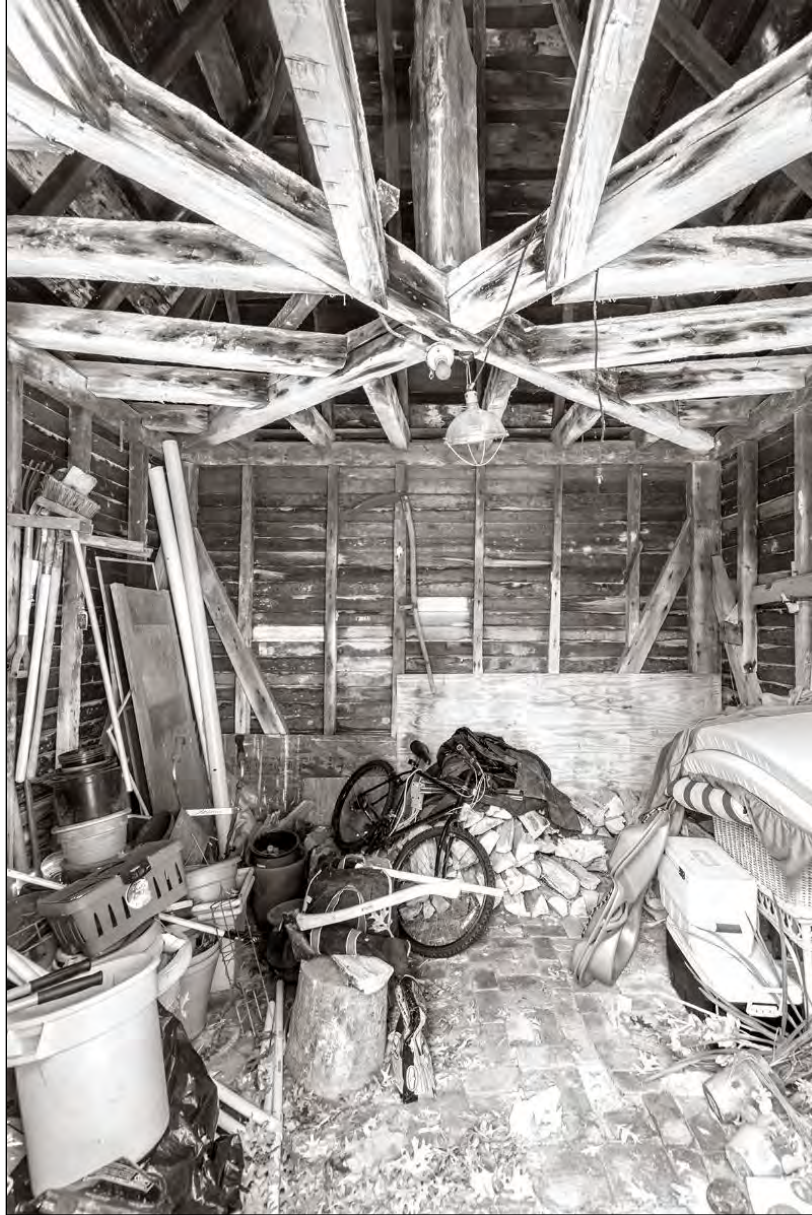
Figure 16. La Grange smokehouse interior (Willie Graham).

The post chamfers act as facets to which the hip rafters butt. Jack rafters are then butted and nailed to the sides of the hips. All rafters sit on a false plate, which is fixed to the top ends of the joists. The joists project modestly over the wall plates to form a shallow cornice. The joists are treated much like the rafters. Since the tie beams are set on the diagonal, the joists lap over the wall plates (set perpendicular to them) and butt and nail to the sides of the tie beams. This heavy grid of framing—joists, tie beams and rafters—were used to carry meat during the curing process.

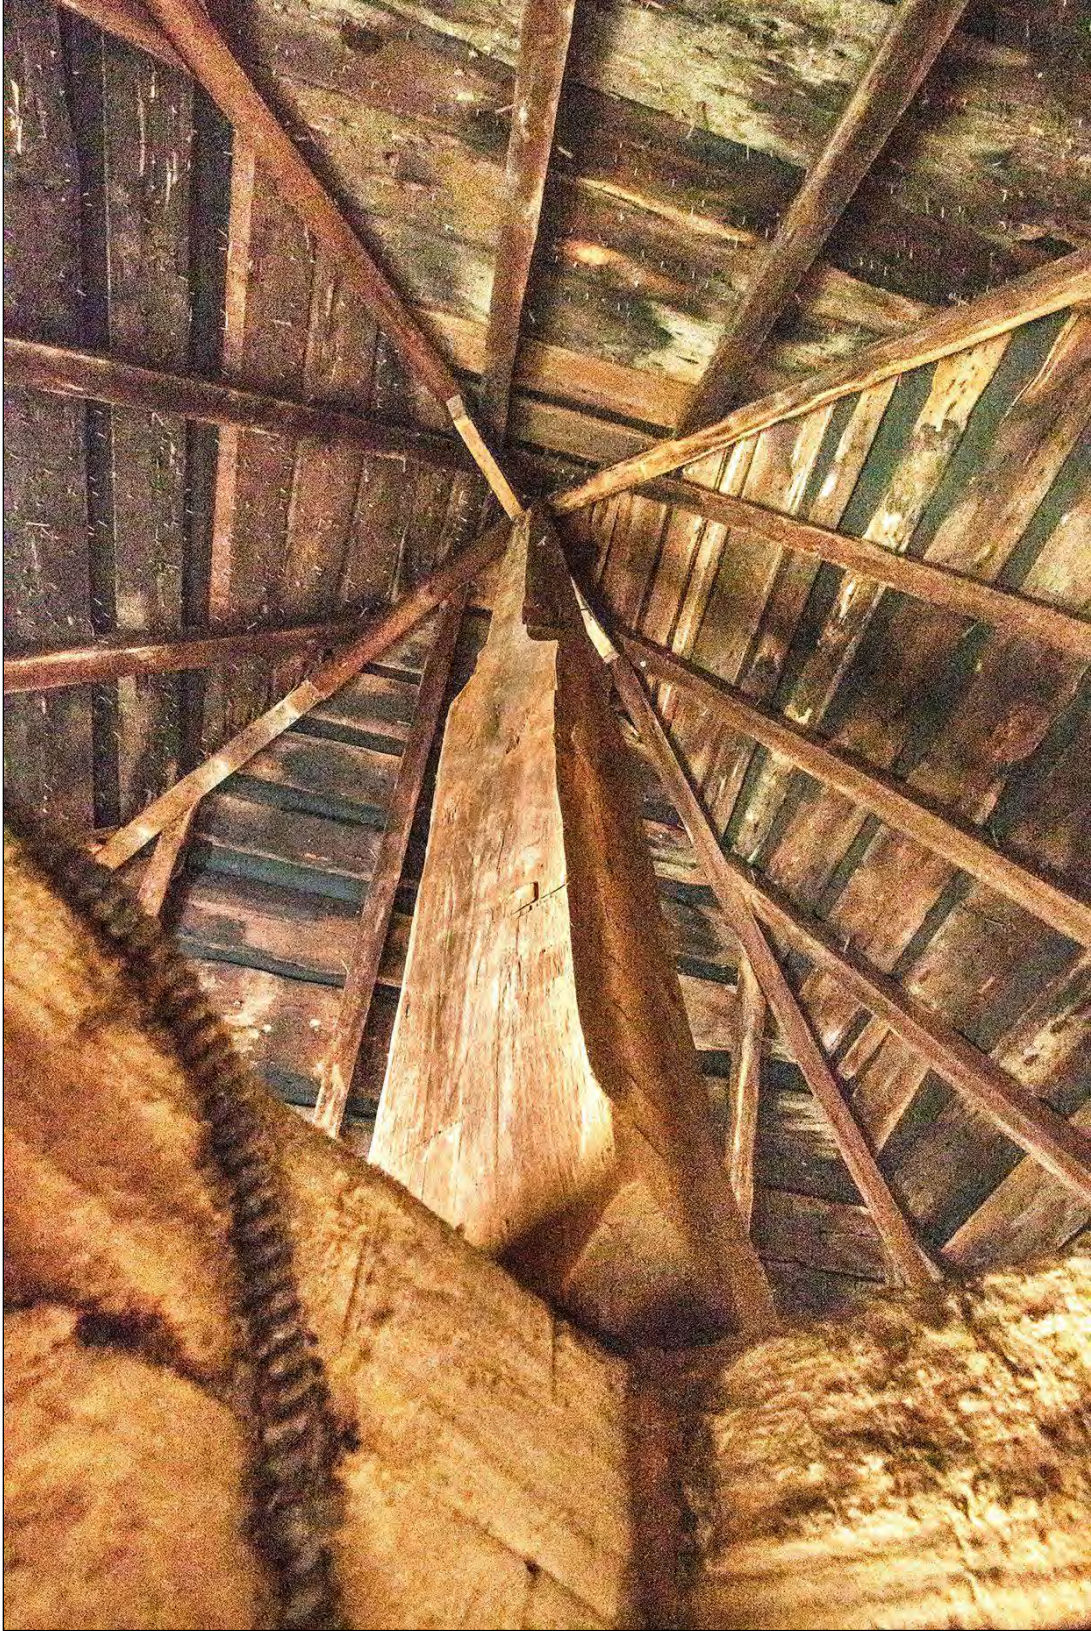
Figure 17. The smokehouse king post at La Grange, near La Plata (Willie Graham).

There is an interesting mix of framing employed in the walls and roof. The sills and walls (except for the door header) are made of oak. In the lower Chesapeake, the extensive, continued use of oak this late was uncommon. However, as expected, most of the roof is made of yellow poplar. The wood species of the false plates was not observed. Otherwise, all but the king post is poplar. The carpenter who fashioned the king post used oak—again, an unusual choice. Oak is heavier and more difficult to work, making poplar a more common choice. Presumably, it was selected here because of its strength. Although more oak was used in the building than perhaps expected, the balance between its use low in the building with poplar higher up is conventional.

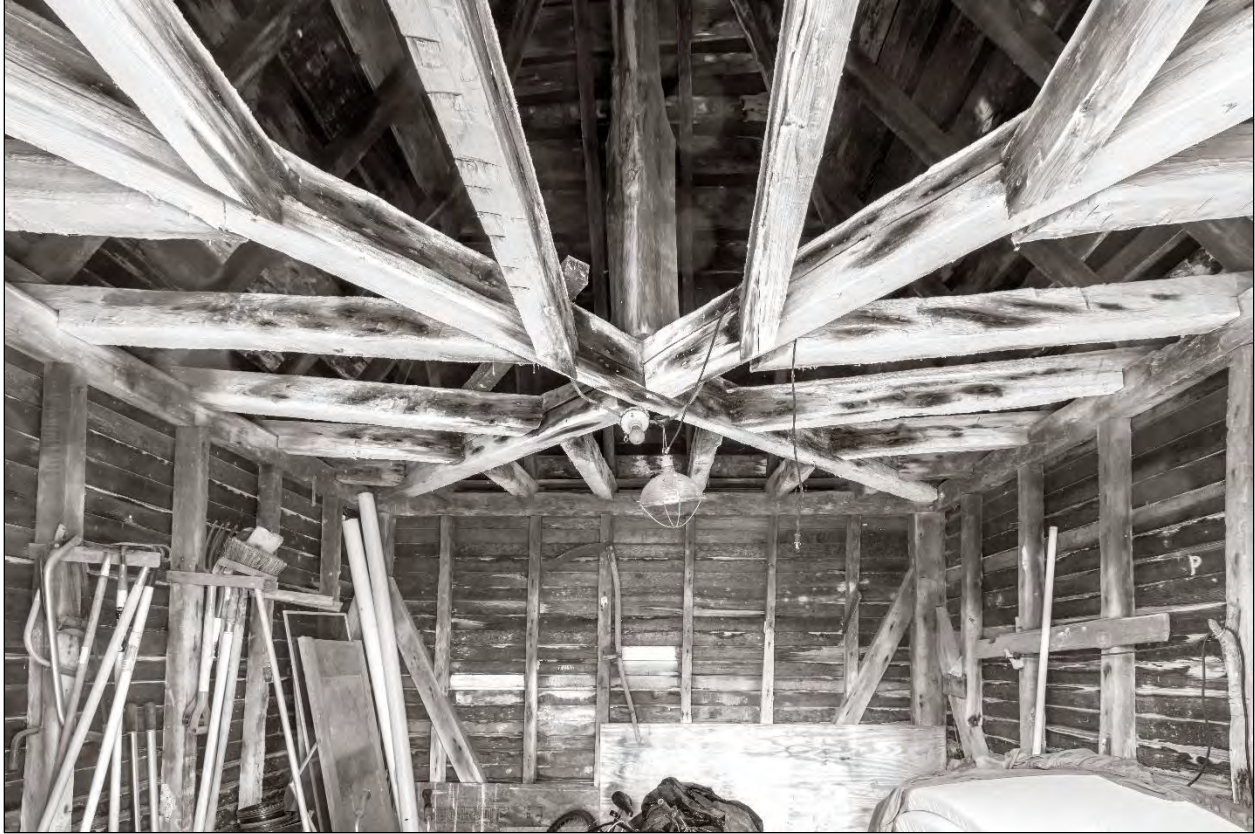
Figure 18. The smokehouse interior at La Grange, near La Plata (Willie Graham).

It is difficult to date this building, in part due to decay and in part because of its contextual relationship to the main house. The frame is made of hewn and pit-sawn stock. The Cremona smokehouse, discussed below, is securely dated to 1828 and has a pit-sawn frame, so one can reasonably expect similar material used elsewhere in the southern counties to potentially date this late. The nails, as noted, are obscured by corrosion. However, the nail fastening the door keeper to its post is a hand-forged rose head nail. A few other framing nails are seemingly of the cut variety with machined heads, while a few may be hand-headed cut nails. If these fasteners are indeed as they appear, the mix is suggestive of a construction date around 1820—the tail end of when double-struck cut nails are used, late enough to account for the machined heads and early enough to explain the hand-forged nail in the hardware.

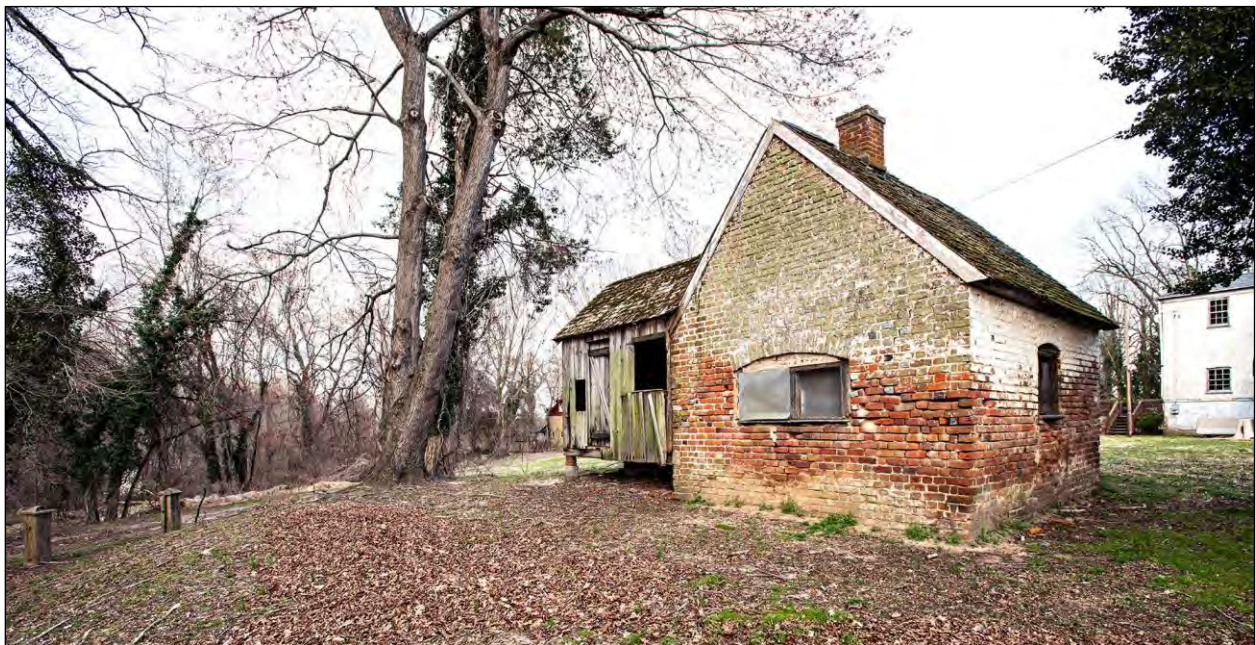
Figure 20. Compton Bassett dairy (Willie Graham).

Rarely do domestic outbuildings survive that were constructed before 1800. The dairy at Compton Bassett is a particularly fine example of one that does (Figure 20). Its large size and construction in brick make it an unusually fine example from that era. Although the building is identified as a “brick store house” on the 1798 Direct Tax list, it clearly was first intended as a dairy. It has a submerged floor—a definitive trait for dairies—and it was well fenestrated. The windows are related to a convention peculiar to eastern Maryland milk houses, which differs from the more predictable treatment of lattice vents set under the eaves that often encircled dairies elsewhere. This building is noteworthy for its lack of eaves overhangs more typically used to shade windows and vents to keep the interior cool. Instead, decorative rafter feet bird-mouthed over the wall plates and were left exposed. The builder relied on the insulative quality of its

excessively thick brick walls, which extend to the upper gables, and on a recessed floor to provide a cool environment for the processing and storage of dairy products.

Clement Hill III's mason raised the dairy with exceptionally fine brickwork. He laid the walls in Flemish bond and finished the mortar with a struck (or "grapevine") joint. He selected closers to clean up the corners and the door and window openings. The brickwork at the eaves is particularly interesting. Since the attic joists do not overhang to create structure for an exterior cornice, a plate simply sits on top of the wall flush with its exterior face. It abuts the inside of the front and rear gables. Pegs driven through it help lock it into the brick walls below. To make the rake boards on the gables cover the wall plates, the mason corbeled the bricks at the four corners the length of a stretcher as seen on the side walls. The corbeling and the resulting hiding of the

ends of the plates provided a satisfying finish to the eaves especially as viewed from the gable ends. That left the rafter feet exposed since the brick corbeling was confined to the four corners and did not run the length of the side walls.

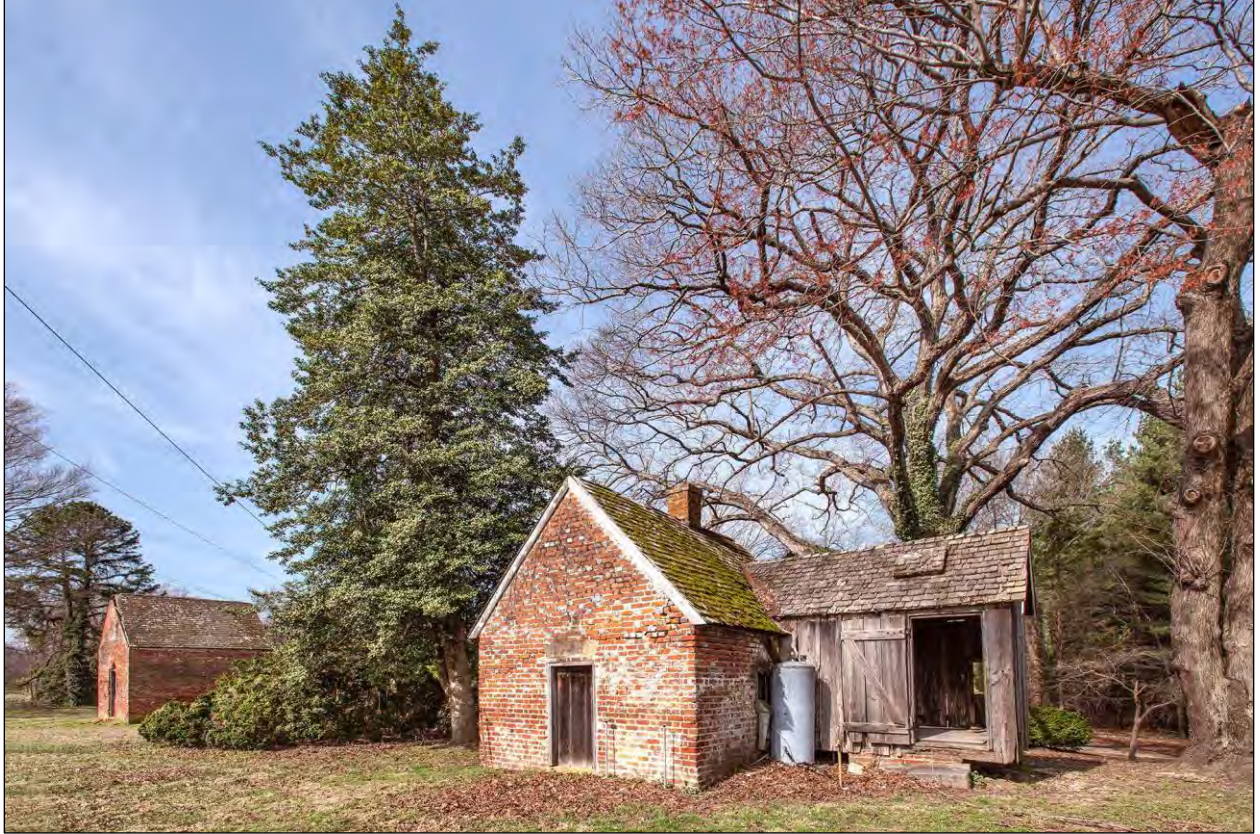
Figure 21. Compton Bassett dairy with the smokehouse to the left (Willie Graham).

The dairy sits in a service yard at the rear of and off center from the house. When the current smokehouse was constructed, it was placed symmetrically relative to the house on the opposite side of the yard so that both act as modest flankers to the main house and are equal distance to it (Figure 21). The smokehouse is conceivably a later replacement of the one recorded in the 1798 Direct Tax (see discussion, below). Dairies are generally the most elaborately finished of the domestic service buildings. Except for the kitchen, of the service structures, dairies are typically set closest to the main house. If indeed the two extant structures were constructed about the same time, the masons may have used differing bond patterns to regulate the hierarchy of the structures by using an inferior bond in the smokehouse, despite placing the two equidistant from the main house.

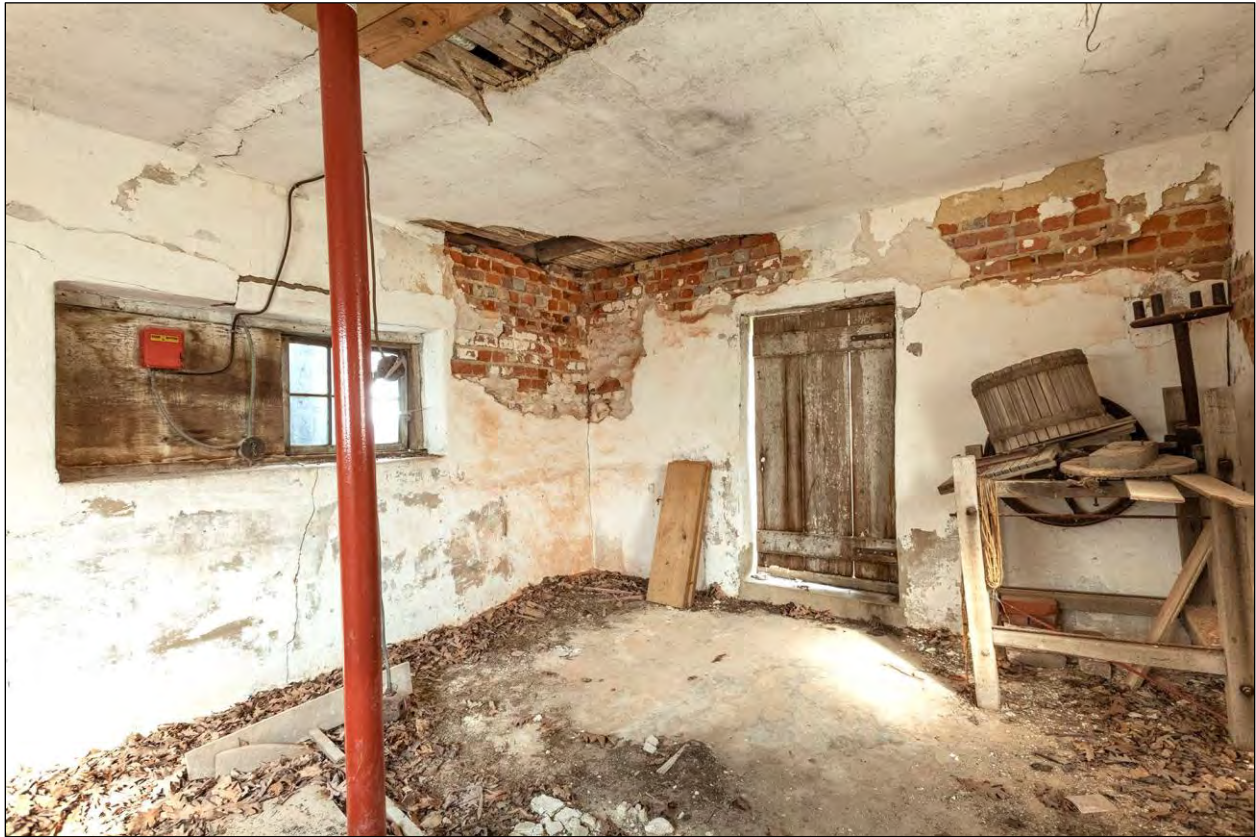
Figure 22. Compton Bassett dairy interior (Willie Graham).

The building once again underwent improvements in the 1960s, documented by a penny set into concrete replacement sill for the front door. Rebuilding of the doorway attempted to

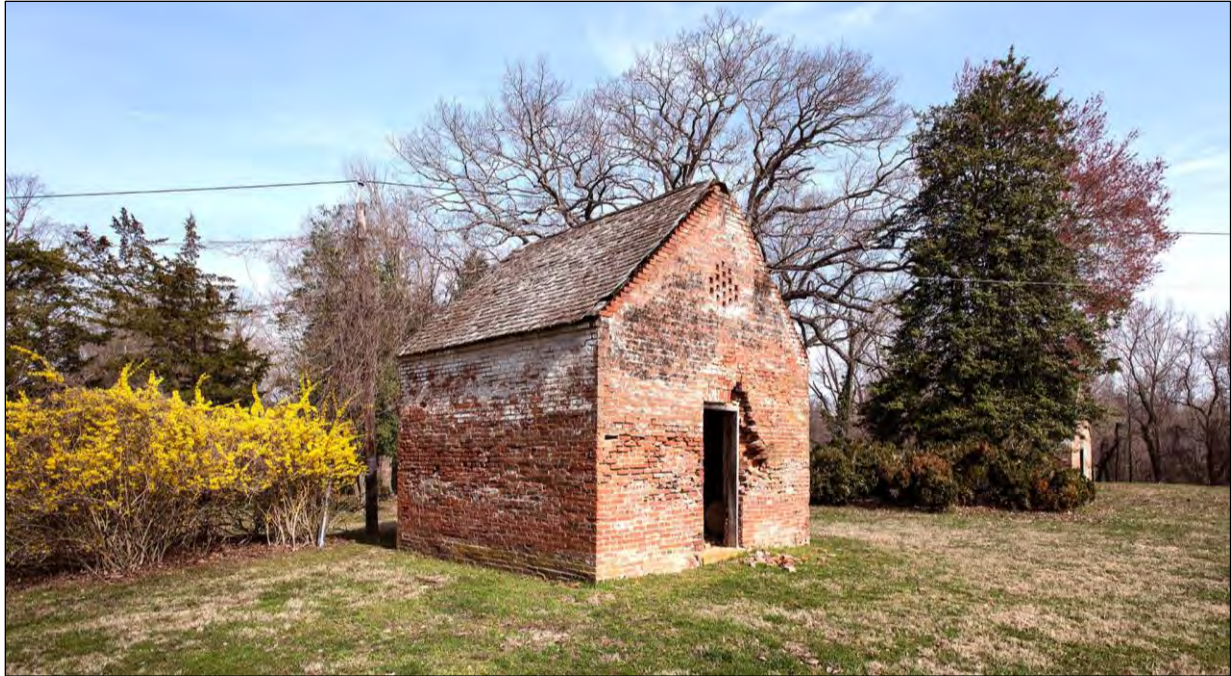
Figure 23. Compton Bassett smokehouse (Willie Graham).

Precisely when the current smokehouse was erected is difficult to pin down (Figure 23). Its size differs from that listed on the 1798 Direct Tax. That combined with its three-to-one brick bonding pattern initially led the field team to think it must date later. Conceivably, it was part of the changes made when James Hoban advised the Hills on site improvements in 1822. Further examination of the tax records and orphan court accounts, however, suggests that those charged with these assessments often were lax in their measurements. Why should a brick smokehouse that was presumably constructed after the main house was built in 1788 need replacement some 30 years later when the dairy did not? Many possibilities come to mind, yet it seems plausible that the extant smokehouse is the one mentioned in the tax roll and the recorder simply sighted

the dimensions on one side, albeit by four feet. Future archaeology may hold the key to more tightly dating this building and fleshing out the story of the development of the rear yard.

Whenever it was built, the smokehouse was positioned to the rear of the main house and flanks it symmetrically with an impressive brick dairy, which had itself survived from the 18th century (see Figure 19). Although its wall bonding pattern makes it inferior to the dairy, the smokehouse is nonetheless quite refined, most notably for its diamond-shaped ventilation piercings in both front and rear gables. Also noteworthy are the survival of three features that are usually removed from early smokehouses: its original firepit, an extraordinary hewn poplar salting trough, and some of its riven sticks on which meat was hung to smoke it. A rare 18th-century ladder, possibly salvaged from the main house (if the smokehouse dates to the 1820s), rises inside for access to a well-framed roof. If the smokehouse was built in the 18th century, then the builder might have made the ladder for its current purpose.

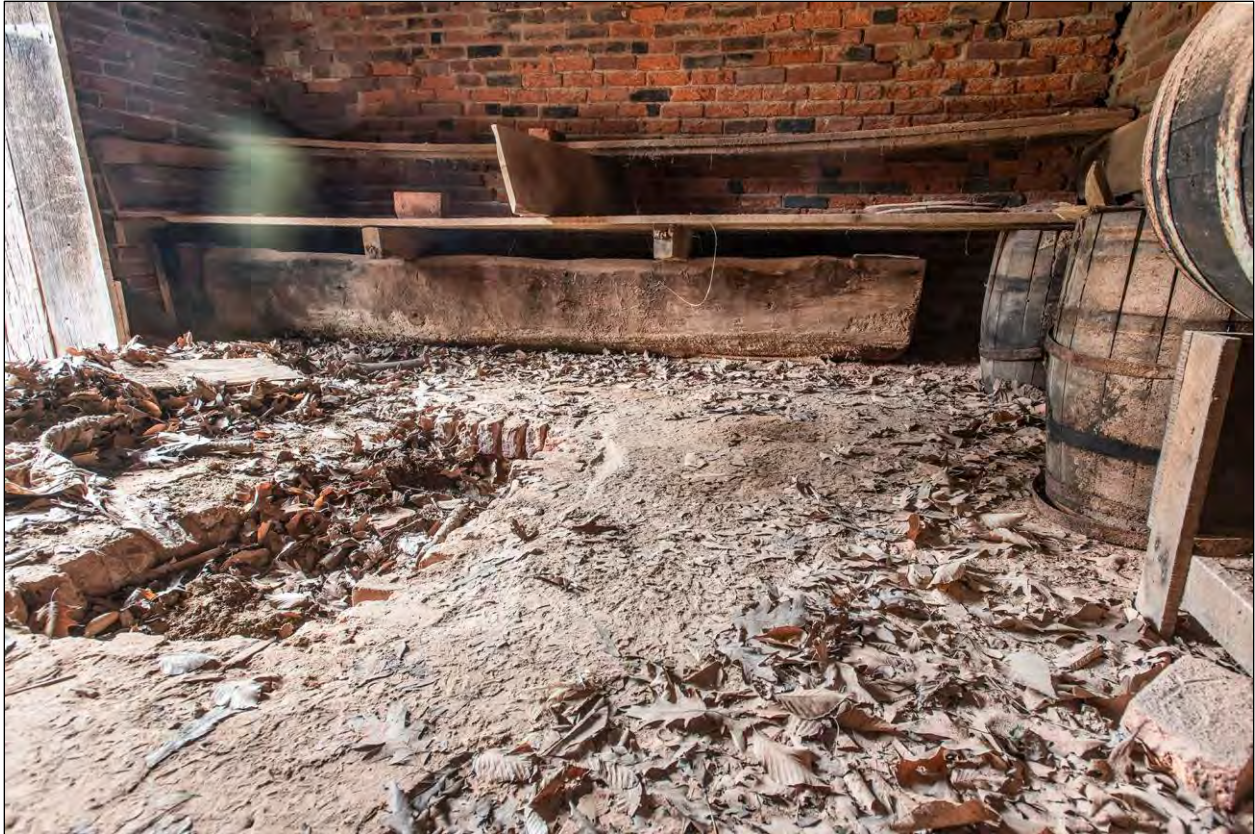
Figure 24. Compton Bassett smokehouse interior with salting trough (Willie Graham).

While buildings for curing meat were often constructed nearly airtight to contain smoke from low-grade fires, the Compton Bassett smokehouse includes vents built into the upper gables on the front and back to exhaust its fumes. Although the vents are small, they nevertheless must have made regulation of temperatures more difficult and required a larger consumption of firewood than in more conventional smokehouses. One might question whether this building was intended and used for curing except that other than its vent, it has all other characteristics common to the building type: the firepit, salting trough, smoke blackening of its walls and roof, and decay in the brickwork associated with the presence of salt. There is no doubt the building

was erected for and served this function. Why venting was deemed a necessity is worth further consideration. Note that the smokehouse at nearby His Lordship’s Kindness has similar gable vents and meat in it was cured in the same fashion.

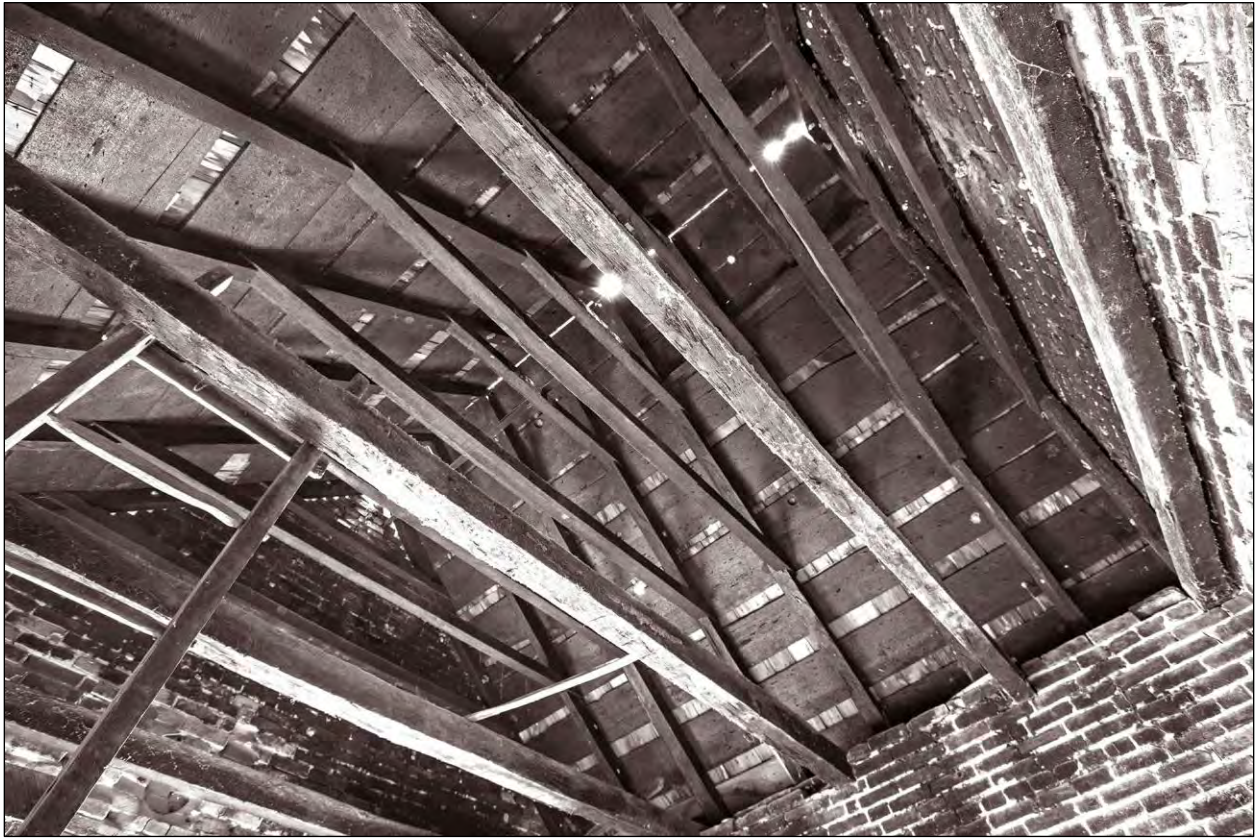
Figure 25. Compton Bassett smokehouse roof framing (Willie Graham).

The roof frame of the Compton Bassett smokehouse is more robust than most encountered as part of this outbuilding study (Figure 25). As with the dairy, the builder avoided overhanging of the eaves to eliminate a framed cornice. Instead, the mason corbeled the top two courses of brick to form a cornice and used the stepping of brick to lock in a small 2-in by 3-in wall plate between the outer cornice brick and the inside courses. Rafter couples are lightly notched on their rear to use a bird mouth to keep them from spreading. Rafters, measuring three by four inches,
