The Architecture of Domestic Support Structures in Southern Maryland

Prepared by:
Willie Graham, Principal Investigator
Scott M. Strickland
Julia A. King

Prepared for:
The Maryland Historical Trust
Crownsville, Maryland

2020

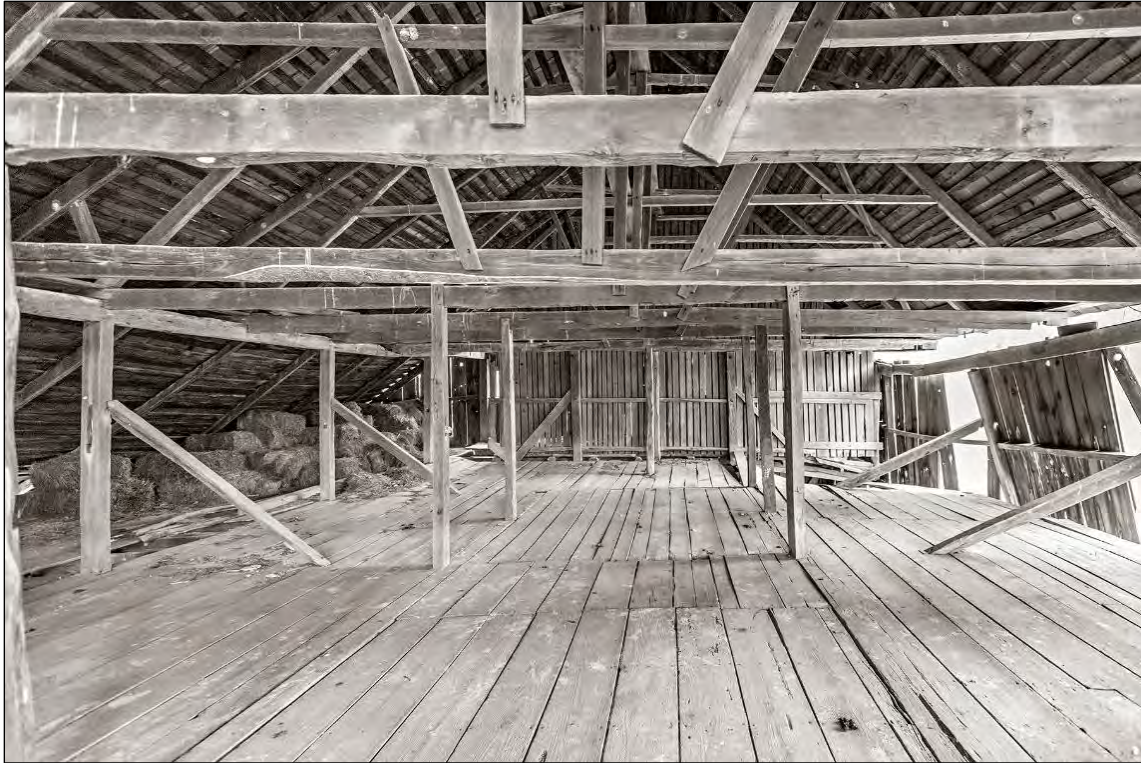
Figure 28. Compton Bassett barn interior (Willie Graham).

with a central aisle on the ground story made with large, earthfast posts set on the edge of a field east of the house. It was built in the middle of the 19th century, perhaps as early as the 1840s.

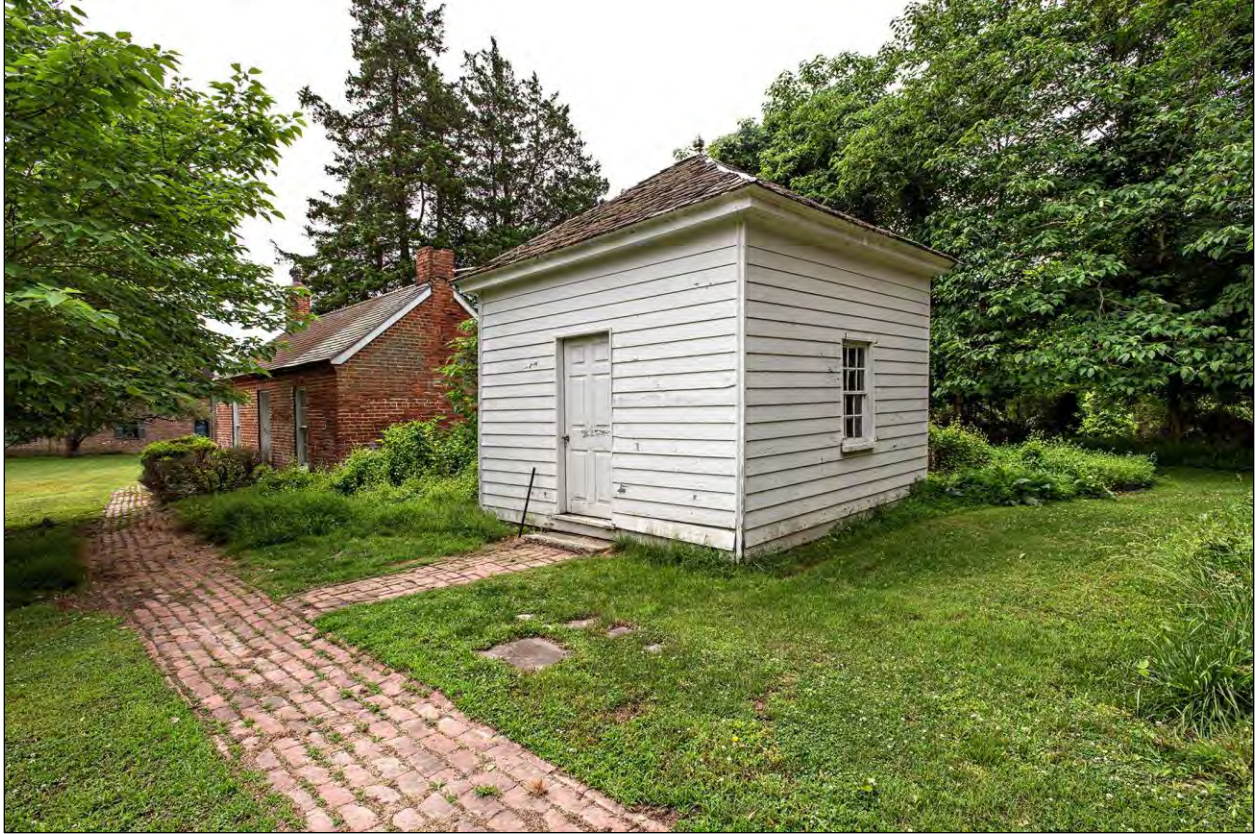
Figure 30. Dairy, Poplar Hill at His Lordship’s Kindness (the “slave infirmary” to the left) (Willie Graham).

The Poplar Hill dairy possess many of the attributes peculiar to structures erected for storing milk products in southern Maryland (Figure 30). It is of frame construction, has a sunken floor, and uses sash windows for fenestration. About 1930, the dairy was transformed into a laundry and remote furnace building to provide steam heat to the so-called slave infirmary next door. At that time, the dairy was retrimmed on its exterior, leaving just its window frames unchanged. The interior was furred out, drywalled, and a concrete floor poured. Decay of laundry alterations inside give glimpses of the original frame and evidence of its finishes.

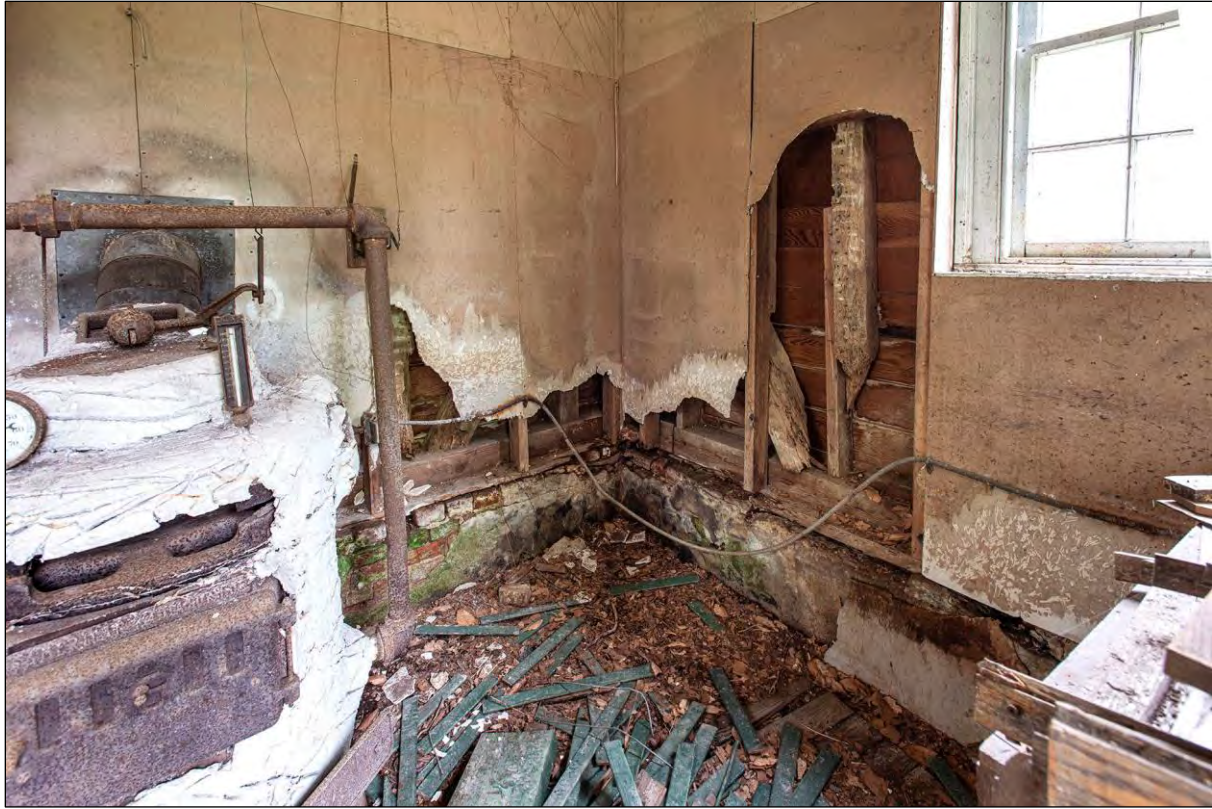
Figure 31. Interior framing, dairy, Poplar Hill at His Lordship's Kindness (Willie Graham).

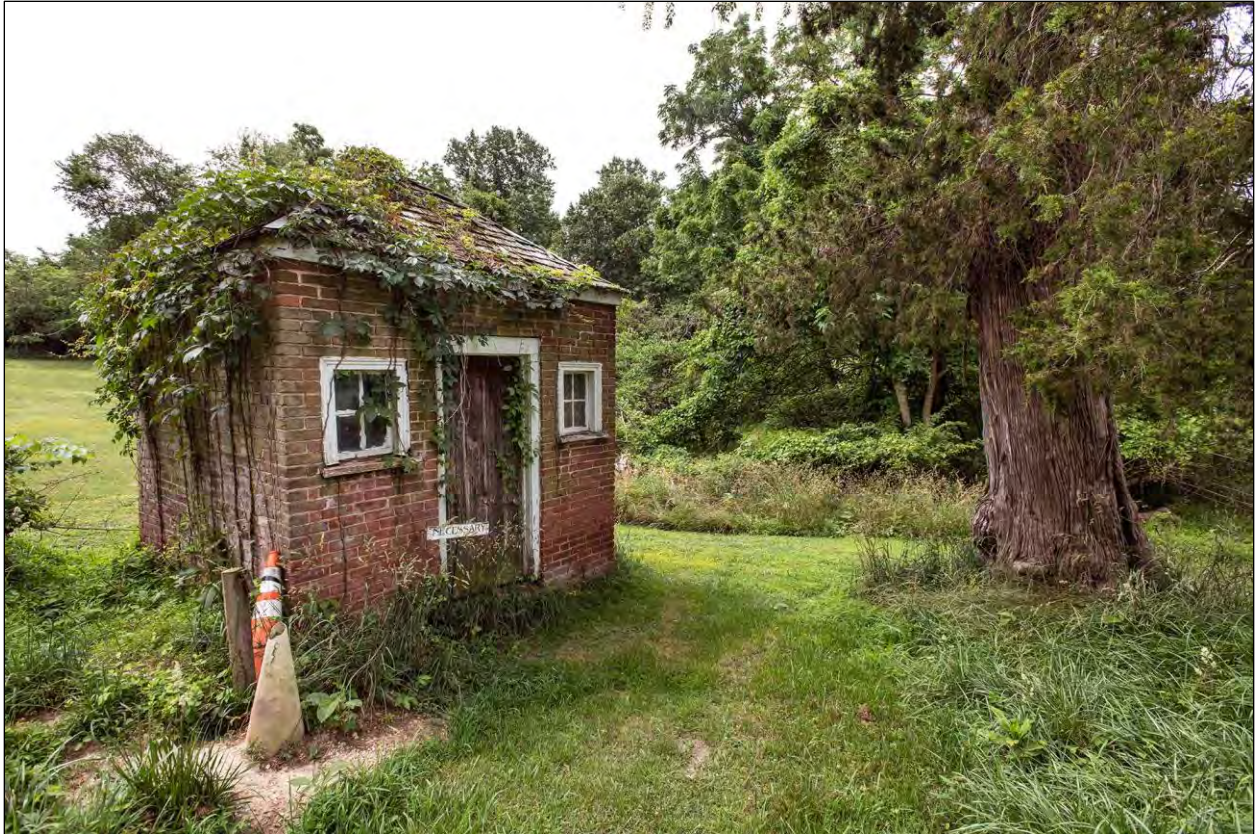
Figure 32. Privy, Poplar Hill at His Lordship’s Kindness (Willie Graham).

The tax list is useful for understanding the Poplar Hill privy. Otherwise, only its form and brickwork survive from original construction to help in its dating. The wall bricks are handmade and were cast in a sanded mold (Figures 32 and 33). The brick mason laid them in a one-to-five American bond pattern, striking the mortar with an overhand joint. Across the Potomac in Virginia, these details would suggest a construction date of about 1820 or later, but in southern

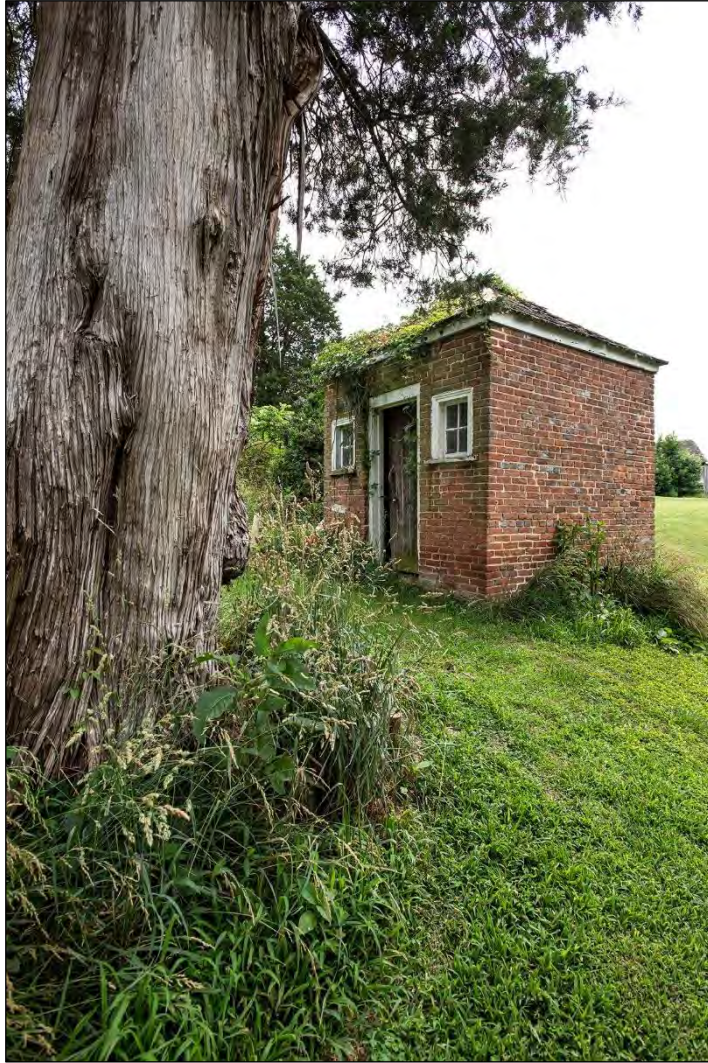
Figure 33. Privy, Poplar Hill at His Lordship's Kindness (Willie Graham).

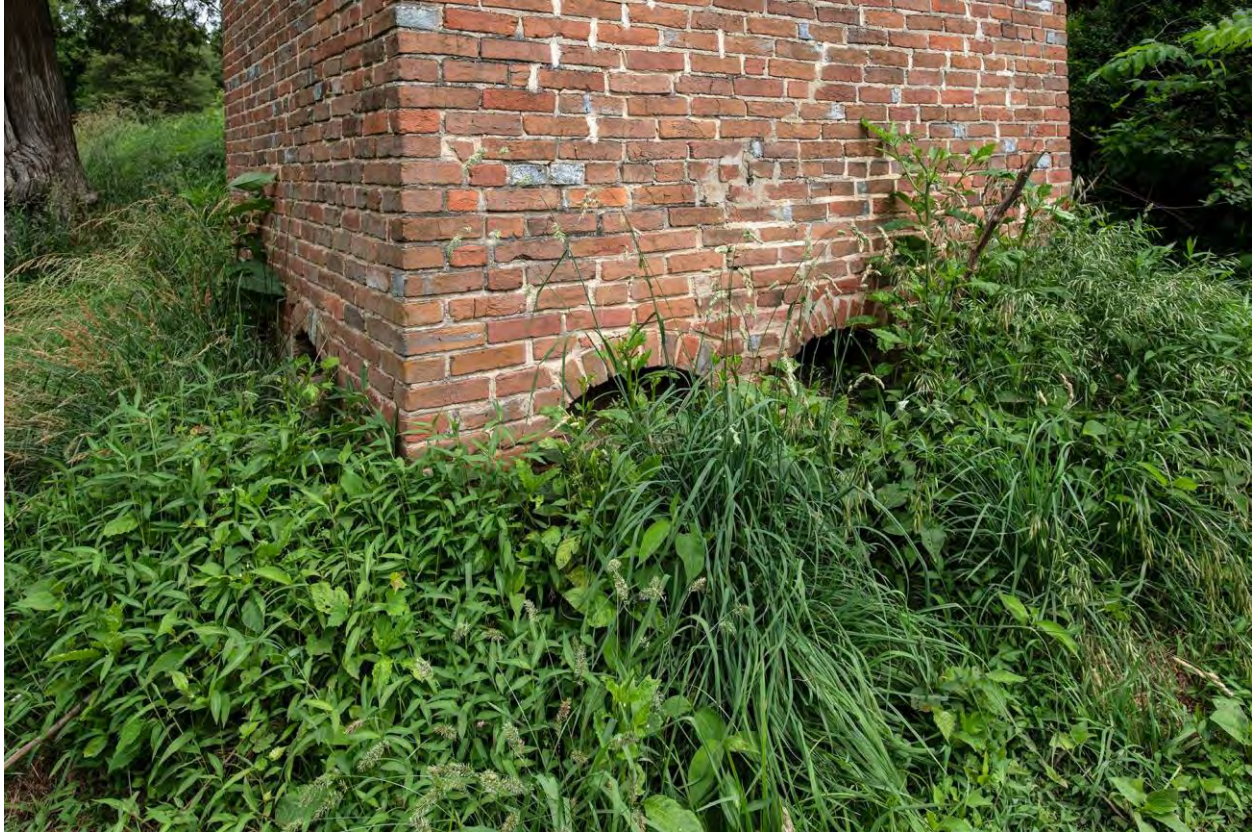
Figure 34. Privy cleanouts, Poplar Hill at His Lordship's Kindness (Willie Graham).

Despite the renovation, the clean-outs do indicate something of the layout of the interior (Figure 34). At 10-ft square, the building is large for its type based on the St. Mary's County

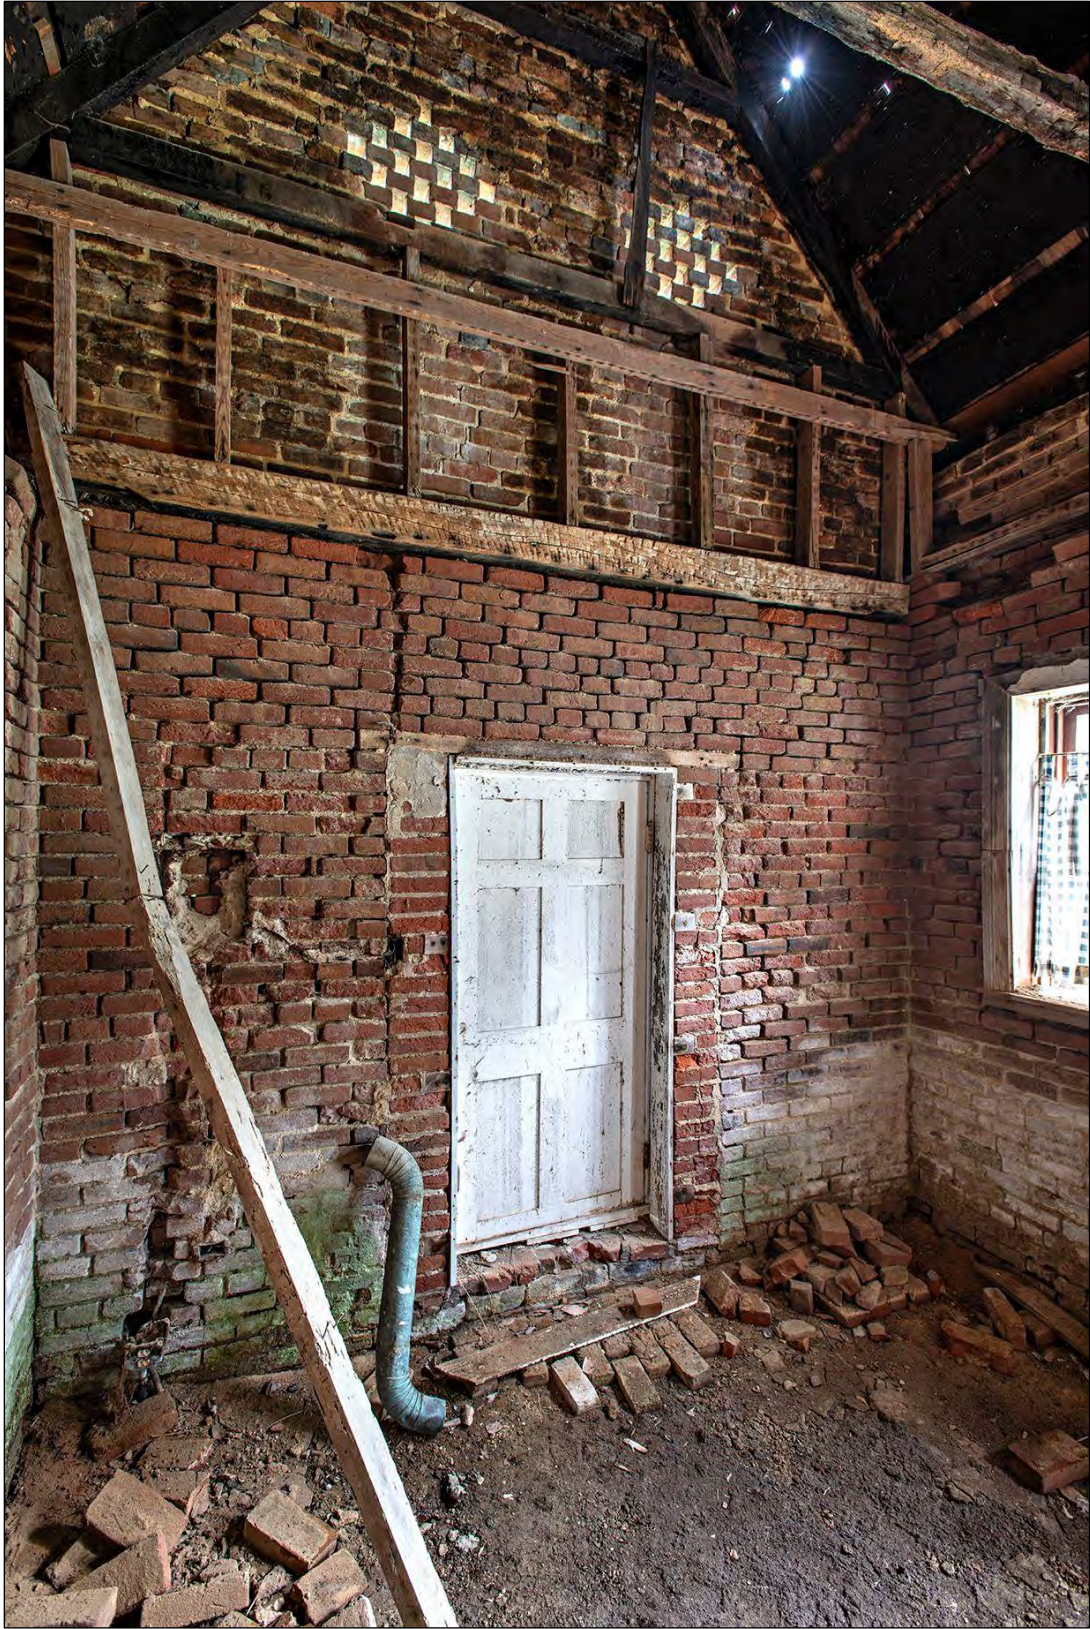
Figure 36. Front gable interior, smokehouse, Poplar Hill at His Lordship's Kindness (Willie Graham).

The most conspicuous feature of the smokehouse is its ventilation system. It consists of voids in the brick walls, which create diamond-shaped patterns in the front and rear gables (Figures 36 and 37). Gaps between headers permit airflow. The vents make for one of the grandest smokehouses seen in our survey. Its resemblance to the nearby Compton Bassett smokehouse of about the same date is noteworthy, both because of their shared use of ventilation (an uncommon feature in smokehouses) and the similarity in their appearances. It is possible that the gables were rebuilt early in the life of this structure. If so, perhaps that work took place around 1820 when it is expected that the Compton Bassett smokehouse was also rebuilt.

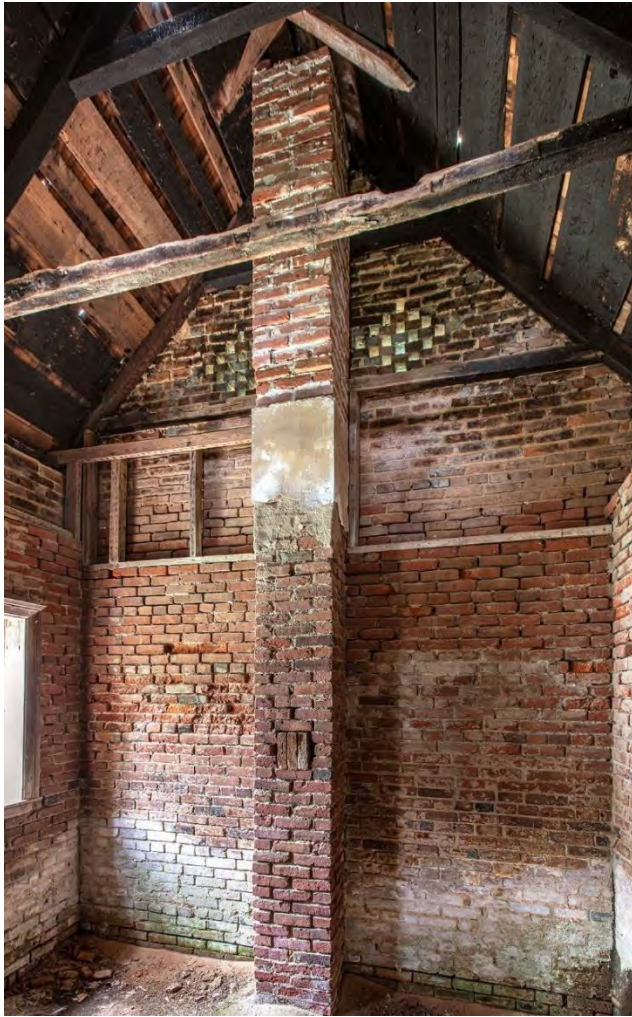
Figure 37. Stove chimney added to rear wall, smokehouse, Poplar Hill at His Lordship's Kindness (Willie Graham).

Probably in the 1930s or '40s when Caroline Dunham owned the property, the smokehouse was converted to use as a work building. Two windows were cut in for light, a stove chimney built on its rear wall (see Figure 37), and joists were added to carry a plastered ceiling. The front door was narrowed, a new jamb installed, and the door leaf was replaced. Little has

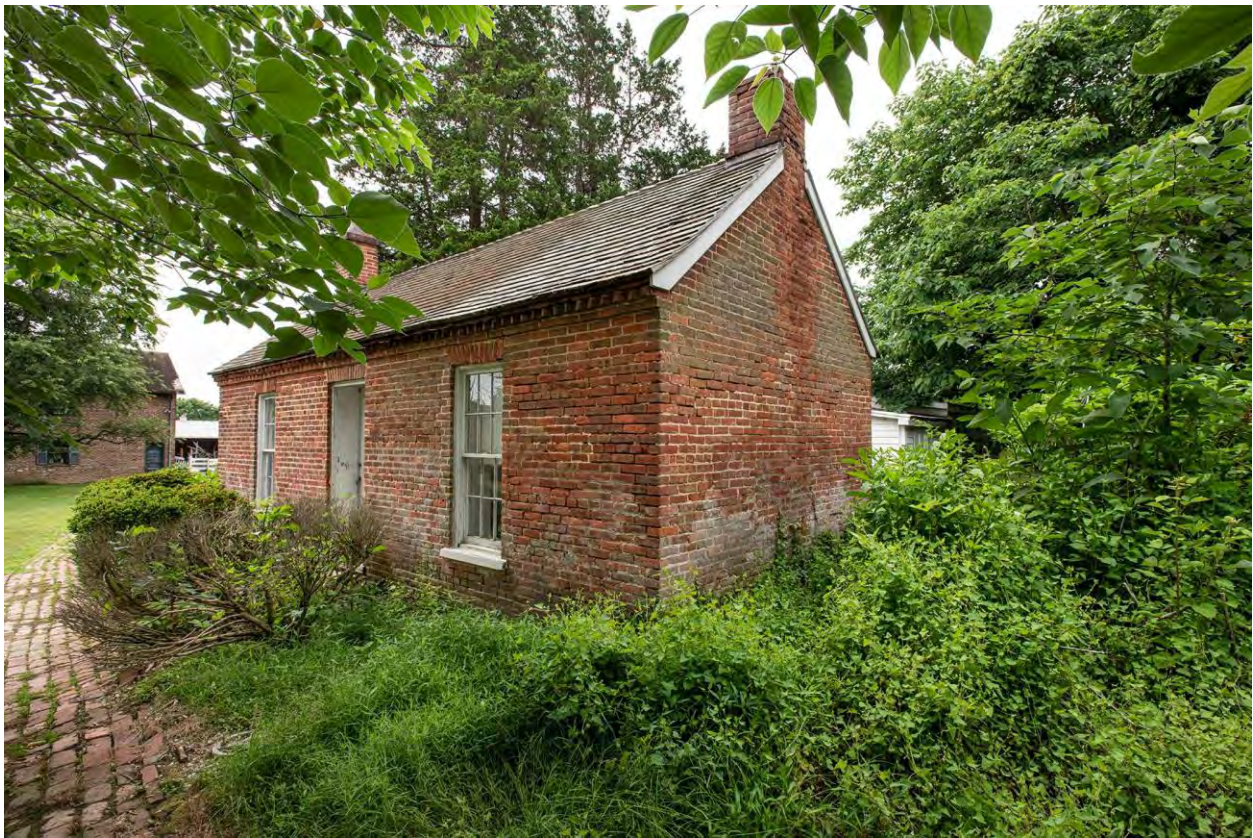
Figure 38. So-called “Slave Infirmary,” Poplar Hill at His Lordship’s Kindness (Willie Graham).

There is an unusual secondary brick structure on site which probably functioned as a dwelling or was used in part as a dwelling (Figure 38). It sits in line with the smokehouse and dairy. Today this structure is referred to as the slave infirmary. No evidence has come to light to support the claim for that function and it is such an unusual assertion that it should be questioned. The structure is quite refined. It is built of brick in a one-to-five bond pattern and is capped with

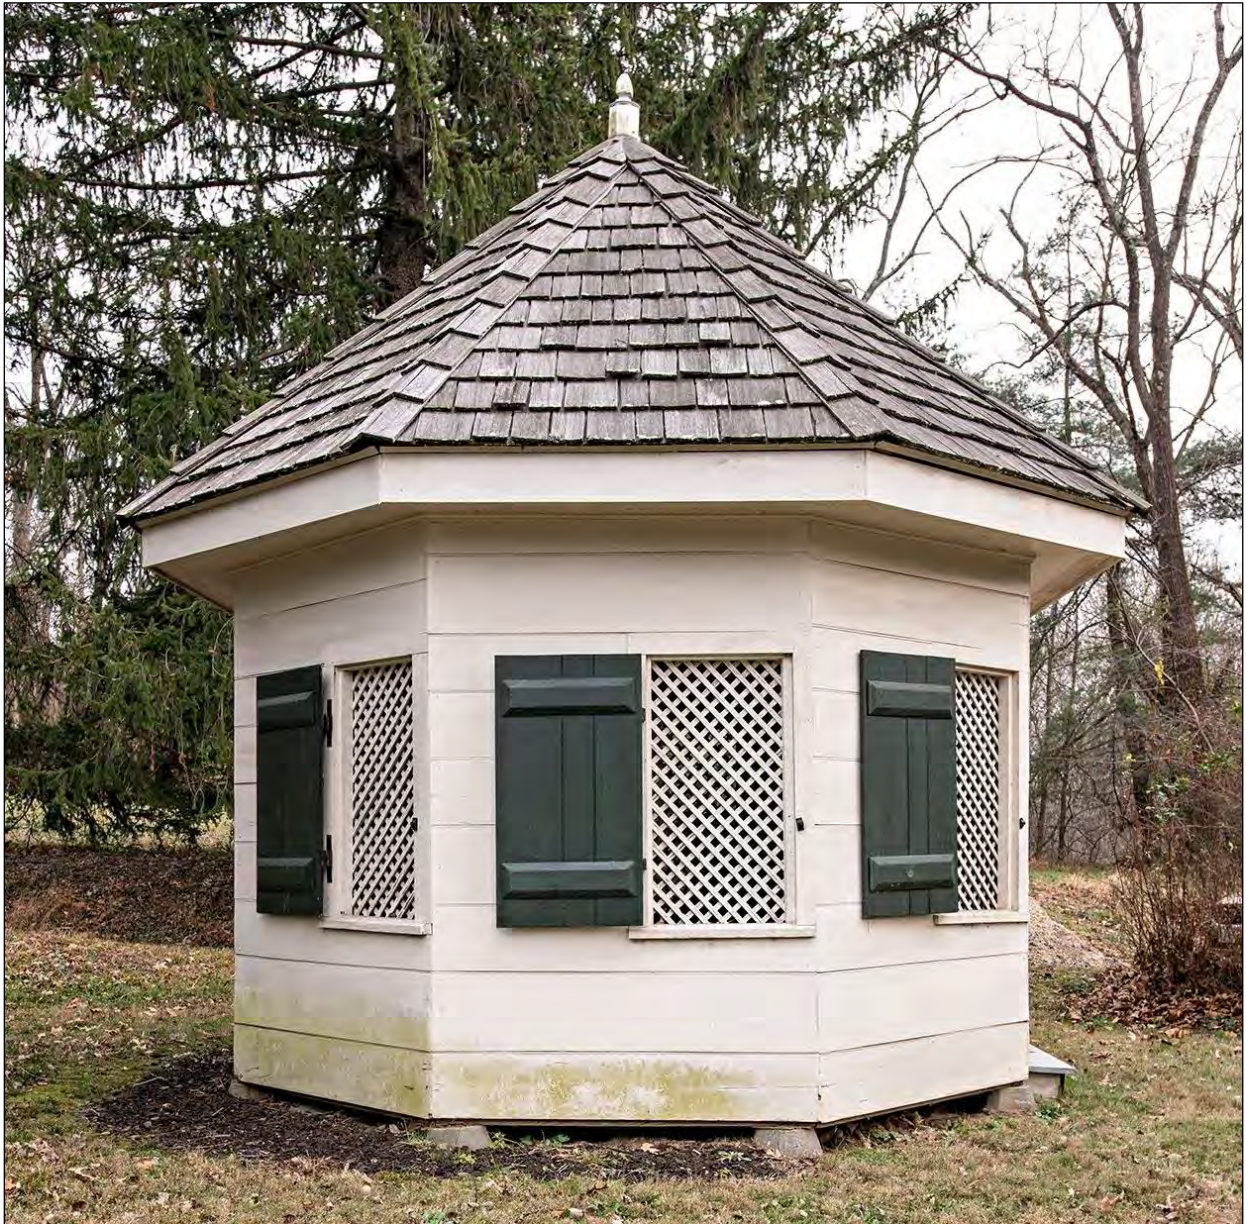
Figure 41. Dairy, Mount Lubentia (Willie Graham).

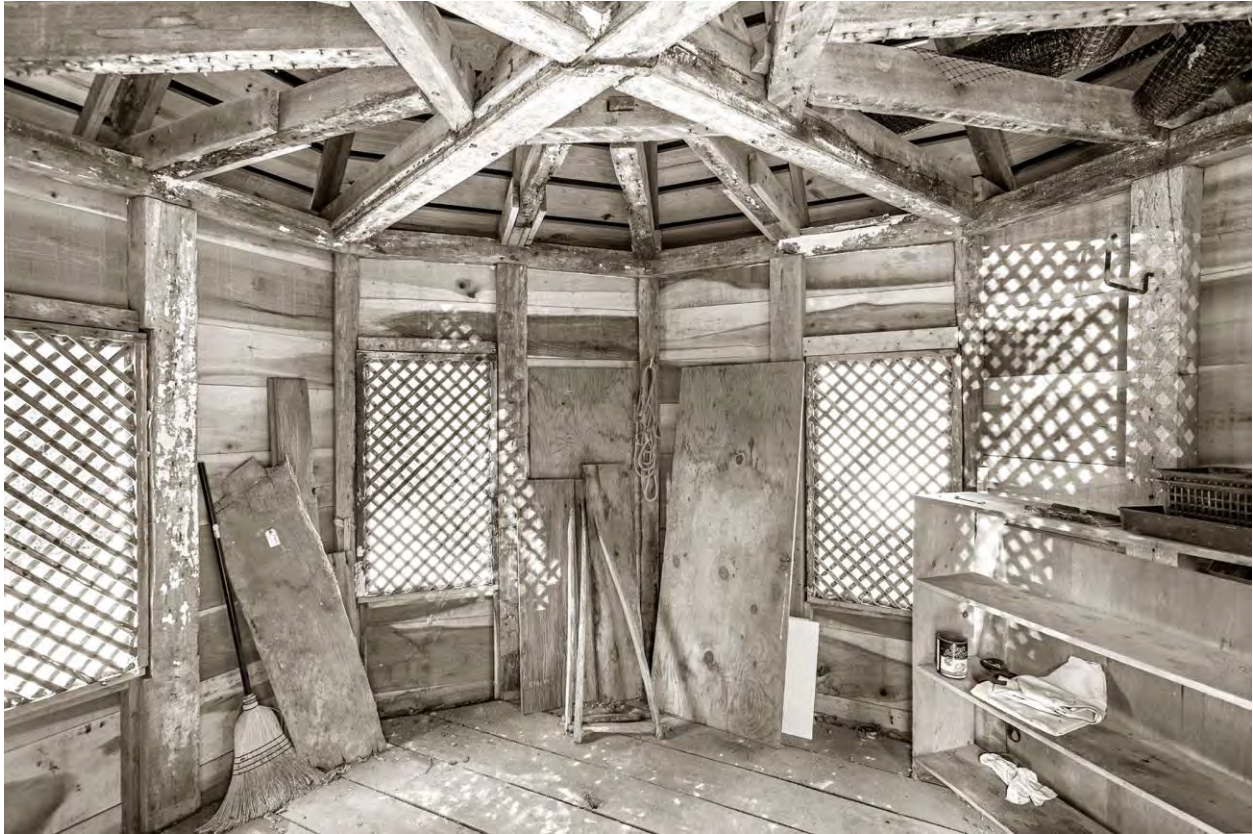
Figure 42. Dairy interior, Mount Lubentia (Willie Graham).

The carpenter also chose to construct the building with an old-fashioned articulated frame—one in which the center bay posts projected more deeply than did the corners, and with the summer beams hanging lower than the secondary joists. Once plastered, these timbers set proud of the finished surfaces. This treatment contrasts with more modern flush framing, which by now was standard for most refined construction in the region. Using a conservative construction method may have required larger timbers and consumed more resources but provided time savings in its fabrication and thus cost less to build.

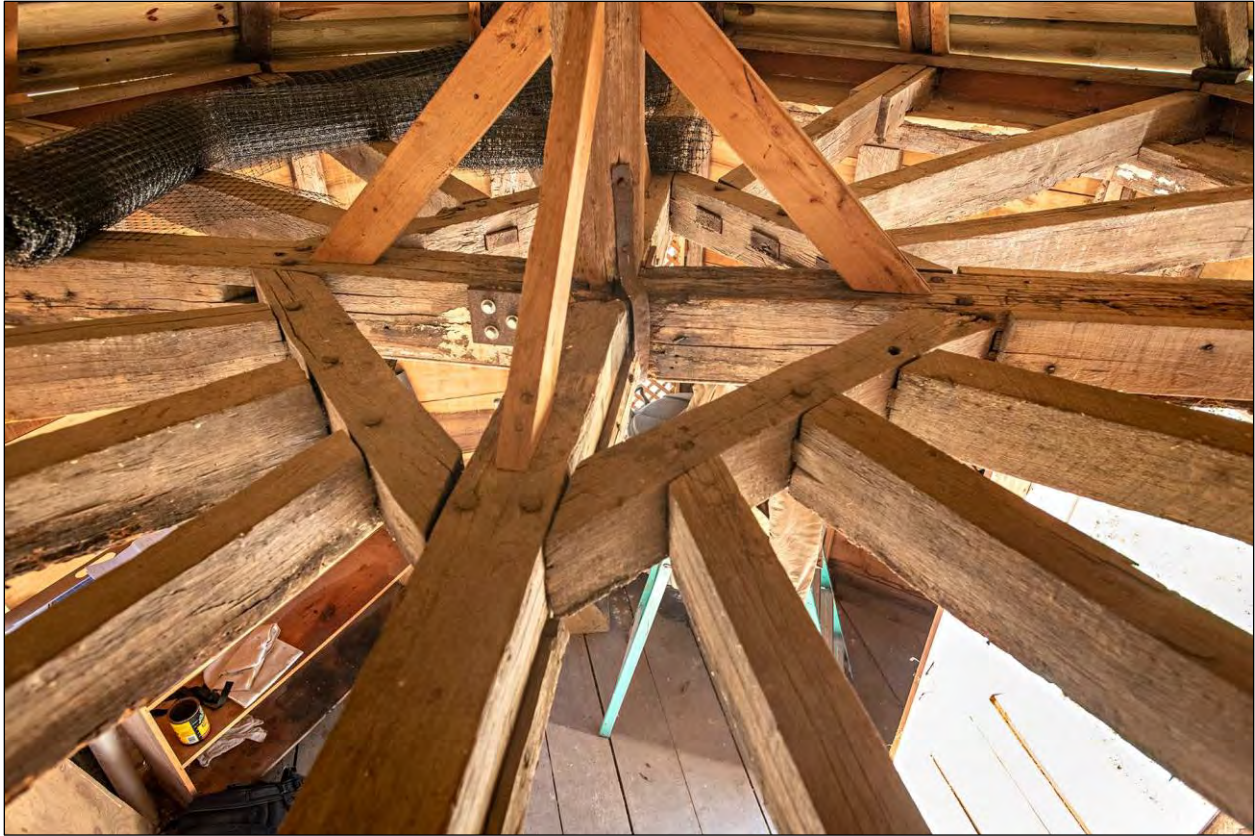
Figure 43. Dairy roof framing, Mount Lubentia (Willie Graham).

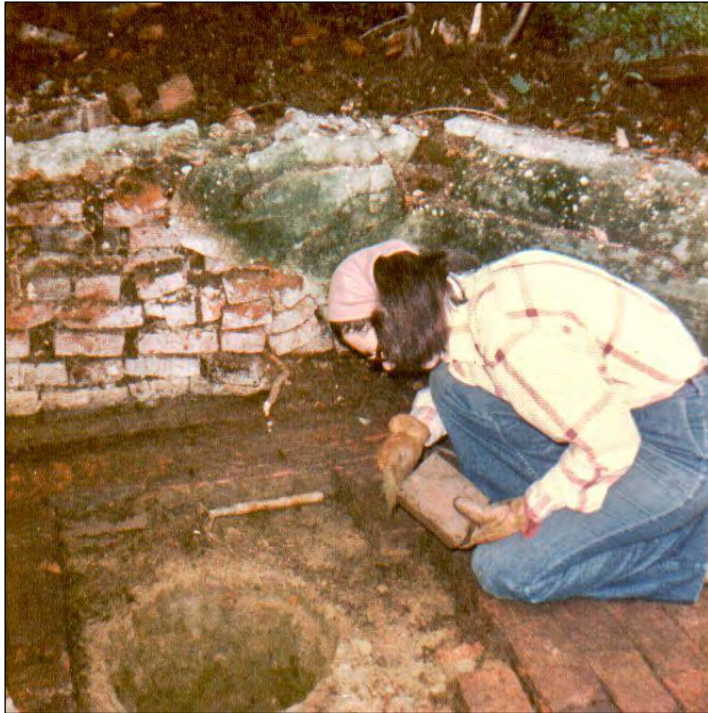
Figure 44. Original floor, dairy, Mount Lubentia (image taken at Graden; Andrew Wallace).

One other treatment of this dairy that was intended as insulation was the use of brick nogging (or “filling” as it was called at the time). A photograph taken by Wallace in 2005 when he restored the structure shows remnants of nogging over the door head. Presumably, all walls were filled in a similar manner. Plaster on the walls, which shows in Wallace’s photographs, must

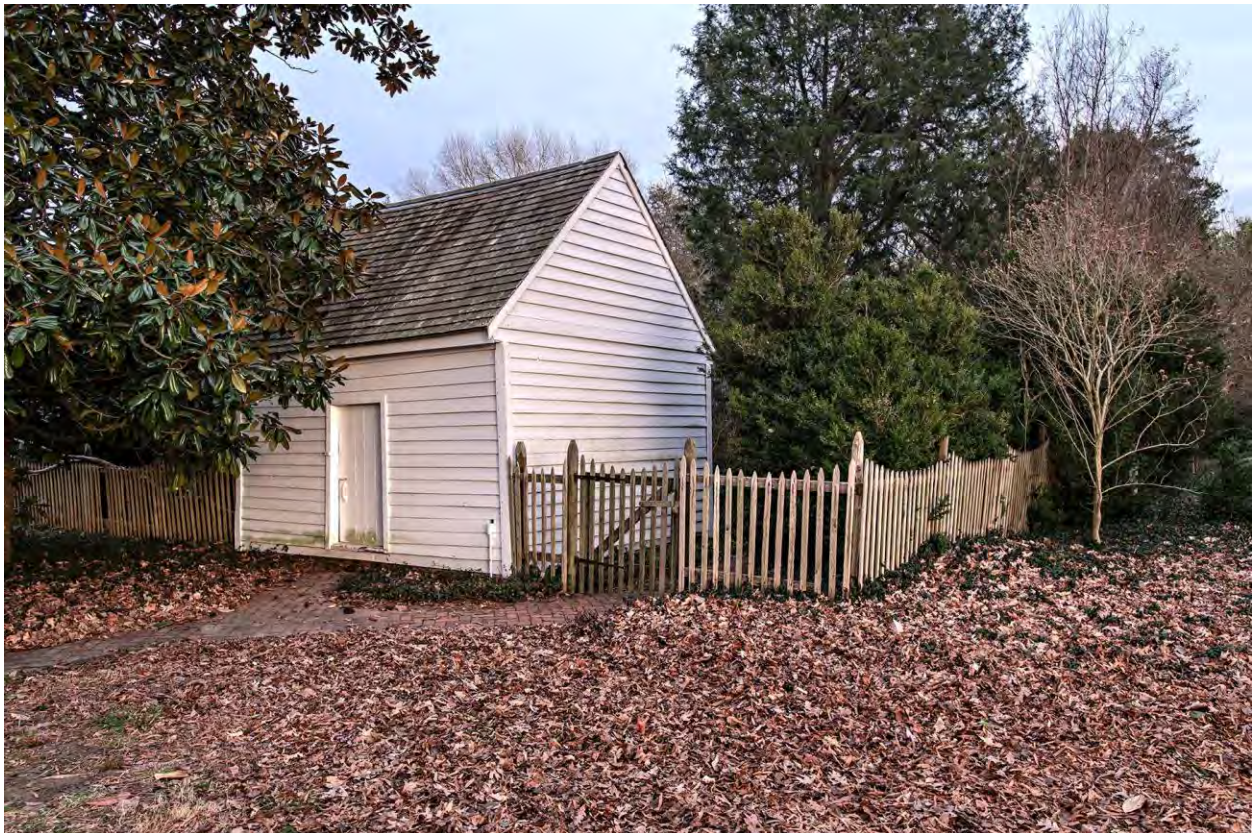
Figure 48. Smokehouse, Cremona (Willie Graham).

This timber-framed structure is unusual in southern Maryland because of how rarely early wooden smokehouses survive there (Figure 48). Roof structures in extant smokehouses in these lower counties are notable for their light framing and widely spaced rafters, contrasting with the heavier frames more common in the lower Chesapeake. The Cremona smokehouse is no exception. It has widely spaced rafter couples each with a double set of collars, which suggest that meat was hung on poles that spanned between the collars and between the joists when smoked. Its construction in wood and the common way in which it is framed makes it likely more typical of smokehouse framing that dominated gentry sites in southern Maryland than suggested by the poor survival of its form.

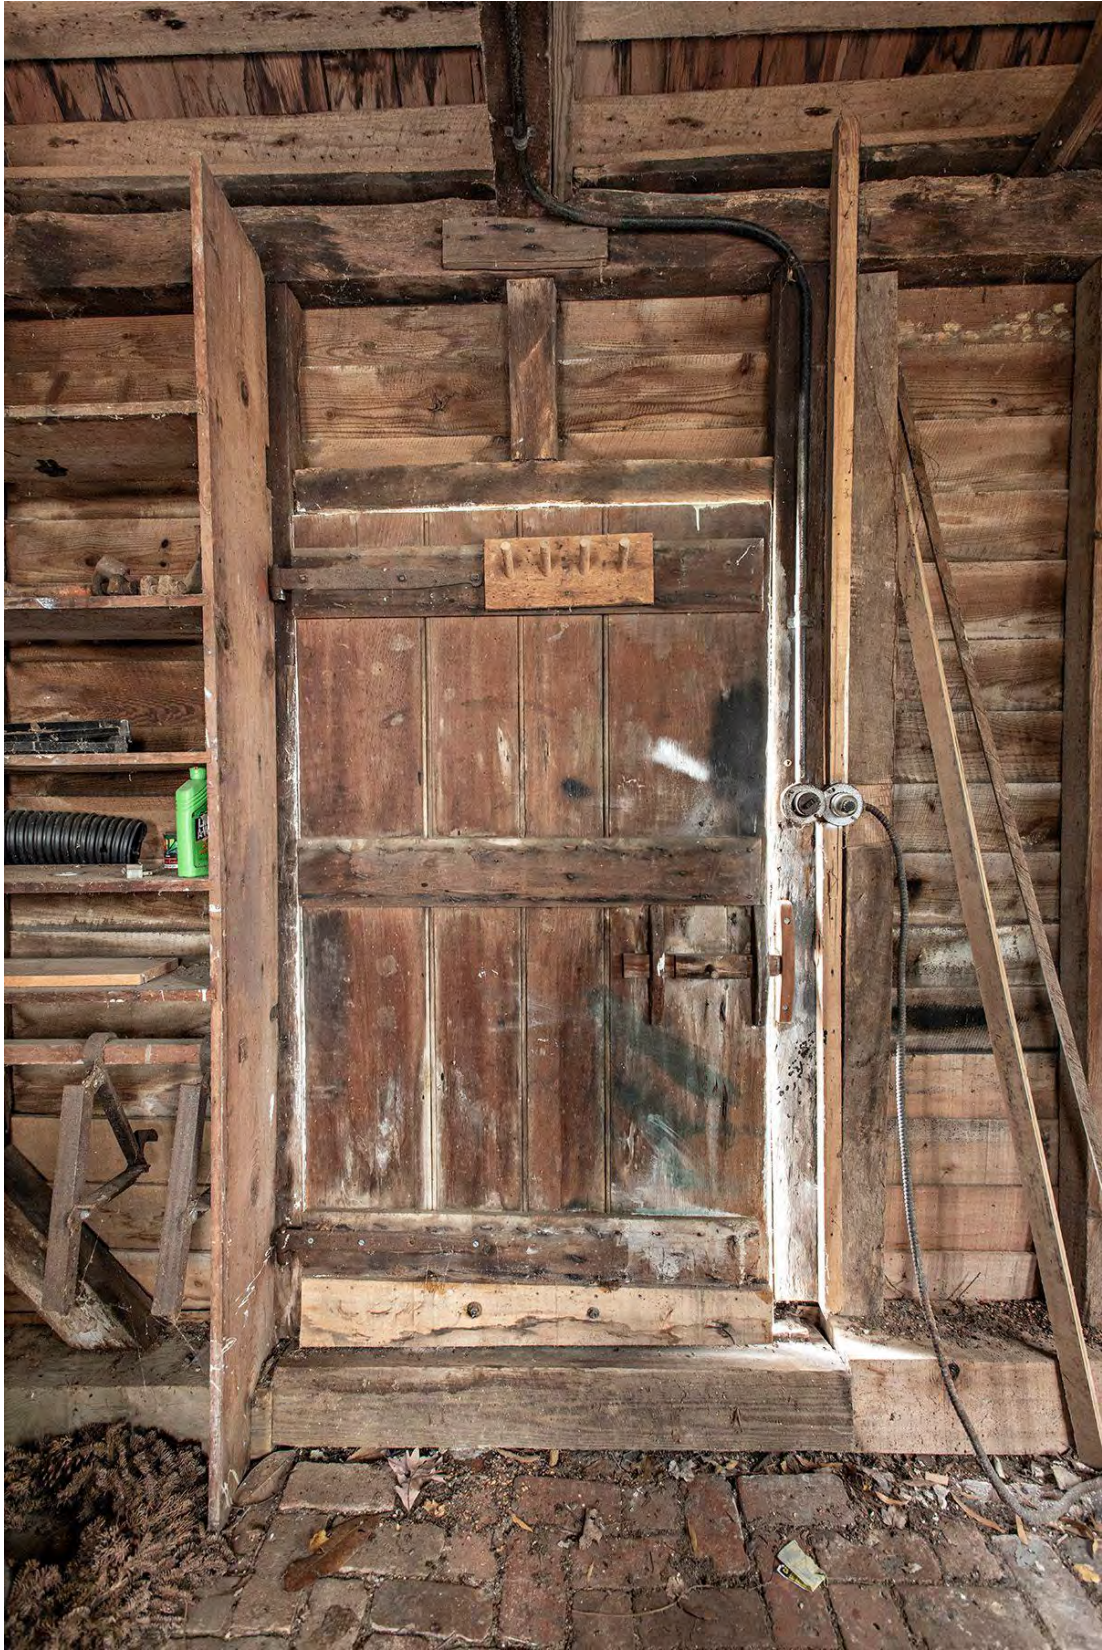
Figure 50. Antique door replacement in the smokehouse, Cremona (Willie Graham).

installed, and the roof was shingled. It is unclear whether replacement of the door and hardware was part of this work or associated with changes made after Dr. Norton T. Dodge bought the property in 1966. In either case, an antique board-and-batten leaf was cut down on its sides and an extension made to its bottom to fit the opening (Figure 50). It was hung on a pair of hand-forged strap hinges and secured with a repaired wooden sliding bolt.

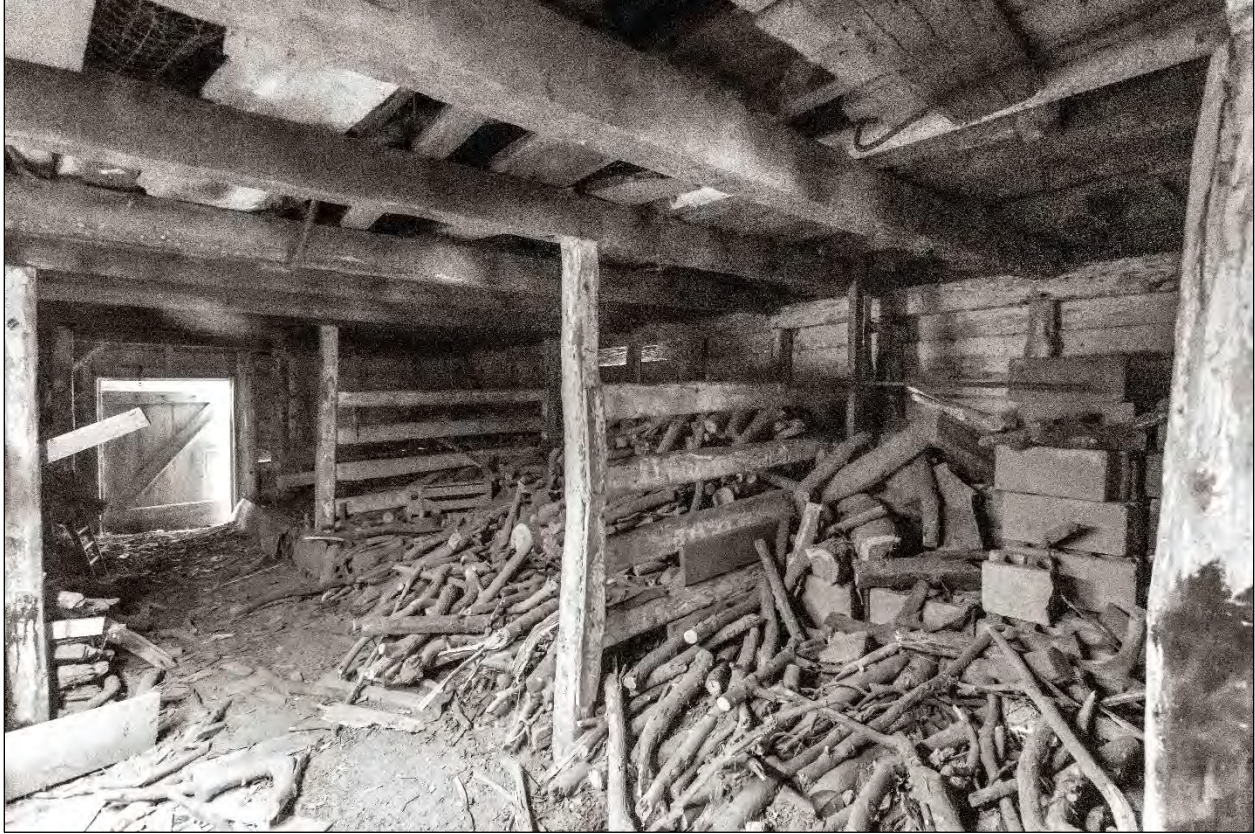
Figure 52. Animal barn, Cremona (Willie Graham).

One other structure in the immediate yard built about the same time is a timber-framed animal barn that probably housed cows (Figure 52). While the ceiling height is quite low, it nonetheless is divided into stalls. The short wall "pitch" (as the height of the wall was known in the period) makes it unlikely that the stalls were used for horses. Dennis Pogue suggests that perhaps the stalls indicate that the barn was intended for a milking operation. The remains of a multi-hole privy seat were thrown into the attic and could be from a now-missing building.

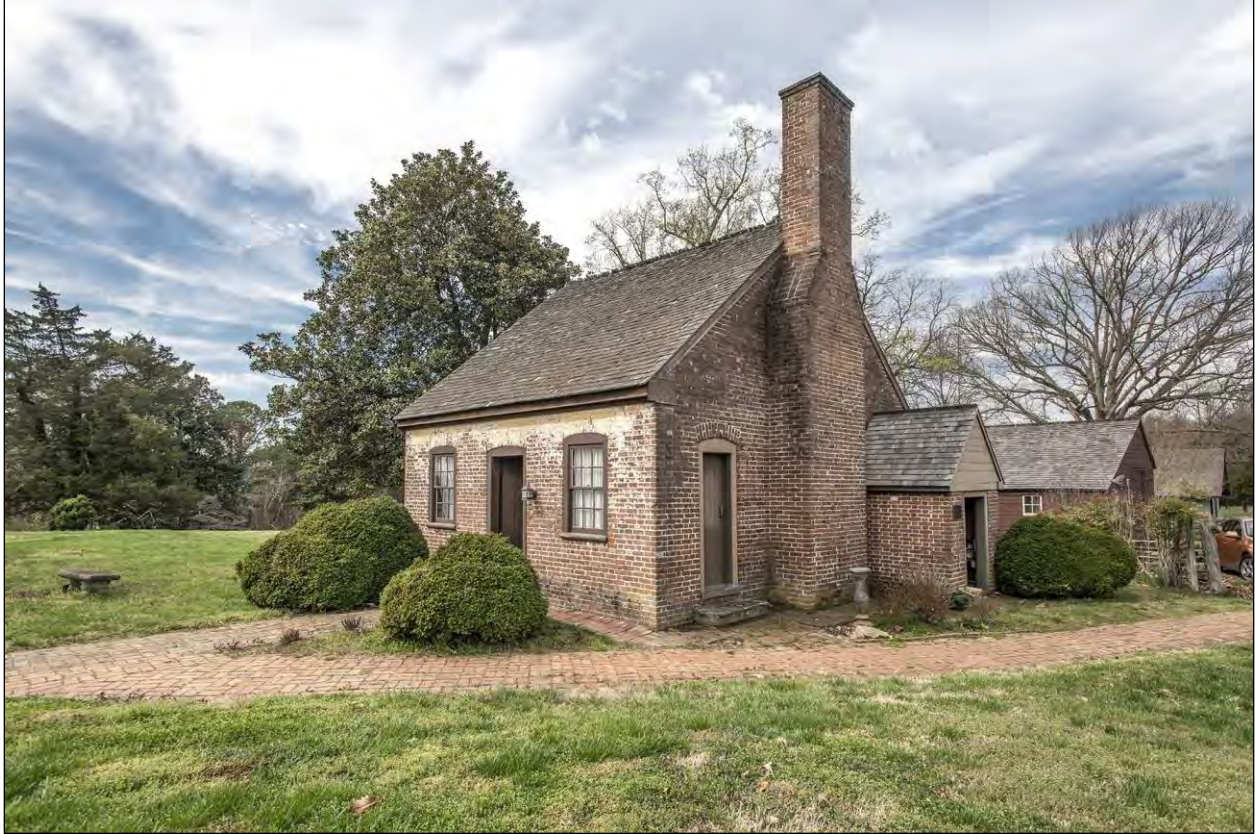
Figure 55. Workhouse/weaving house, Mulberry Fields (Willie Graham).

1814 (Figure 55). This pair of dependencies are the finest encountered as part of this project and are rivaled by few others in the state. Evidence suggests the two were constructed during the opening decade of the 19th century. Reportedly “1805” was carved adjacent to the firebox in the kitchen. Dendrochronological testing of the weaving house indicates that trees were felled for its construction in the winter of 1804 and was thus likely completed the following year.¹⁶⁸

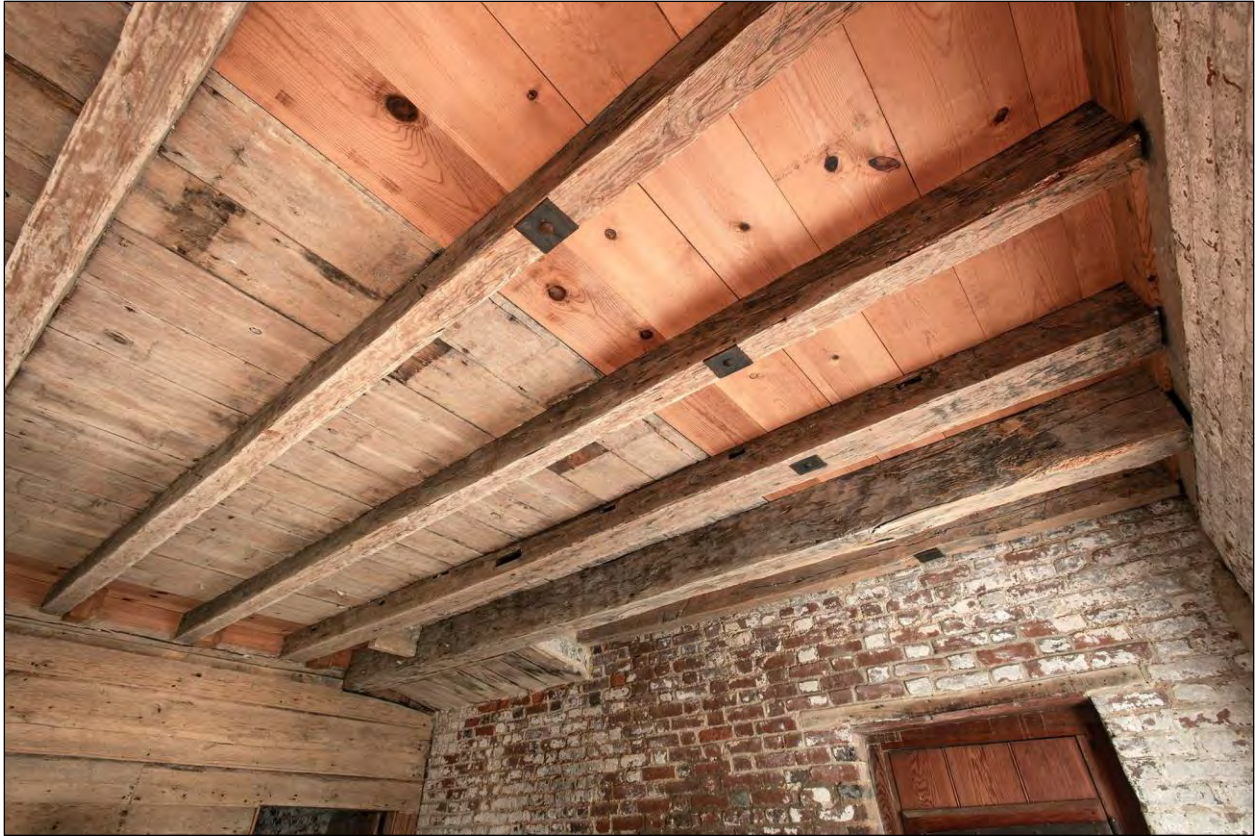
A frame partition separates this larger room from two chambers behind it. The framing carries a plate on which the attic joists break to allow for a reasonable joist span (Figure 56).

Figure 56. View of the ceiling in the main room of the workhouse/weaving house, Mulberry Fields (Willie Graham).

However, the large summer beam set in front of the hearth runs the full 27-ft depth of the building and helps prove that the three-room plan is an original feature. Some of the wall framing is made of reused material, including one of the door posts, which is built from an early, hand planed and beaded joist. It has quite large 11/16-in beads on what was its original lower corners. The wall is covered with wide, beaded weatherboards as its finish. Restoration efforts in the late 20th century included patching and repairs to the weatherboards, cleaning down of surfaces, and the cutting off of joints at the bottom of the studs and posts to allow for replacement of the joists and flooring. Door frames in the wall were adjusted, as were their leafs. As a result, it is now difficult to tell what is original and what was newly created out of older parts at the time of the restoration.
