The Architecture of Domestic Support Structures in Southern Maryland

Prepared by:
Willie Graham, Principal Investigator
Scott M. Strickland
Julia A. King

Prepared for:
The Maryland Historical Trust
Crownsville, Maryland

2020

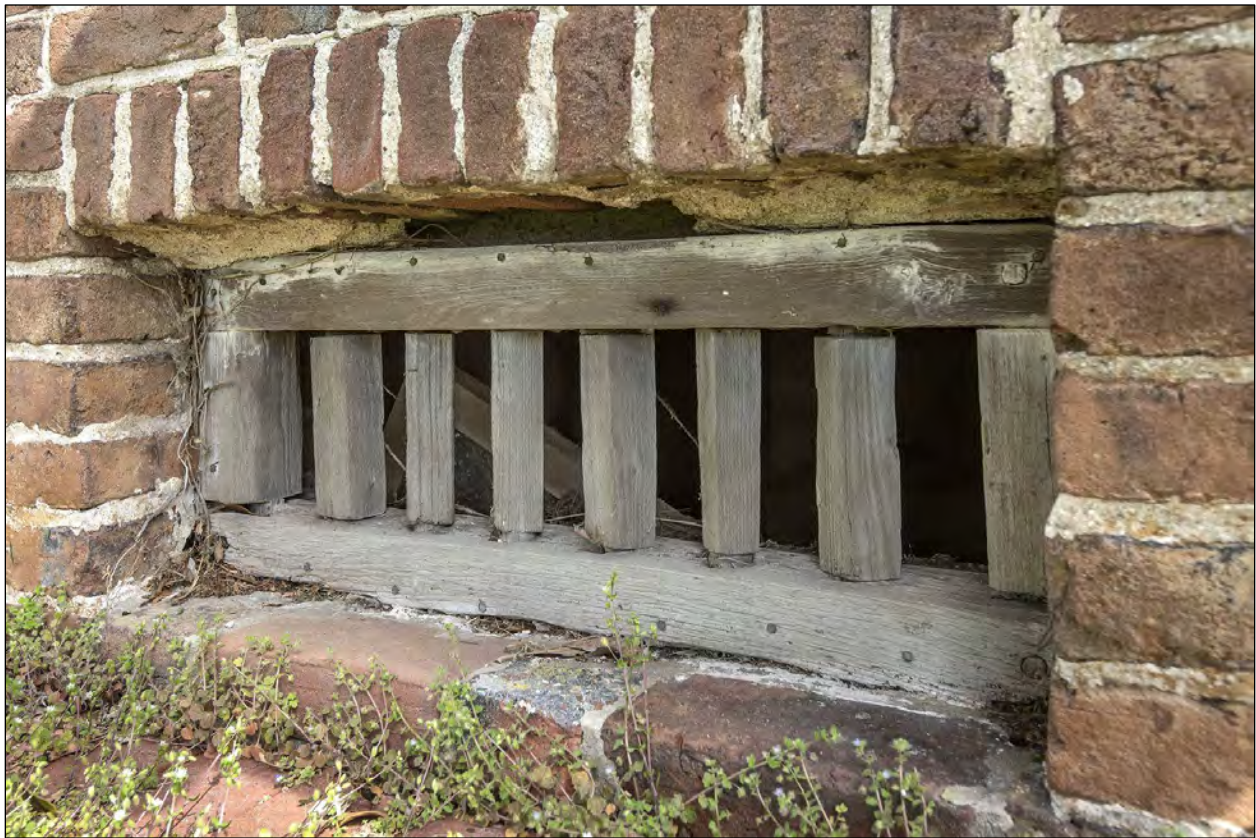
The cellar might have had a function unrelated to the rest of the building. Amazingly, original cellar window vents survive (Figure 57). Three were constructed on the south, riverside gable. The joiner who built the vents rived at least some of their surfaces before planing them to shape. This left a fair amount of waney edges on corners. Where the wane was planed away, the joiner lightly eased the corners of the frame. For security, he built six vertical bars into each. What is most unusual about the frame construction are the turned tenons on the ends of the diamond-set bars. This is the earliest example of tenons not made with a rectangular form seen in the survey. Moreover, the mortises were cut completely through the head and sill. The windows are small, but they did provide some ventilation and gave very modest light to the cellar.

Figure 57. Cellar window vents, workhouse/weaving house, Mulberry Fields (Willie Graham).

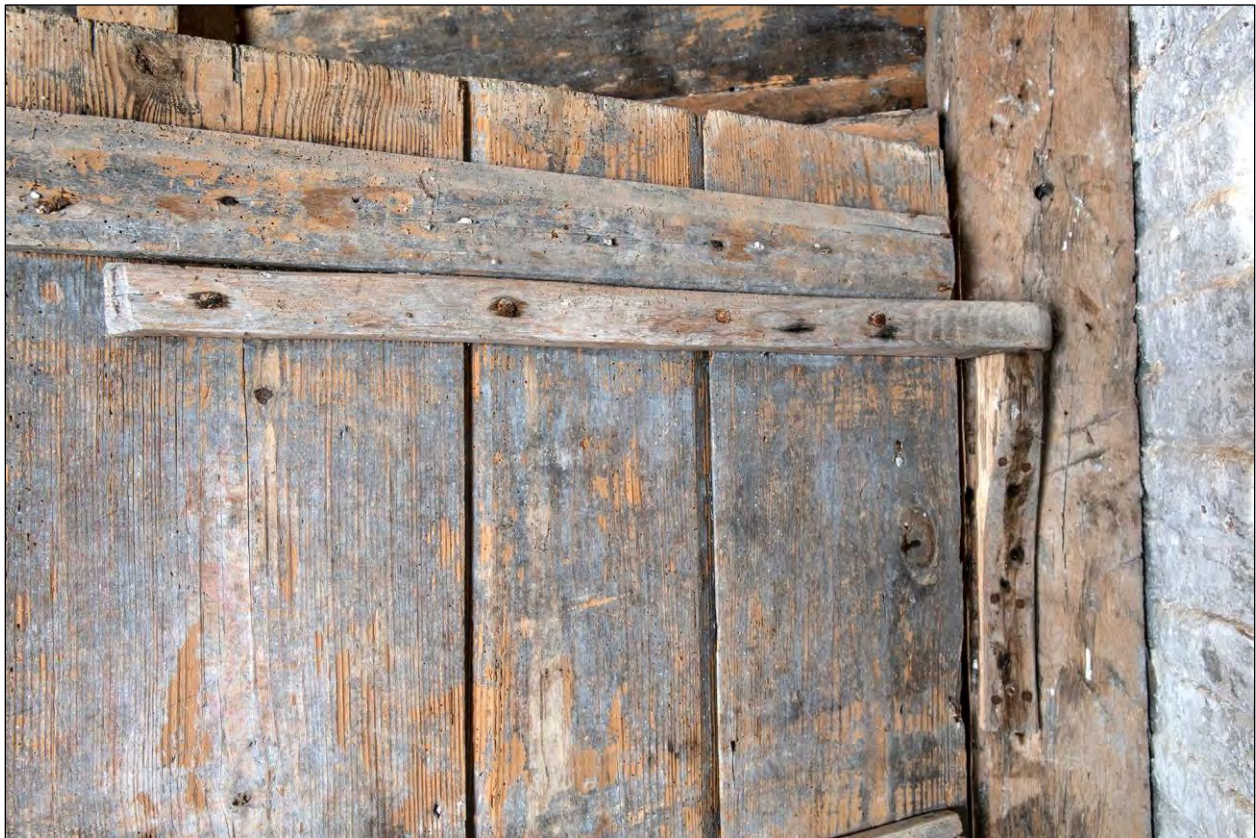
One of the most surprising finds is the use of wooden hinges on a board-and-batten door at the south end of the first-story partition (Figure 58). Wooden hinges are known as an inexpensive alternative to forged hardware in the Chesapeake. Seeing them associated with a building as refined as this, much less with one constructed of brick, is unusual. The door was rehung as part of the restoration, yet its finish suggests that it was always associated with this structure. The hinges are made from oak elegantly dressed to shape. At least the wooden pintles were created from riven stock before they were planed. The tops of the pintles are turned round on which the drilled eye of the hinge pivots.

Figure 58. Wooden hinges, board-and-batten door, workhouse/weaving house, Mulberry Fields (Willie Graham).

The door leaf is as unusual as the hinges. Four battens (instead of the usual three) of varying but short heights hold vertical boards in place. These battens are beveled on three sides; the fourth (against the hinged side of the leaf) are simply cut off straight. Instead of butting the boards together, ship-lapping, or splining them, or using a tongue-and-groove joint, the joiner beveled or “cyphered” the edges of each board and lapped them together. On the room side, an old-fashioned style bead (almost an ovolo instead of a full bead) was cut into one edge of each board and the bevel of the adjoining board is seen beyond it. This form of construction is reminiscent of early panel construction in Maryland, a wall surface type that survives best on the Eastern Shore.

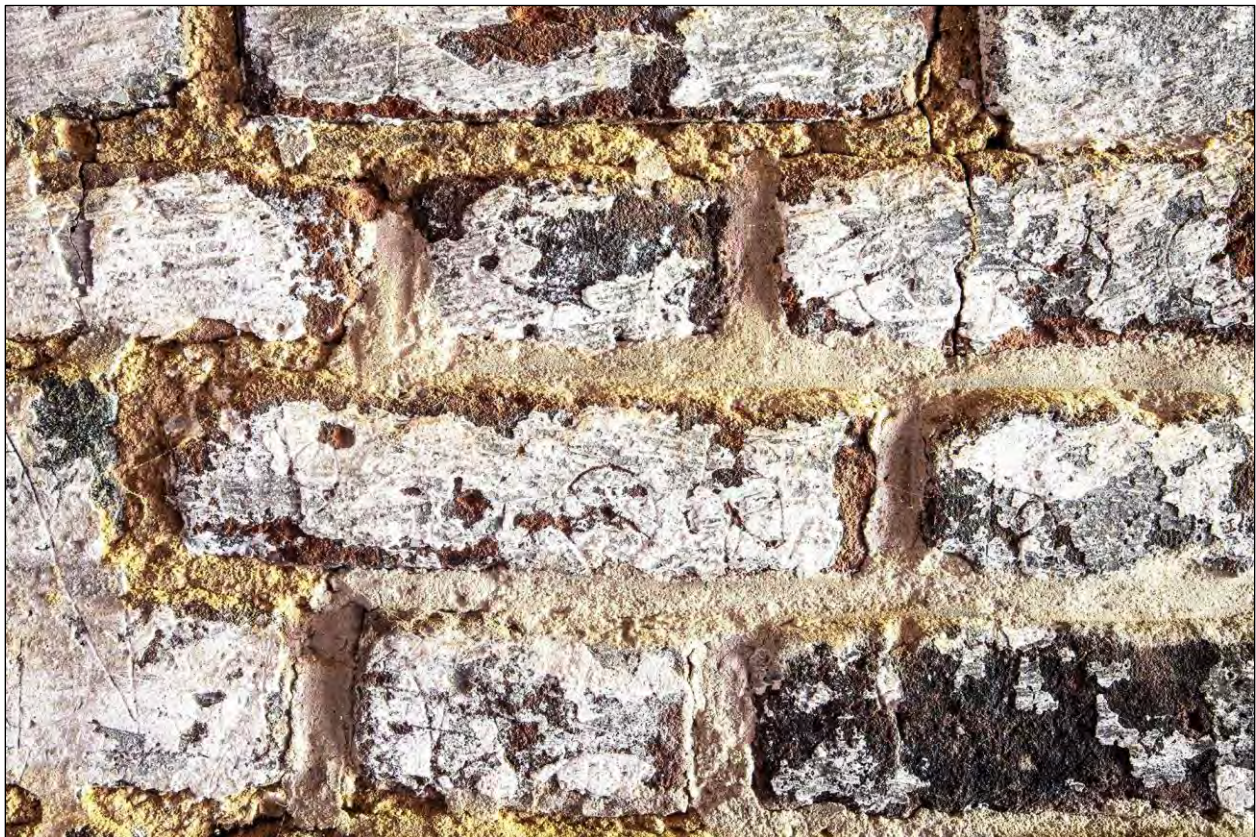
Raking a light across the face of the wall above the fireplace in the main room revealed markings which predate the application of whitewash and appear to be early, if not original (Figure 59). There are at least a dozen attempts at making hexafoils—or daisy wheels as they are commonly known. Some scholars consider them witch marks or apotropaic symbols and, indeed, many were likely made for the purpose of protecting buildings and spaces from evil. Another

Figure 59. Daisy wheels, workhouse or weaving house, Mulberry Fields (Willie Graham).

common mark that scholars often classify as apotropaic are burn marks and they show up here as well. Someone may have added those on the face of the wall above the hexafoils later, as they seem to cut through some of the whitewash layers. One discovered on the framing of the partition is potentially early. Whether these were intentionally created as additional protection or are accidental due to a lamp or candle placed too close to the walls is unknown.

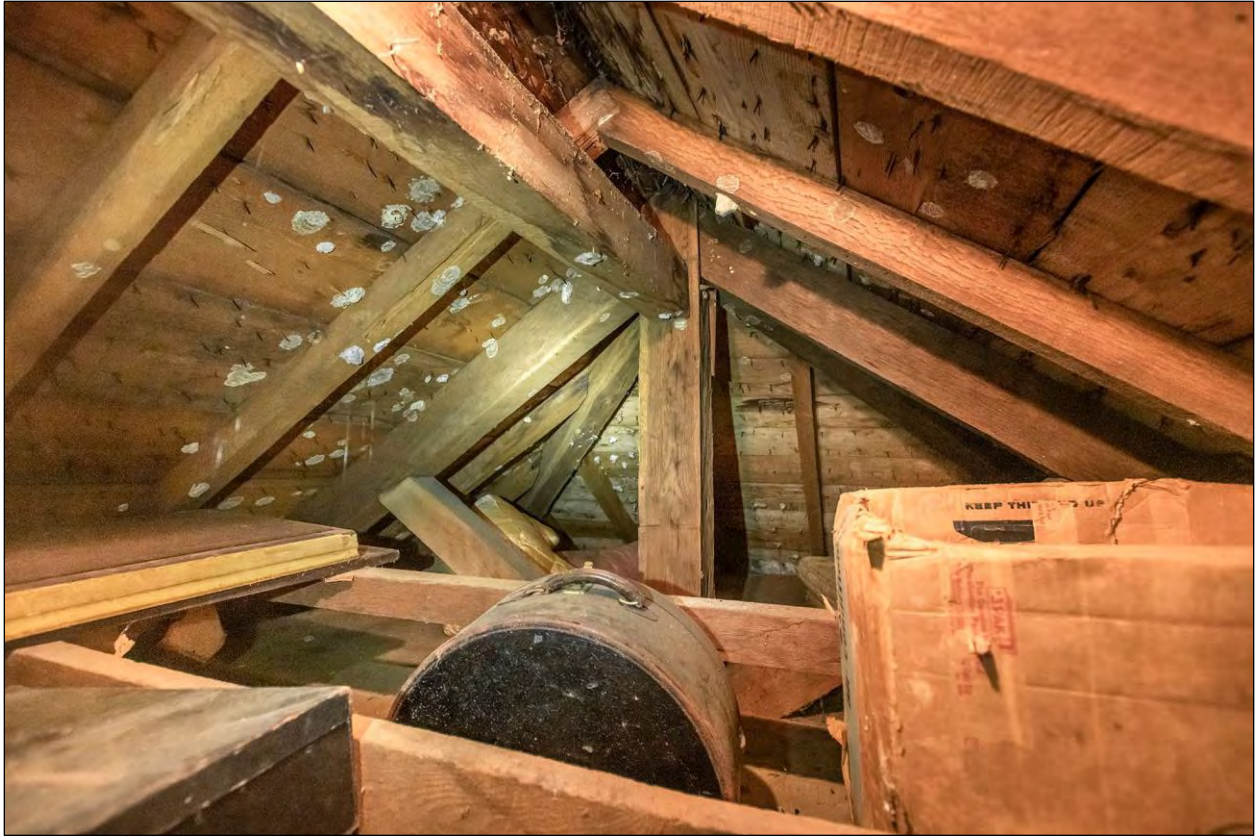
A magnificent hipped roof covers the house (Figure 60). It is framed with a king-post truss at each hip and the trusses are connected by a heavy dropped ridge board (for lack of a better term). This timber tenons into each king post presumably to stabilize them as the rest of the roof is framed to or against them. This dropped ridge board arrangement is strange for Maryland. To date, researchers have only observed it in South Carolina, where it is commonly found on hipped roofs in Charleston and noted in Beaufort. Framers of the Southern roofs, however, used a thinner board for this purpose.

Figure 60. Main house roof, Mulberry Fields (Willie Graham).

It requires further examination to determine the precise arrangement of the trusses, but it does appear that the king posts extend from the ridge down to tie beams on the attic floor (and are not limited to the collar level). However, this needs more investigating. The trusses are buried within partitions and are only visible above the collars. What is clear is that the base of the king post is lower than collar level, but the struts are set high relative to the collars. One other oddity is that joggles were omitted at the peak of the king posts. Each post has a pair of struts supporting principal rafters, to which purlins are joined. The purlins carry the common rafters, which are joined at their ridge and set on a heavy false plate of oak at their feet. Not surprisingly, the frame was hewn and pit sawn to size and hand-forged rosehead nails were used for fasteners.

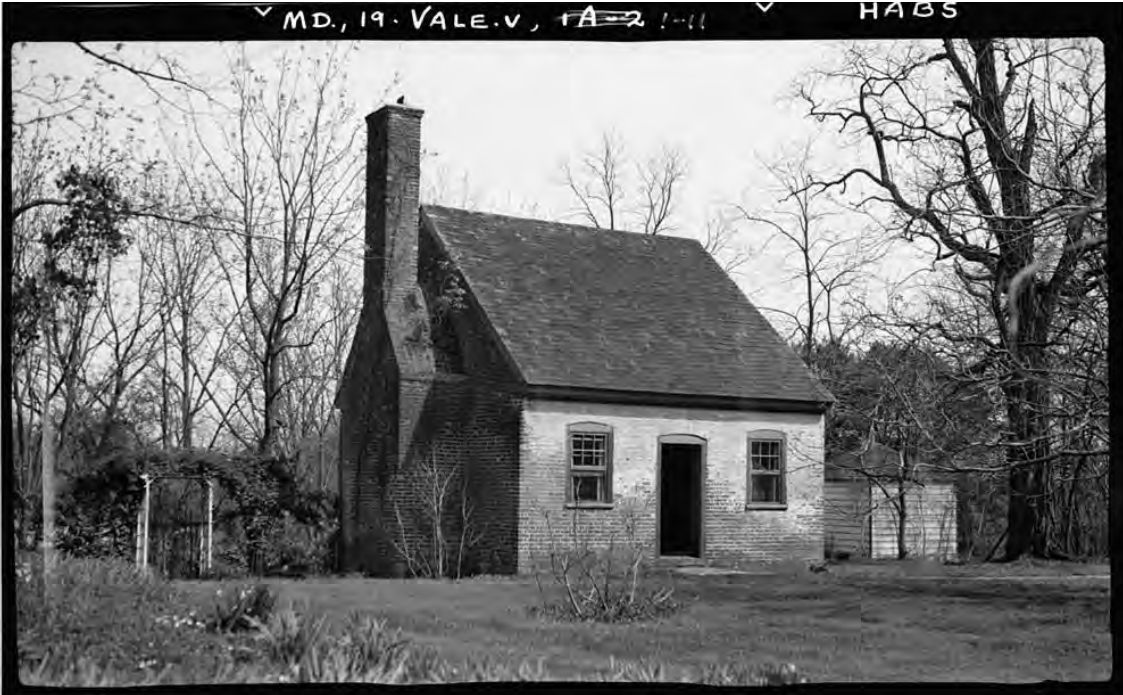
The interiors of these two buildings were inaccessible and thus not studied as part of the project. The kitchen was built flanking the main dwelling to balance the weaving house, opposite (Figure 61). It reportedly has the date “1805” inscribed in a brick adjacent to its fireplace (dendrochronology dating was not used in the kitchen). If this reflects its construction date, it parallels construction of its flanker. The kitchen is built of brick laid in Flemish bond, nicely matching the work on the weaving house. It has a large chimney with steeply sloped shoulders with paved weatherings. It was restored in the 20th century, which included replacement of the exterior door and window frames, leaf, and sash.

Figure 61. Kitchen, Mulberry Fields (HABS).

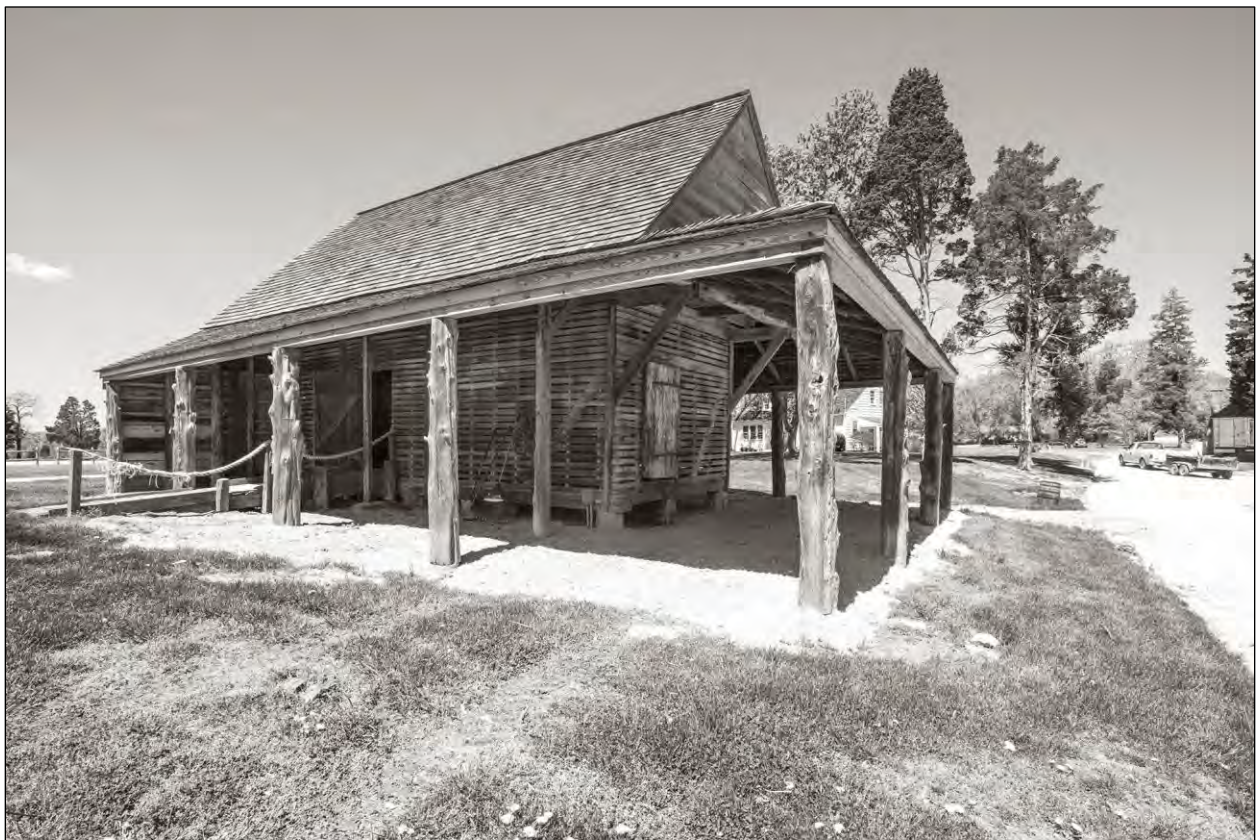
The corn house at Sotterley, constructed around 1800 of reused parts from an earlier structure, is an extremely complex building (Figure 64). It was unusually large for a corn house and constructed very stoutly. The carpenter raised its walls with bays of articulated posts interspersed with lighter studs and securely braced them to accommodate the force of the weight of unshelled corn when fully loaded. A tilted-false plate carried its common rafter roof in a time-honored tradition (Figure 65). In the 1830s, the front wall was pulled in to create an overhanging gable and sheds were built on earthfast posts on three sides. While the remodeling diminished the capacity of the ground floor, an upper story was created to store shelled corn. The corn house

Figure 64. Corn crib, Sotterley (Willie Graham).

as built was equal in size to the top 15 percent in the county that were extant during the last quarter of the 18th century. As remade by the Briscoes in the 1830s, it was updated to accommodate more modern ways of managing corn storage in southern Maryland. The Sotterley corn house is a complicated building with a large amount of surviving building fabric from its first two iterations. Its study makes for a useful comparison to other corn storage buildings across the region.

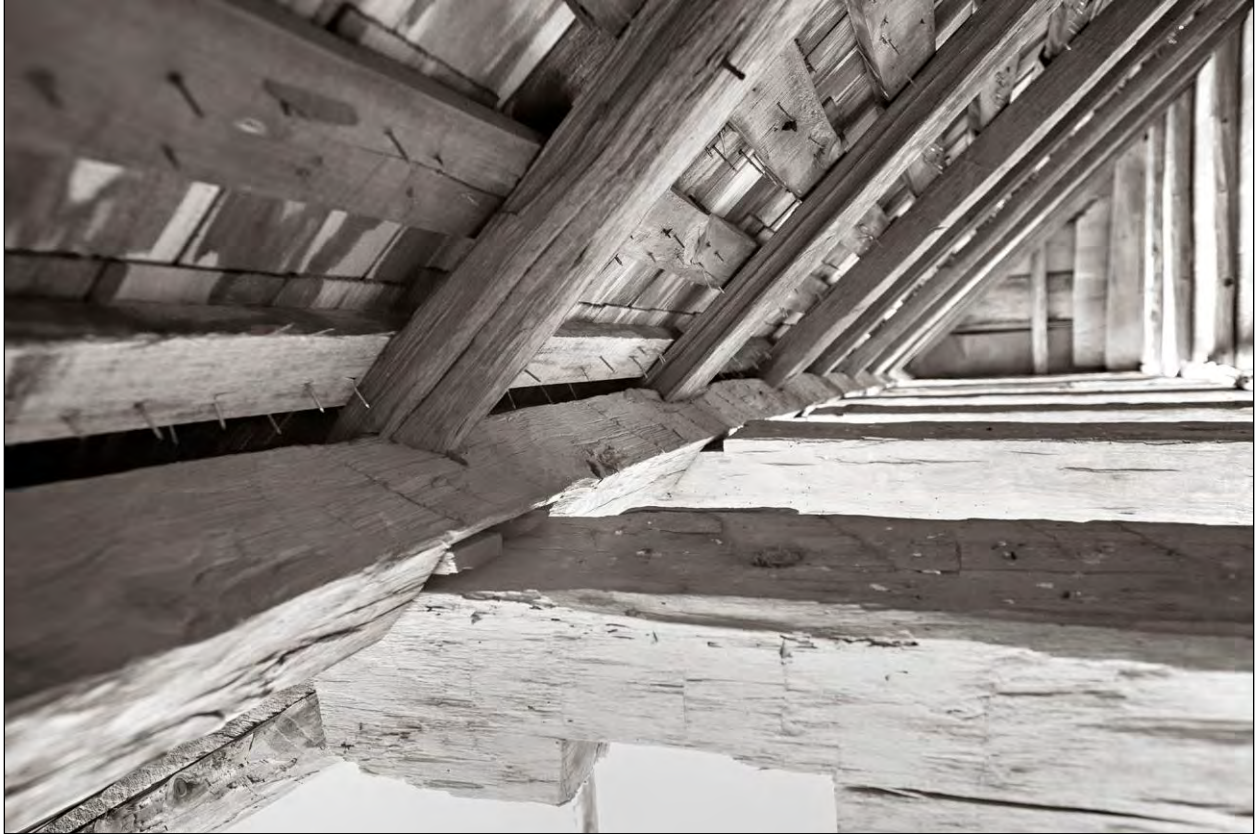
Figure 65. Tilted false plate, corn crib, Sotterley (Willie Graham).

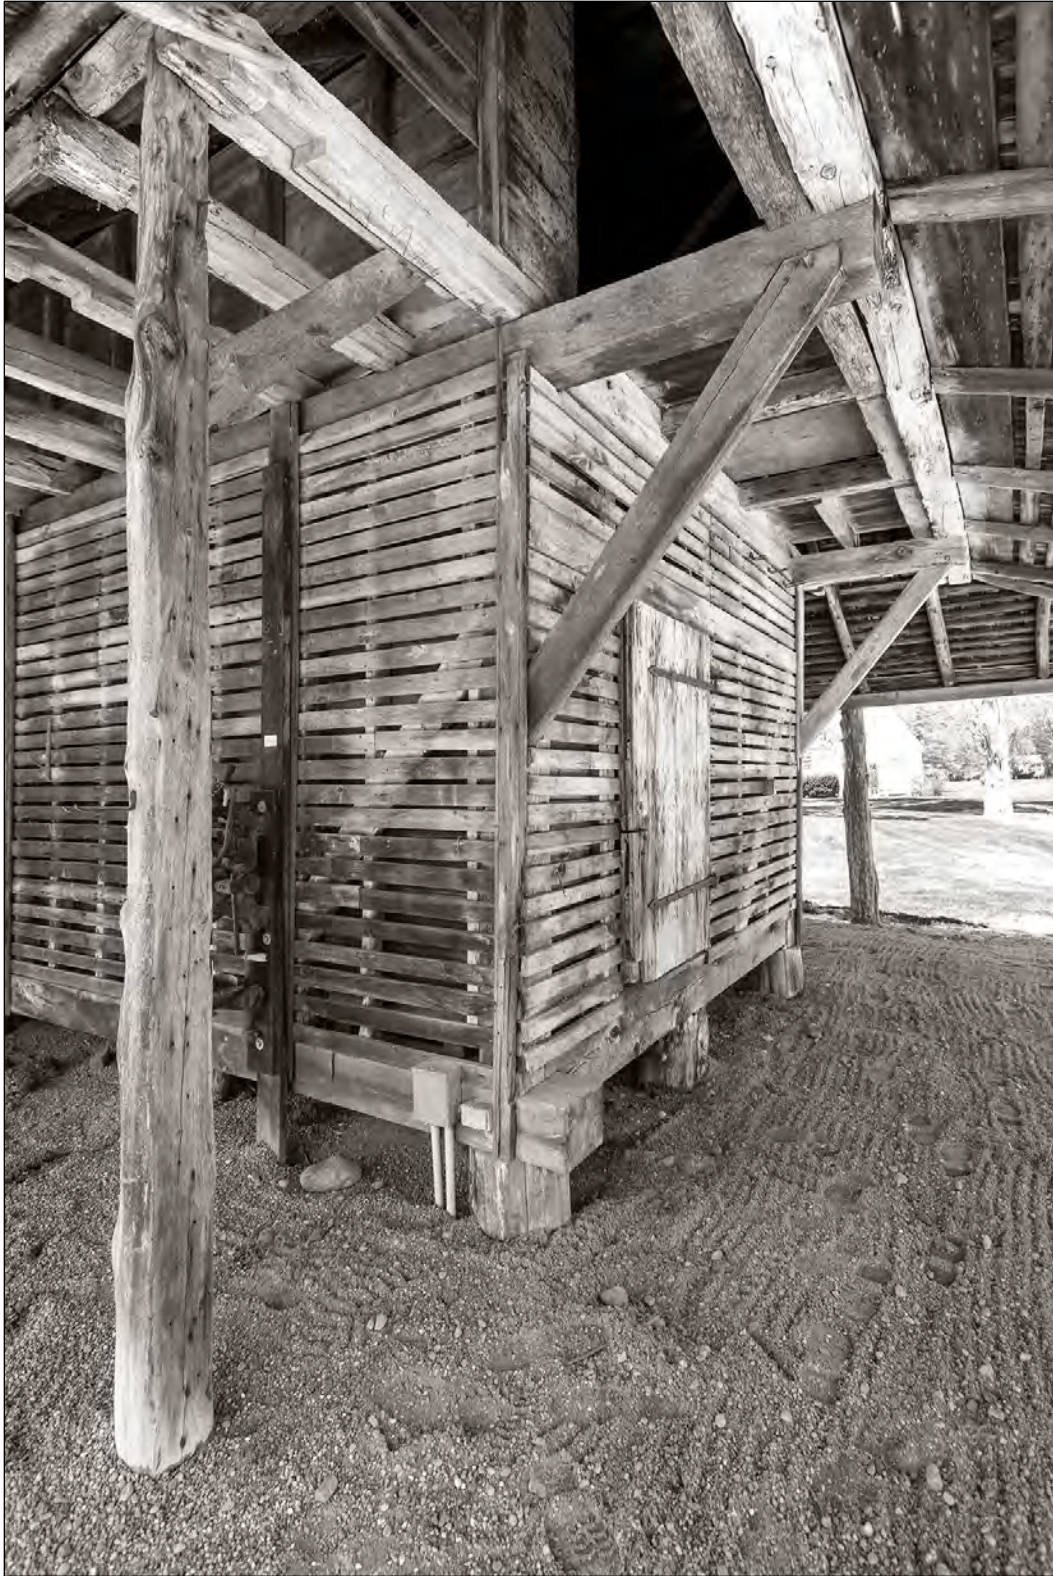
So, who was responsible for building the Sotterley corn house? It is tempting to credit the Briscoes with building it anew, albeit with many reused parts. The form and finishes of the building do point to the Briscoes' hands. The mere size of the building, placement of gapped slats on its exterior (Figure 66), and the fitting of the loft to store additional grain are all suggestive of a late antebellum date (Figure 67).

Figure 66. Gapped slats, corn crib, Sotterley (Willie Graham).

The Briscoes repaired the aging structure, modernized it in several ways, created a separate storage area for shelled corn, and added sheds. The sheds, built with earthfast cedar posts and pole rafters, likely provided cover for farm wagons and equipment but also protected three of the walls, while at the same time allowing for good ventilation. The Briscoes had the fourth wall—the back end—lathed over and shingled to protect it from storms that came from the southwest.²⁰¹ Those shingles are unusual for being made of oak, a rare shingle material for eastern Maryland. They are also quite thin, measuring about 7/16-in at their butt. Otherwise, they look like the roof shingles common to the region at this date: square butt and made from riven stock neatly dressed on both broad faces. As noted, the Briscoes ordered the original siding replaced with horizontal slats mounted to the outside of the frame in keeping with the new trend

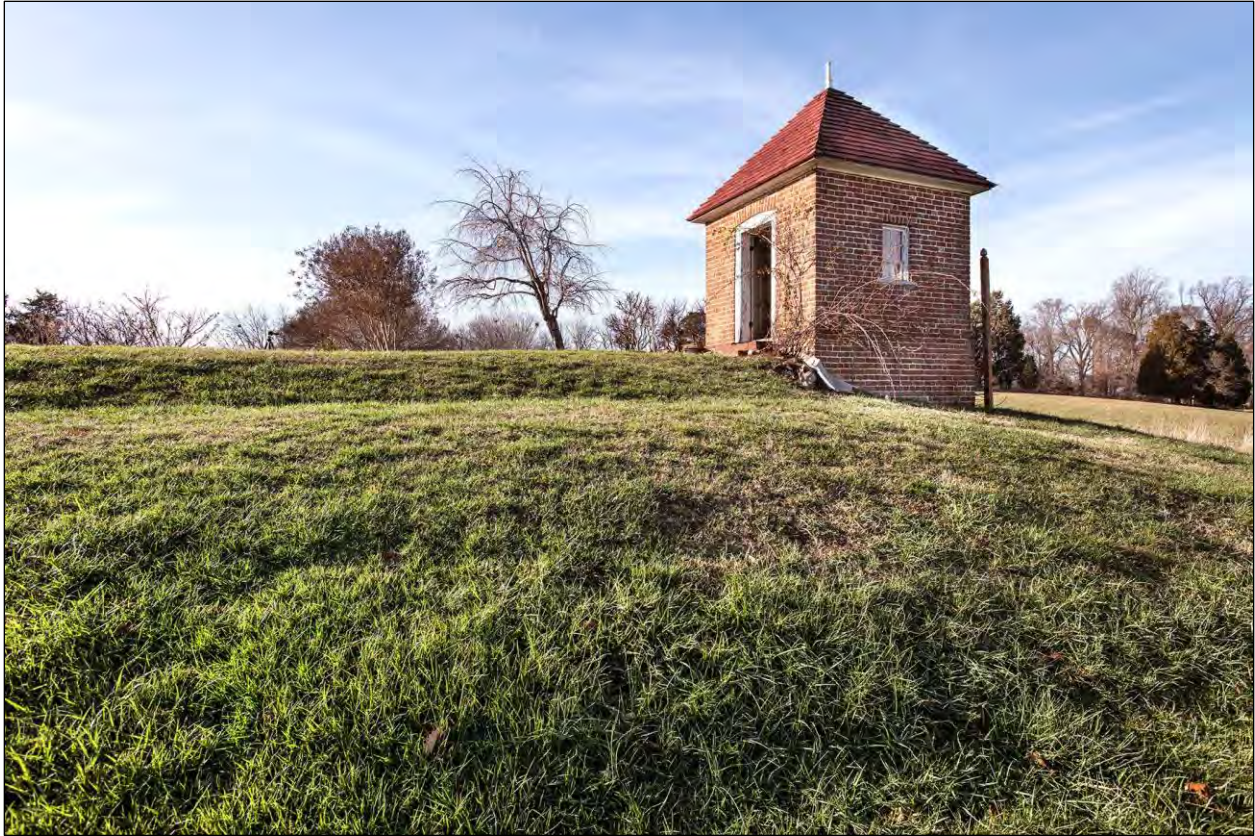
Privies were rare in Maryland and Virginia until the 19th century. Moreover, the survival rate of privies built prior to about 1850 is poor relative to other domestic outbuildings. Two brick privies sit on the north edge of the garden at Sotterley, one of which dates to the late 18th or early 19th century (Figure 68) and the other built by the Satterlees in the 20th century. The survival of the early privy makes it exceptionally significant. The quality of its brickwork attests to the importance that the Platers placed on it. Not only are the bricks particularly well formed and tightly laid, but its façade was carefully worked with selected rubbed bricks to highlight the corners, arch, and upper wall. Another feature of note are the paired arched openings on the backside that served as the cleanout for the building. The privy sits on the edge of a terrace, which hides the cleanouts from the garden. Like most surviving privies of this date, its original fittings no longer survive. However, the floor joists and flooring remain, and they show evidence of the extent of its first seat configuration. During an early 20th-century renovation, the Satterlees created an admirable Colonial Revival interior, which complements their contemporary rebuilding of the farm.

Figure 68. Early privy, Sotterley (Willie Graham).

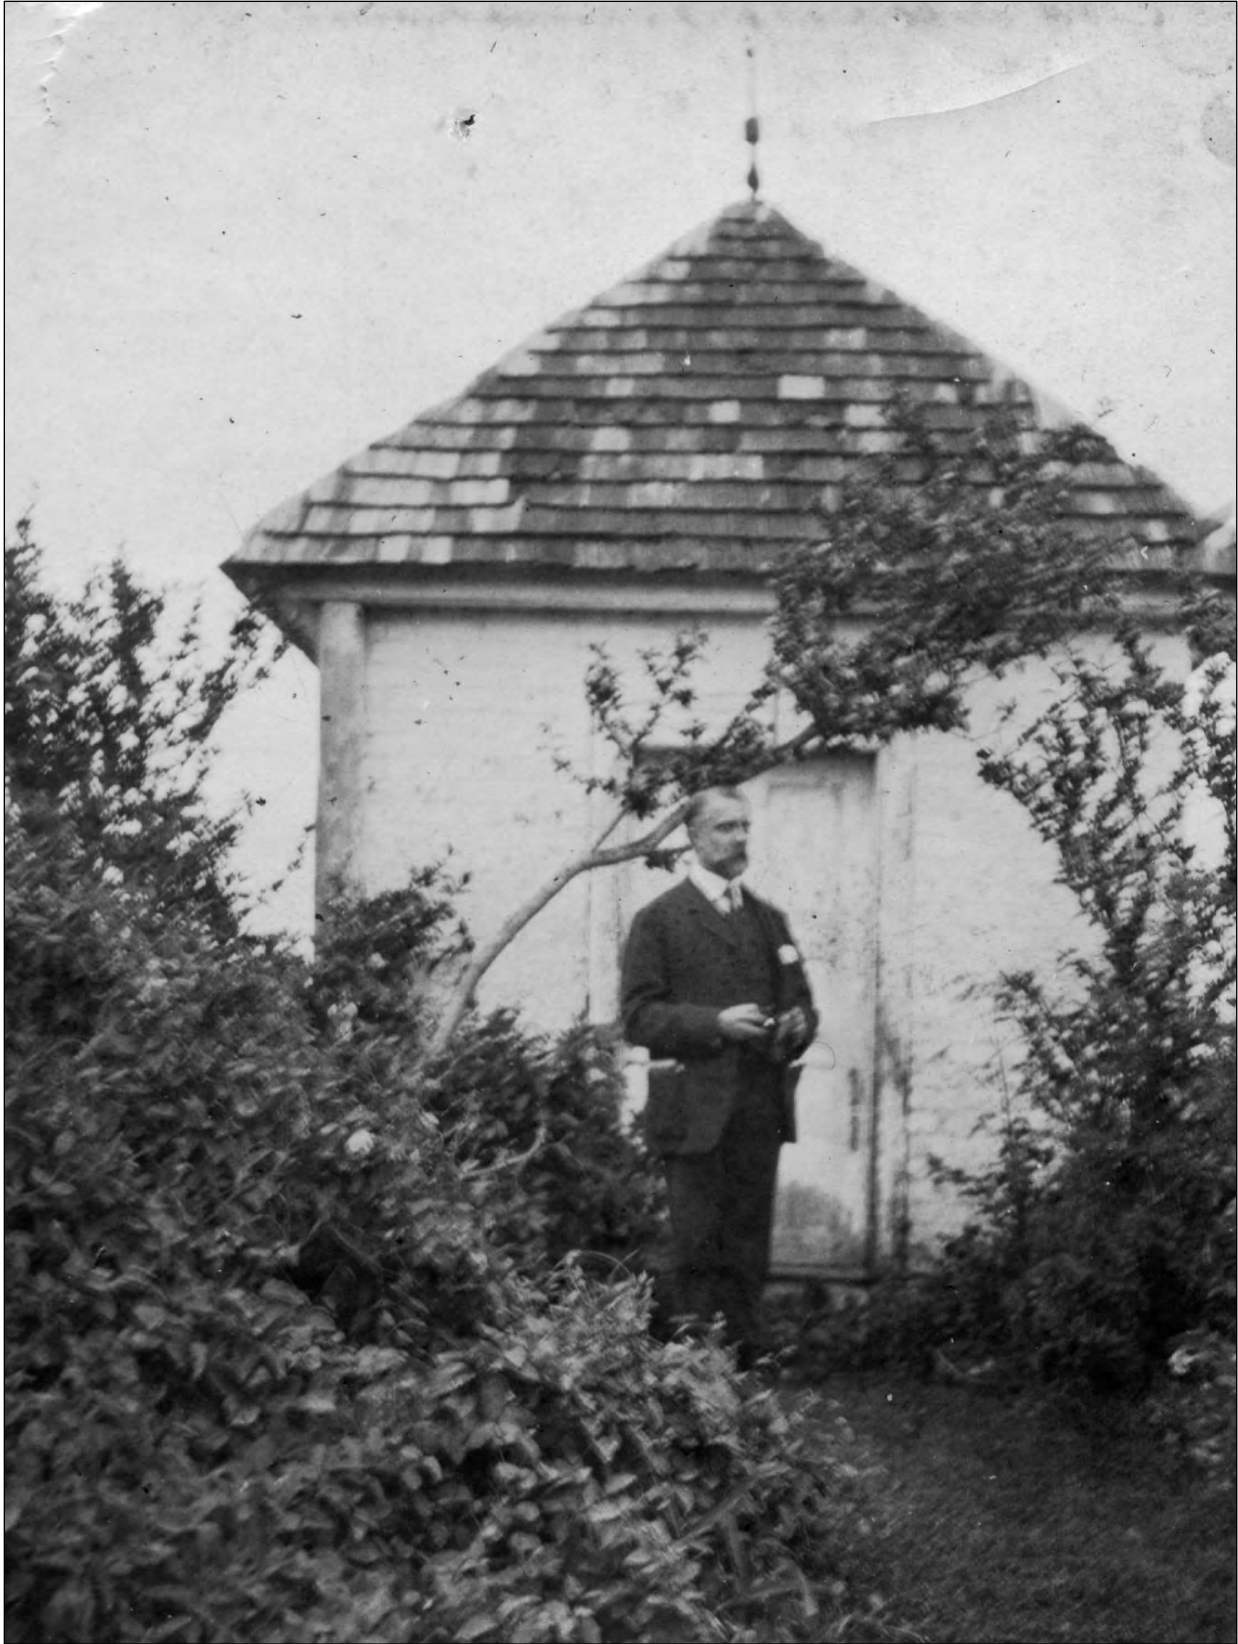
One was possibly the privy, listed as an outhouse of brick, 14-ft square with a single window (Figure 69). Without noting their functions, “outhouse” was a generic term used by this assessor to describe all the outbuildings he recorded and was not itself a designator of function. Although the present building measures only 10-ft square, it does have a single window and is built of brick—details that otherwise match the tax record. While the size difference seems to preclude the two being the same, assessors at the time were notorious for roughly measuring buildings and their dimensions were often wrong. The “good repair” of that listed in the tax roll and the physical evidence indicating construction date of the extant building about this time are suggestive, though not definitive, that the two are the same.

Figure 69. Sotterley privy before restoration, c. 1914 (Historic Sotterley).

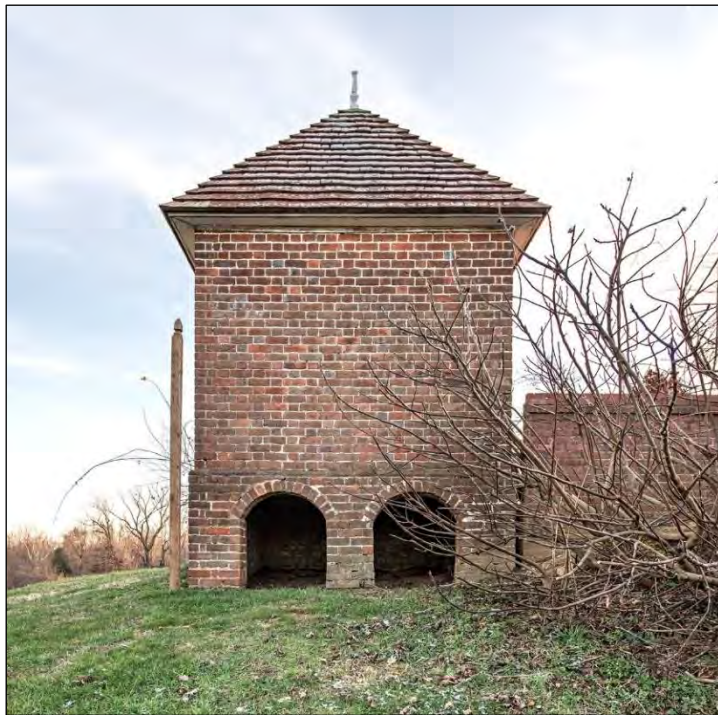
Figure 70. Privy cleanouts, Sotterley (Willie Graham).

Two large cleanouts are built into the lower side of the building (Figure 70). Because the structure sits on the edge of the terracing, the cleanouts are not visible from the garden. They measure 33-in wide and are made as a pair, suggesting that the seat must have had more than one hole.

bond was more casually laid here than the front. Also, all rubbing is omitted and the arches over the window and clean-outs on the rear are plainer. A rowlock course sufficed for the window and arches, with the former set flat and the cleanout arches laid semicircular.

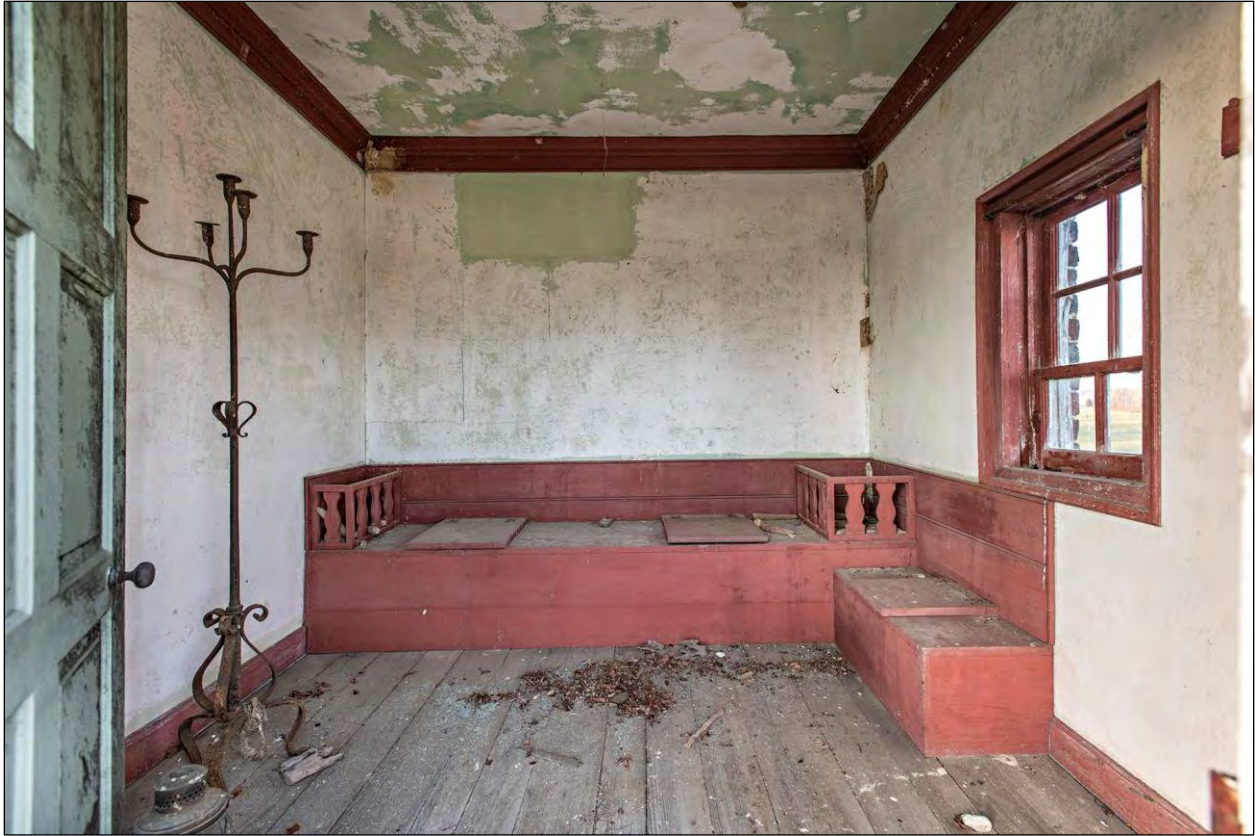
Figure 71. Reconstructed interior, privy, Sotterley (Willie Graham).

replaced, as were the door, jambs, window frame, and sash. The Satterlees ordered all the interior fittings and the plaster on the walls and ceiling renewed, including the seat. However, flooring and its framing survive from original construction. They indicate that the seats were initially located against the rear wall. As reconstructed, two adult seats are also built along the rear of the building, while a lower and smaller seat is fitted perpendicular to it underneath the window (Figure 71).

The privy was heavily remade by the Satterlees sometime after their acquisition of the property in 1914. The roof covering, probably the roof structure, and the cornice were entirely

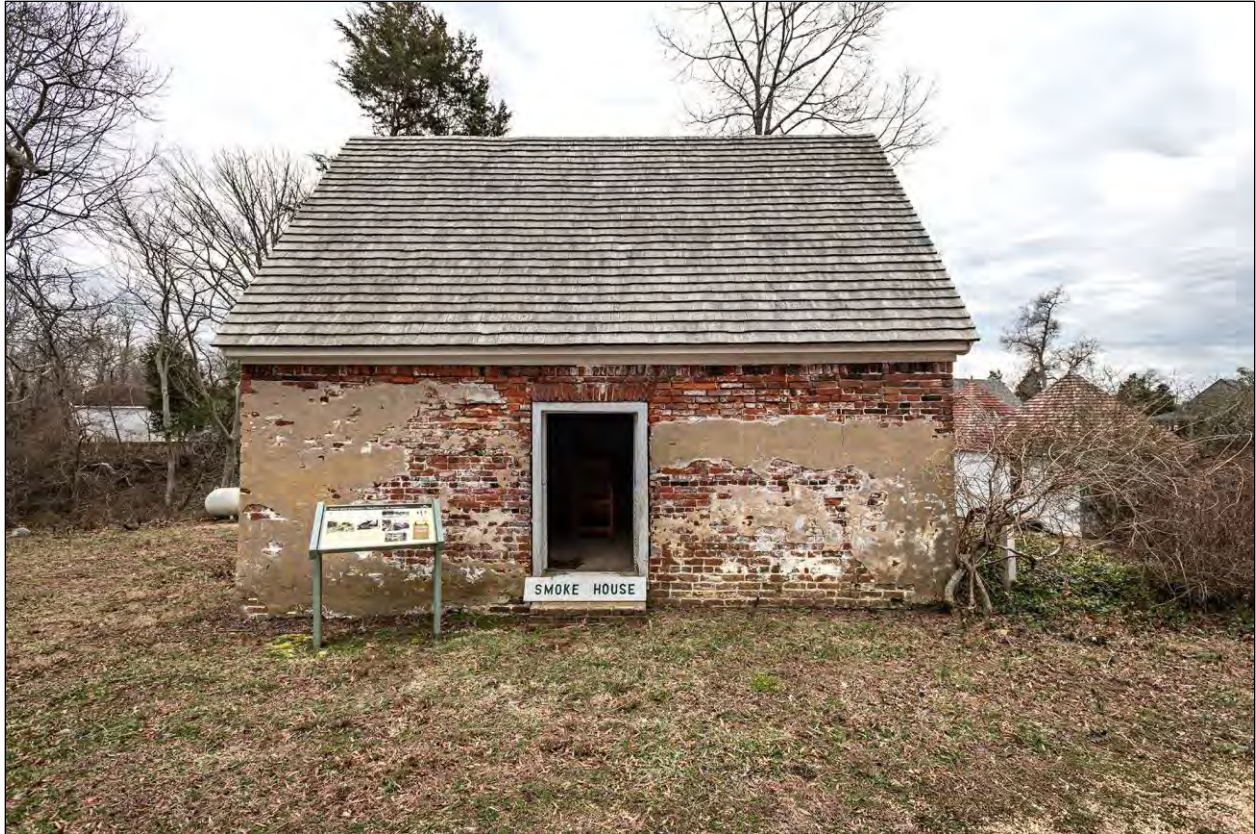
Figure 72. Smokehouse, Sotterley (Willie Graham).

The smokehouse at Sotterley is both extraordinarily large and constructed of brick, two features which distinguish it from those of most neighboring farms (Figures 72 and 73). A massive hewn-poplar salting trough—fitting for such a generously sized smokehouse—survives inside. While the roof was rebuilt in the early 20th century, lap joints in the surviving wall plates indicate something of the form of the original upper frame. The building is notable for the presence of imported yellow bricks mixed with more conventional red ones used for the construction of the walls. Historians have questioned whether this building served as a smokehouse or if the builder intended it as a storehouse before a 20th-century rebuilding of the roof. Yet smoke blackening of

the interior, which clearly predates the current rafters, and evidence of early degradation of the brick walls due to the salting of meat, argue otherwise.²⁰⁴ This evidence, the lack of windows, and the presence of the salting trough combine to suggest that the building was indeed erected to smoke and store meat in it from the outset.

O'Rourke discovered hand-forged nails on top of the plates from where gable studs were once toe nailed to them. The walls were raised in three-to-one American bond, with the bricks laid in shell-lime mortar. American bond brickwork shows up early in this part of the Chesapeake and shell-lime mortar is a telltale sign of work dating before about 1820. While the bricks are handmade, they are a mix of common red bricks made in this region and yellow bricks that undoubtedly came to the county as ballast. They were likely sourced either from Holland or conceivably Southeast England. Similar yellow bricks are blended with red ones in the main house Red Parlor chimney. That chimney was rebuilt sometime in the late 18th or early 19th century, an event potentially related to construction of the smokehouse.²⁰⁵ These factors combine to suggest the smokehouse was constructed sometime between the 1780s, when American bond first shows up in southern Maryland, and about 1810, the tail-end of when shell lime was still mixed and hand-forged nails were waning for structural use. Noting the inaccuracies in dimensions that often attend assessments such as the 1798 Direct Tax, the enumerating of a 16-

At 16-by-24 feet, one cannot overstate the extraordinary size of the smokehouse; few in Maryland could hold as much meat as this one could. Its size demanded generous framing to span it. The plates that surround the four walls retain lap joints for large joists, indicating that the roof was framed to hold a significant amount of weight. The plates also indicate that the roof had gabled ends. Now-missing joists once lapped over the wall plates to create an overhang. While “jettied” cornices are the common way to frame early roofs in the region, they are not universal for outbuildings, especially in southern Maryland.

The building shows the typical signs of decay due to the heavy presence of salts, from which brick smokehouses usually suffer. The building was stuccoed in the 19th century, inside and out, to repair this decay, indicating the use of salts before the Satterlee era. The building was renovated in the early 20th century by the Satterlees to make it once again useable as a smokehouse (Figure 74). The Satterlees replaced the roof frame, front door, and doorjamb, which left little wood or nails to help in the dating of this brick structure. Sometime in the past 20 years the roof was again repaired, this time by carpenters John O’Rourke and Gus Kiorpes on behalf of Historic Sotterley.

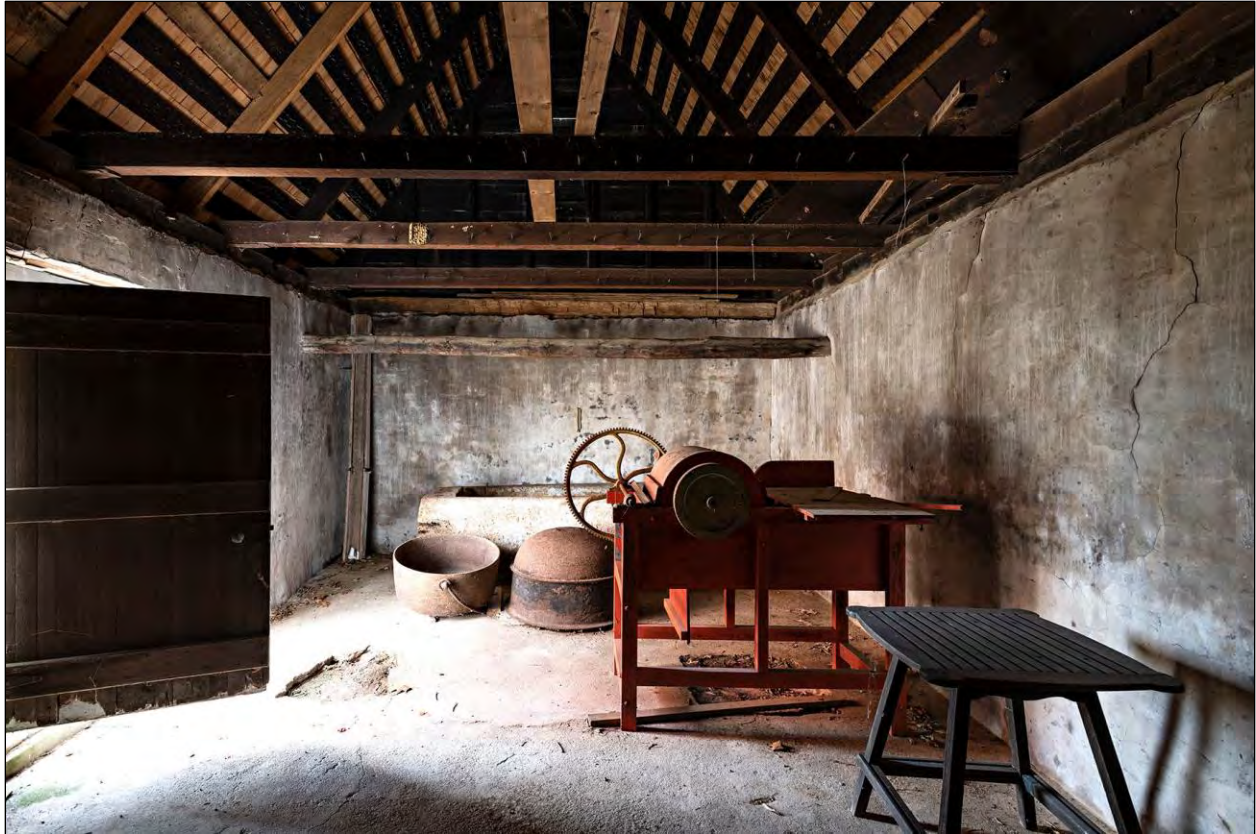
Figure 74. Smokehouse interior, Sotterley (Willie Graham).

²⁰⁴ Mark Wenger and others noted that a ghost of a feature inside the front door looks suspiciously like the remains of shelving or a built-in dresser. If so, its presence could suggest that the building was used as a store or a storehouse. However, if indeed shelving or a dresser, it sat perpendicular to the wall just inside the door. That makes little sense for a storehouse and, if a store, there are no windows to light the space. The feature appears to be an anomaly associated with the breakdown of the brickwork from long exposure to salts that created the indentation and that it is not what remains from fittings.

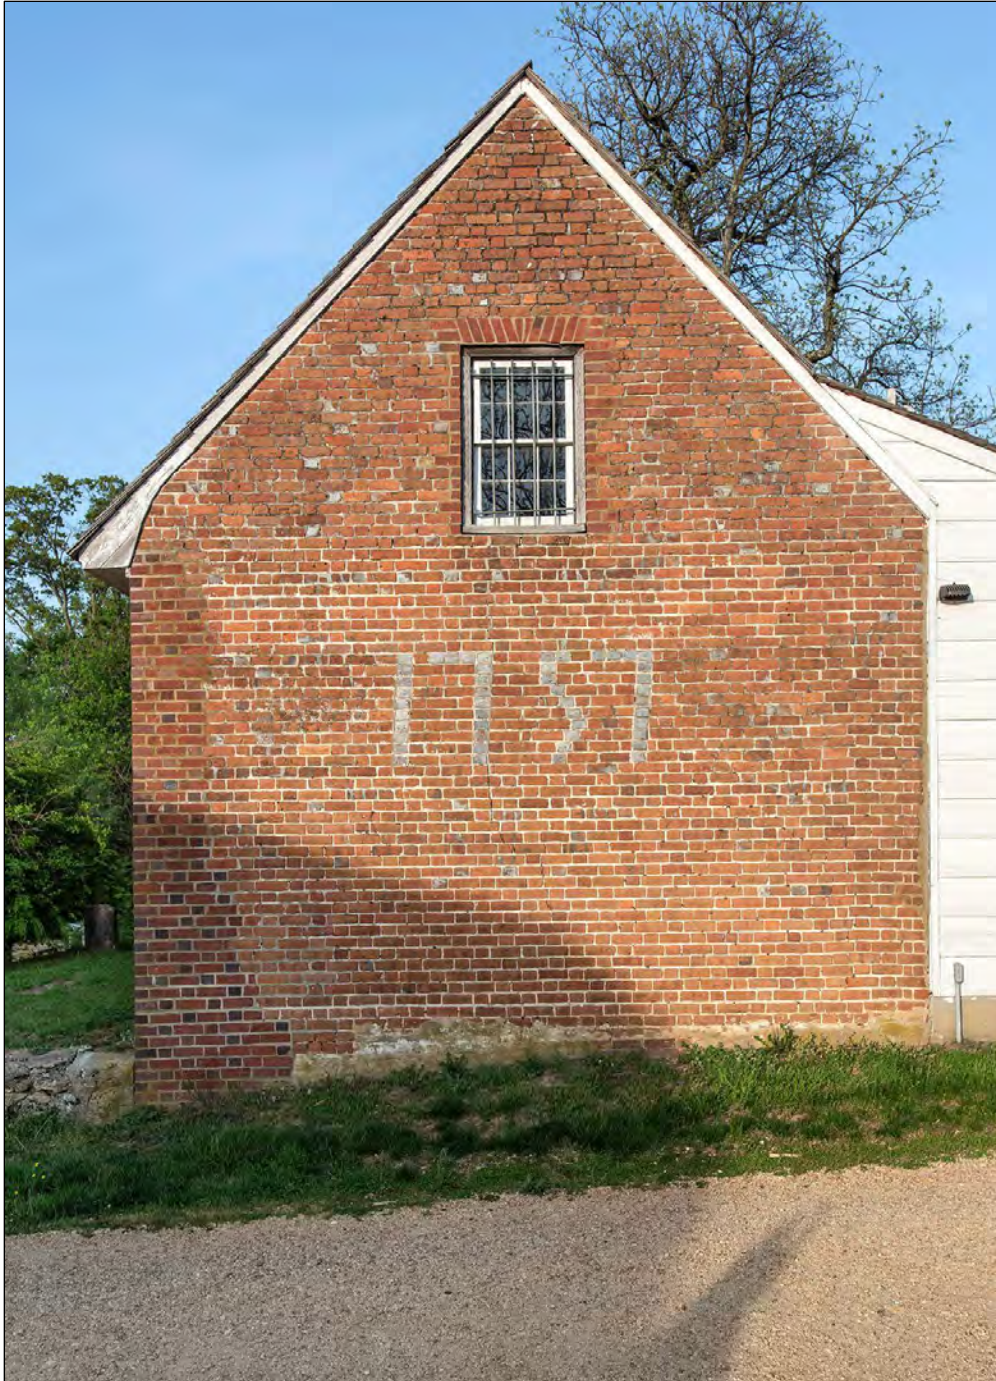
Figure 75. Store (“customs house”), Sotterley (Willie Graham).

The so-called brick customs house has not received the same degree of attention as other early structures at Sotterley, in part due to the extensive remodeling it received in the 20th century (Figure 75). It was likely built as a store and its function puts it beyond the scope of this project.

While much of its original building fabric is compromised or removed, it is noteworthy for having glazed brick headers memorializing its construction date of 1757 in a gable end. The structure once had a tilted false plate to carry a common rafter roof; the plate has since been replaced.

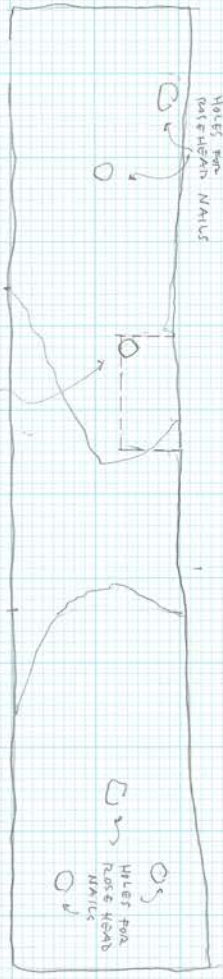
OAK LOCK KEEPER

DOOR JAMBS RESTORED
 C. 2000 BUILDING
 RESTORED SAME
