**The Martinak Boat (CAR-254, 18CA54)
Caroline County, Maryland**

**Bruce F. Thompson
Principal Investigator**

**Maryland Department of Planning
Maryland Historical Trust, Office of Archeology
Maryland State Historic Preservation Office
100 Community Place
Crownsville, Maryland 21032-2023**

November, 2005

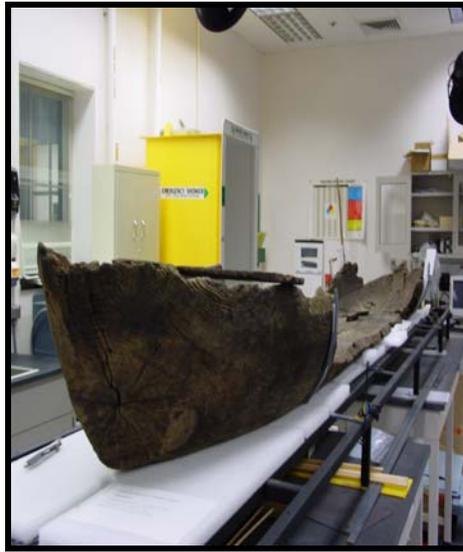
Figure 3: The LaTrappe Canoe (18TA303 ca. 1780-1840) was excavated at the mouth of LaTrappe Creek (a tributary of the Choptank River south of the present study area) by MMAP staff and volunteers in December 1993. It is shown here during reconstruction at the Maryland Archaeological Conservation Laboratory. Photograph by Chris Maple.

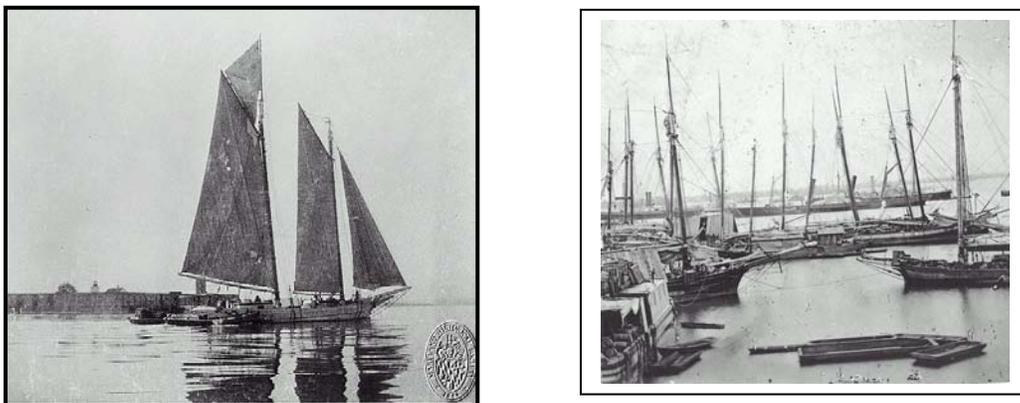
Figure 4: Photograph of the pungy *Wave* by Mellon (courtesy Maryland Historical Society) and several schooners docked at City Point, Virginia circa 1864-1865 (courtesy of the Naval Historical Center, Photo #: NH 1753).

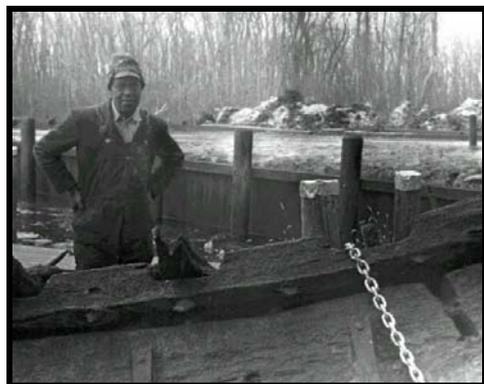
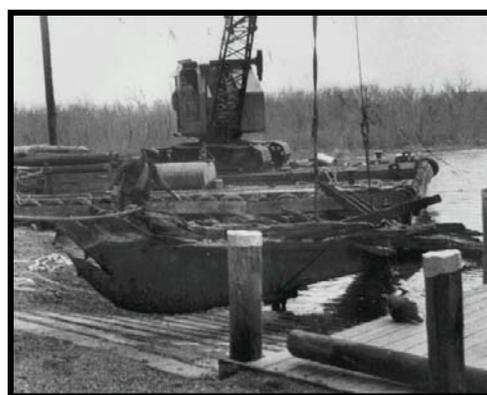
Figure 5: The forward section of the hull being hauled out of the waters of Watt’s Creek in January, 1969. Photographs were provided by Richard Dodds, CBMM.

The Martinak boat’s stern section was pulled out of the Watt’s Creek mud in 1964 and in January 1969 the longer forward portion of the wreck was recovered (Figure 5). That prompted the February 5, 1969 *County Record* article titled “Remains of 100-year-old Pungy Recovered off Martinak State Park” (*County Record*, 1969). The article explained how workmen, dredging to construct a launching ramp, came upon the remains. W.A. Stewart Wright, Denton attorney and “...student of Chesapeake Bay craft...”

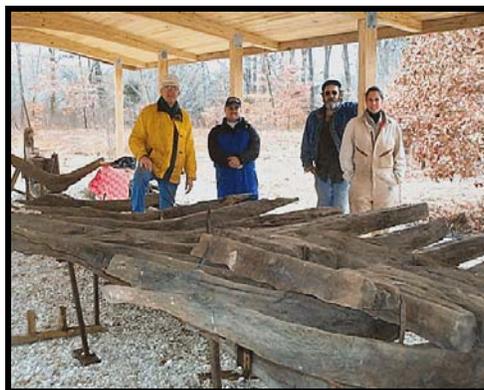
Figure 6: MMAP staff, volunteers and Martinak State Park staff after reconstructing wreck timbers. Photograph by Chris Maple.

In January 29/30, 2001 MMAP staff, volunteers and park rangers moved the wreck remains to their present location under the newly constructed pavilion. The following day the small team relocated positions for frames, half-frames and keelsons and reconstructed the wreck remains (Figure 6). After some final measurements and photographs on March 03 and 13, 2001, the author completed pencil drawings of the reconstructed wreck remains.

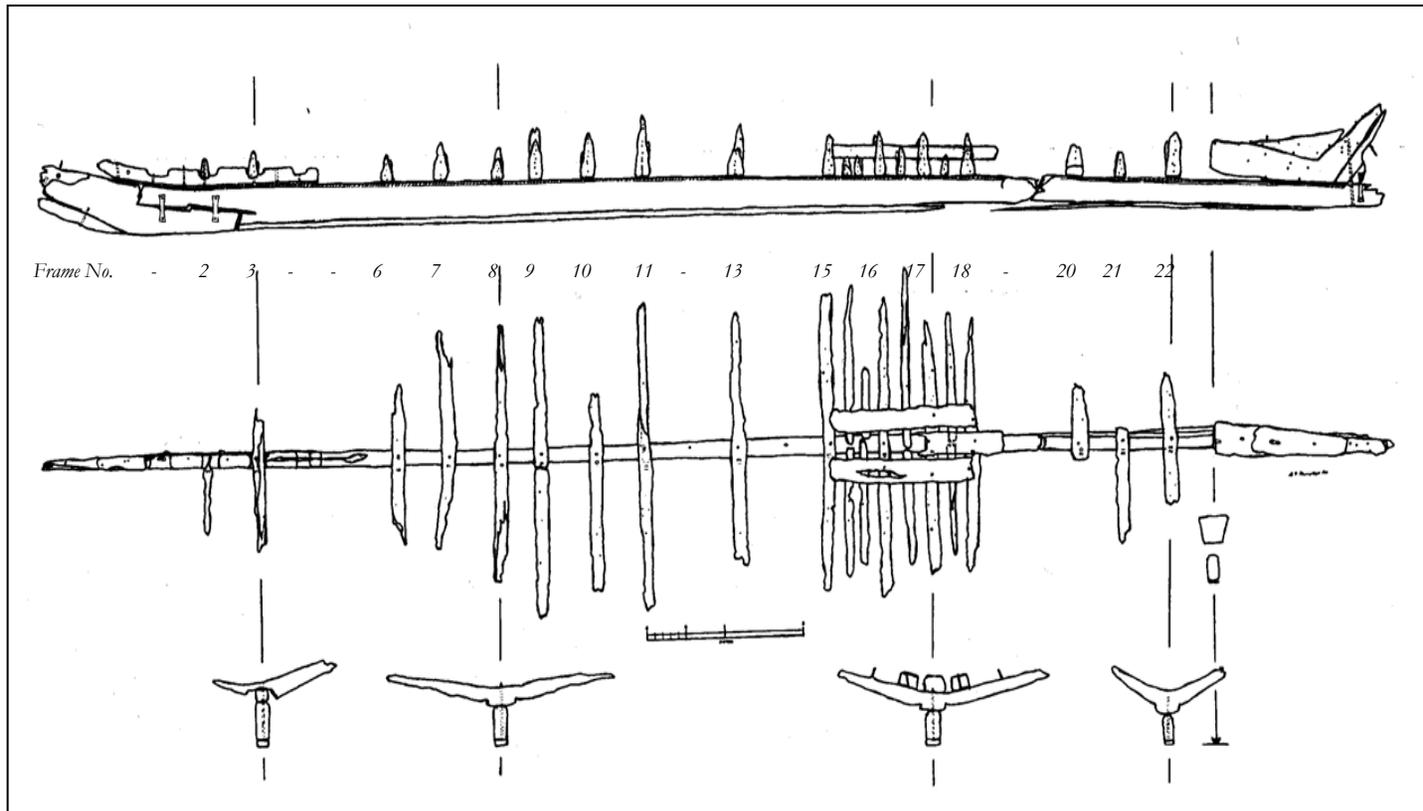
Figure 7: Reconstructed wreck plan of hull remains (scale 1cm = 1.5m). Drawing is by the author.

The wreck remains exhibit an extant length between uprights (stern post to stem post) of 17m 34cm (56.89ft), an estimated maximum beam amidships of 6m 62cm (21.7ft), an estimated depth of hold amidships of 1m 45cm (4.76ft) and a length to beam ratio of 2.6:1 (Figure 7). When originally discovered the wreck was heeled over to port as indicated by the amount of deterioration on the starboard frame ends relative to the port frame ends.

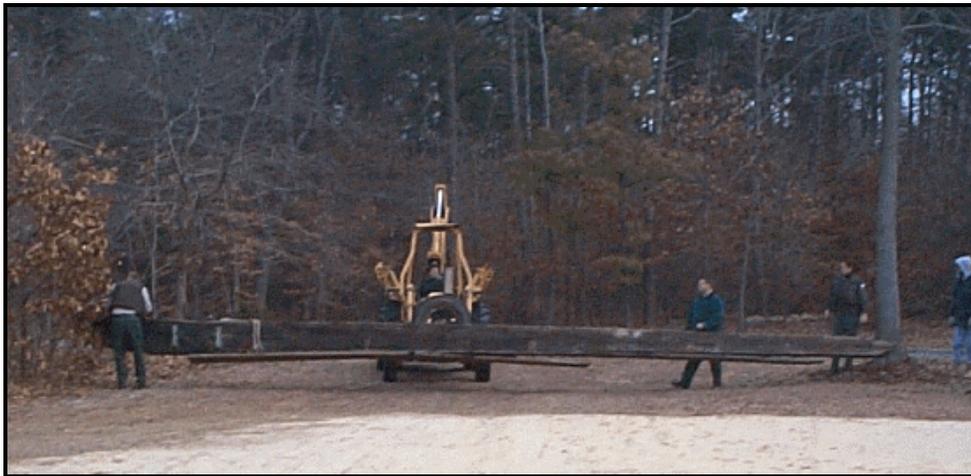
Figure 8: Martinack State Park staff moving the forward section of the keel to its final display area. Photograph by John Lewis.

Initially a single timber (overall length 17m 1cm (55.8ft)) the keel was broken into two sections when the vessel was extracted from the marsh. The forward section of the keel (Figure 8) is 12m 8cm (39.6ft) long and the stern-most section is 4m 3cm (13.22ft). Sided and molded measurements vary over the length of the keel. Sided measurements for the keel are: Frame (Fr) 3 is 44cm (17.32in); Fr 8, 39cm (15.35in); Fr 17, 32cm (12.60in); and, Fr 22, 29cm (11.42in). Molded dimensions along the keel are: Fr 3 is 16cm (6.3in); Fr 8, 16cm (6.3 in); Fr 17, 19cm (7.48in); and, Fr 22, 14cm (5.5in).

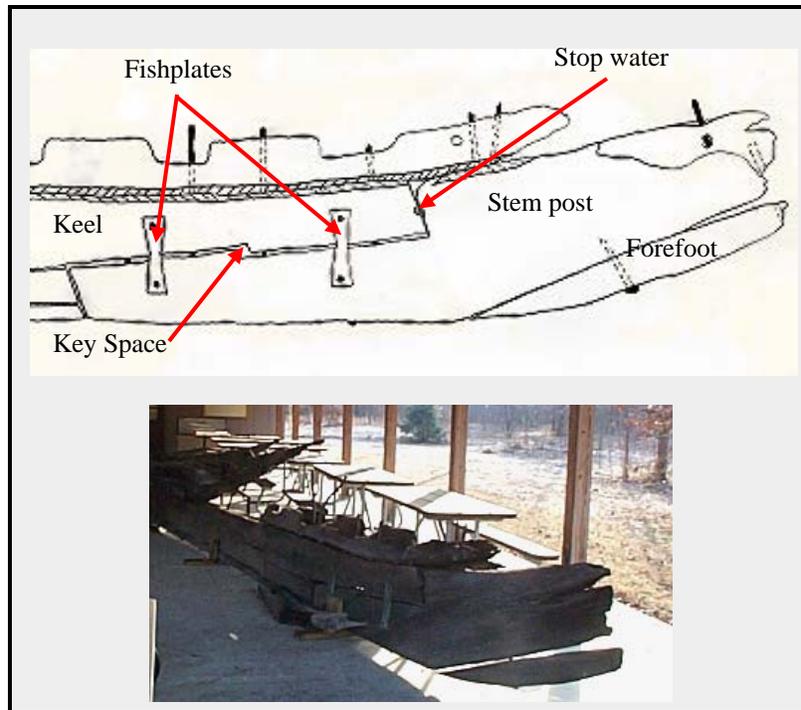
Figure 9: Very little of the stem post is extant but the forefoot is almost complete. Sketch by author and photograph by John Lewis.

The stem post is composed of two timbers, the stem post itself and a forefoot (Figure 9). The stem post is 2m 57cm (8.43ft) long, with a maximum sided measurement of 56cm (22.05in) and a molded measurement of 12cm (4.72in). At the scarf face the stem post is sided 23cm (9.06in). A 38cm (14.96in) long chamfered rabbet runs along the top (on both sides of the stem post) and is 5cm (1.97in) wide. A 3cm (.8in) diameter

wrought iron drift bolt attaches the forefoot to the molded side of the stem post. The forefoot (sometimes referred to as the outer stem post) is 2m 22cm (7.28ft) long, with a molded dimension of 12cm (4.72in) and a sided of 14cm (5.51in). The outside edge of the forefoot is rounded. Together the taper of the stem post and forefoot indicate a raking bow rather than a blunt vertical bow. A 3.2cm (1.26in) diameter plugged stop water with dowel in-situ (the dowel is split and has a wedge through its center) runs perpendicular to the axis of the keel between the keel and stem post at the forward face of the scarf.

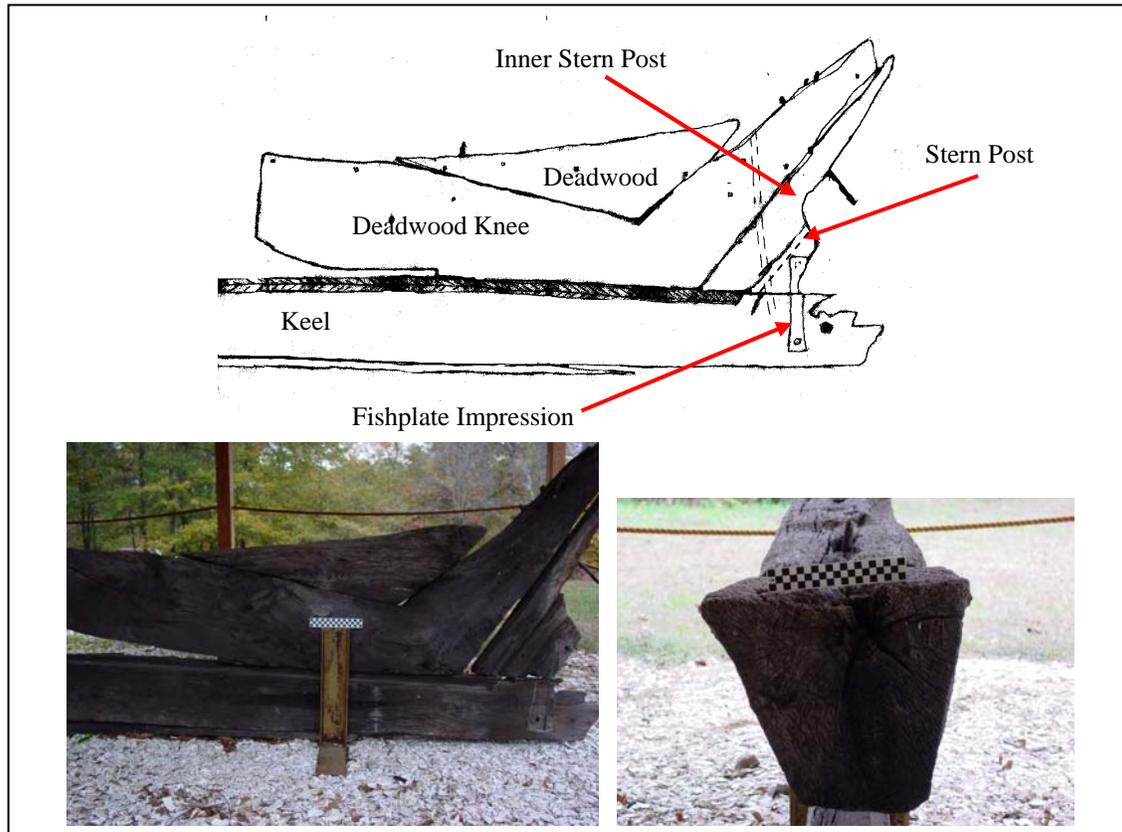
Figure 10: Field sketch and photographs of the stern components. Note that the sternpost and inner sternpost have been properly aligned in the sketch. The deadwood knee's face is trapezoidal in shape (bottom right). The field sketch is by the author and the photographs are by Chris Maple.

The stern components consist of a sternpost, an inner sternpost, a deadwood knee and a deadwood timber (Figure 10). A small portion of the sternpost is extant and measures 24.1cm (9.5in) long, 10.4cm (4.1in) wide and 12cm (4.7in) thick. The piece is fastened to the keel by means of two copper alloy fishplates, one on either side and attached by two copper alloy bolts that have been preened on both sides. One-half of a fishplate is extant on the starboard side with only fishplate impressions on the port.

Associated with this timber is an inner sternpost measuring 106cm (41.7in) long, 15cm (5.9in) at its maximum width and 18cm (7.09in) at its maximum thickness. A 4cm (1.57in) diameter stop water (without dowel) is located between the inner sternpost, the sternpost and the keel. A 2cm (0.79in) diameter bolt hole runs through the deadwood knee, the inner sternpost, sternpost and keel. A 45cm (17.72in) - long,

2cm (0.79in) - diameter iron bolt runs through the deadwood knee and inner sternpost. Two iron spike shafts protrude from the upper surface - above the iron bolt. Looking from the stem to the stern, the shape of the deadwood knee is trapezoidal (see Figure 10, bottom right), beveled on two sides with a maximum width of 32cm (12.6in), minimum width of 20cm (7.87in) and overall length is 2m 22cm (7ft 2in) with square nail holes on the outer surfaces.

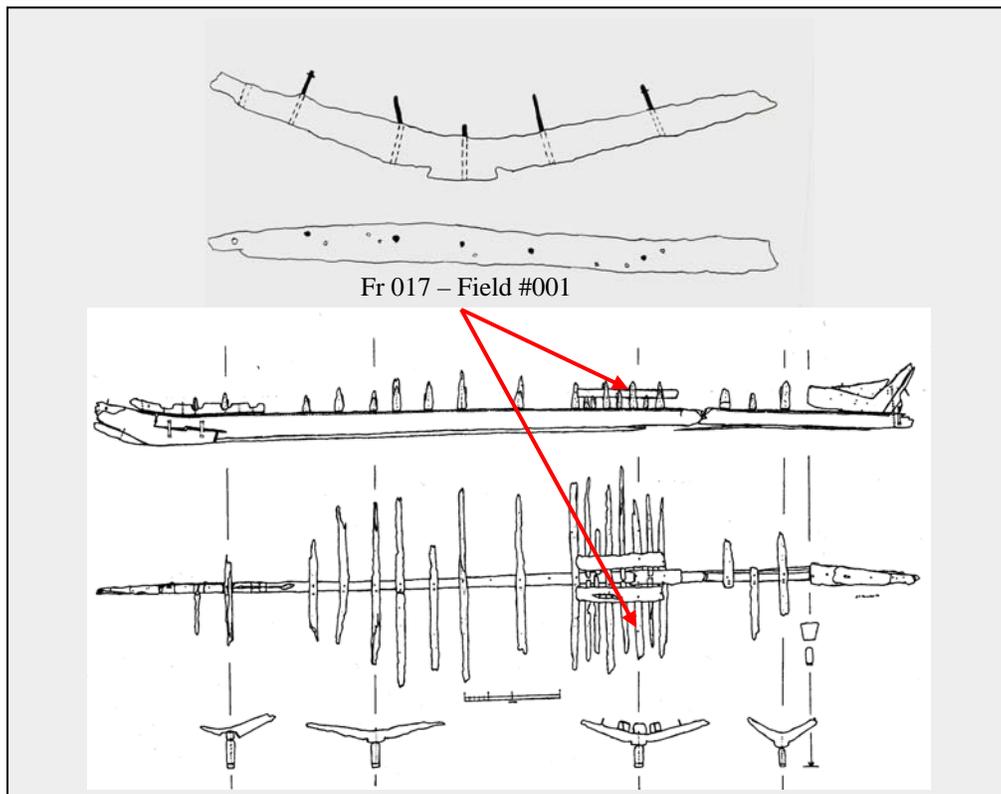
Figure 11: Looking from the stern to the bow the floor frames exhibit a relatively flat amidships. Drawings are by the author.

All of the sixteen extant floor frames (Table 2 and Figure 11) have two limber holes notched out along their bases. Nail patterns along the upper surfaces indicate the one-time presence of ceiling planking. Frames 15, 16, 17 and 18 each have two iron drift pins of 2.0cm (.8in) diameter to accept the sister keelson. Frame 17 includes two bronze drift pins of 2.0cm (.8in) diameter each that may have held additional cross timbers.

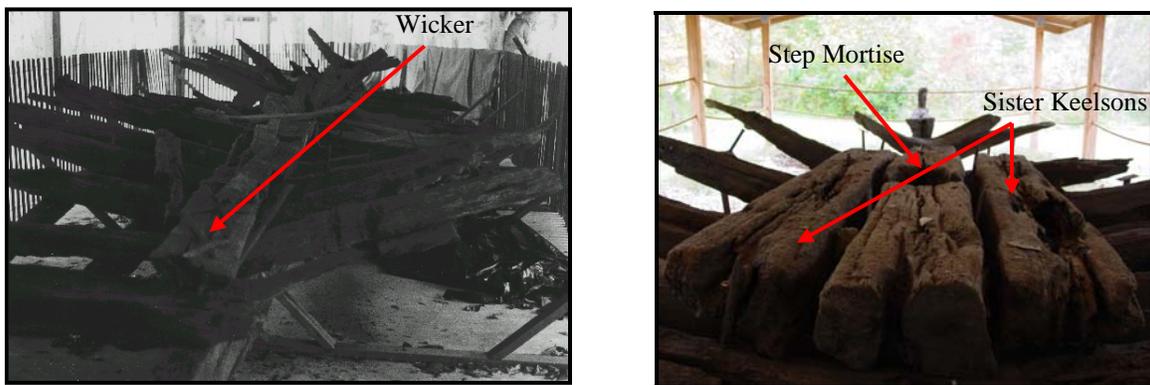
Figure 12: The keelson has very little of its original length, however the sister keelsons appear to be intact. In the photograph on the left (1960s) there appears to be substantial keelson remains. Also note the wicker cross-pattern on the upper surface of the keelson. The left photograph is courtesy of Richard Dodds and the right photograph is by Chris Maple.

A small portion of the keelson is extant at 1m 14cm (3.7ft) in length, 26cm (10.2in) molded and 18cm (7.1in) sided. Similarly, a small portion of the step mortise (for the mast) is extant, with a length of 17cm (6.7in), width of 15cm (5.9in) and depth of 18cm (7.1in). Iron drift pins fasten the keelson to frames 17 and 18. Two sister-keelsons (Figure 12) have been recorded (their undersides are both very worn where they rested over frames 15, 16, 17 and 18 - and the eight half frames) with a maximum length of 1m 81cm (5.9ft), maximum width 28cm (11.0in) and maximum thickness 15cm (5.9cm).

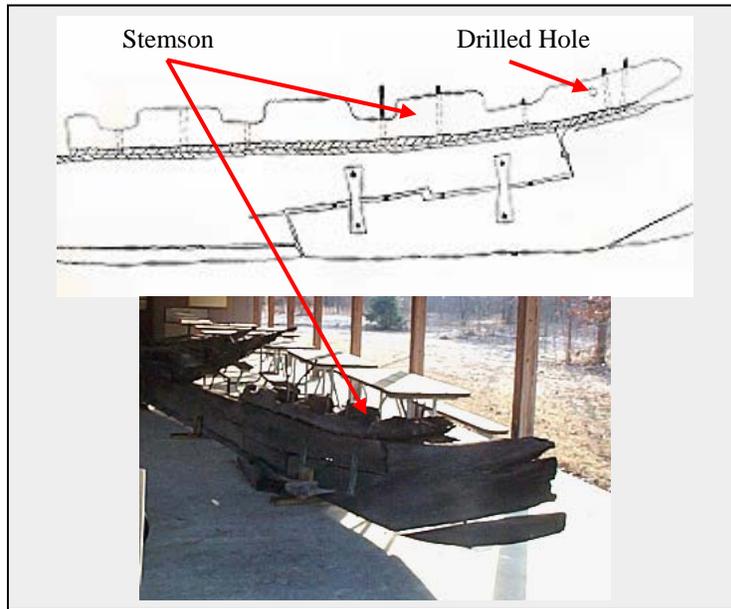
Figure 13: Starboard view of the stemson. Sketch (mirrored) by author and photograph by John Lewis.

The stemson is 2m 82cm (9.3ft) in length, with a molded dimension of 17cm (6.7in) and sided measure of 22cm (8.7in). A 5cm (2.0in) - wide rabbet runs the length of the stemson's base on both the port and starboard (Figure 13). Four notches are noted along the upper surface to accept frames 1, 2, 3 and 4 (average 23cm (9.1in) length, and 10cm (3.9in) depth). The stemson is fastened to the keel and stem post by eight 2.0cm (.8in) - diameter drift pins one in each frame slot, two toward the stem, one between frames 1 and 2, and, one between frames 3 and 4. A 5.0cm (2.0in) - diameter hole is drilled across the axis of the stemson in the forward portion of the stemson. The exact function of this feature is unknown.

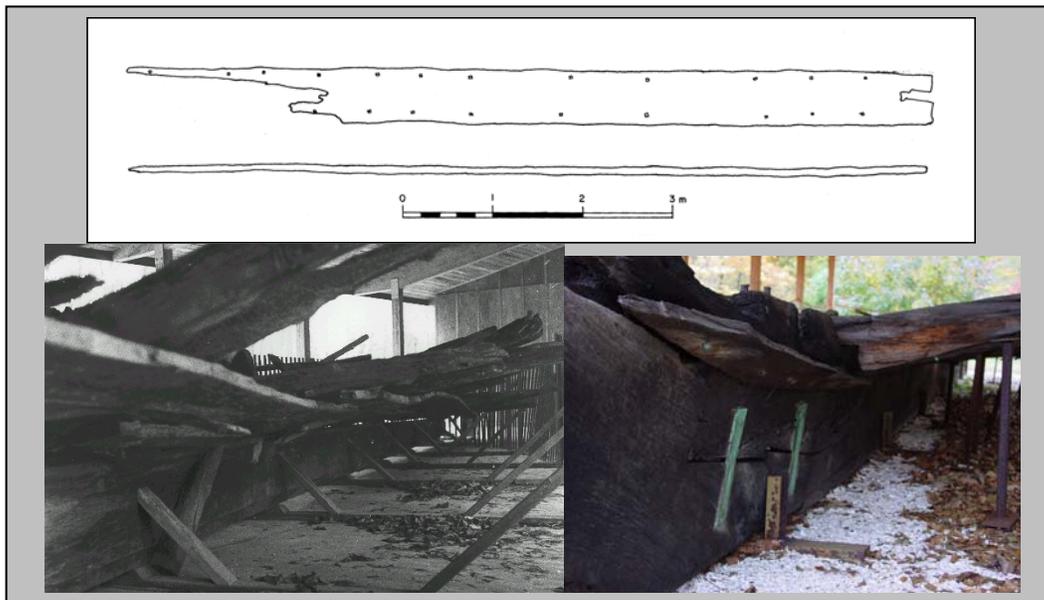
Figure 14: When the hull remains were first placed under protective covering in the 1970s some outer planking was still fastened to the frames (left). When MMAP staff visited the site in 1989 the planking and frames had been removed and only a small portion of a garboard strake (right) was noted in the bow area. Plank 003 is representative of all ten extant outer planks. Drawing is by the author, the photograph on the left was provided by Richard Dodds and the photograph on the right was taken by Chris Maple.

There are ten disarticulated outer planks (Figure 14) and one in-situ piece of a garboard strake attached

to the stemson on the port. The average length of the outer planks is 9m (29.5ft), average width is 54cm (1.8ft) and average thickness is 3.8cm (1.5in). Nail-hole pairs (with slight offset) are evenly patterned down the length of each plank's width and the average space between hole-pairs is 40cm (1.3ft). All planks were drawn at 1:1 ratio.

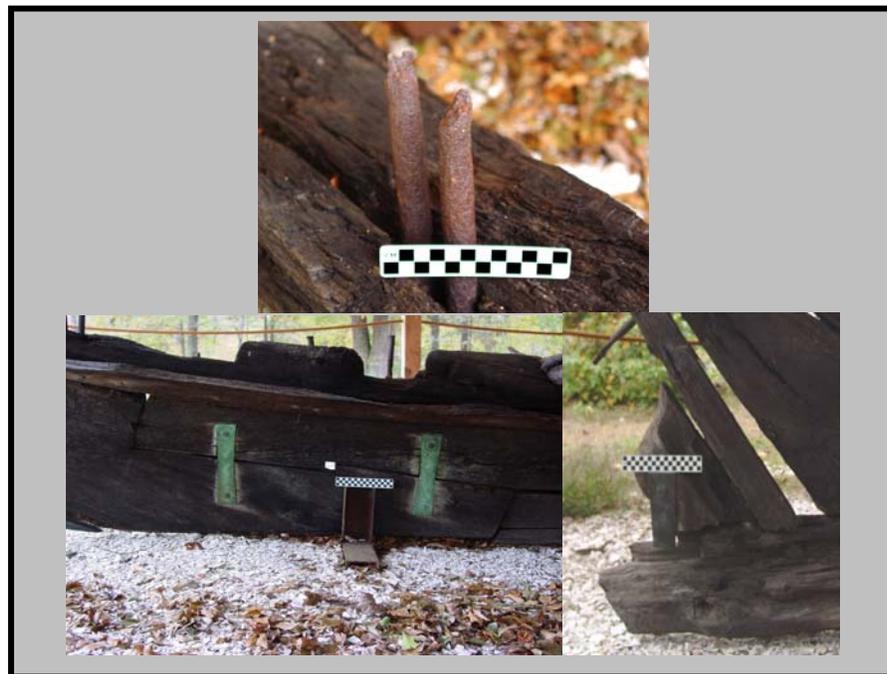
Figure 15: Iron drift pins (top) are used throughout to fasten large timbers such as frames, keelson, stern structure, stem structure and keel. A keyed hook scarf near the bow (bottom left) is further strengthened by a pair of copper alloy fishplates (one pair per side) and bolted by copper alloy drift pins. A partial fishplate is noted for the port of the stern (bottom right). Photographs are by Chris Maple.

A wide variety of fasteners are used to connect the various timbers and planks. Large timbers are primarily fastened with 2.0cm (.8in) diameter iron drift pins (Figure 15 top) of varying lengths. The half frames and frames that support the keelson-set have four copper alloy 2.0cm (.8in) diameter drift pins, all have been peened over and two have 3.0cm (1.2in) diameter washers under the peened end. Several 2.8cm (1.1in) – diameter wooden treenails are noted in several frames. Both iron square-shank spikes and copper alloy square-shank spikes have been recorded, mostly for the attachment of planks.

The butterfly-shaped fishplates are 30cm (11.8in) in length, 9.0cm (3.5in) at the widest part of the “wing” and 6.0cm (2.4in) at the “waist.” The copper alloyed plates (average thickness is 1.2cm (.5in) are paired and fastened by 2.0cm (.8in) diameter copper alloy drift pins (Figure 15 bottom left and right) that have been peened on each end.

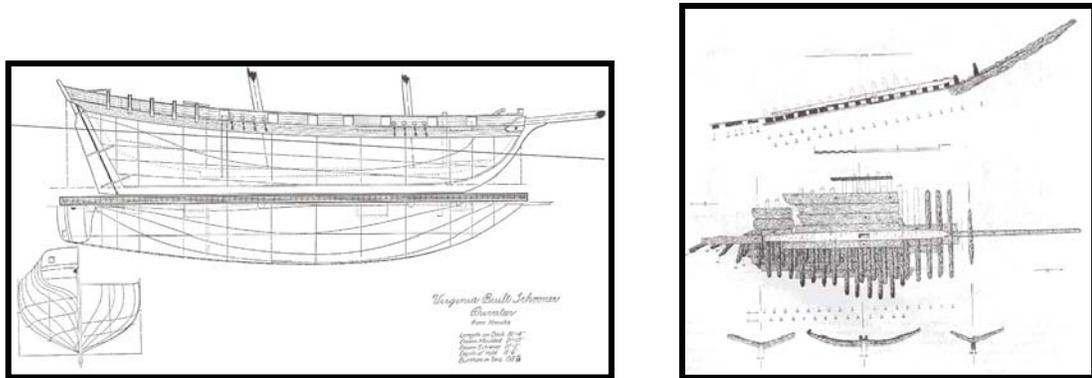
Figure 16: Two examples of late 18th century ships. The one on the left is a Virginia Pilot Boat possibly the predecessor to the Pungy. The example on the right is the Little Landing Wreck (LL1) (Thompson, 1991), an archeologically excavated sloop on the Cooper River, South Carolina. Drawing on the left is from Chapelle (Chapelle, 1973) and the drawing on the right is by the author.

Figure 18: When one compares the Martinak Boat's frame shapes to Figures 16 and 17 the closest match appears to be the Little Landing Wreck.

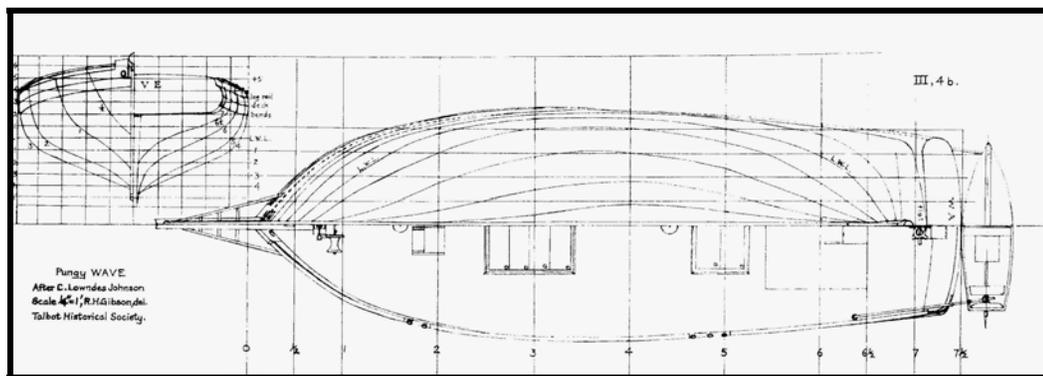
Figure 17: Lines drawing of the Pungy Wave. Drawing provided by the Talbot County Historical Society after C. Lowndes Johnson.

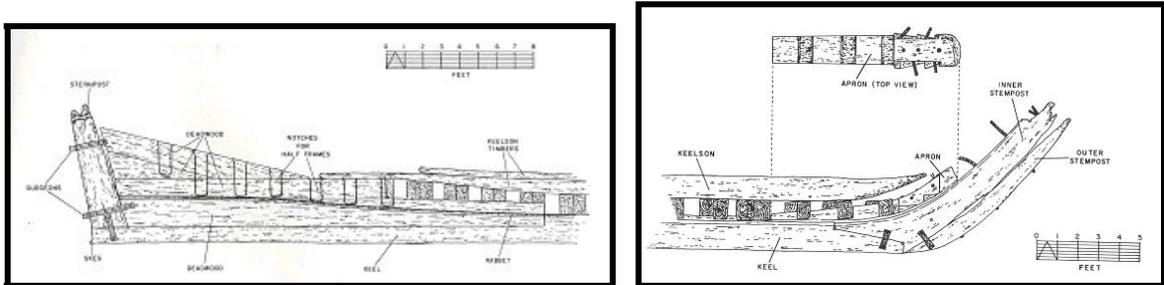
Figure 19: Stern and stem features on the *Eagle*, built in 1814, are very analogous of those recorded for the Martinak boat. Drawings are by Kevin Crisman (Steffy, 1994).

Although the layout and shape of the deadwood (in the stern) on the *Eagle* (Figure 19) is different from that of the Martinak boat the remaining stern structure is attached by fishplates and the stern post angle is very similar. The timbers that make-up the bow section (Figure 19) of the *Eagle* is very analogous. The forefoot (outer stem post) is attached by iron drift pins, the stem post is scarfed to the keel with fishplates and the stemson (apron) is notched for frames and attached to the keel, stem post and forefoot by iron drift pins.
