STAMP Tag Deploying Form

1. Tagged by: DONNA RACINE VOLUNTEER COORDINATOR ASSATELUE STATE PARK
PUNOLS, MD
2. Tag Number(s) (####): MH0027
3. Date: 6-9-25 Time: 18:52 am pm
Tide level: ☒ High ☐ Medium ☐ Low HIGH TIDE AT TIME OF TAG
4. Name of wreck (if known): ?
5. Description: How did the wreckage reach its present position?
☒ Float ☐ Uncovered ☐ Other

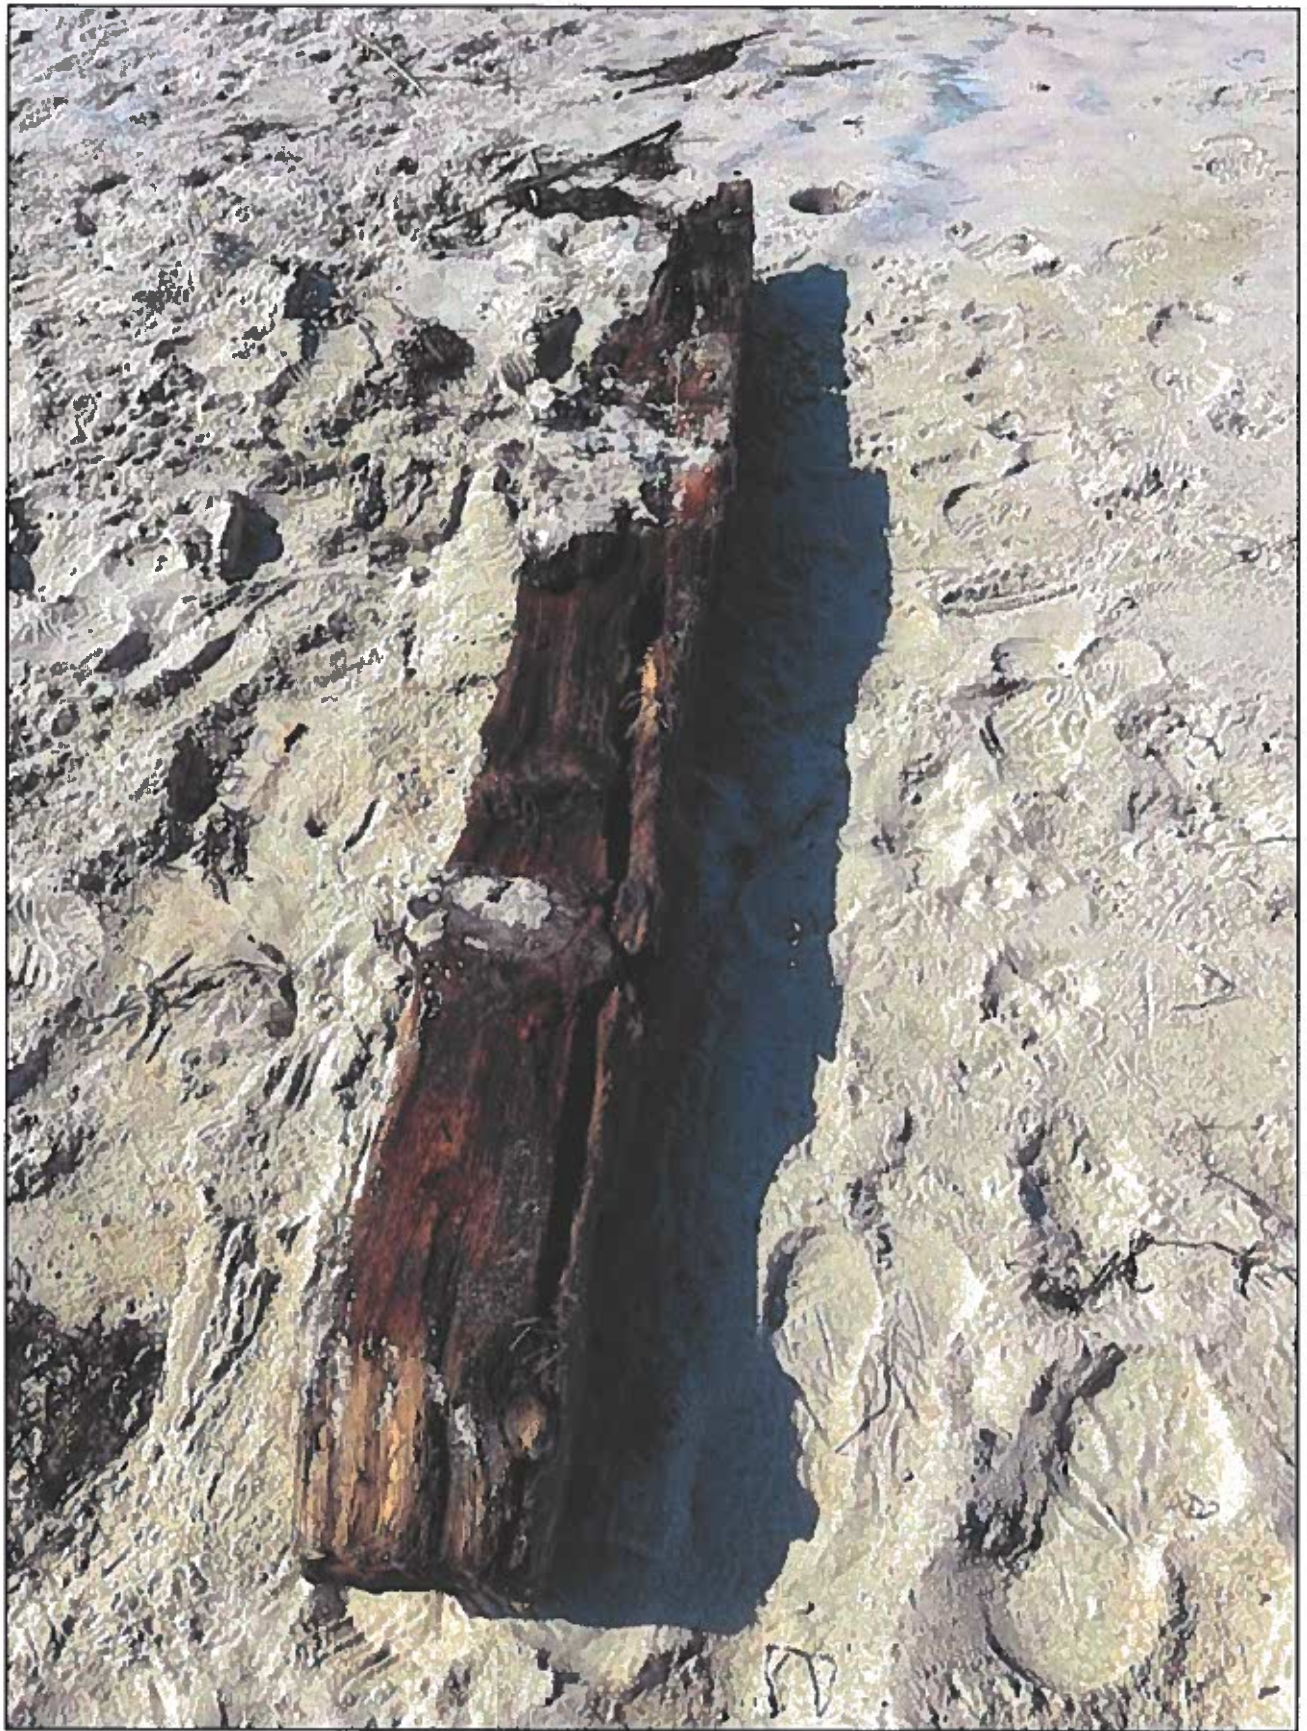
First fullback

☐ No deterioration ☒ Partially deteriorated ☐ Heavily deteriorated

ONE END WAS SPLINTERED WITH SOME BLACK BURNED EVIDENCE
5 ROUND SPIKE NAILS

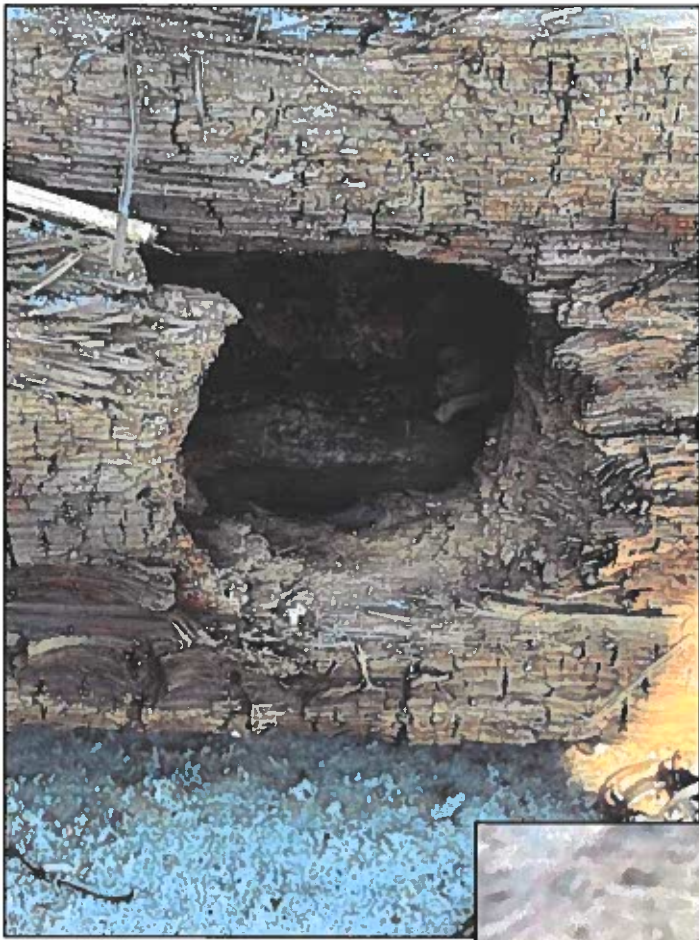
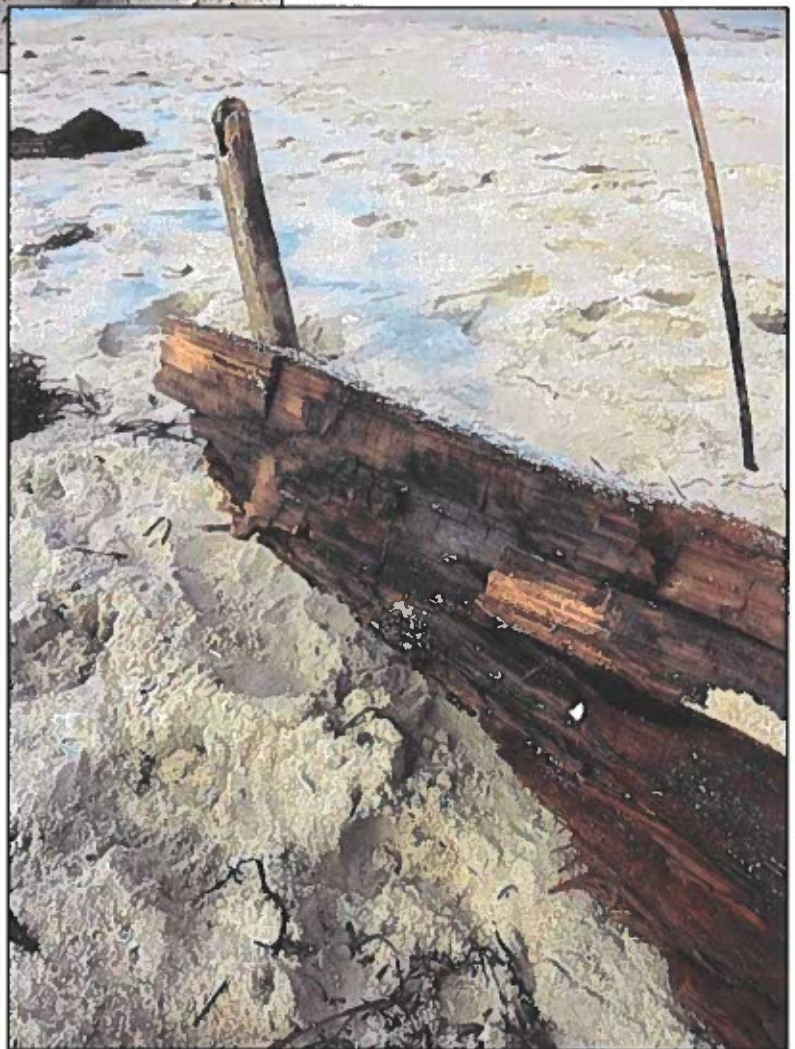
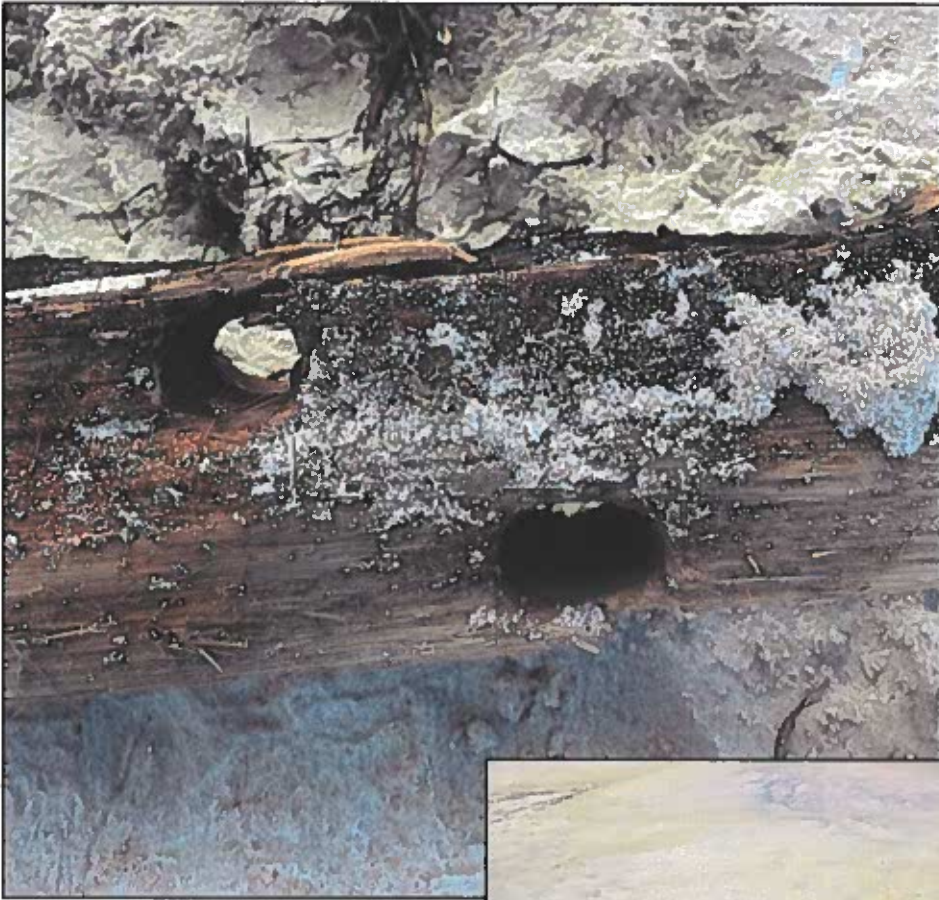
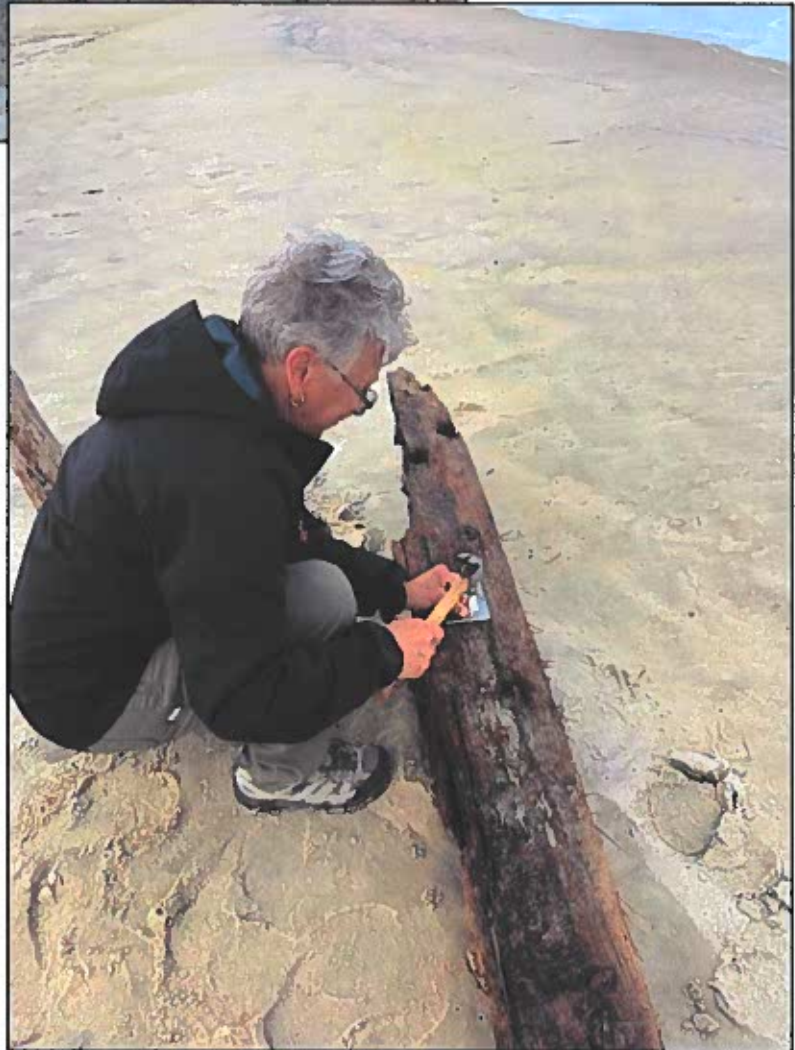
13. Pictures: _____ (Name/Id#)

☒ Completely exposed ☐ Partially exposed ☐ Nearly covered

Length: 7' 8" () Width: 2 1/2" () Thickness: 10" ()

The identification as a first futtock is accurate; at least it is likely to be one of the upper segments versus lower in the hull.
