# Southern Maryland Tobacco Barn Survey

**Final Report Submitted to the Maryland Historical Trust**

Dennis J. Pogue, PhD  
University of Maryland  
September 15, 2024

Cultural Resources Survey and Evaluation

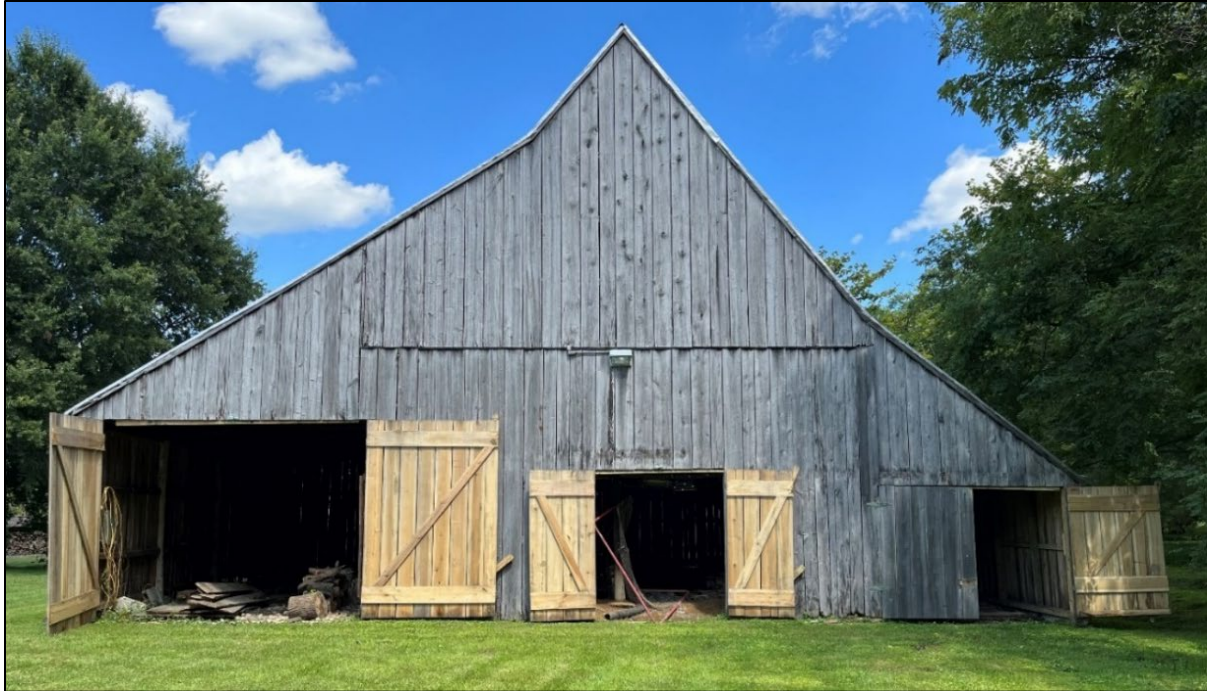
Figure 2. Tobacco barn at Rose Hill (AA-191), constructed ca. 1821; original shed on the left, early added shed on the right; the barn is in good condition and with high integrity (facing east).

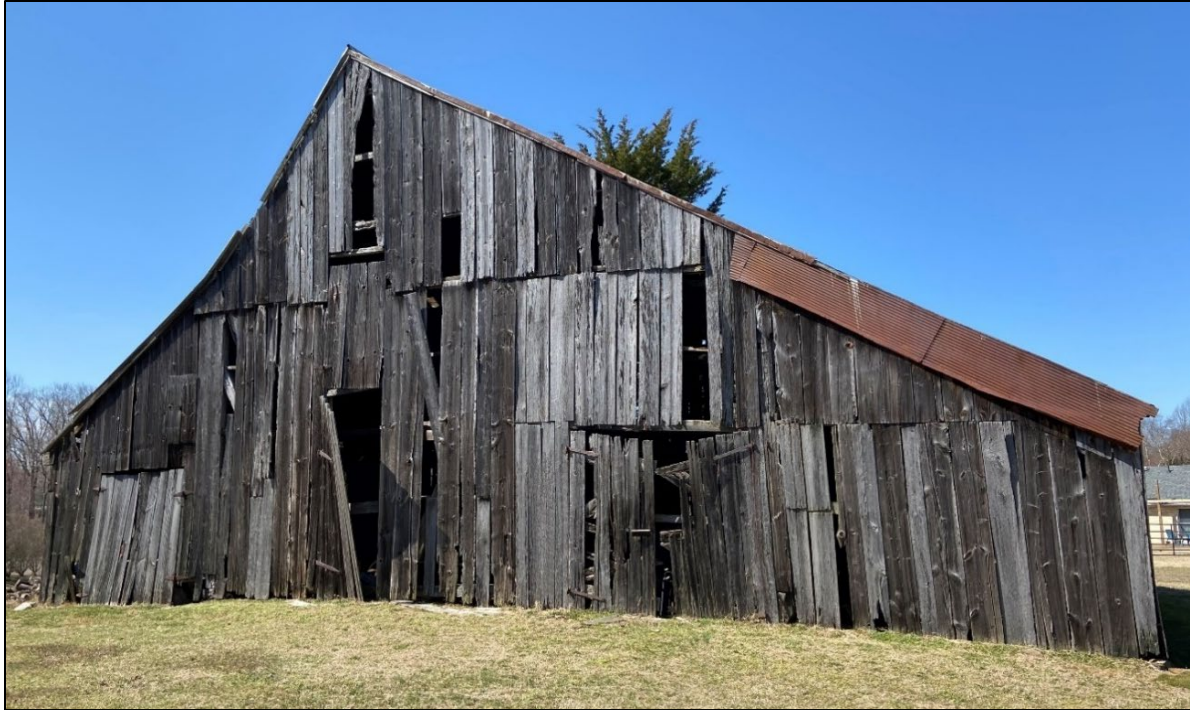
Figure 3. Buckler tobacco barn (CT-1090), with one original shed on the left and one added shed on the right; the barn is in fair condition with medium integrity (facing west).

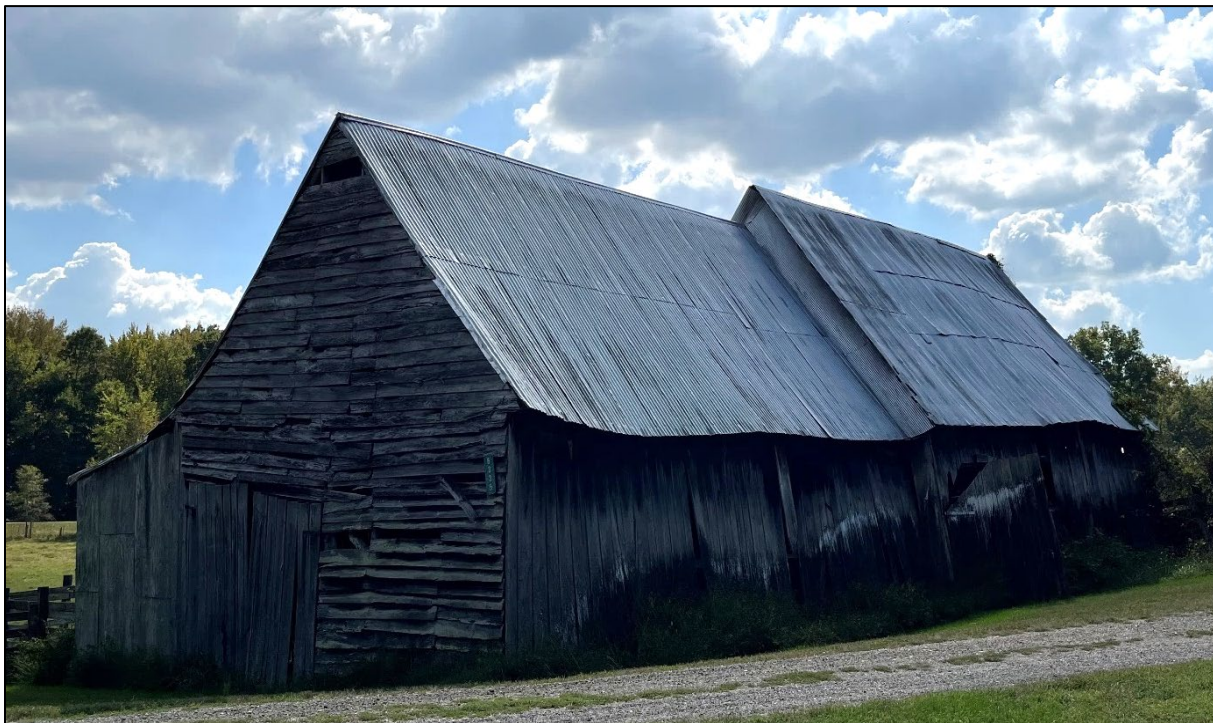
Figure 4. Plank Bridge tobacco barn (CH-174); original, earthfast section on the left; poor condition and medium integrity (facing southwest).

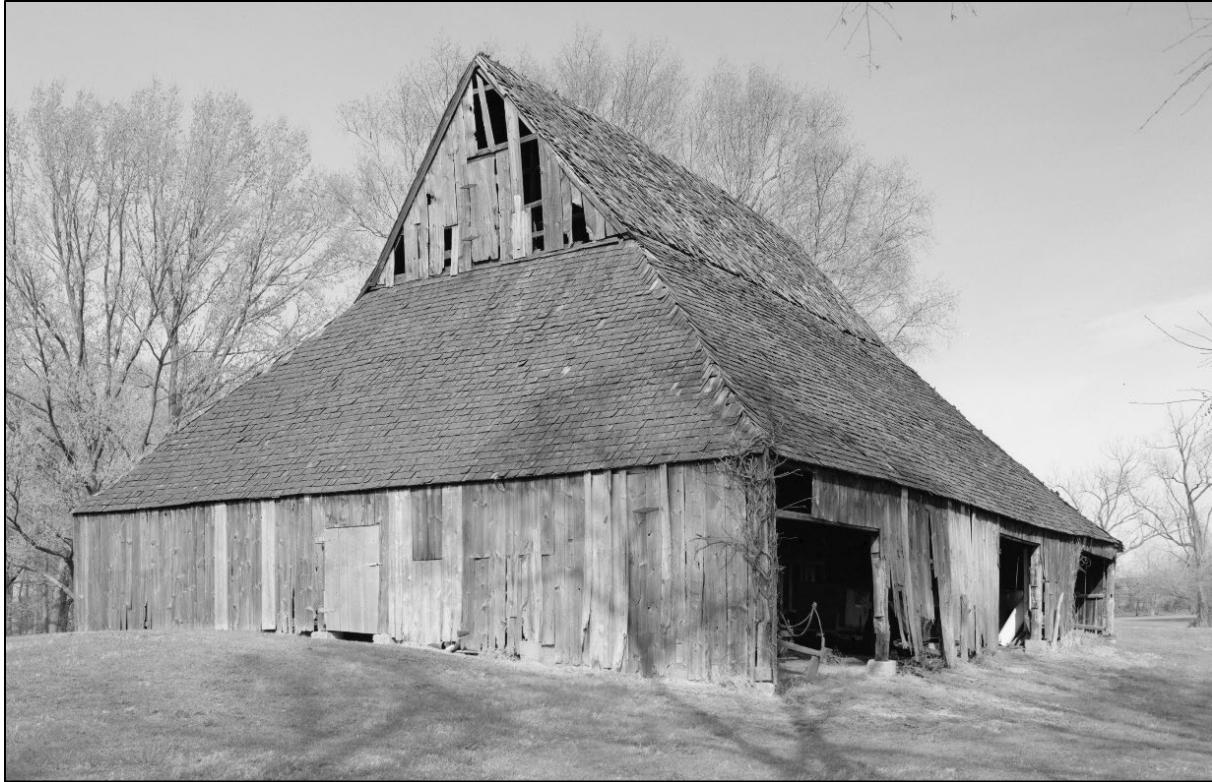
Figure 5. Warington tobacco barn (PG-733-6, HABS MD-980-1), ca. 1840s, fully framed with one original and two added sheds (non-extant).

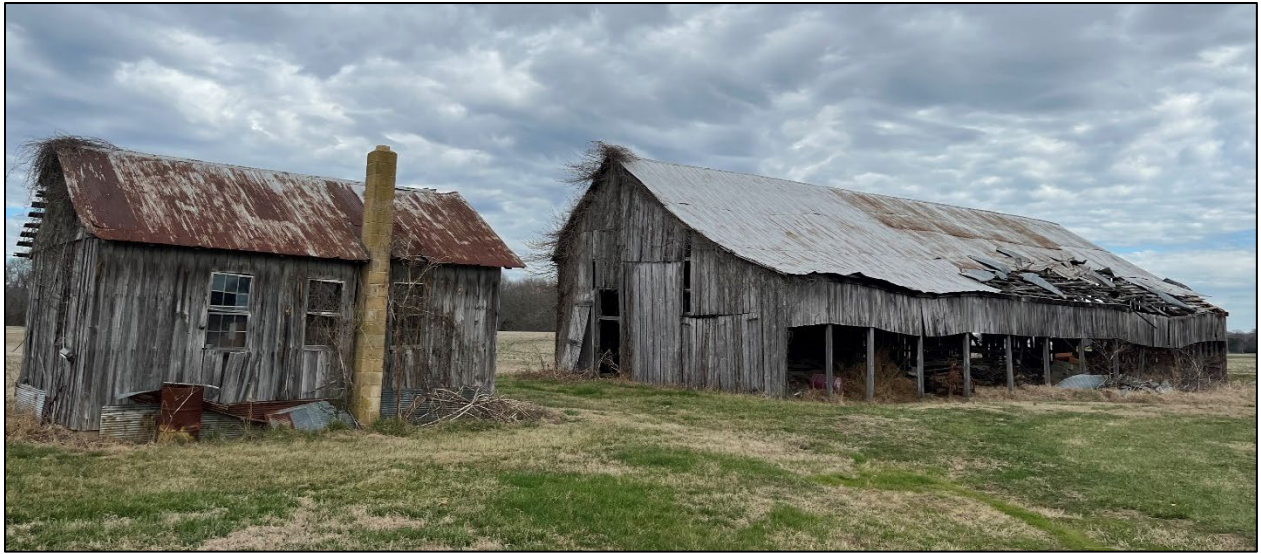
Figure 6. Albert Guy Farm, tobacco barn #2 (SM-157), with adjacent 20<sup>th</sup>-century stripping shed; the barn and the open-sided shed have been extended in the direction of the stripping building; the original portion of the barn is in good condition, with medium integrity (facing northeast).

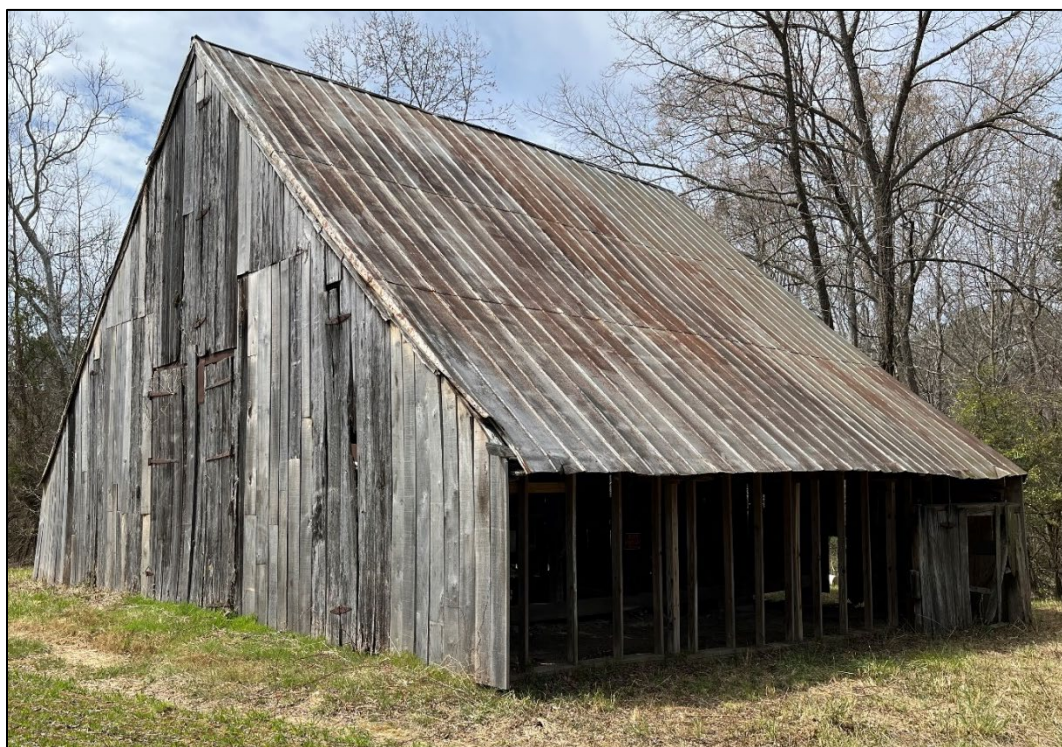
The De La Brooke barn (SM-411), from 1797, is the best-preserved, earliest dendro-dated example of a frame barn following the ascendant 4'-design. The timber-framed, gable-roofed structure is rectangular in form, 40' x 32' in dimension overall, with a 20'-wide central section framed in 8'-bays, and two 10'-wide open-sided sheds that were supported by hole-set posts. The central bay is supported by substantial sills, with a fifth (intermediate) sill bisecting the plan. Remnants of masonry, including short sections with several intact courses of brick, indicate that the central bay had been supported by a nearly continuous foundation. Substantial double doors, each carried by three pairs of wrought iron strap hinges (and unusual double pintles), are centered on both ends, with single doorways centered on the long walls. The sheds were eventually enclosed and outfitted to hang tobacco, and the beaded horizontal weather boards on the former exterior long walls were removed, along with the doors. As was common practice beginning at the turn of the 20<sup>th</sup> century, the barn was re-sided with vertical circular-sawn boards, with rails inserted within the frame as needed to act as nailers, and boards attached with hinges were incorporated in the siding to swing open to facilitate ventilation. The long walls facing the sheds remained uncovered and retain the wall studs.

Figure 7. The remarkably well-preserved De La Brooke barn (SM-411) is representative of the early fully framed type, with two sheds (facing southwest).

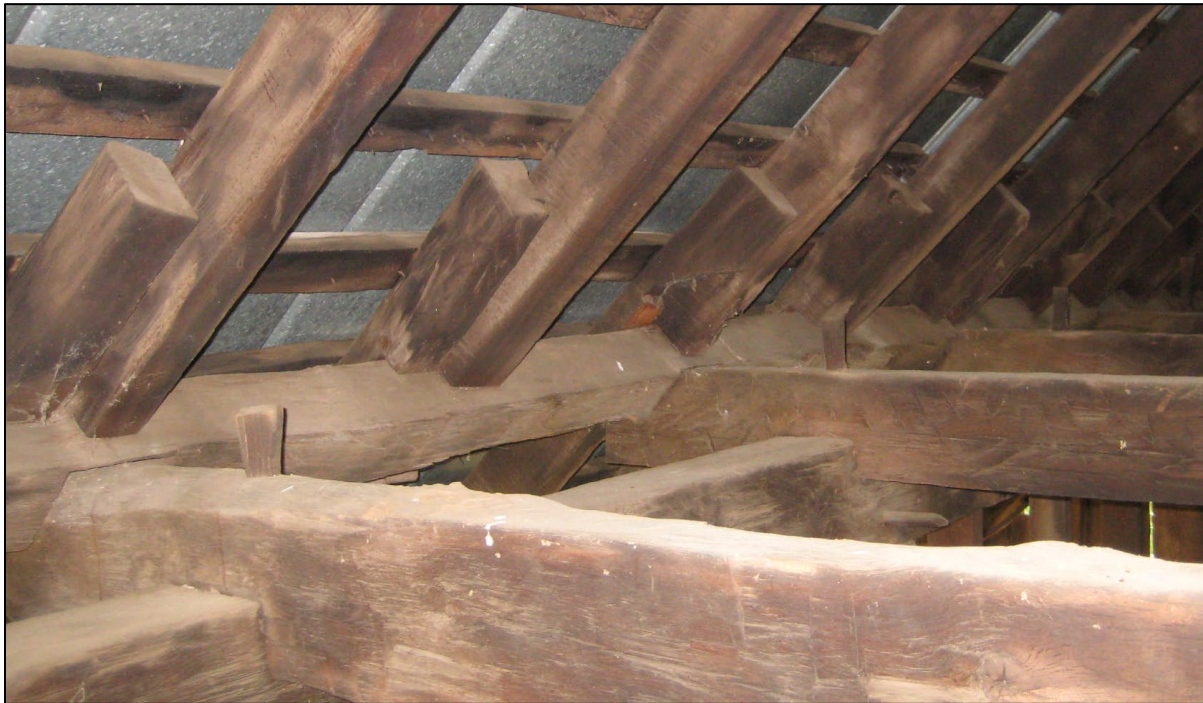
Figure 8. Even though the De la Brooke barn was originally outfitted with nailers to mount rows of wood shingles, the rafters were set in the traditional close-spacing of 2' that was suited to attaching clapboards.

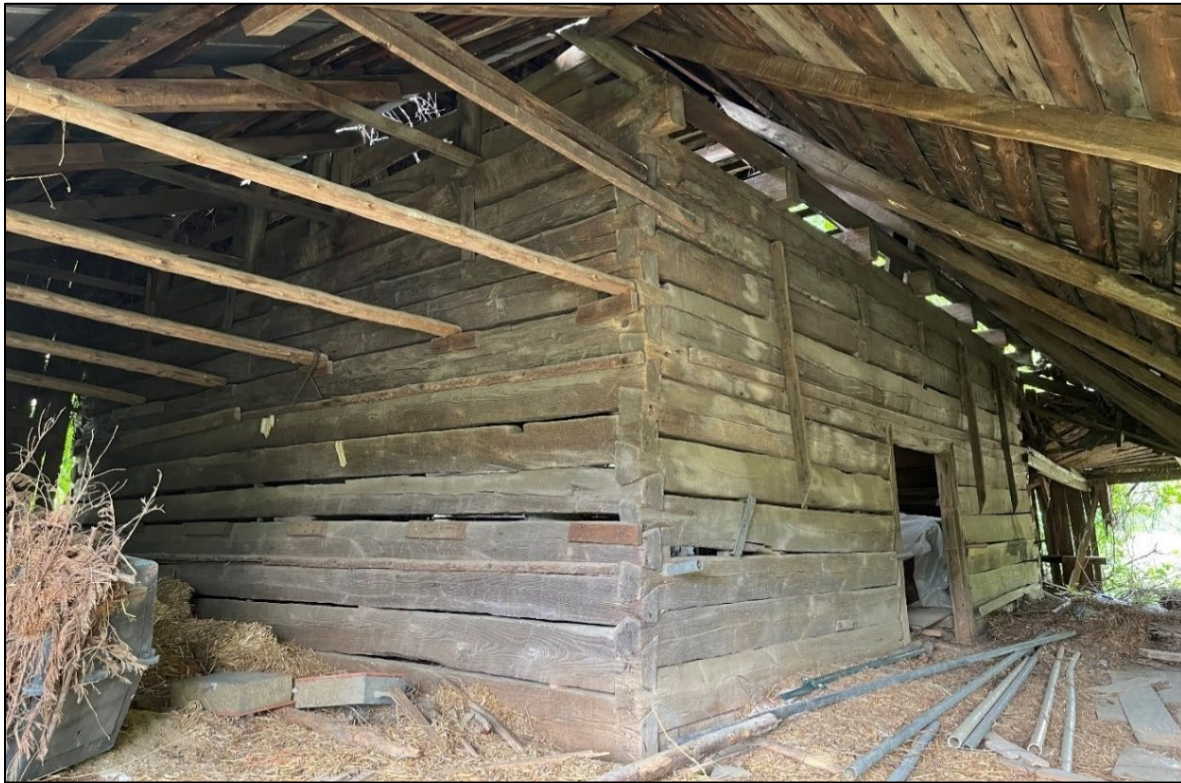
A row of short boards was installed along each long wall of the Spalding barn to block the opening between the top log and the bottom of the roof. Only one board survives in place, but patterns of nails and holes indicate the former presence of the others. Tight envelopes were a feature of barns that used fire to assist in curing the tobacco. The simplest method was to dig a shallow pit to contain a smoldering fire, and fire pits were documented at two no longer extant barns in Calvert County (Ranzetta 2005), and oral history indicates their use at the Johnstontown #2 tobacco barn (CH-742) in Charles. A framed rectangular opening in the west gable of the Spalding barn likely served as a ventilator, and a second opening may have been installed in the opposite gable, which no longer survives. If the barn had been built to accommodate fire curing, the ventilators presumably would have been added when that practice was discontinued. Or

Figure 12. Spalding tobacco barn (SM-170). The well executed full-dovetail notching at the corners testifies to the high level of skill of the builders, but also produced a relatively tight fit for the logs that is surprising given the need for ventilation to help cure the tobacco (facing northwest).

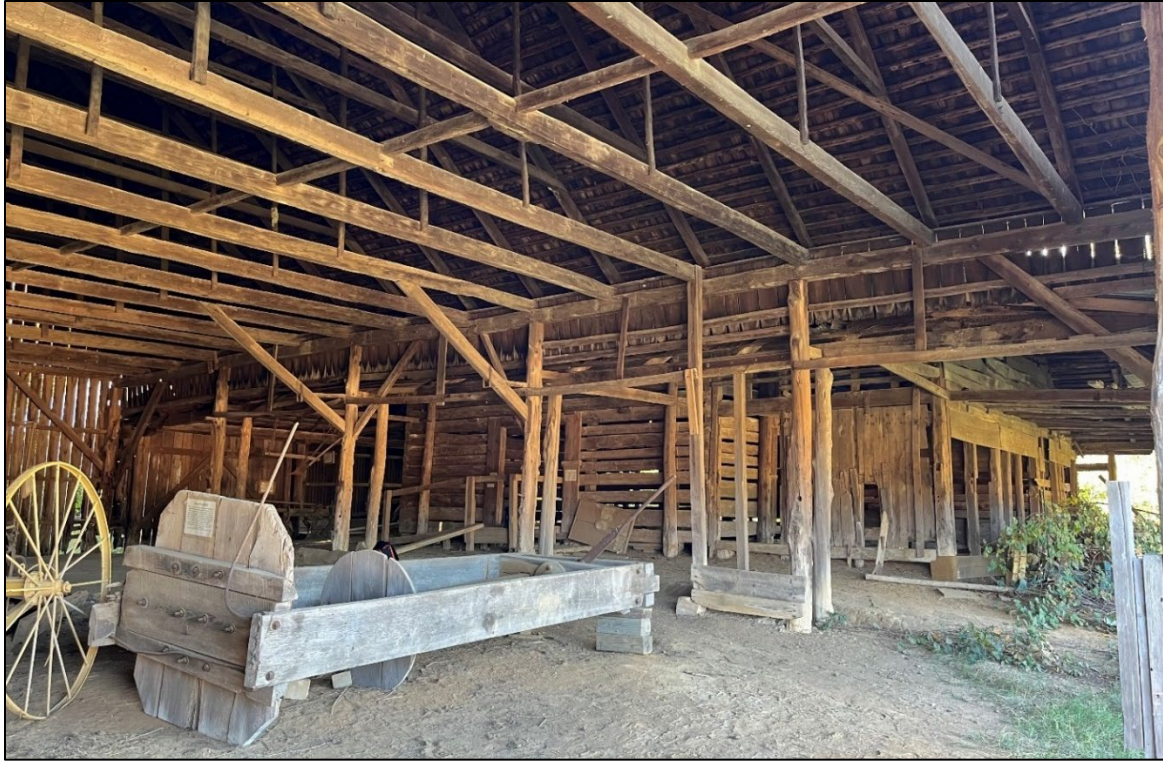
In addition to the earthfast extension to the 1837 log tobacco barn at the Sims farm, four other barns supported by hole-set posts are documented as having existed on the property, none of which incorporated sills. A substantial gable-roofed tobacco barn, measuring approximately 60' x 29', survives just to the south and running parallel to the log barn, at a distance of 13'. The structures were joined together by adding a shed roof to the south side of the earlier building. The southern barn is supported by round hole-set posts, regularly spaced at 12'-intervals on the east, and more irregularly with eight bays on the west. Diagonal up-braces connect the corner posts and two intermediate posts on each long wall with the tie beams, but otherwise the posts are not braced. Access to the much larger earthfast barn is unrestricted all along the north wall, and an exterior double doorway centered on the east end wall led to two aisles running the length of the barn, separated by a row of tobacco tier support posts, which do not survive.

Figure 13. The Sims barn (SM-246) combines both a log crib and two types of earthfast construction. The earlier log barn, dendro-dated to 1837, was expanded within a decade by an earthfast addition with interrupted sills, then a few years later was enlarged again by the double-aisle, earthfast barn (foreground).

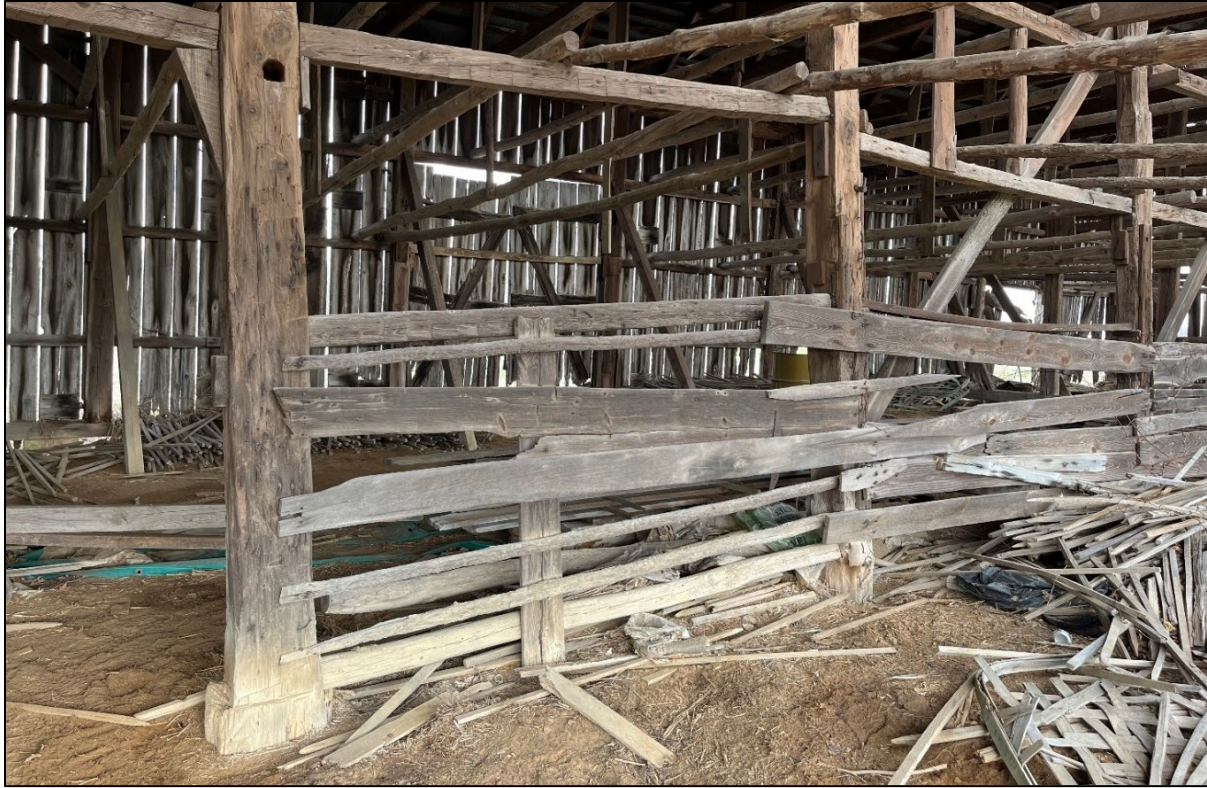
The decision to erect earthfast barns without incorporating interrupted sills in the design seems to have represented a perilous trade-off between stability and accessibility. While the absence of the sills reduced conflicts to movement, the evidence from several barns in the sample testifies to the relative weakness of the un-silled walls. The condition of the Briscoe-Petty barn (SM-), dating to ca. 1890, is instructive in this regard. The structure is 80'6"-long and 20'6"-wide, with three rows of hole-set posts set at 10'-intervals forming two aisles, and a shed 14'7"-wide running along one wall. In addition to a lack of sills, the posts are unbraced, with only the post in the center of each row forked at the top to bridge the junction of the two-part plates and middle girt. The roof is traditionally framed, with joists notched over the plates, and rafter pairs set at a 4'-interval, each with three tiers of collars. The hole-set posts are severely racked in the direction of the shed; connections between the posts and plates have been broken, and joists and rafters have been fractured and displaced. Historical documents reference the prevalence of damage to tobacco barns caused by the frequent heavy windstorms that are common in the region (Ranzetta 2005:88). This was likely the cause of the displacement and damage to the Briscoe-Petty barn, as the building is positioned on a ridge fully exposed to the elements and less than a half-mile from the Patuxent River. If not for the sturdy roof frame and the support of the shed, the barn likely would have collapsed.

Figure 16. The Albert Guy Farm barn #2 (SM-157), hole-set posts in the foreground frame a section of one wall with continuous sills on the others.

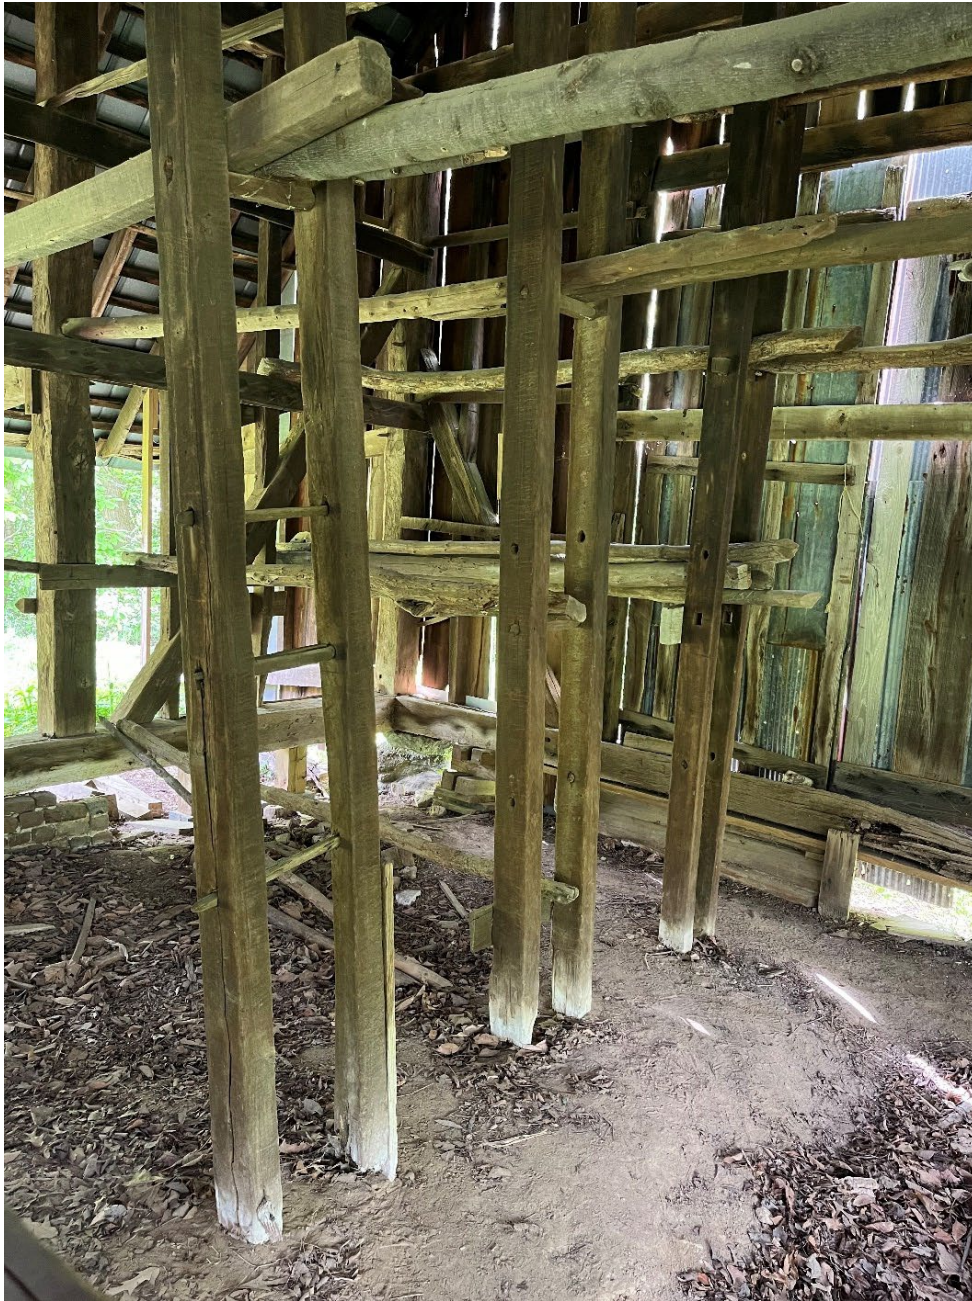
Figure 17. Ladder-style tier pole supports at De La Brooke (SM-411), dating to 1797.

The ladder-type system has been documented at six barns in the region, with three surviving examples. The method of supporting hanging poles does not survive at the 1785 Brome-Howard barn (SM-33H). However, the second-oldest dated tobacco barn in the region, De La Brooke (1797), has a remarkably well-preserved system of hanging ladders. Dendrochronology confirmed that the tier ladders are original features, as one of the three samples that were

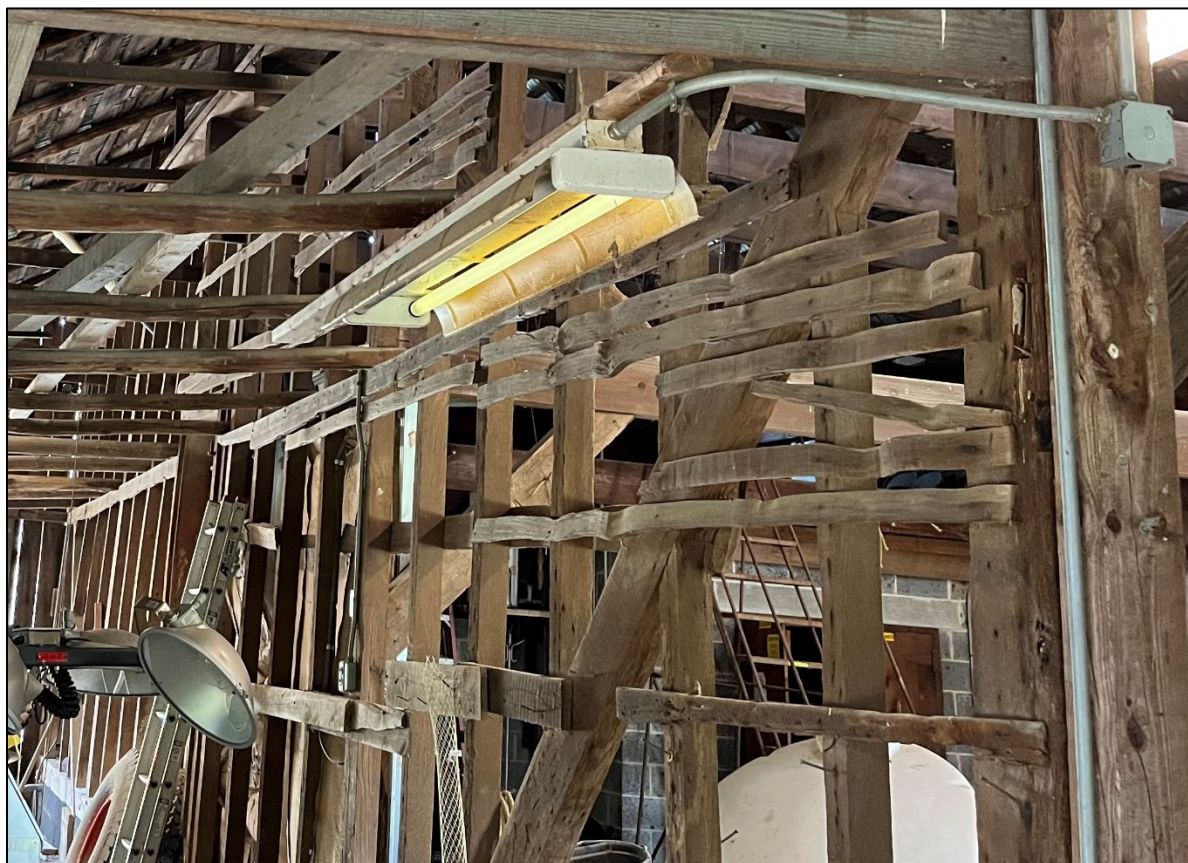
The evidence from numerous barns in the sample point to another means of ventilation that took advantage of the presence of open-sided sheds. The exterior wall facing the shed was sheathed with either vertical or horizontal battens that were spaced one to three inches apart, while the other walls were covered with standard siding. The non-extant Dryadocking barn (SM-546) may have been the earliest documented example of this feature, but it is found at both the Longevity (CH-71) and the Black Friars (CH-42) barns, dendro-dated to 1835 and 1836, respectively. At the Parrans (CT-58) barn, the horizontal siding was replaced with spaced, narrow riven clapboards when the shed was added along that wall. The sheds were at least partially open-sided, and presumably the roofs provided adequate protection from the weather, which allowed the spaced battens to be used to provide air circulation. At De la Brooke (SM-411), narrow sawn battens were attached to the underside of the projecting eaves, which presumably helped to ventilate the barn while the walls remained covered in tightly overlapping weatherboards. The use of spaced battens on an exterior wall is documented as late as the ca. 1890s Briscoe-Petty barn (SM-). In this instance, there does not appear to have been an original shed running along that wall, but the roof has an unusually generous overhang of 2’, which presumably provided sufficient protection from rain to allow installing the more porous wall finish.

Figure 18. Parrans tobacco barn (CT-58) with remnants of a covering of spaced riven battens attached to the exterior wall facing the open-sided shed.

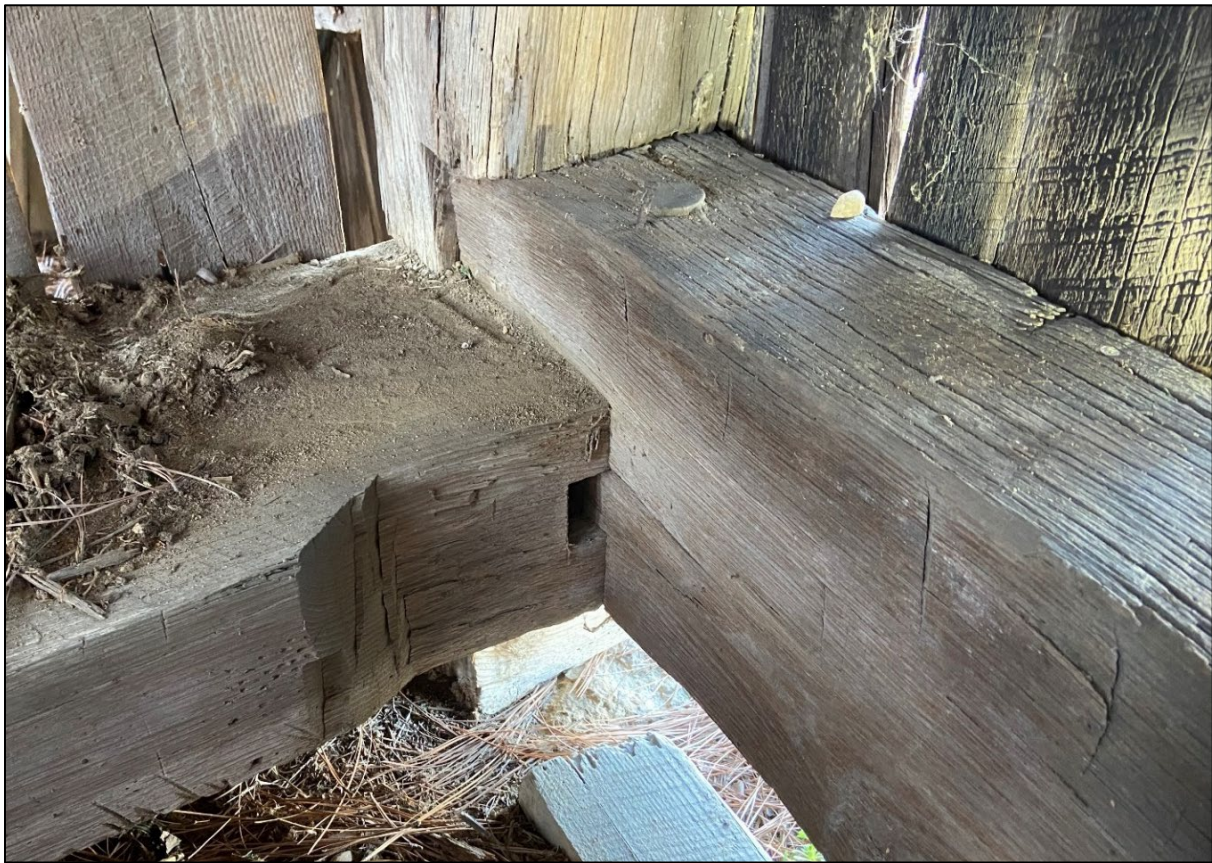
A notable framing feature has been recorded at as many as 22 barns in the documented sample. The examples are concentrated in Calvert County, at 14 of the total, with two found in Anne Arundel and another six in Charles. The earliest dated barn with this feature is Tracy's Landing #2 (AA-756, 1805) and the latest is Hadlow #2 (CH-118, ca. 1890-1900). The distinctive joint consists of two "tenons" projecting from the end of the transverse sill, with the lower projection inserted as usual into a horizontal mortise. The transverse sill is oriented with a taller vertical

dimension to provide sufficient material to enable the upper tenon to overlap the wall sill, and the post is notched to fit over and “clench” the tenon. One or two pegs penetrate from the top of the transverse sill through both tenons. This condition is most commonly found in relation to corner assemblies, but it also has been found joining transverse sills at intermediate wall posts. In some of the barns the posts attach to the plates in a somewhat similar fashion. The secured double tenons provided an especially tight joint, which seems to have been particularly valued by Calvert barn builders for reasons known only to themselves.

Figure 19. Buckler barn (CT-1090), double-tenoned corner joint with clenched post.
