Christ Episcopal Church, (William and Mary Parish)

Architectural Survey File

CHRIST CHURCH (William and Mary Parish)

INVENTORY FORM FOR STATE HISTORIC SITES SURVEY

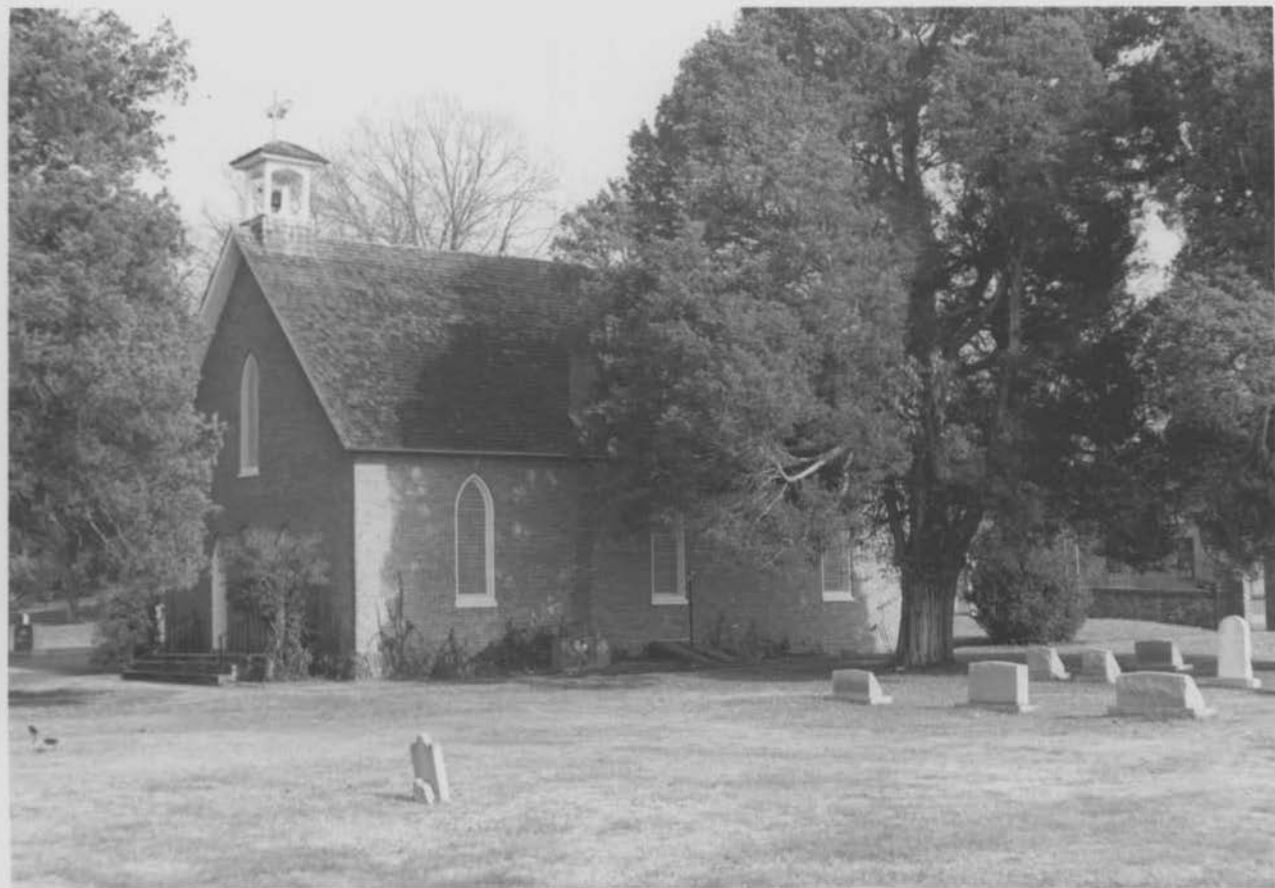
View From E. JRRivoire, 1978

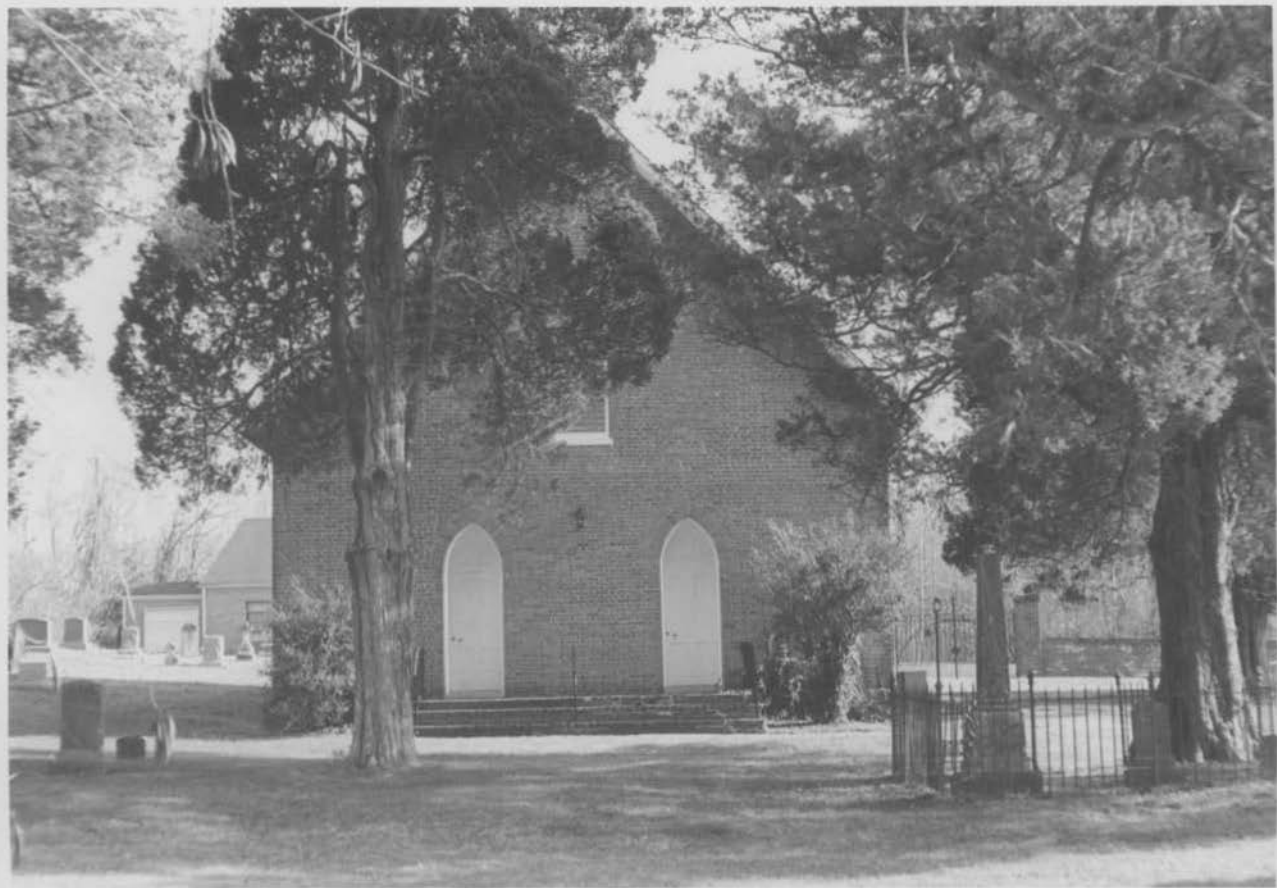
South Front JRRivoire, 1978

A one-story, rectangular, Flemish bond brick structure with chamfered watertable, Christ Church is the smallest of the county's five eighteenth century Episcopal churches. The principal facade is at the south end and has two lancet arched entrance doors with a lancet arched window centered in the gable above. To the right of the left hand door is a seam marking the right side of an earlier door opening. Above both doors are areas of reworked brick that suggest the possibility that there were once two small gable windows that were later removed and replaced by the existing window. Both doors are of a single leaf design of four panels and are framed by paneled reveals. The window is of leaded stained glass fronted by a painted wire screen.
