Maryland Inventory of Historic Properties number: AL-I-A-083

Name: US 40 over Fifteen Mile Creek

Maryland Inventory of Historic Properties  
Historic Bridge Inventory  
Maryland State Highway Administration  
Maryland Historical Trust

SHA Bridge No. 1036 Name: US 40 over Fifteen Mile Creek

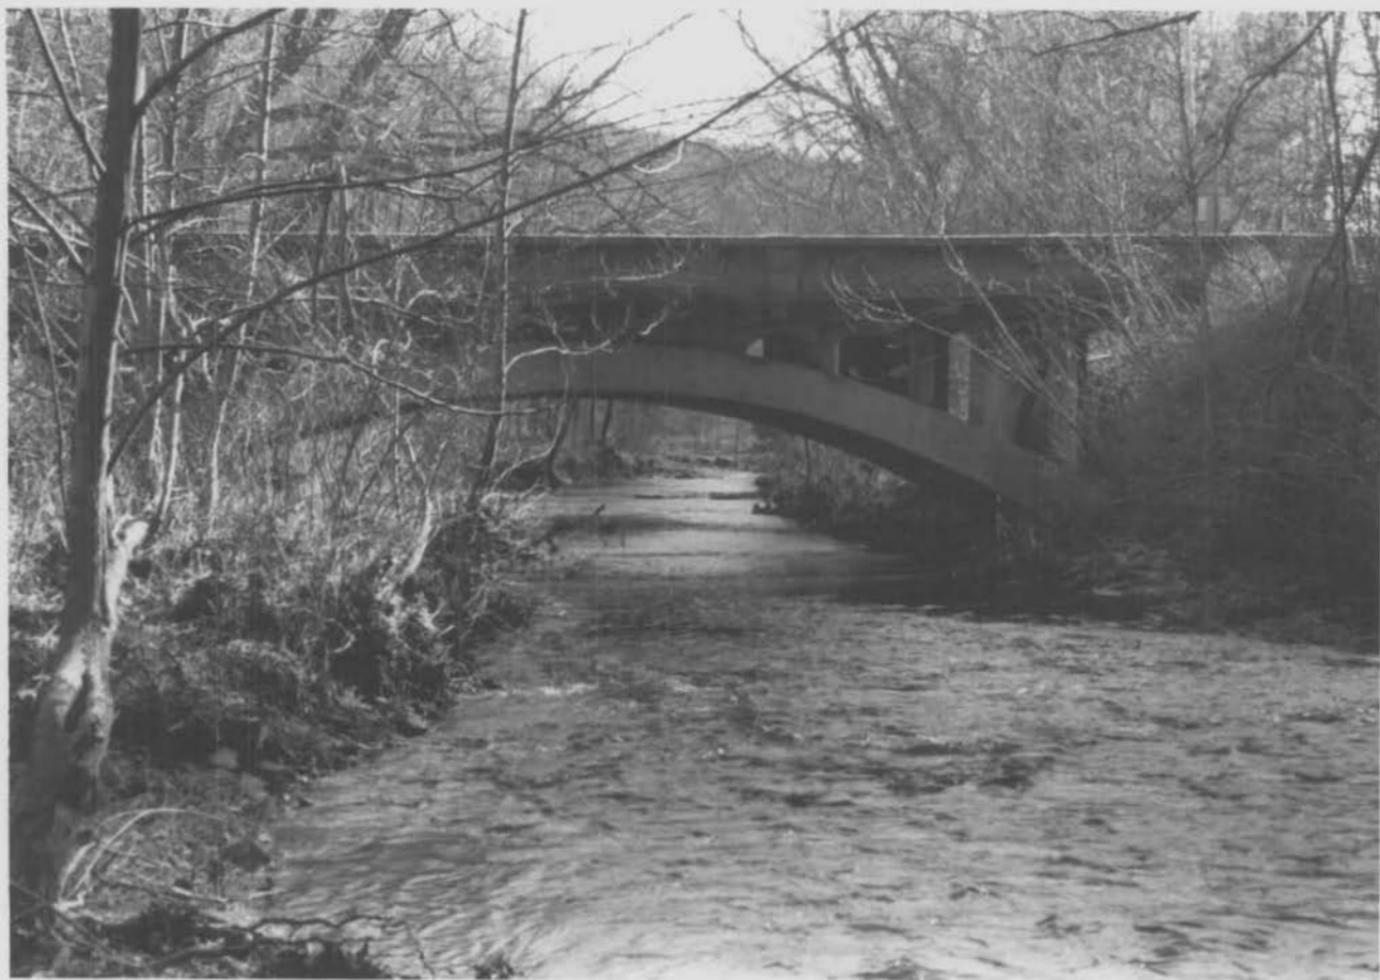
1. AL-1-A-083
2. US 40 over Fifteen Mill Creek
3. Allegany Co., MD
4. Wallace, Montgomery & Assoc.
5. 12/97
6. MD SHPO
7. Elevation looking downstream
8. 10F4

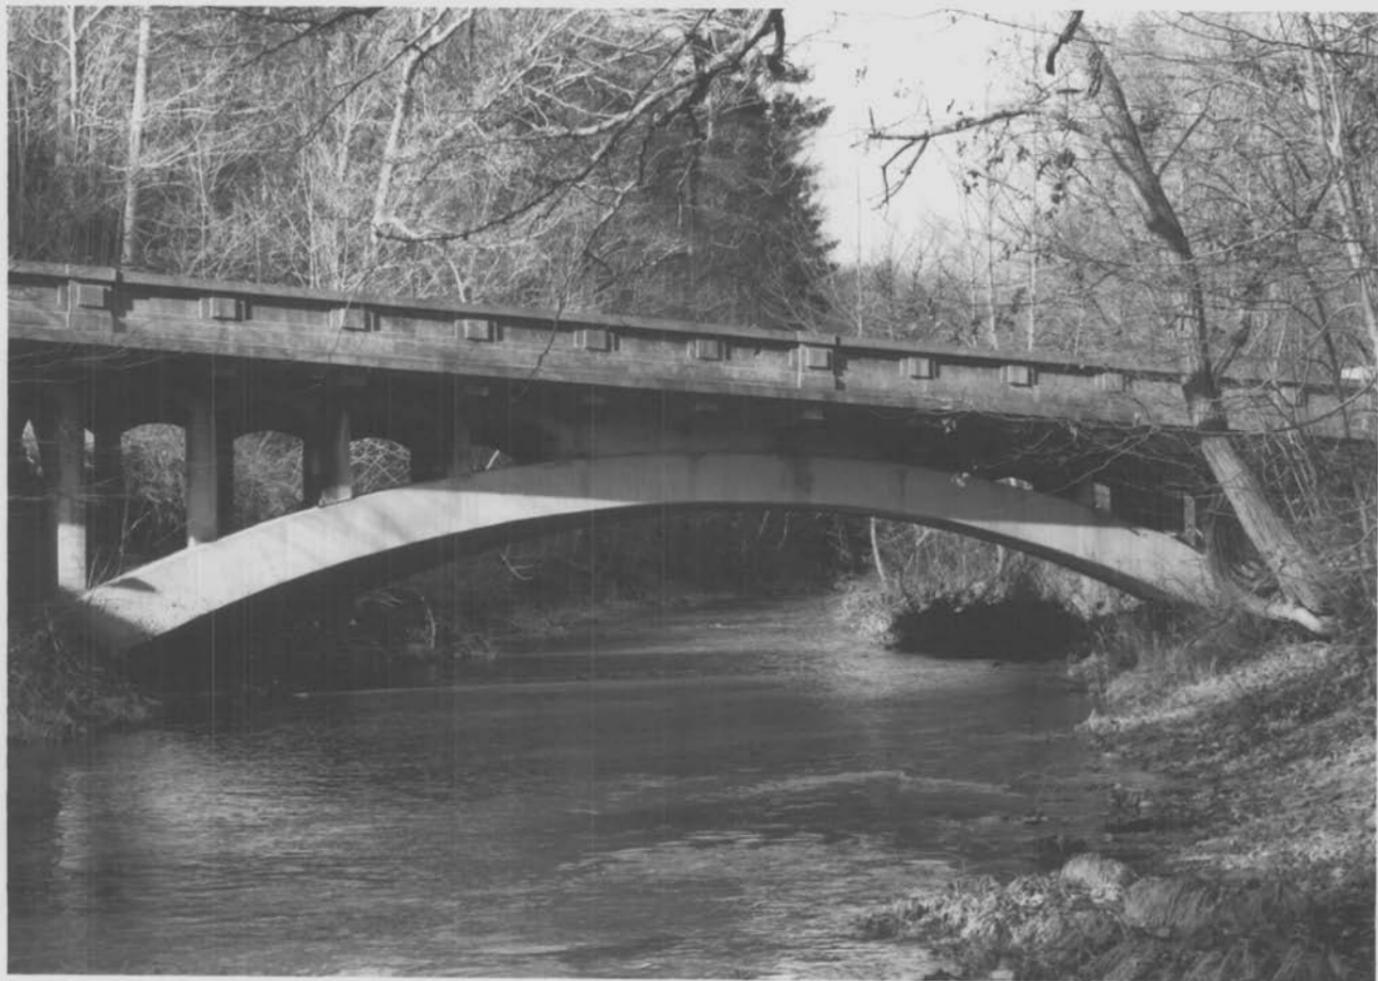
1. AL-1-A-083
2. U.S. 40 over Fifteen Mill Creek
3. Allegany Co., MD
4. Wallace, Montgomery & Assoc.
5. 12/97
6. MD SHPO
7. Elevation looking upstream
8. 2 of 4

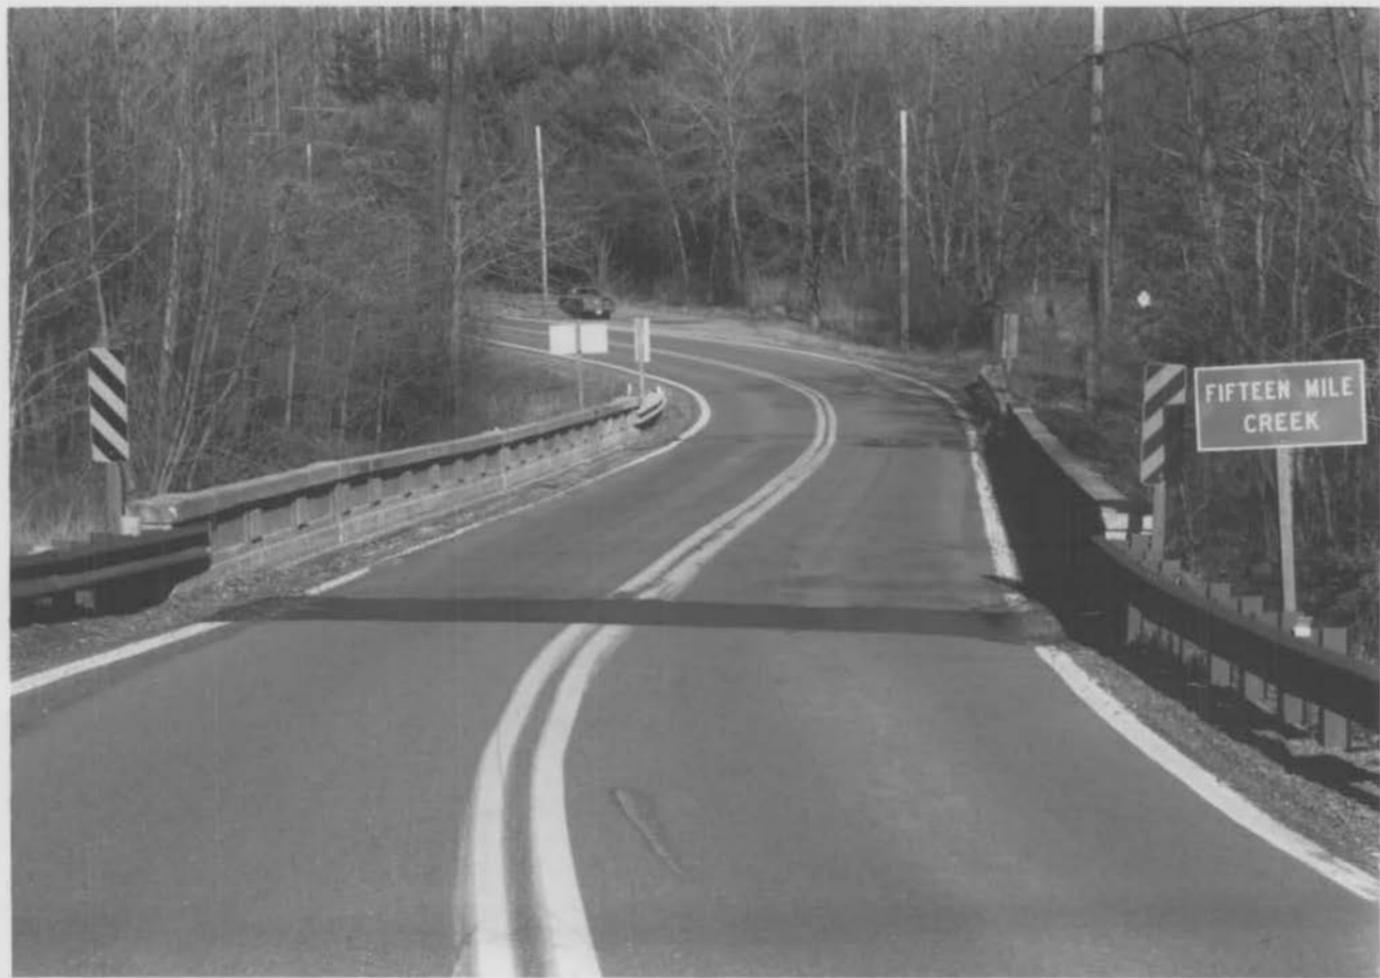
1. AL-1-A-083
2. US 40 over Fifteen Mill Creek
3. Allegany Co., MD
4. Wallace, Montgomery & Assoc.
5. 12/97
6. MD SHPO
7. Looking East
8. 3 of 4

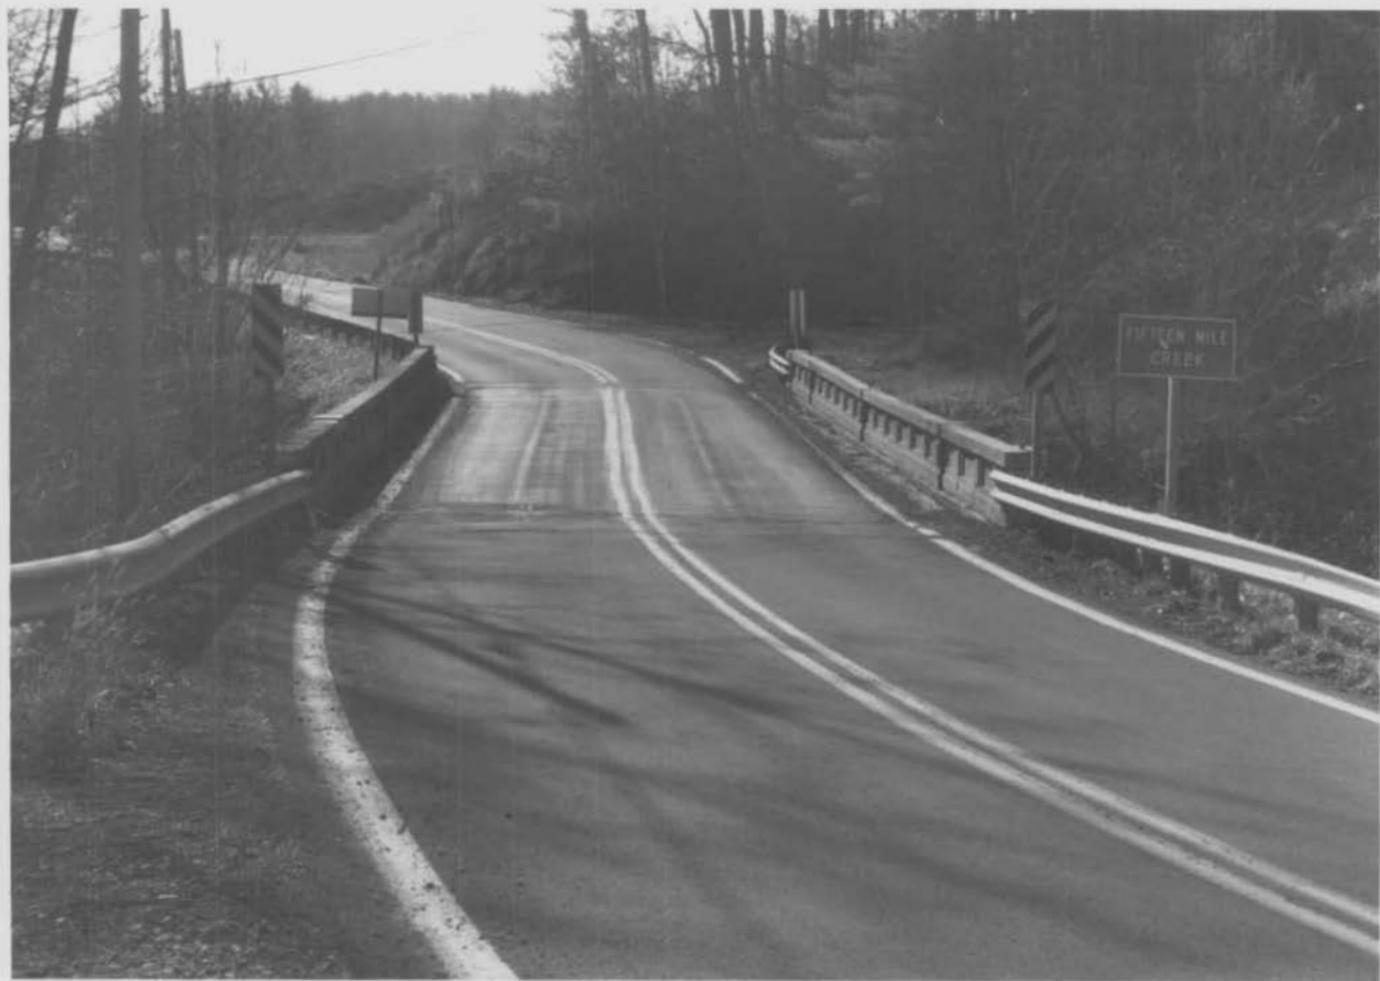
1. AL-1-A-083
2. US 40 over Fifteen Mill Creek
3. Allegany Co., MD
4. Wallace, Montgomery & Assoc,
5. 12/97
6. MD SHPO
7. Looking West
8. 4 of 4

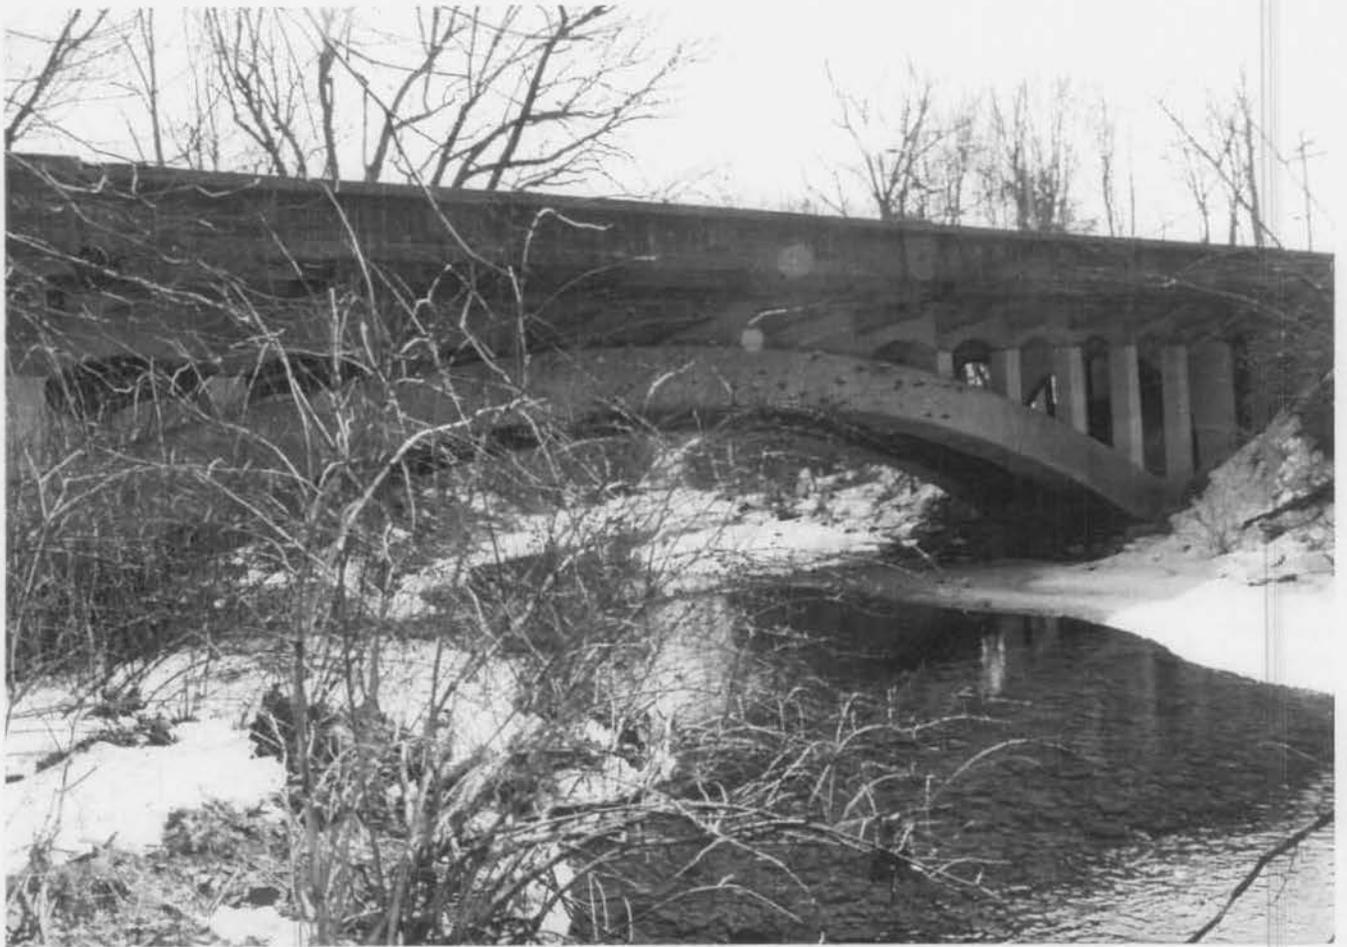
View of SHA Bridge # 1036 (AI-I-83).
