**MARYLAND HISTORICAL TRUST
NR-ELIGIBILITY REVIEW FORM**

Property Name: Wigfield Complex Inventory Number: AL-II-B-032

Project: Razing request for Wigfield log structures Agency: Maryland Department of Natural Resources

Maryland Inventory of Historic Properties Form

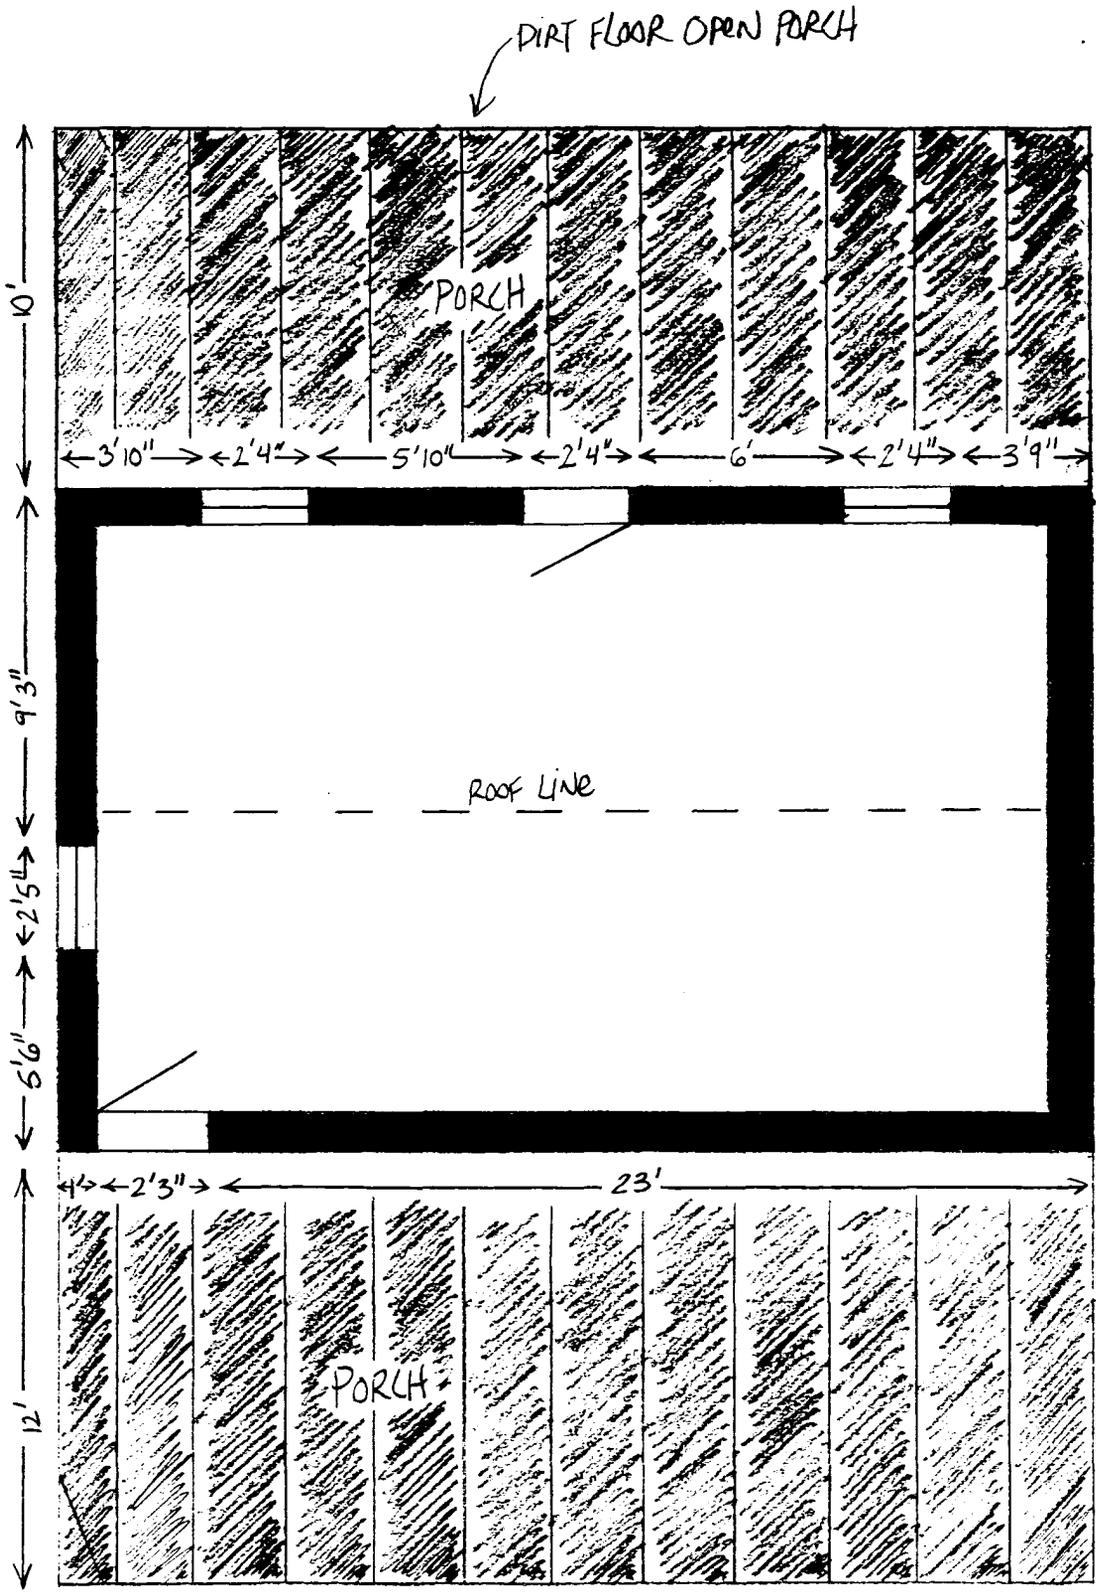
WIGFIELD LOG HOUSE, WAGNER ROAD, AL-II-B-032

- • 2 STORIES TALL
- • LOG STRUCTURE
- • WOOD CHINKING
- • TIN ROOF (REPLACEMENT?)
- • 1 ROOM / 1 ROOM

DIRT FLOOR OPEN PORCH

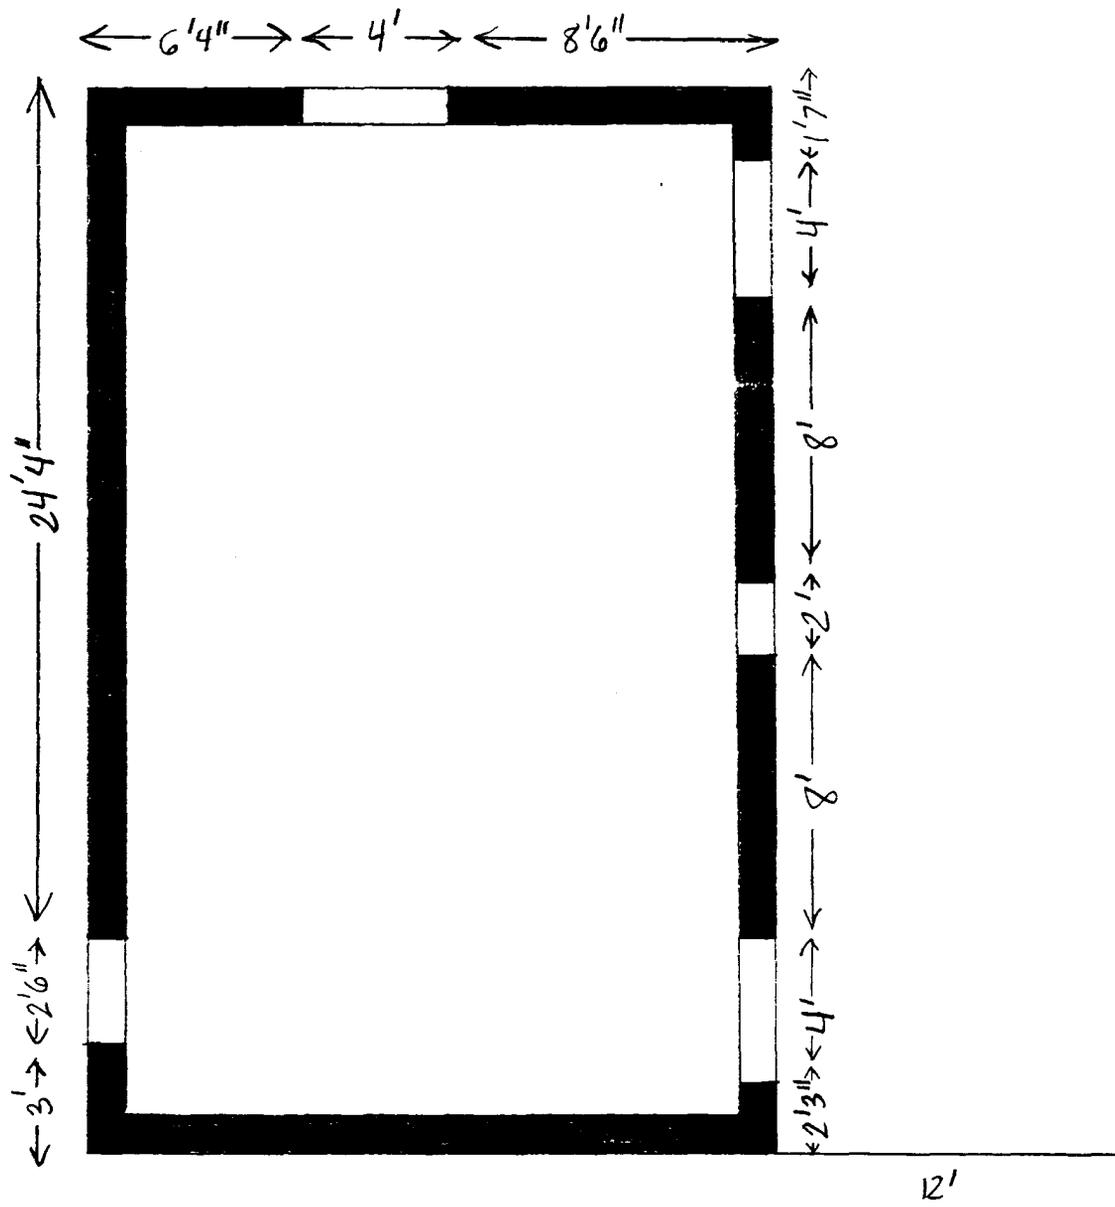
WIGFIELD LOG HOUSE, WAGNER ROAD, AL-II-B-032

LOG BARN RUIN

- • NO ROOF
- • LOGS DETERIORATING
- • NO CHINKING LEFT
- • PREVIOUSLY USED AS LIVESTOCK BARN

The log barn located approximately 150 feet away, however is not in good a condition as the frame barn, due to the loss of the roof. Overall dimensions are 19 feet by 30 feet and just like the log house the logs on this barn have been constructed with V-notching. They are spaced closer together than the house and there is no evidence left of any sort of chinking used. Vertical siding covered the log structure, however most of this has deteriorated away. It appears as though the barn was only one story tall, however on the south elevation there is a remnant of a wooden ladder so the structure may have had a loft. The interior appears to have been only one room. There are various doors and windows on the structure that have been boarded up.

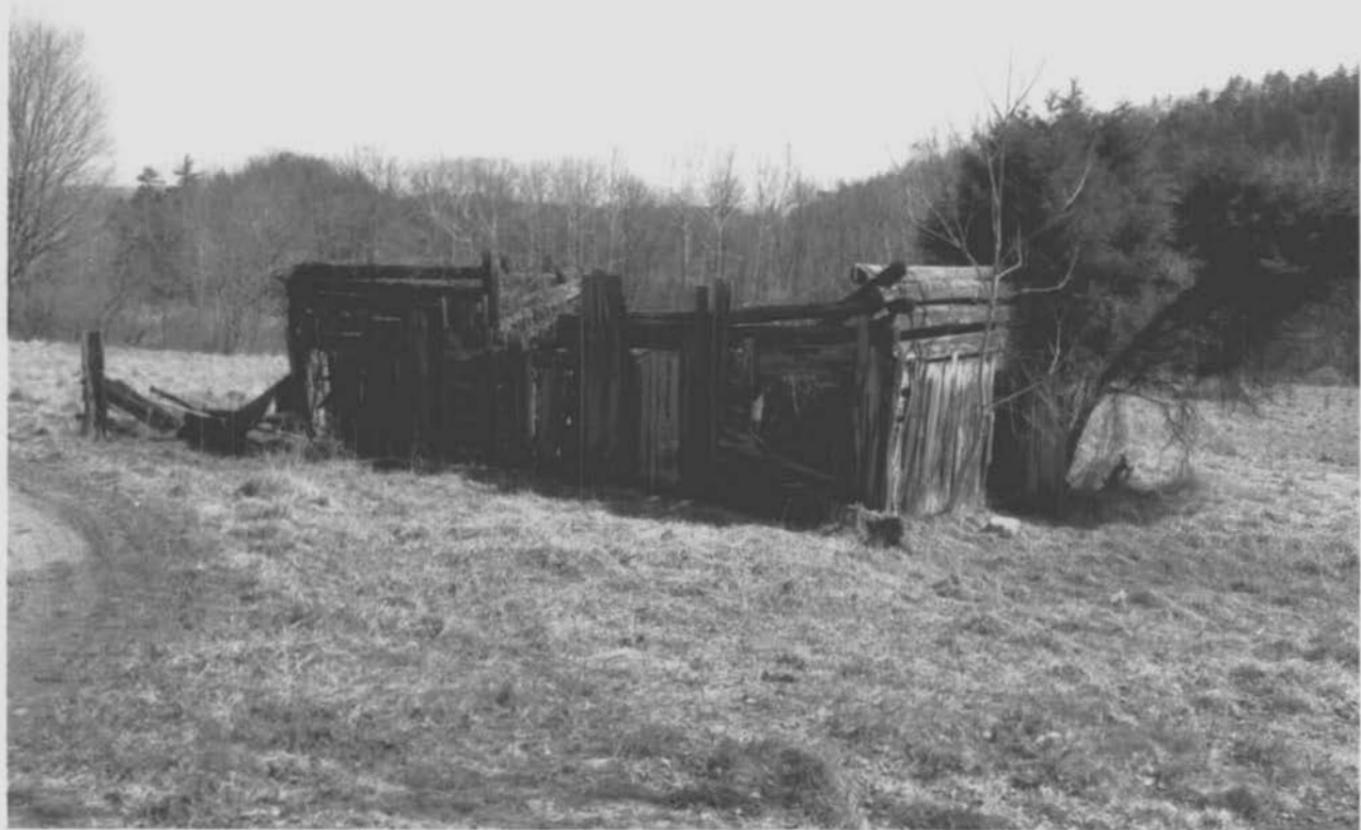
1 OF 6

Co's House, NORTH FACADE

The north elevation is a gable end and consists of one window on the first floor located directly under a window on the second floor. Window trim is minimal and crudely constructed, and the sashes have all been removed. In a previous inventory form completed in 1976 it was stated that the only remaining window contained 6/6 lights. The gable has wood siding laid vertically.

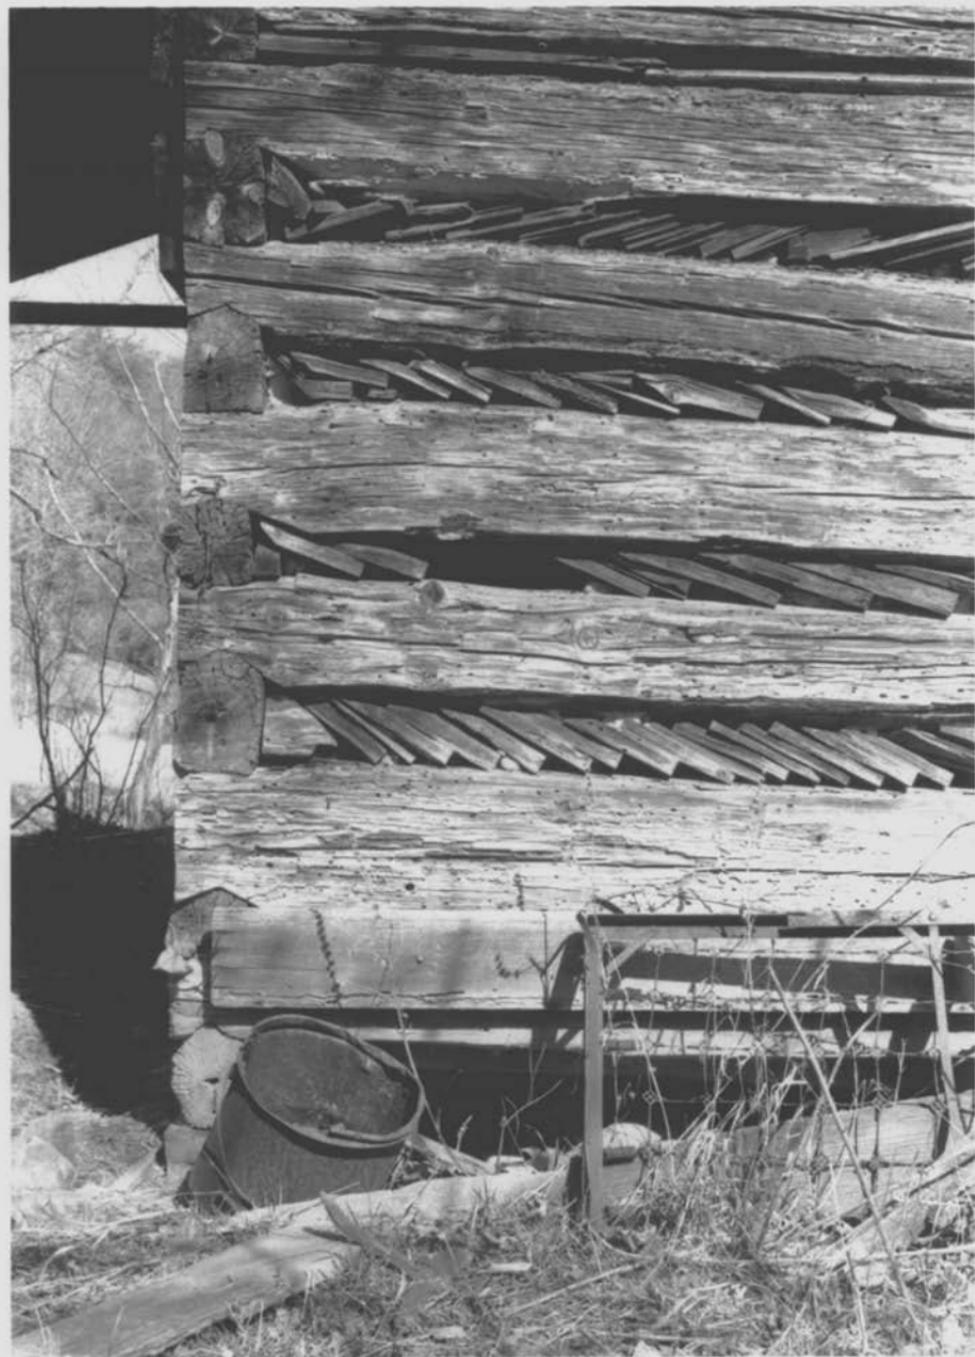
WIGFIELD LOG HOUSE

The Wigfield Log House represents one of Allegany County's older log structures that has been left to deteriorate. Hewn logs compose the walls, which rest directly on the ground. Dovetail notching was used to pin the corners together on the house. Windows and doors have been removed to facilitate the present usage as a cattle shelter.

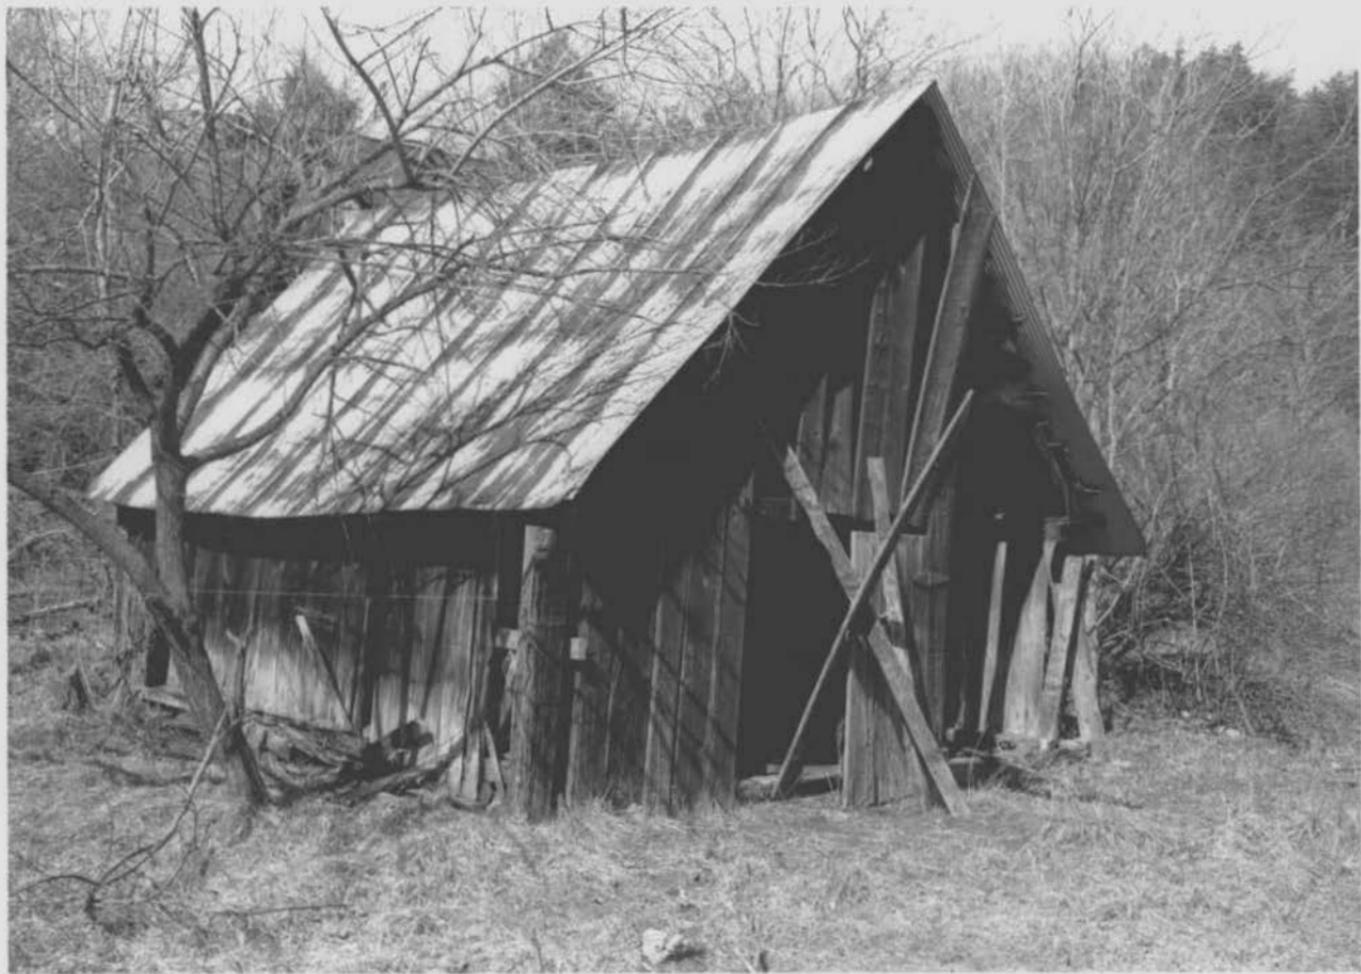
3 of 6

LOG HOUSE, NORTH FACADE

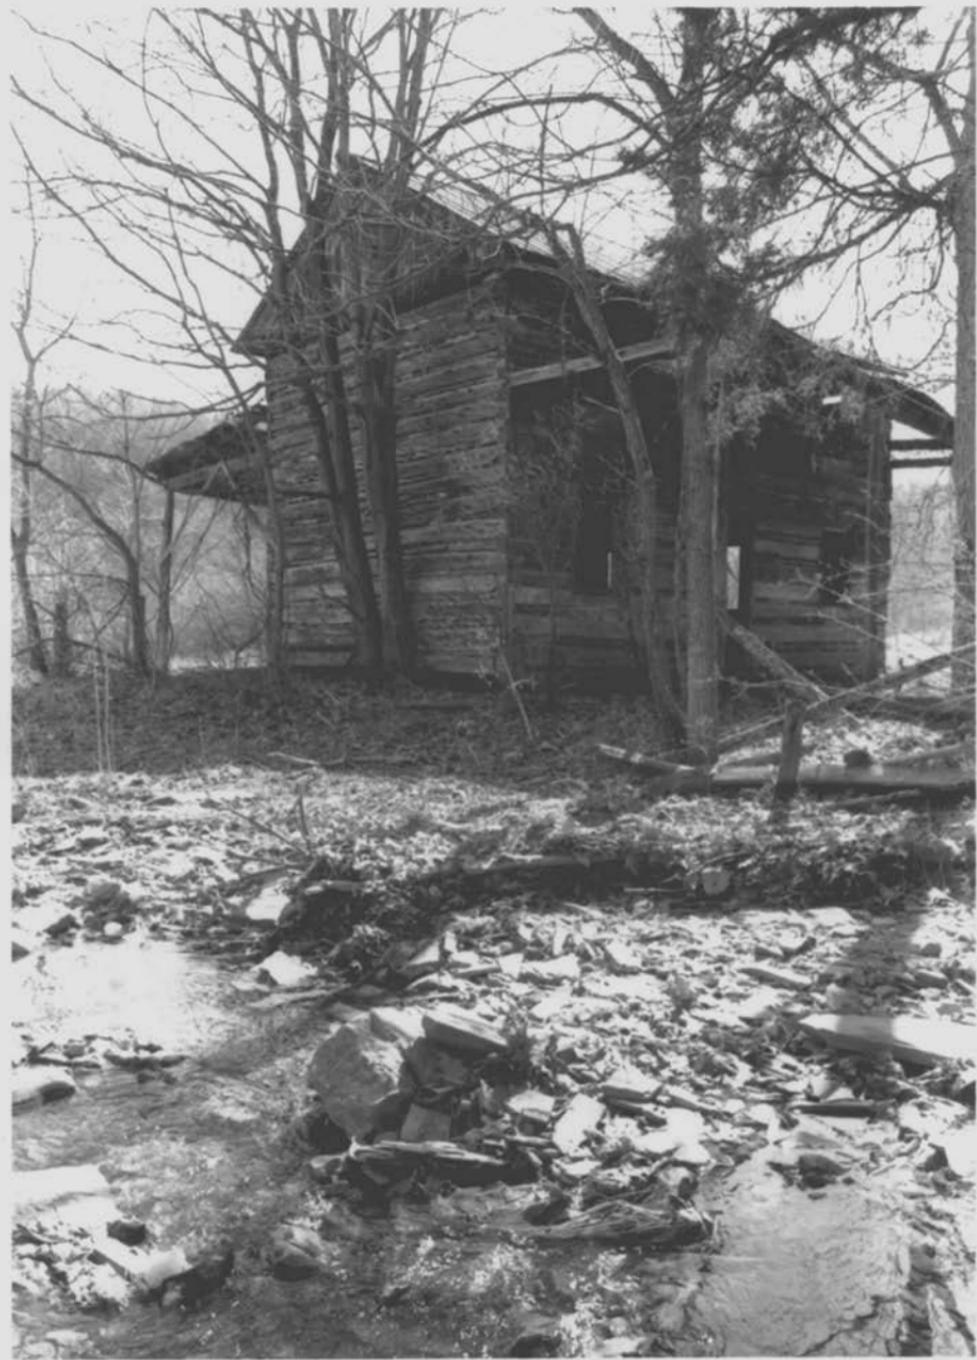
4 OF 5

FISH & BIRD, 1. EAST

The east elevation is the front elevation and consists of two windows on the first floor with a door between them, and three windows located directly above these on the second floor. A porch extension which extends 10 feet out from the facade is not enclosed, but provides some protection from the elements. It is held up with log posts, however the flooring has deteriorated leaving just a dirt floor underneath. The porch roof forms a catslide roof as it extends from the main structure.

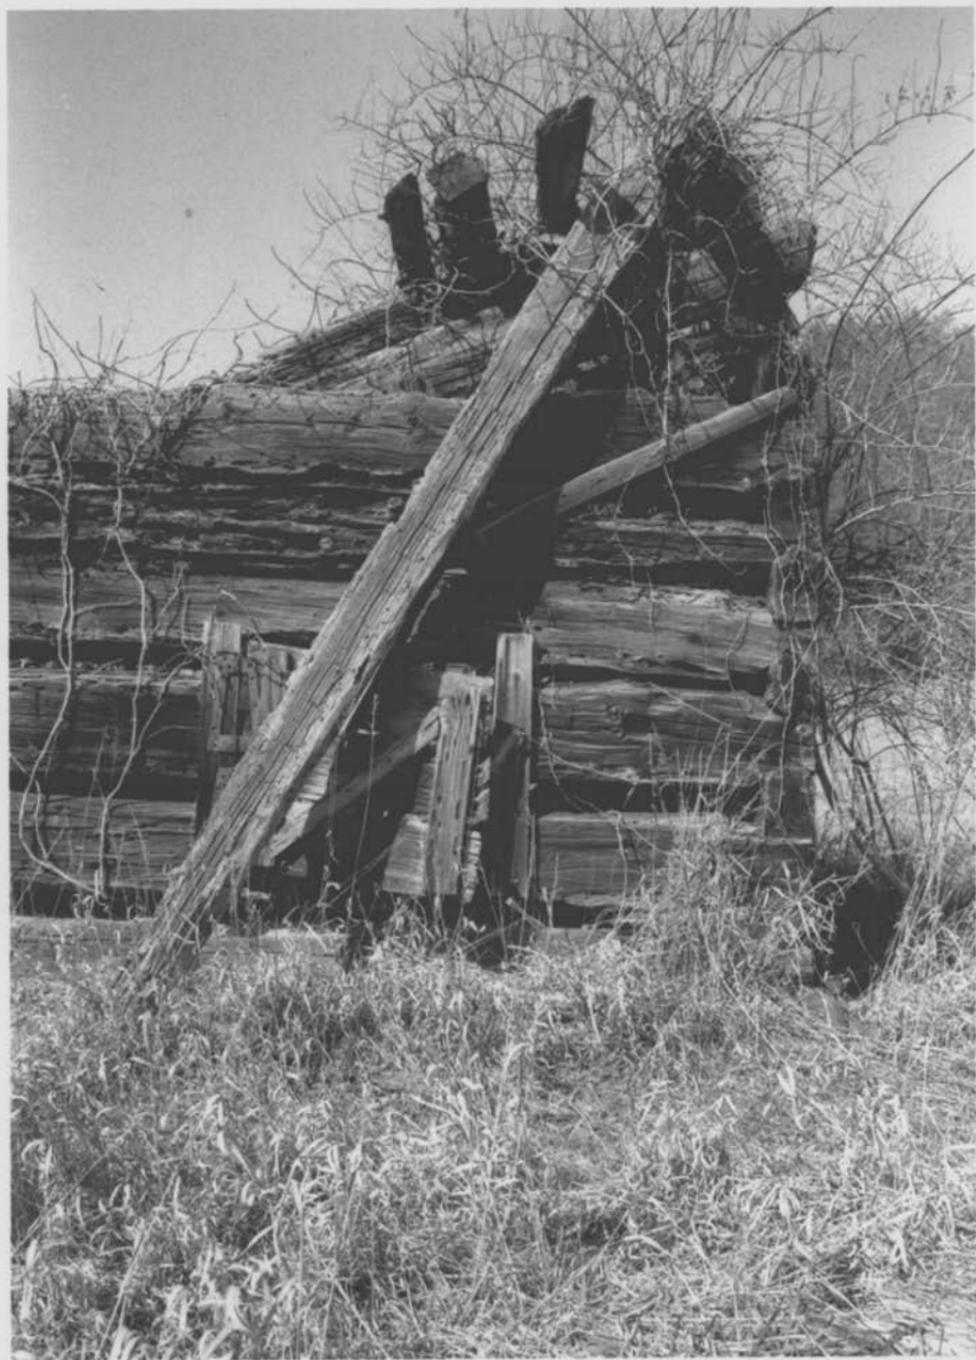
5 OF 6

Log House; SE F-10-1105

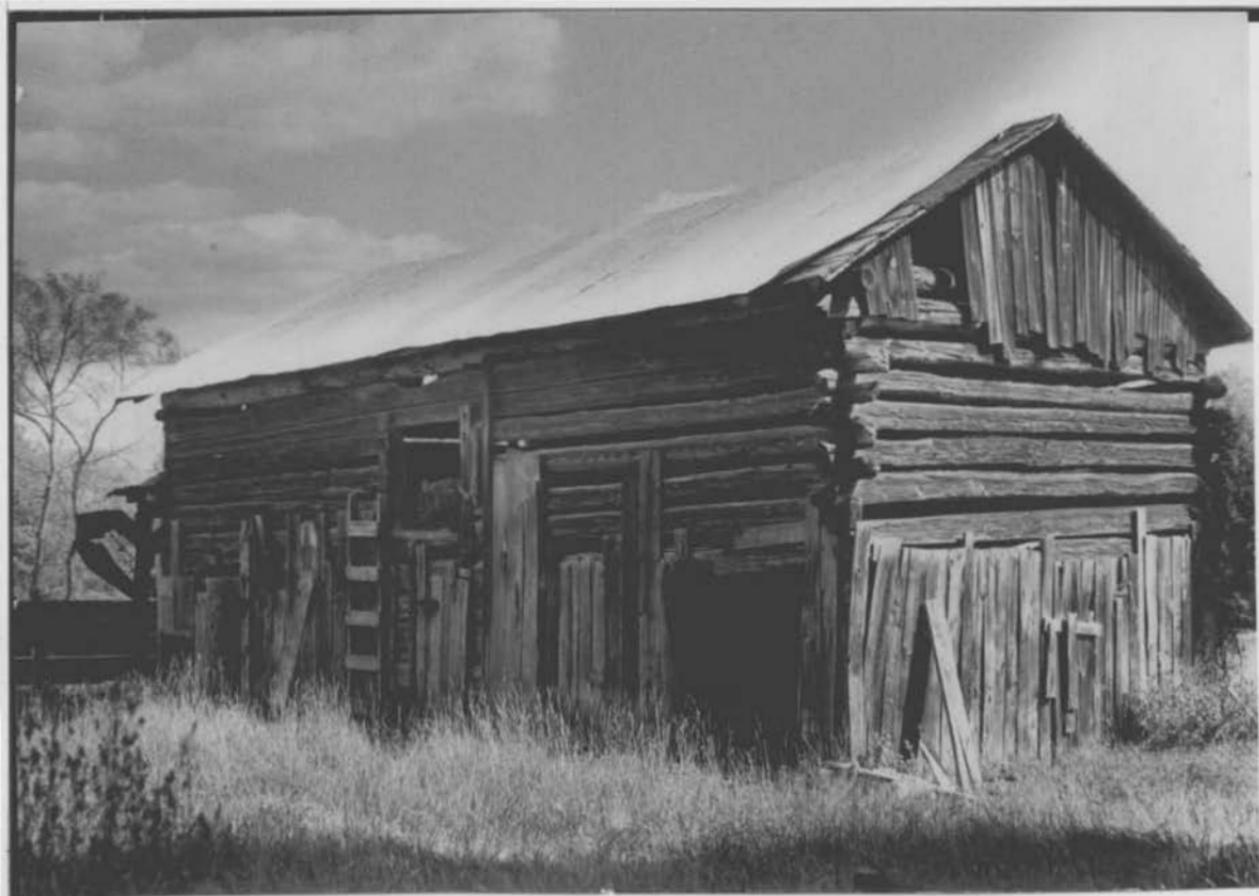
Wigfield Log House (Barn)

Northeast
