DRAFT--POTOMAC HIGHLANDS ORCHARD

ADDENDUM 1979 SURVEY FORM

State Historic Sites Inventory Form

HISTORIC Potomac Highlands Orchard
AND/OR COMMON

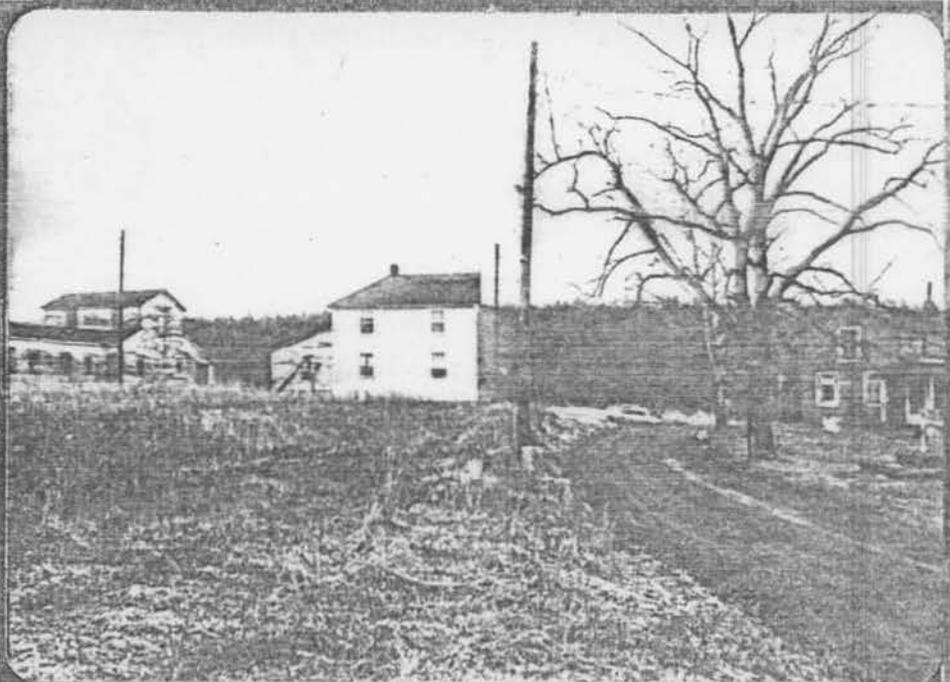
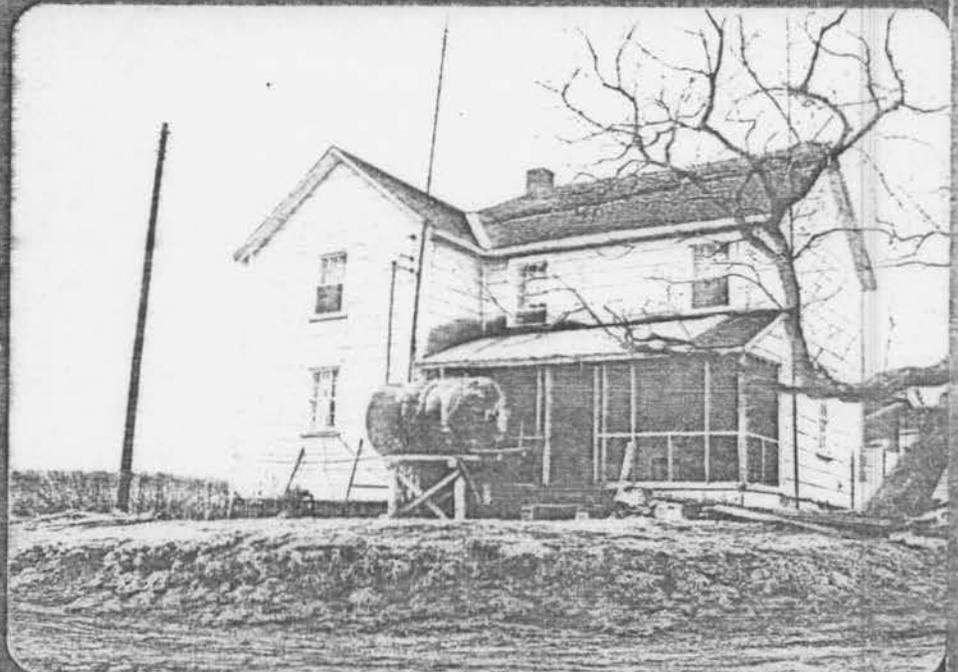
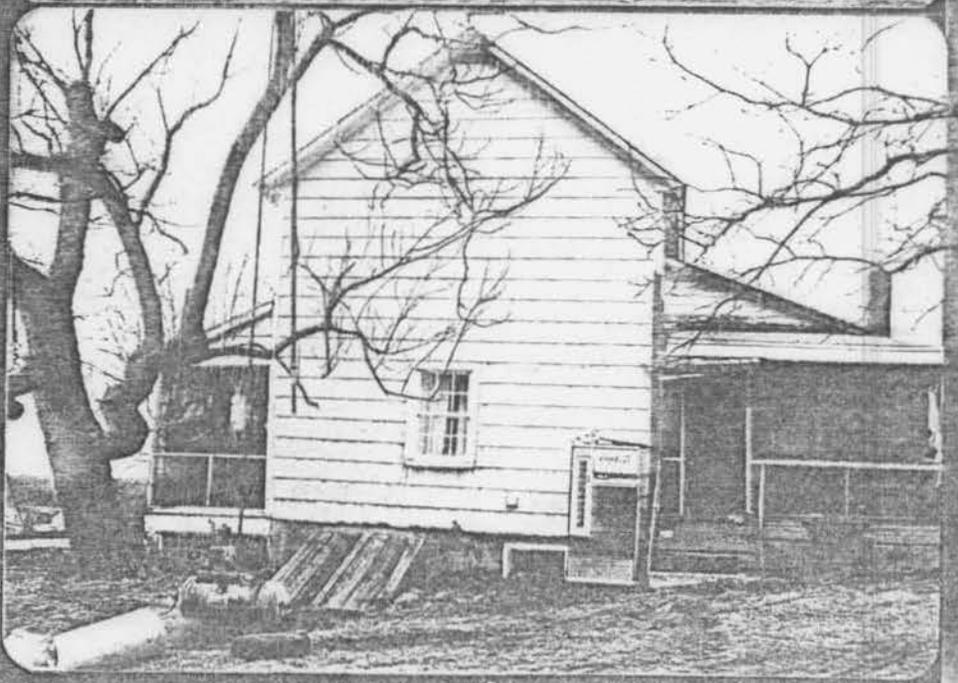
46-II-B-129 Potomac Highlands Orchard
bp - View from West
center - House No. 9 - South facade
bottom - " " East facade

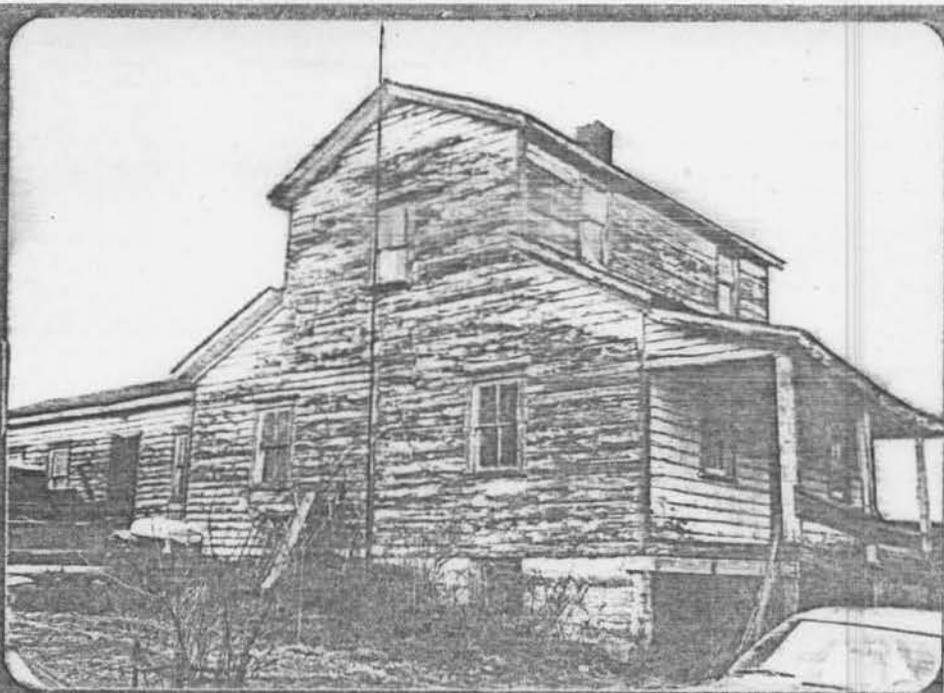
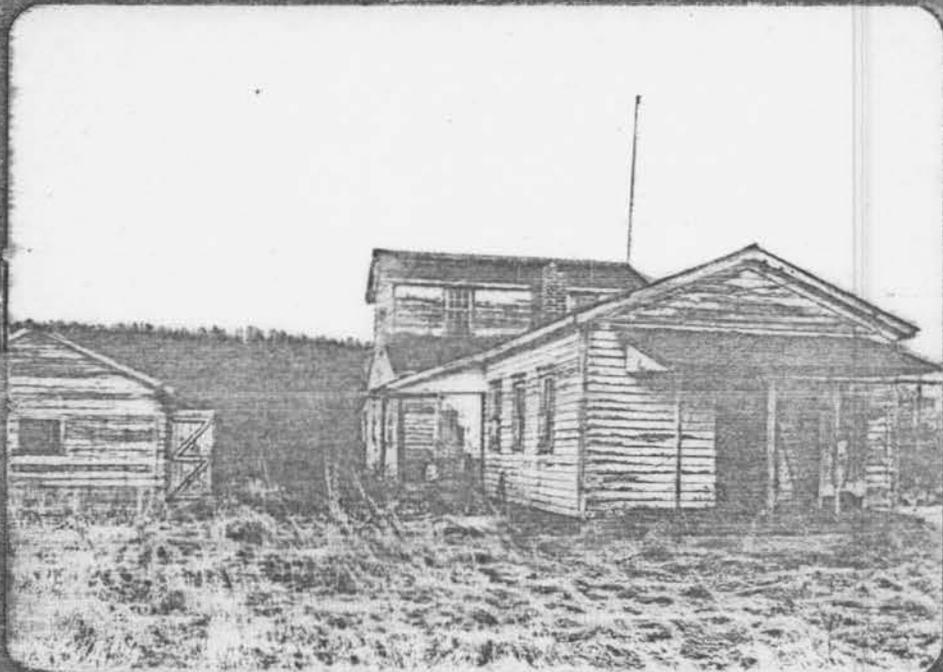
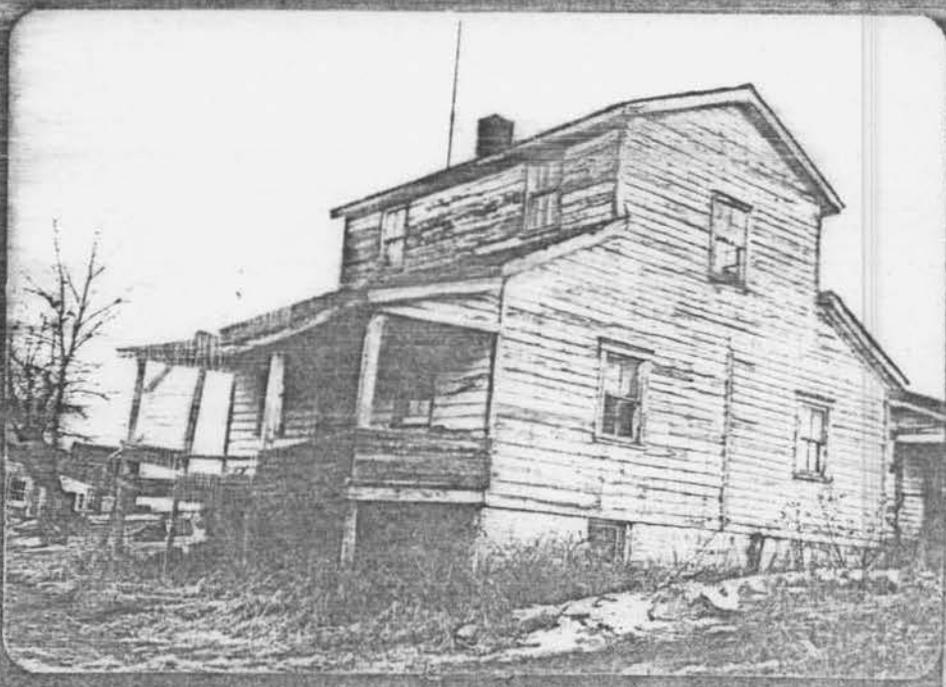
44-II-B-129 Potomac Highlands Orchard

top - House No. 5 East & South Facades
center - " " North & West Facades
bottom - " " East & North Facades

House #5 is a two story, three bay wood sided structure with an enclosed shed roof extension along its west wall. To this is added a one story, five bay wing. The entire structure rests on concrete block foundations. This house is still in use as a residence and is in fair condition. Windows in the main section have six over six pane sashes. The one story addition has two over two pane sashes with architraves with molded top pieces.

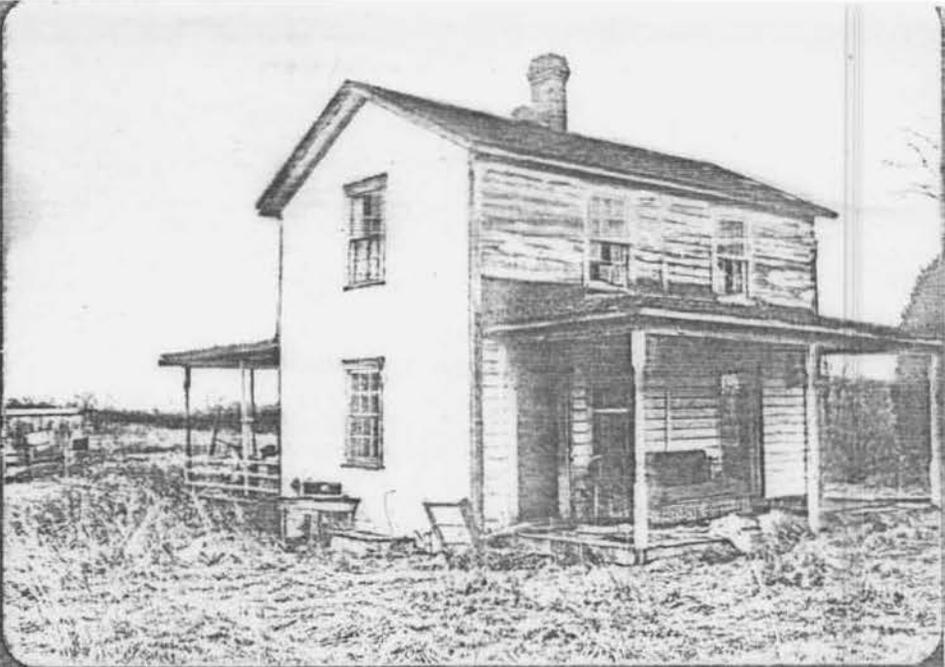
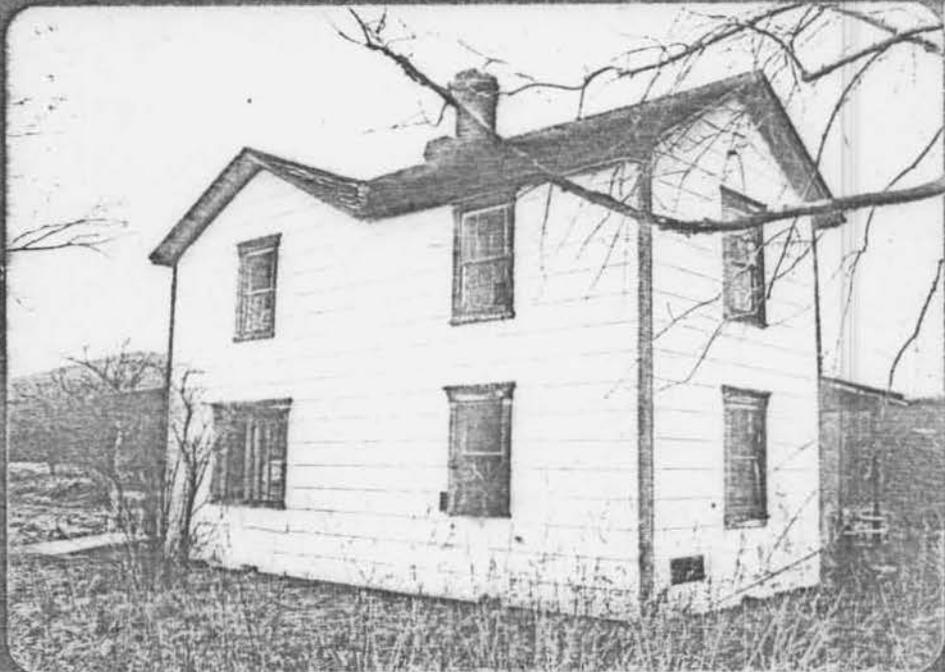
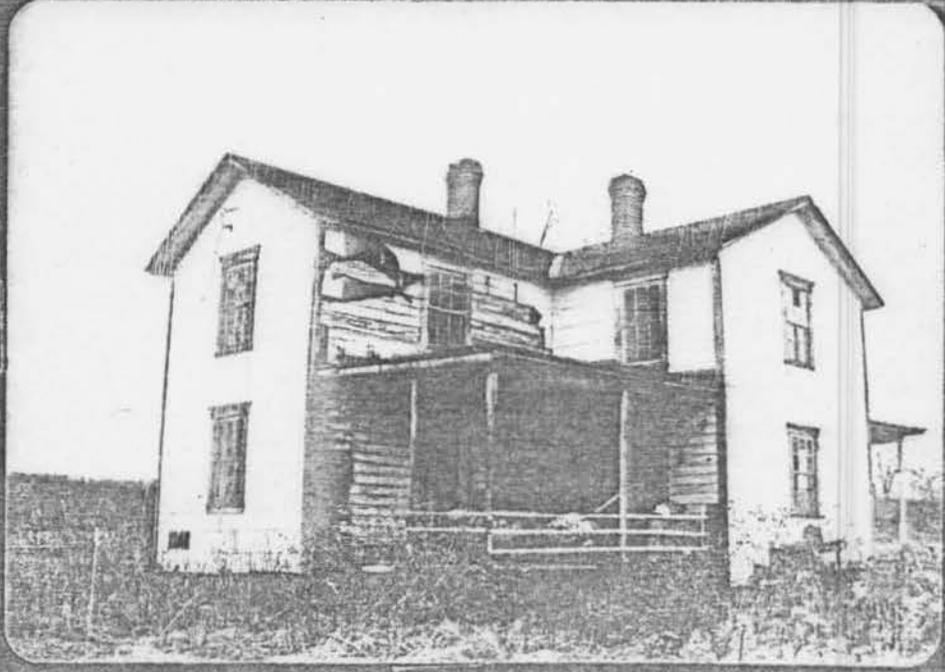
Two-Story Frame House With L-shaped Plan. This structure is located west of the other structures. It is a small frame house. The exterior is covered in wood siding with an ~~asbestos~~ ^{abestos} siding from the gable ends. This structure contains more ornamentation than the other houses in its window frames and interior woodwork. It is a three-bay by one-bay structure with a one-bay ell. The main facade has entrances in the outer two bays and a six-over-six window in the center bay. The second story has two windows with six-over-six sash. The window frames throughout the structure have molded board frames and a serpentine lintel. There is a full-length, one-story front porch with turned posts. The east gable end has a six-over-six sash window on each story. The west gable end has a double-window on the first story and a six-over-six window on the second story. There are also similar windows on the first and second story on each facade of the ell. On the inner side of the ell is a one-story porch with trim similar to that on the front porch. The structure has corner boards and a box cornice. The interior had a center partition~~ed~~ wall with a boxed-in stair rising along the east side of the partition~~ed~~ wall. The interior wood trim includes window frames with molded frames and corner blocks. The structure dates from the early twentieth century.

AL. II. B. 129 Polkma Highlands School
 top - Frame House North & East Facades
 center - " " West & South Facades
 bottom - " " South & East Facades

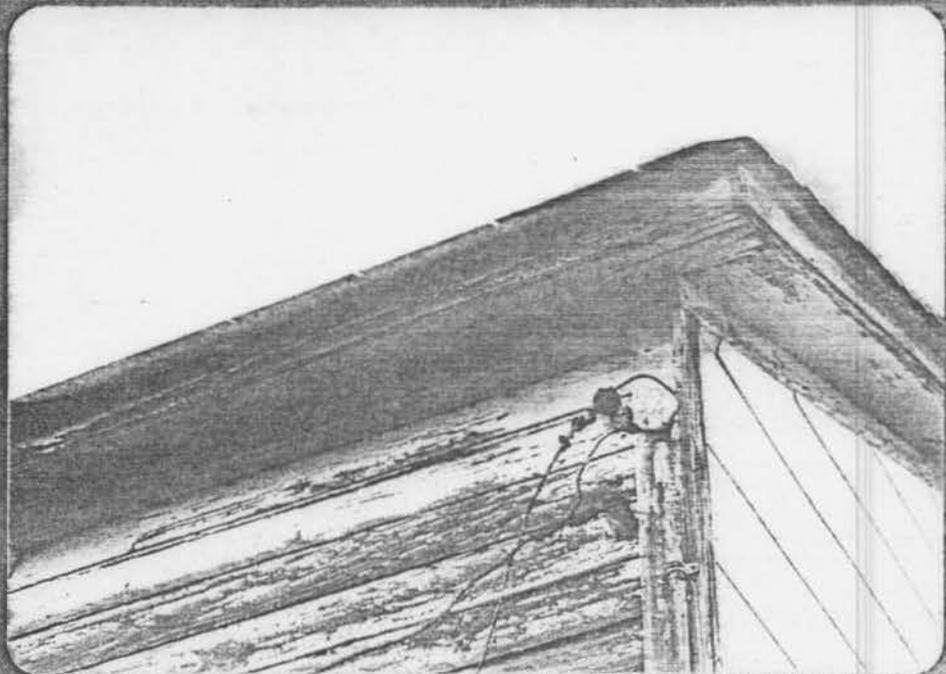
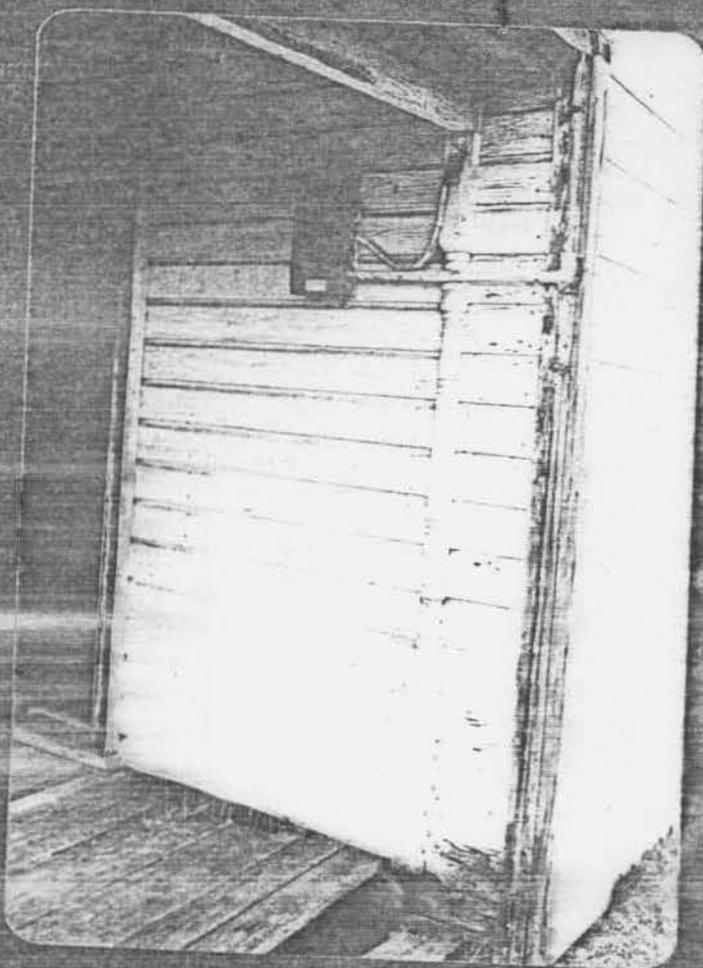
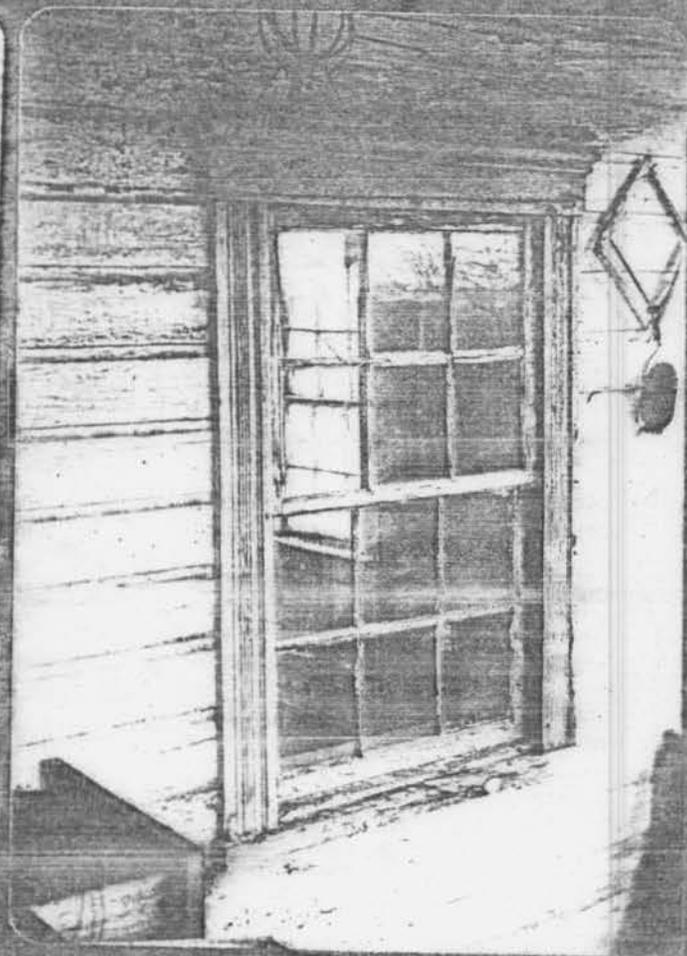
AL-II-B-129 Potomac Highlands Orchard
 top- Frame House Cornice
 bot. left- " " Porch Detail
 bot. right- " " Window Frame

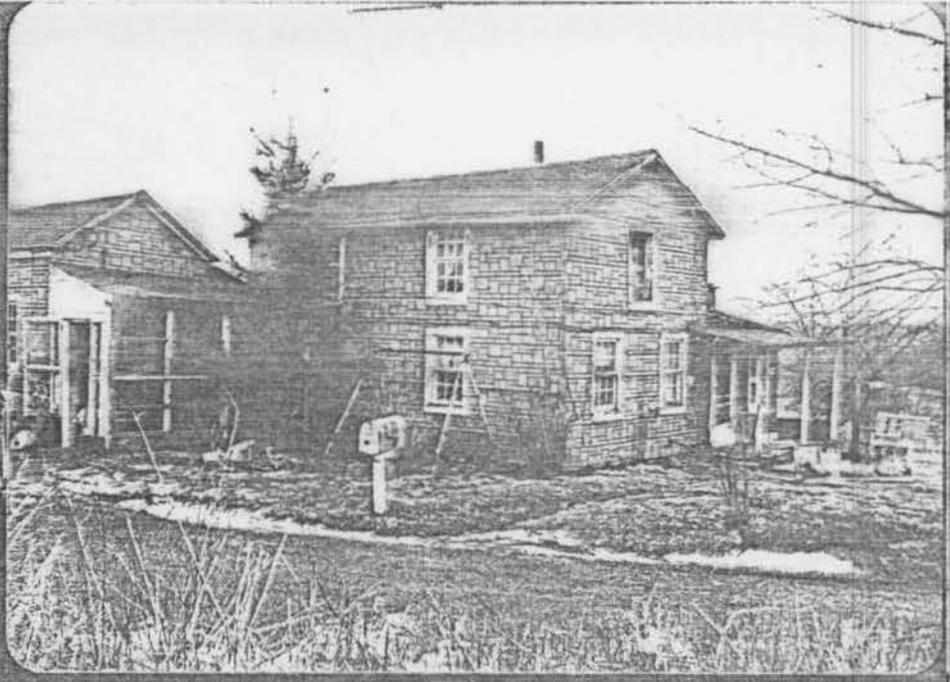
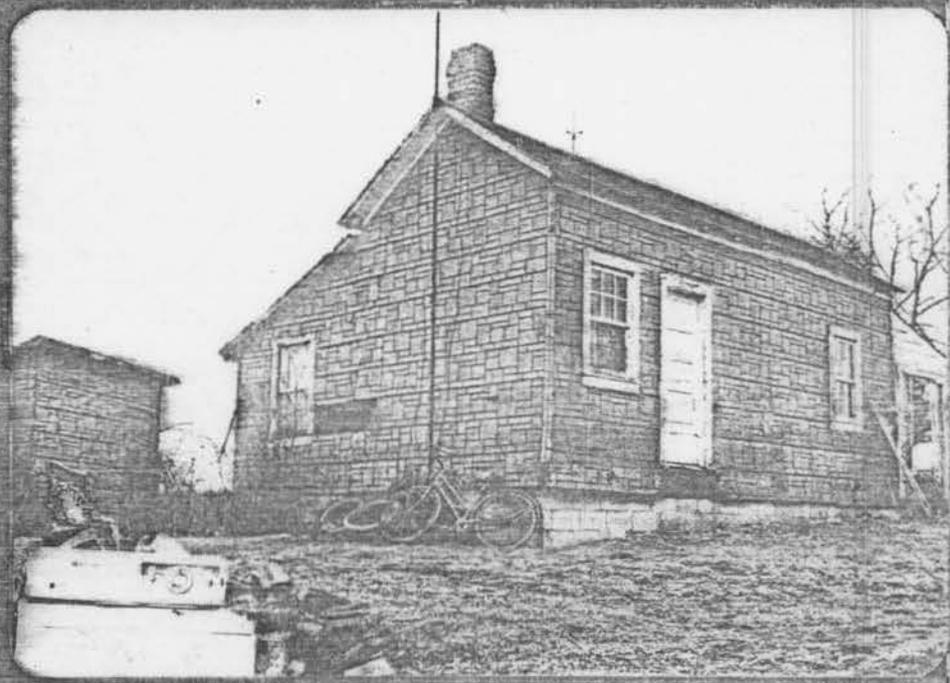
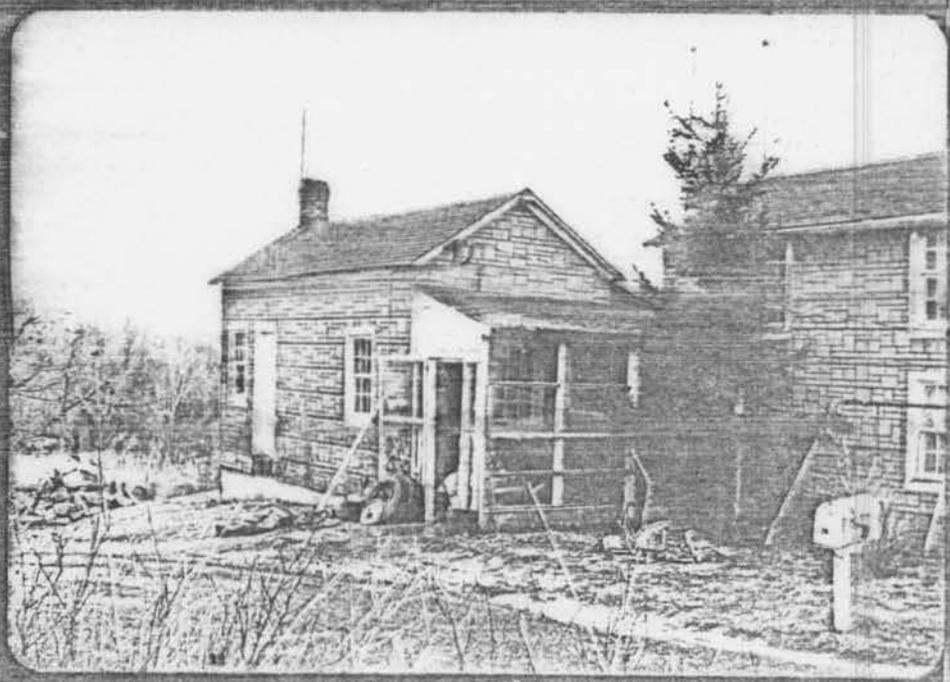
At-II-B-129 Potomac Highlands Orchard
 top - Attached Houses - West House
 East side - " " East House
 West side - " " East House

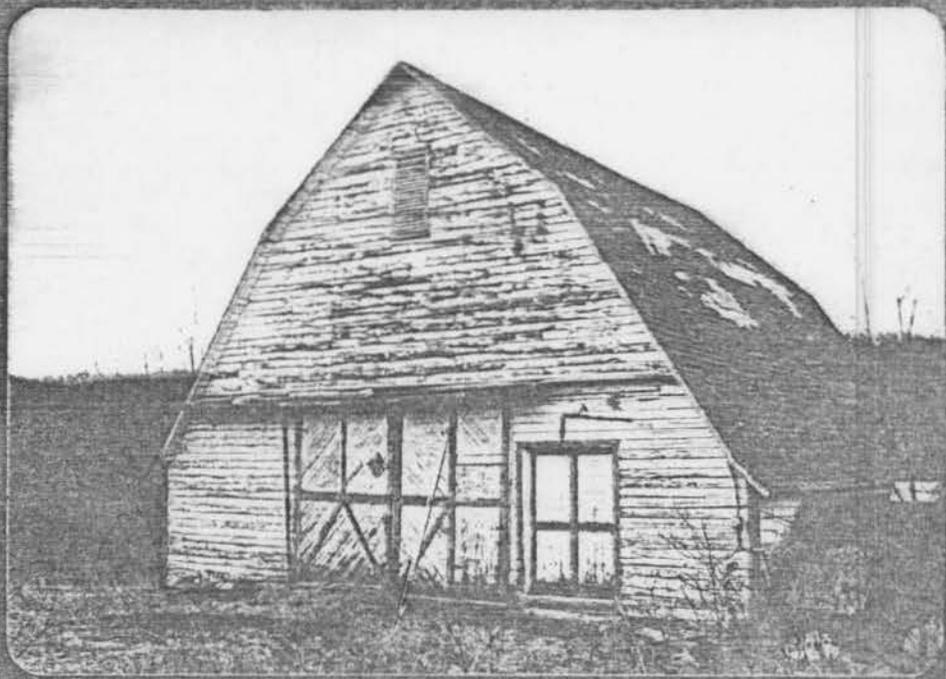
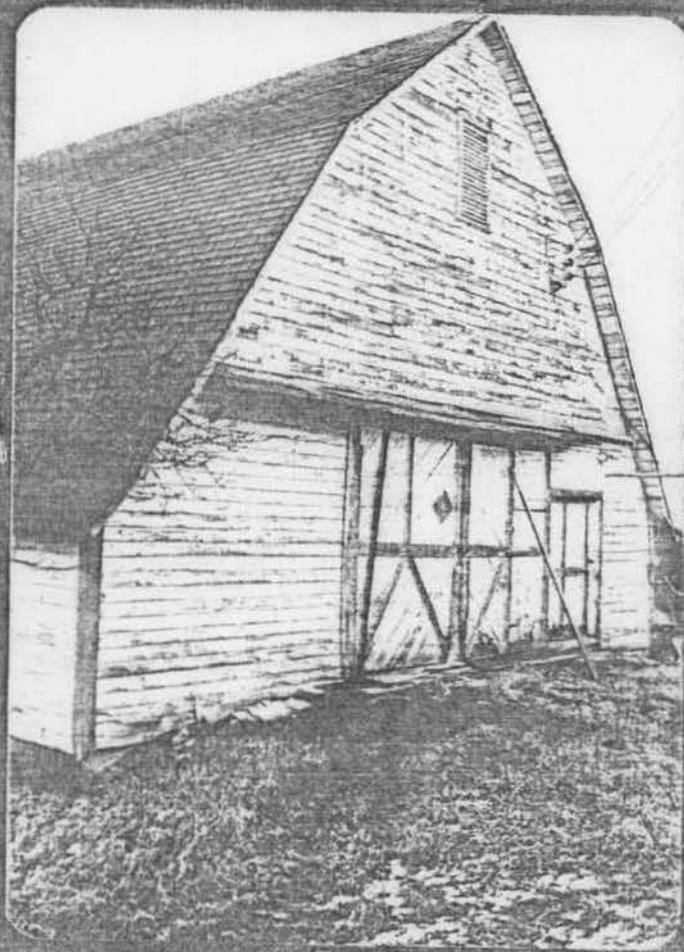
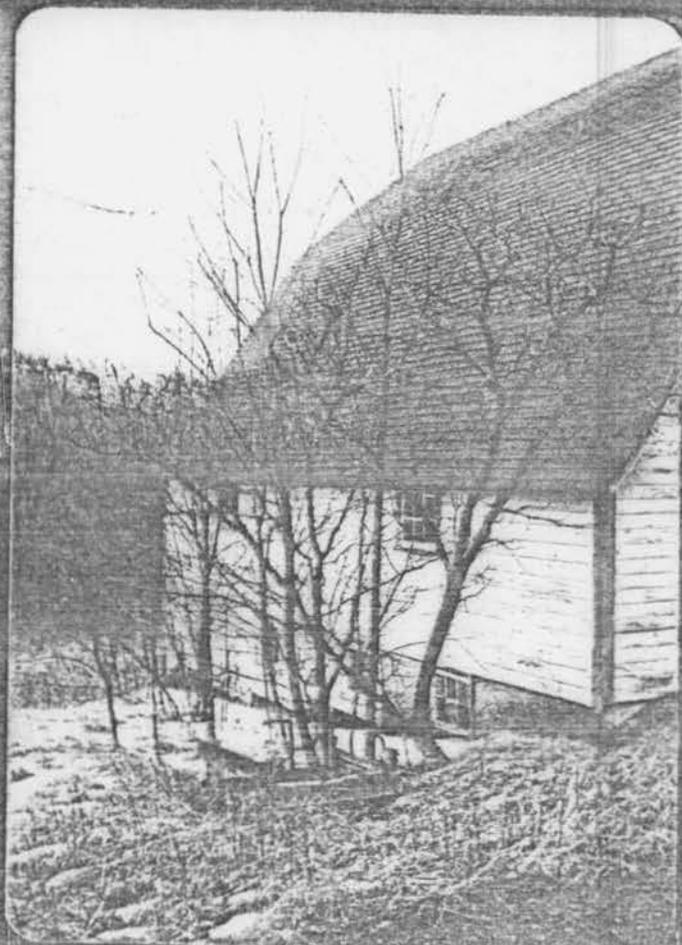
Gambrel-roof Barn. The gambrel-roof barn is constructed into a slope and has a one-story wing on its south side. One gambrel end is located on the west side where there is a large double door wagon bay and one entrance. A ventilator is located in the gambrel. The east gambrel end has a foundation level barn door with asymmetrical pattern of windows spaced along the facade.

L-II-B-129 Potomac Highlands Orchard
 top Gambel Roof Barn Sides West Facade
 left " " West Facade
 right " " North Facade

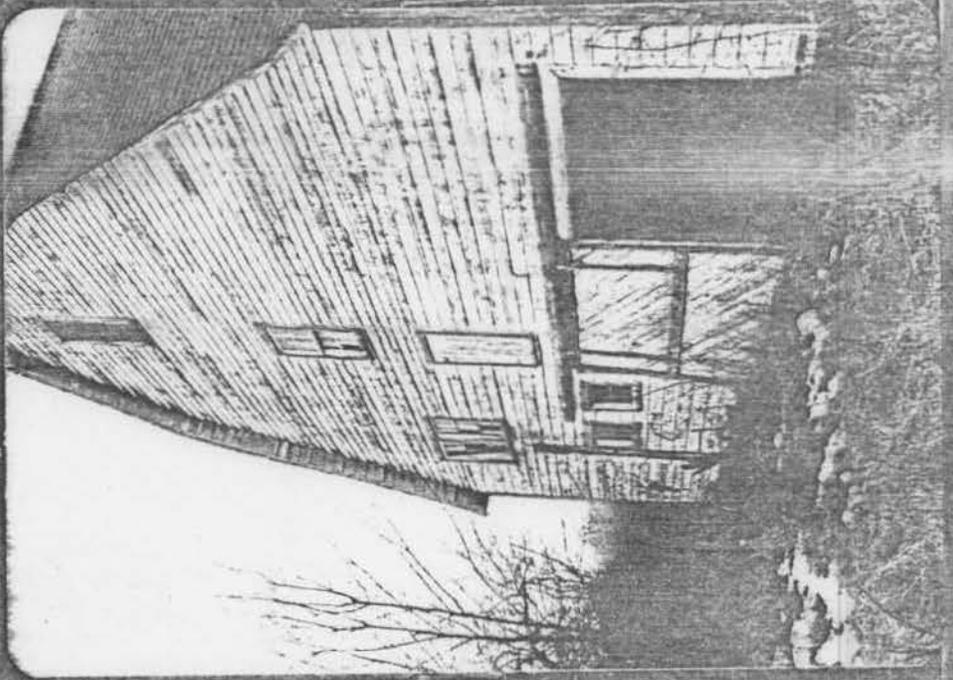
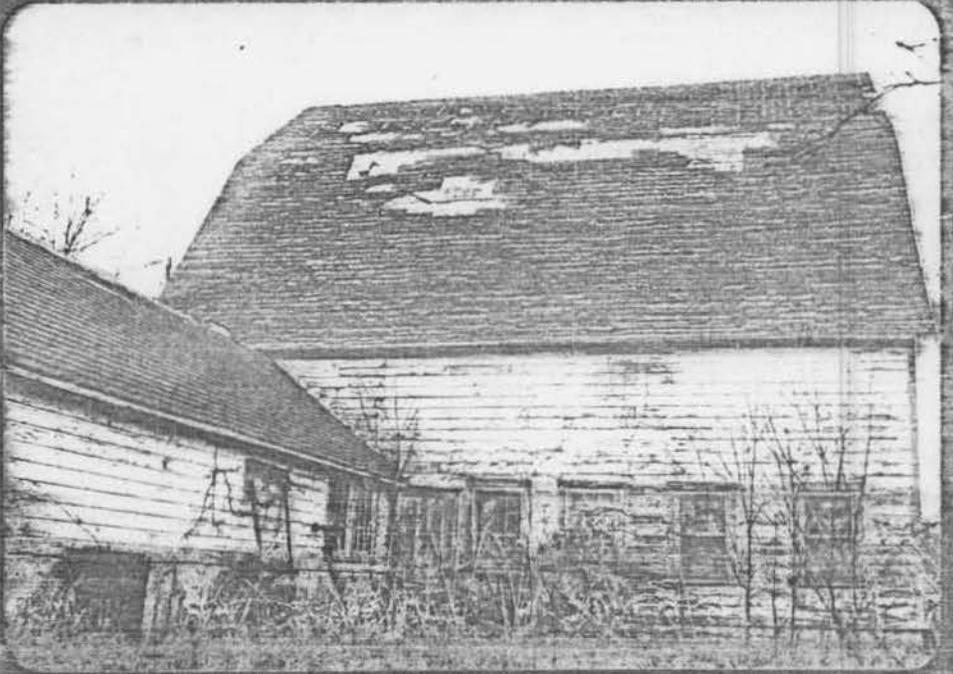
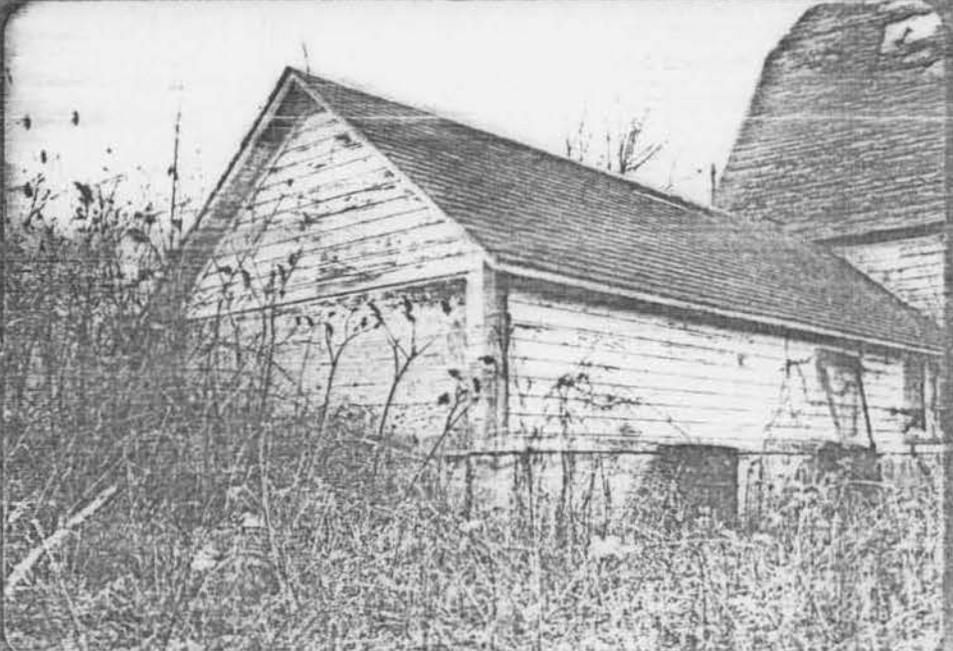
ALB-129 Potomac Highlands Orchard

There are two six-pane windows on the foundation level. There is a door and a double window on the first story. There is a six-over-six sash window located above the door and there is a ventilator window in the gambrel. The barn is constructed of frame and covered in wood siding. The gambrel roof makes a sharp projection out at its lower ends. On the south side of the structure is a one-story wing with a gable roof on a poured-concrete foundation. The barn is painted in a white and green color scheme. The interior indicates the barn was used mainly for storage of machinery for the apple processing operation. The barn dates from the early twentieth century.

top -	Gambrel-Roof Barn	East Facade
center -	" "	South Facade
bottom -	" "	South Wing

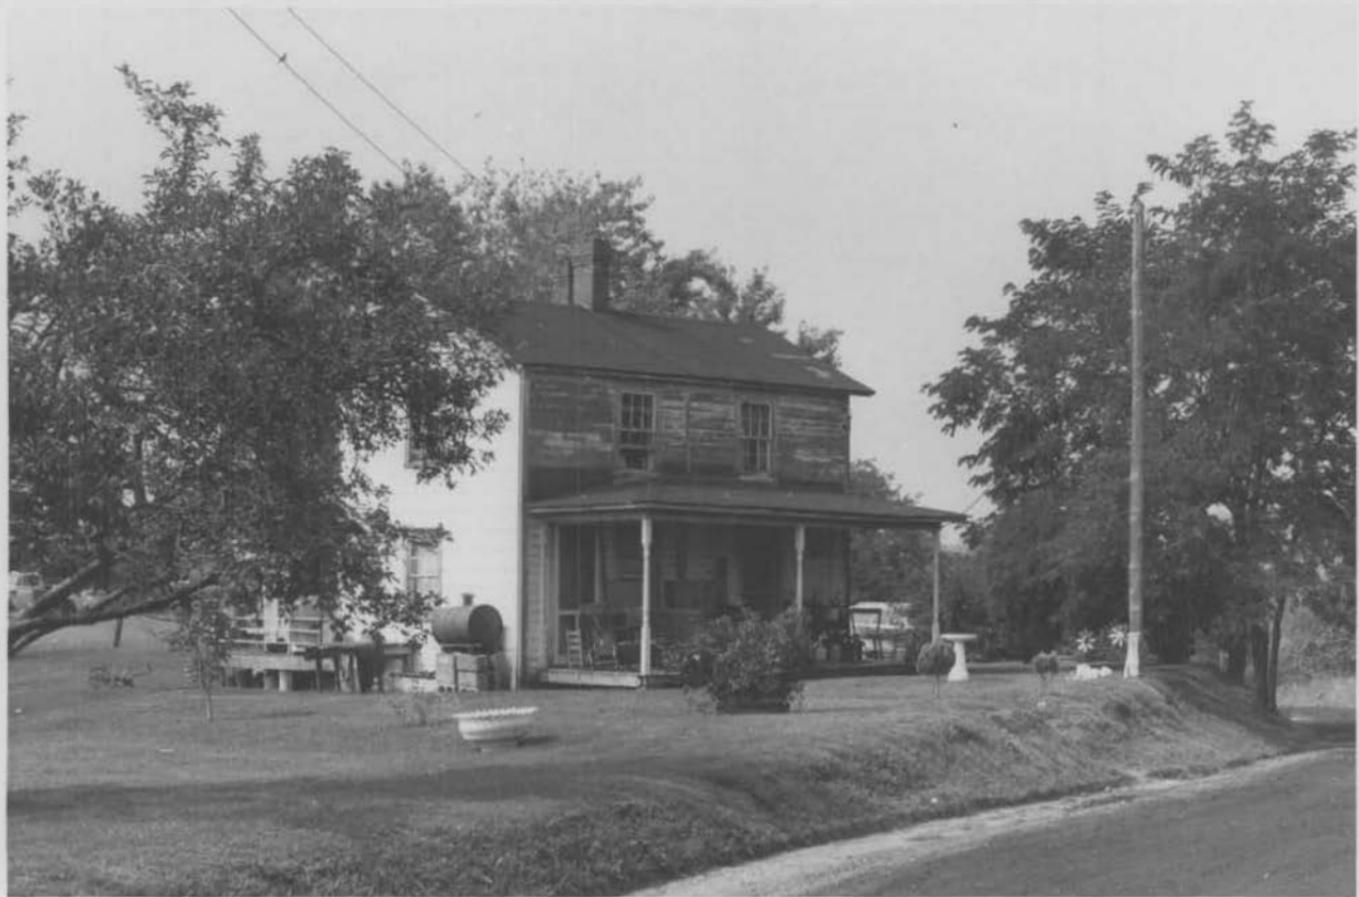
Ah-II-B-129

Another building in the complex is a multipart one story frame house on concrete block foundations. It is sheathed with composition siding and has windows with six over six pane sashes. Also present is an L-shaped two story, three bay German sided house with six over six sash windows and a side front entrance. A small barn with a steep gambrel roof stands at the south end of the complex.

Frame house

S.W. View

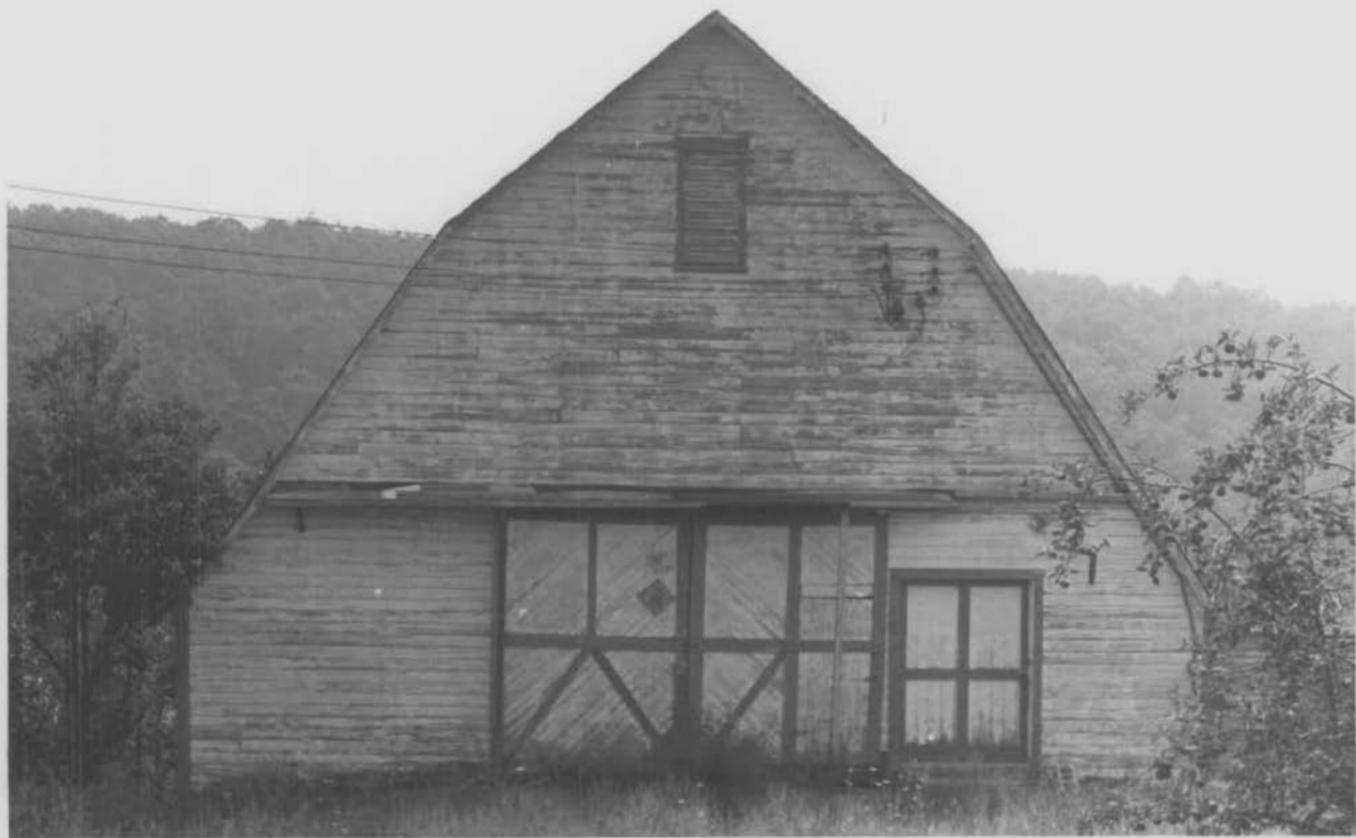
AK-II-B-129

Barn

E. View

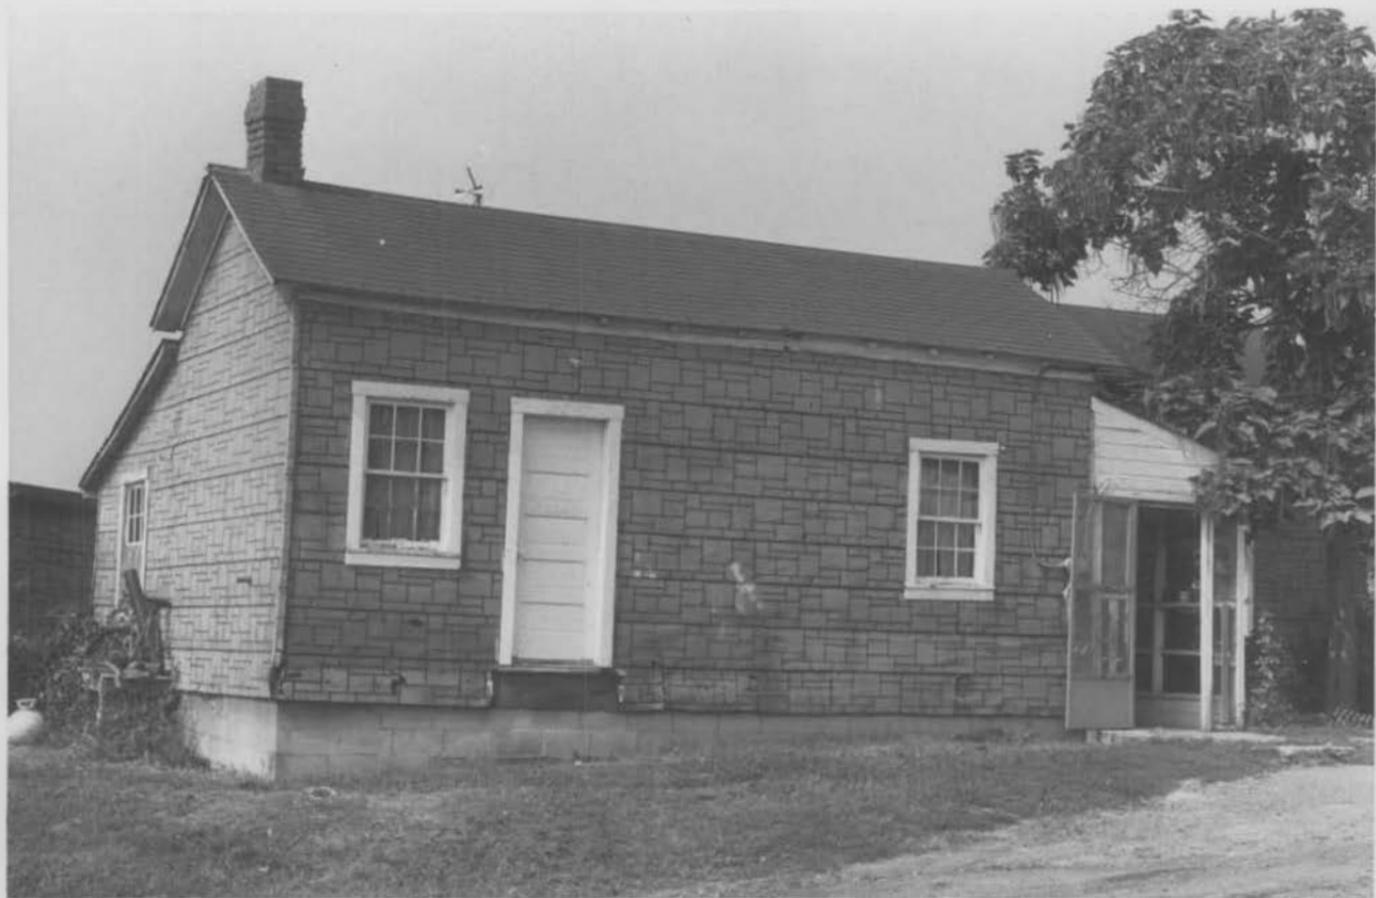
AL - II - B - 129

Frame house

Sw. view

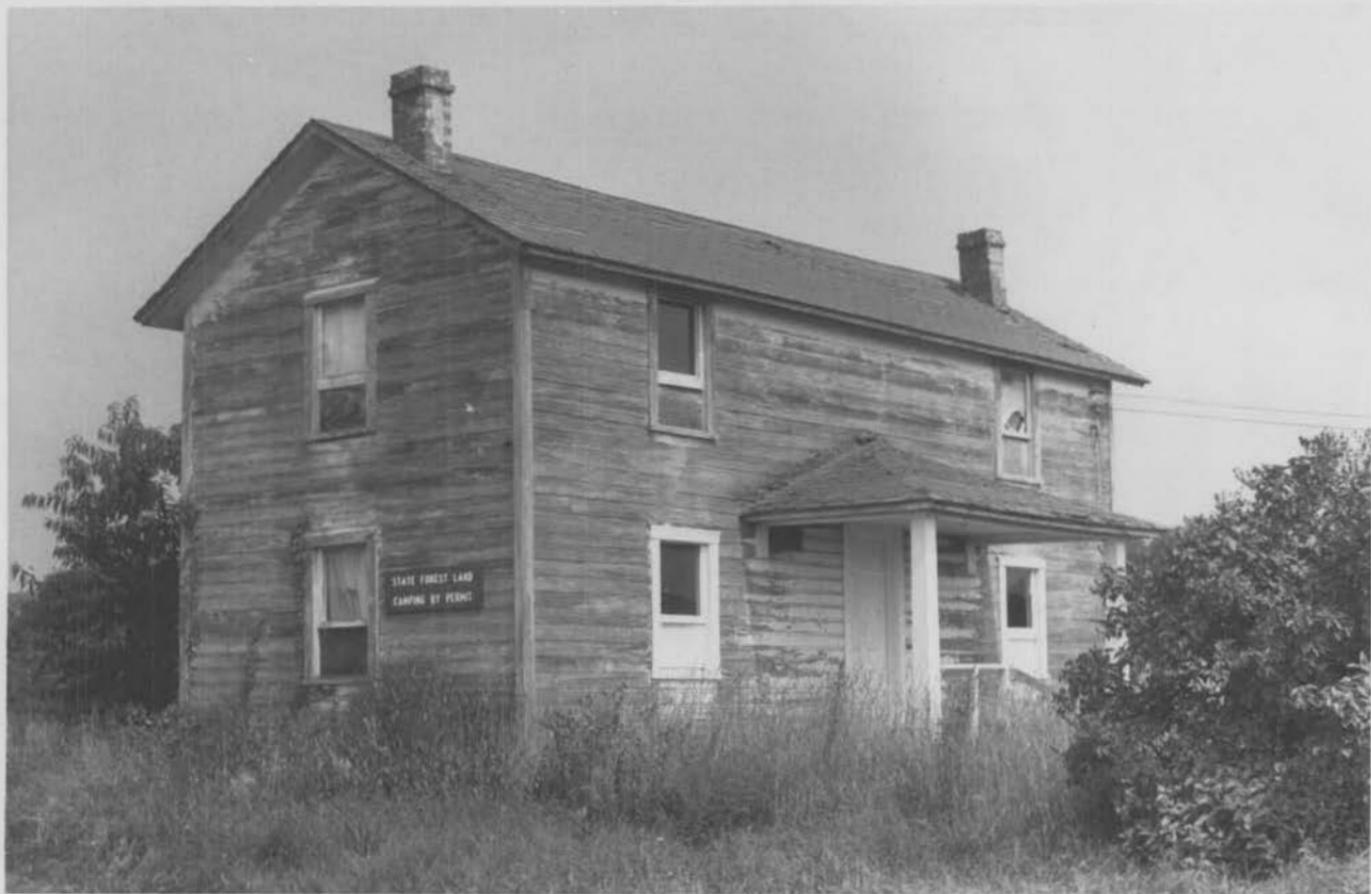
AL-II-B-129

Wilson Cottage is located several hundred feet west of the main complex. It is a two story, three bay residence, now vacant. Sheathed with German siding, it rests on concrete block foundations. Windows have been partially boarded shut. The central front entrance consists of a four panel door without a transom.

Wilson Cottage

N. View

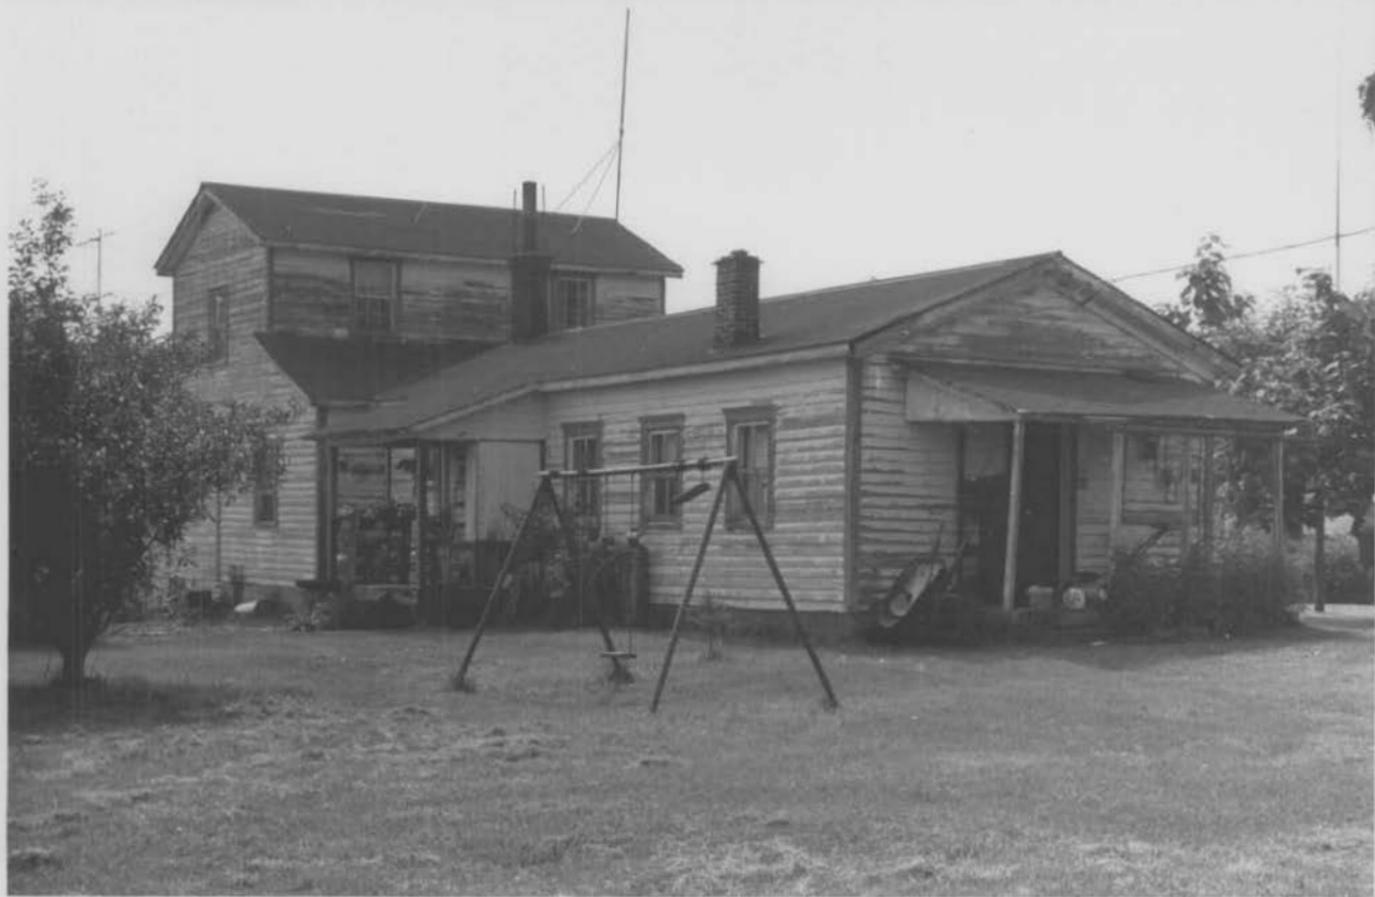
AK-II-B-129

House #5

SE View

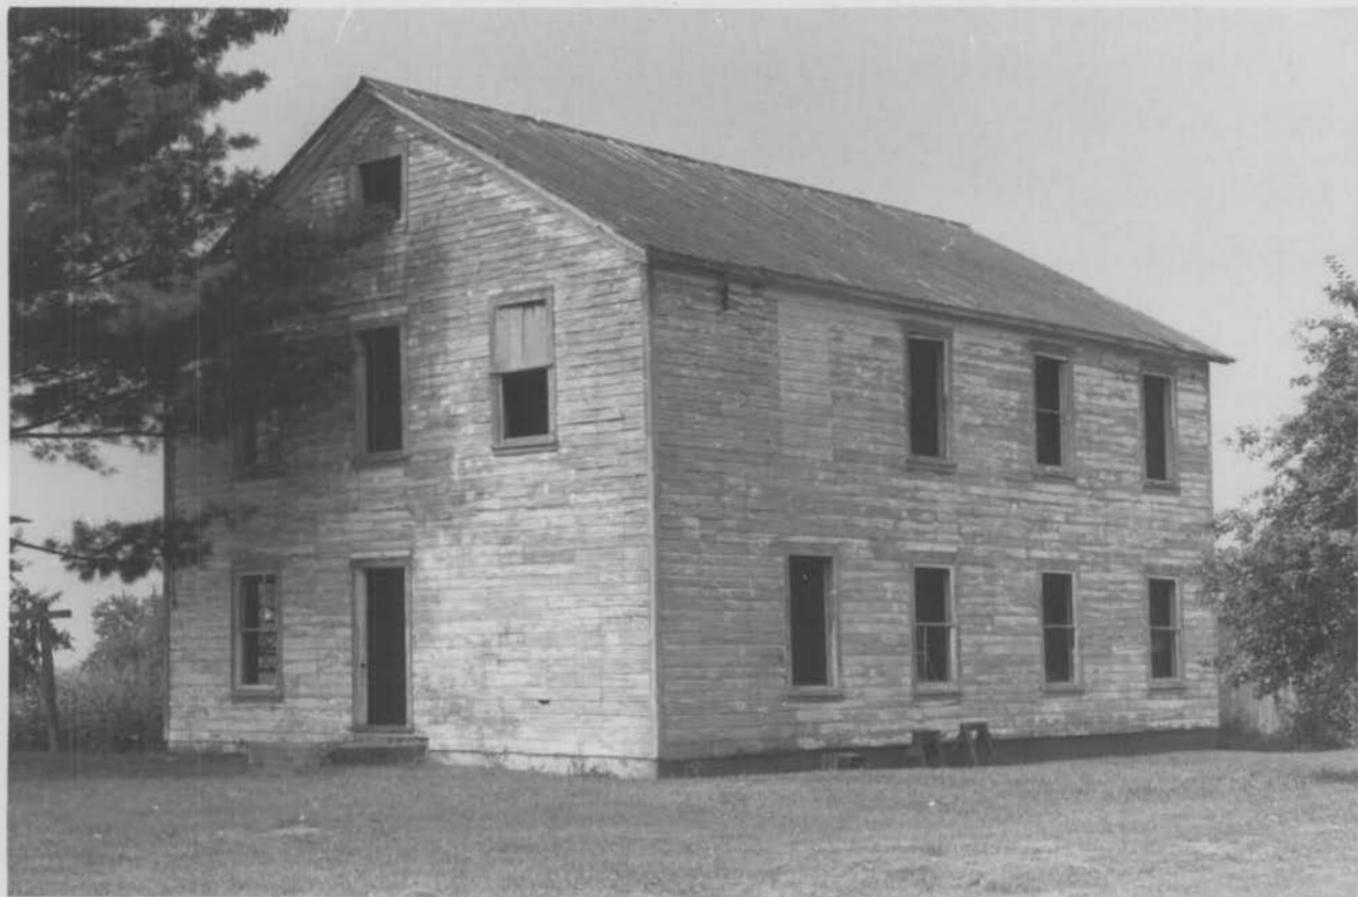
HL-II-B-129

The former dormitory, also in deteriorated condition, is a two story, three bay by four bay German sided structure now vacant. Its gable end entrance is centrally located but the door is missing. Window sash where they remain have two over two panes.

Territory

W View
