DRAFT--POTOMAC HIGHLANDS ORCHARD

ADDENDUM 1979 SURVEY FORM

State Historic Sites Inventory Form

HISTORIC Potomac Highlands Orchard
AND/OR COMMON

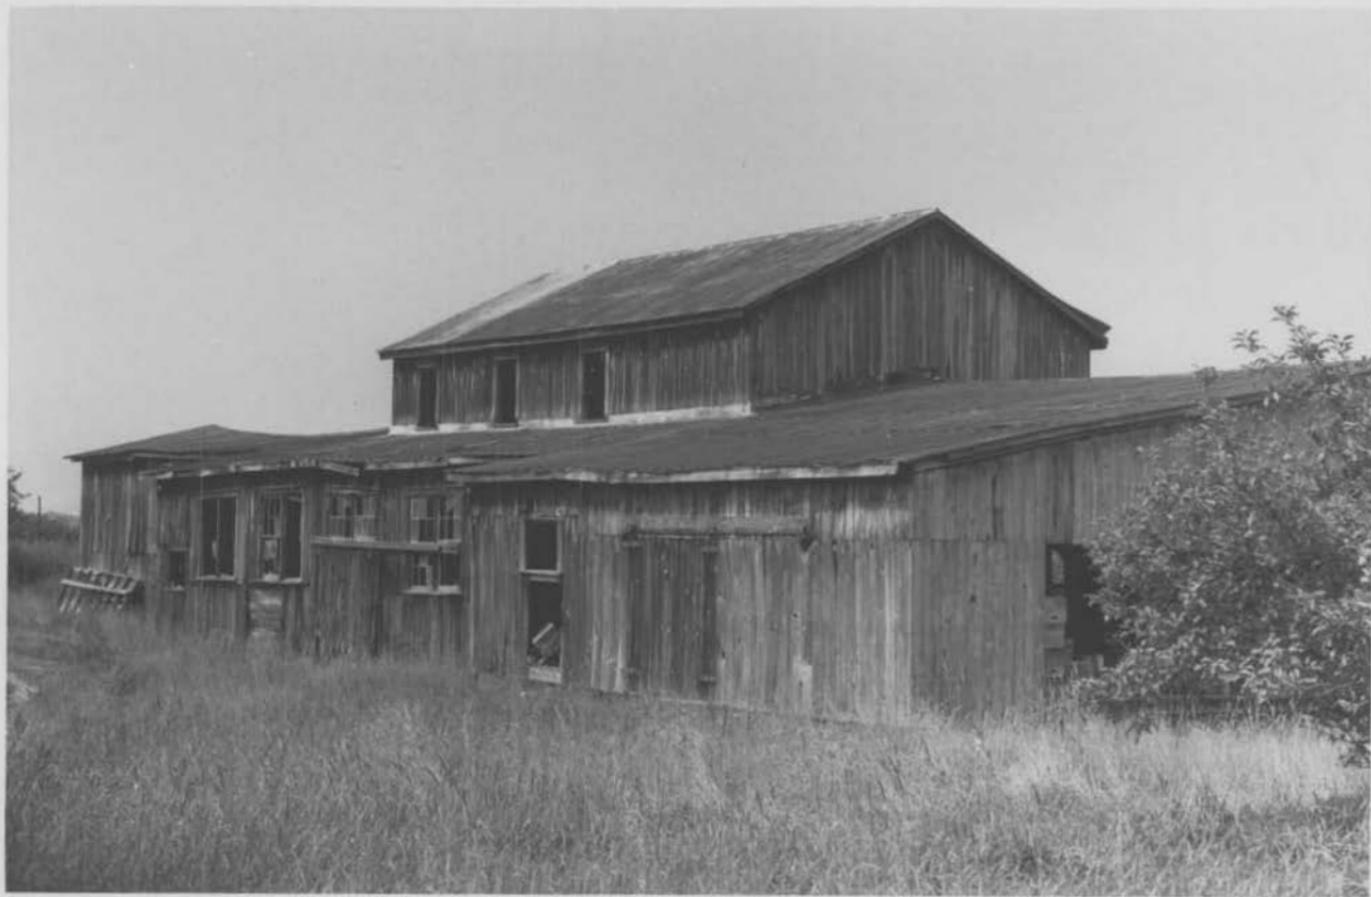
HL-II-B-129

The packing house is in deteriorated condition. It consists of a broad one story gable roofed building with a two story, three bay central gable roofed structure projecting above the roof of the one story section.

Packing Shed

Site View

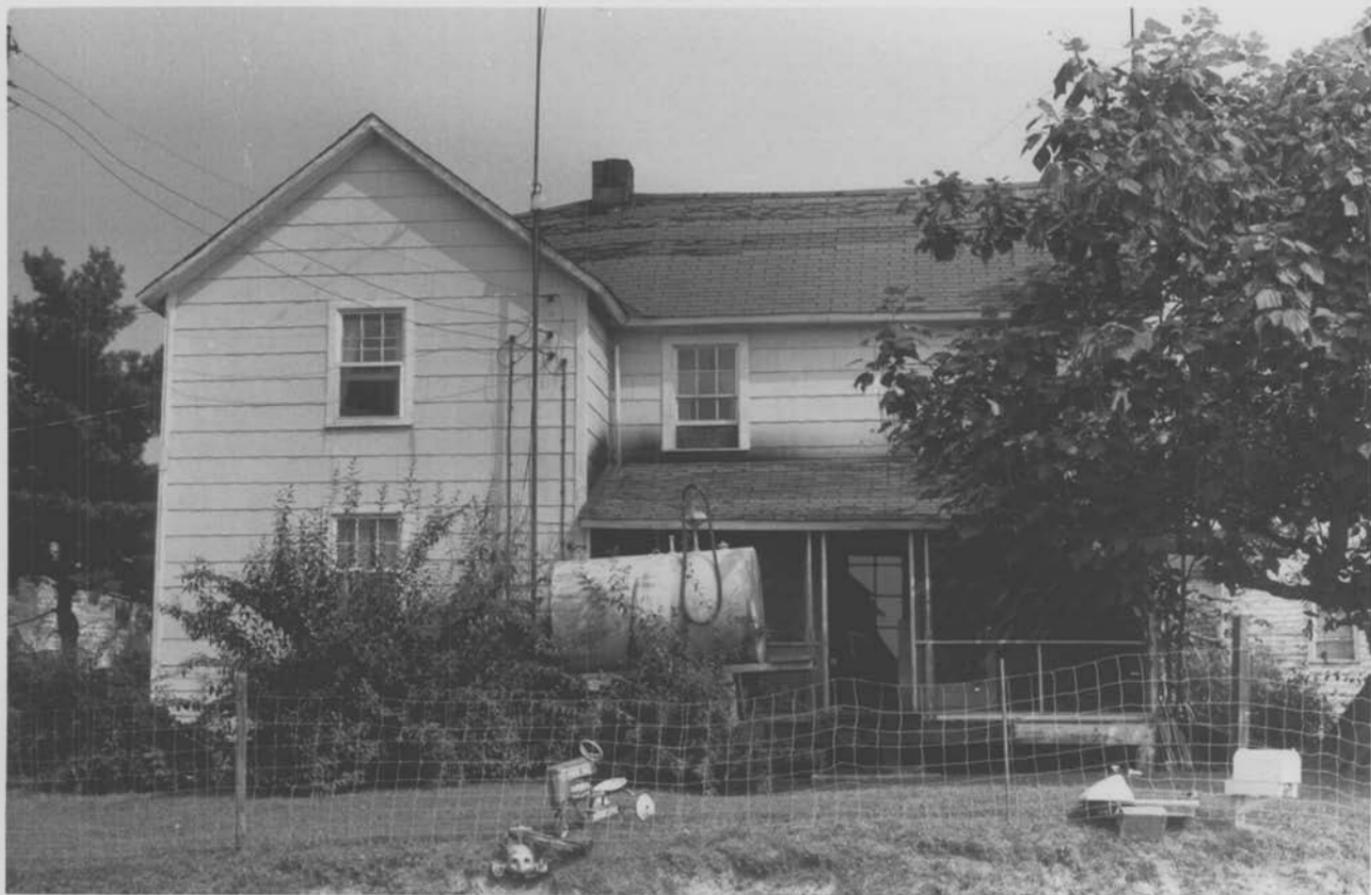
AL-II-B-129

House #9 is a two part, two story building covered with asbestos shingle siding. Windows have six over six sashes with plain architraves. The house appears to be in fair condition.

House #9

W. View
