INVENTORY FORM FOR STATE HISTORIC SITES SURVEY

HISTORIC Clover Hill Farm, McLuckie

AND/OR COMMON Part of Rocky Gap State Park

Draft--Clover Hill Farm  
Addendum to 1979 Survey Farm

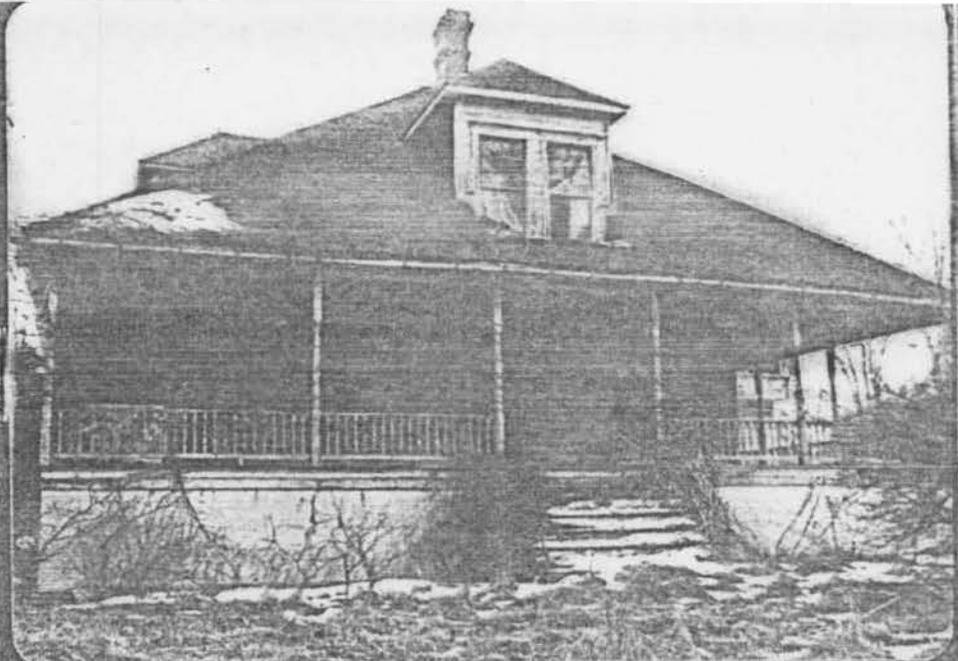
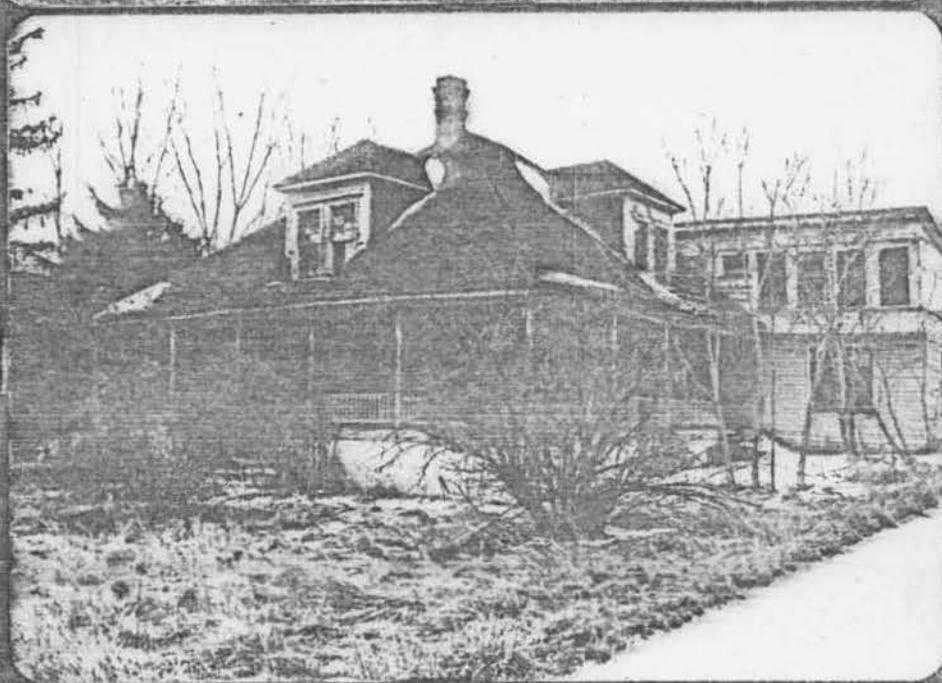
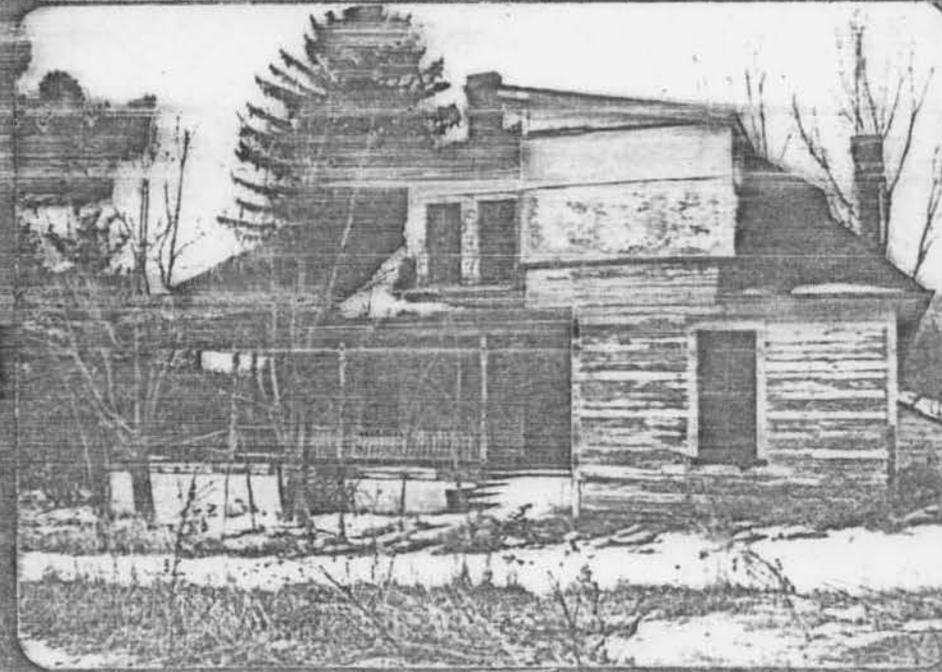
top - South Facade  
center - South + East Facades  
bottom - East Facade

The house is a one and a half story three bay bungalow structure with a deep overhanging porch on three of its four sides. The roof is hipped and steeply pitched. A one story addition also with a hipped roof extends to the northeast from the rear corner of the house. A shed roof extension has been attached to the upper part of the wing giving it a second story. In each of the four slopes of the main section's roof is a hipped roof dormer with double six over two pane sash windows. The entire wall surface of the building is sheathed with german siding.

Windows are long with broad flat topped architraves and two over two pane sashes. There is no evidence of the windows having had shutters. While most windows have two over two pane sashes, two windows in an enclosed porch at the back of the house have four over four panes.

The main entrance is located in the center bay of the front elevation. It is trimmed similarly to the windows and has a four panel door beneath a single pane transom.

The porches which extend around the house are supported by turned posts and enclosed by a balustrade with turned balusters. The roof is sheathed with asphalt shingles and a central chimney of brick has several courses of decorative corbeling. A similar chimney is located at the rear of the house at the kitchen.

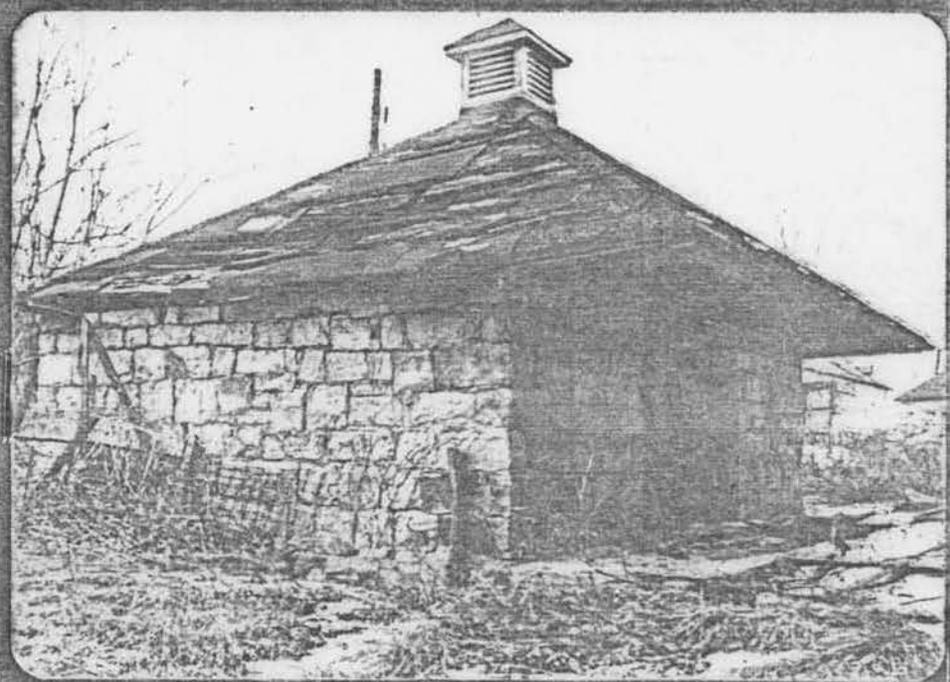
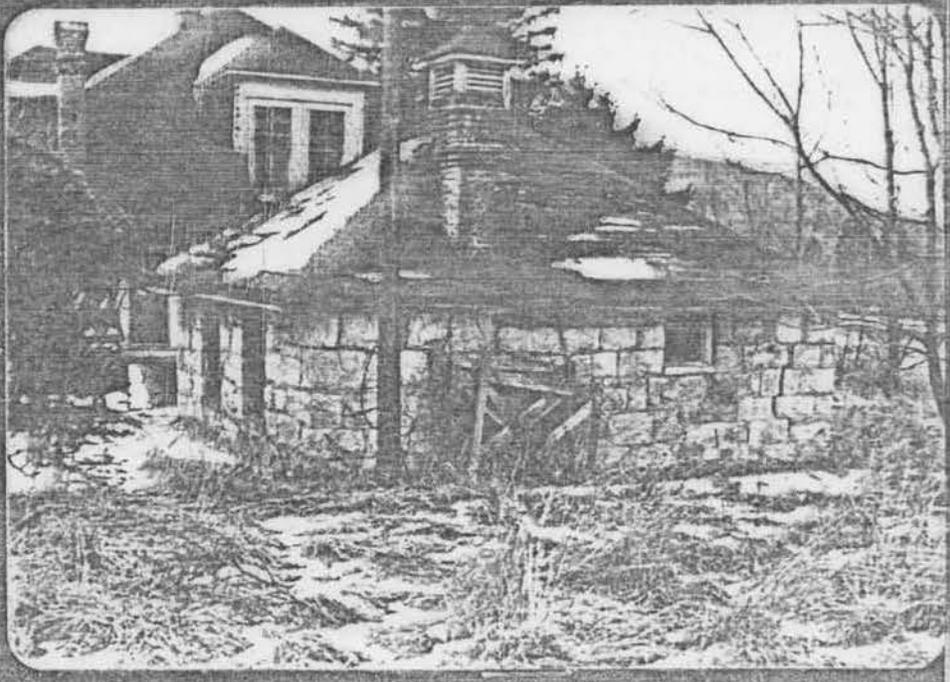
AL-III-C-068 Clove Hill Farm  
top - North & West Facades  
center - Dairy West and South Facades  
bottom - " East and North Facades

To the rear of the farmhouse is a stone dairy and washhouse. It is located ten feet behind the rear wall of the farmhouse. It is constructed of quarry stone with one-foot, eight-inch thick walls. The structure has a hipped roof with a ventilator cupola. The structure has a two-room plan with a stone partition wall running down the center. There is no access between the two rooms. The eastern room has a brick flue that would have served an early twentieth century cast-iron stove. The western room has a concrete trough used for a dairy. The structure had a double entrance on the front and windows into the east room. The west room which contains the dairy had smaller windows for ventilation purposes. The dairy has the trough located on its west wall, constructed <sup>of</sup> with stone covered with concrete. The trough opening is about three-feet <sup>wide</sup> and runs the full-length of the stone structure. The ceiling of both sections <sup>is</sup> ~~was~~ tongue and groove board painted white. The roof ~~is~~ structure consists of eight rafters from each side of the building rising to the peak of the roof with braces at the middle on each side.

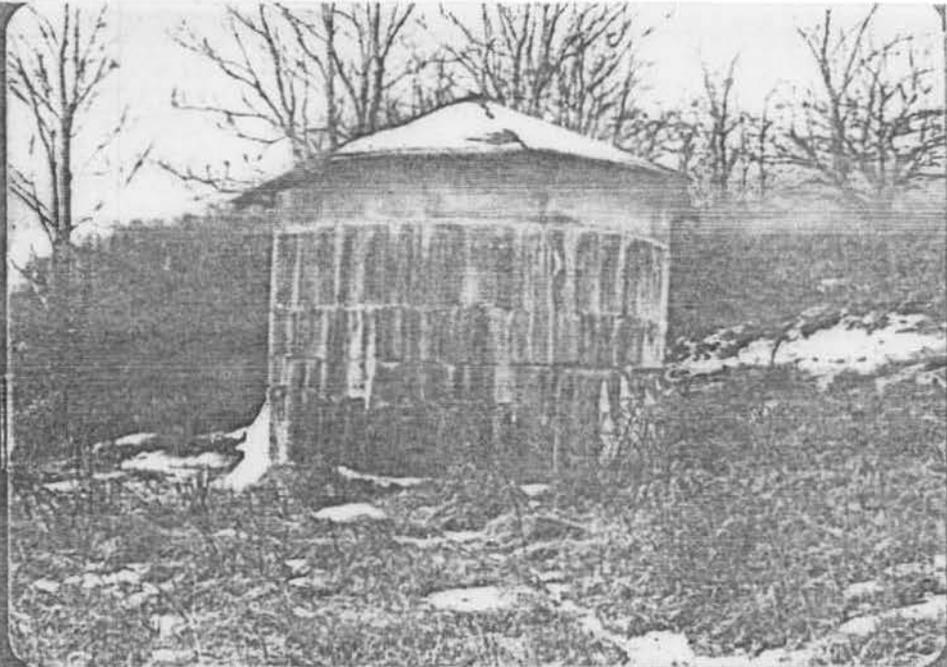
top - Cast-Concrete Cistern  
center - Wagon Shed / Corn Crib  
bottom - Garage

The dairy and other farm buildings on the property received water from a poured-concrete cistern. The cistern was located on a bluff west of the house. It was fed from a stream located on the opposite side of U.S. Route 40. The cistern has a polygonal roof of wood sheathed in asphalt shingles.

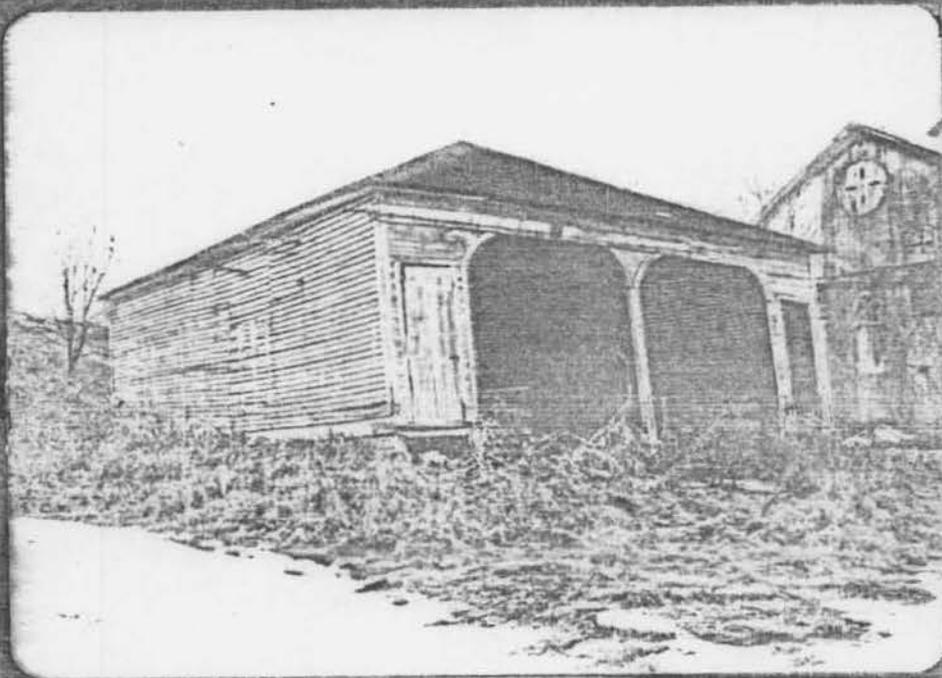
In the complex of farm buildings is a double-bay wagon shed/corncrib. The structure has a hipped roof covered in asphalt shingles. The north and south facades contained double wagon bays with a corncrib at the east and west ends of the structure. It is a frame structure that is covered in boards on the east and west ends set slightly apart for ventilation of the corncrib. The area on the north and south is covered in German siding.

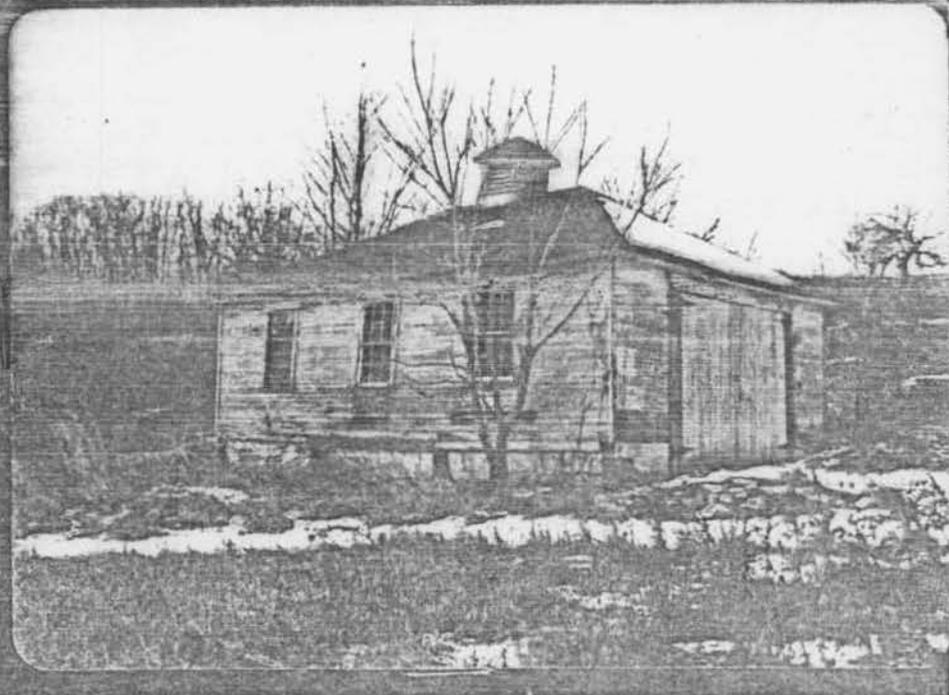
Between the wagon shed-corncrib and the farmhouse is a frame garage. The garage has a hipped roof with a ventilator cupola that has a hipped roof. It is a frame structure covered in German siding. The garage door opening is double doors on the east facade. The other facades have two windows each.

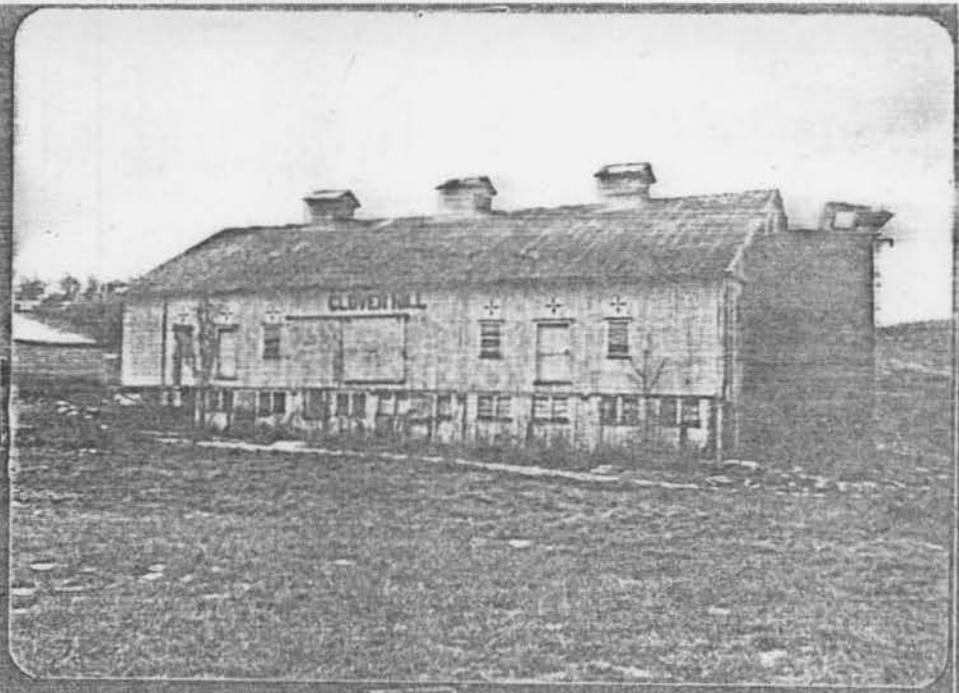
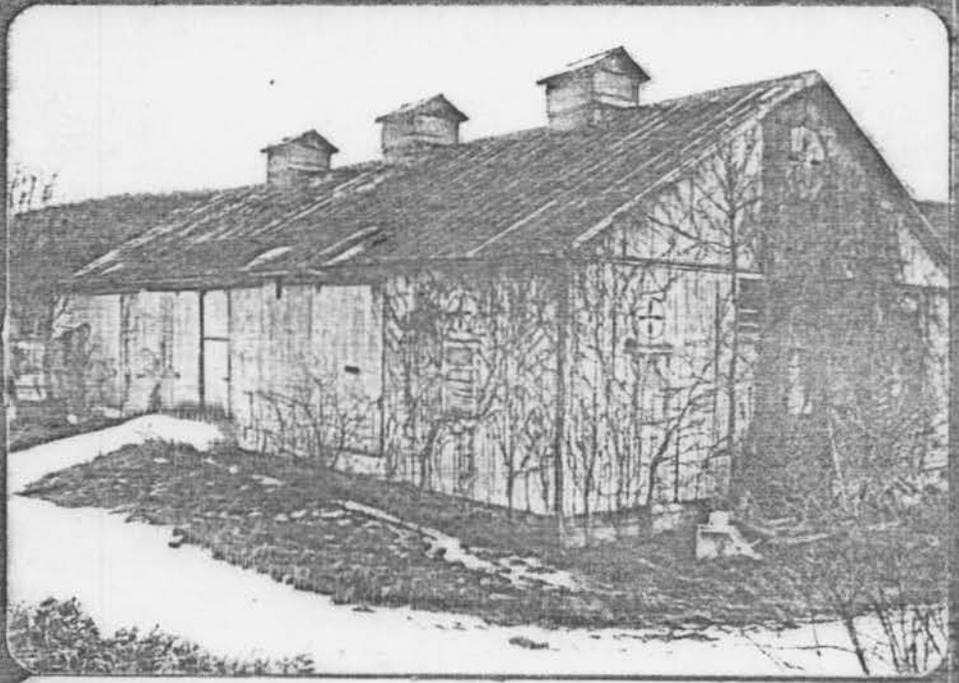
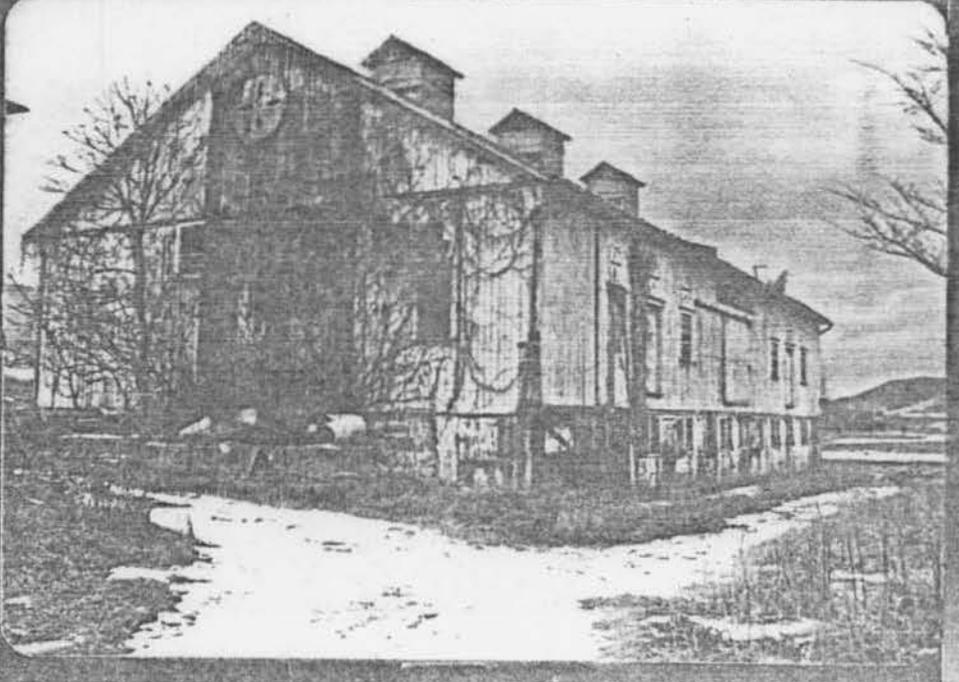
AL-III-C-068 - Clover Hill Farm  
 top - Bank Barn South & East Facades  
 center - " " North & West Facades  
 bottom - " " South & West Facades

The bank barn at Clover Hill is a large <sup>frame</sup> ~~stone~~ structure with a stone foundation. The <sup>forebay</sup> ~~forebay~~ is located on the south facade and is enclosed in wood siding with numerous windows and door openings.

The main floor of the barn contained <sup>rectangular</sup> ventilator windows <sup>with</sup> ~~above~~ <sup>located above them</sup> ~~which were~~ circular decorative ventilators with a floral motif. The barn has a gable roof covered in sheet metal. The gable ends have similar ~~ventilator~~ windows with ventilator circles, with a large ventilator circle located in the gable. On the peak of the roof are three ventilator cupolas with gable rooves. At the east end of the barn is a pair of silos. A large one constructed of tile has a collapsed roof. The smaller one is a stave silo.

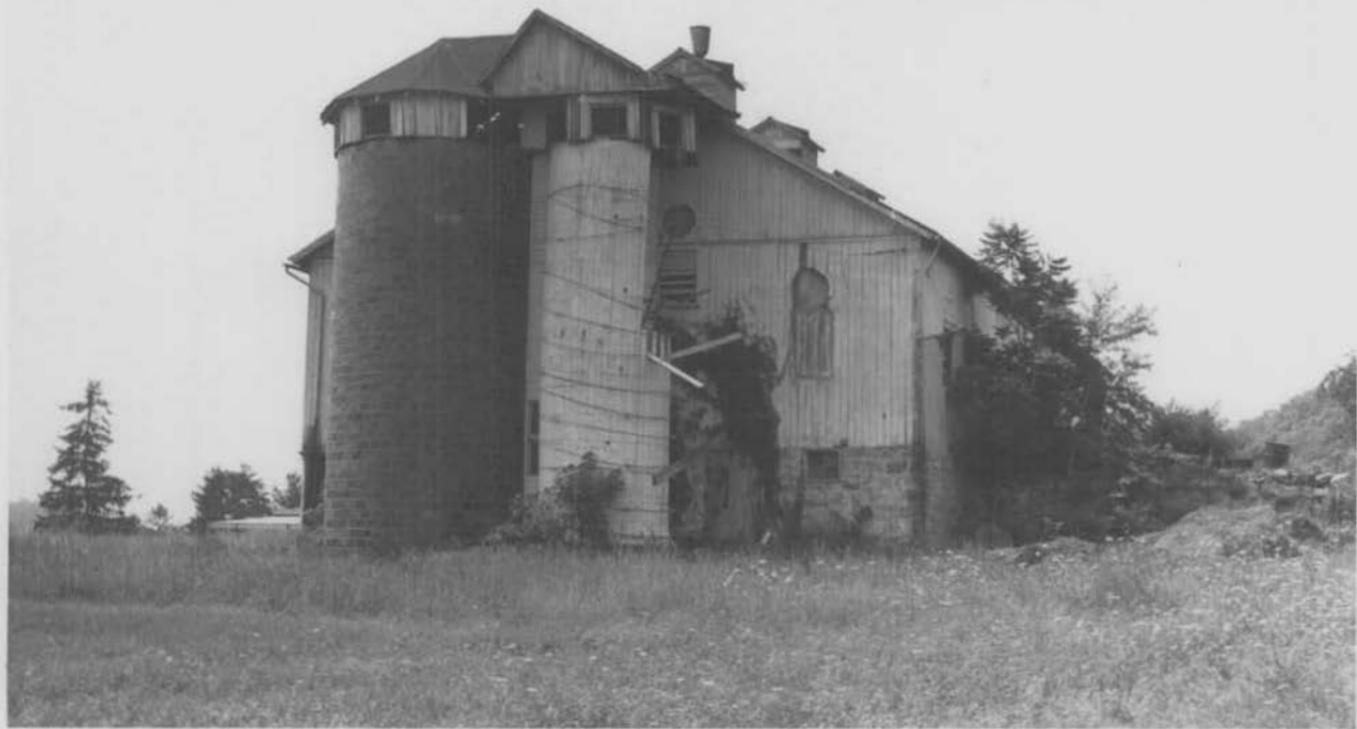
"Clover Hill Farm" - Barn

Northeast of the house are agricultural buildings and a barn. The barn is a large frame structure with decorative round ventilators cut in its walls. It also has three gable roofed ventilating towers in the roof. A modern milking barn has been added to one end. Two silos stand against the east end wall. One is of wood construction and the other is tile. A series of windows are present in a work area between the tops of the silos and their roofs. The barn roof is of standing seam sheet metal.

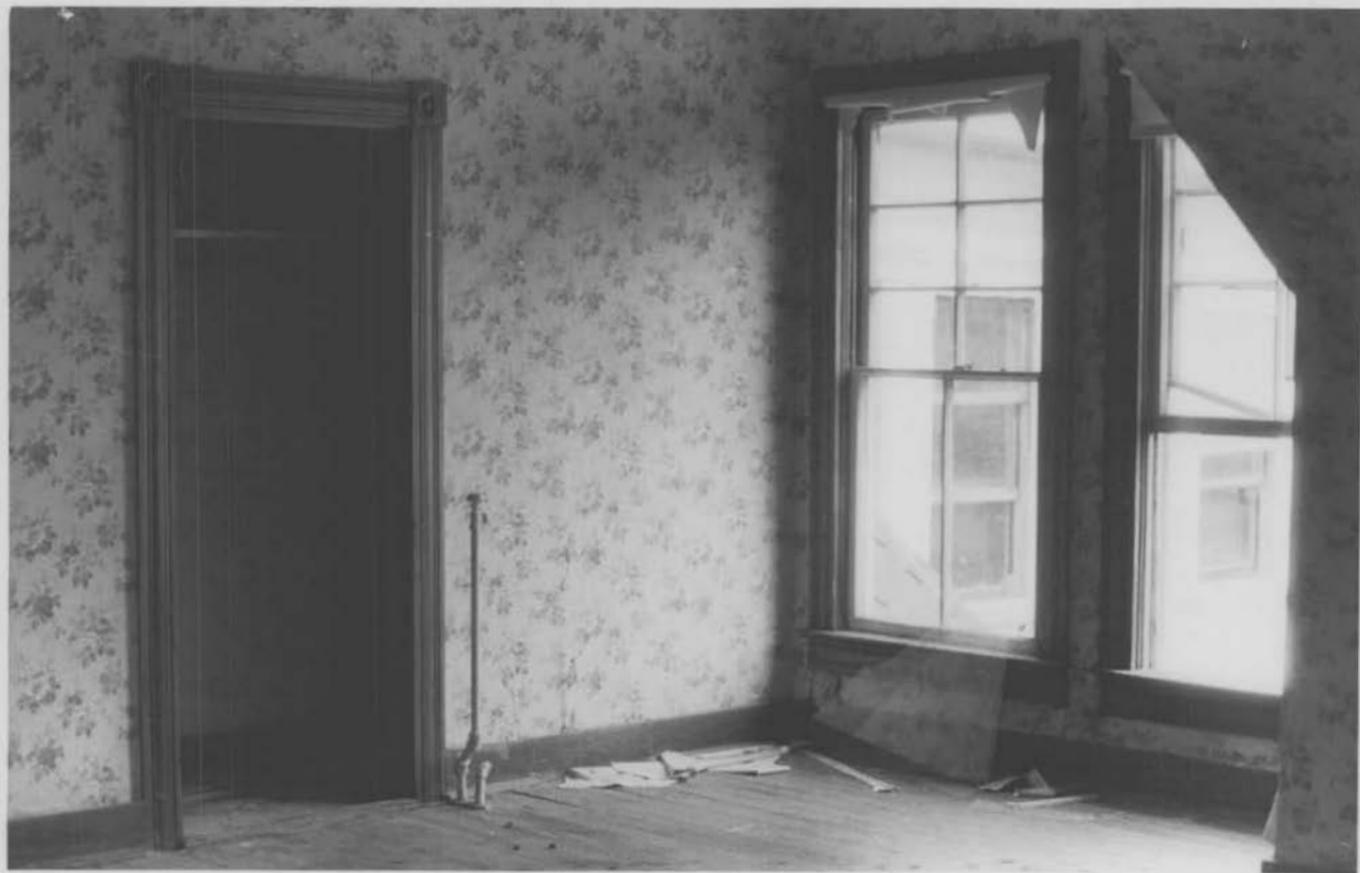
2nd floor N. Room

Large rooms at the second story are lit by the dormer windows. Their woodwork and trim is similar to that at the first story level.

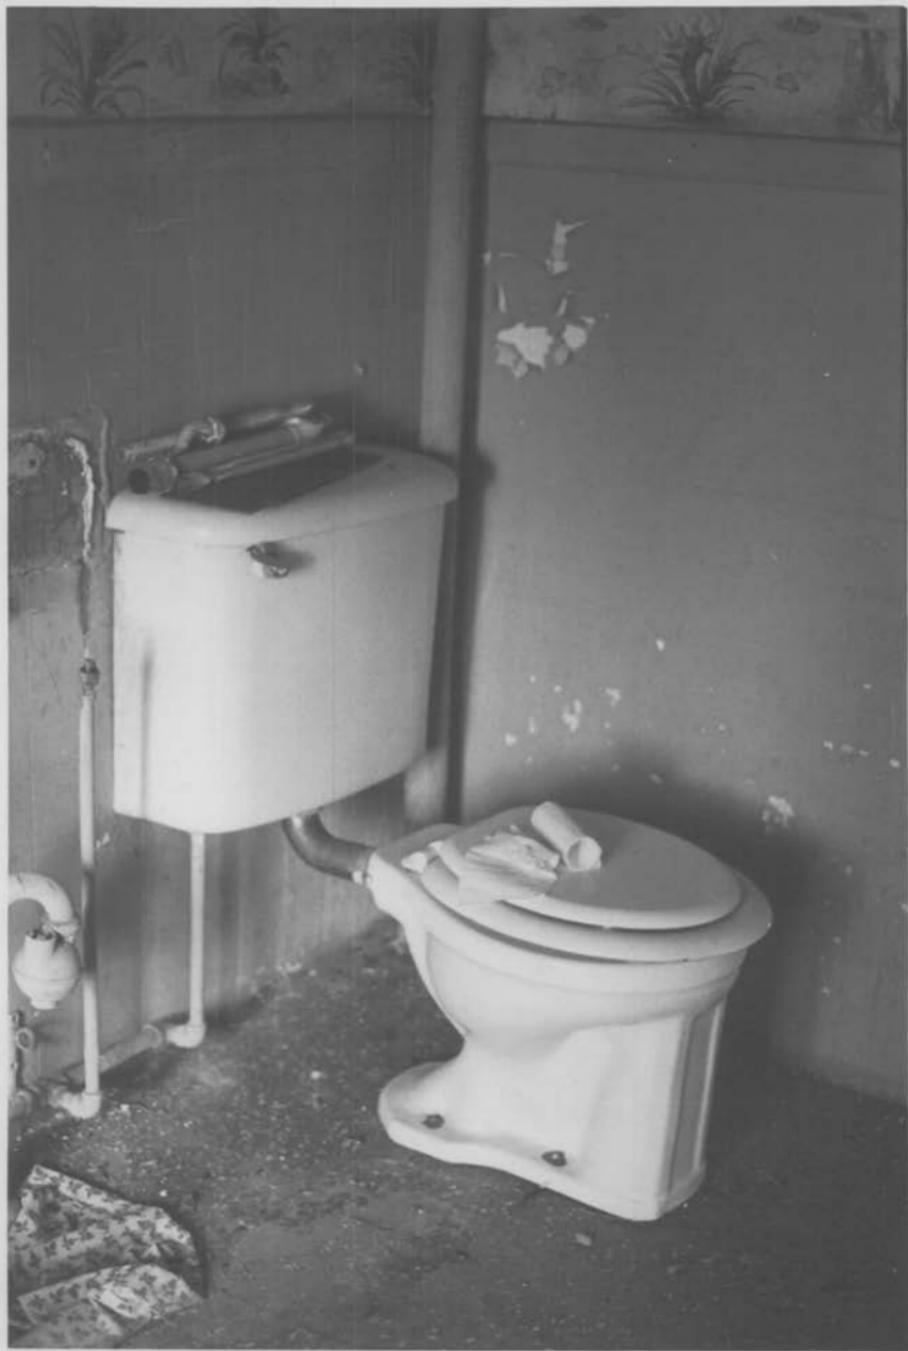
1st floor W. Room - bath

Behind the parlor is a large bathroom which retains early 20th century fixtures.

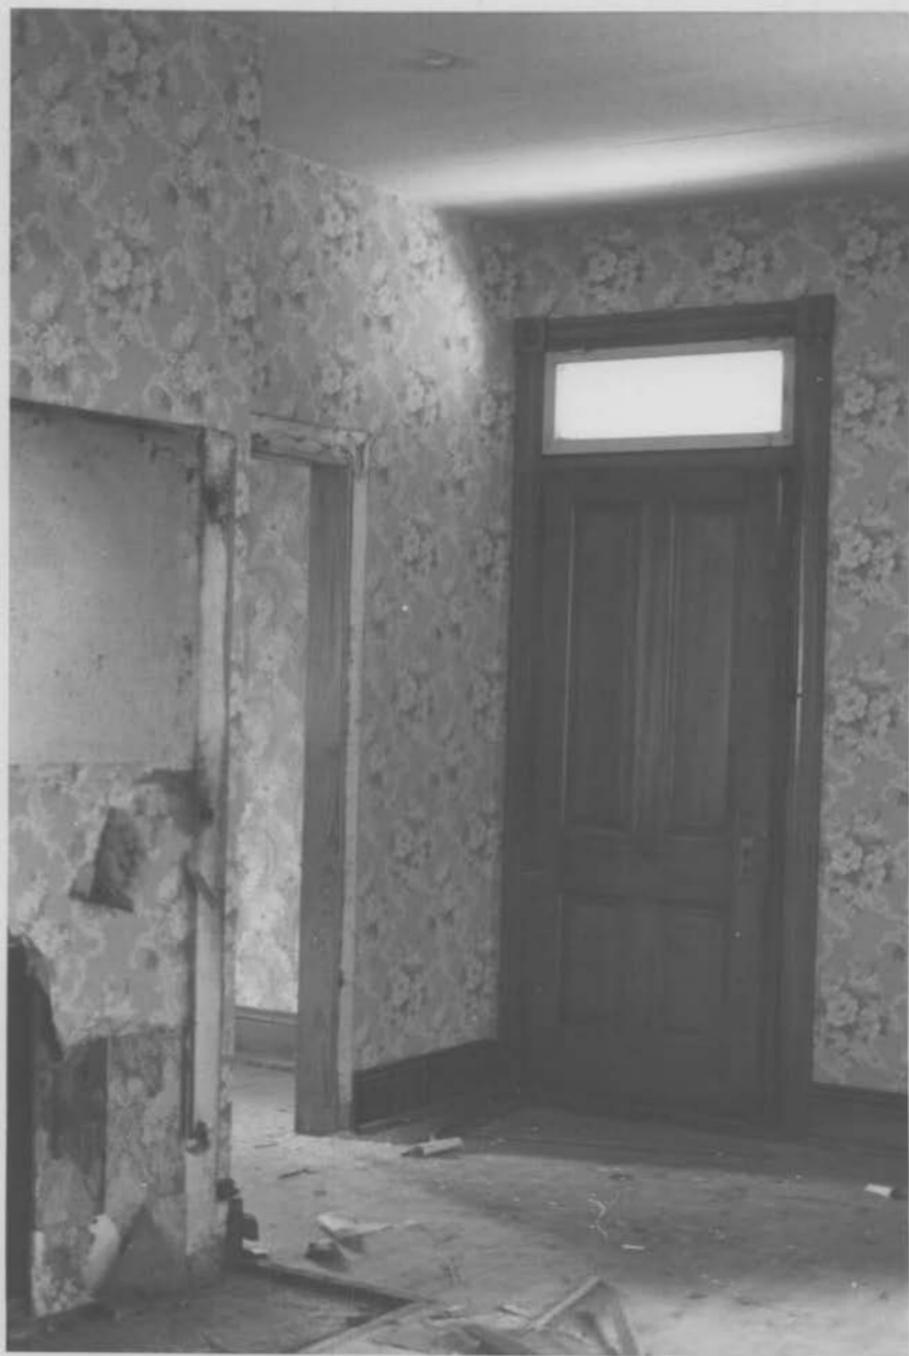
1st floor S. room

The interior of the house is divided into four rooms. The main entrance opens into the south room which is a parlor. It contained a fireplace along its interior wall. Recently the house was vandalized and the fireplace woodwork and trim was removed. Several door architraves were also taken. Remaining woodwork is pine with original painted wood graining. One architrave still in place has symmetrical molding and decorated corner blocks. The mantel piece is said to have been quite elaborate with a mirror above the fire place and numerous moldings.

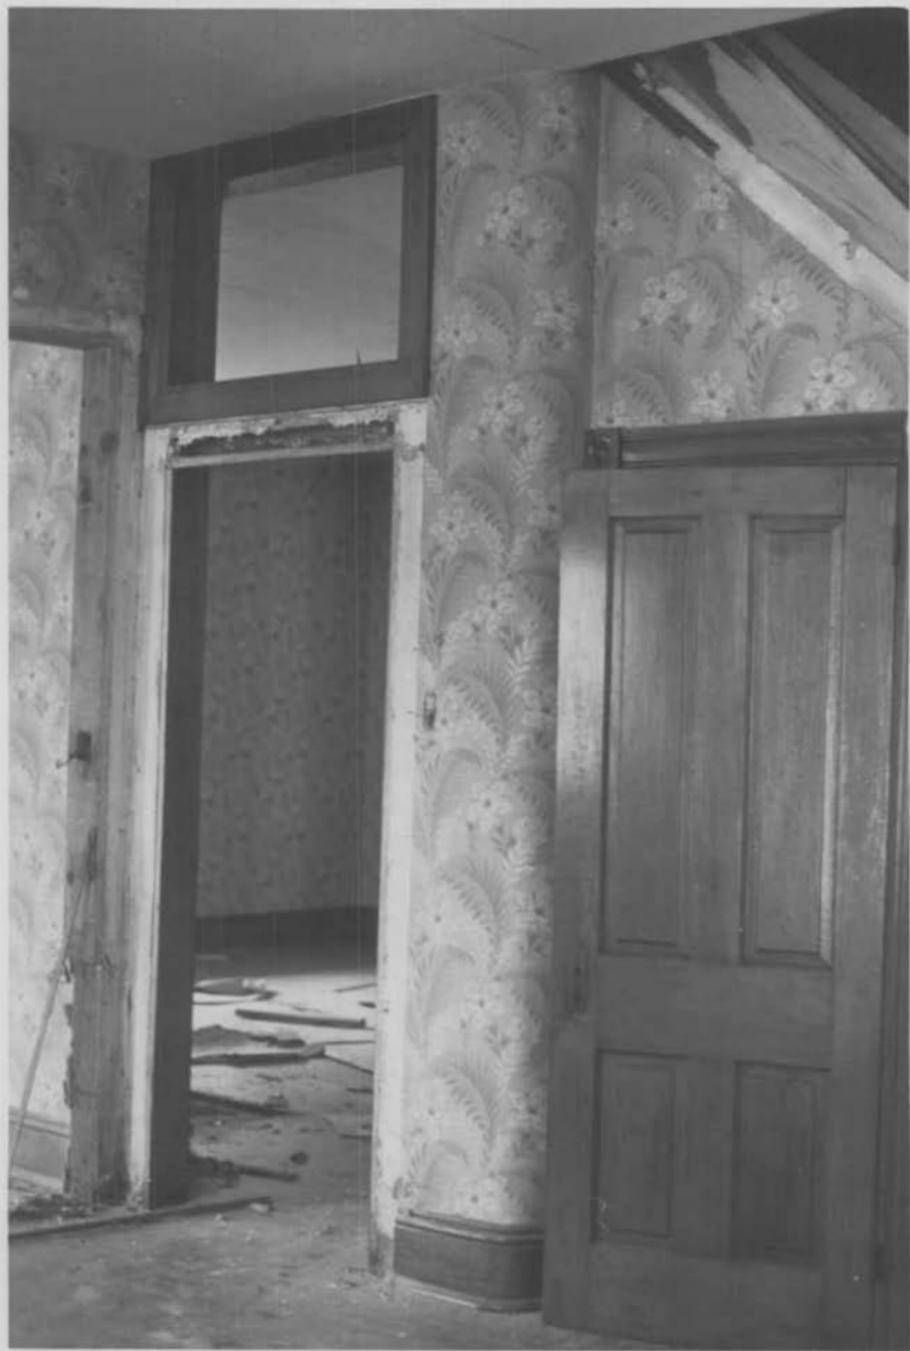
Rocky Gap St. Park  
"Clover Hill Farm" - house  
1st Story, N. Room  
August, 1978

The main staircase is located in the north room. The hand rail, balustrade and trim have been removed. One notable feature in the stair room is a section of curved wall between a door frame and the back of the staircase.

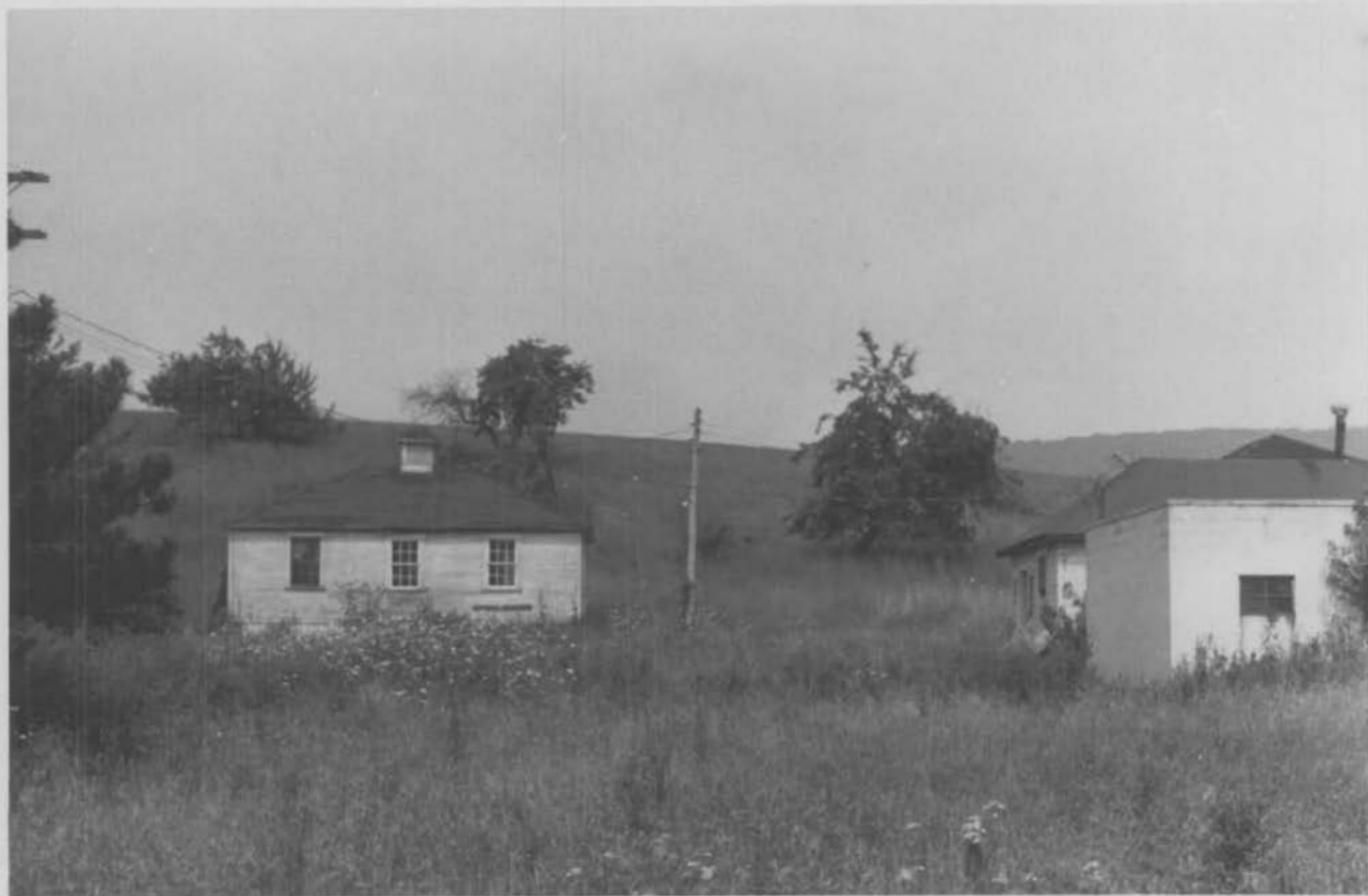
"Clover Hill Farm" - outbuildings

Near the barn is a frame wagon shed with a hipped roof. Other frame agricultural buildings are present including a chicken house and a milk house. Except for the barn all of the buildings in the complex have hipped roofs and appear to have been built following the pattern of the house. With the exception of the modern milking barn, all of the buildings appear to be contemporary and to have been built during the first quarter of the 20th century.

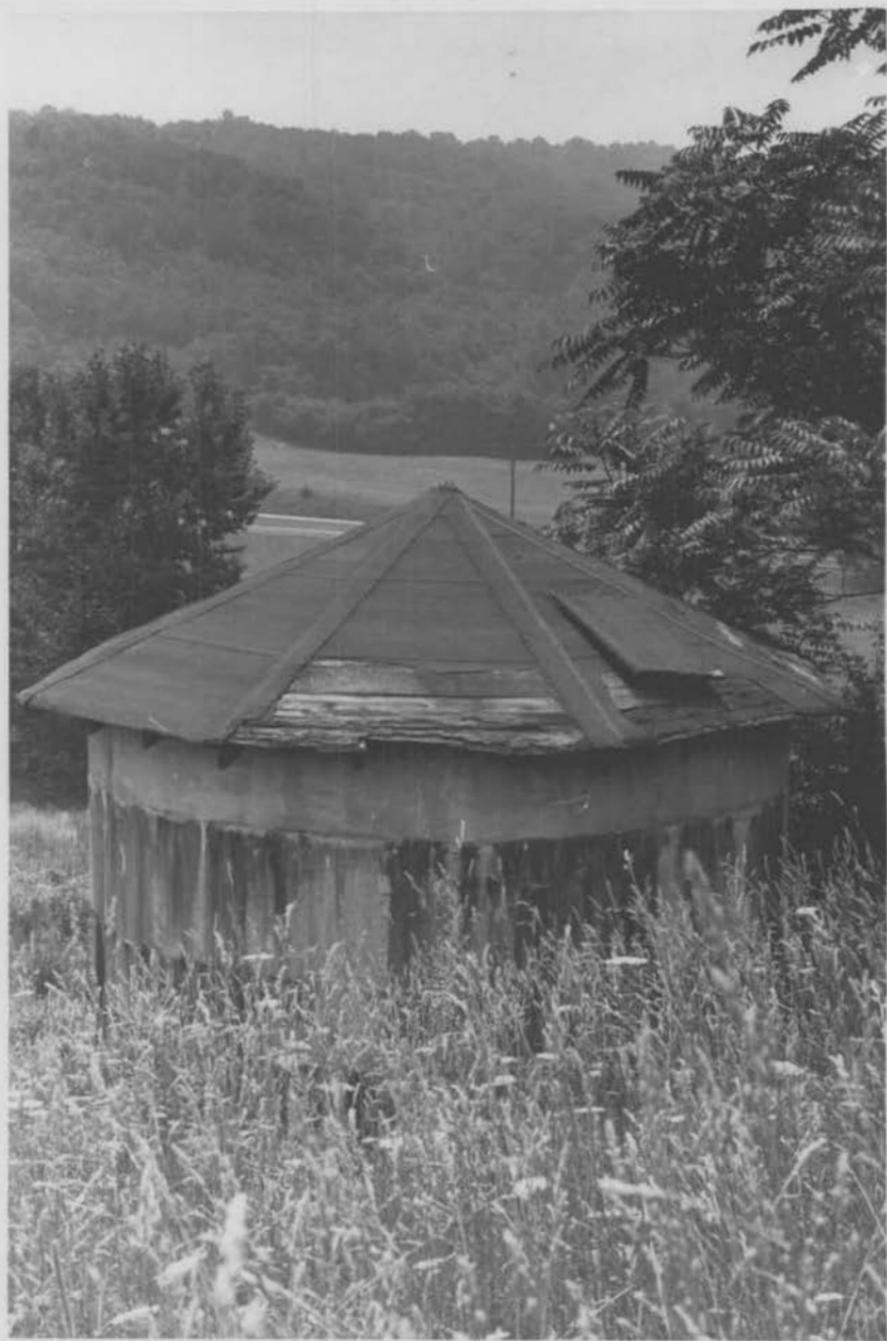
Cistern - SW view

On a bluff west of the house is a round cast concrete cistern. It is fed from a stream which is located on the opposite side of US Route 40. The structure has a polygonal roof of wood sheathed with composition paper.
