MARYLAND HISTORICAL TRUST WORKSHEET

NOMINATION FORM
for the
NATIONAL REGISTER OF HISTORIC PLACES, NATIONAL PARKS SERVICE

1. NAME				
COMMON: Gillette Building				
AND/OR HISTORIC:				
2. LOCATION				
STREET AND NUMBER: 70-72 Baltimore Street and 1-5 North Liberty Street				
CITY OR TOWN: Cumberland				
STATE Maryland			COUNTY: Allegany

Gillette Building

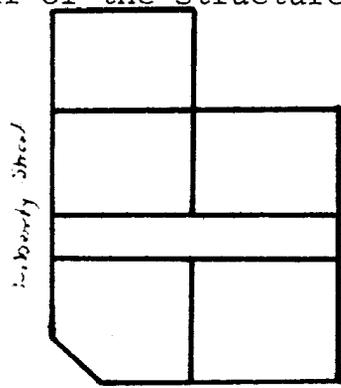
1st floor plan, upper levels
NOT to scale

2nd floor, Liberty St side,
3rd window from North
etc

Entrance to the upper stories is gained through a doorway on the west side. The entranceway is below the second bay from from the south side. This entrance also leads to one of the first floor shops. The present arrangement of the principal rooms of the upper levels consists of two rooms to the south of the stairhall and three to the north with two of these along North Liberty Street. The north room on the third floor is very small. (See drawing).

The balustrade and the decorative detailing of the third floor are simple in design and in character with the exterior of the building. The balustrade extends up the steps from the second floor and on to the top of the steps leading to the attic. The window trim of the second and third floor consists of mainly flat, beaded boards with decorative molding applied to the outer edges. The window trim on the second floor may be original. (See drawing).

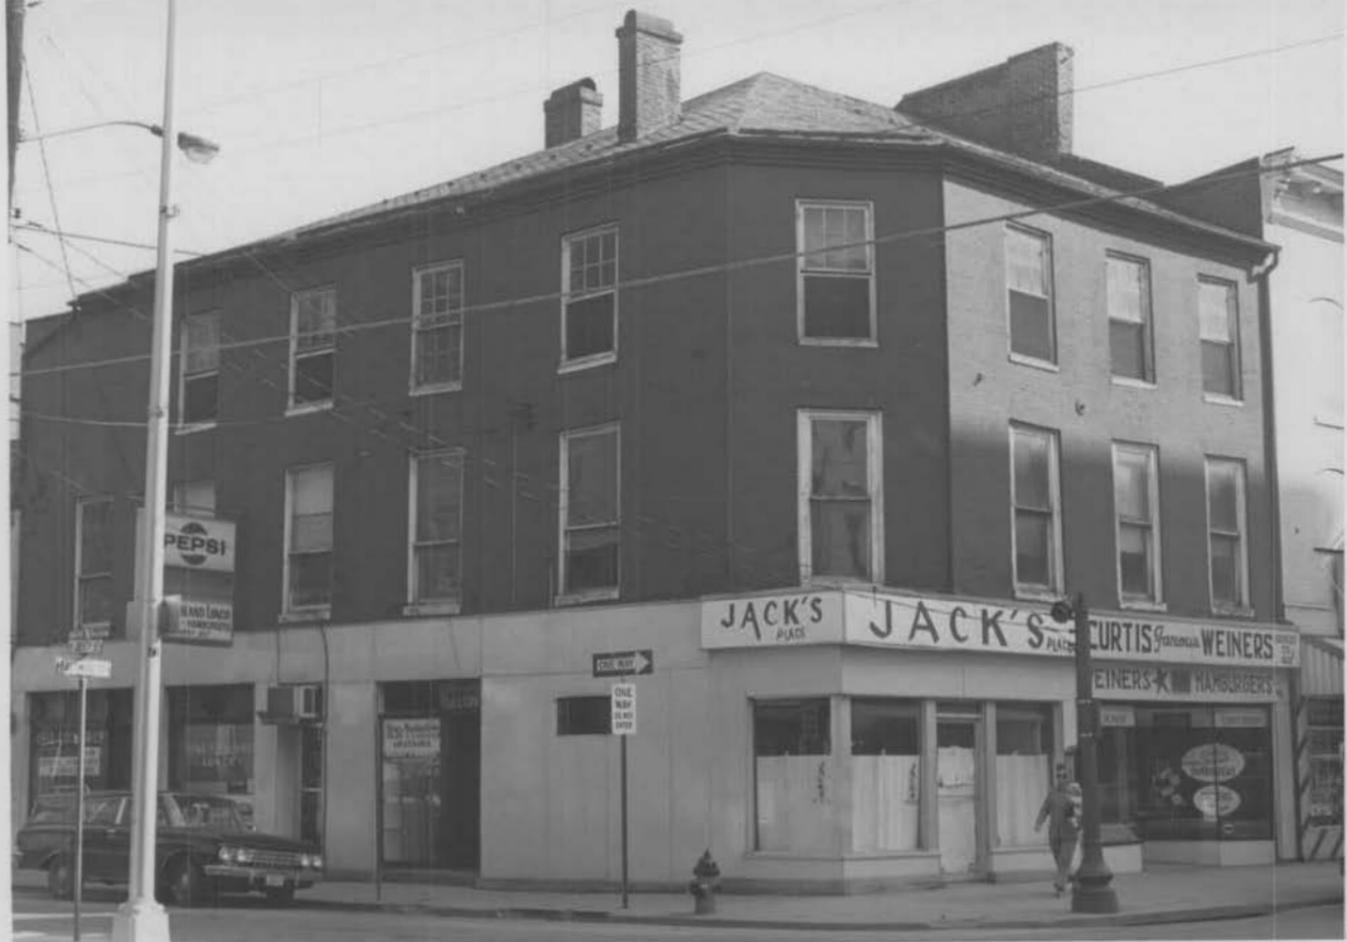
Gillette Building
70-72 Baltimore St. and
1-5 N. Liberty St
Cumberland
Allegheny Co., Maryland
SW view
May, 1974

The Gillette Building is a three and a half story, brick structure from the first half of the nineteenth century. The bricks are laid in Stretcher Bond. The building has a brick cornice and a low pitch roof which appears to be covered with slate shingles. On the upper levels there are three bays along the south side, five along the west side, and one set on a diagonal in the southwest corner. The street facades of the first floor have modern shop fronts and siding. The roof is pierced by three internal chimneys, one of which is on the east wall. The east wall extends above the roof line on both sides of the chimney and it appears that there may have been double chimneys on this wall at one time. The north wall running perpendicular to Liberty Street appears to have been altered sometime in the past. There is no evidence of a basement. There are two tie rods between the second and third floors, one each on Baltimore and Liberty Streets sides.

Each of the windows of the upper levels have brick flat arches above them, double-hung, wooden sashes, and wooden sills. The window frames are round on the external sides. The windows of the third floor - three on the south side, one on the diagonal, and only four on the west side - have six-over-six lights. There are shutter hooks on the exterior sides of these window frames. The windows of the second floor have one-over-one lights. The top sashes of the five windows on the west side of the second floor are larger than the bottom sashes as though they have nine-over-six lights. The second story windows on the south side and the diagonal have fairly equal size sashes on the top and bottom. The sashes, however, are narrower than those of above and on the west wall. The openings are narrowed by the installation of boards along the sides and the top of the sashes.

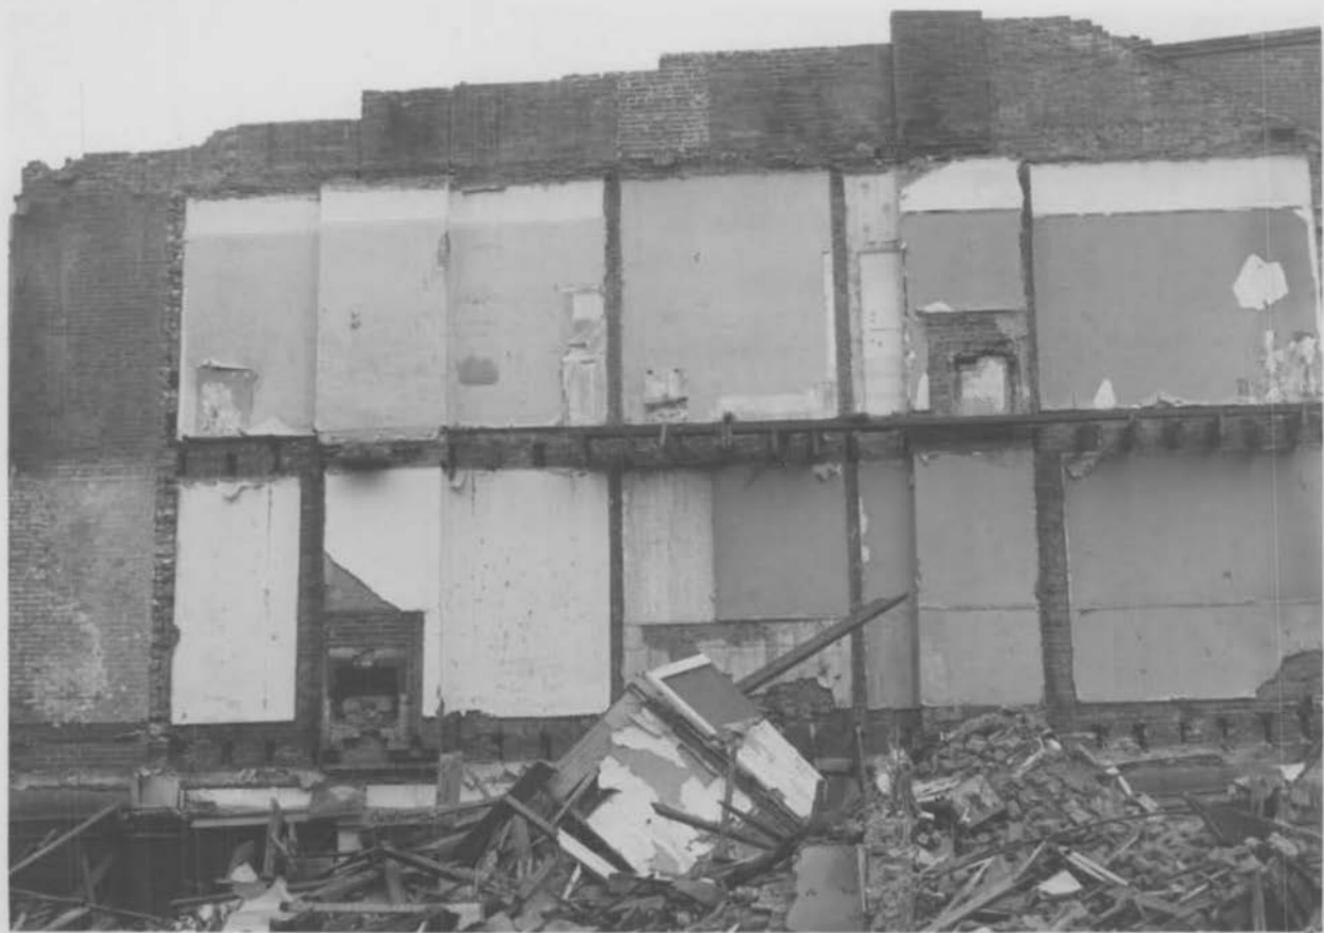
Gillette Building
70-72 Baltimore St.
Cumberland
Allegany Co., Md
East wall following
demolition, August 1974

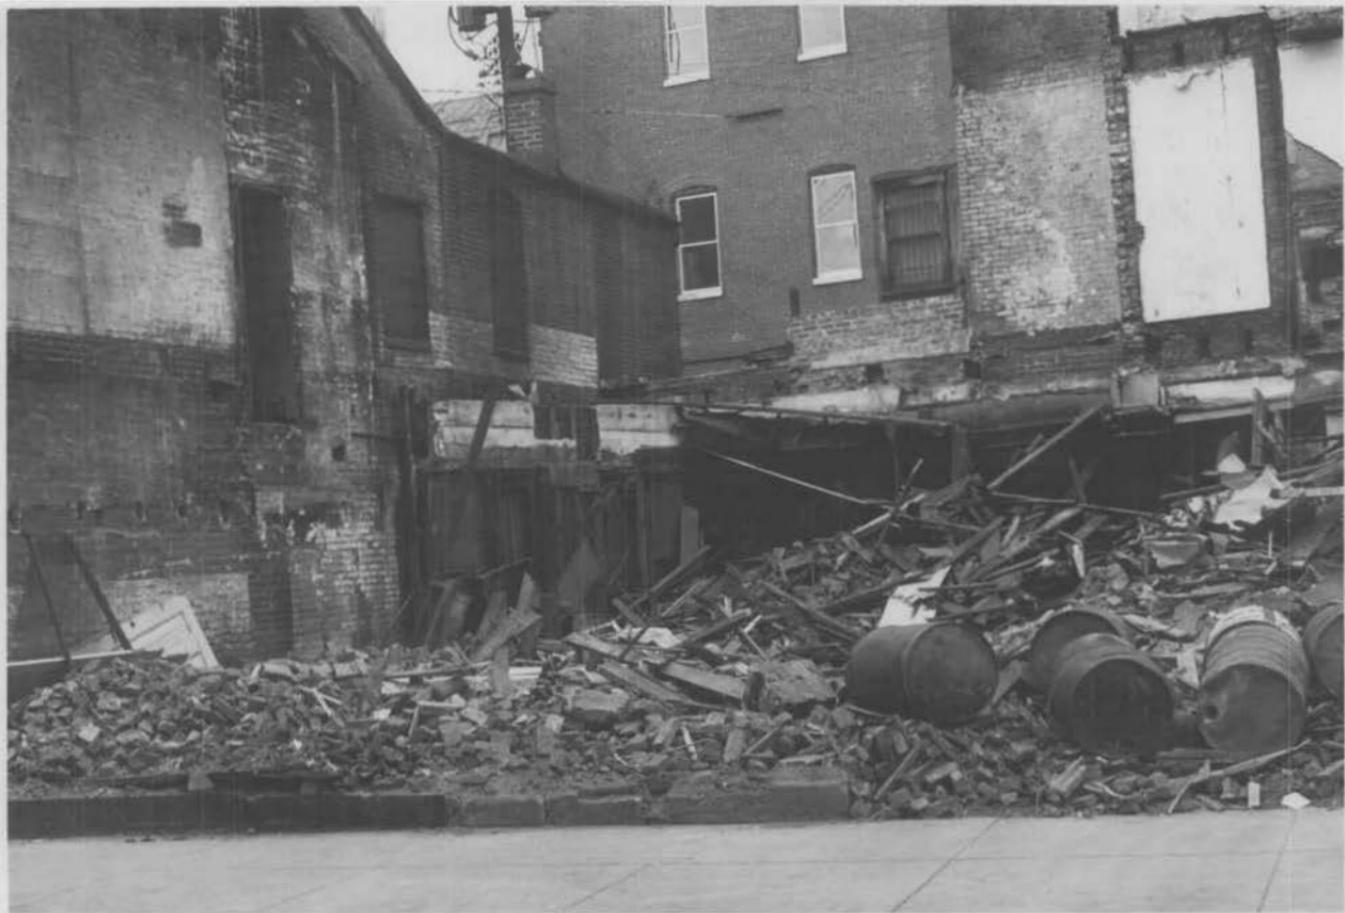
Gillette Building
70-72 Baltimore St
Cumberland
Allegany Co., Md

rubble following demolition
in August 1974
panelling from restaurant

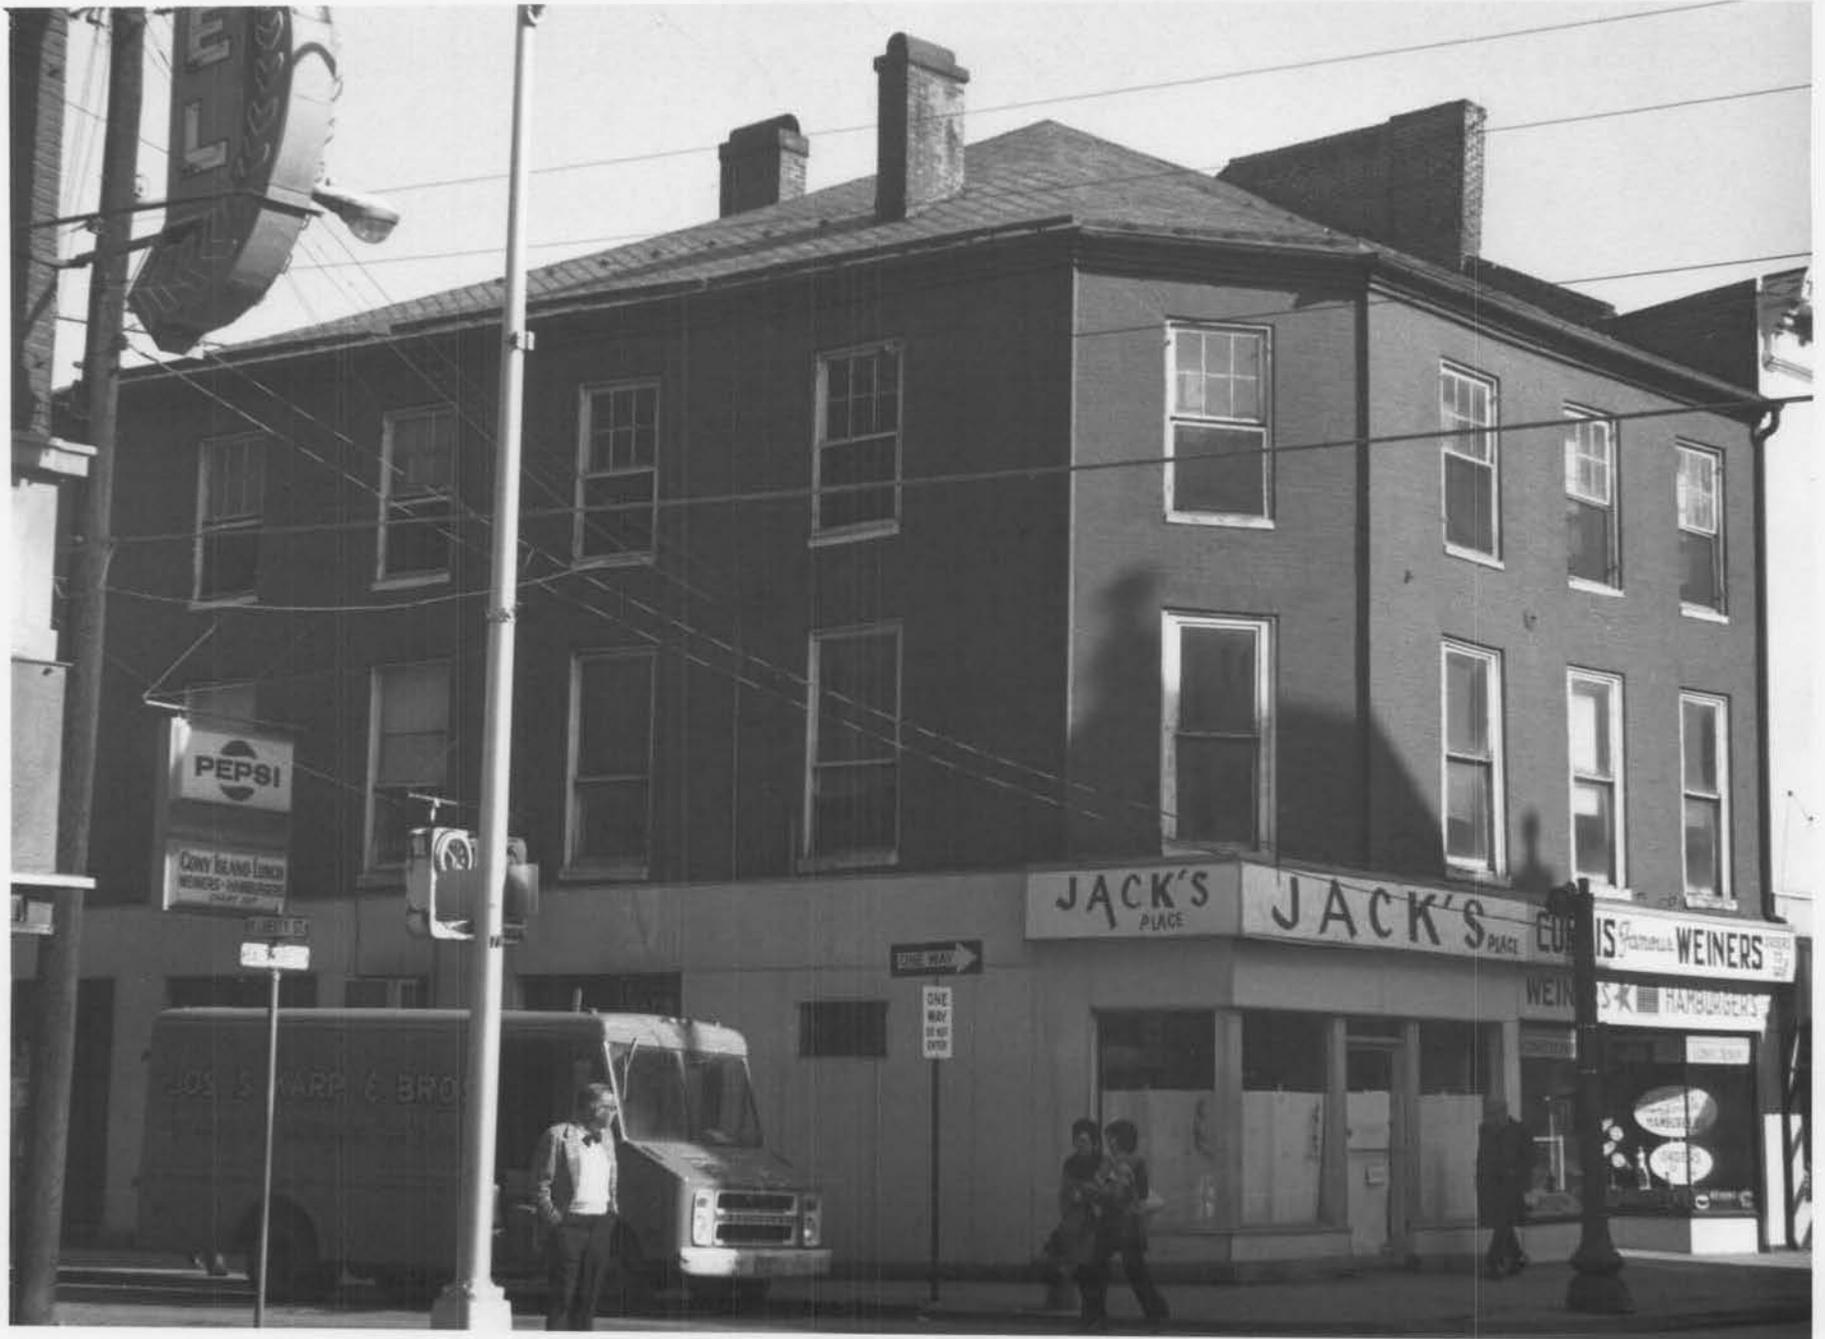
Gillette Building
Baltimore & Liberty Sts.
Cumberland
Allegany Co., Md
1974
built c. 1830s-1840
razed 1974
