MARYLAND HISTORICAL TRUST WORKSHEET

NOMINATION FORM
for the
NATIONAL REGISTER OF HISTORIC PLACES, NATIONAL PARKS SERVICE

1. NAME				
COMMON: <u>Brownstone Building</u>				
AND/OR HISTORIC:				
2. LOCATION				
STREET AND NUMBER: <u>29-33 South Centre Street</u>				
CITY OR TOWN: <u>Cumberland</u>				
STATE: <u>Maryland</u>			COUNTY: <u>Allegany</u>

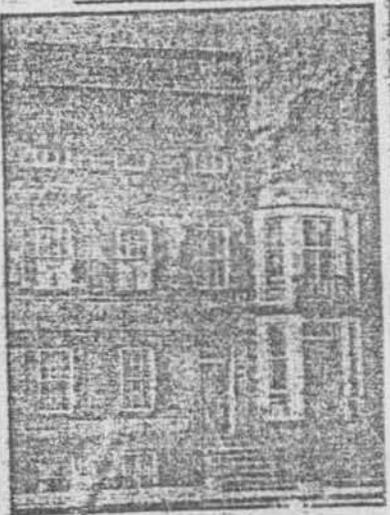
brownstone building
29-33 South Centre Street
Cumberland
Allegany County, Maryland

This early twentieth century newspaper advertisement shows the northern portion, number 29, of the building when it was occupied by Dr. H. W. Hodgson. This side was altered in the mid twentieth century when the first floor was renovated for a ground level shop and entrance to the upper level.

A circa 1914 photograph of the northern portion shows that the first floor facade was originally three bays with the entrance in the outer bay, as is the present entrance to the upper level and two windows on the basement level. Evidence of the original fenestration arrangement is visible above the shop front on the northern portion and along the sides of both fronts. On each side of the entranceway on the north side and on the north side of the entranceway on the south are attached turnings of stone. The circa 1914 photograph shows an iron balustrade that probably rested on these turnings. Markings on the wall above these turnings indicate where the balustrades were probably tied into the wall.
