MORGAN BRICK FARM HOUSE

AL-V-A-048
Old Legislative Road
Between Midlothian and Carlos
ca. 1840

Maryland Historical Trust State Historic Sites Inventory Form

INVENTORY FORM FOR STATE HISTORIC SITES SURVEY

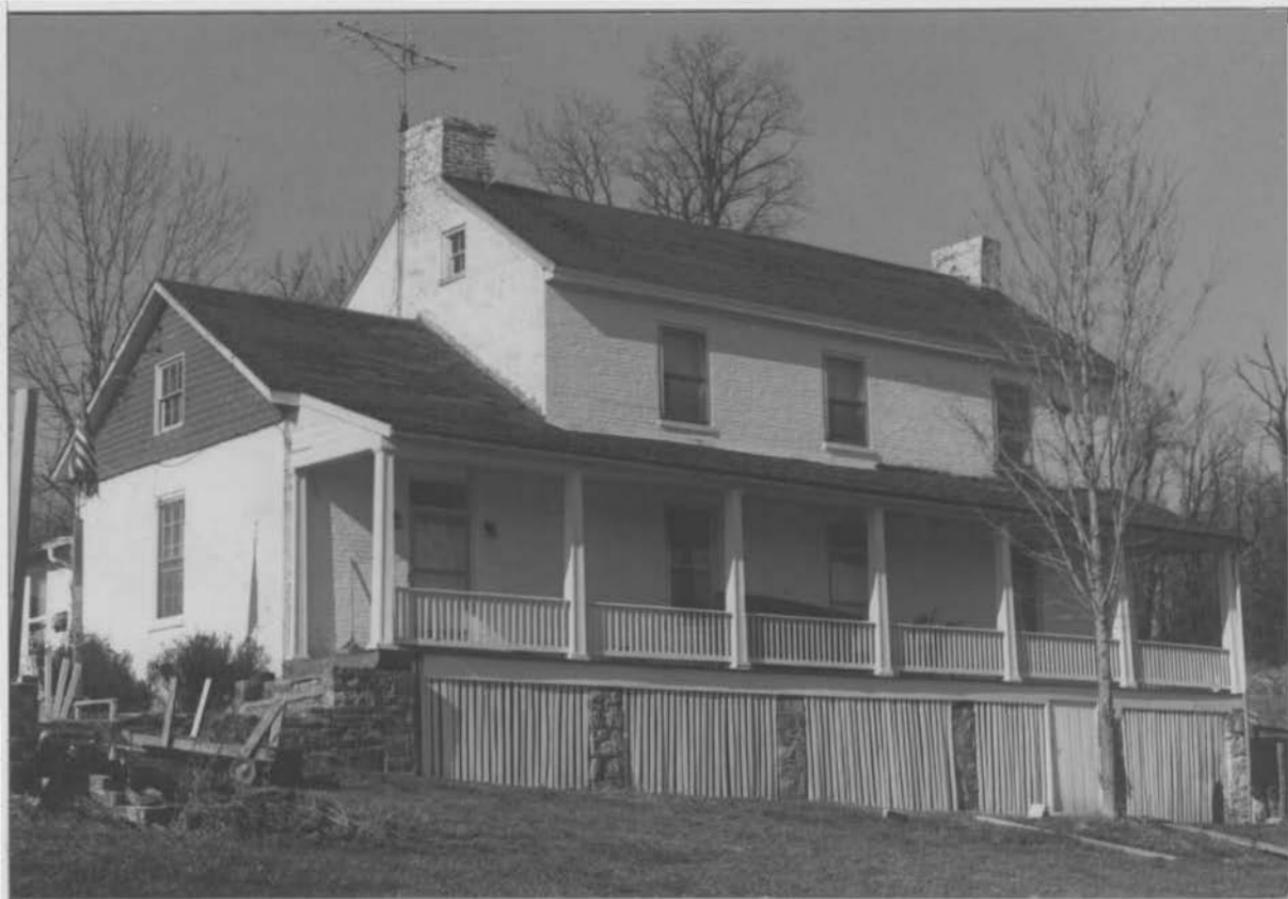
Northwest

Morgan Brick Farmhouse
Off Old Legislative Rd.

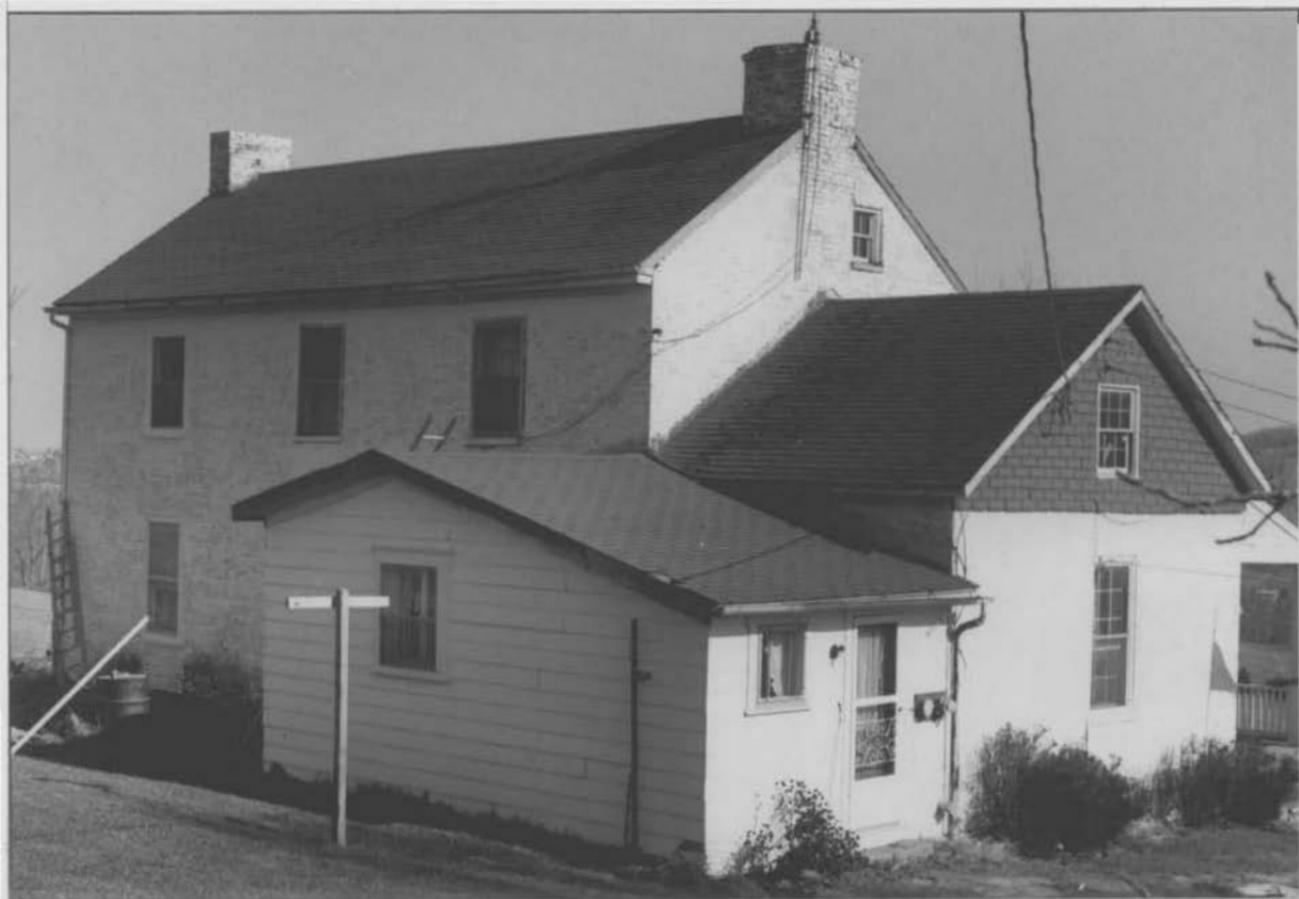
Northeast

Morgan Brick Farmhouse

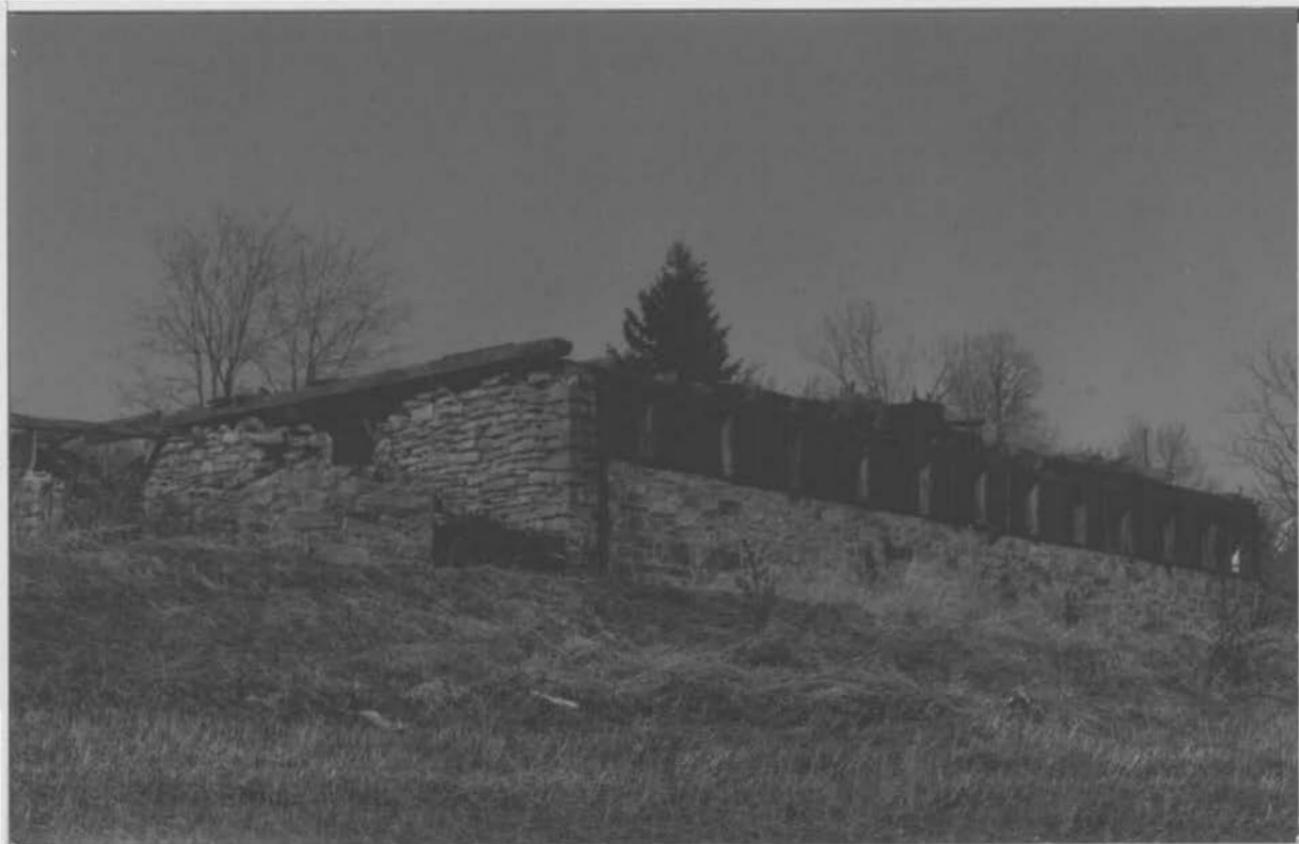
Barn Foundation

Located near by the main house is the foundation of a log barn. What remains is constructed of stone laid in random ashlar and coased rubble pattern. The remaining logs are hewn and mortised and tenoned together.

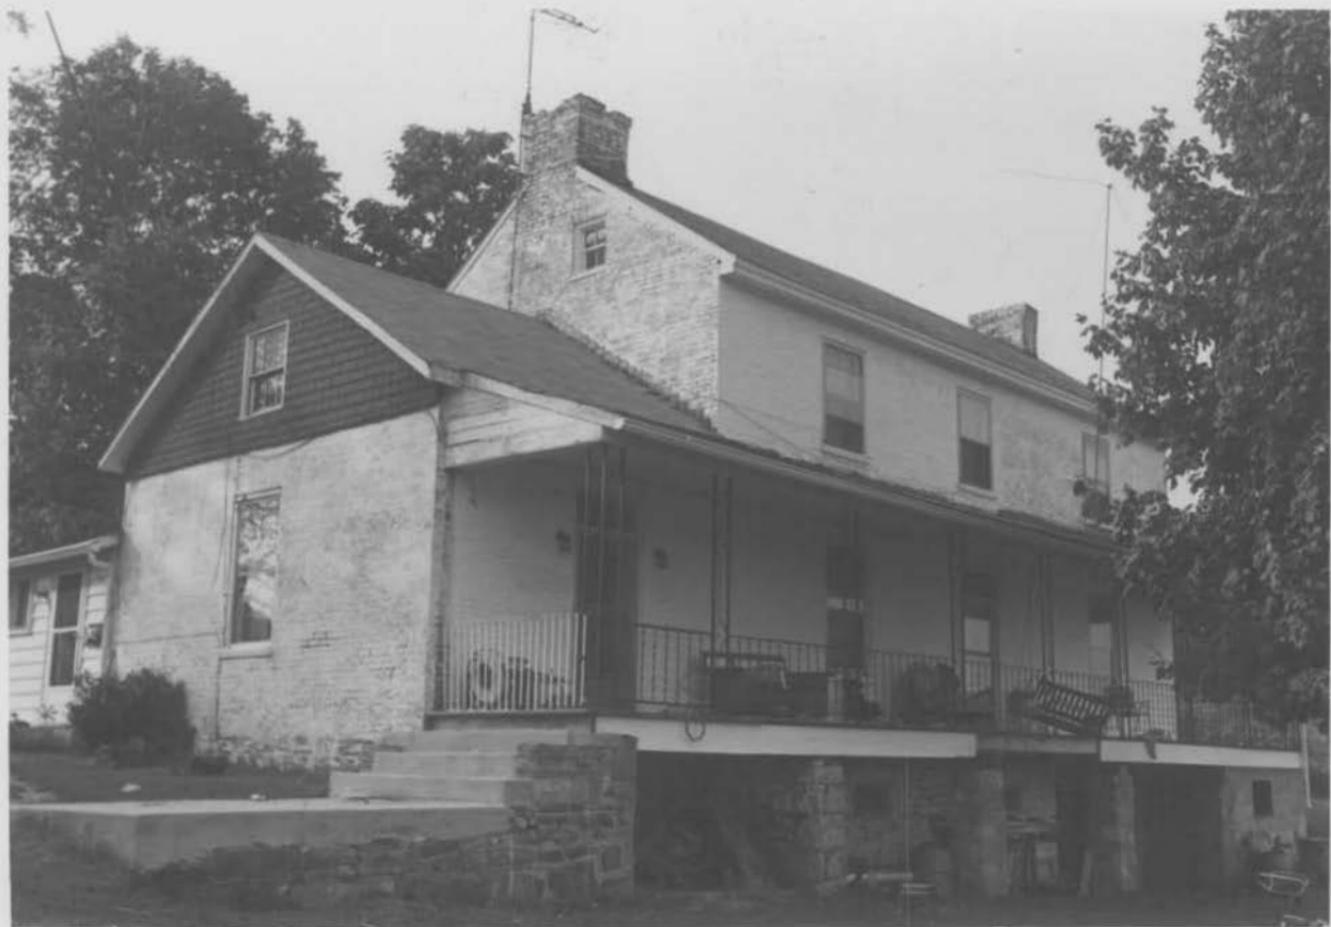
S & E elevs.

The three-bay farmhouse faces east. An original one story, one bay by one bay kitchen covers the south end. Either section is covered by a gable roof. As the hill slopes to the east, the stone cellar is fully exposed on this side. A one story, shed-roofed porch shelters the facade of both sections. An interior brick chimney heats either end of the main structure.

The facade of the entire structure is laid in 3:1 common bond. The remaining masonry exhibits 5:1 common bond. The south end of the kitchen is constructed in frame above the eaves line. Plain flat arches top the door and window openings. The house stands on a random rubble stone foundation with large, well-cut blocks forming quoins at the corners.

The exposed east wall of the cellar includes an entrance featuring a batten door to the north and two vents to the south. Each vent is a rectangular opening set horizontally under a single-stone lintel. Seven vertical bars fill the opening.

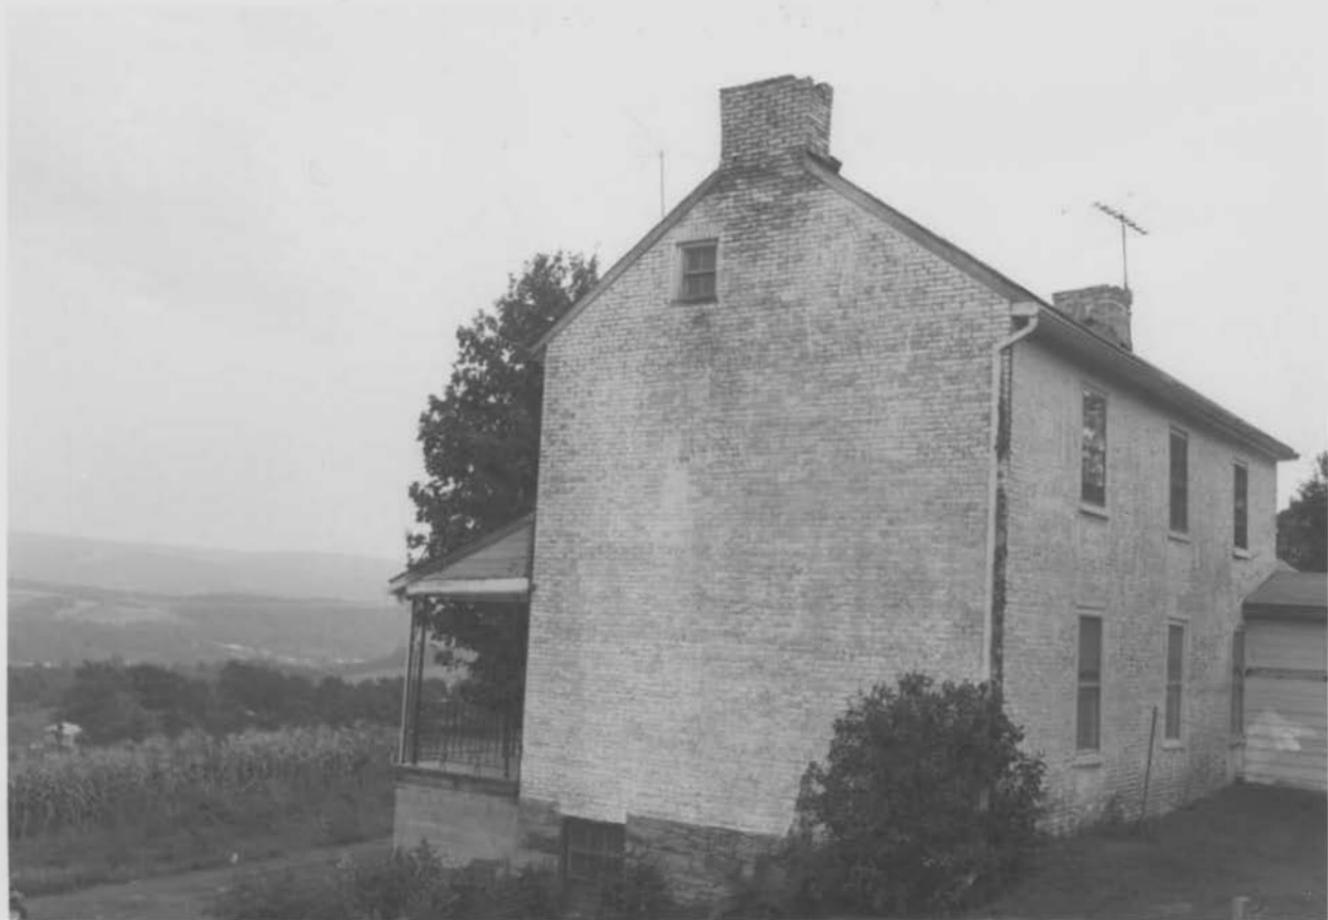
N & W elevs.

A modern, one story frame kitchen covers the rear of the original brick kitchen and the rear of the main block to the first window.

On the rear wall, small wooden blocks have been inserted in the mortar at the first and second floor levels, indicating that a porch or other structure may have been built onto this side at one time. All roof surfaces are covered with asphalt shingles.

On the facade, the main section includes a central entrance featuring a six-panel door topped by a three-light transom. A similar entrance opens into the kitchen. At the rear, the two end bays appear to have once accommodated doors. These openings have been bricked at the bottom, and are lit by 9/6 windows in the remaining space.

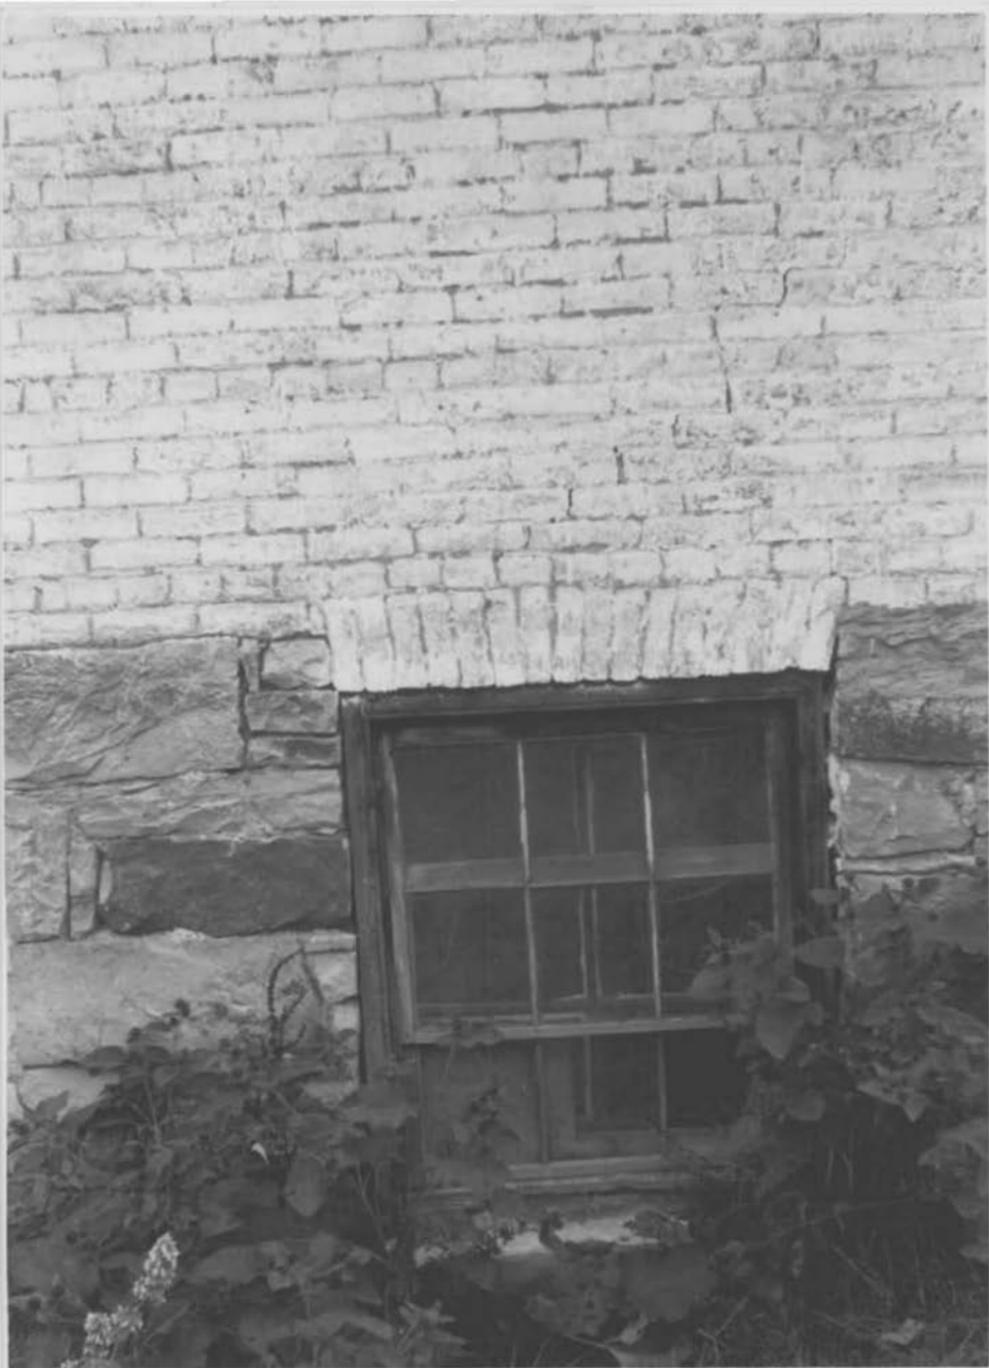
The Morgan Farm House is a two story, three bay wide, rectangular brick structure constructed of brick laid in American Common Bond. A small one and a half story addition abuts the main block on the south side. A second more modern addition is located at the rear of the building. Both the main house and the two additions have gable roofs, covered with replaced asphalt shingles. The main block is supported by a low stone foundation. Windows in the structure are double hung, pegged, wooden sash frames with six over six lights. Flat structural arches are located over the windows. Two entrances are located on the main facade and feature paneled doors with transom lights. Both entrances are covered by a four bay shed roof end porch. Two original brick chimneys are located at the flush ends of the house.
