**Maryland Historical Trust  
Determination of Eligibility Form**

Property Name: Midlothian Schoolhouse Inventory Number: AL-V-A-150  
 Address: Brode Mine Road Historic District: Yes  No  
 City: Midlothian Zip Code: \_\_\_\_\_ County: Allegheny  
 USGS Quadrangle(s): Frostburg  
 Property Owner: Howard Brode Tax Account ID Number: \_\_\_\_\_  
 Tax Map Parcel Number(s): 283 Tax Map Number: 23  
 Project: Midlothian Improvement Project Agency: Abandoned Mine Land Division & Soil Conversation  
 Agency Prepared By: Suzanne Trussell  
 Preparer's Name: Suzanne Trussell Date Prepared: 06/07/2015  
 Documentation Is Presented In: MIHP form and DOE report submitted to Maryland Historical Trust  
 Preparer's Eligibility Recommendation: Eligibility Recommended  Eligibility Not Recommended  
 Criteria:  A  B  C  D Considerations:  A  B  C  D  E  F  G  
*Complete if the property is a contributing or non-contributing resource to a NR district/property:*  
 Name of the District/Property: \_\_\_\_\_

**Midlothian Schoolhouse**

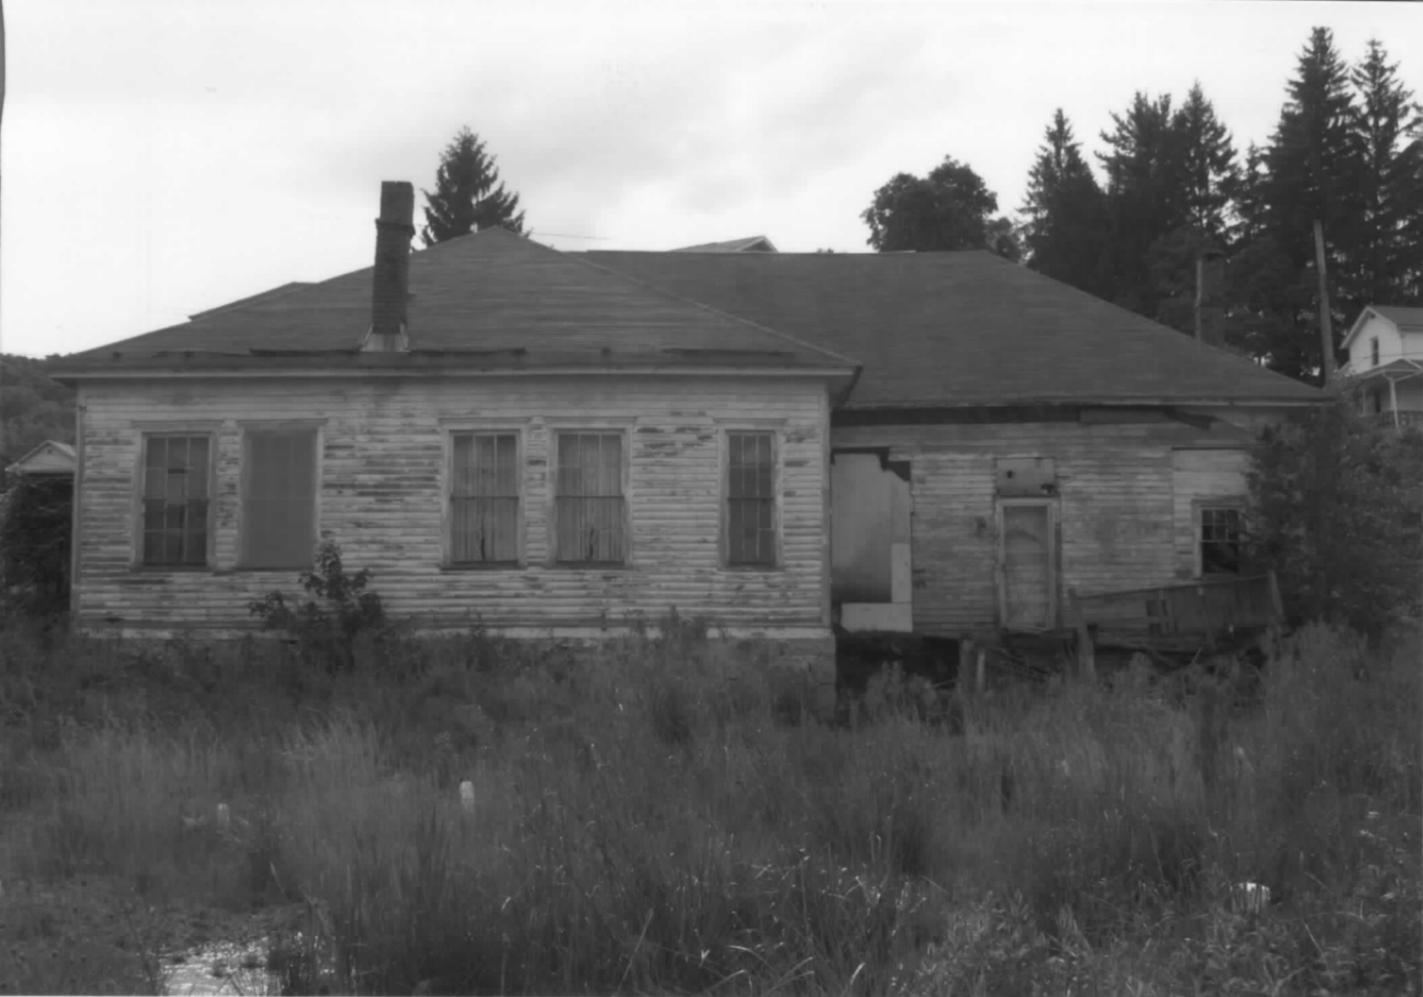
PHOTO # 1 of 11

East (side) Elevation: The east main block façade consists of three bays containing two pairs of large sized six-over-six windows and one narrow six-over-six window. The main block east façade windows are all extant and in poor condition. The rear wing east façade has three bays that originally consisted of two large windows and a center doorway; all three of these window and door features have been significantly altered by removal or demolition and the areas where these features once existed is now in poor condition.

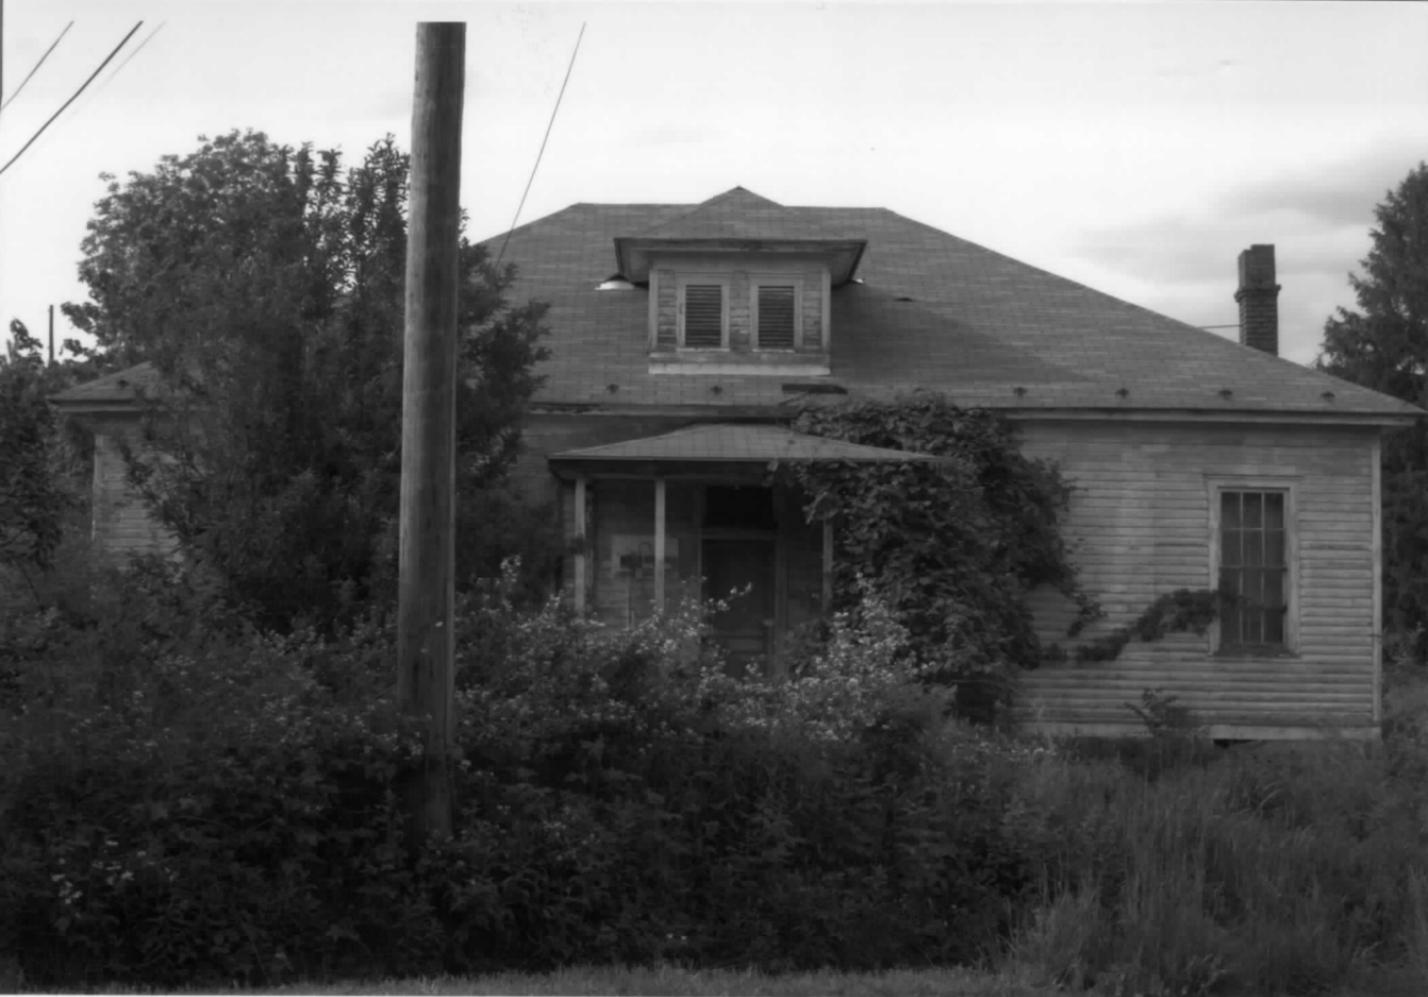
PHOTO # 2 of 11

South (front) Elevation: This façade consists of five bays containing four original large size six-over-six window units, one of which is boarded over; all the wood window sash and trim retain original integrity but are in poor condition.

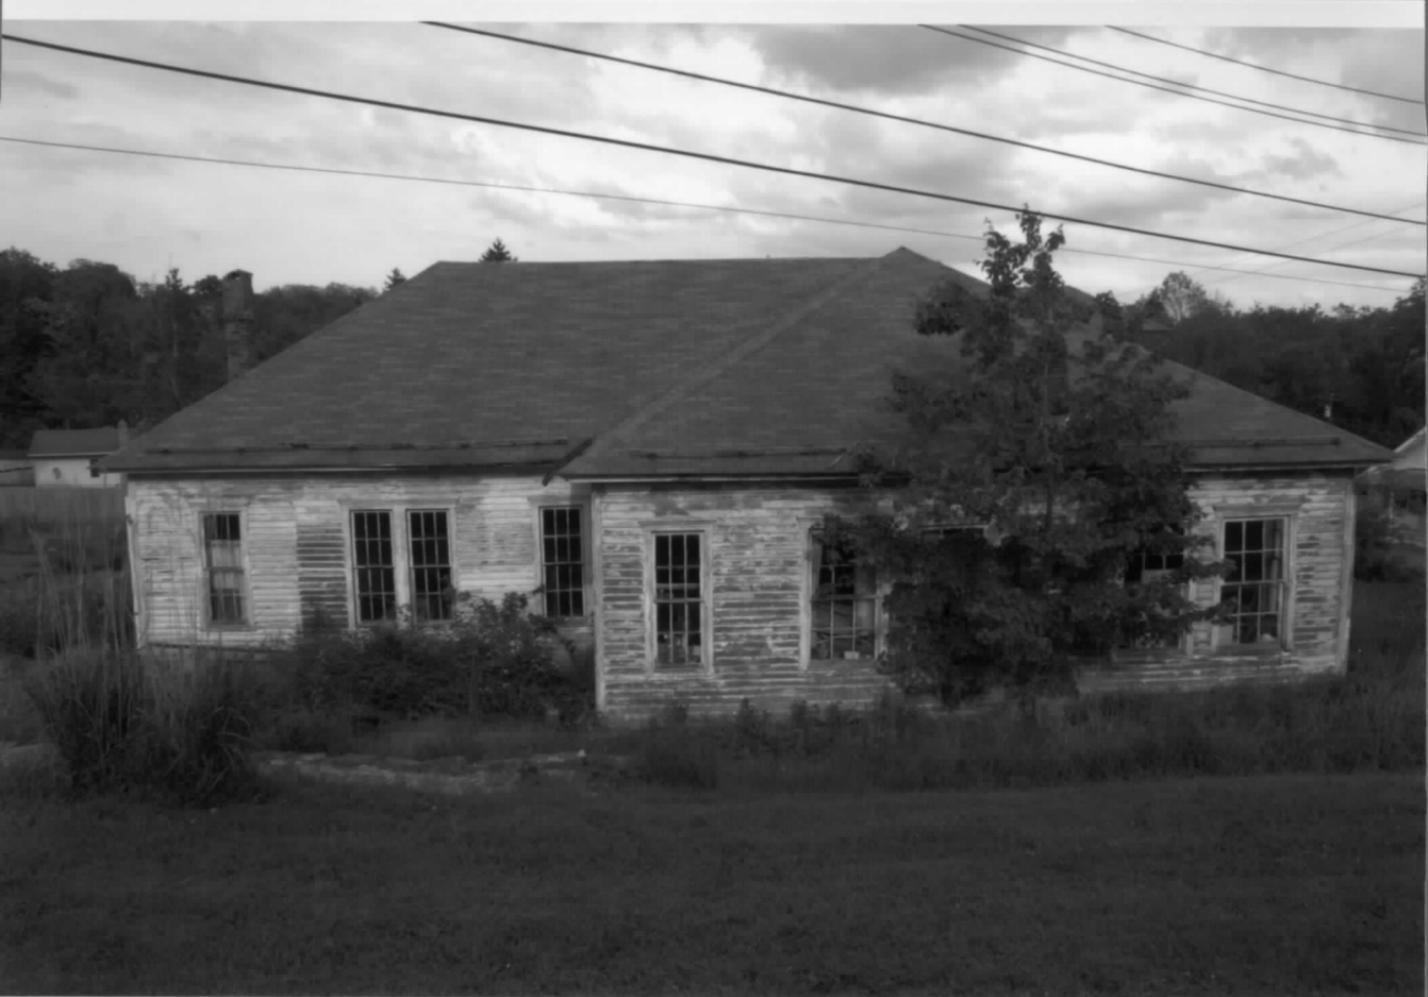
AL-V-A-150  
Midlothian Schoolhouse  
Allegany County, MD  
Suzanne Trussell  
5/29/15  
West (side) elevation  
Photo # 3 of || 7766901, pict0010ck\_003

West (side) Elevation: The west elevation main block façade contains two sets of paired large six-over-six sash windows and one narrow six-over-six sash. The west elevation rear wing façade contains a set of paired narrow six-over-six windows and two additional narrow six-over-six windows. All the north elevation windows retain original integrity and are in fair to poor condition. During the period of schoolhouse use, all the Midlothian Schoolhouse interior surfaces were of consistent throughout the structure. The floors were wooden flooring. The wall treatment consisted of stained wood beaded board wainscoting with a molded chair railing and plaster walls. Interior door and window casing used plain trim. The ceilings were stained wood beaded board with a crown molding.

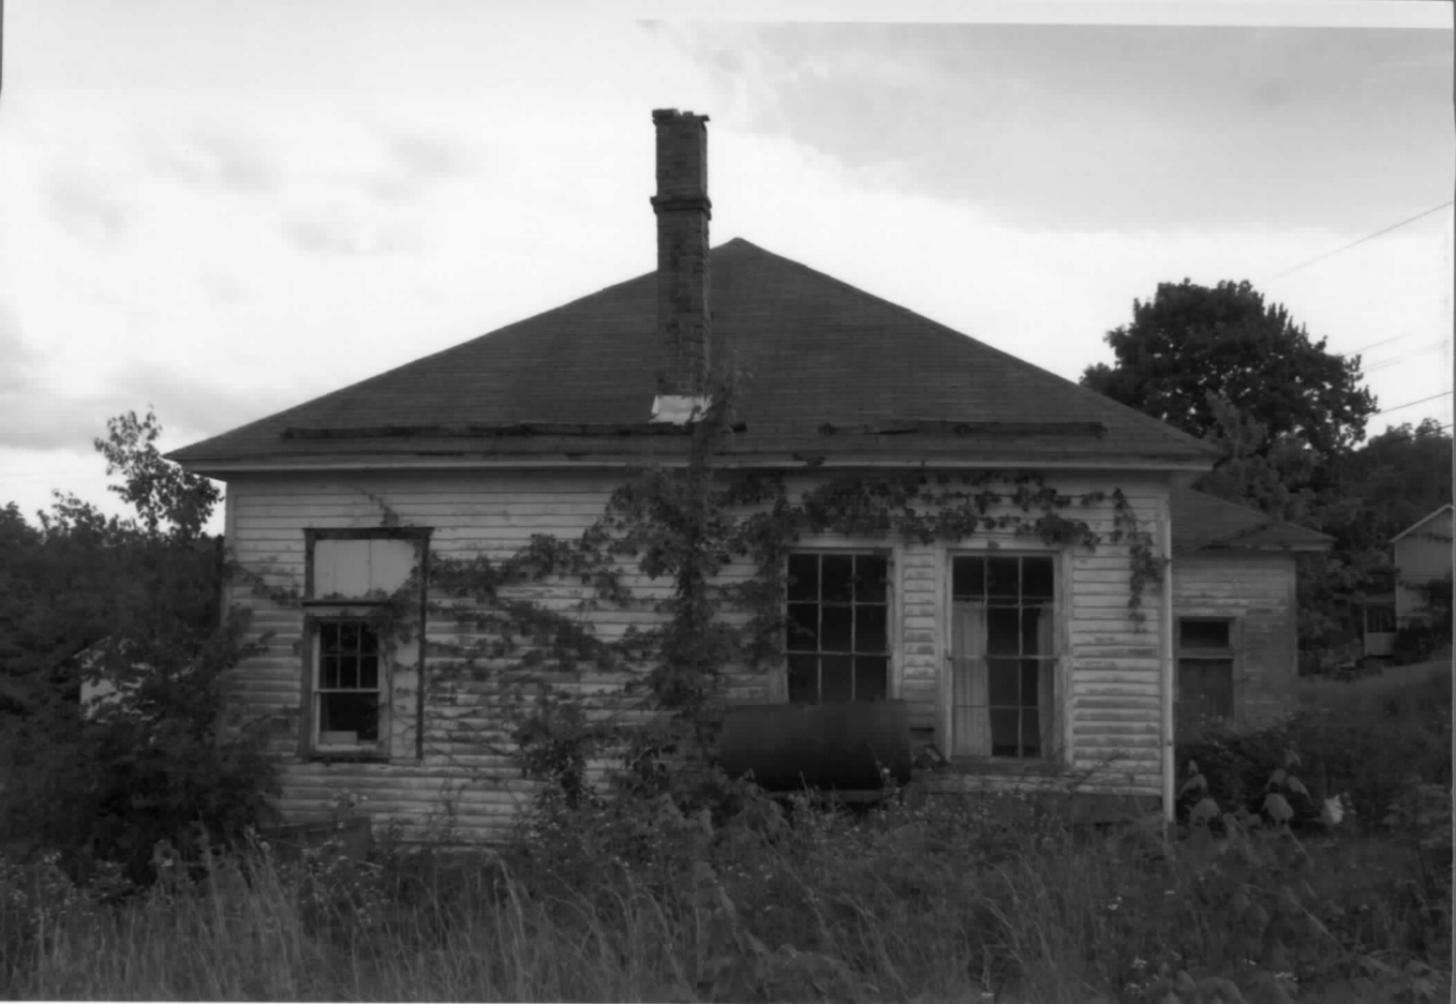
AL-V-A-150  
Midlothian Schoolhouse  
Allegany County, MD  
Suzanne Trussell  
5/29/15  
North(rear) elevation  
7766901, Pict0013\_004  
PHOTO # 4 of 11

North (rear) Elevation: The north rear wing façade consists of three bays with one set of the large six-over-six paired windows and one large six-over-six window that was removed and replaced with a smaller double hung window during the rehabilitation. The rear wing façade is flanked on either side by the rear elevation of the main block main. These two flanking facades consist of two bays that contain a historic doorway with single light transom above and a narrow six-over-six window. The historic transom light over the door on the east side of the main block rear façade has been boarded over. All the historic doors and windows at the north elevation retain original integrity but are in poor or failed (unsafe) condition.

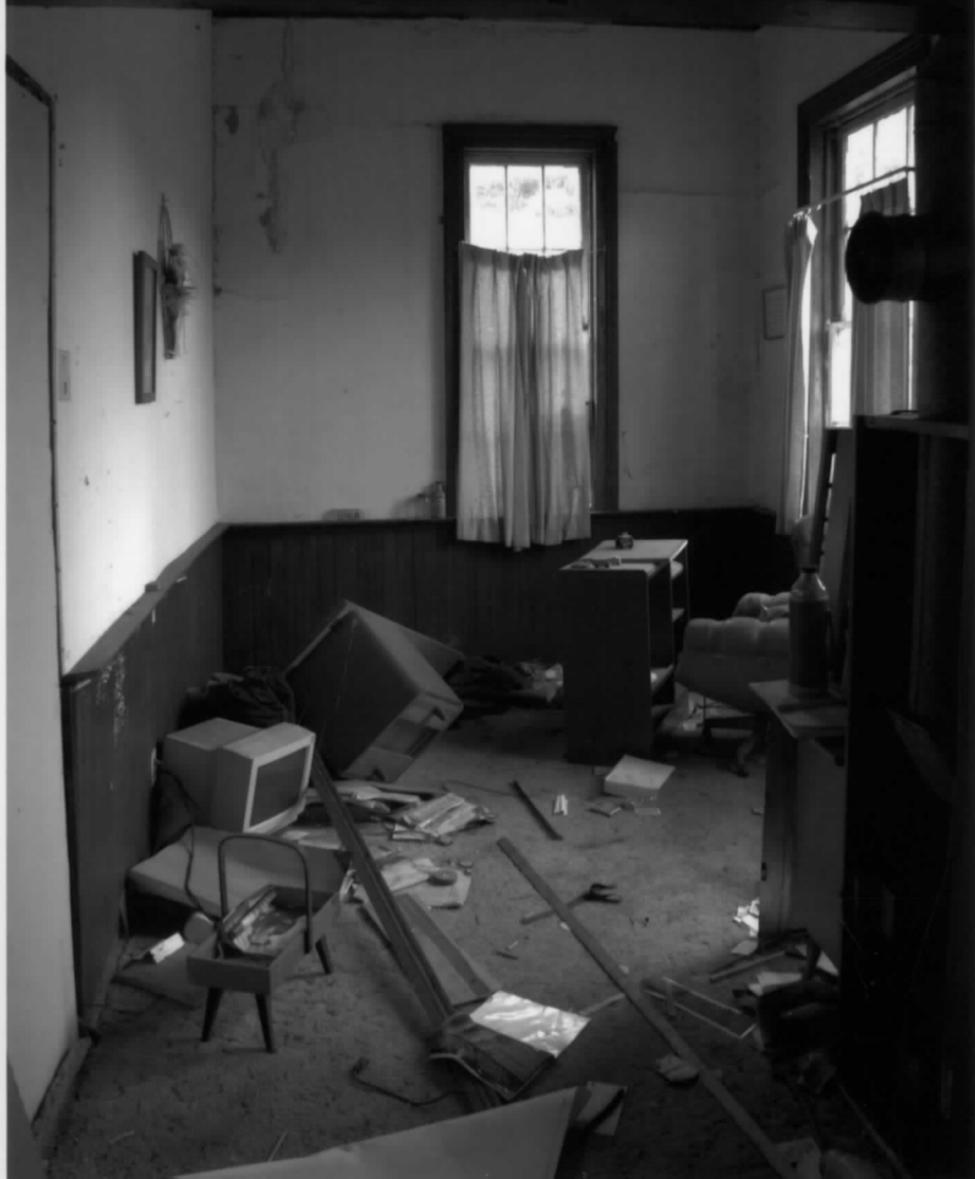
PHOTO # 6 7766941, pict0022\_006  
of 11

Rear wing classroom: Some interior finishes intact, areas of demolition and new construction. Loss of building fabric integrity, poor condition.

AL-V-A-150  
Midlothian Schoolhouse  
Allegany County, MD  
Suzanne Trussell  
5/29/15  
Rear classroom

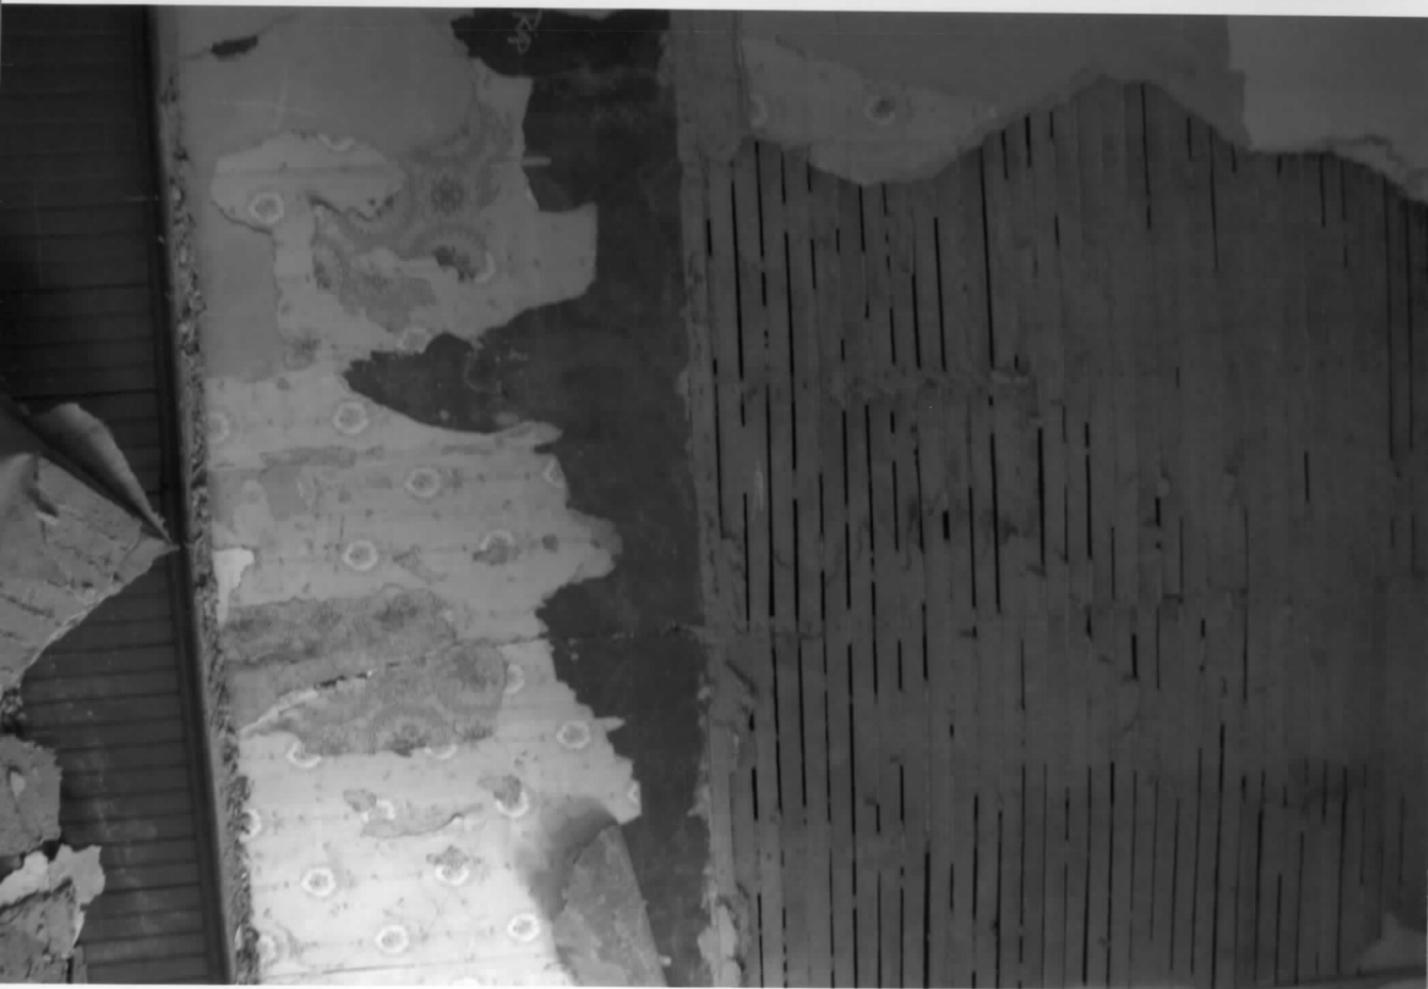
Photo # 7 of 11 7766901, pict0024\_007

Deteriorated wall in small room
