AL-V-A-280

Fairview Farm
Midlothian
Private

circa 1900

INVENTORY FORM FOR STATE HISTORIC SITES SURVEY

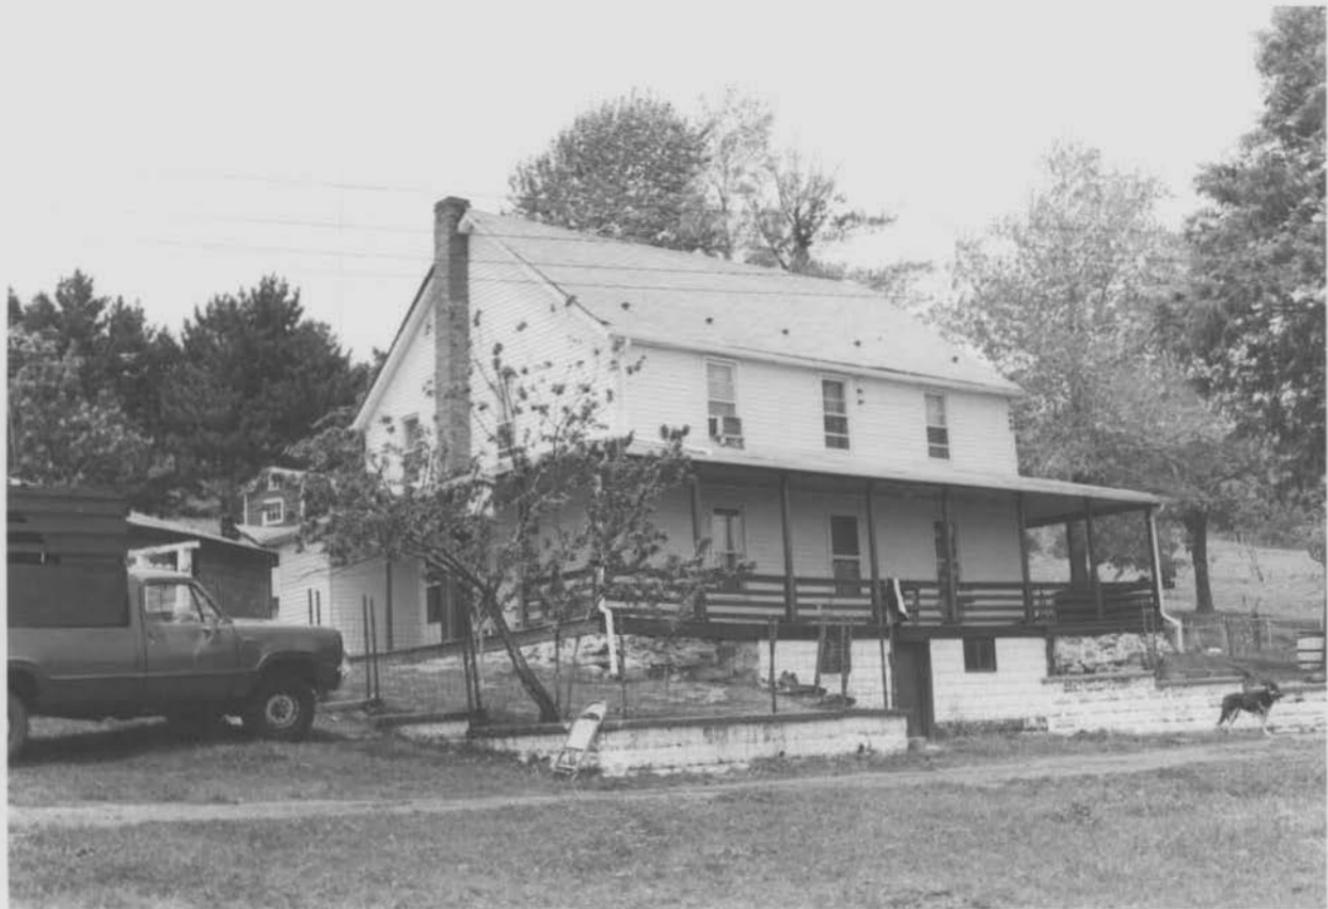
Willaim Barnes Hs. E elev.

The earlier of the dwellings is the William Barnes House. The two and one-half story building is three bays wide on the facade (eastern elevation), and two bays deep. Wall construction of the house is frame with vinyl siding covering the original wooden siding. It rests on a high random rubble stone foundation. The gable roof is covered with asphalt shingles. A wrap or round veranda on the facade and the northern and southern elevations has a hipped roof supported by square wooden posts. Windows are 1/1 sash. An entrance is in the center of the facade. An exterior brick chimney is on the southern elevation.

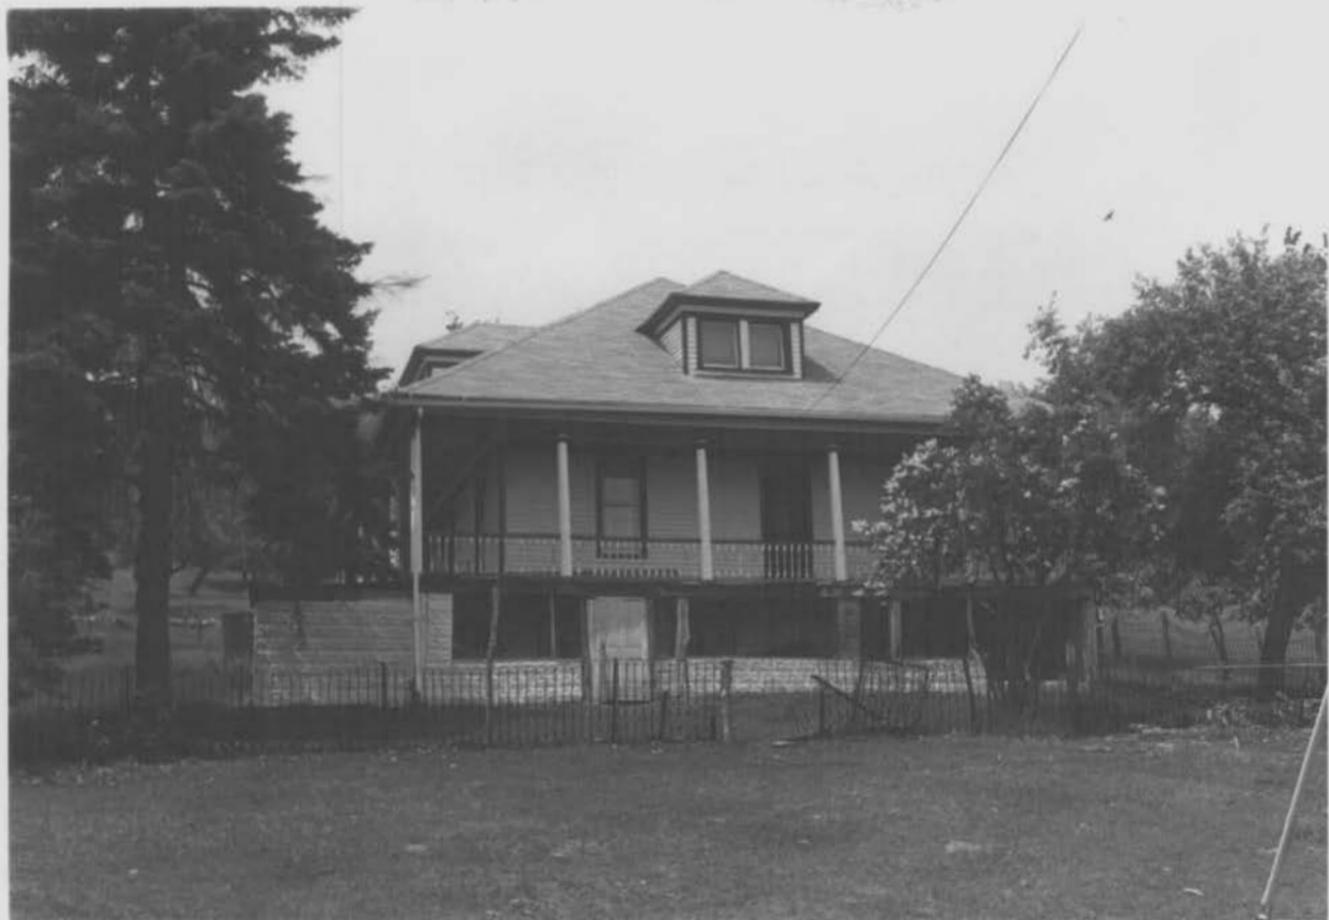
Henry Barnes Hs. E elev.

The other dwelling is the Henry Barnes House. This one and one-half story dwelling is three bays wide on the facade (eastern elevation), and three bays deep. Wall construction is frame covered with weatherboard siding. The building rests on a high rubble stone foundation. The pyramidal roof is covered with asphalt shingles. Eaves consist of a boxed cornice, soffit, bed mould, and a wide frieze. An umbrage porch on the facade and southern elevation has turned balusters and wooden Kaman Doric columns. Windows are 1/1 sash. An entrance in the center of the facade includes a mine light frame and glass door which is surmounted by a transom. A brick chimney is located on the interior of the house. Hipped dormers, each with a pair of single pane windows, are located on the facade and southern elevation.

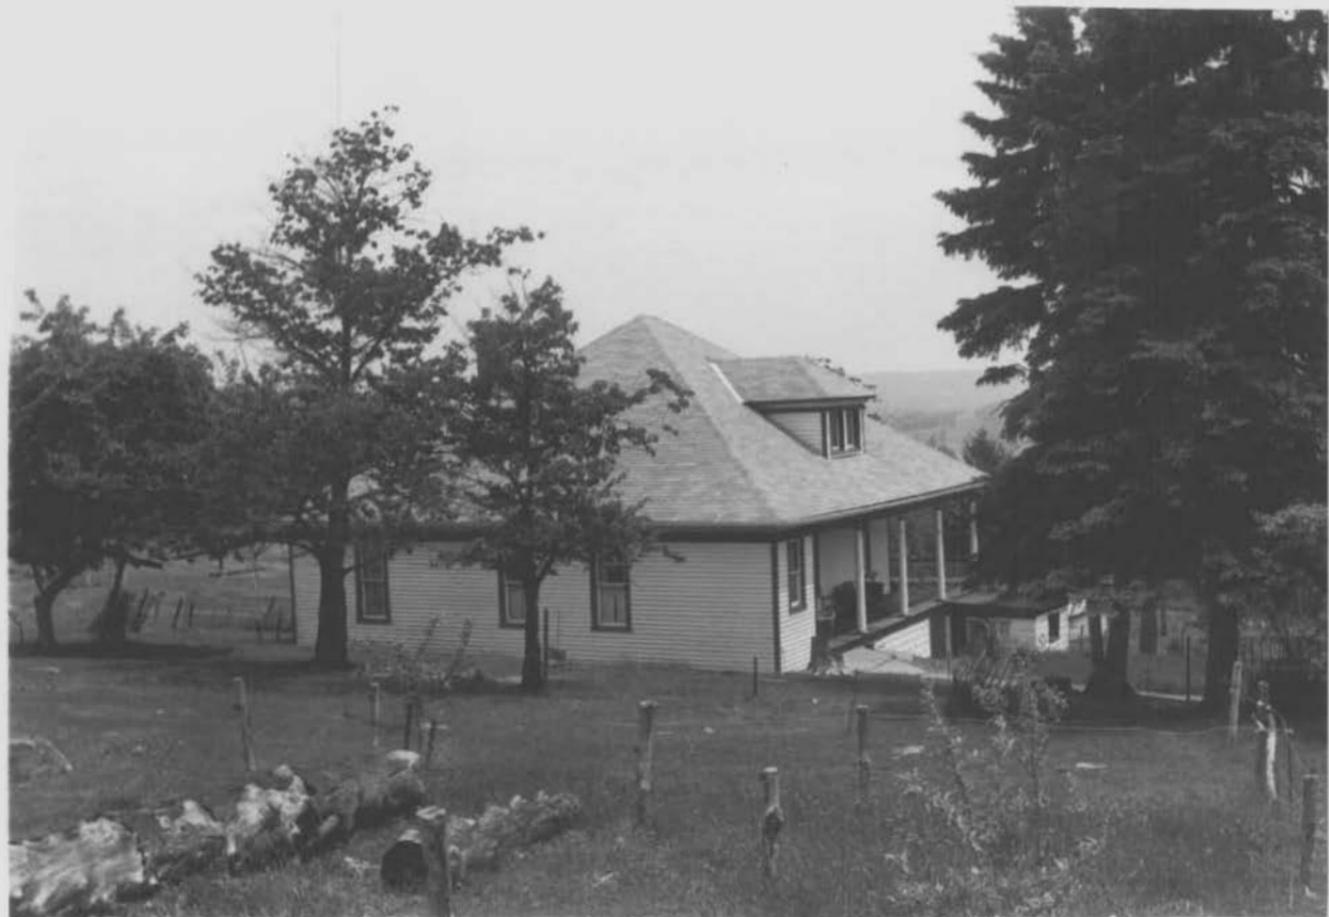
Henry Barnes Hs. W elev.

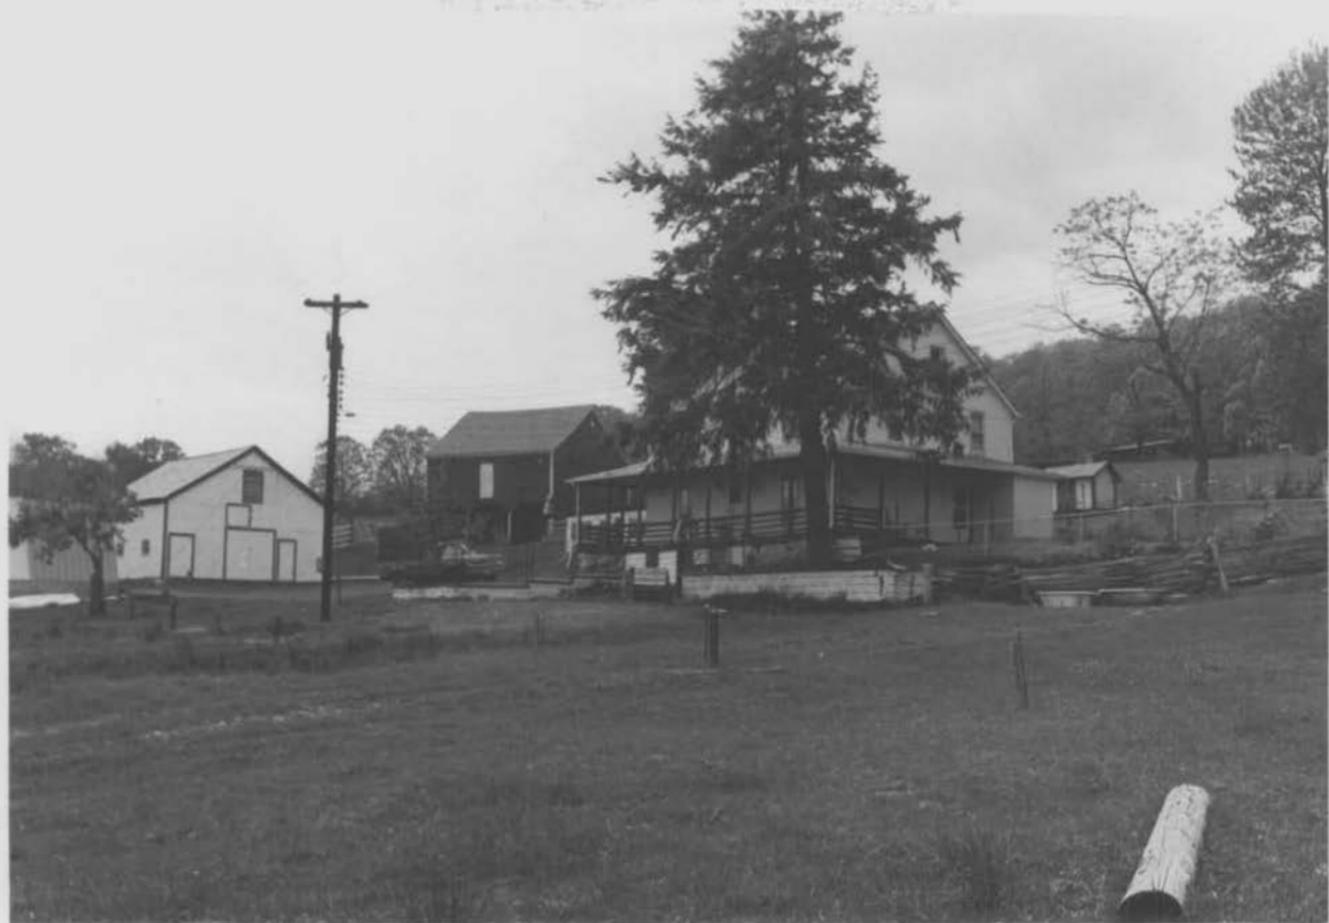
AL-V-A-280
Fairview Farm
Allegany Co., MD
David A. Dorsey 6/81
William Barnes Hs. N elev.

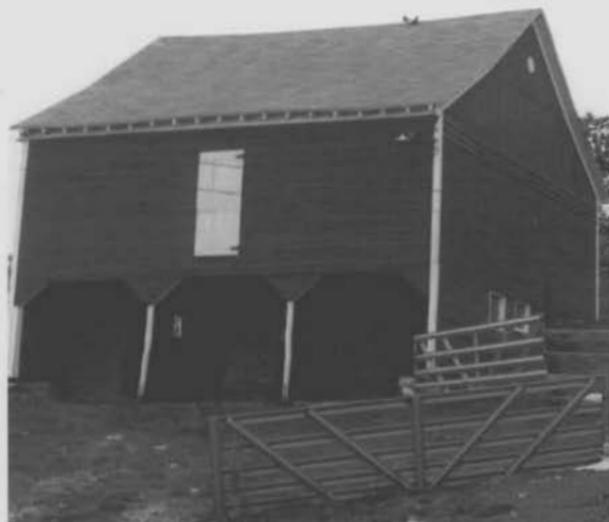
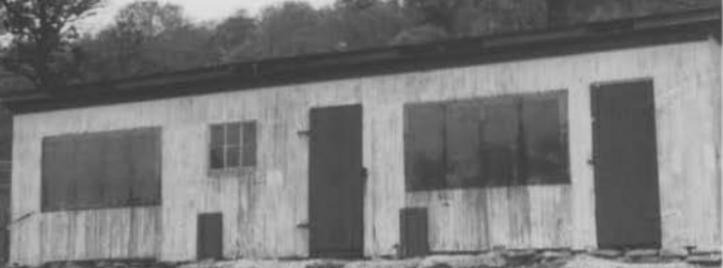
Barn & Coop, View to SE

Two barns are located to the south of the William Barnes House. A bank barn is of frame construction and is covered with german siding, weatherboards, and beaded flushboards. It rests in a high rubble stone foundation. A forebay on the eastern elevation of the barn is supported by wooden posts. The gabled roof of the barn is covered with corrugated metal. The second barn, also of frame construction, is covered with german siding. The gabled roof is covered with slate shingles.

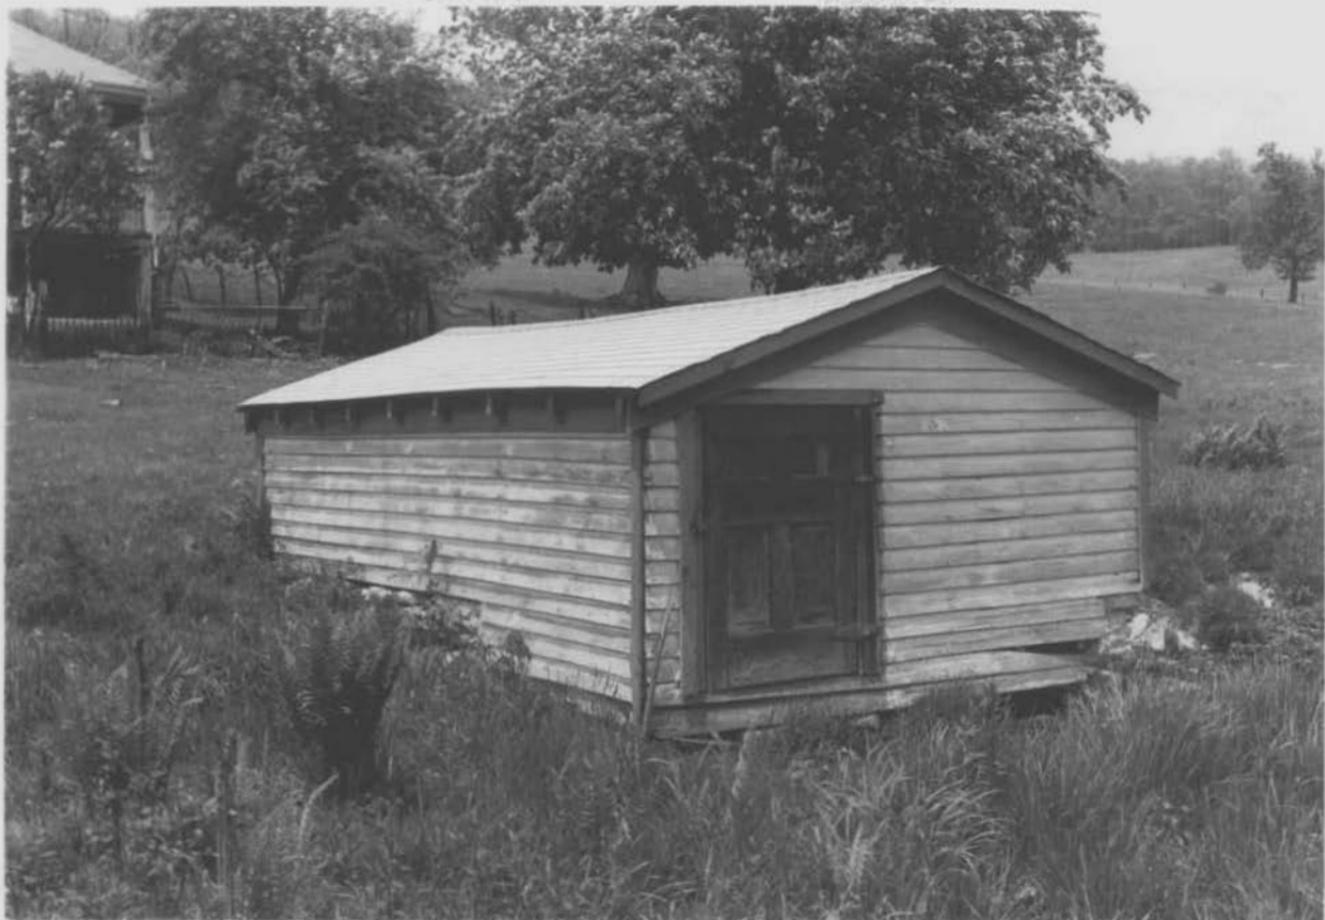
AL-V-A-280
Fairview Farm
Allegany Co., MD
David A. Dorsey 6/81
Springs. E elev.

Outbuildings include two vertical board chicken coops, a hutch, sheds, a small board and batten structure, a garage, and a springhouse. The frame springhouse is covered with weatherboards. It rests on a low rubble stone foundation. The gabled roof is covered with asphalt shingles. An entrance is on the eastern elevation of the springhouse.

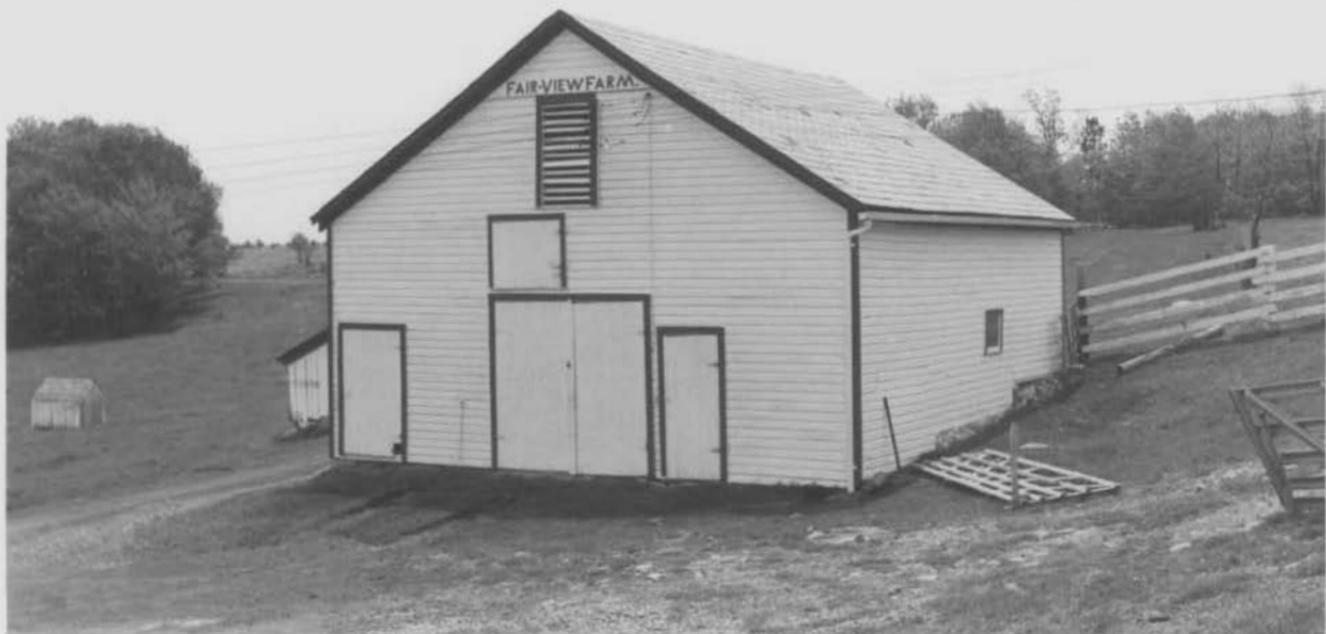
AL-V-A-280
Fairview Farm
Allegany Co., MD
David A. Dorsey 6/81
Barn N elev.

The barn rests on a low rubble stone foundation. Four vertical board doors on the northern elevation, including a loft door, open on hinges. A louvered ventilator is located in the peak of the gable.
