State Historic Sites Inventory Form

Lawson Duckworth House

DAN'S MOUNTAIN STATE PARK

LAWSON DUCKWORTH HOUSE

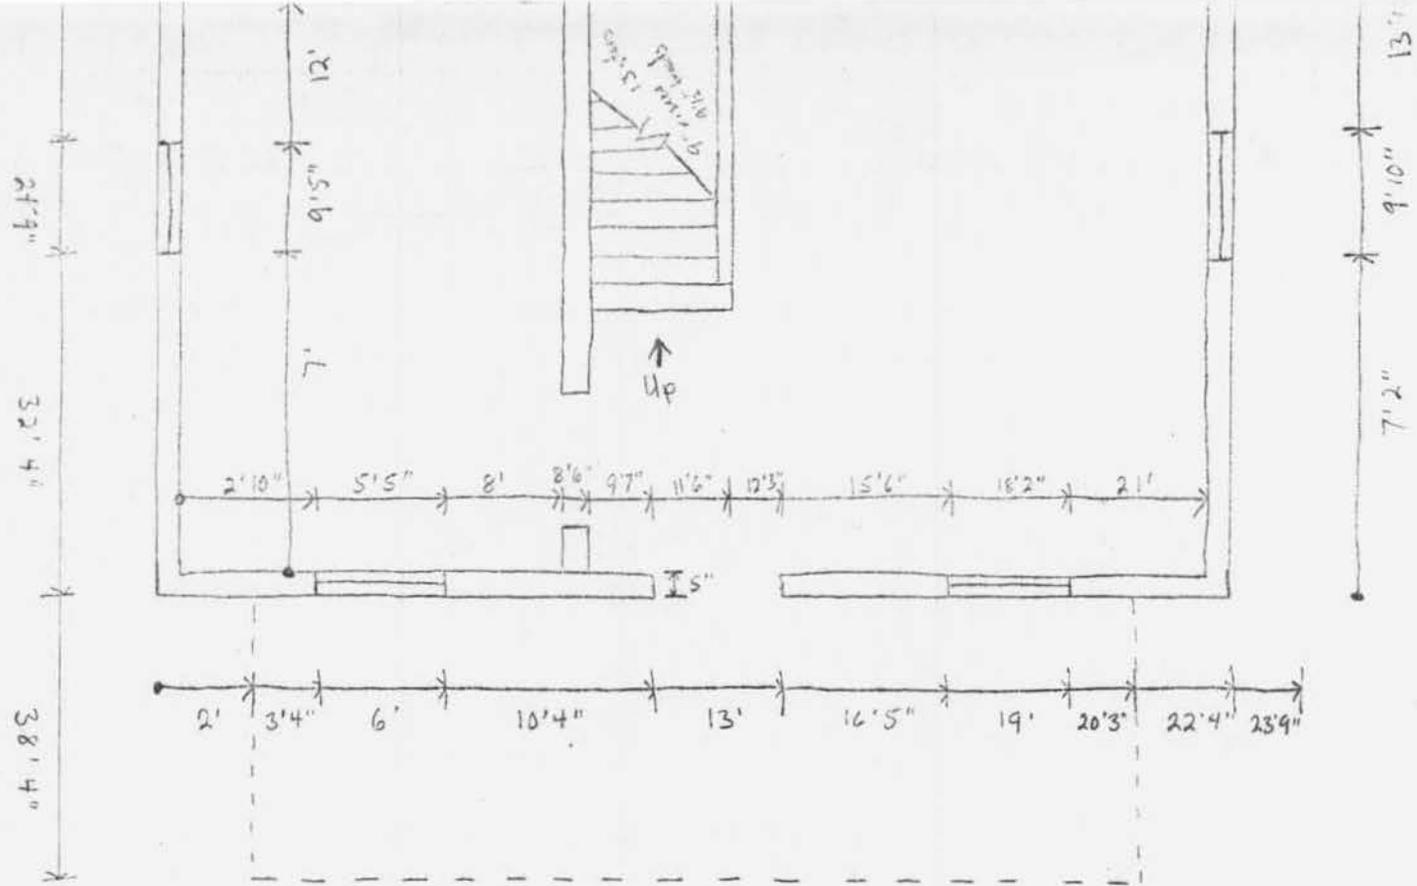
First Floor Plan

The interior of the structure has a two-room plan with a central enclosed stairway in the main section and a single room for a kitchen in the ell. The northern room in the main section has slightly more elaborate woodwork with panels below the windows and an eight inch baseboard with molded lip. This room probably served as a parlor. It has been shortened by the installation of a bathroom at the rear of this room in the mid-twentieth century. The second floor plan is similar with two rooms in the main section and a single room in the ell.

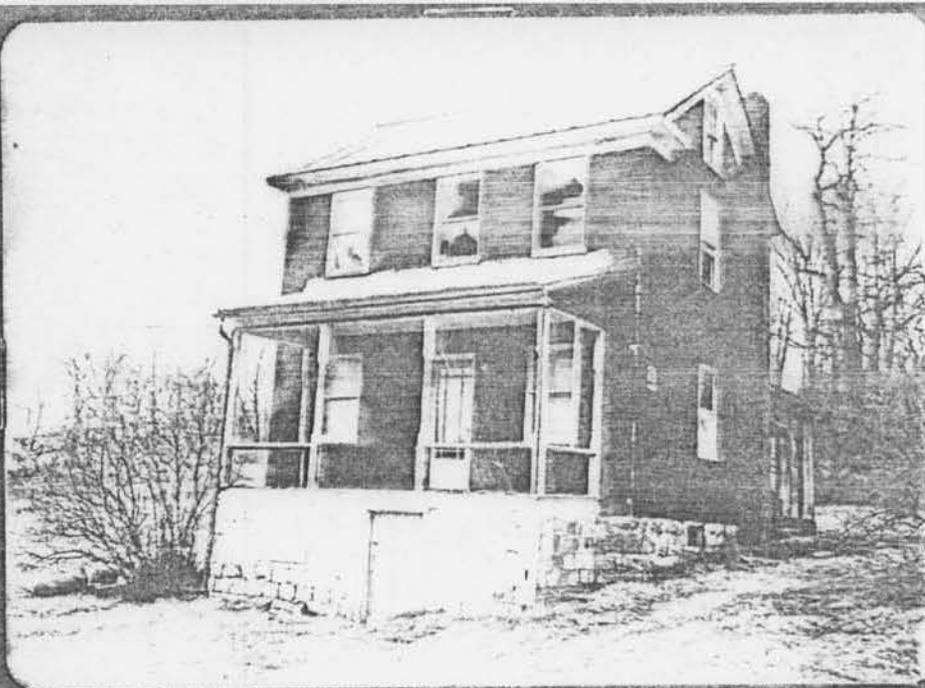
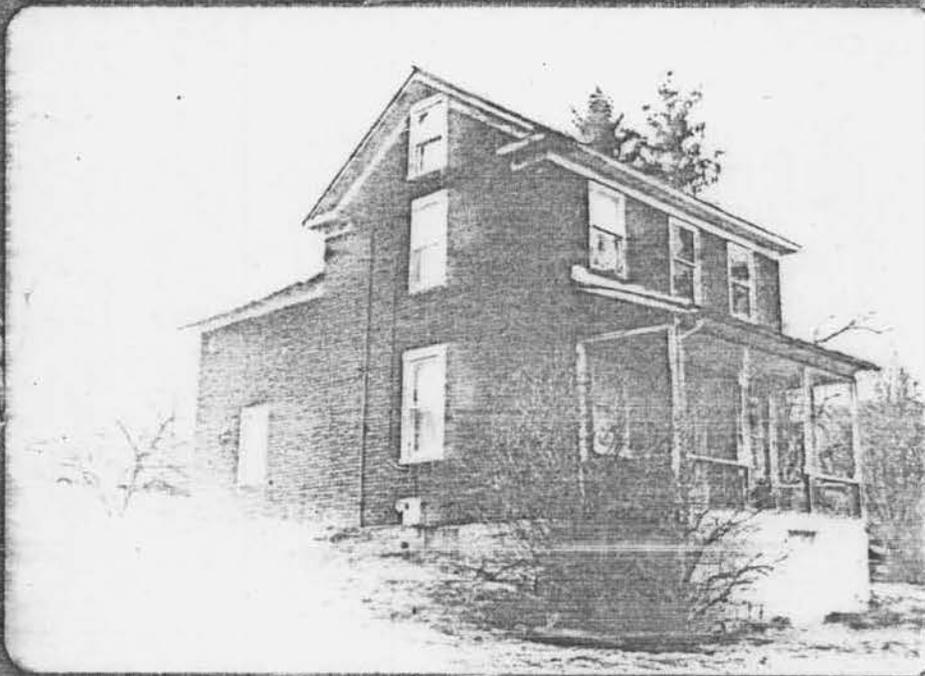
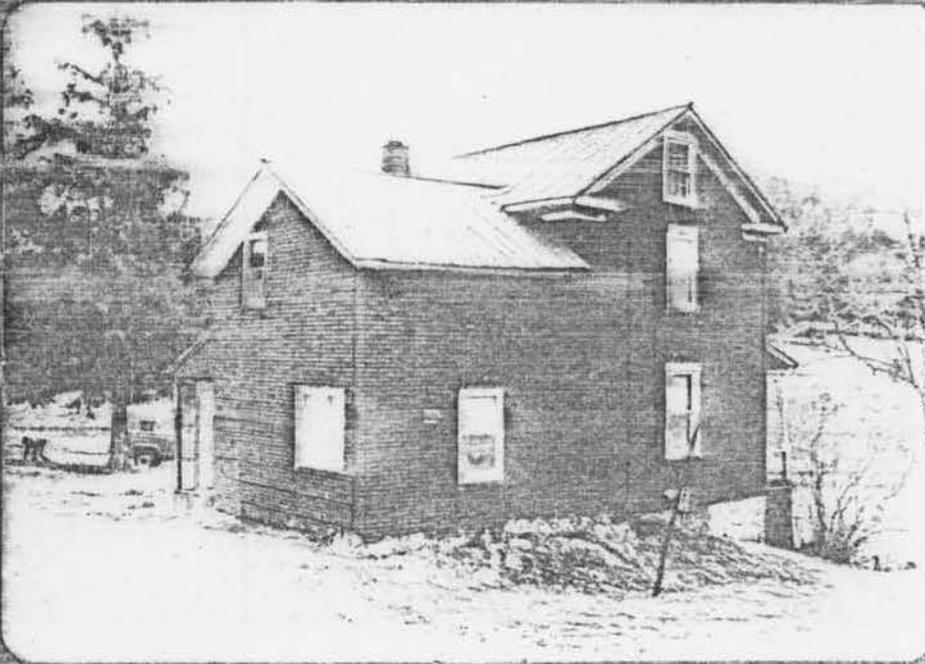
top West & South Facades
center West & North Facades
bottom North & East Facades

The Lawson Duckworth House is a two-story, three-bay by one-bay structure with a one-bay ell, ~~wing~~. The structure has a stone foundation that is constructed into a slope so that there is a full story on the main (west) facade. The structure has a gable roof with a box cornice that returns at the corners. The roof is covered in sheet metal.

The main facade has a central entrance with one-over-one sash windows on the outer bays of the first story and the three bays of the second story. Window and door frames are plain

Each gable end of the main section has a single one-over-one sash window on each story and a small six-over-six sash window in the gable. The windows in the gable have molded frames while the other windows have plain board frames. The ell wing has a one-story porch with a shed roof on the south side of the structure. While the porch has a modern floor and screen framing, the roof ^{a-d} other features make it appear to be original. The east gable end of the ell has a double window on the first story and a single window on the second story. The north facade of the ell contains a single window on the first story.

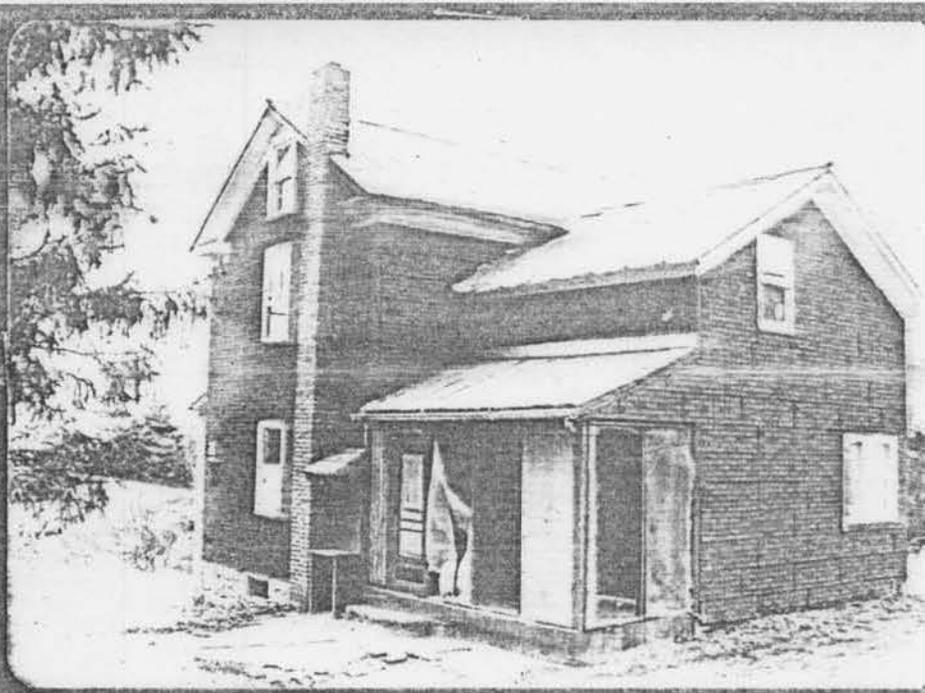
top South + East Facades
center Porch Detail South Facade
bottom Vertical Board Construction

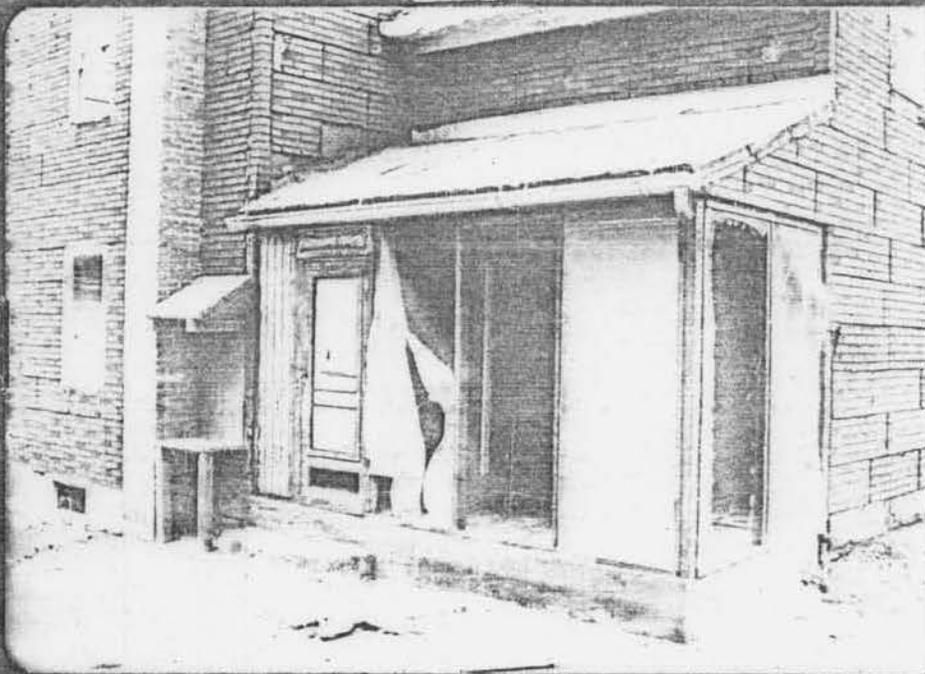
board frames. A one-story porch with a shed roof and turned posts is supported by a high porch foundation constructed of a red clay block. The surface of the blocks are twelve inch by eight inches. In the center of the foundation level porch is a doorway that enters into the basement of the building. The foundation of the building is constructed of a squared stone that appears to be a type of regional sandstone that was easily shaped for constructing foundations.

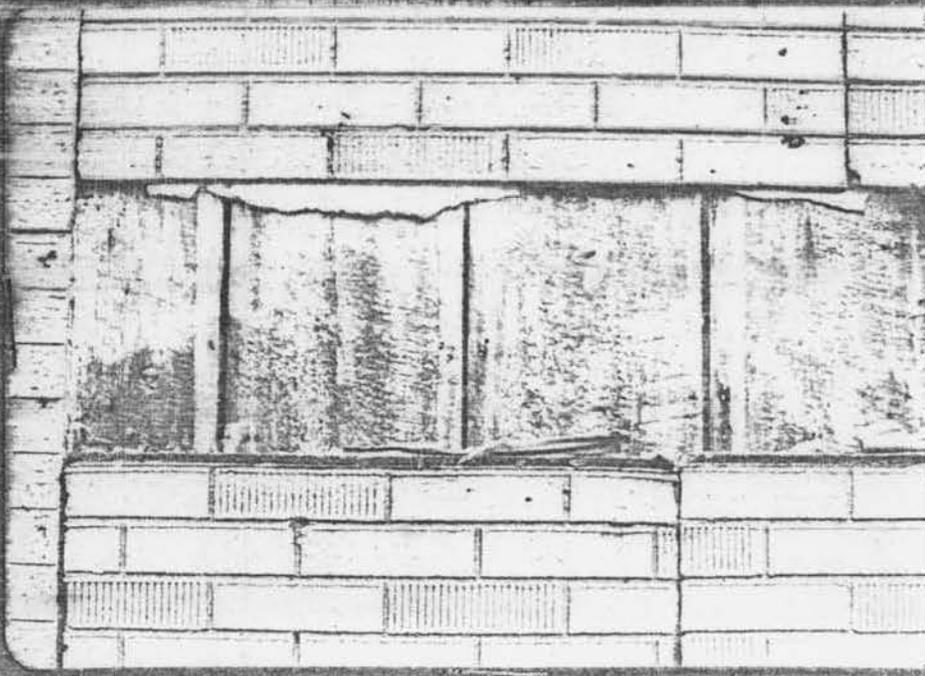
The building is constructed of a wood frame structure with two-by-two studs. The studs are then covered with vertical boards that vary in width from eight to ten inches. The vertical board structure is then covered in a asphalt siding that imitates brick. From the construction details, it appears that the ^{L-} ~~ell~~ shaped plan of the structure is original but that the front porch is a later addition. It may be that the porch foundation is later but the porch posts and roof are reused from an original porch on the structure. The present ranger at Dan's Mountain who lived in

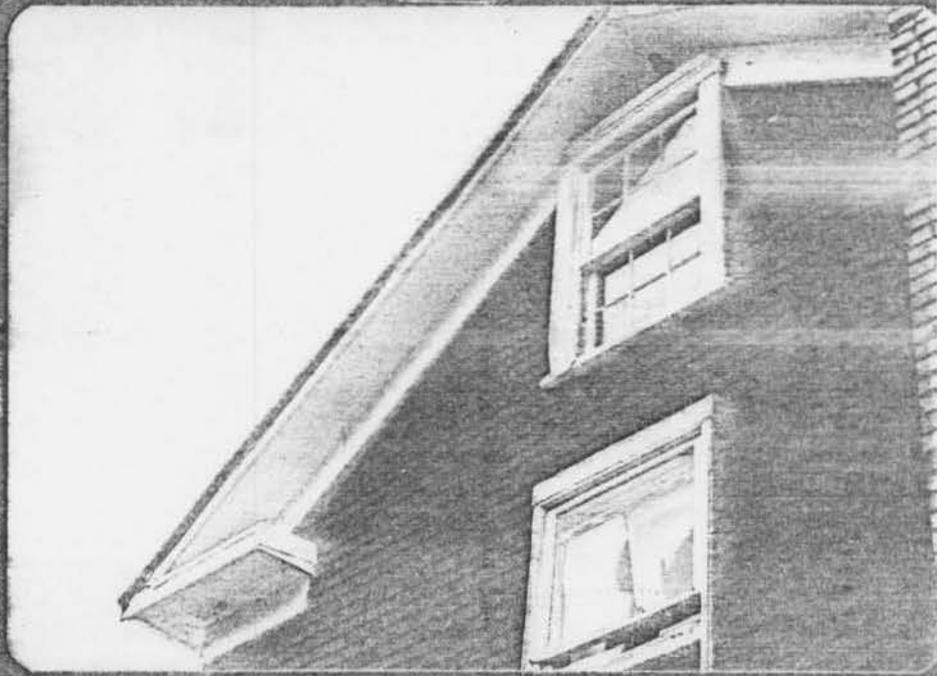
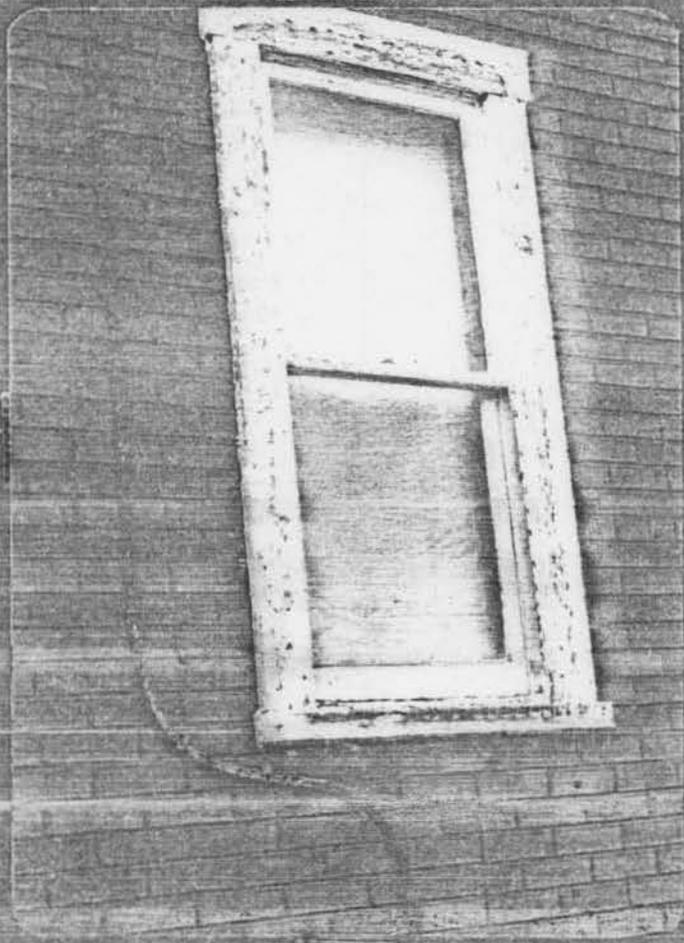
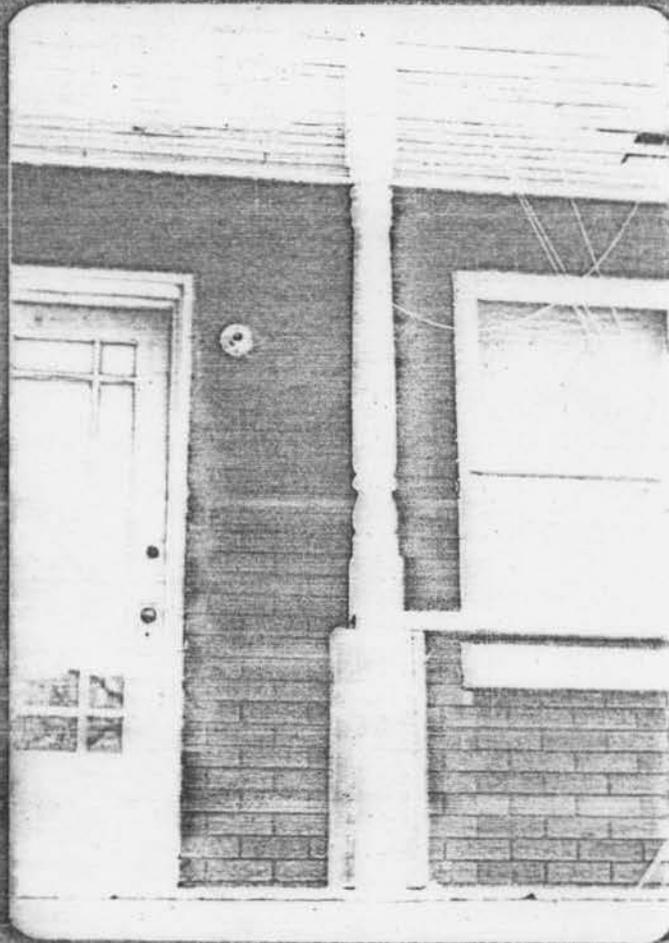
The structure was a practical farmhouse for a resident of this area. In construction techniques it was easy and inexpensive to construct. Local stone was used in constructing the foundation. A wood frame covered in vertical boards ^{is} ~~was~~ also a frequently found construction technique in this area. It was then covered with a modern type of siding. As in many houses, ornamentation is sparse and ~~pretty-much~~ confined to the porch and its turned posts. An unusual feature in this house is the six over-six sash windows in the gable with their molded frames.

top - Gable detail
bot. left - Window detail
bot. right - Porch post

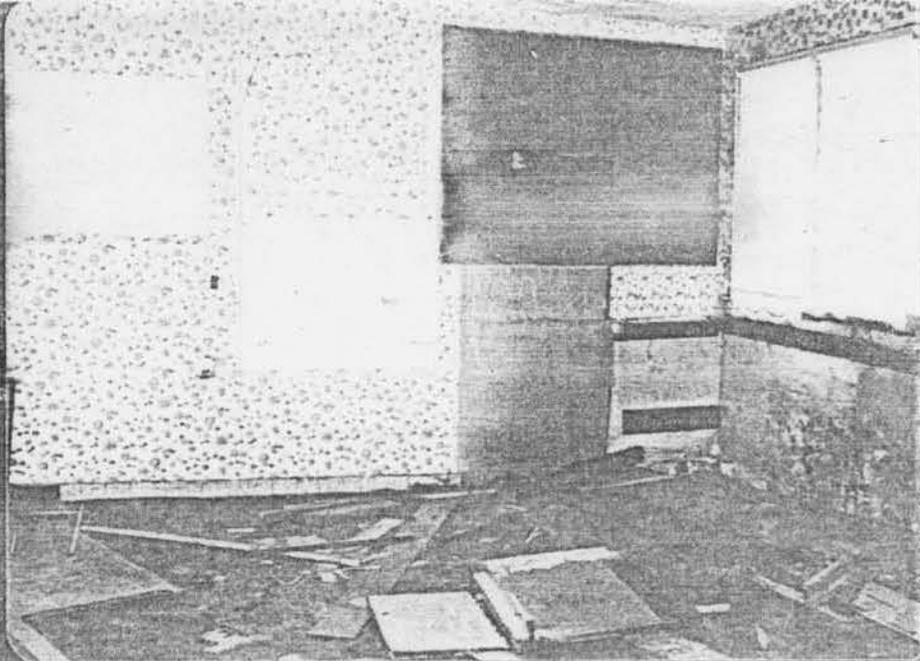
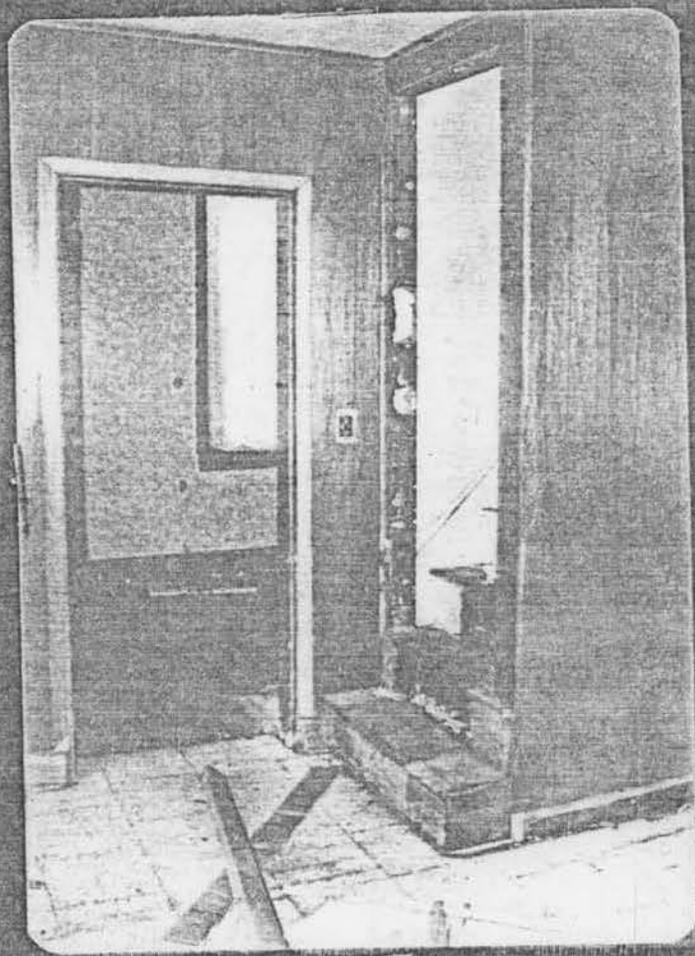
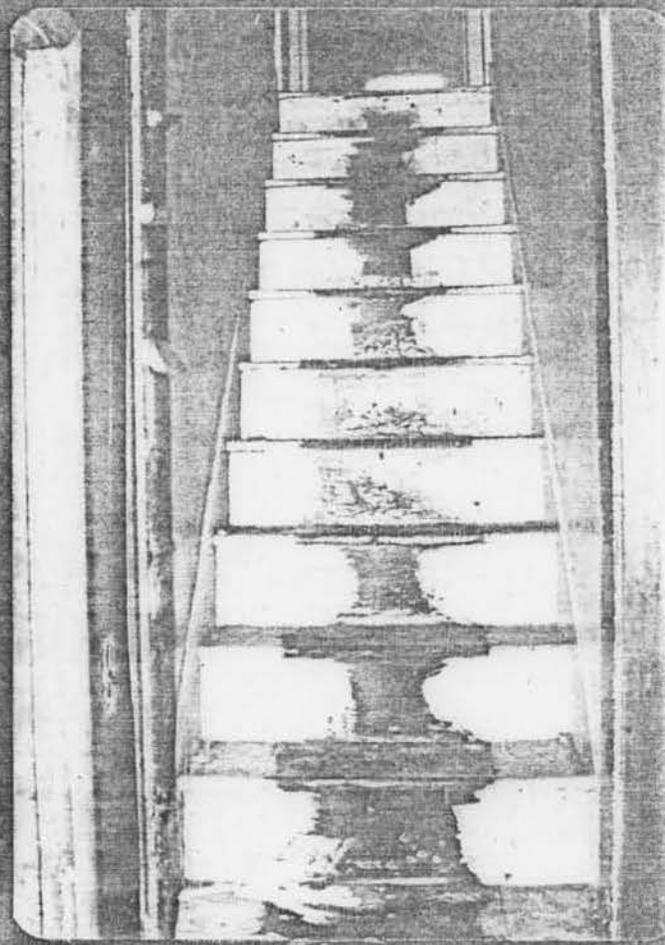
INTERIOR top - kitchen
b.t. left - parlor door & stairs
bot. right - stairs

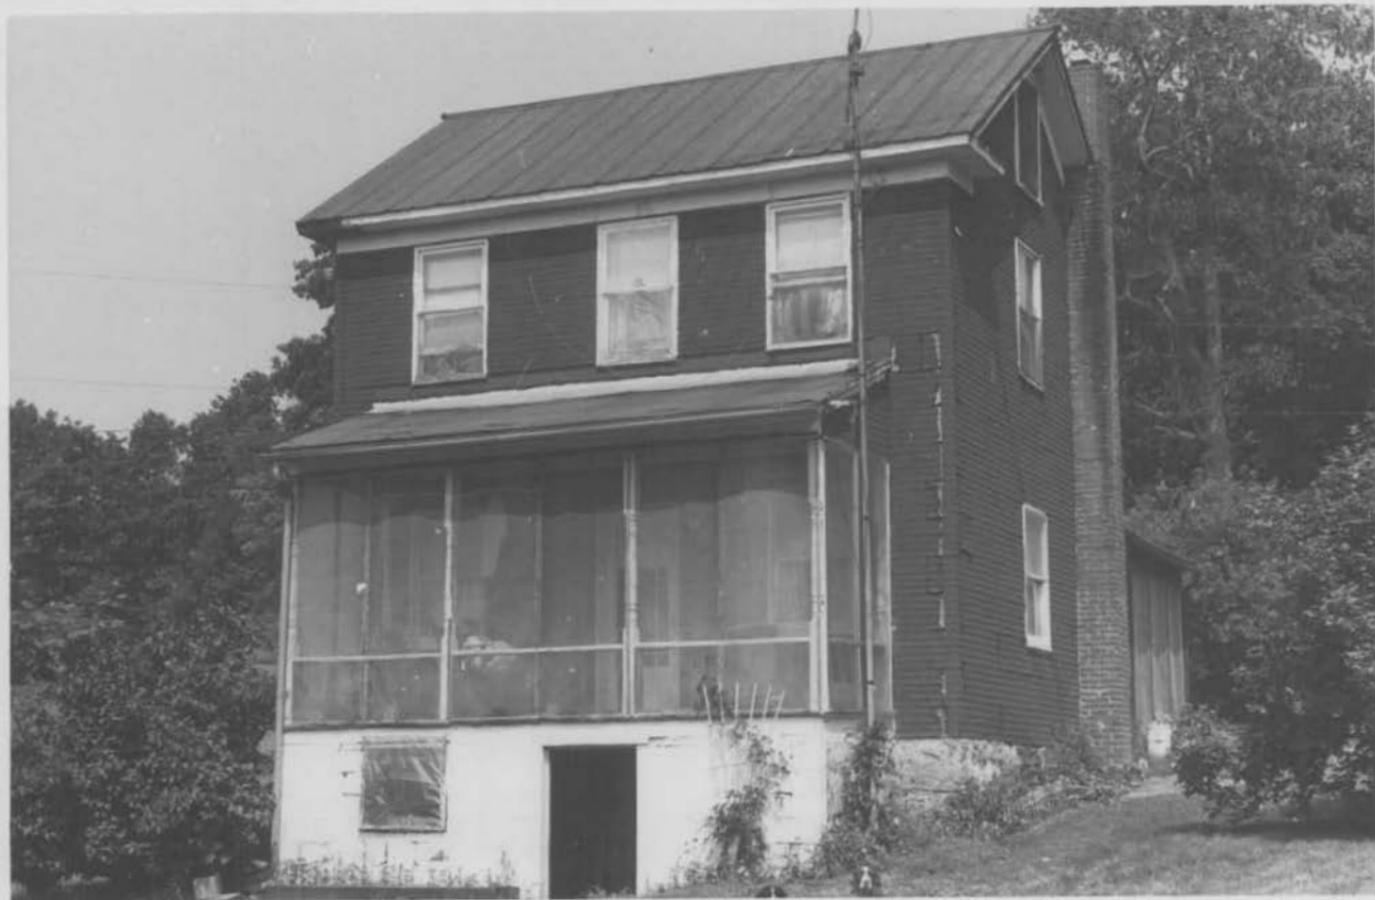
A-1

This house is a two story, three bay balloon frame structure resting on fieldstone foundations which become almost a full story in height at the front elevation. The building is sheathed with composition siding and has a one and a half story, two bay ell extension to the rear. The house faces south.

N. View

Frame House
