DETMOLD FARM

AL-VI-C-117
Seldom Seen Road, Detmold
ca. 1850

INVENTORY FORM FOR STATE HISTORIC SITES SURVEY

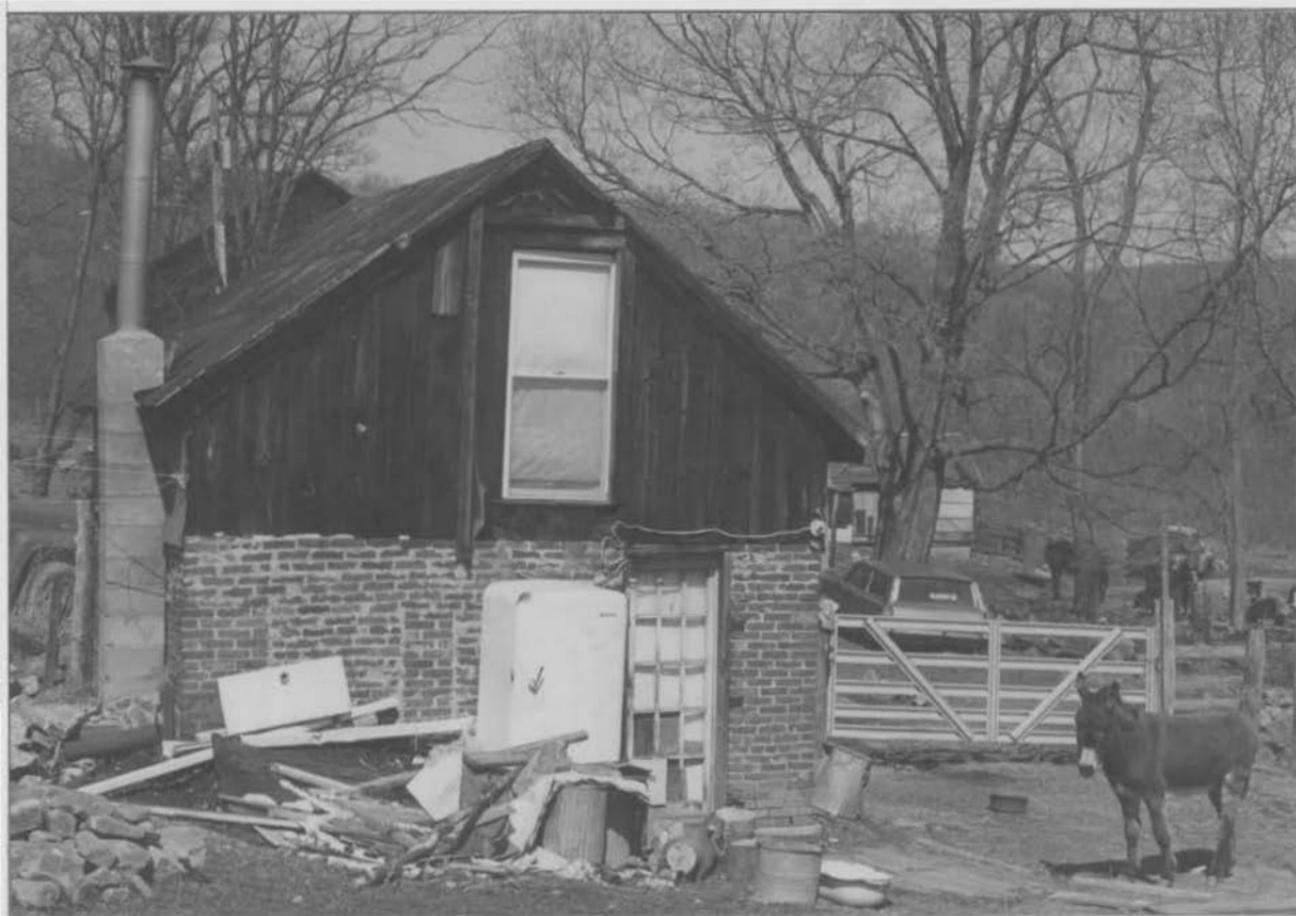
AI-VI-C-117

The buggy shed is constructed of brick laid in American Common Bond and is a one story, one bay wide rectangular building. It has been altered extensively since its original construction and new doors and windows have been put in. In addition the gable ends have been covered with board and batten and a cement block outside end chimney was constructed.

Detmold Farm - ^{brick} outbuilding

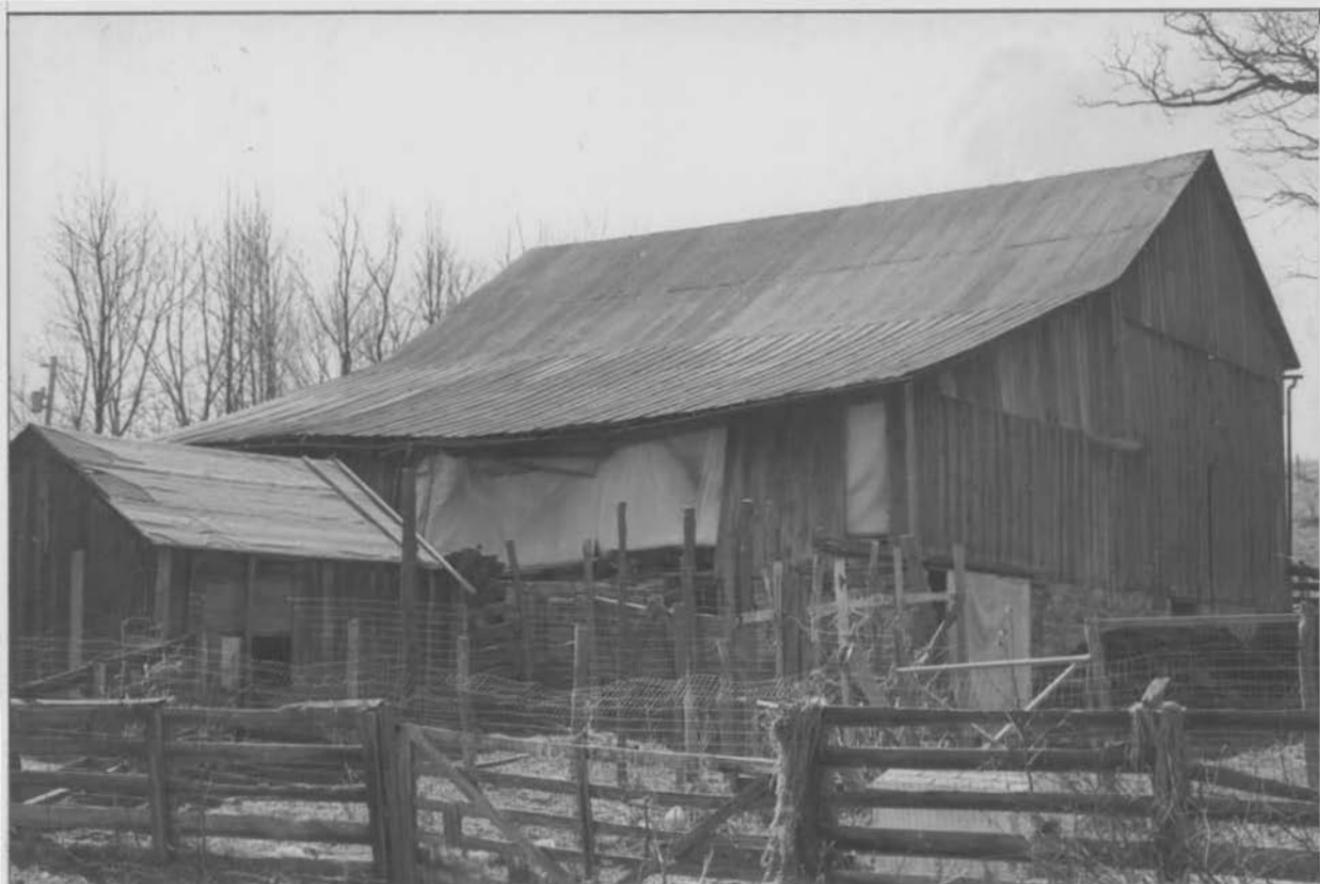
AI-VI-C-117

The barn is a large frame building with a mortised and tenoned frame and high stone foundation. Its roof is gabled and is covered with tin. The barn remains in near original condition.

Dstmold farm - barn
