Duckworth Farmhouse
AL-V1-C-200

INVENTORY FORM FOR STATE HISTORIC SITES SURVEY

Duckworth Farmhouse

INVENTORY NO: A2-VI-C-200

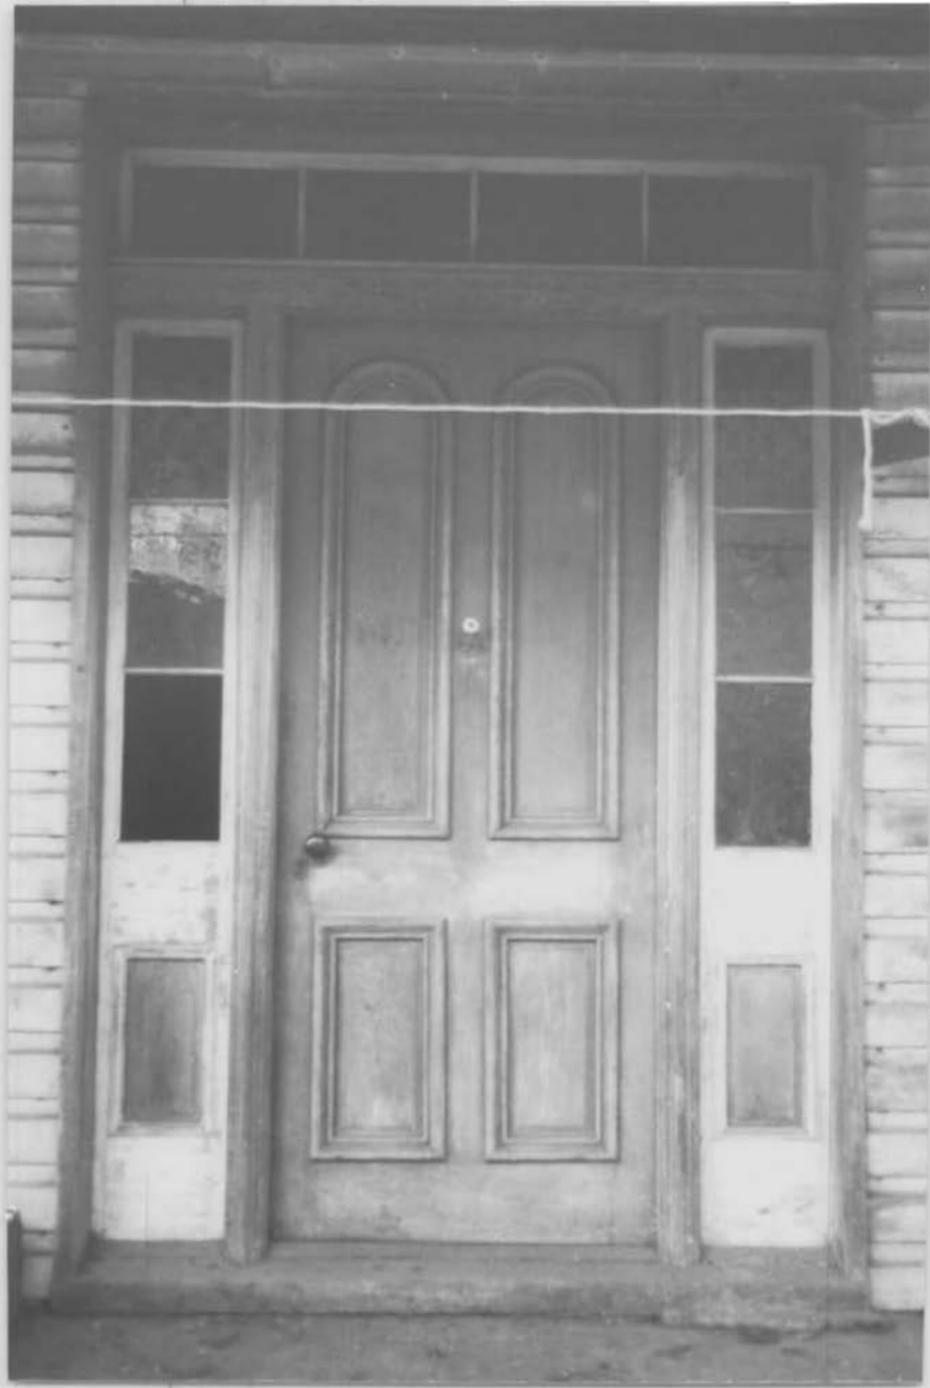
The main entrance in the center of the northwestern facade includes a four light transom, sidelights of three lights and one moulded panel each, and a wide door with two semicircular arched and two rectangular moulded panels and original hardware. Windows are wide, pegged six over six lights with wooden lugsills. A two tiered veranda runs the length of the southeastern and southwestern facades. It rests on tall wooden posts with lattice work. The shed porch roof is supported by square wooden posts with decorative brackets and a plain balustrade.

DETAIL - ENTRANCE
N.W. FACADE
