AA-1026

Reigle Farm (Crawford Property)

Waugh Chapel Road, Odenton

State Historic Sites Inventory Form

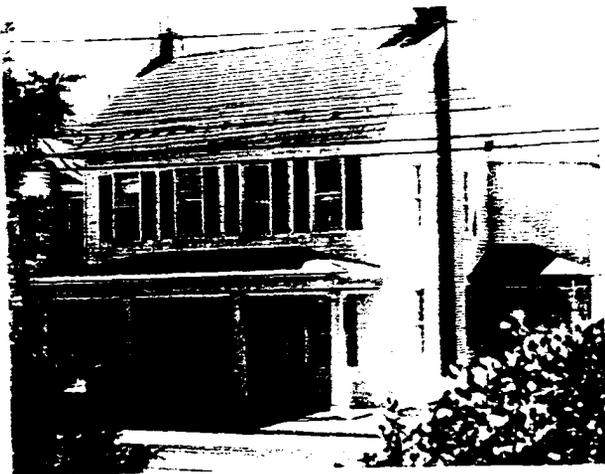
The John Robert's House, located in Schaefferstown, Pennsylvania, is a classic "Pennsylvania Farmhouse" or, more correctly, kreuzehaus. Note the similarity of this dwelling and the Reigle Farmhouse. (source: Charles Bergengren, *The Cycle of Transformations in Schaefferstown, Pennsylvania, Houses, in Perspectives in Vernacular Architecture*, Vol. IV, Univ of Missouri Press, 1991).

Above: John Robert's House
Below: Riegle Farmhouse

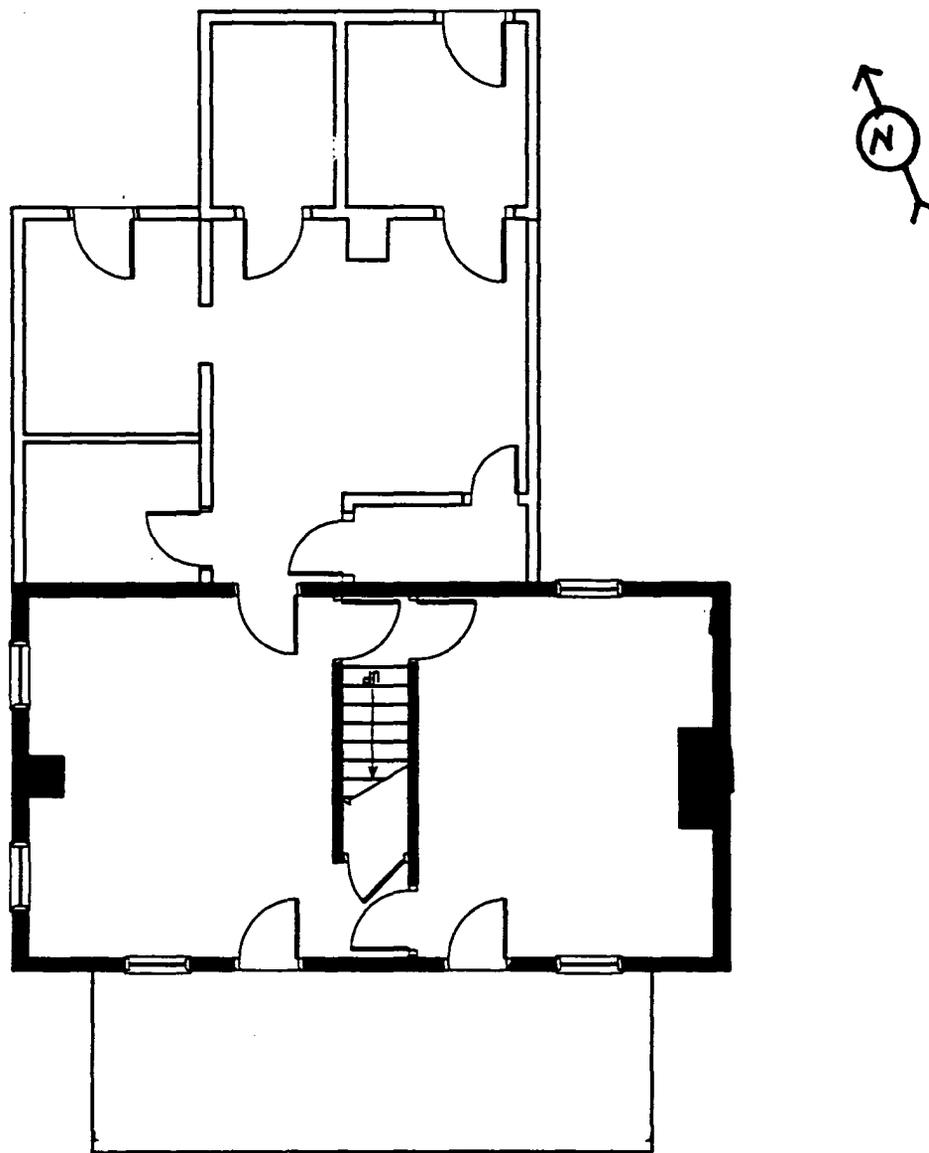
Reigle House, 1st Floor Plan
Note double front doors and reversed stair

With respect to internal arrangement, the Reigel House possesses a classic 19th-century Kreuzehaus internal arrangement that fuses Anglo-American and Germanic building traditions. The house's front block is divided into two, roughly equal size rooms forming a double-parlor plan. Each of these two rooms communicates directly with the outside via front door opening without benefit of an intermediate center passage.

The center passage, or more commonly center hall, containing a front-facing staircase leading to the second level is a classic feature of the American I-house. The Reigel House lacks this key feature. In German fashion, the Reigel house staircase is de-emphasized. The entire staircase is boxed in, and in keeping with German tradition, oriented to the back of the house.

German vernacular architecture typically rejects the "closed plan" created by the passage, instead preferring an "open plan" allowing unhindered access from the outside into the private living space of the house. In keeping with the German tradition, the stair is not emphasized. The staircase is boxed in and oriented toward the rear of the house.

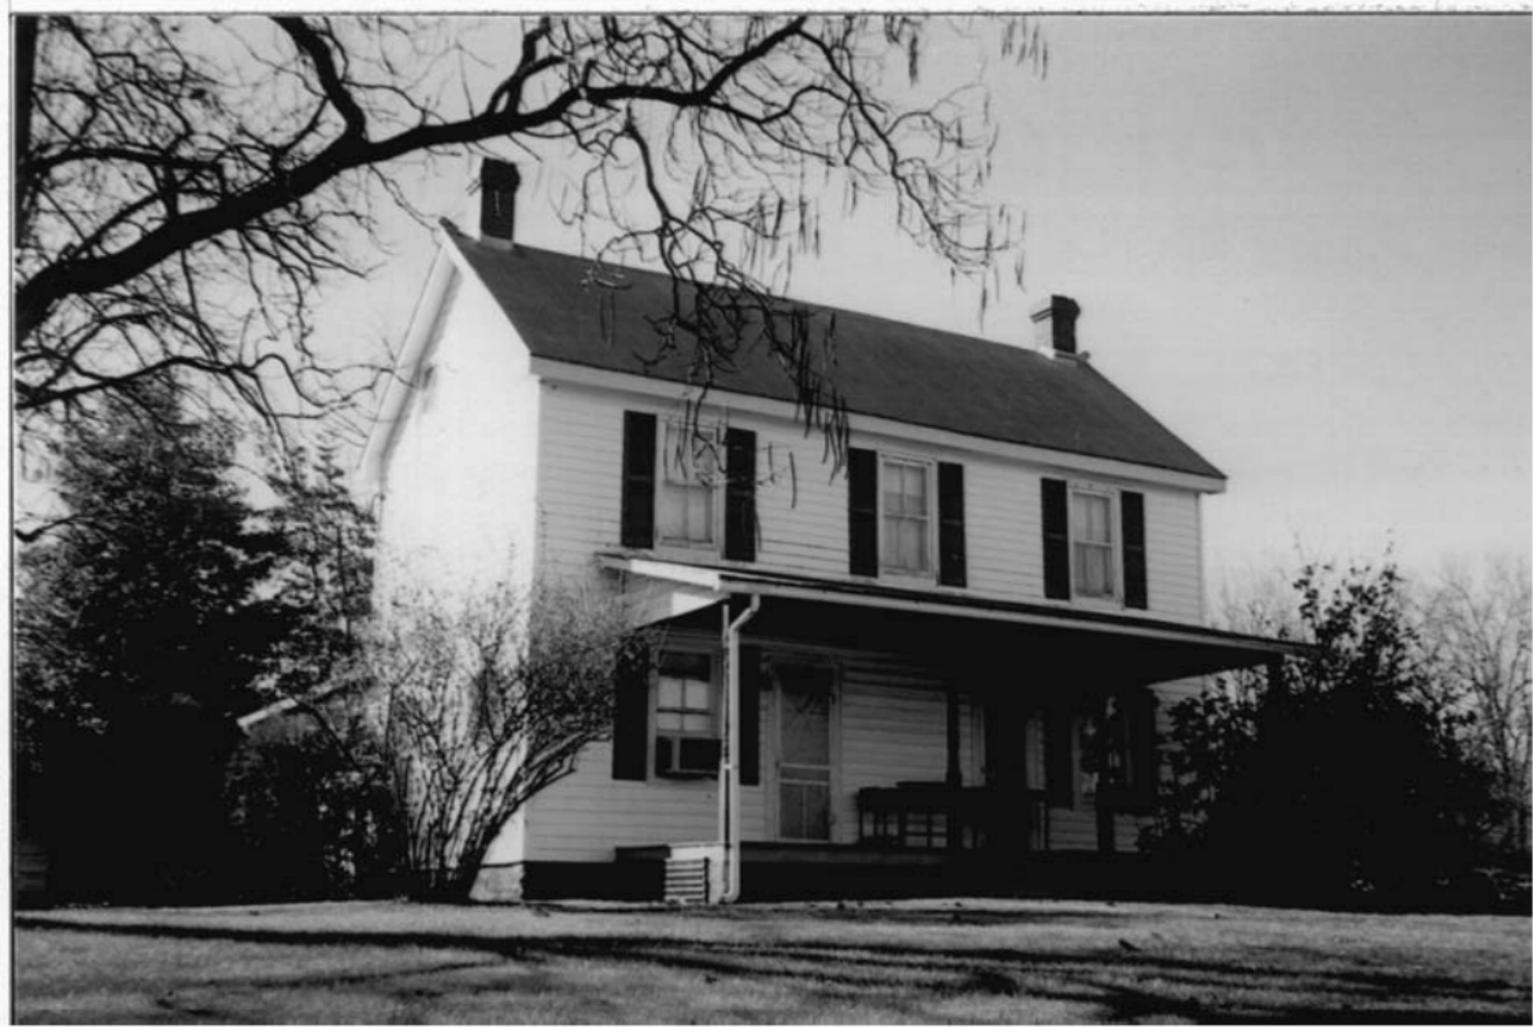
1 of 4

EAST facade

An unusual fenestration pattern provides the most telling exterior clue to the dwelling's Germanic associations. The second story possesses three evenly spaced bays, each containing a single 2/2 window. The house, however, is characterized by its first floor fenestration. This level is divided into four bays, with the first two being a mirror image of the third and fourth. Specifically, openings alternate window-door, door-window, with a disproportionately large wall space existing between the entrances. The doors are typical, four-panel types; each is fronted by a wooden screen door.

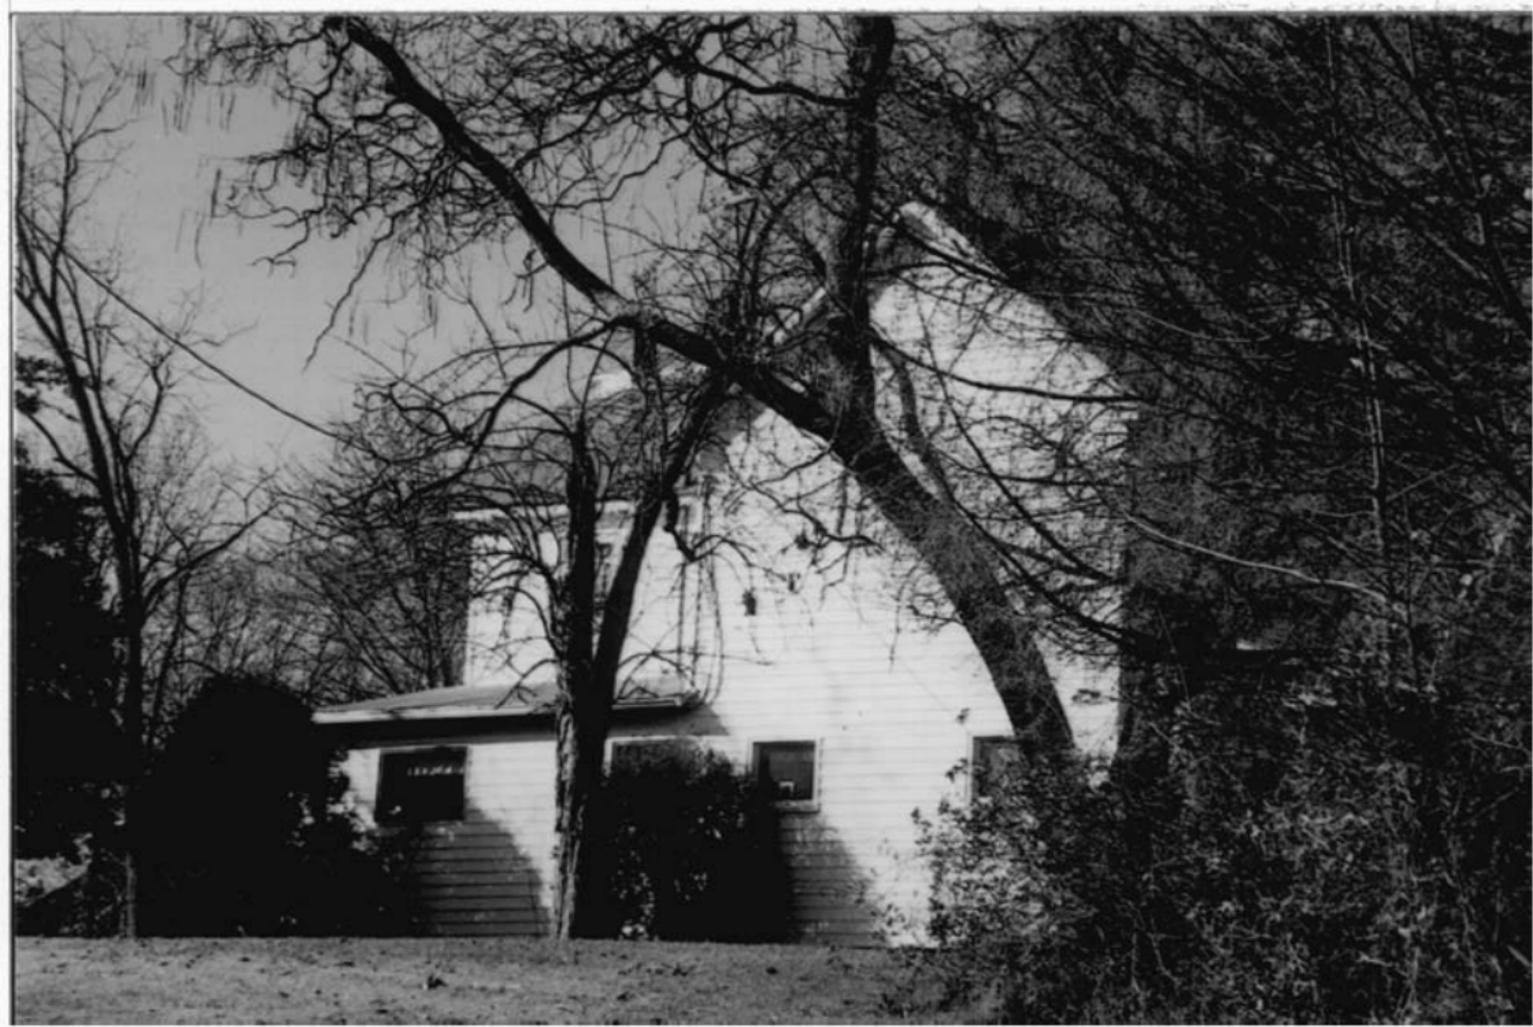
Photo 2 of 4

Southeast perspective

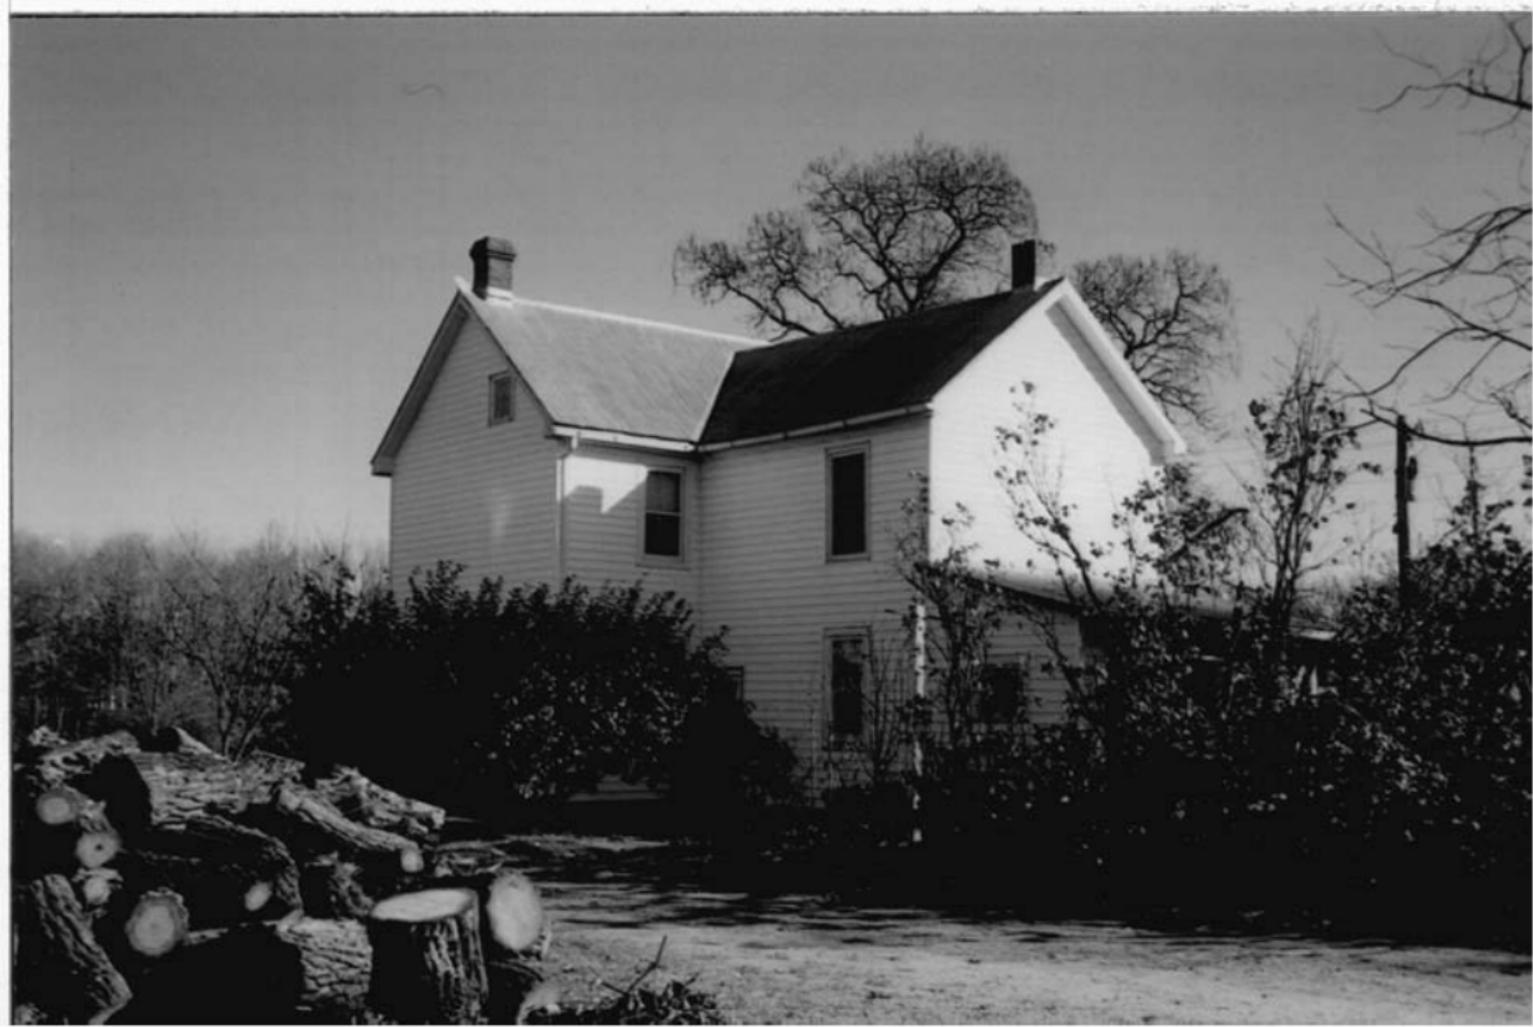
photo 3 of 1

NW Perspective

Two secondary entrances provide access to the inside. One is a somewhat deteriorated 4-light over 2-panel door, located on the left side of the ell's north wall. A wooden screen door is also present. A window is located immediately to the right of the door. Two second-floor windows align with the openings below. The remaining entrance is located on the left side of the enclosed rear shed porch. This opening is fitted with a modern wooden door and aluminum storm door.

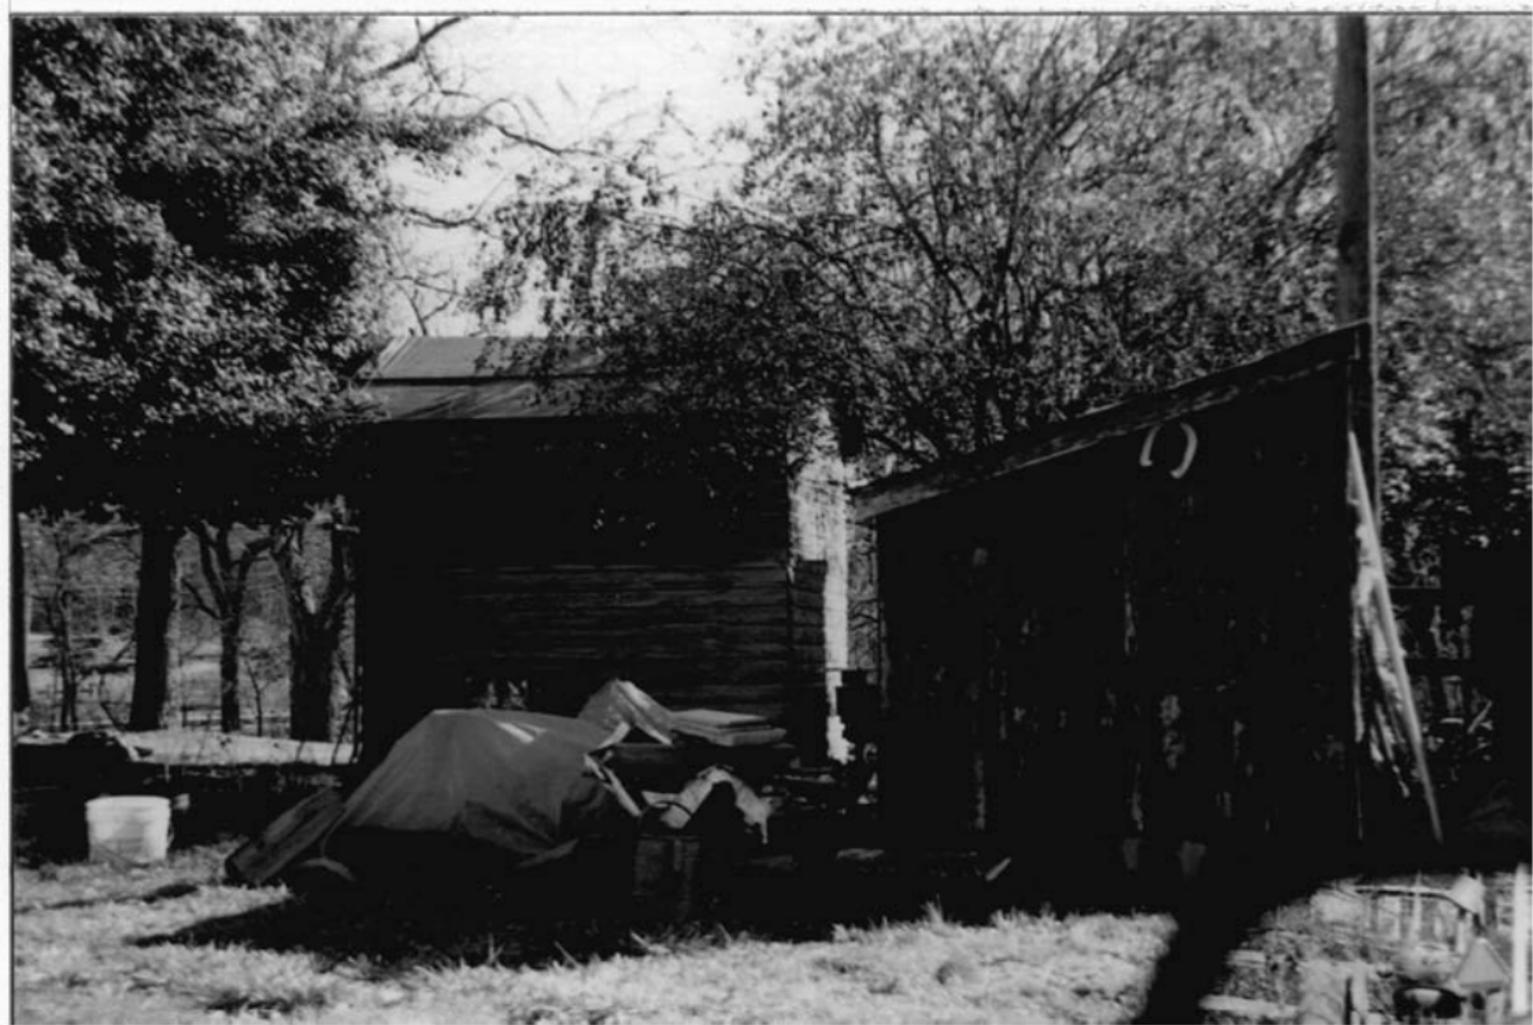
photo 4 of 4

Sheds

The Reigel House is well maintained and in very good condition. Associated outbuildings display some deterioration, but overall are in fair condition.
