HISTORIC SITES SURVEY FIELD SHEET
 Individual Structure Survey Form

SURVEY NUMBER: <u>AA 1161</u>
NEGATIVE FILE NUMBER:
UTM REFERENCES: Zone/Easting/Northing
U.S.G.S. QUAD. MAP:
PRESENT FORMAL NAME:
ORIGINAL FORMAL NAME:
PRESENT USE: <u>Apartments</u>
ORIGINAL USE: <u>Residence</u>
ARCHITECT/ENGINEER:
BUILDER/CONTRACTOR:
PHYSICAL CONDITION OF STRUCTURE: Excellent () Good (X) Fair () Poor: ()
THEME:
STYLE: <u>Four Square</u>
DATE BUILT: <u>c.1910</u>

COUNTY: <u>Anne Arundel</u>
TOWN: <u>Annapolis</u>
LOCATION: <u>147 Prince George Street</u>
COMMON NAME:
FUNCTIONAL TYPE: <u>Res Map32 Par 536</u>
OWNER: <u>Sharyn G. Fuller</u>
ADDRESS: <u>147 Prince George Street</u> <u>Annapolis, MD 21401</u>
ACCESSIBILITY TO PUBLIC: Yes (X) No () Restricted ()
LEVEL OF SIGNIFICANCE: Local (✓) State () National () <input checked="" type="radio"/>

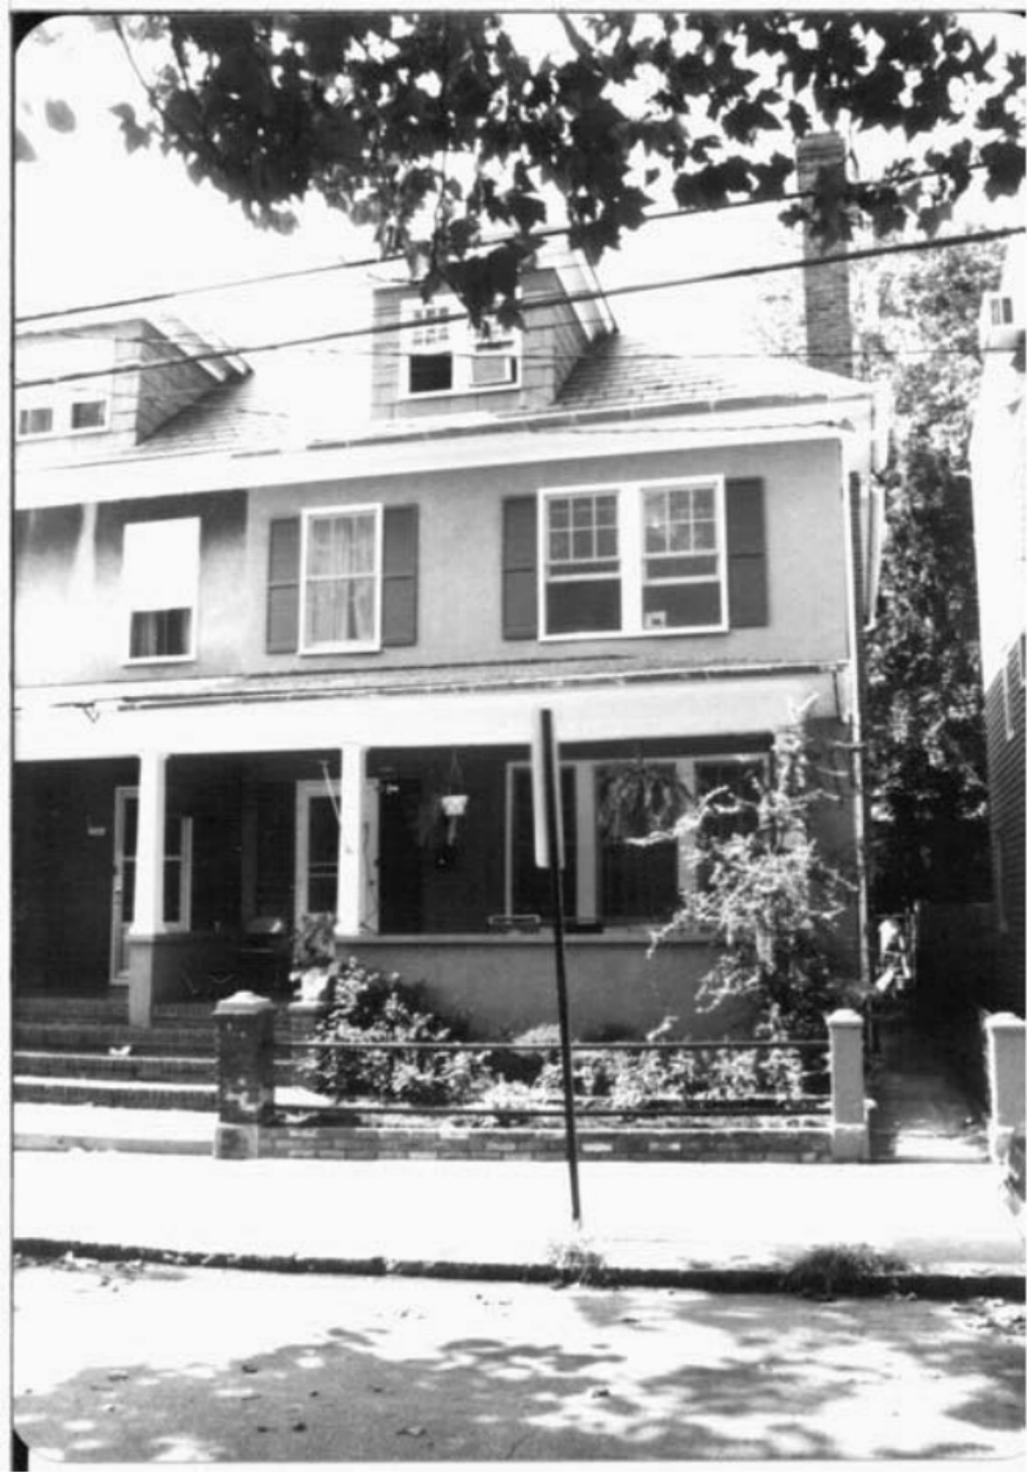
147 Prince George AA1161
Annapolis, Anne Arundel County
Russell Wright July, 1982
Maryland Historical Trust,
Annapolis, Maryland
NW Elevation/camera facing SE

Hipped dormer, boxed cornice, slate hipped roof; second floor windows double at outer bay, tripled at first floor; full width porch continues across contiguous structure, with tapered square posts, stucco infill below rail.

One half of a double Four-Square style residence, altered by stucco facades but still contributing to streetscape. Only structures in block set back from sidewalk line, which sets off row of more important townhouses to the north.
