AA-118
Benson-Hammond House
Linthicum Heights
Public

National Register of Historic Places
Registration Form

historic name Benson-Hammond House
other names/site number Ann Arrundell Historical Society Headquarters AA-118

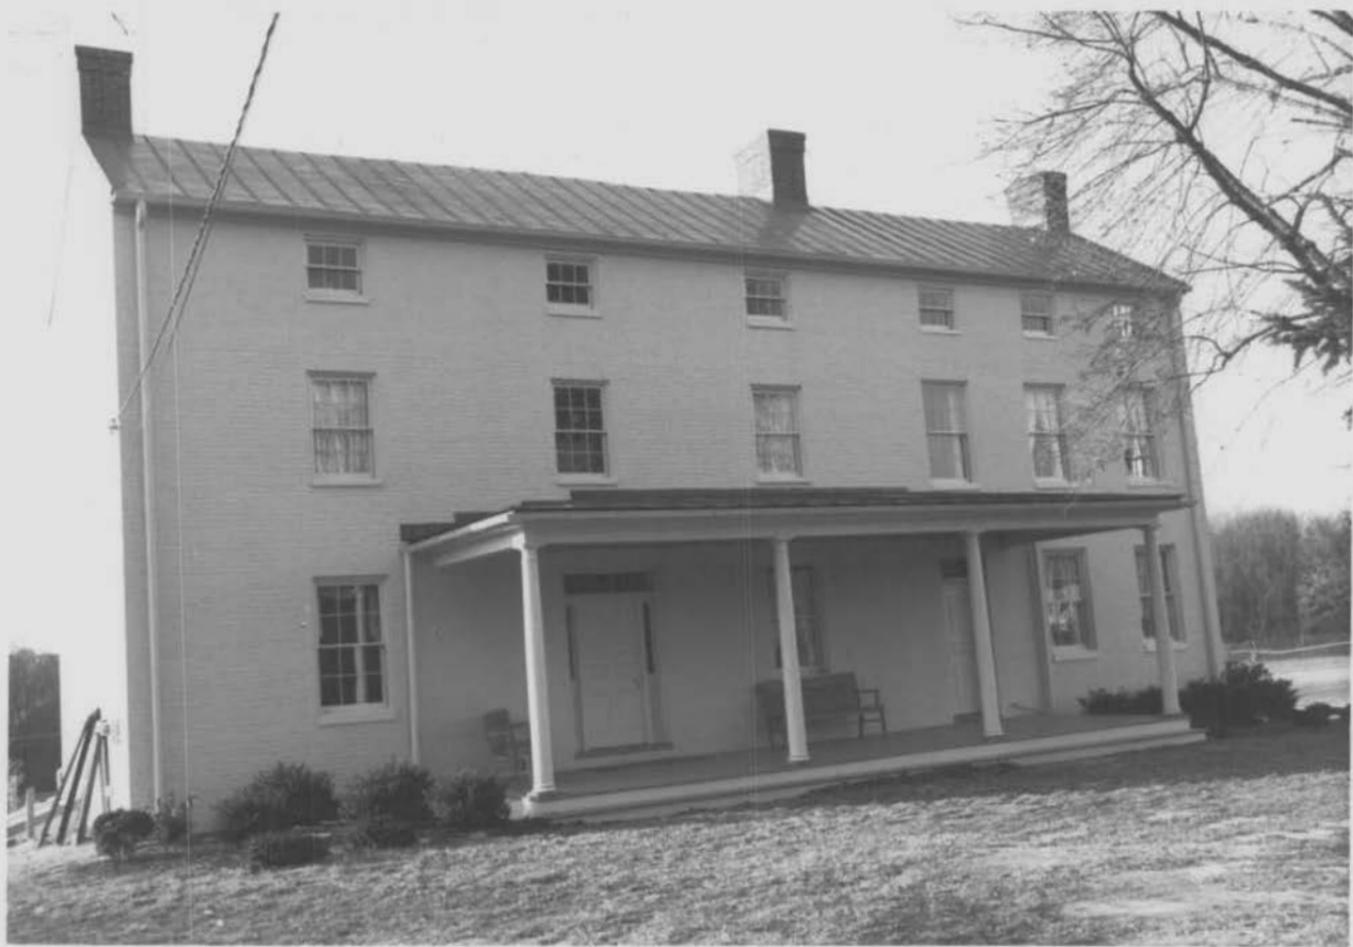
Facade: east elev.

The central three bays of the facade, east elevation, are covered by a wood porch with a hip roof. The roof is covered with standing seam metal, painted brick red, and is supported by four Doric columns. It covers the two main entrances into the house: the southern one enters into the earlier central passage section and the northern one into the later addition. This porch is a recent reconstruction of a similar, late 19th-century porch which had collapsed.³

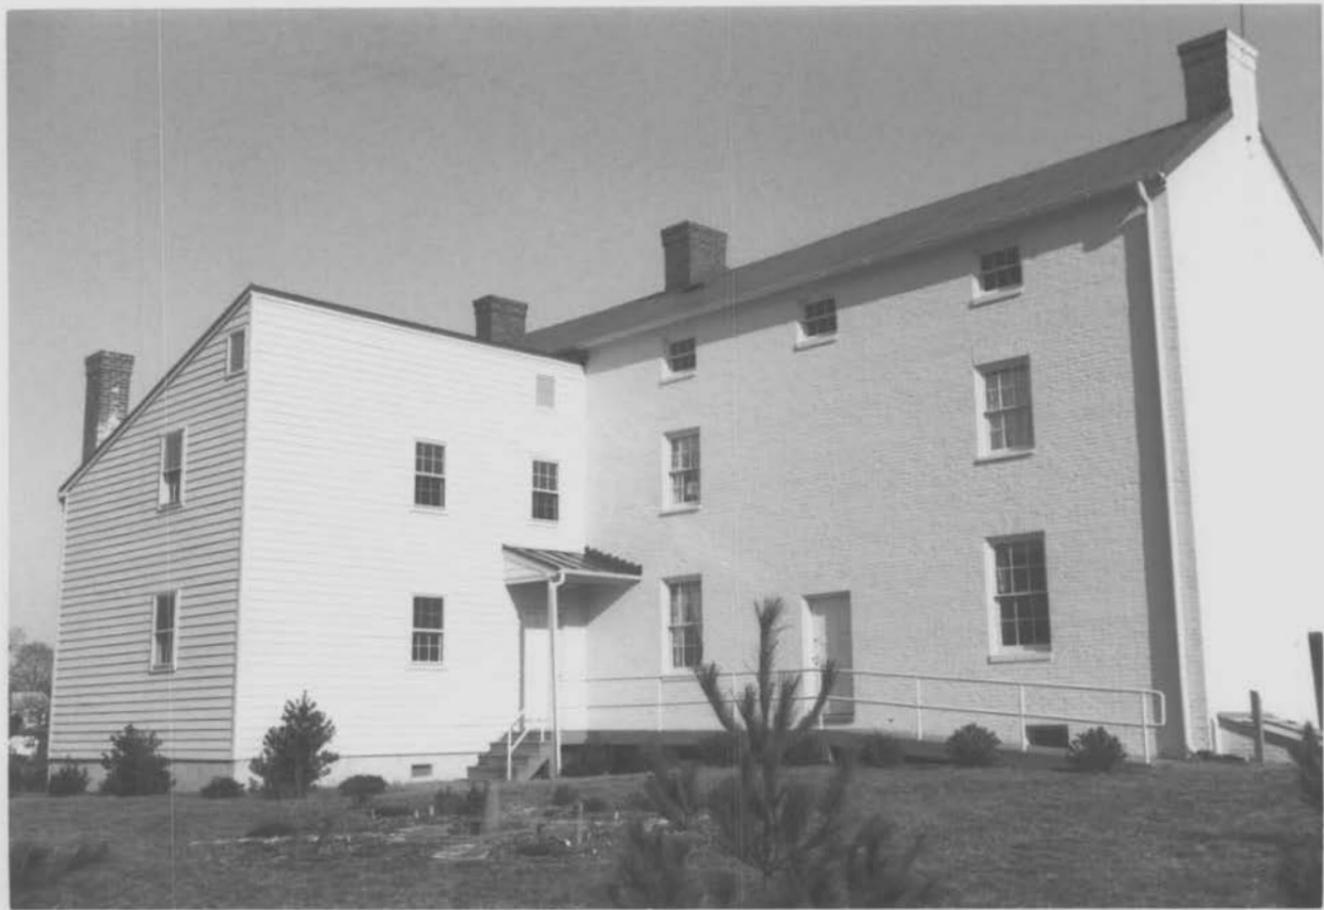
Rear - west elev.

The main block of the house is 2½ stories and measures 6 bays by 2 bays, the overall dimensions being 19 x 58½ feet. It is constructed of brick laid in common bond. A frame, 2-story shed addition extends from the rear, west elevation, of the house at the north end.
