**MARYLAND HISTORICAL TRUST
DETERMINATION OF ELIGIBILITY FORM**

Property Name: Trusty Friend Inventory Number: AA-123

Project: Shannon's Glen Agency: Army Corps of Engineers

**MARYLAND HISTORICAL TRUST
NR-ELIBILITY REVIEW FORM**Continuation Sheet No. 1

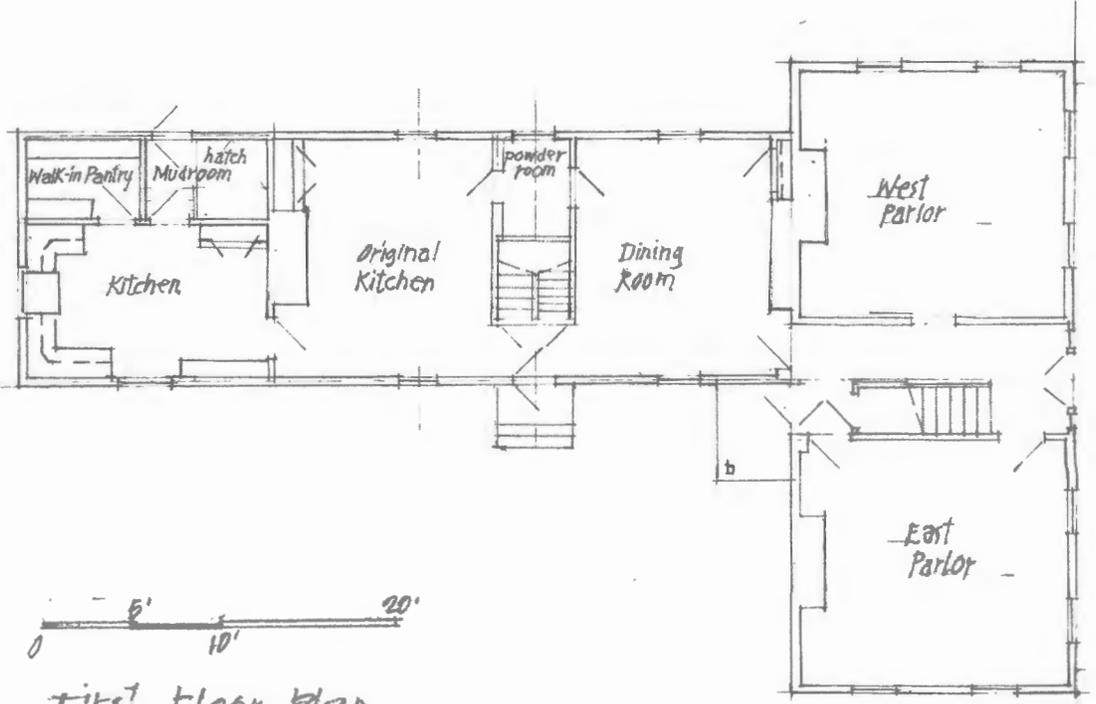
First Floor Plan

Figure 2	Terry Necciai, RA Architect & Arch. Hist.	Brian Kelly AIA Architect	TRUSTY FRIEND, Jessup MD MHP AA-123
----------	--	------------------------------	--

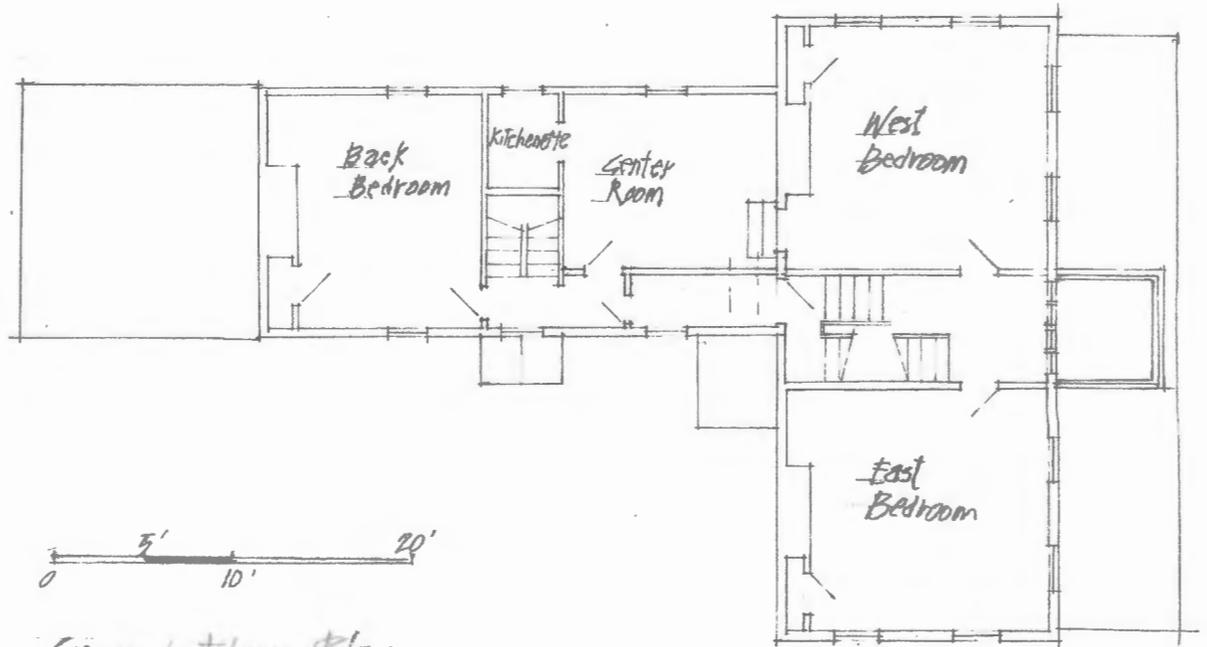
Second floor Plan

Figure 10	Terry Necciai, RA Architect & Arch. Hist.	Brian Kelly AIA Architect	TRUSTY FRIEND ; Jessup MD MIHP AA-123
-----------	--	------------------------------	--

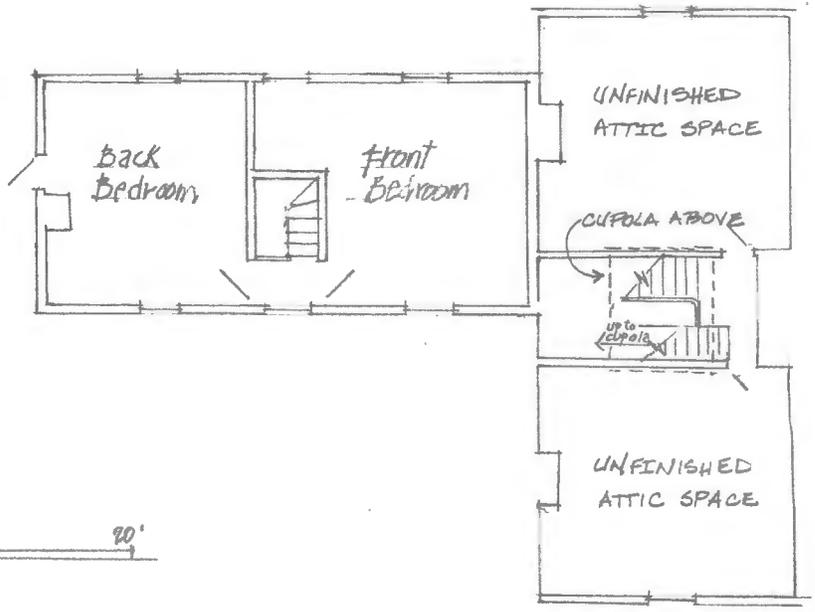
Attic plan

Figure 11	Terry Necciai, RA Architect & Arch. Hist.	Brian Kelly, AIA Architect	TRUSTY FRIEND, JESSUP, MD MHP AA-123
-----------	--	-------------------------------	---

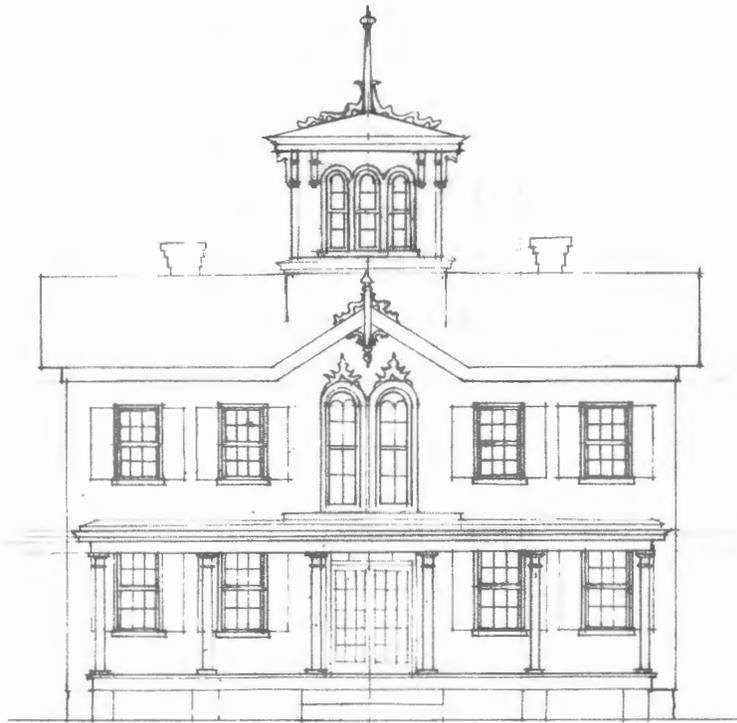
<p>Figure #12 Façade Drawing</p>	<p><u>Brian Kelly, AIA, Architect</u> with Terry A. Necciai, RA, Historic Preservation Consulting (Preservation Architect and Architectural Historian)</p>	<p><u>Trusty Friend – AA-123</u> 2839 Jessup Road, Jessup, Md March 2014</p>
--	--	--

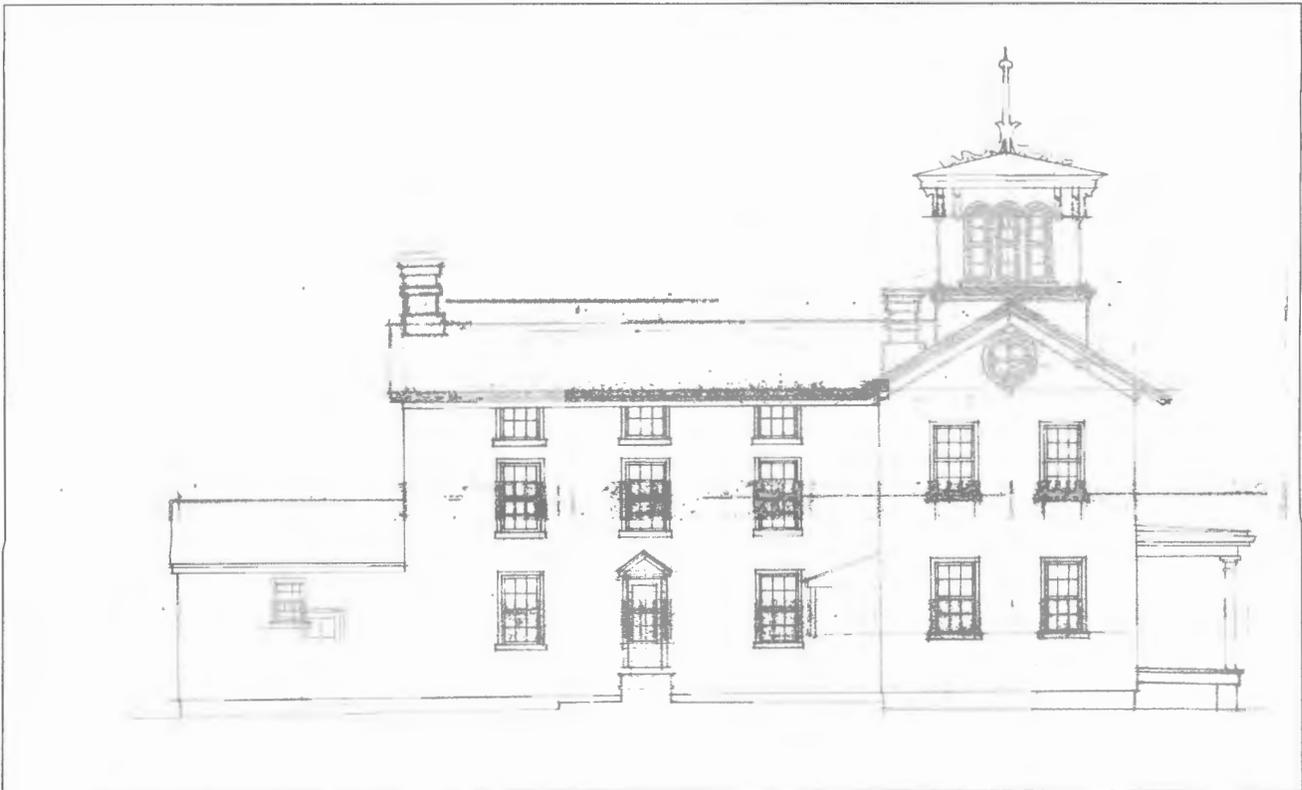
Figure #13
East Elevation

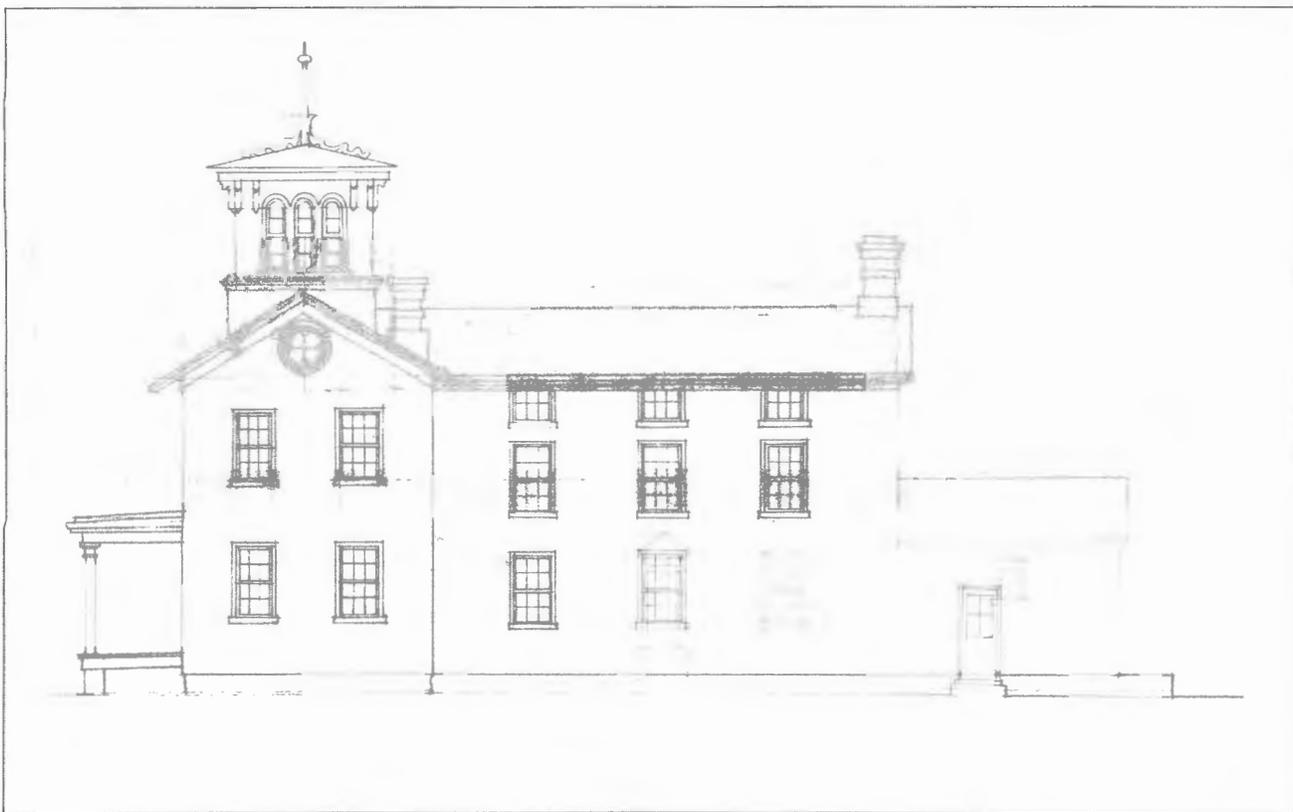
<p>Figure #14 West Elevation</p>	<p><u>Brian Kelly, AIA, Architect</u> with Terry A. Necciai, RA, Historic Preservation Consulting (Preservation Architect and Architectural Historian)</p>	<p><u>Trusty Friend – AA-123</u> 2839 Jessup Road, Jessup, Md March 2014</p>
--	--	--

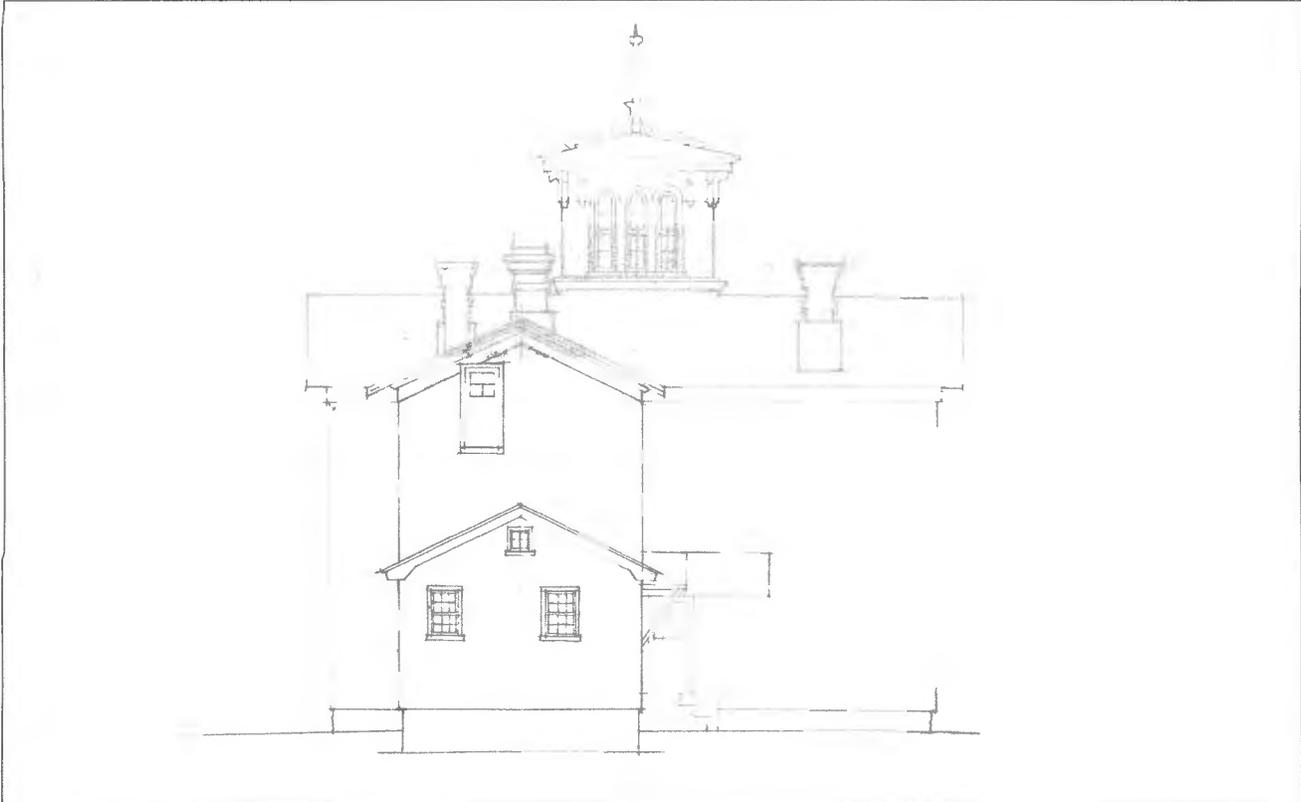
<p>Figure #15 Rear (South) Elevation</p>	<p><u>Brian Kelly, AIA, Architect</u> with Terry A. Necciai, RA, Historic Preservation Consulting (Preservation Architect and Architectural Historian)</p>	<p>Trusty Friend – AA-123 2839 Jessup Road, Jessup, Md March 2014</p>
--	--	--

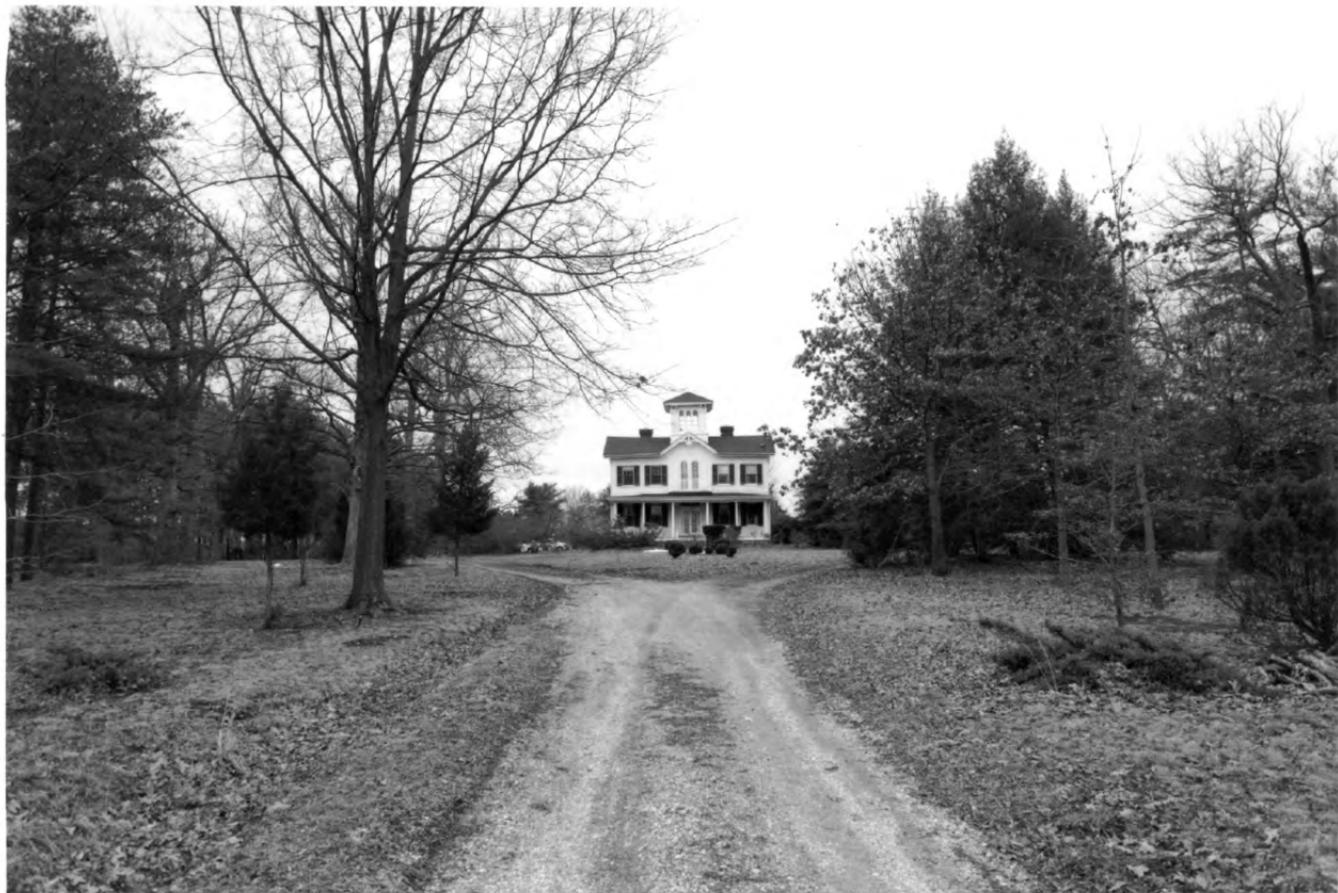
AA-0123-2014-03-11-01

VIEW OF PROPERTY FROM MD. RT. 175 (SEE ALSO MHP-992)
FACING SOUTH.

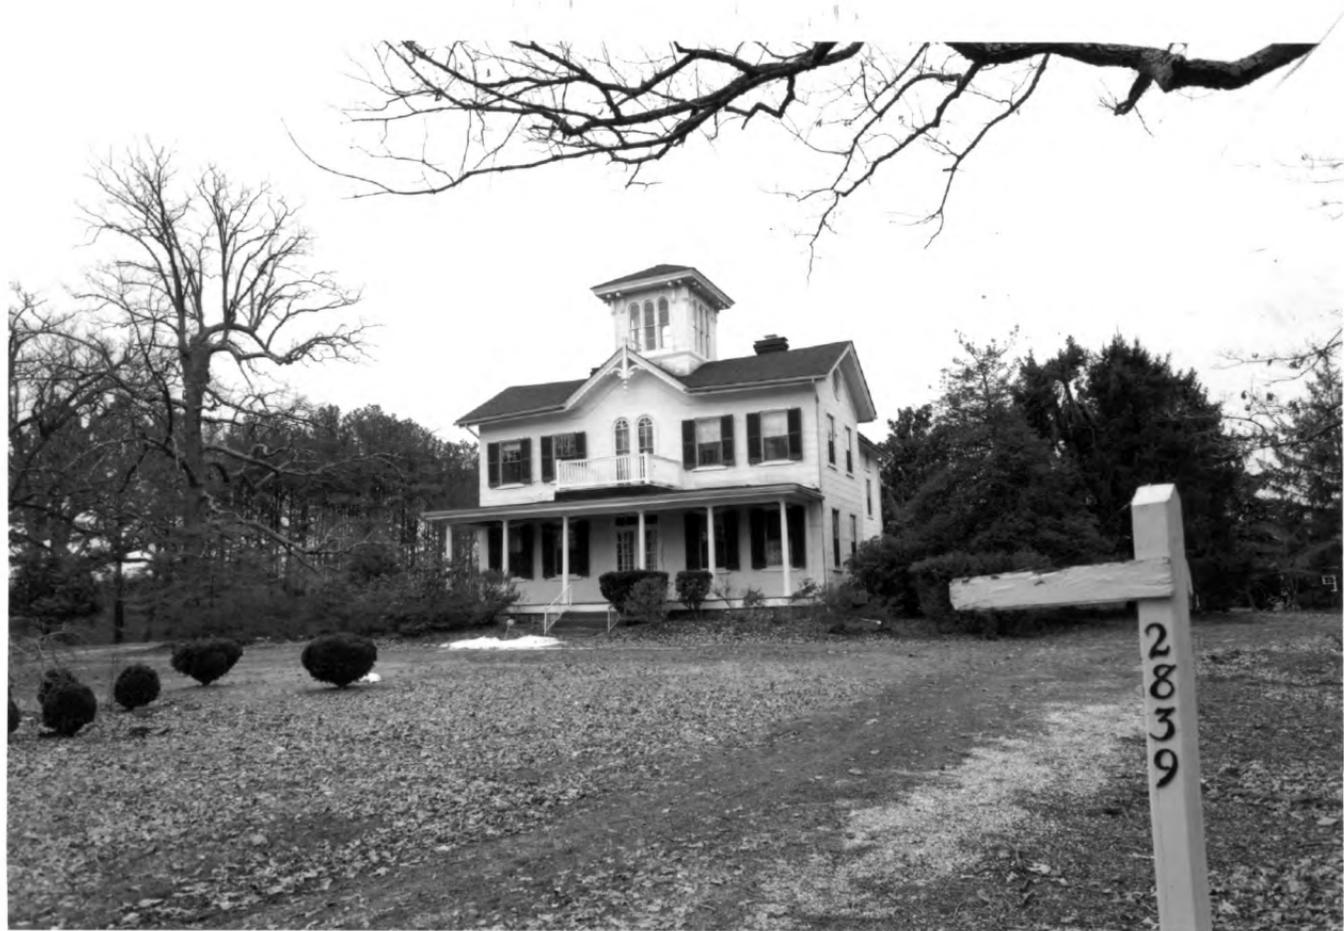
The Veranda covers the full width of the five-bay front (North) elevation (see photos #1 - #2). On the center axis, there are concrete steps leading to the 8 ft. deep (north-south) floor of tongue-and-groove wood floor boards. The roof is supported by six lathe-turned Tuscan columns and a plain wood entablature. The soffit area has been covered with vinyl. The ceiling is penny-spaced wood slats for ventilation and the roof is asphalt over flat seamed tin.

FAÇADE (NORTH) AND WEST ELEVATION OF THE HOUSE
FACING SOUTHEAST.

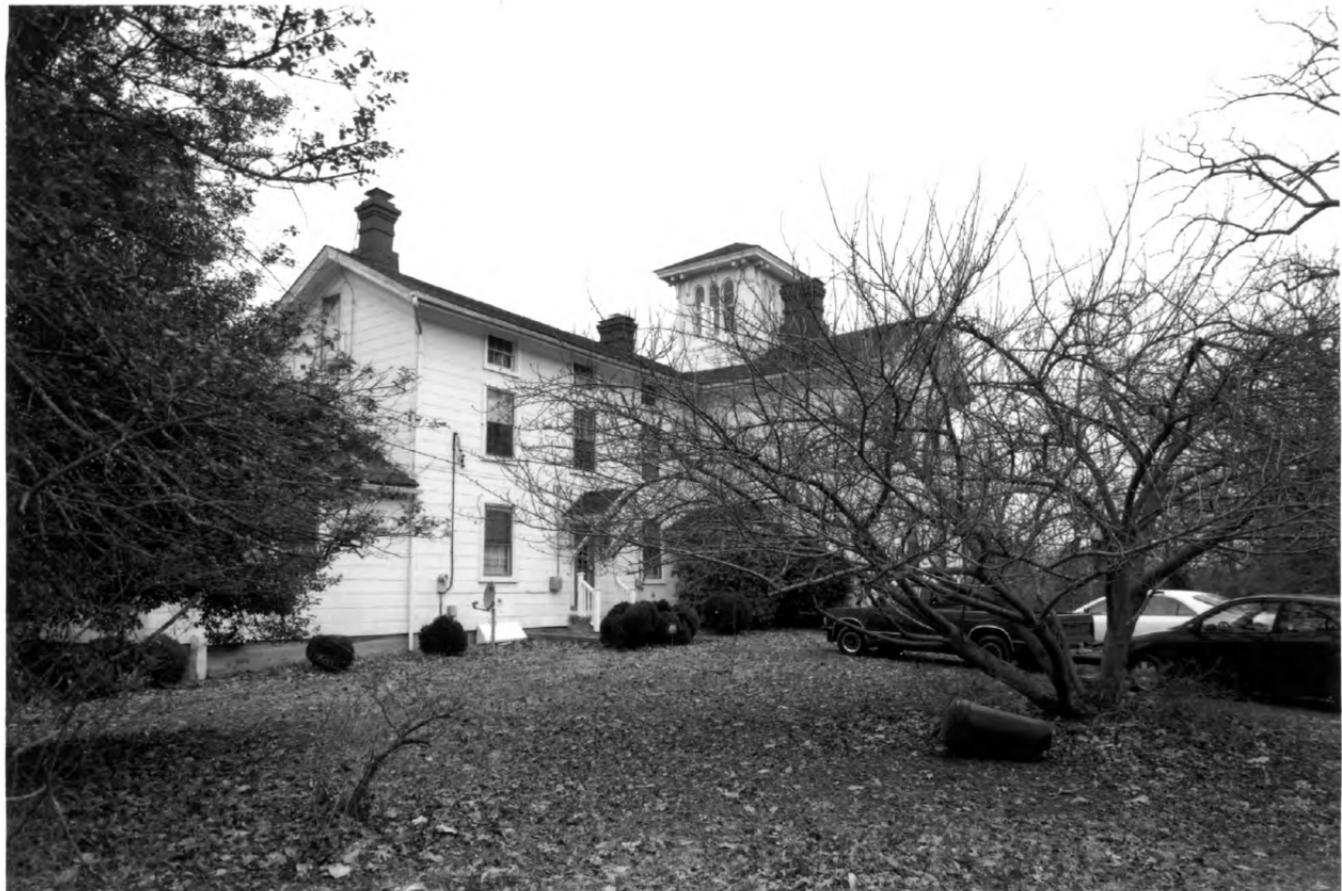
AA-0123-2014-03-11-03

The canopy-covered entrance faces east and has precast concrete steps leading to a concrete landing. A ca.1920 gabled wood canopy supported by knee-braces hangs over the landing (see photo #3). The surfaces have been clad with vinyl siding and trim.

EAST AND SOUTH ELEVATIONS OF THE HOUSE
FACING NORTHWEST.

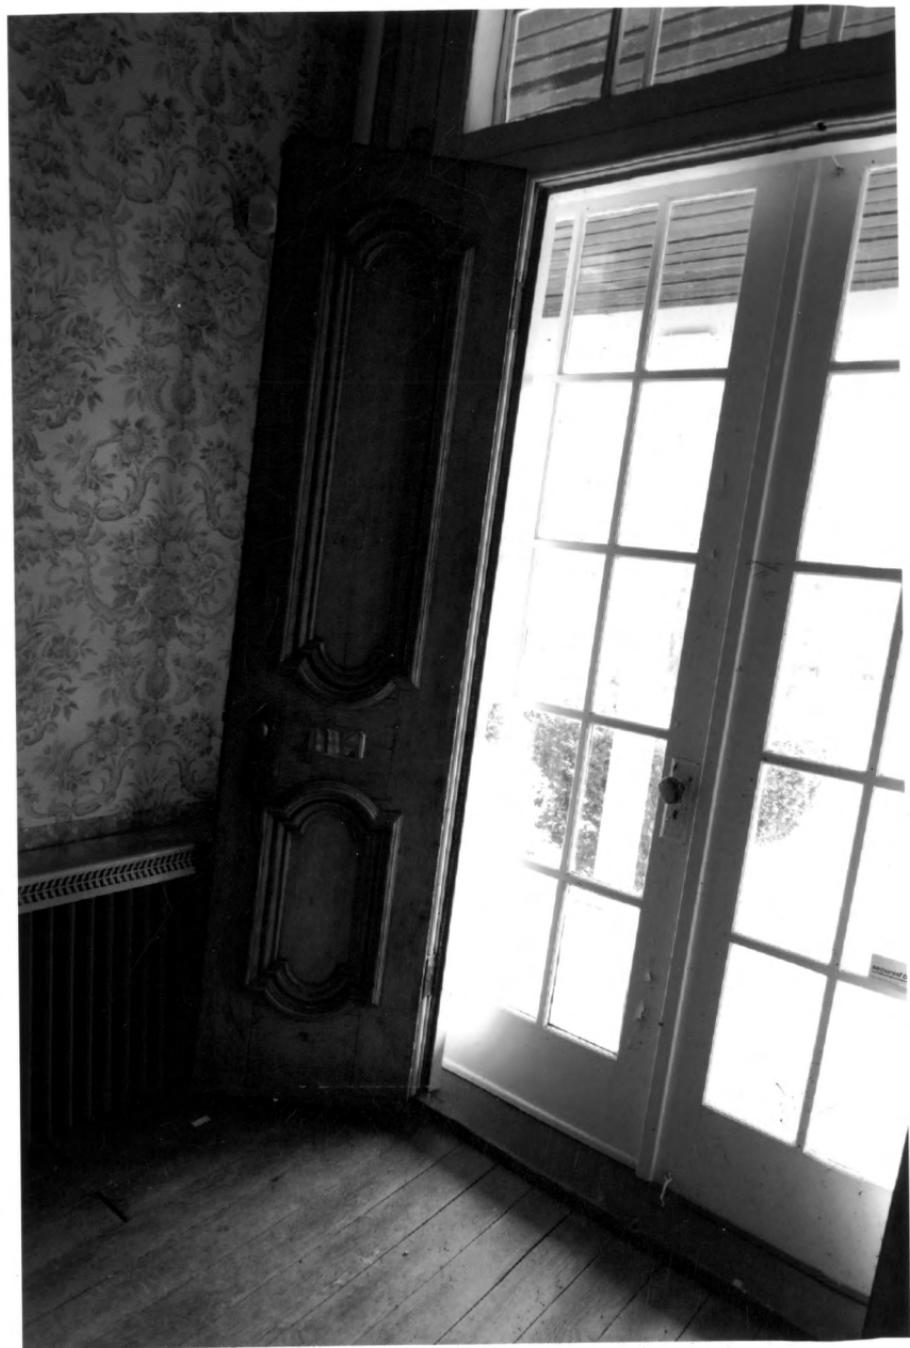
AA-0123-2014-03-11-04

The front double doors are pine stile-and-rail with an inset of Baroque geometry in the upper and lower panels (heavy-profile, stepped and ogival panel molding including a half-circle shape mitered into the top and bottom of each of the panels; each door leaf has two tall panels of this description) (see photo #4). The design of this door is also repeated at the nearby Dr. Asa Linthicum House (MIHP AA-91). The doors are surrounded by half-glass three-light sidelights and a four-light transom. In front of the doors, a pair of light-weight, pre-manufactured French doors has been installed to serve as storm doors.

OUTER FACE OF FRONT DOOR LEAF FROM INSIDE
FACING NORTHWEST

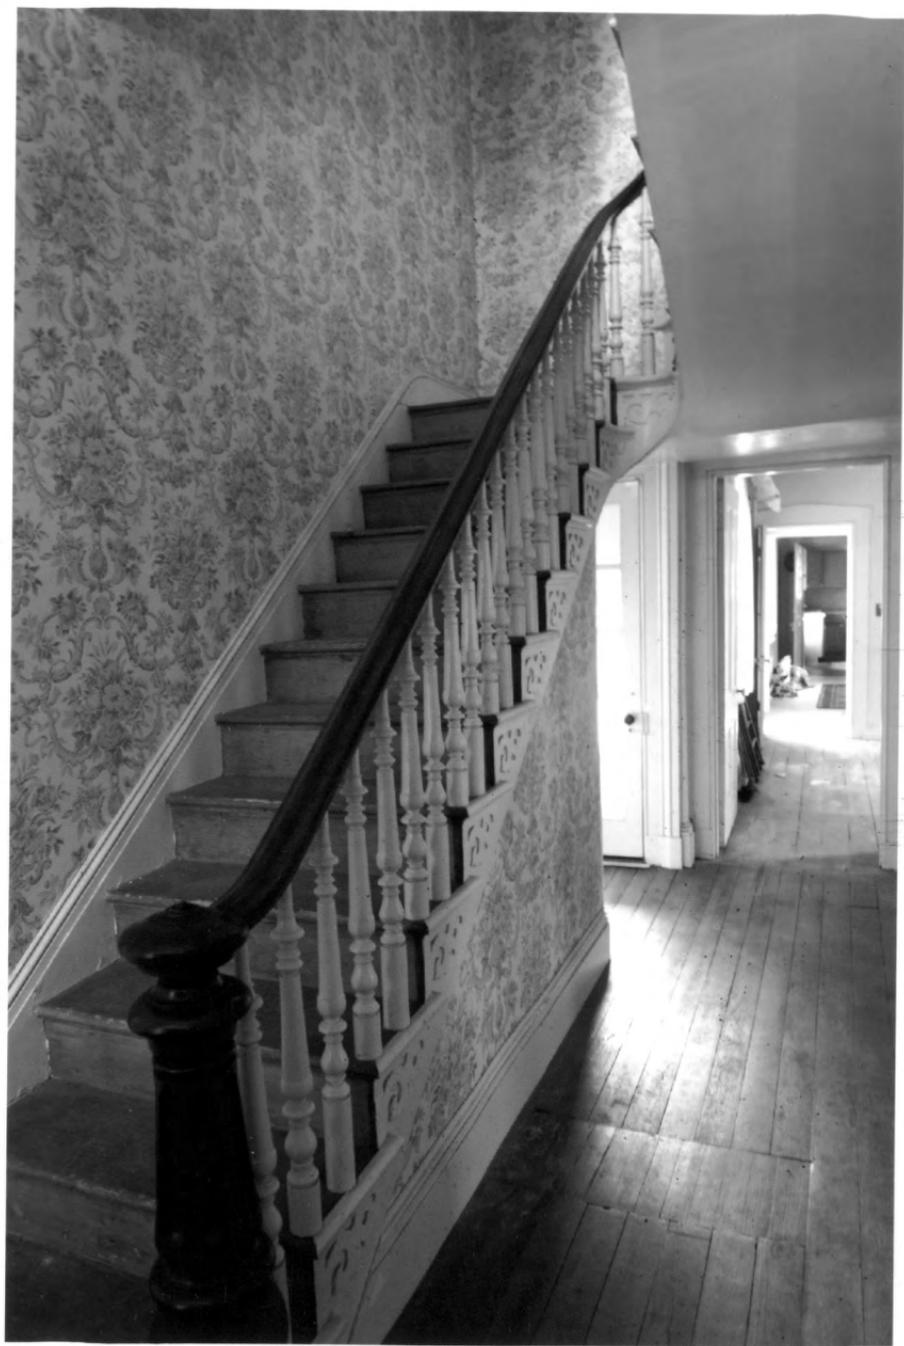
CENTER STAIRWAY AND DOORWAYS BACK TO KITCHEN
FACING SOUTHEAST

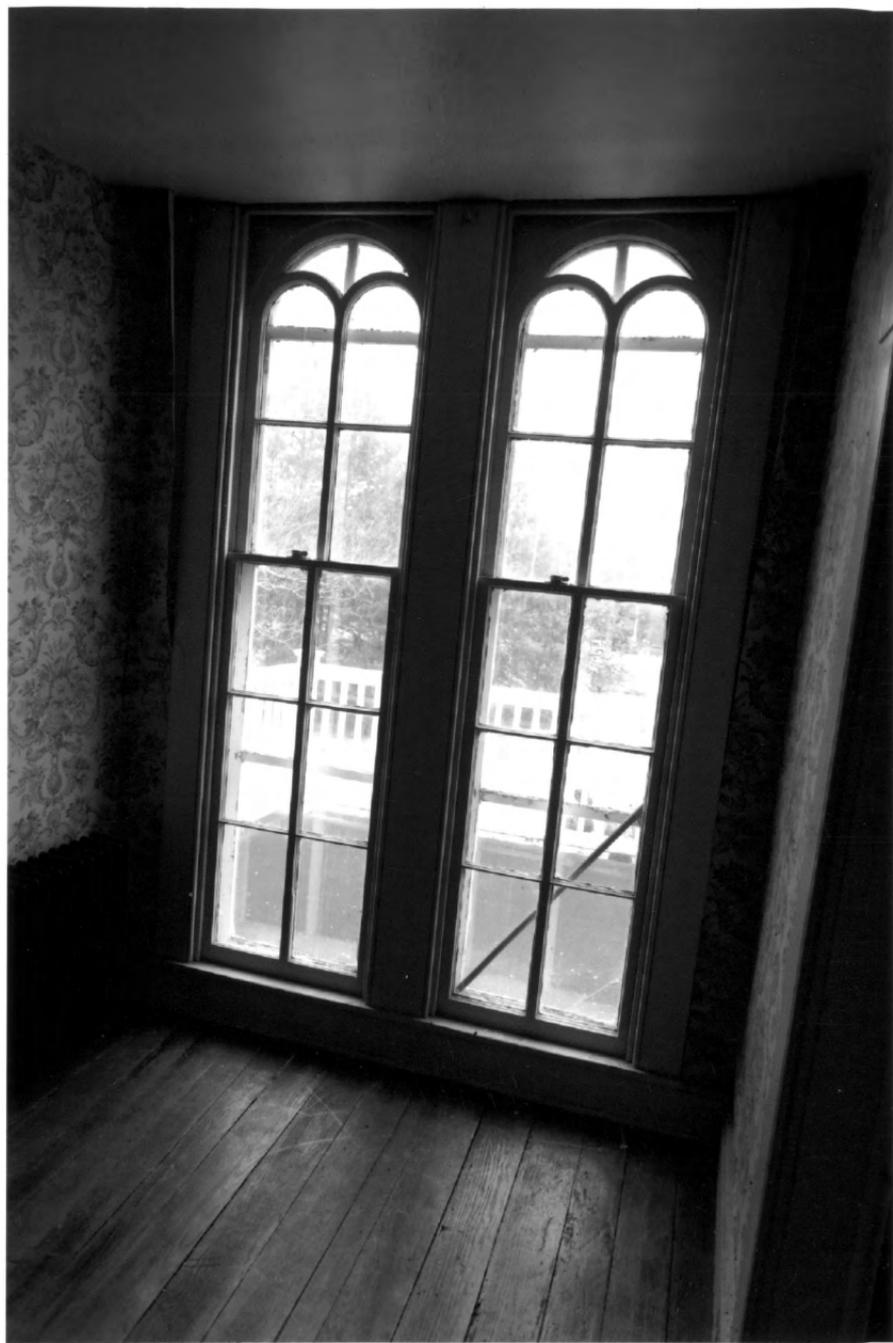
AA-0123 - 2014-03-11-06

On the second floor, in the center bay of the façade, a pair of full-height round-arched windows opens onto a balcony built into the middle of the Veranda roof. Each of the two arched windows has biforate wood tracery, dividing it into two round arches within the single round arch of that sash (see photo #6).

SECOND STORY BIFORATE WINDOWS LEADING TO BALCONY
FACING NORTH WEST

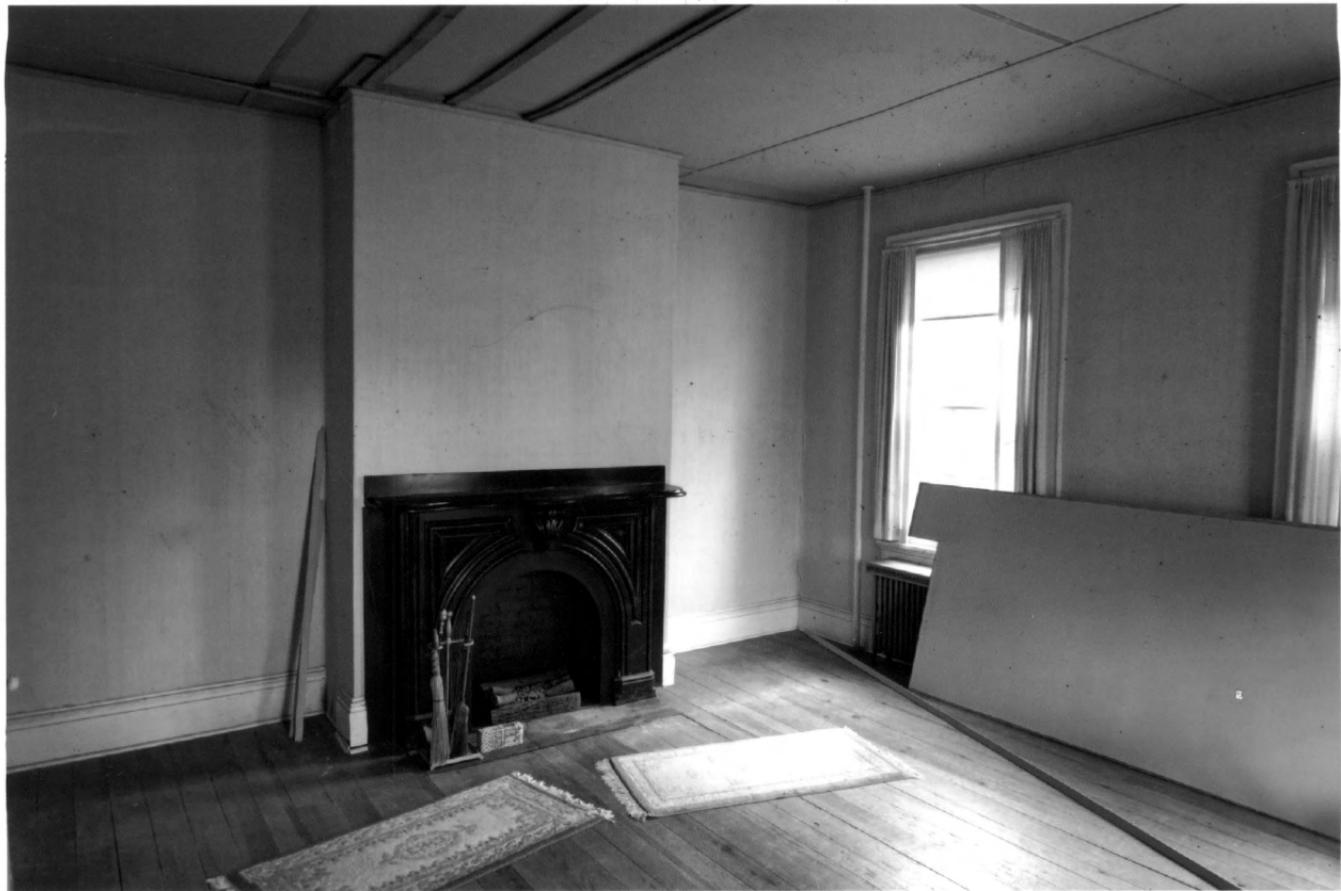
The parlor and sitting room have the same round-arched Empire style slate or marble fireplaces as found in Italianate-style houses (see photo #7). The sitting room's mantelpiece retains its marbleized slate finish while the parlor's has been painted over and is missing the volute. The fireplaces in the two bedrooms are wood and of the same design as the one in the ell (see photo #8).

WEST PARLOR MANTELPIECE
FACING SOUTHWEST

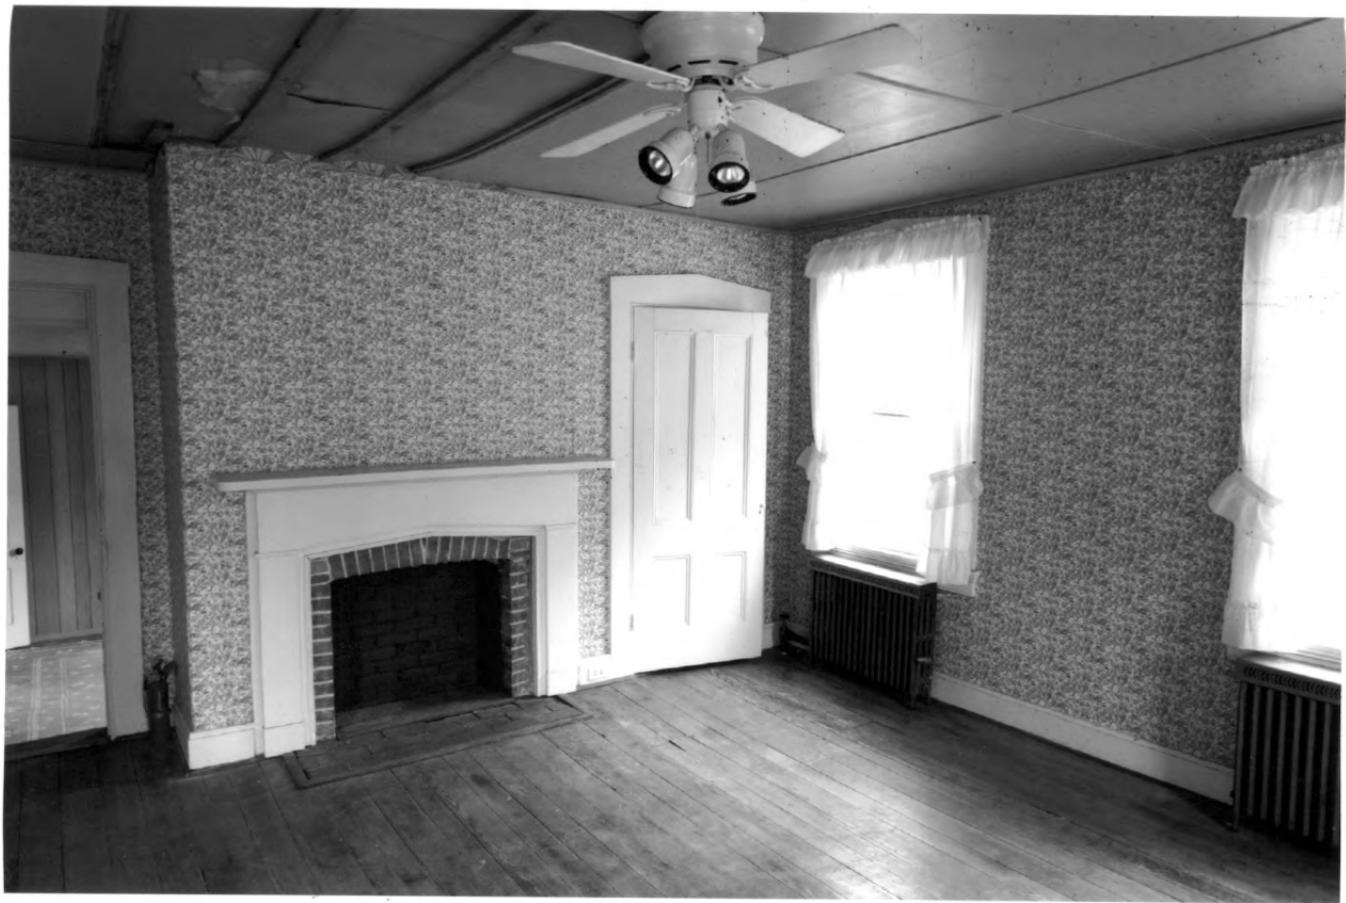
AA-0123-2014-03-11-08

WEST FRONT BEDROOM FIREPLACE AND CUPBOARD,
FACING SOUTHWEST

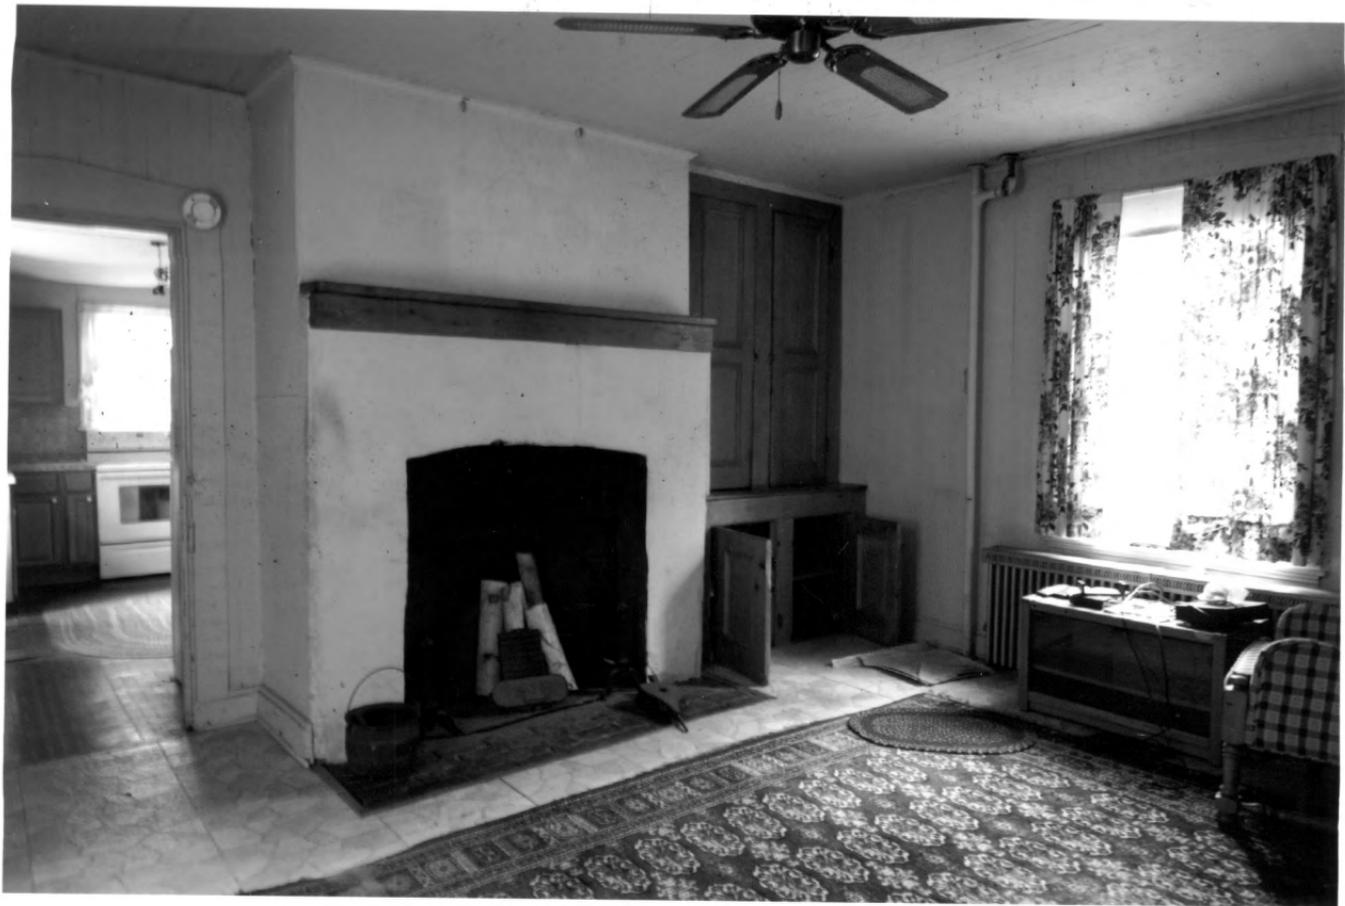
COOKING FIREPLACE AND PINE CUPBOARD IN ORIGINAL KITCHEN
FACING SOUTHWEST

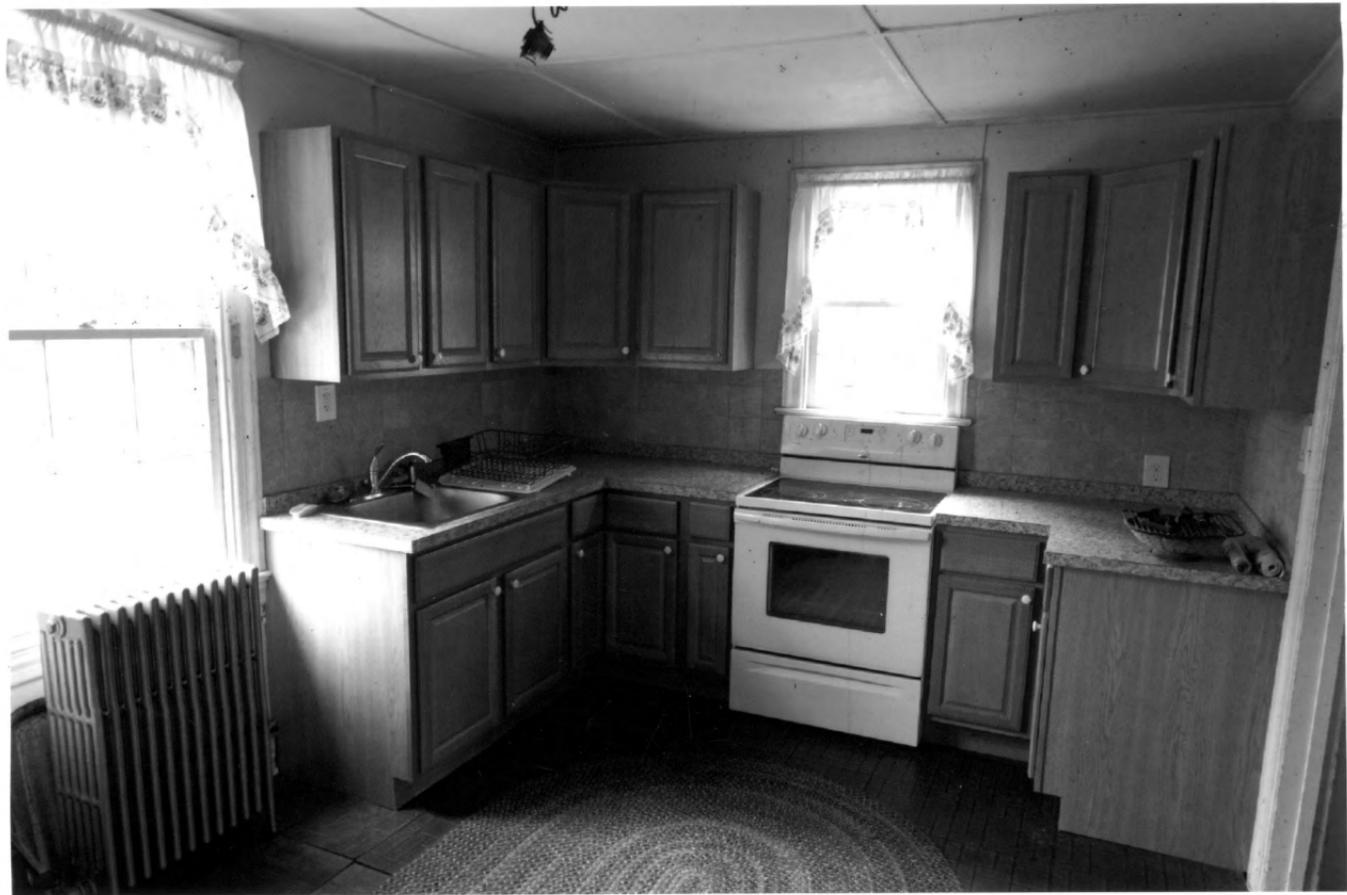
AA-0123-2014-03-11-10

KITCHEN, SHOWING MODERN CABINETS
FACING SOUTHEAST

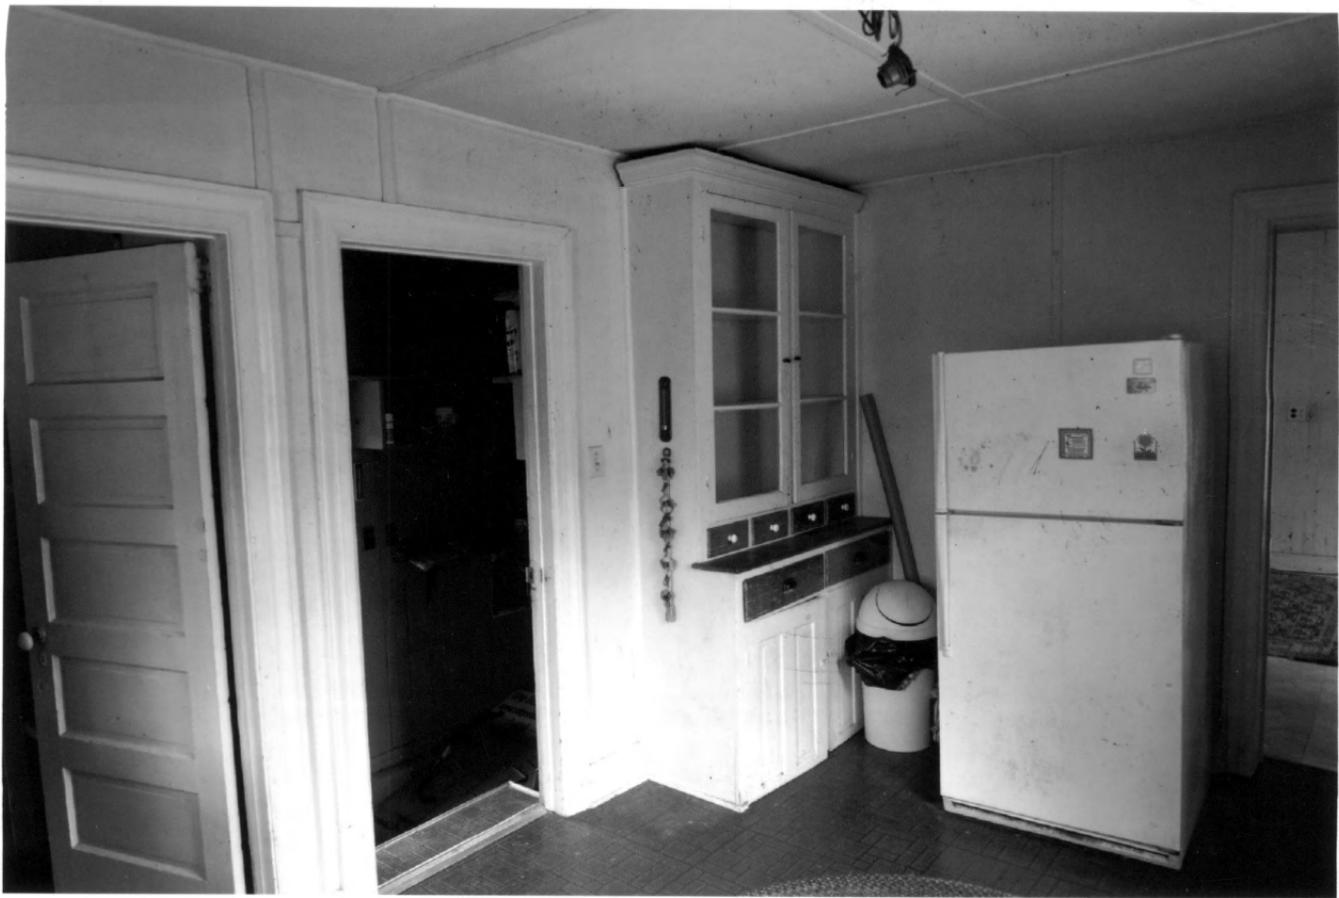
AA-0123 - 2014-03-11 - 11

KITCHEN, SHOWING CA. 1920 CUPBOARD WITH GLASS DOORS,
FACING NORTHWEST

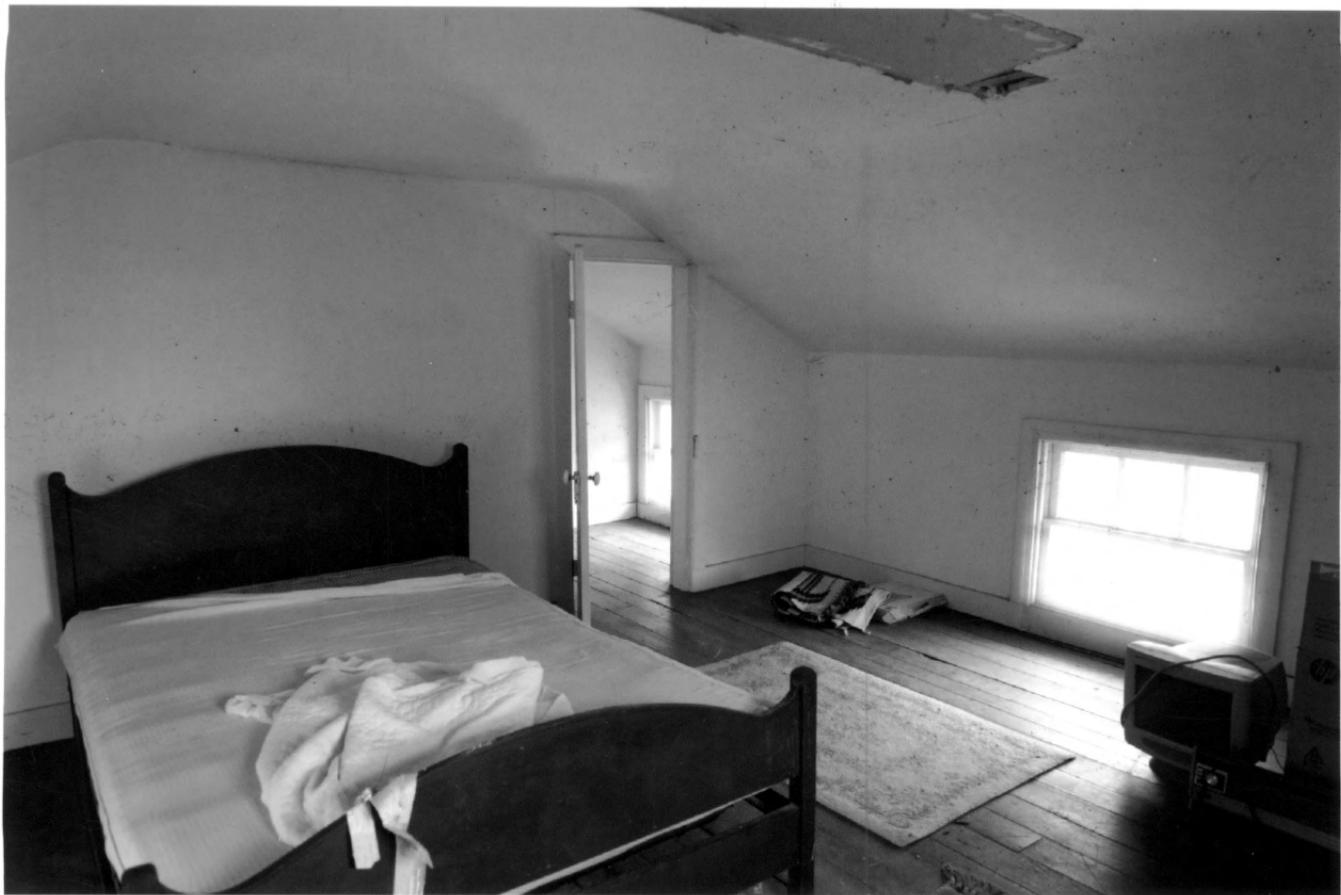
AA-0123 - 2014-03-11 - 12

THIRD FLOOR BEDROOM IN ELL
FACING SOUTHWEST

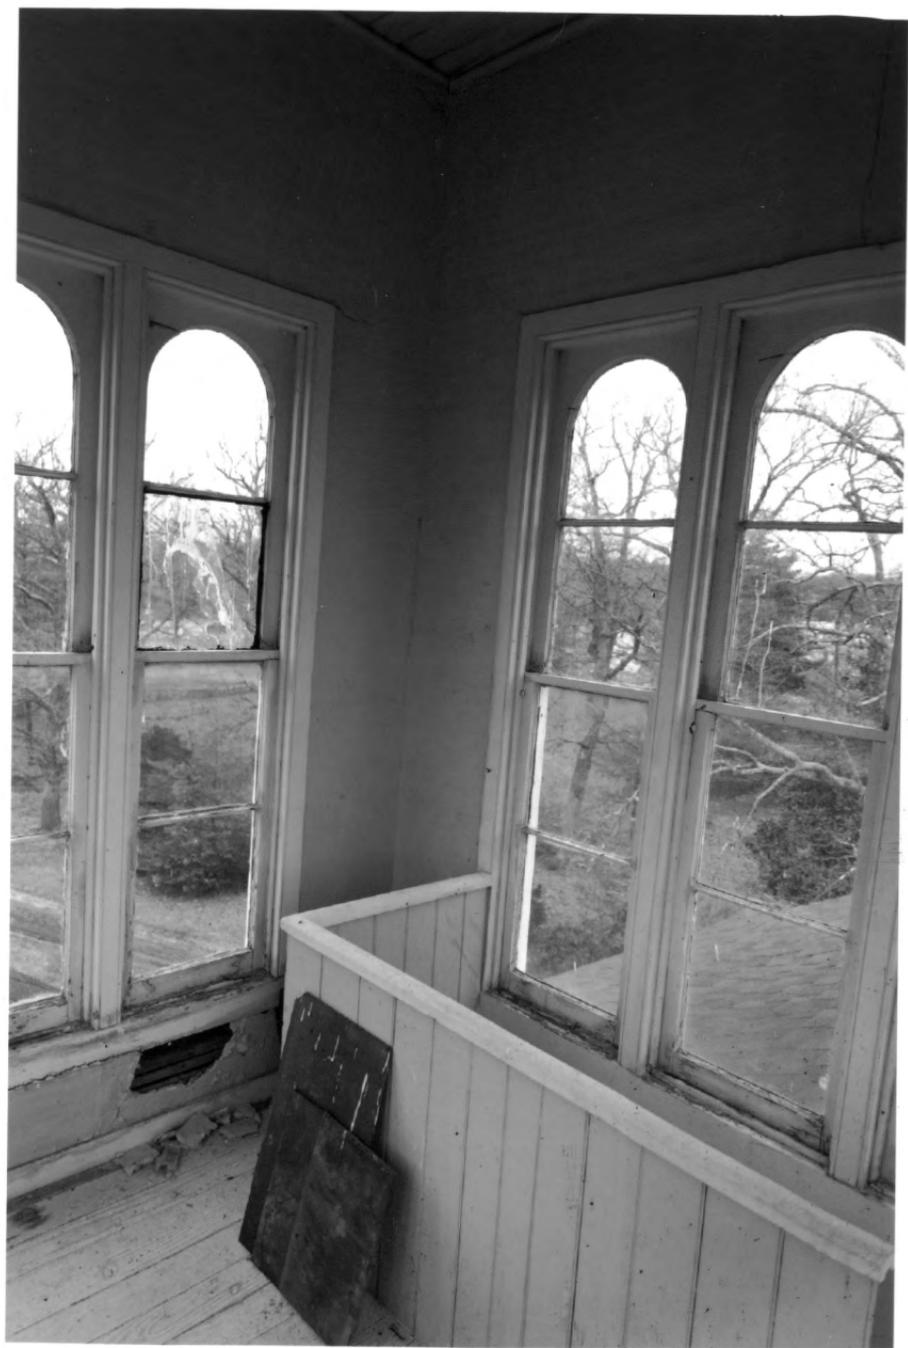
AA-0123_2014-03-11_13

The cupola, or belvedere, is nearly a cube with a shallow pyramidal roof. Three abutting arched windows are found on each side (see photos #2 and #13). The eaves overhang about 1 ft. and are supported by two pairs of decorative brackets at each corner. The finial and volutes have been removed and stored in the crawl space of the Tenant House.

CUPOLA WINDOWS, STAIR ENCLOSURE, AND VIEW
FACING NORTHEAST
