**MARYLAND HISTORICAL TRUST
DETERMINATION OF ELIGIBILITY FORM**

Property Name: Trusty Friend Inventory Number: AA-123

Project: Shannon's Glen Agency: Army Corps of Engineers

**MARYLAND HISTORICAL TRUST
NR-ELIBILITY REVIEW FORM**Continuation Sheet No. 1

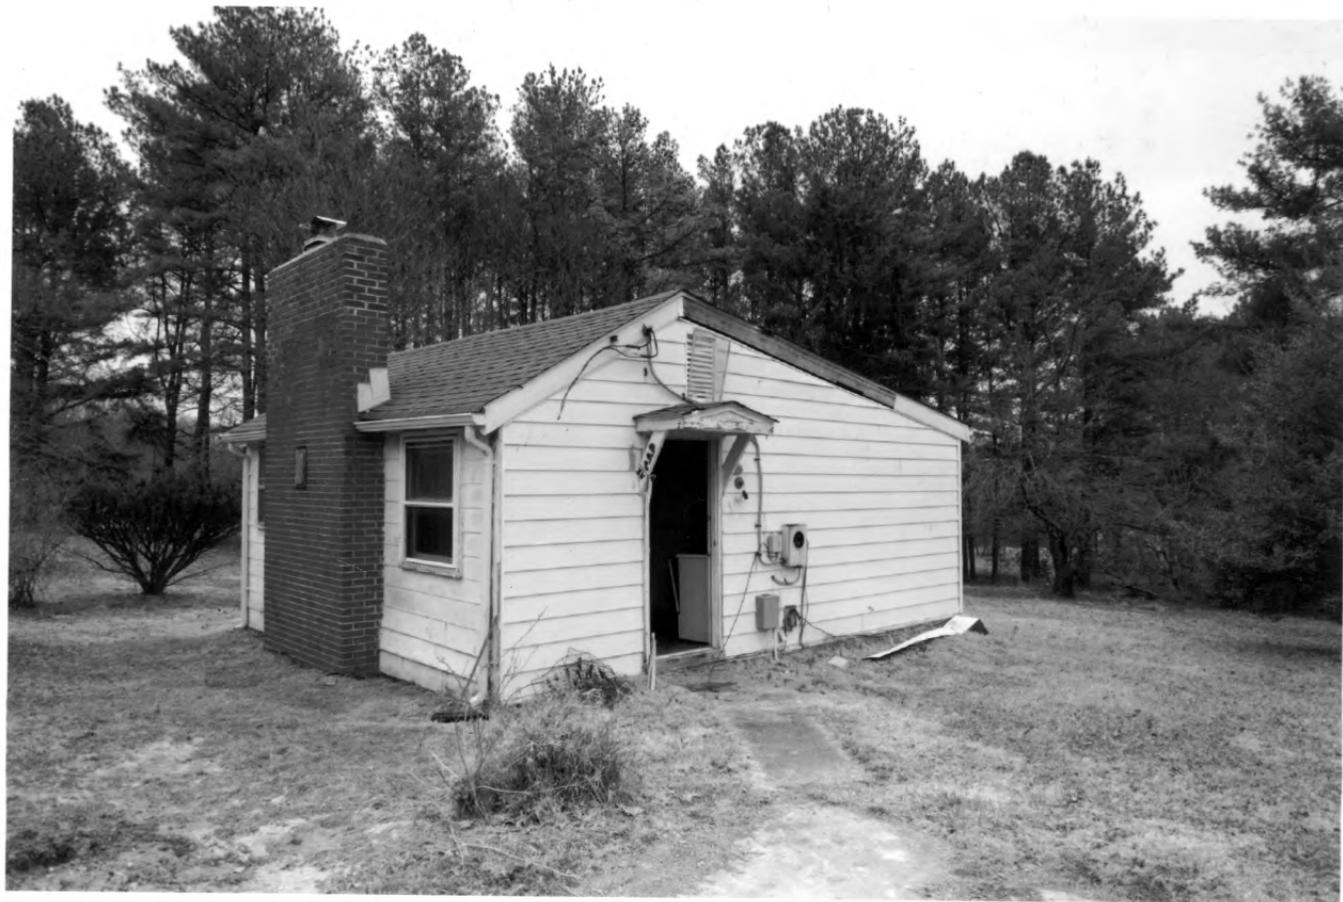
AA-0123-2017-03-11-15

CHIMNEY HOUSE OUTBUILDING, NORTH AND WEST ELEVATIONS
FACING SOUTHEAST

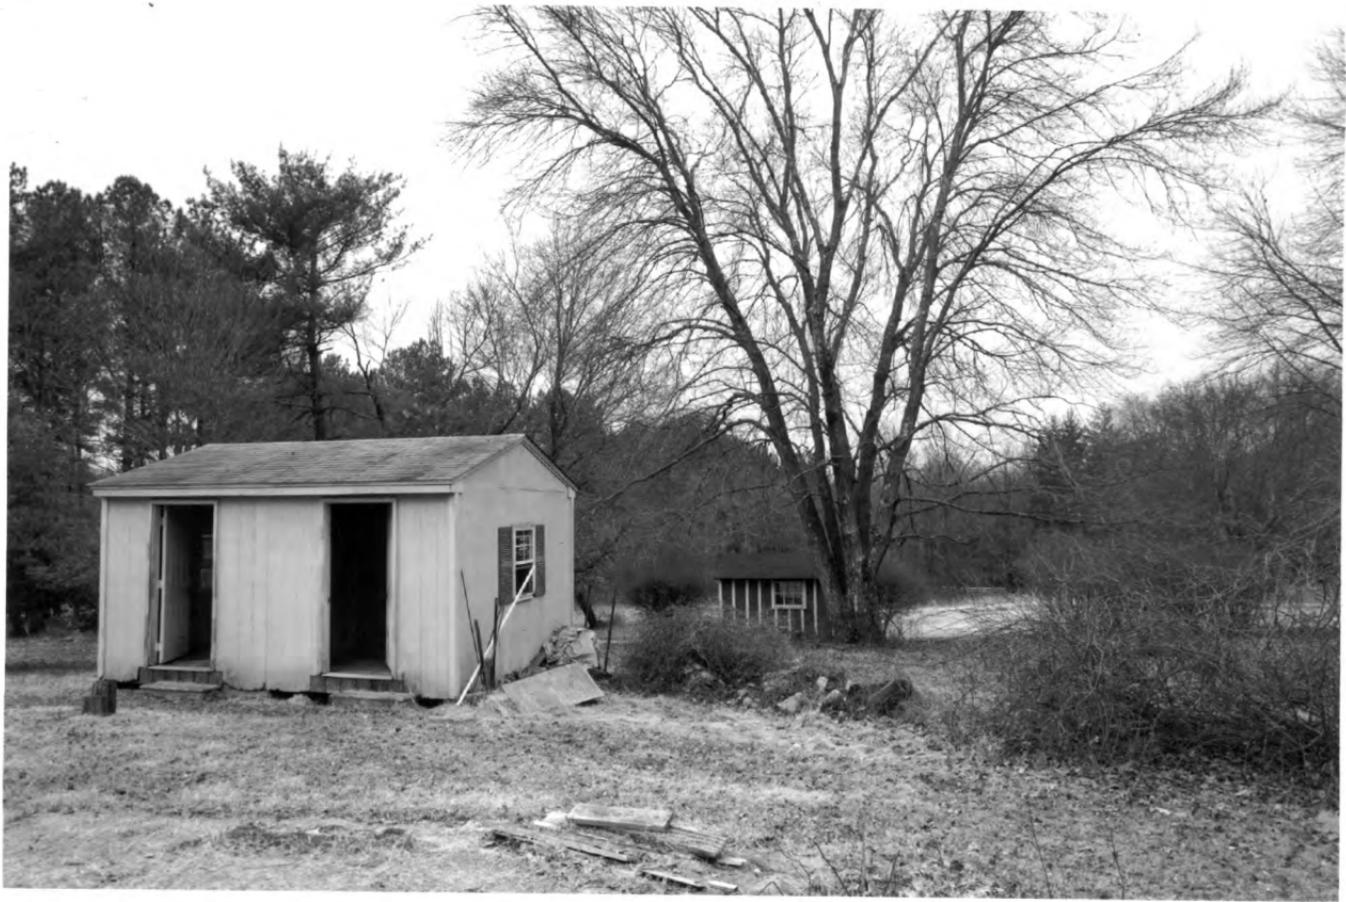
AA-0123_2014-03-11_16

This small wood shed with a gable roof is located just behind the light gray shed (see photo #16). This is of dimensional lumber construction with vertical boards used as siding and applied batten strips painted yellow. The floor is plywood, which has begun to deteriorate and is no longer stable enough for use. The construction appears to date to about 1965. The vertical siding boards (barn siding) are weathered and look older than the other components of the building. Built after the Period of Significance, the Red Shed is not a contributing component of Trusty Friend.

GRAY SHED AND RED SHED (SARAH'S PLAYHOUSE)
FACING SOUTH

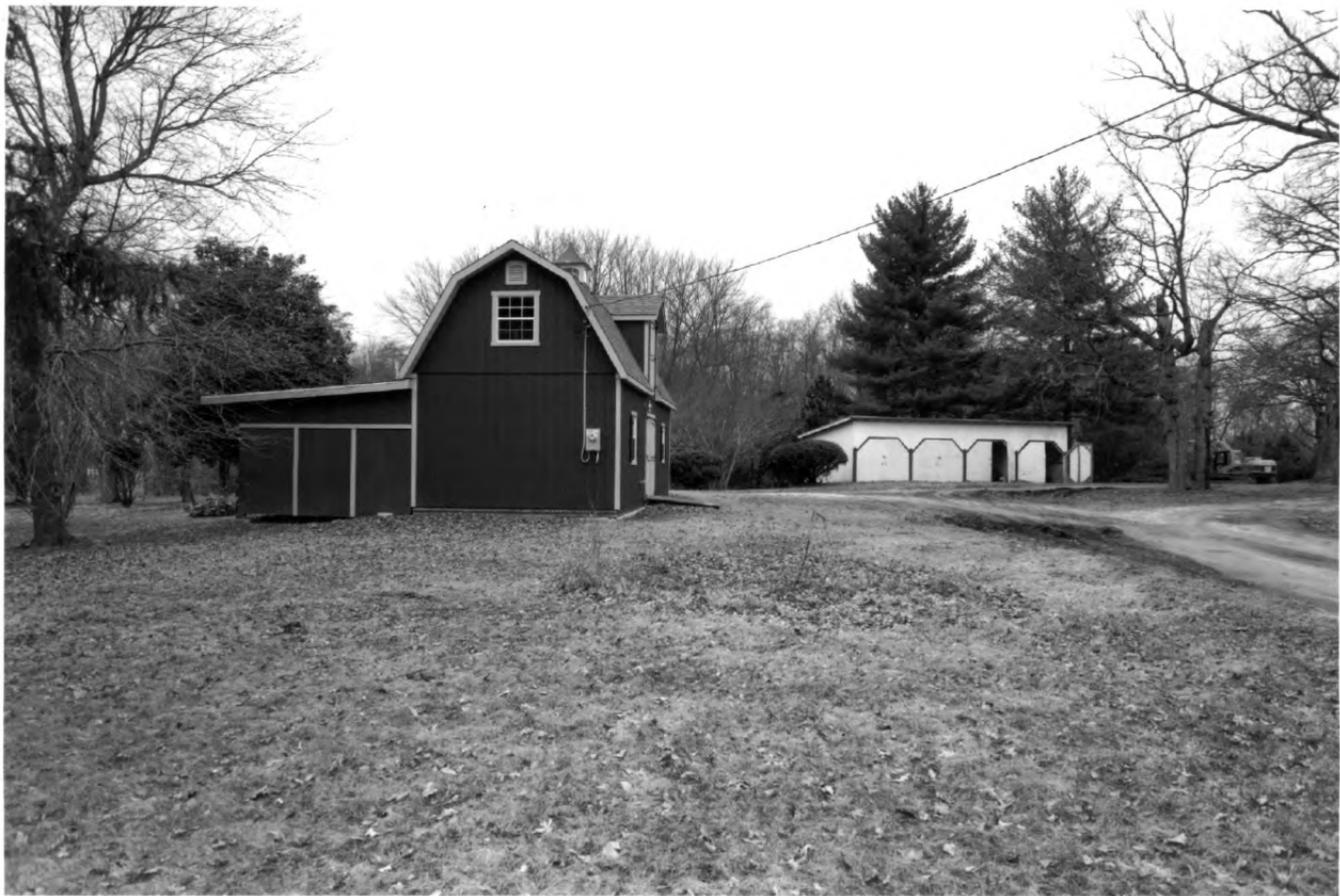
AA-0123-2017-03-11-17

1990S BARN AND MACHINE-SHED-STYLE GARAGE
(FORMERLY REFERRED TO AS "CARPORT")

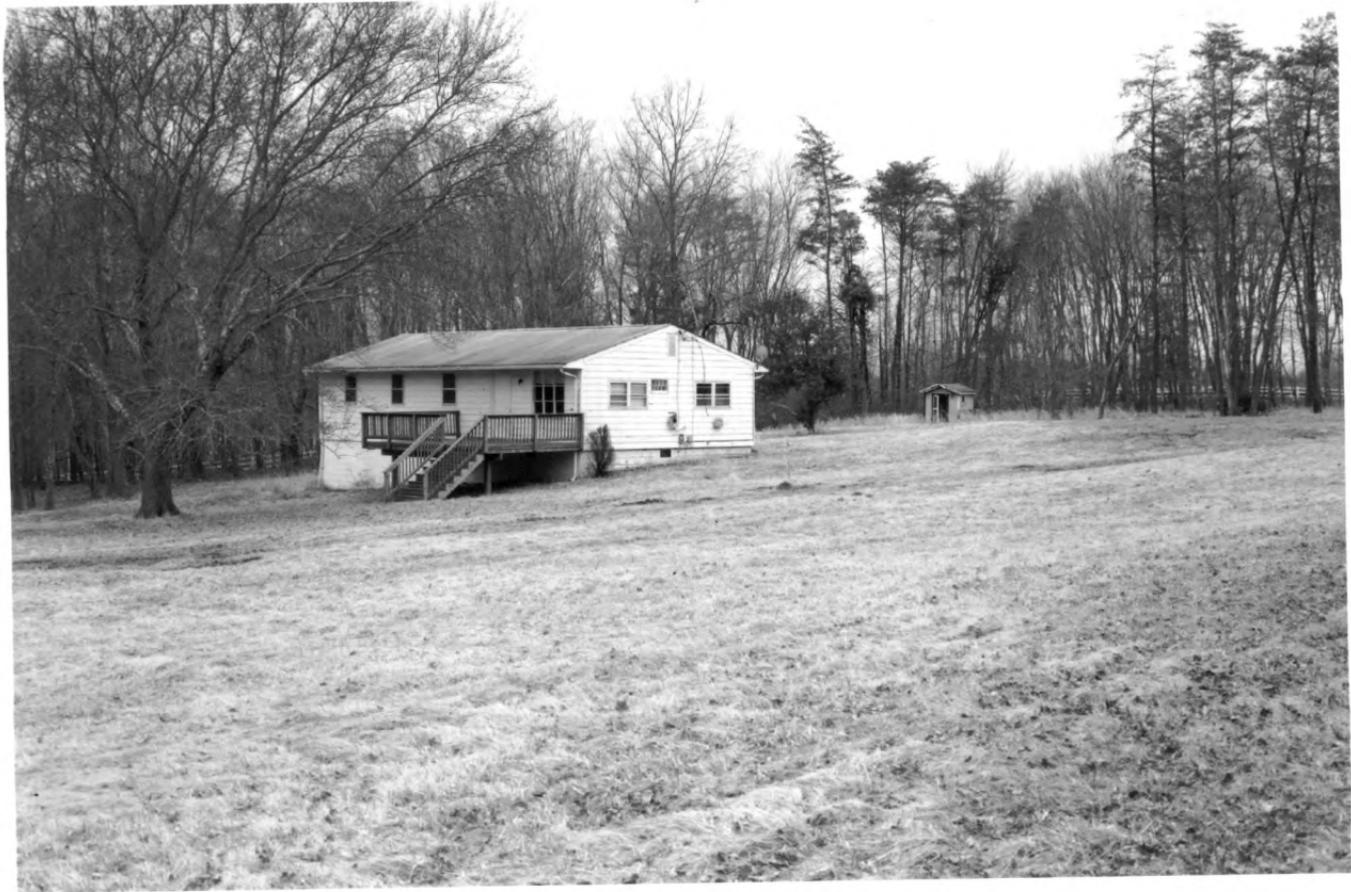
AA-0123 - 2014-03-11 - 19

This single story house, the southernmost building on the property, down a swale from the ca.1990 barn, appears to have been built about 1960 (see photo #19). Because of the slope of the land, the basement is mostly above grade. The foundation walls are concrete block and the exterior walls have aluminum siding. The roof is pitched at about 3/12 and is covered in asphalt shingles.

EAST (FAÇADE) AND NORTH ELEVATIONS OF RENTAL HOUSE
FACING SOUTHWEST
