AA-1342
183-185 Duke of Gloucester Street
Annapolis
Private

1885-1891

HISTORIC SITES SURVEY FIELD SHEET
 Individual Structure Survey Form

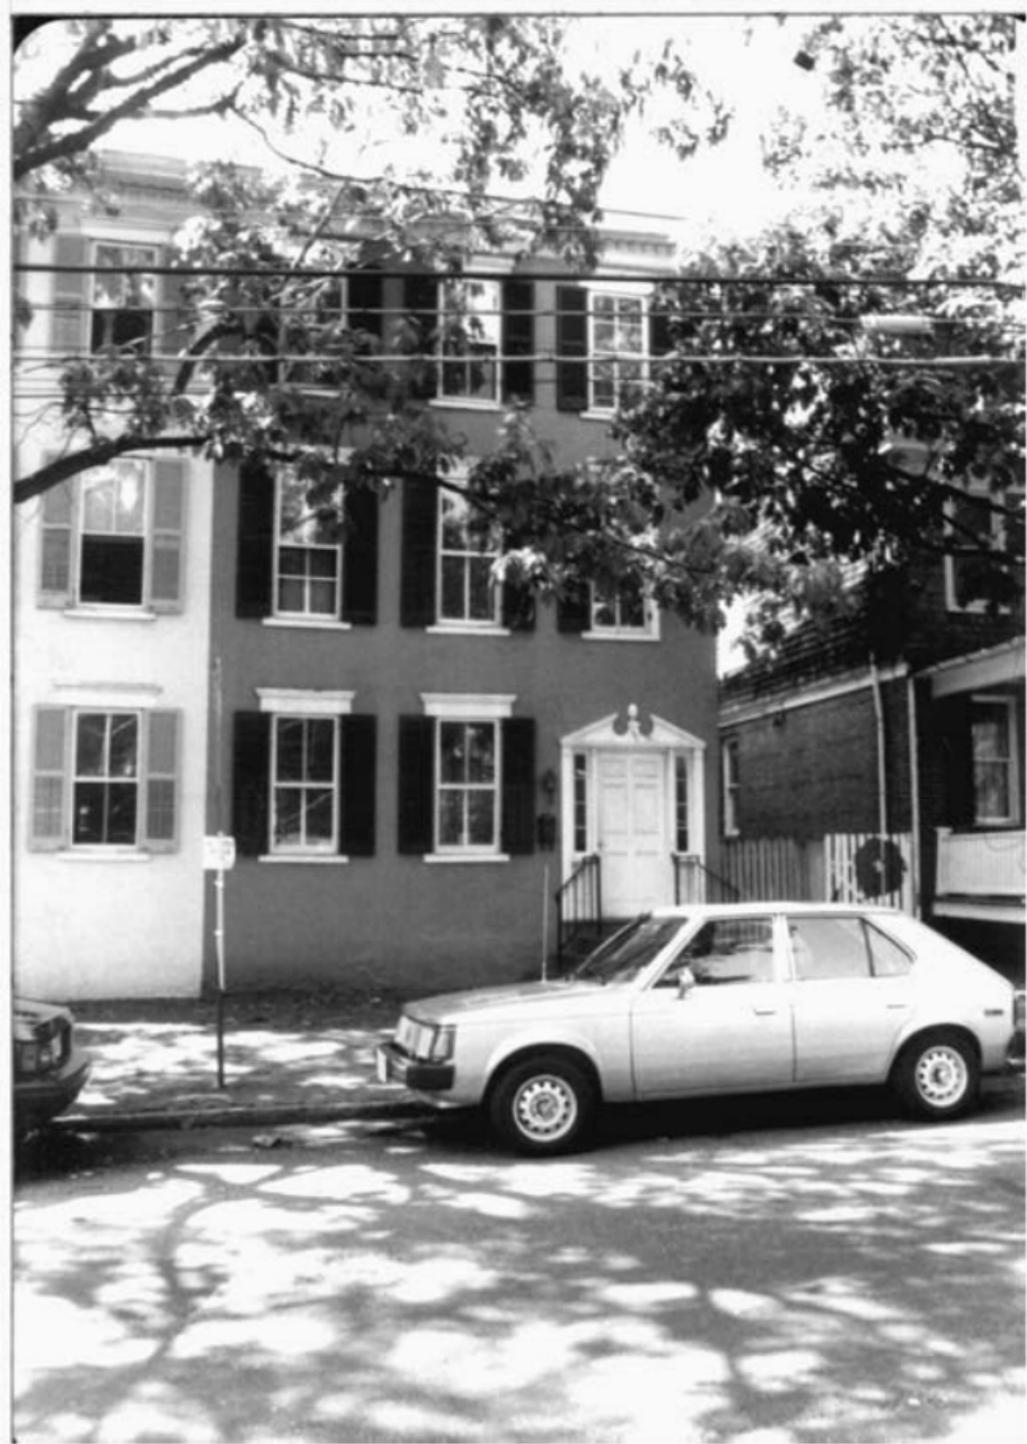
185 Duke of Gl

Bracketed cornice, molded window heads, later "Colonial" broken pediment entrance, later stoop.

NWElevation/camera facing SE

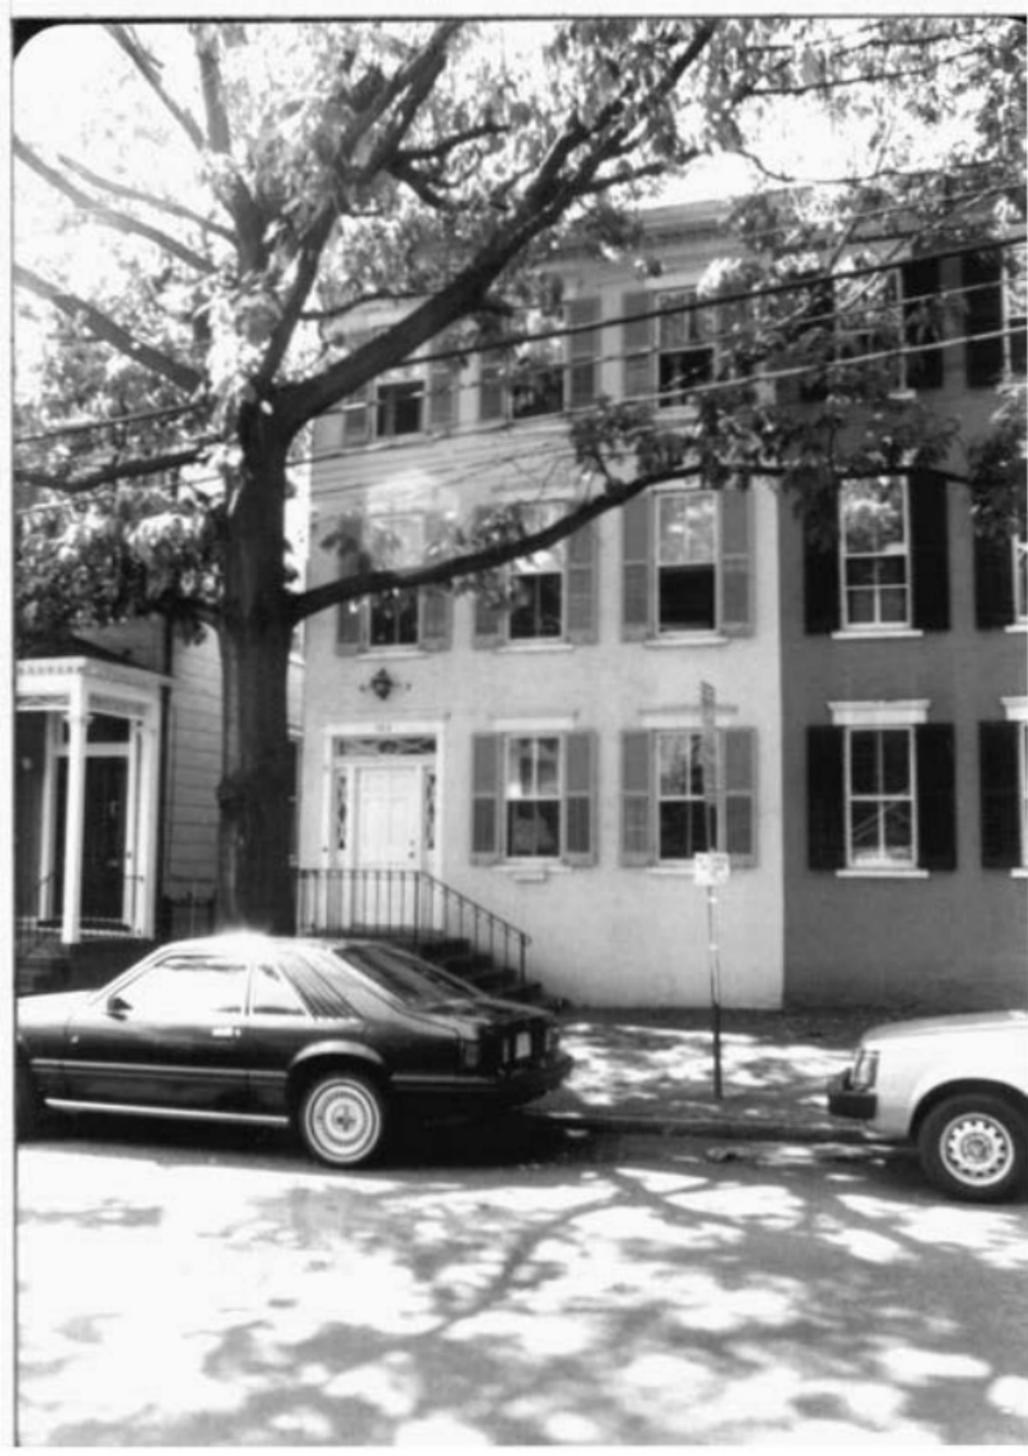
183 DUKE OF GL

Bracketed cornice, molded window heads, transom and sidelit entrance later alteration, later stoop.

Moderate example of Vernacular townhouse with Italianate cornice. Entrance design is of wrong period as is stucco over novelty siding (in place). Contributes to streetscape as one of a pair, could be significant as a type if restored.

183 Duke of Gl AA 1342
Annapolis, Anne Arundel County
Russell Wright July, 1982
Maryland Historical Trust,
Annapolis, Maryland
NW Elevation/camera facing SE
