AA-1501

74 Southgate Avenue  
Annapolis  
Private

# Maryland Historical Trust State Historic Sites Inventory Form

HISTORIC SITES SURVEY FIELD SHEET  
 Individual Structure Survey Form

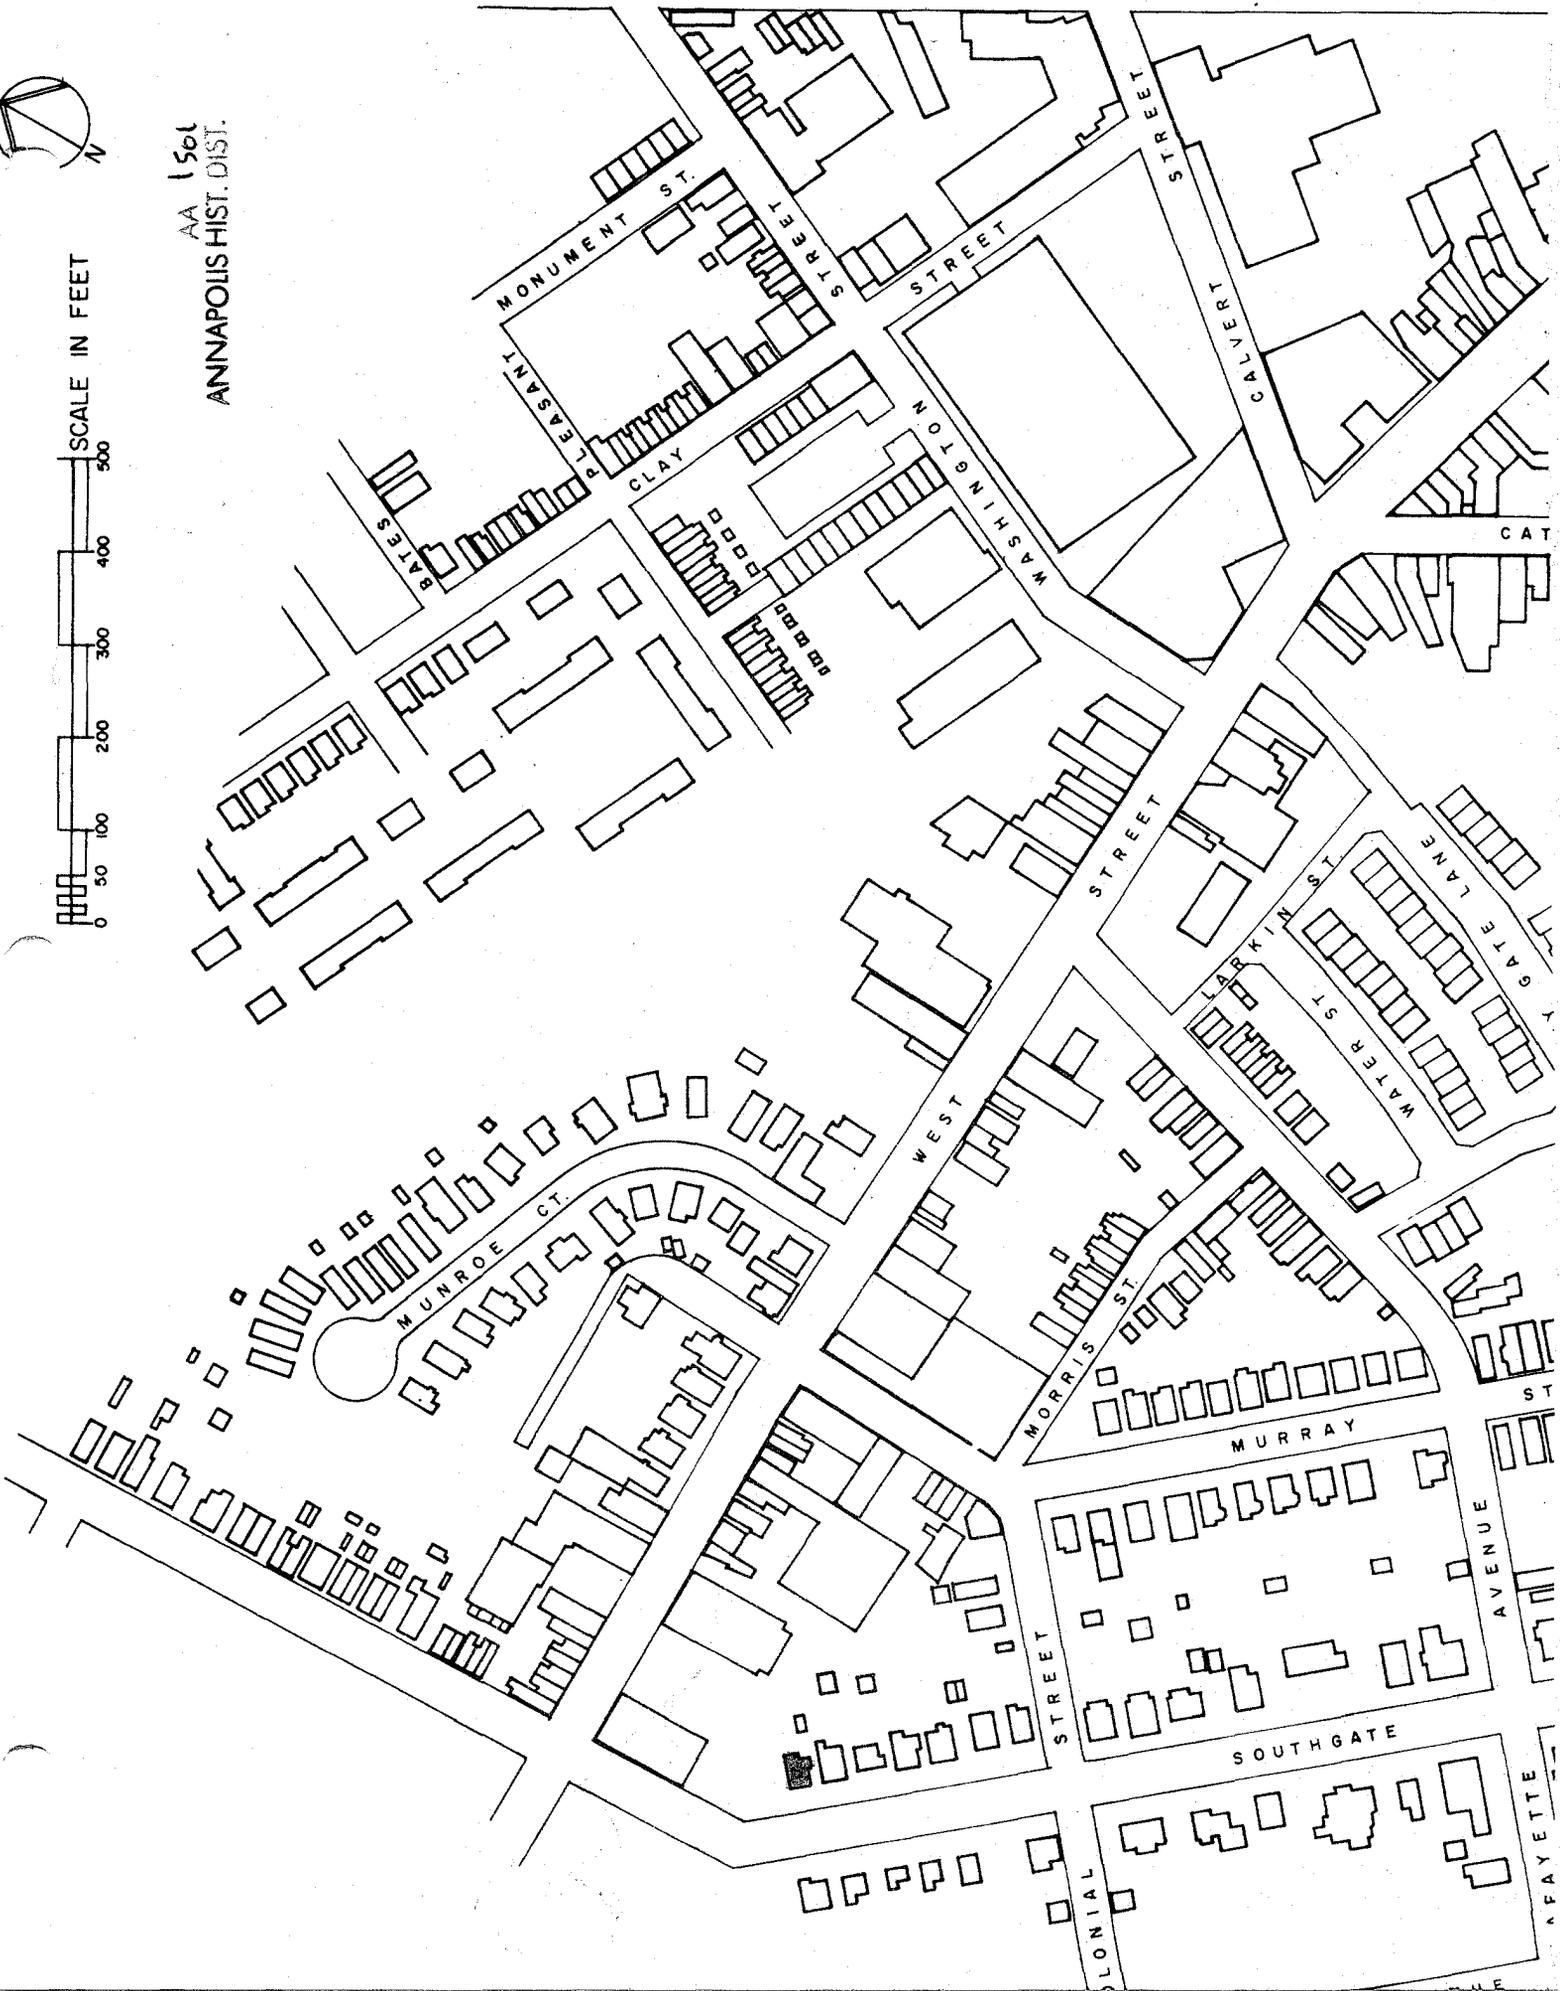
P7

74 Southgate AA1501  
Annapolis, Anne Arundel County  
Russell Wright July, 1982  
Maryland Historical Trust,  
Annapolis, Maryland  
sw Elevation/camera facing ne
