HISTORIC SITES SURVEY FIELD SHEET  
Individual Structure Survey Form

SURVEY NUMBER: <u>AA 1651</u>
NEGATIVE FILE NUMBER:
UTM REFERENCES: Zone/Easting/Northing
U.S.G.S. QUAD. MAP:
PRESENT FORMAL NAME:
ORIGINAL FORMAL NAME:
PRESENT USE: <u>single Family Residence</u>
ORIGINAL USE: " " "
ARCHITECT/ENGINEER:
BUILDER/CONTRACTOR:
PHYSICAL CONDITION OF STRUCTURE: Excellent ( ) Good (x) Fair ( ) Poor: ( )
THEME:
STYLE: <u>Vernacular-Annapolis Federal</u>
DATE BUILT: <u>1891-1897</u>

COUNTY: <u>Anne Arundel</u>
TOWN: <u>Annapolis</u>
LOCATION: <u>84 Market</u>
COMMON NAME:
FUNCTIONAL TYPE: <u>Res Map 33 Par 1</u>
OWNER: <u>Seamon Richard M &amp; Nancy</u>
ADDRESS: <u>84 Market St.</u> <u>Annapolis, MD 21401</u>
ACCESSIBILITY TO PUBLIC: Yes (x) No ( ) Restricted ( )
LEVEL OF SIGNIFICANCE: Local (x) State ( ) National ( ) <input checked="" type="radio"/>

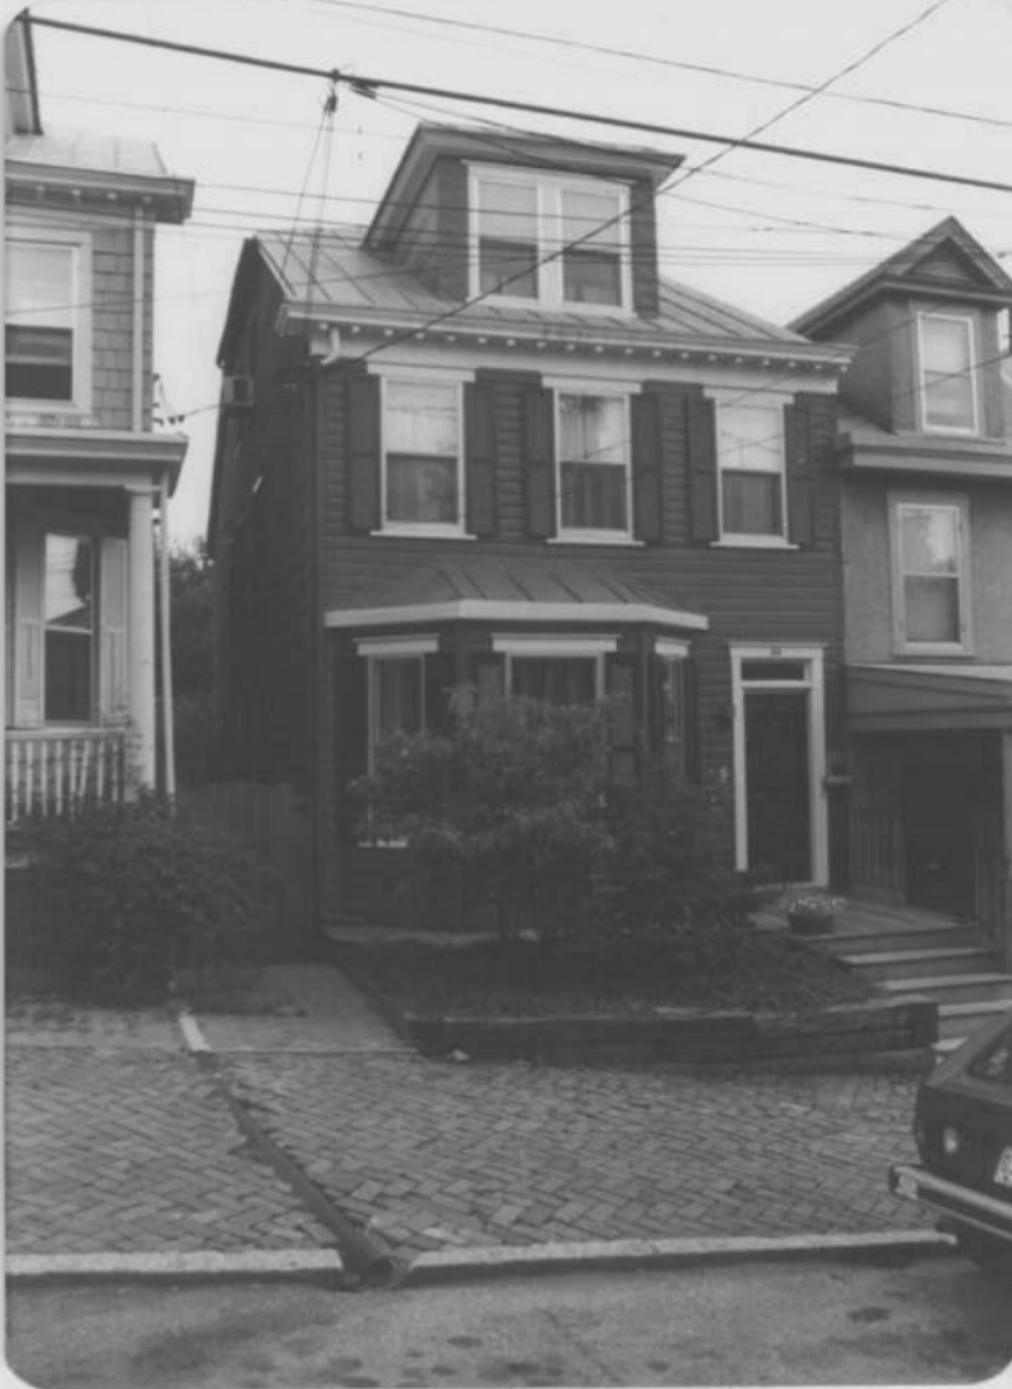
AA 1651

Large double dormer with hipped roof at standing seam roof; bracketed cornice with deep frieze panel, molded caps at all windows, including those in three-part projecting bay at first floor and at transom lit entrance; door good Italianate round headed panel.

NE Elevation/camera facing sw
