HISTORIC SITES SURVEY FIELD SHEET
 Individual Structure Survey Form

SURVEY NUMBER: <u>AA 1740</u>
NEGATIVE FILE NUMBER:
UTM REFERENCES: Zone/Easting/Northing
U.S.G.S. QUAD. MAP:
PRESENT FORMAL NAME:
ORIGINAL FORMAL NAME:
PRESENT USE:
ORIGINAL USE:
ARCHITECT/ENGINEER:
BUILDER/CONTRACTOR:
PHYSICAL CONDITION OF STRUCTURE: Excellent () Good () Fair () Poor: ()
THEME:
STYLE: Vernacular
DATE BUILT: 1885-1891

AA 1740
ANNAPOLIS HIST. DIST.

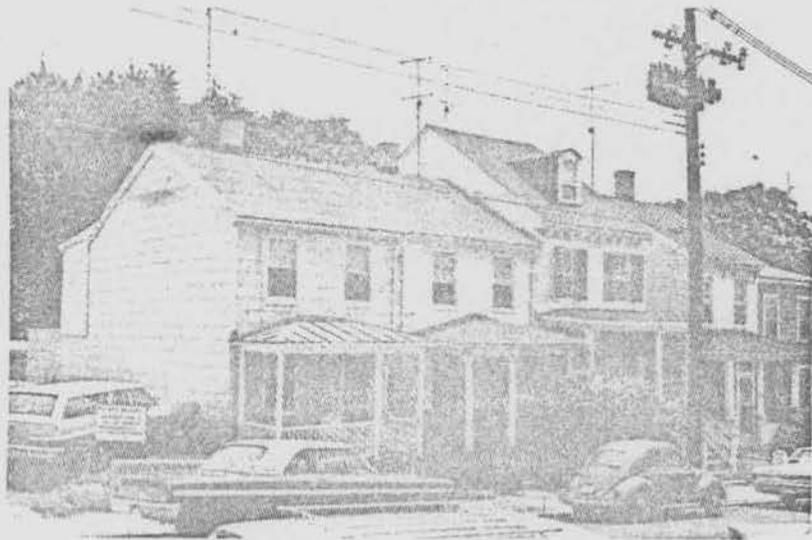
These four residences on South Street form a very nice visual quartet. Stylistically they look early 19th C. perhaps Federal, but as is common in Annapolis, probably built post Civil War in an earlier style. All have porches over first storey with door and window and two windows (108, 110 = 2/2; 112-114 = 6/6) on 2nd storey. 110, and 108 have brackets under cornice. Woodwork in all appears original. 108 has original roofing. 110 has handsome triangular, gabled dormer. Though none of these houses are outstanding by themselves, the group typifies Annapolis 19th C. residential. Possibly older at anyrate, they add immeasurably to a street which has been desecrated on the opposite side. Their visual appearance is heightened by the fact that they are built on a slope. Nos. 106, 104, 102 South Street also in this general category, however, are not as interesting, though they have original bracketed cornices.

Exterior **Fair**
