# National Register of Historic Places Inventory—Nomination Form

historic Indian Range

# 7. Description

### DESCRIPTION SUMMARY:

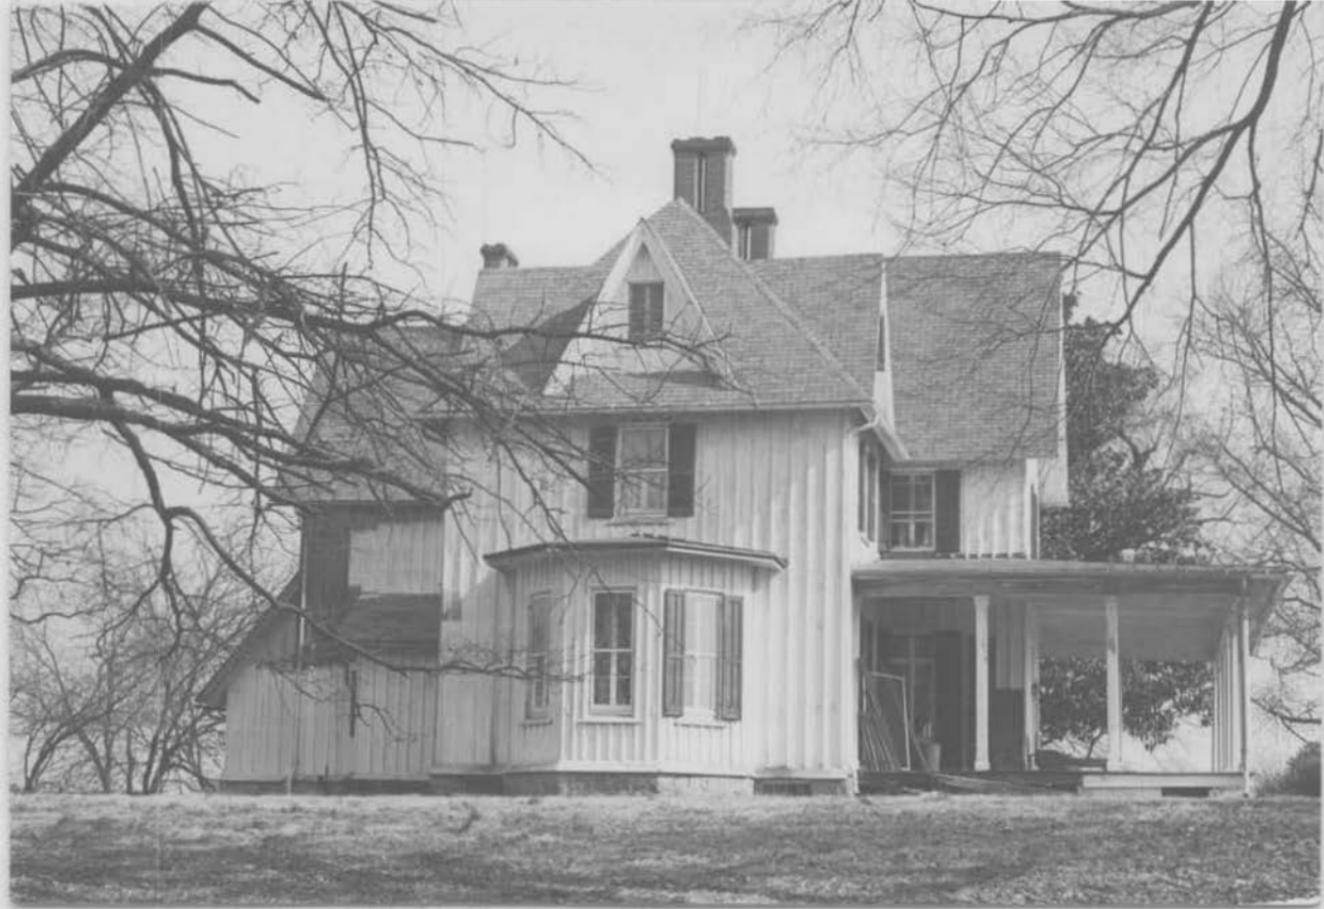
aa-29-N-a <sup>(map 22)</sup>  
"Indian Range"  
main house  
West Elevation

On the west facade of the main section is a semi-octagonal, one story, bay. There are three pair of four pane in-swinging casement windows. The bay has the same type of metal roof as the porch. On the second floor, centered above the bay, is a window and directly above this is a gabled dormer with a window. On each side of the bay is a small basement window.

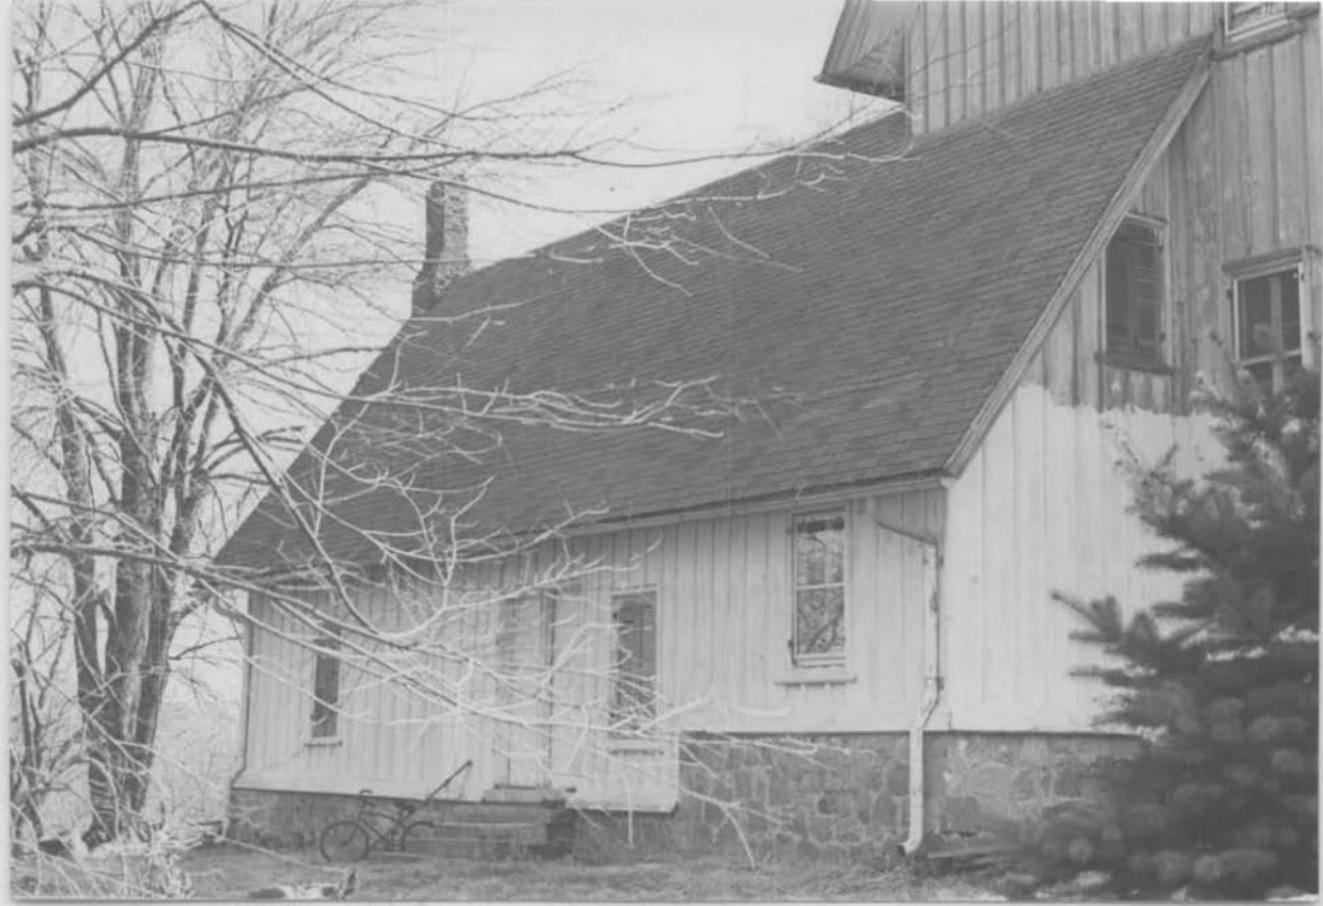
AA-29-N-a (map 22)  
"Indian Range"  
Service wing  
North elevation

The north facade of the L-extension is gabled. The roof of the L-extension joins the center of the facade midway between the first and second floors. This roof continues around at the northeast corner and becomes the roof of the wing. On the right side of this facade is a pair of windows. To the left is an entrance with double doors of beaded boards, further to the left, is another pair of windows.

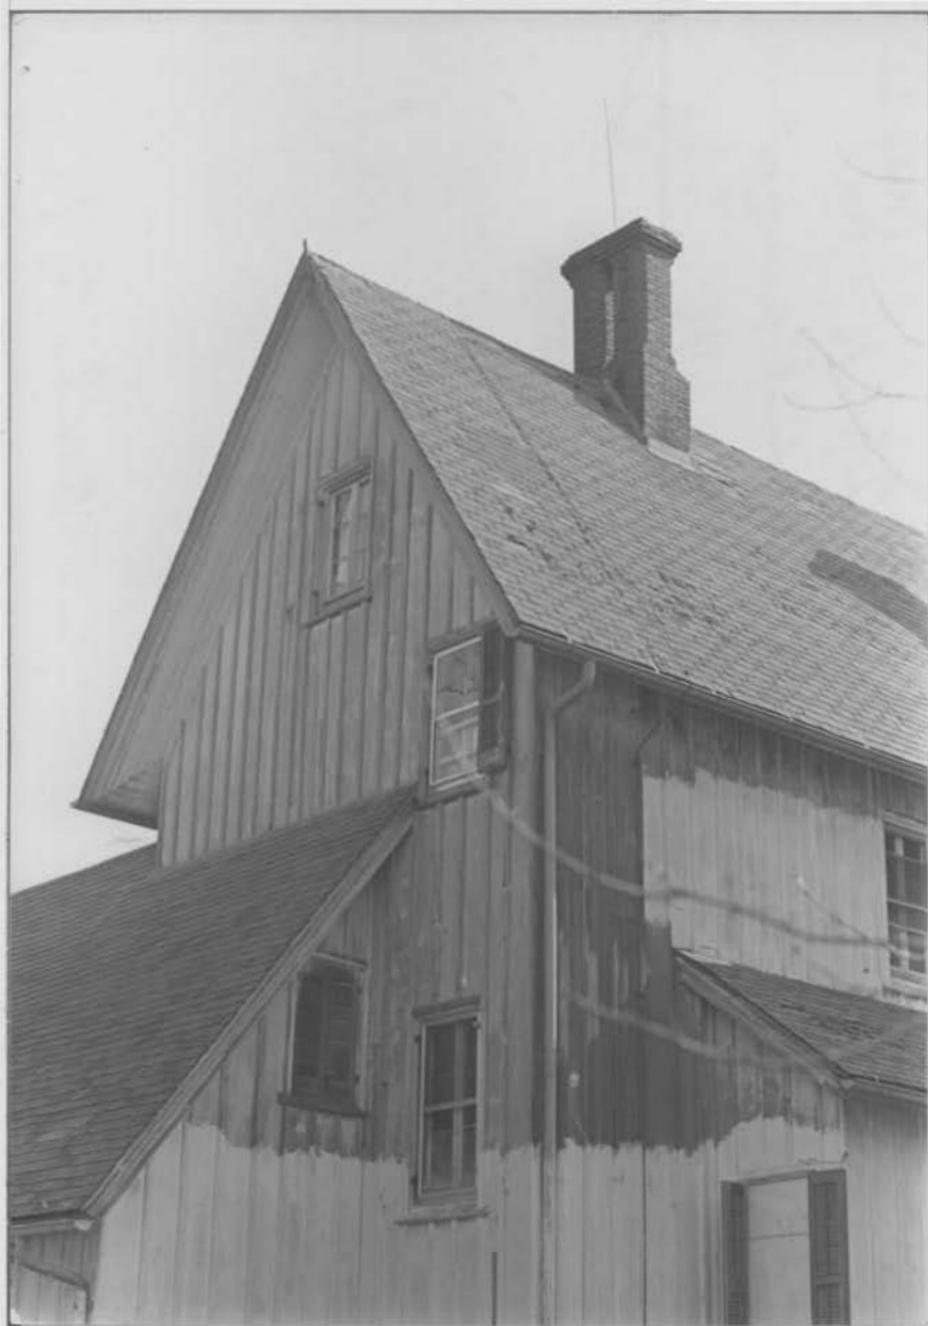
aa-29-N-a <sup>(map 22)</sup>  
"Indian Range"  
detail north wing
