INVENTORY FORM FOR STATE HISTORIC SITES SURVEY

HISTORIC TILDEN LAWN

Tilden Lawn AA-203  
Anne Arundel County

MARYLAND HISTORICAL TRUST WORKSHEET

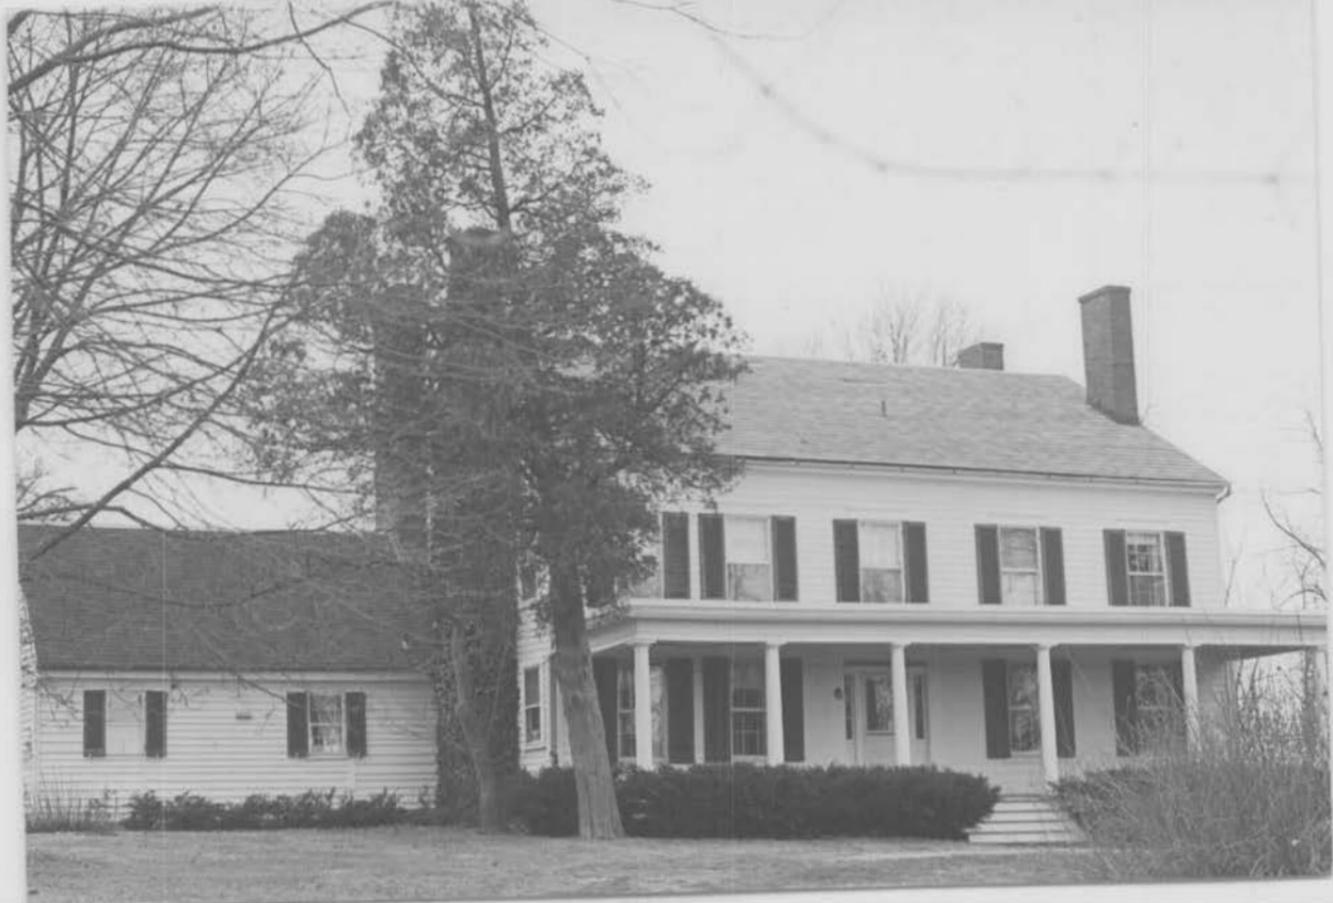
AA-  
203

(map 22) aa-30-N-a  
"Tilden Lawn"  
East Elevation

The front facade of the enlarged house faces east. The principal entrance is located in the center bay, framed with sidelights and a four-light transom and flanked by two large 6/6 windows on each side. Five 6/6 windows are ranged across the second story; there are no dormer windows on the roof. The entire front facade was renovated when the house was enlarged. The front door and all of the windows date to the third quarter of the 19th century, and the siding and cornice were also replaced at that time. A more radical change was made to the roof of the original section. The height of the front facade was increased and the early steeply pitched roof was concealed below a higher, more moderately pitched gable roof, now covered with asphalt shingles. The early roof, still covered with wood shingles, remains in place and is visible from the attic. The one story open porch with simple columns was probably added in the early 20th century. The continuous brick foundation of the porch conceals the house foundation. The foundation of the original section is laid in three-course common bond, the later section in random common bond. Notable details on the front facade include the Victorian paneling below the sidelights of the front door, the molded wood window lintels, beaded cornerboards and the box cornice with simple crown mold and bed mold.

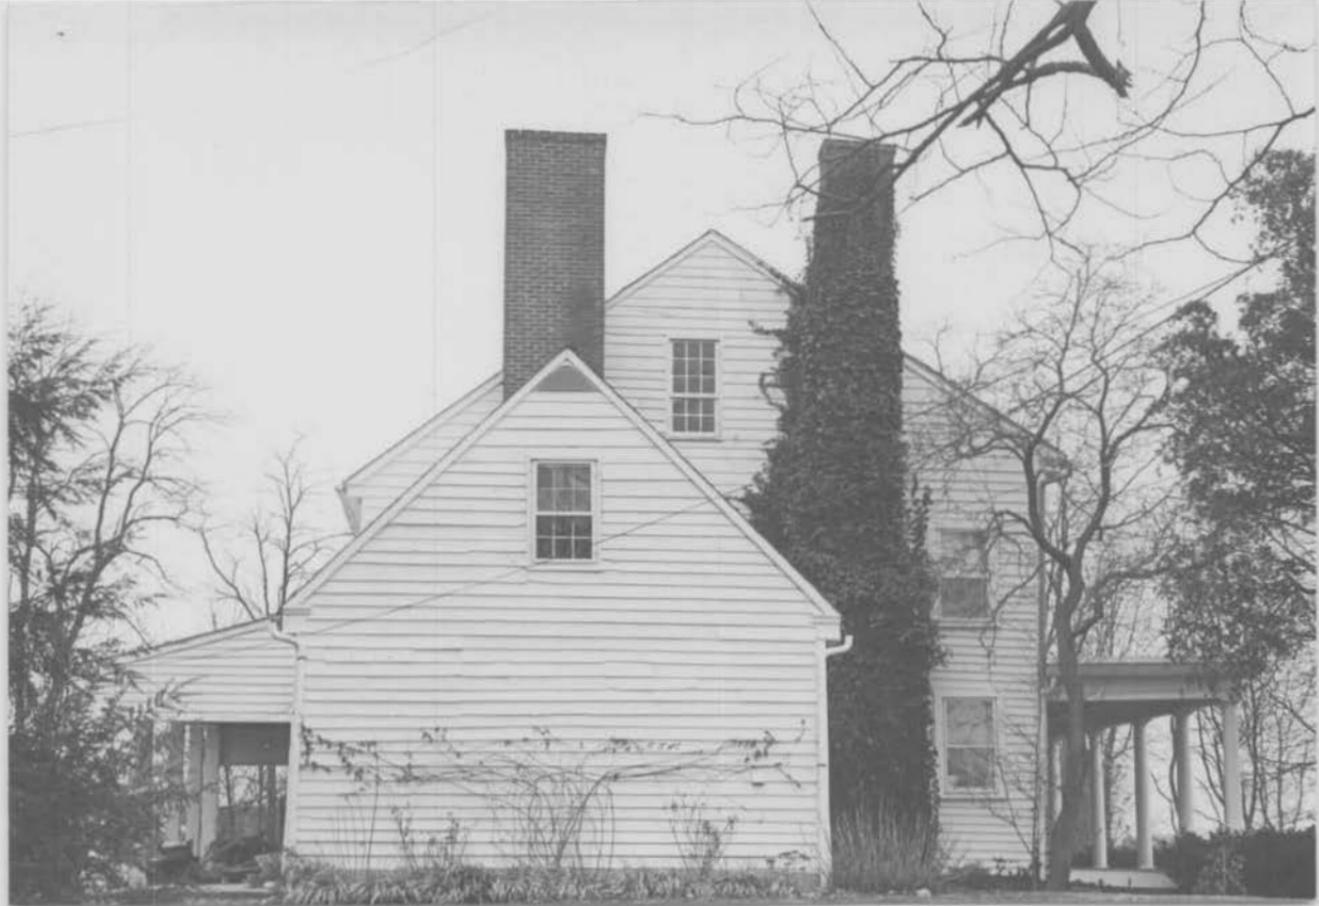
AA  
203

aa-30-N-a  
"Tilden Lawn"  
South Elevation

The west portion of the south gable wall of the main house is concealed by the one story frame wing. There are two exterior brick chimneys on this gable. The west chimney is larger due to the additional flue for the wing and has been rebuilt above the roof of the wing. The east chimney is undisturbed and shoulders in at the second story level. Single 6/1 windows are located to the east of the east chimney on the first and second stories and an early 9/6 window is centered between the chimneys in the upper gable. The plain weatherboard siding is random-width, the rakeboards are tapered but not beaded. The alteration to the front pitch of the roof is evident in the asymmetrical form of this gable.

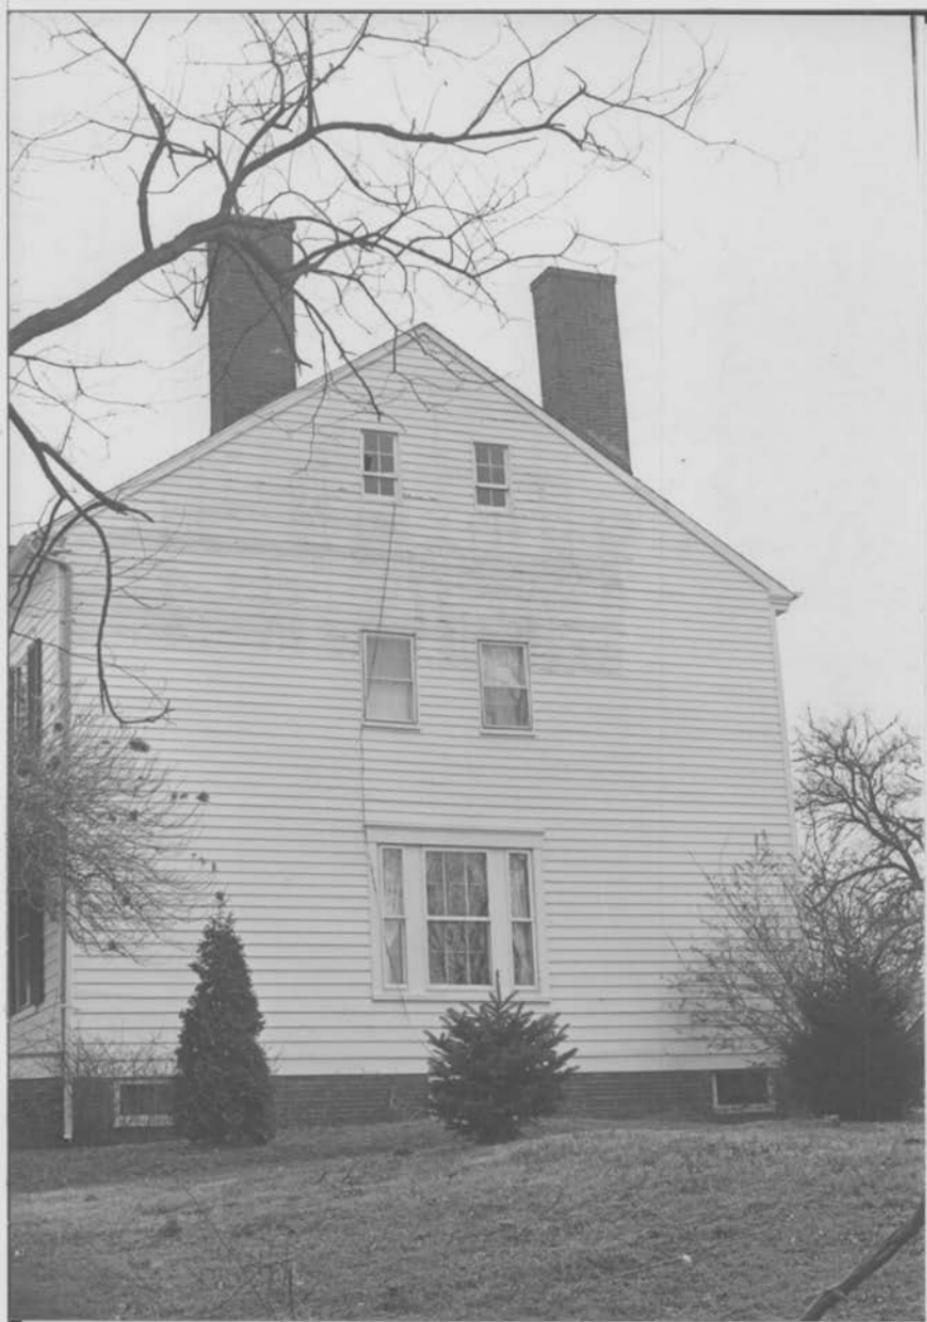
AA-  
203

"Tilden Lawn"  
North Elevation

On the north gable wall, dating entirely to the second period of construction, there is a large triple window on the first story, a pair of 6/6 windows on the second story and a pair of 4/2 windows in the upper gable. All of the window openings are located between the paired flush chimneys. The triple window on the first floor consists of 6/6 sash in the center flanked with single 2/2 sash on either side. Three three-light cellar windows pierce the brick foundation, which is laid in five-course bond. The plain weatherboard siding matches the front facade. The gable eaves are trimmed with unbeaded, tapered rakeboards.

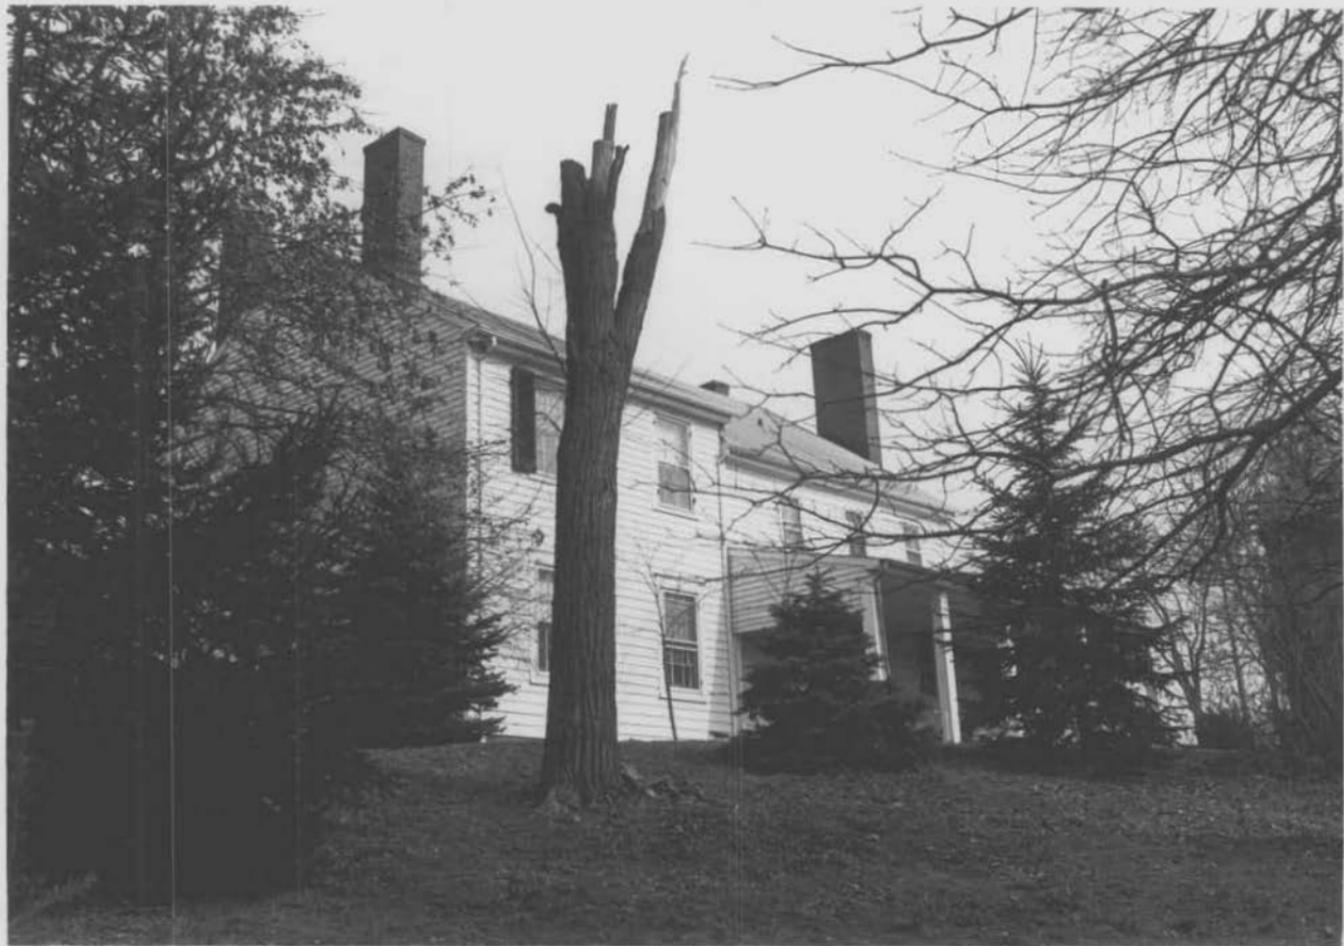
AA-203

Tilden Lawn  
Davidsonville, Anne Arundel County, Md.  
1982  
Orlando Ridout V  
Rear facade from Northwest

The division between the first and second period parts of the house is quite obvious on the rear facade. The steeply pitched roof of the original section remains visible and does not align with the more moderately pitched roof of the later addition to the north. The siding, cornice, and windows also reflect the two periods of construction. The rear door of the original house is located in what is now the center bay of the enlarged house, with two early 9/6 windows to the south and two larger 6/6 windows to the north. There are small early 6/6 windows in the center bay and the two south bays of the second story and two large 6/6 windows to the north. A bulkhead cellar entrance is located in the center bay of the original section. The early portion of the rear facade is covered with random-width weatherboard siding and the eaves are boxed in and trimmed with an incorrectly mounted bed mold. The later portion of the rear facade is covered with plain siding with standard six-inch exposure. The eaves are boxed in and trimmed with a simple crown mold and bed mold.

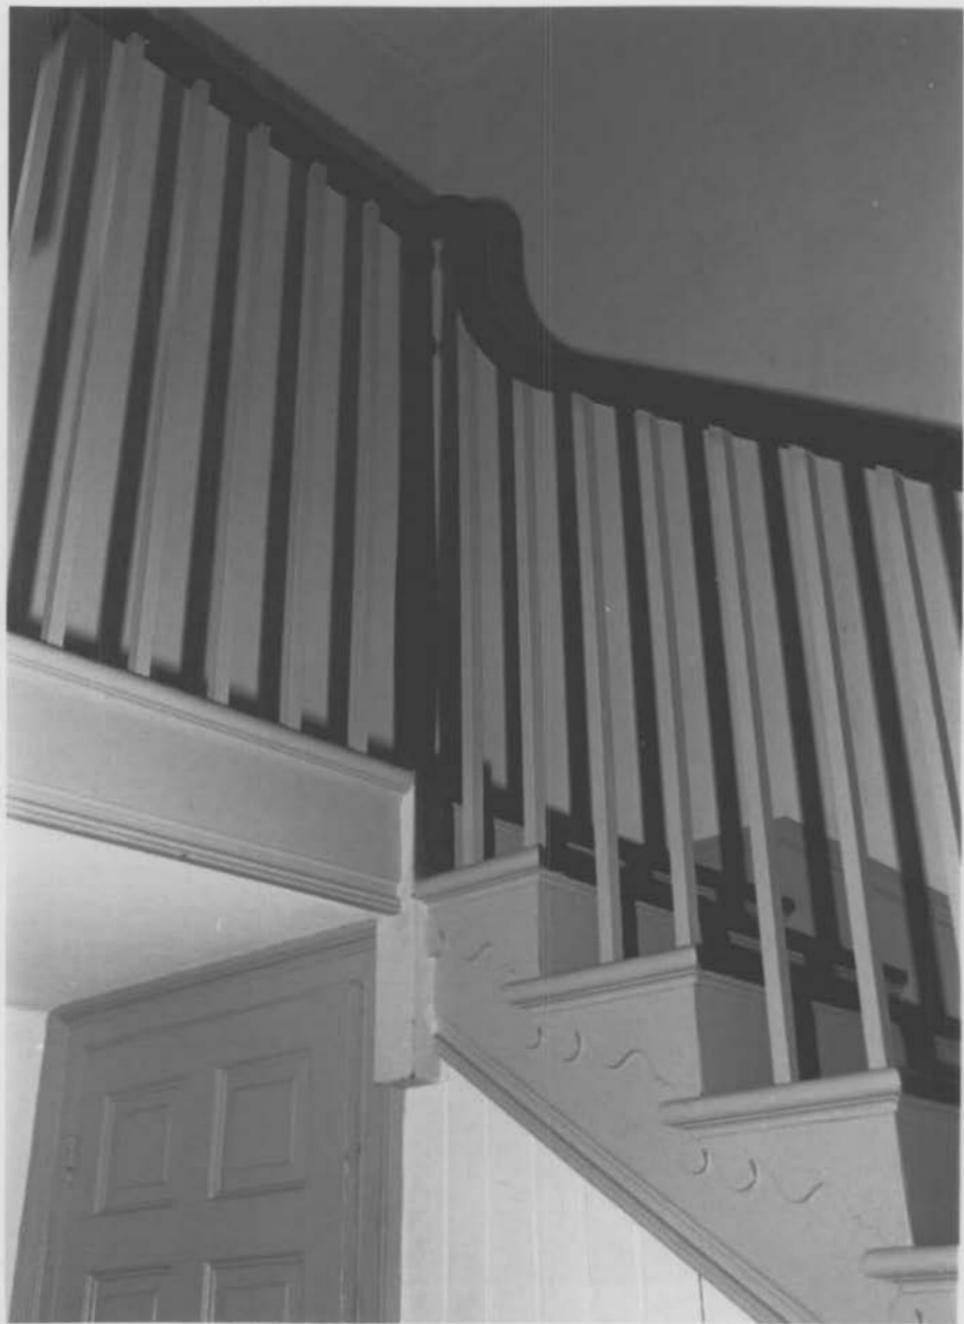
AA-203

First floor stair.

The interior of the original house consists of a side passage, double parlor plan house with the stair passage to the north. Later in the 19th century the house was enlarged to the north, forming a center passage plan with the original paired parlors to the south and one large room to the north. The stair passage is somewhat wider than usual, with the stair rising against the north wall to an intermediate landing at the west end. It is an open-string stair with delicate turned walnut newel posts, a handsome continuous ramped walnut rail and square painted balusters. The stair ends are decorated with scrolled brackets and the carriage piece is molded to match the baseboard. The area below the carriage is enclosed with vertical beaded paneling. A six-panel door originally opened onto an interior cellar stair. The cellar stair has been removed and replaced with a closet. Original trim in the stair passage includes the molded baseboard and the Federal architrave trim to the rear (west) door and the interior doors to the two south rooms. The front door with sidelights and transom dates to the post-Civil War enlargement and is trimmed with Victorian architrave trim. The paneled front door and the door to the north room are Victorian. The rear door is an early six-panel door with the top two panels removed and replaced with glass. The doors opening into the two south rooms have been removed. Early hardware includes a large carpenter lock on the rear door and a small, unmarked box lock on the door to the closet under the stairs. Also of interest is a large, boxed-in "summer" beam in the

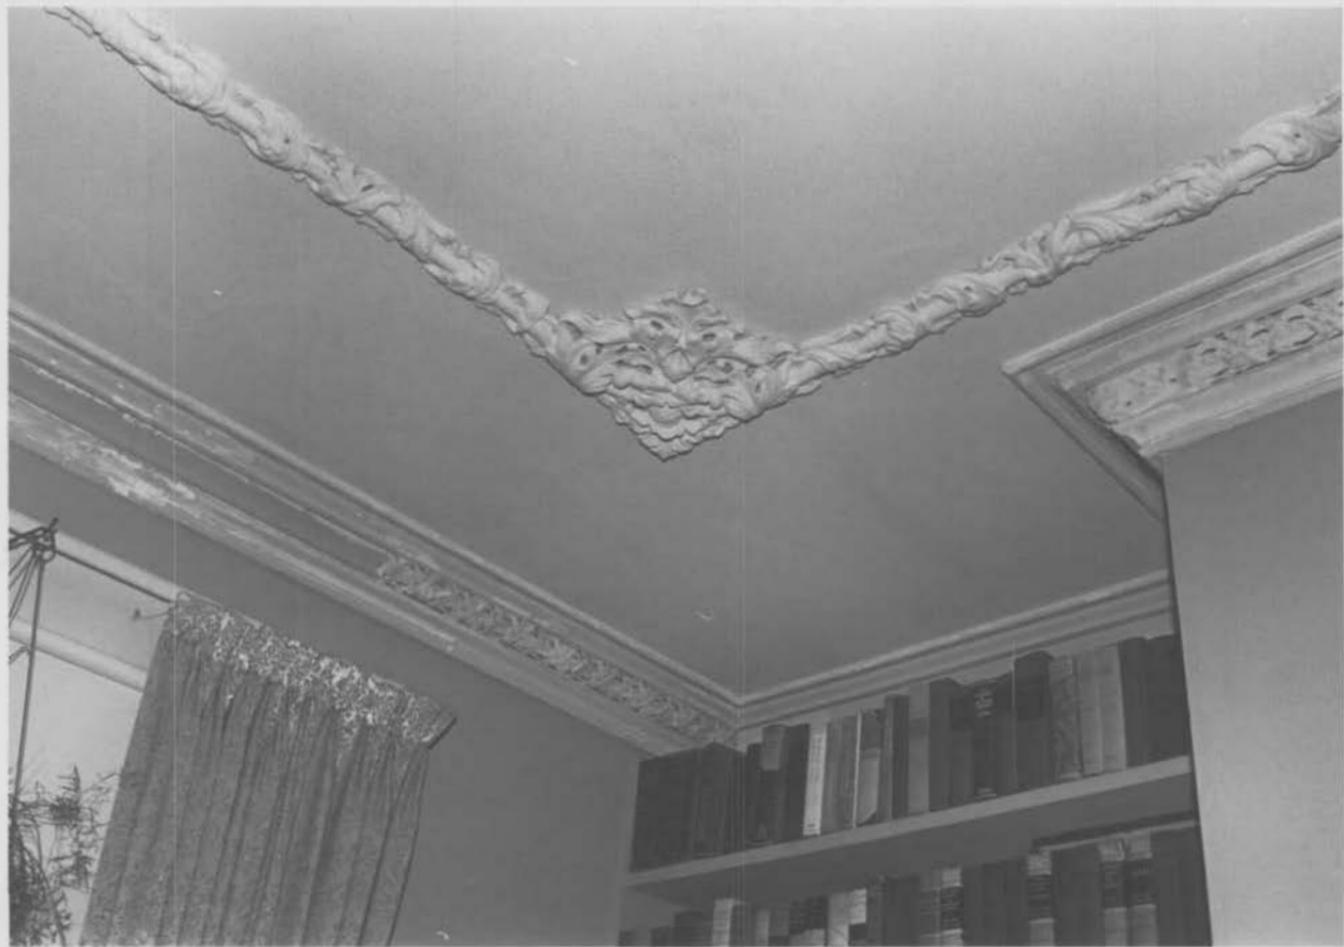
AA-203

Tilden Lawn  
Davidsonville, Anne Arundel County, Md.  
1982  
Orlando Ridout V  
Decorative plaster cornice and ceiling,  
North room, first floor.

The most unusual architectural feature of the house, however, is the decorative plasterwork in the first floor room of the north addition. The complex molded plaster cornice and decorative plaster ceiling in this room comprise one of the finest and most carefully preserved examples of Victorian decorative plasterwork in Tidewater Maryland.

The first floor of the north addition extends the full depth of the house, comprising one large formal room that measures approximately 19 feet wide and 31 feet deep. Paired interior fireplaces are symmetrically placed on the north gable wall, flanking a large triple window in the center. The fireplaces are trimmed with white marble Victorian mantels and white marble hearths. Both fireplaces were originally lined with iron backs and sidepieces, but these have disappeared. The most important feature of this room, however, is the original decorative plaster cornice and ceiling. A complex plaster cornice with exquisite ribbon-and-leaf decoration completely encircles the room. The ceiling is embellished with cast plaster floral decoration that divides the ceiling into two fields, with floral medallions in the center of each field. This decorative work is in pristine condition, and only a short section of the cornice requires repair. This repair will involve reinserting sections of the cast floral work (with a dowel core)

into the trough of the molded plaster cornice, and in fact the cornice is of more interest to historians in its present unrepaired state, which demonstrates clearly how the cornice was made. Other original details in this room include the simple architrave trim, a six-panel door to the passage and some of the original baseboard trim.

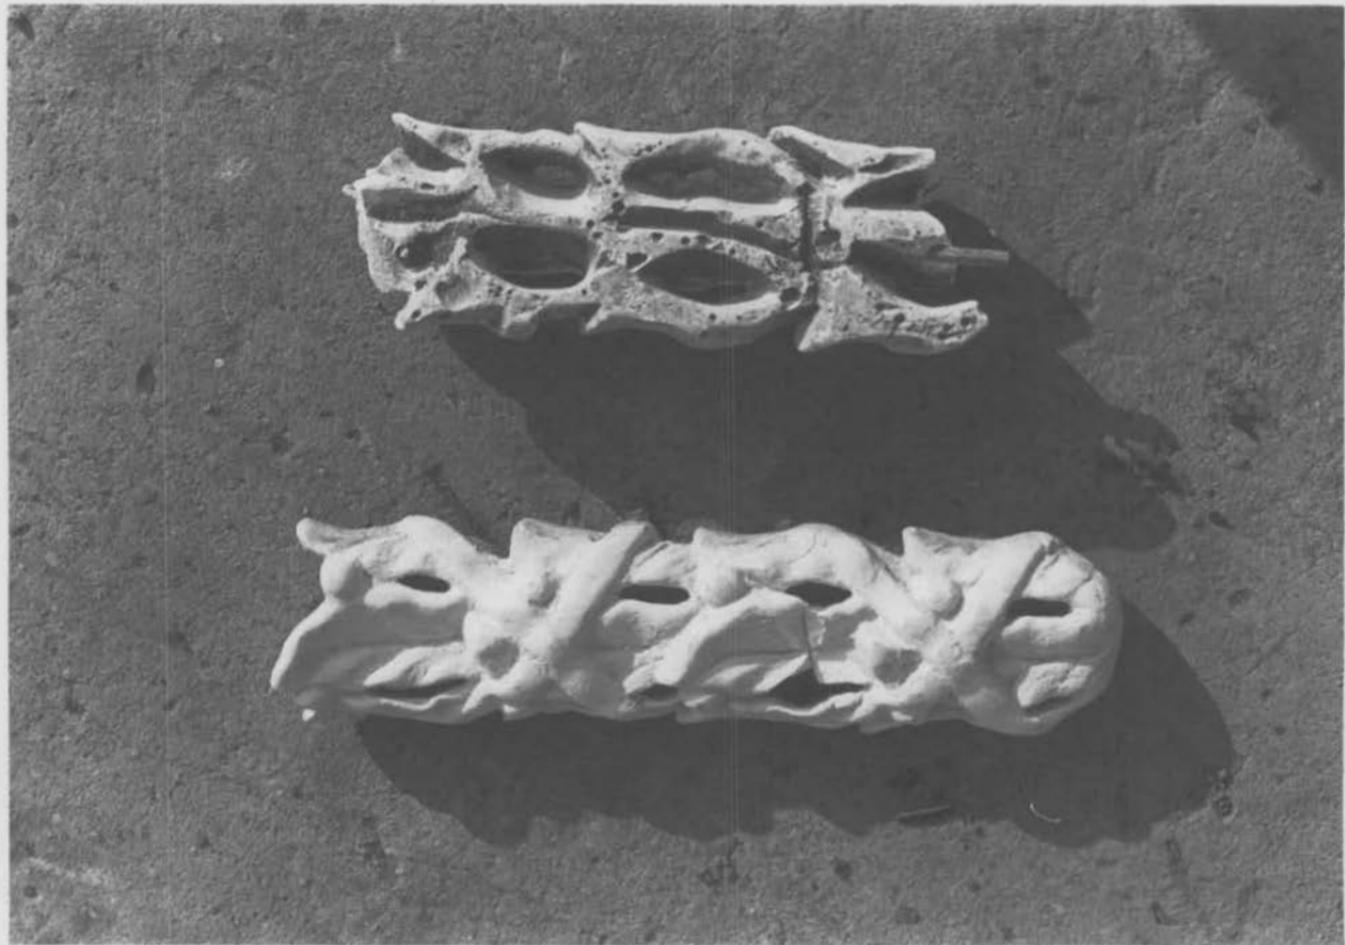
AA-203

Plaster decoration from interior cornice.

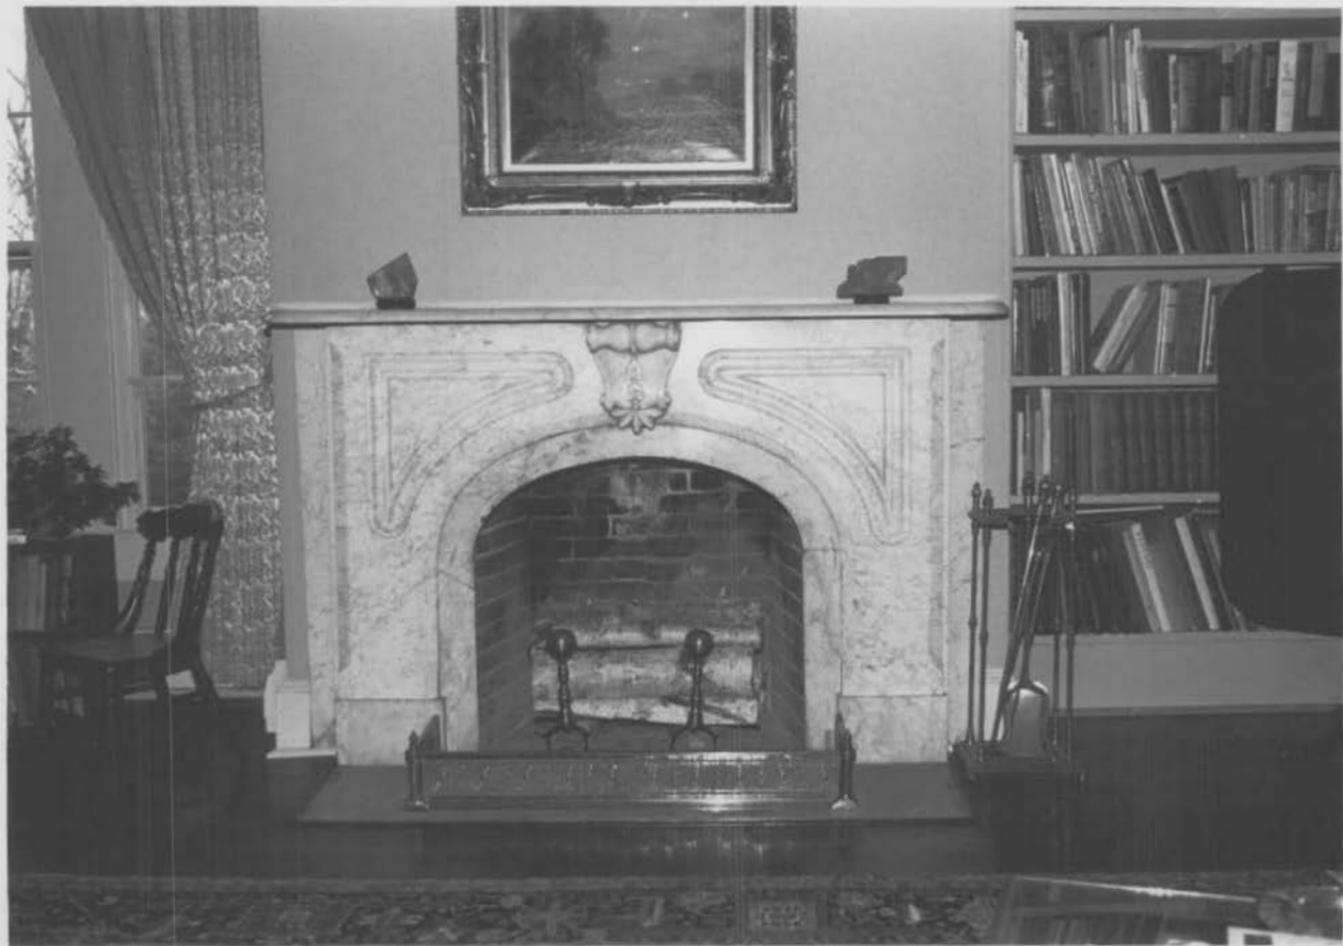
AA-203

Tilden Lawn  
Davidsonville, Anne Arundel County, MD.  
1982  
Orlando Ridout V  
Marble mantel in North room, 1st floor.

The first floor of the north addition is one long elegant room. There are two exterior chimneys on the north wall, with white marble mantels and a three part window between them. The ceiling has ornate plaster borders and medallions. The floor is original, with wide boards. The windows have larger panes than those of the earlier house.

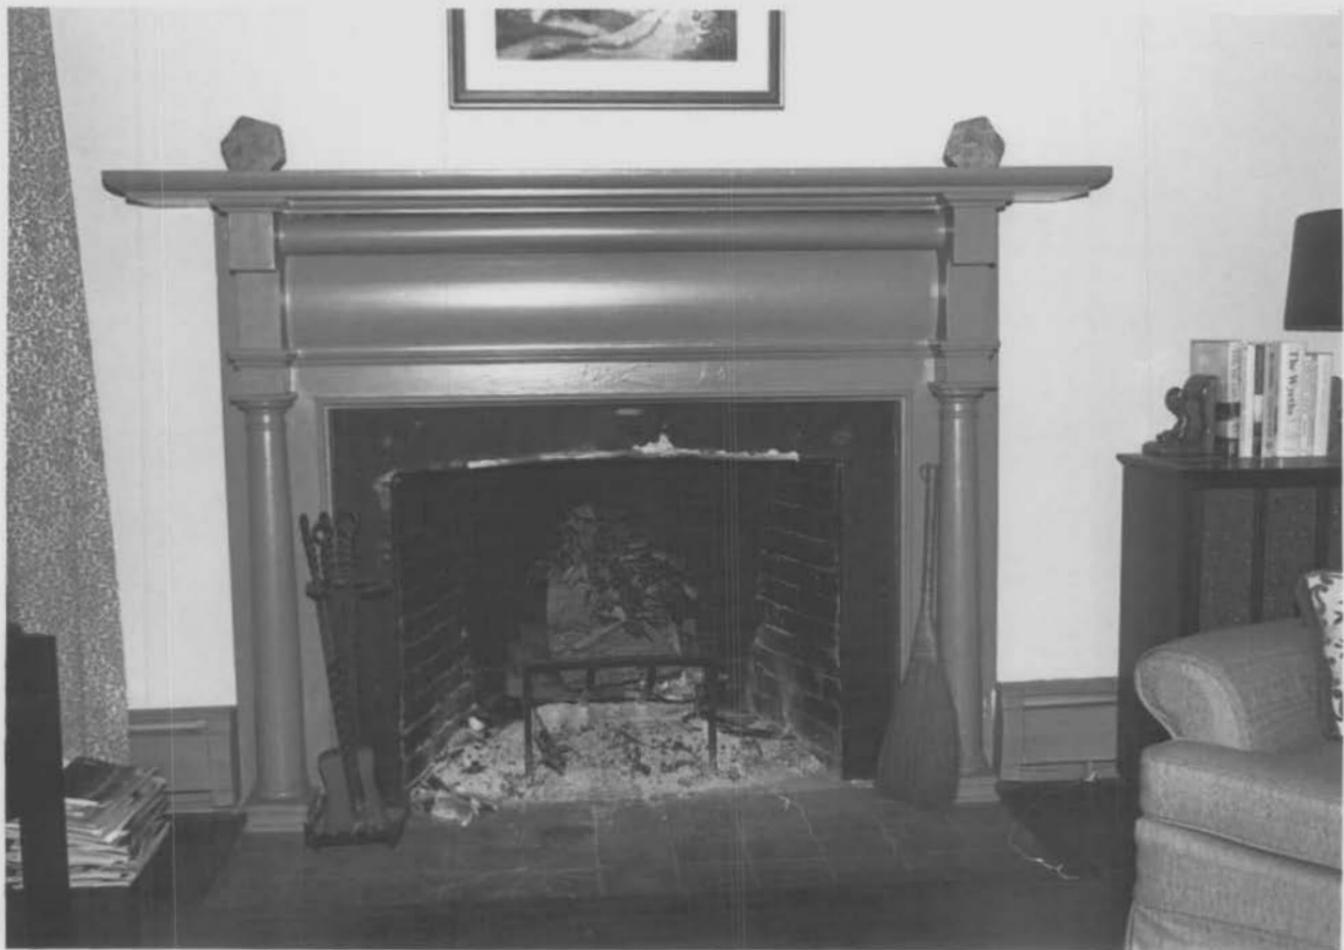
AA-203

Greek Revival mantel in Southeast  
room, first floor.

The interior of the early house includes all of the original mantels and most of the original interior trim. Particular features of interest include the two handsome Greek Revival mantels on the first floor and a pair of smaller transitional Federal/Greek mantels on the second floor, the painted and grained door to the attic stair, and a variety of early hardware.
