AA-373

HISTORIC SITES SURVEY FIELD SHEET
 Individual Structure Survey Form

COUNTY: Anne Arundel
TOWN: Annapolis
LOCATION: 97 Cathedral Street
COMMON NAME:
FUNCTIONAL TYPE: Res Map 30 Par 565
OWNER: Paul Panneton
ADDRESS: 3102 Tinder Place Bowie, MD 20715
ACCESSIBILITY TO PUBLIC: Yes (X) No () Restricted ()
LEVEL OF SIGNIFICANCE: Local (✓) State () National ()

97 Cathedral

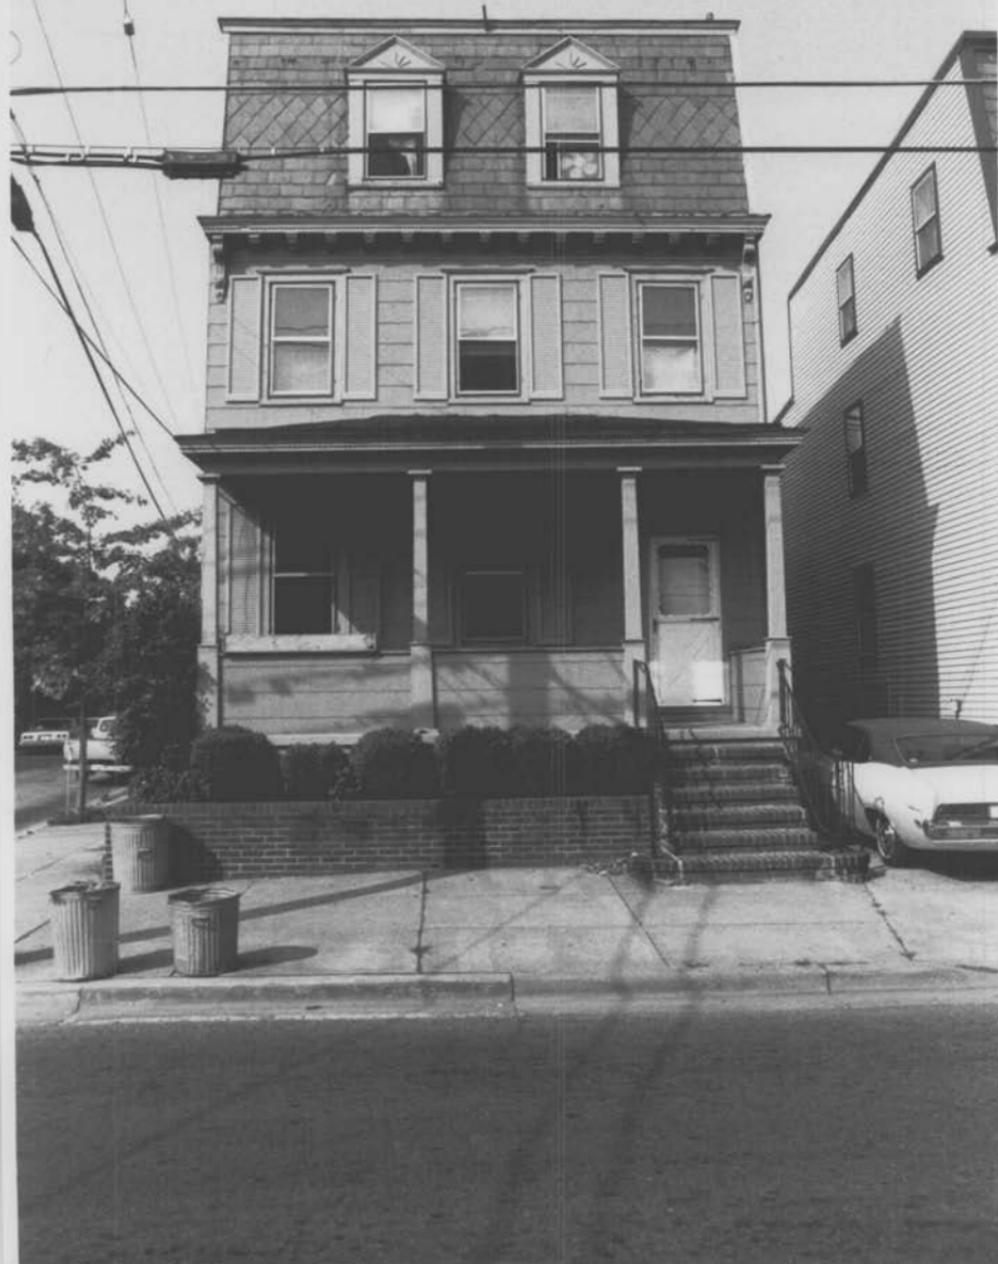
J2 29

Excellent pedimented dormers with applied sunbursts in gables, on patterned slate false Mansard roof; good bracketed cornice with end consoles; molded window caps; full width front porch with square columns, transom lit door; asbestos shingles, including porch from rail to floor.

NW Elevation/camera facing SE
