CAPSULE SUMMARY
Samuel Hutton House
30 Cornhill Street
(AA-443)

MARYLAND HISTORICAL TRUST
MD INVENTORY OF HISTORIC PROPERTIES

Inventory No. AA-443

historic name Samuel Hutton House
common/other name _____

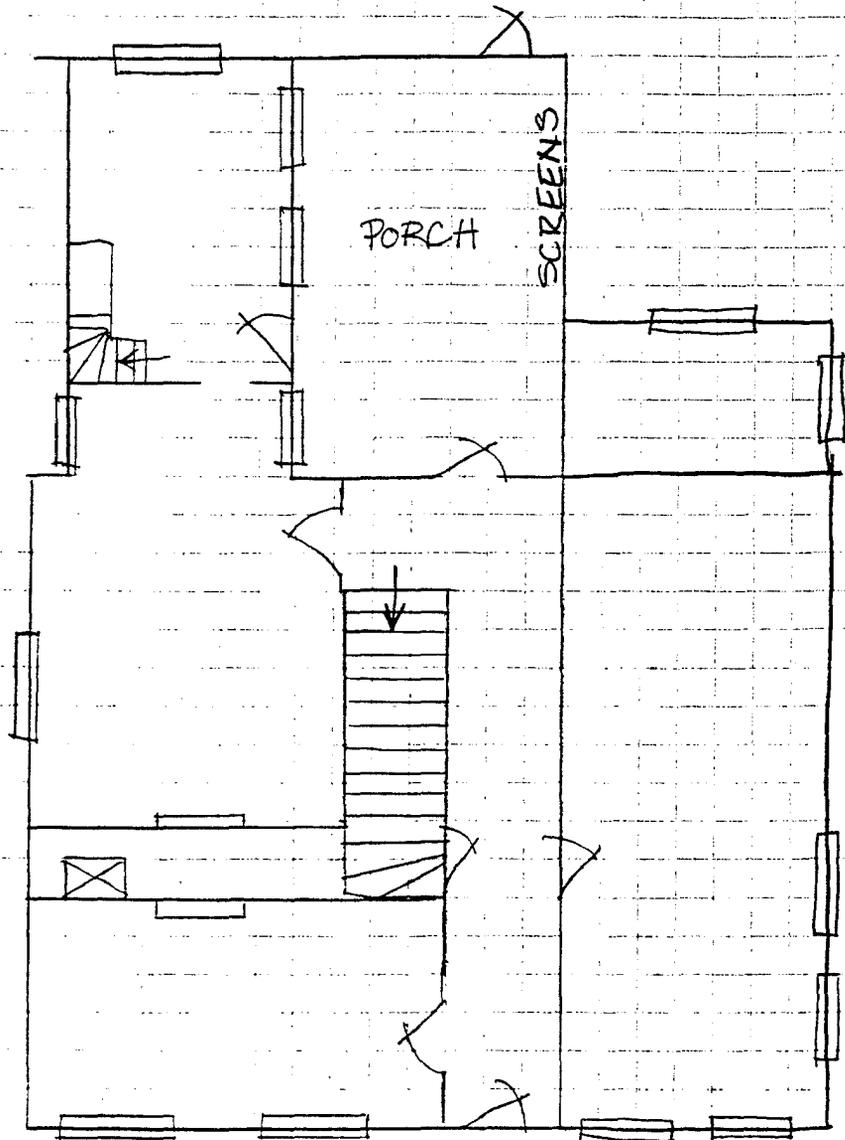
FIRST FLOOR

The interior of the original main block of 30 Cornhill Street consists of a side-passage, double-pile plan; however, the two-story frame addition of the building at 28 Cornhill Street on the east side of the house has converted the interior into a central-passage, three-room plan with a kitchen located in the rear wing. A quarter-flight stair, located against the northwest interior wall of the hall, is accessible from the eastern end of the hall. The interior includes both original 18th-century detailing and period replacement detailing from the 1980s renovation.

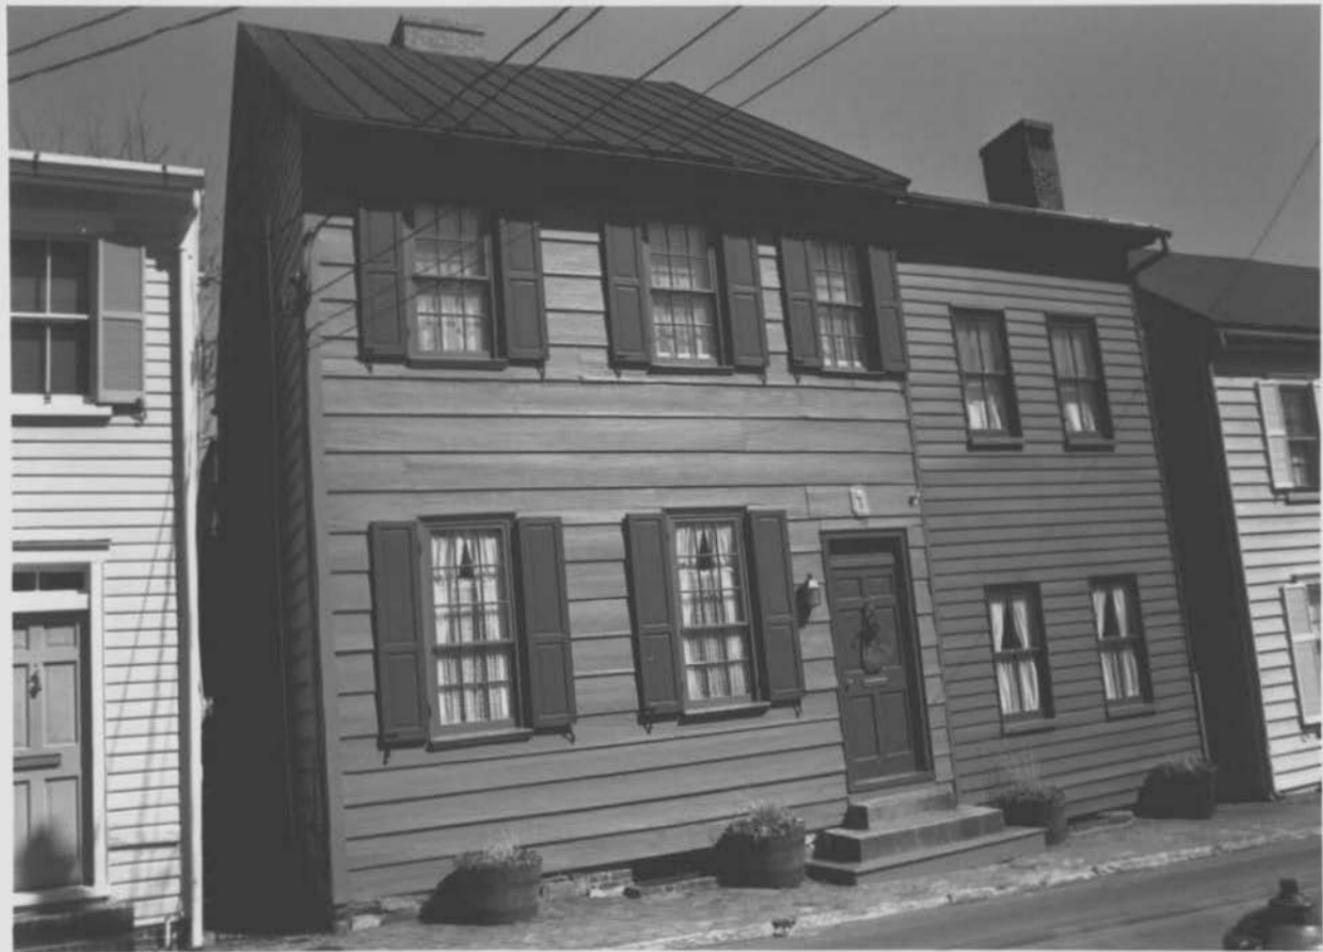
1 OF 8

The facade (south elevation) of the main block of the dwelling fronts directly onto Cornhill Street and is divided into three bays, the eastern end bay being narrower than the other two. This facade is clad with wide random-width, beaded weatherboards ranging in width from ten to thirteen inches. The first story consists of a side entry door located in the east end bay and two 9/6 windows, while the second story has three 6/6 windows. All of the windows, molded wood surrounds, and wood sills are contemporary period reproductions. The side entry has a six-panelled wood replacement door with a narrow three-light transom.

SOUTH ELEVATION

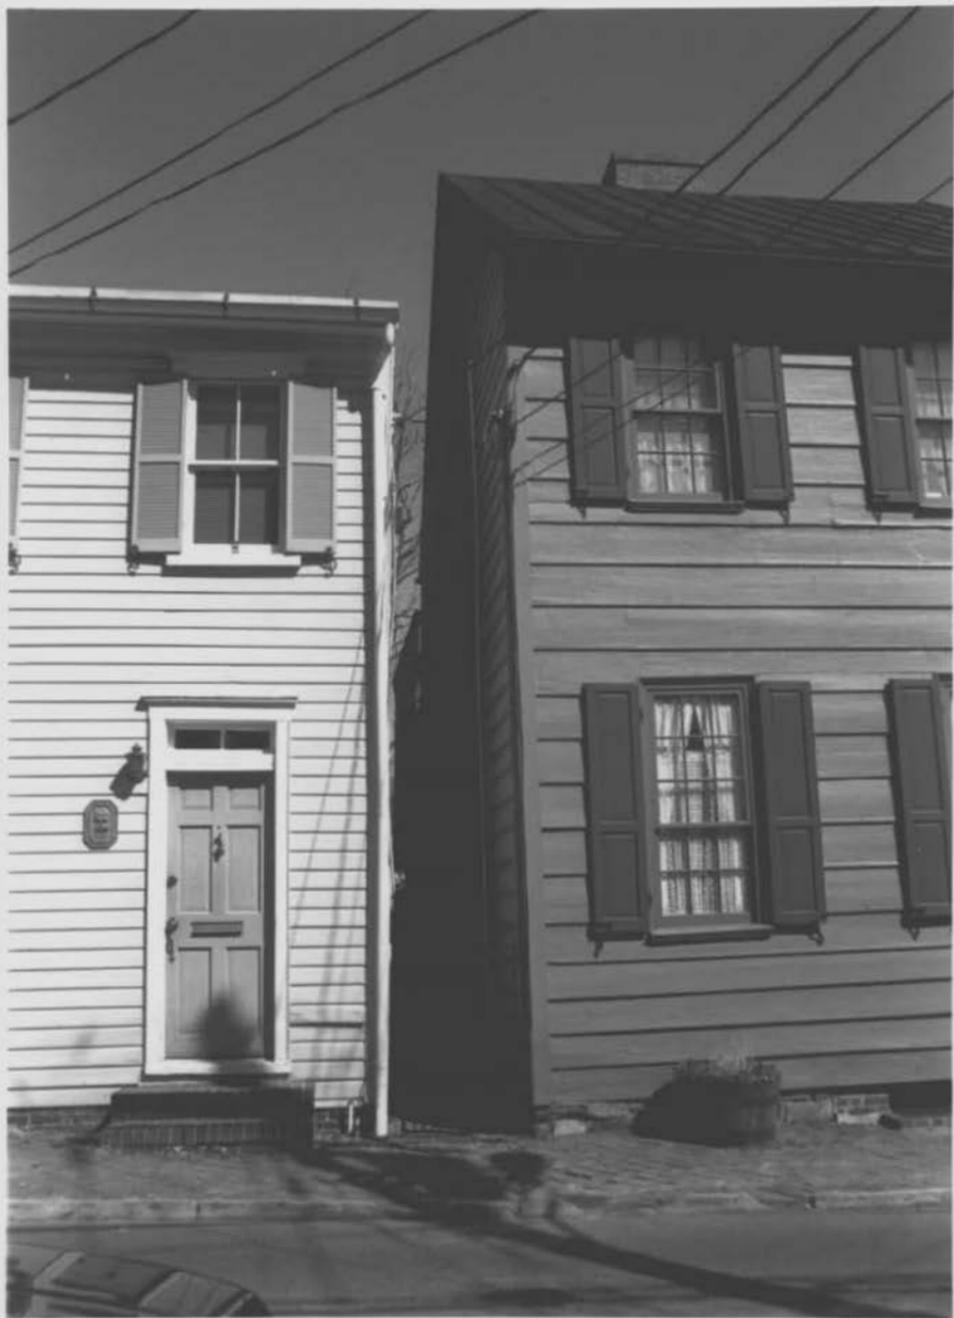
AA-443
30 CORNHILL STREET
ANNAPOLIS, MD
TRACERIES
MARCH 1996
MD SHPD
WEST ELEVATION
2 OF 8

The west elevation of the main block of the house opens onto a narrow passage located between 30 and 32 Cornhill Street. This side wall has been re-clad in reproduction beaded siding. A single 6/6 window is located in the first story and two 4/4 windows are located in the attic level; no openings are found on the second story. The west elevation of the rear ell is not clearly visible

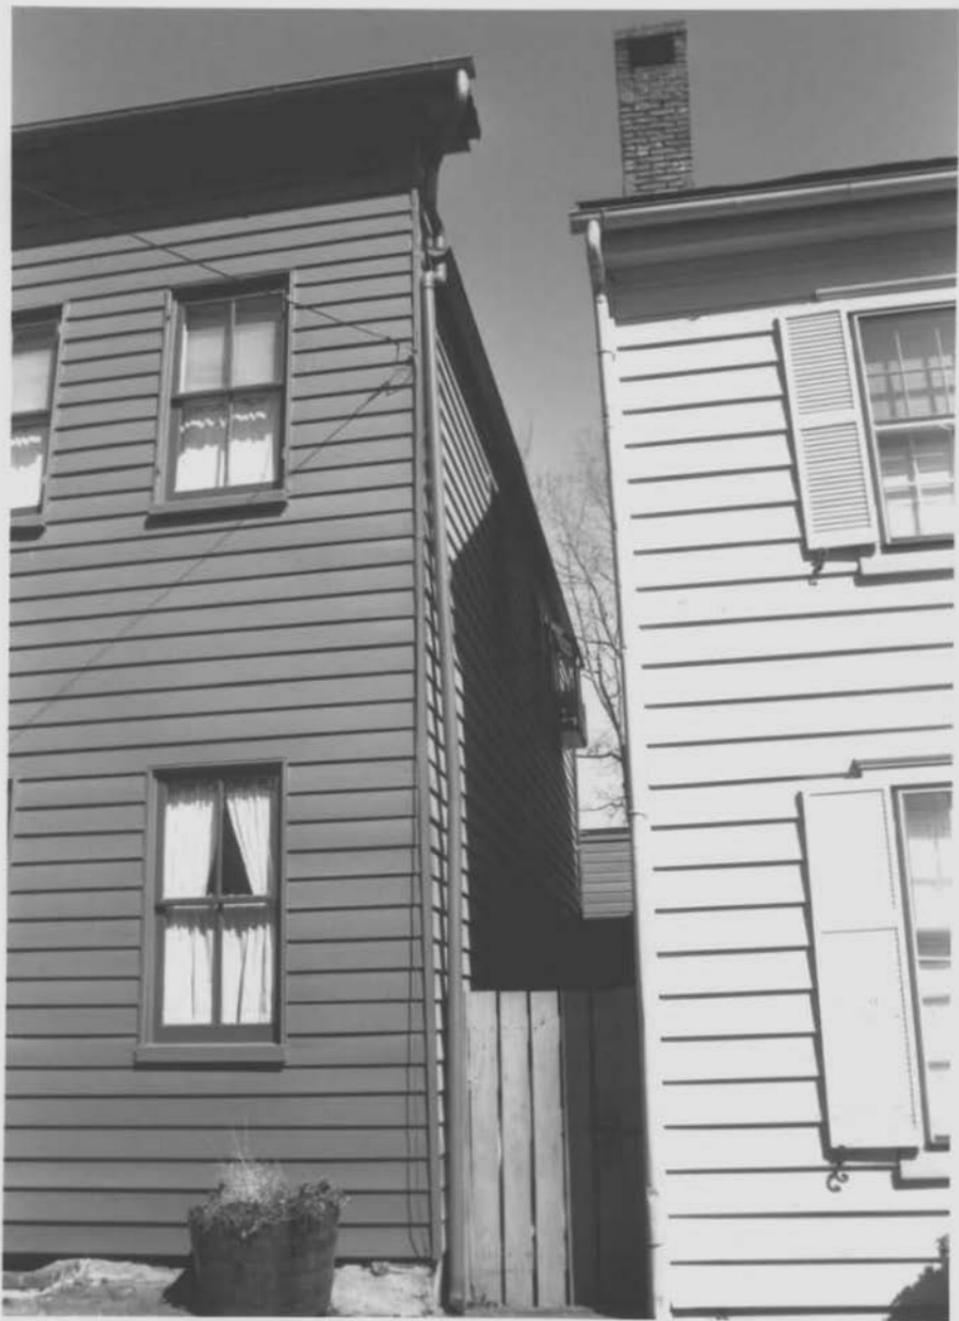
3 OF 8

The east elevation includes the east wall of the two-bay house at 28 Cornhill Street and the attic level of the gable end of the main block which rises above it. This gable end is lit with two 6/6 windows. The east wall is clad with weatherboard walls and lit by three 6/6 windows on the first and second stories and one plate glass window in the rear bay of the second story.

EAST ELEVATION

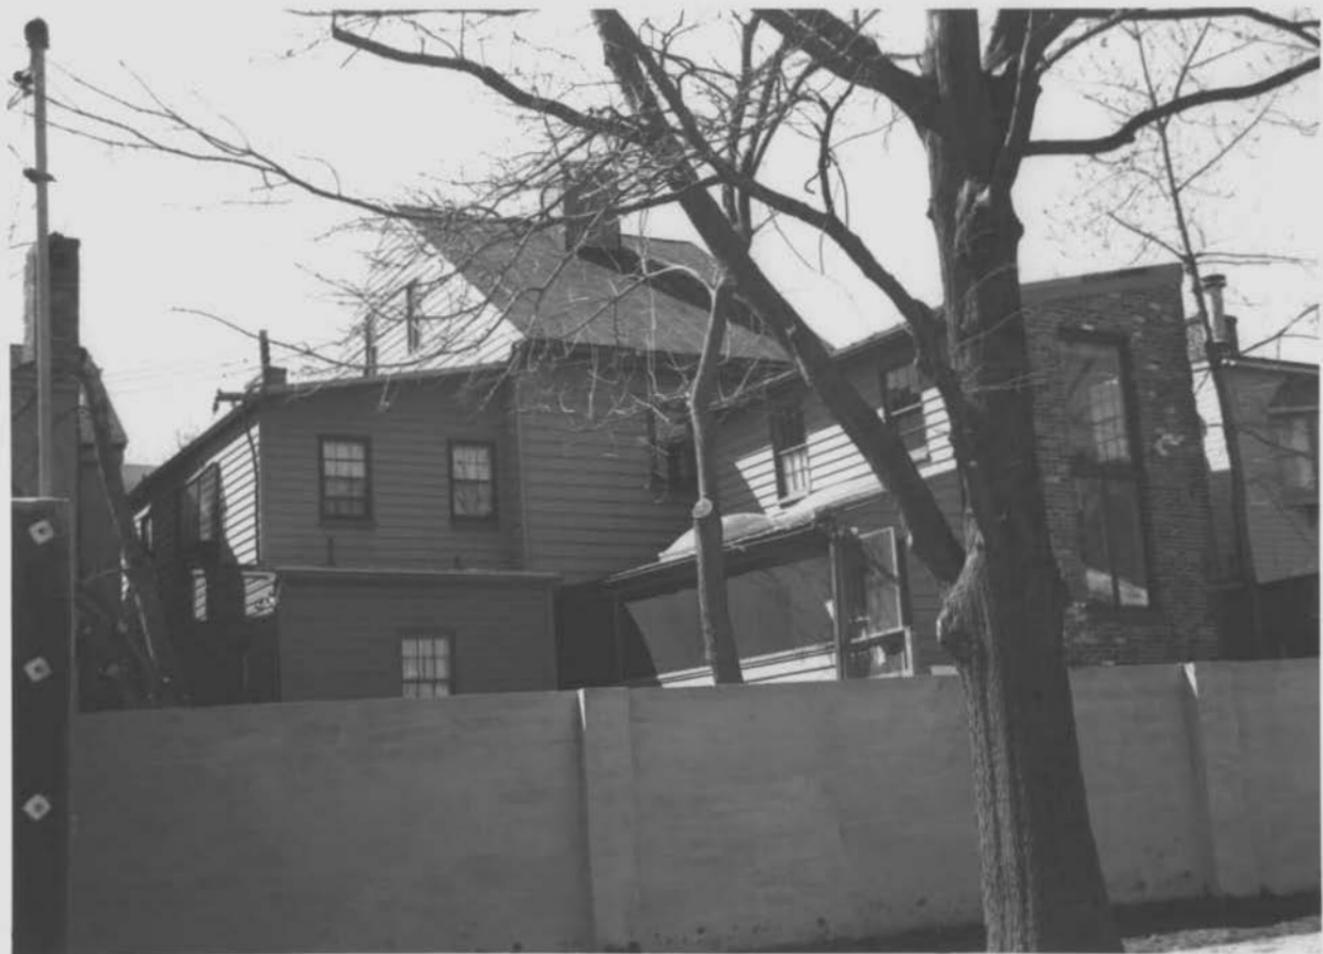
4 OF 8

The north (rear) elevation includes an exposed bay on the main block of the house, the two-story rear wing, and the north wall of the two-bay building at 28 Cornhill Street. The exposed bay of the main block is clad with beaded board siding and has a single 6/6 window in the second story. The two-story rear wing is connected to the main block of the house by a narrow two-story hyphen covered with a flat roof. The east side wall of this hyphen is also clad with beaded board siding.

NORTH ELEVATION

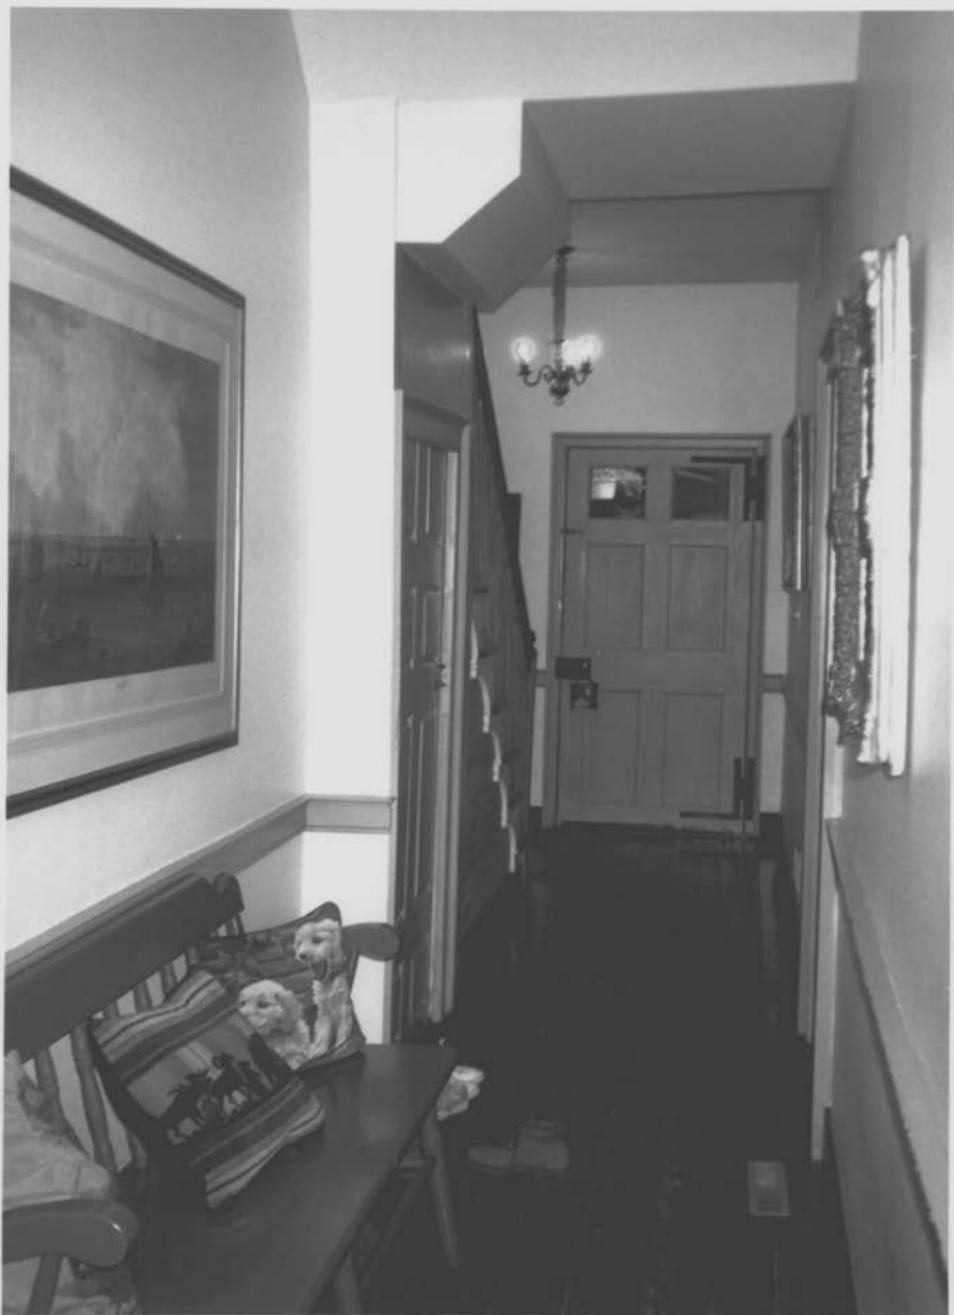
5 OF 8

The hall is a narrow space and extends eastward along the depth of the house to a rear door that leads to the exterior porch. This door is an original raised panel door; the top two of the six panels have been removed and replaced with glass. The hall retains its original random-width wood floorboards, but has period replacement baseboards, based upon the original ones, and a

ENTRY HALL LOOKING NORTH

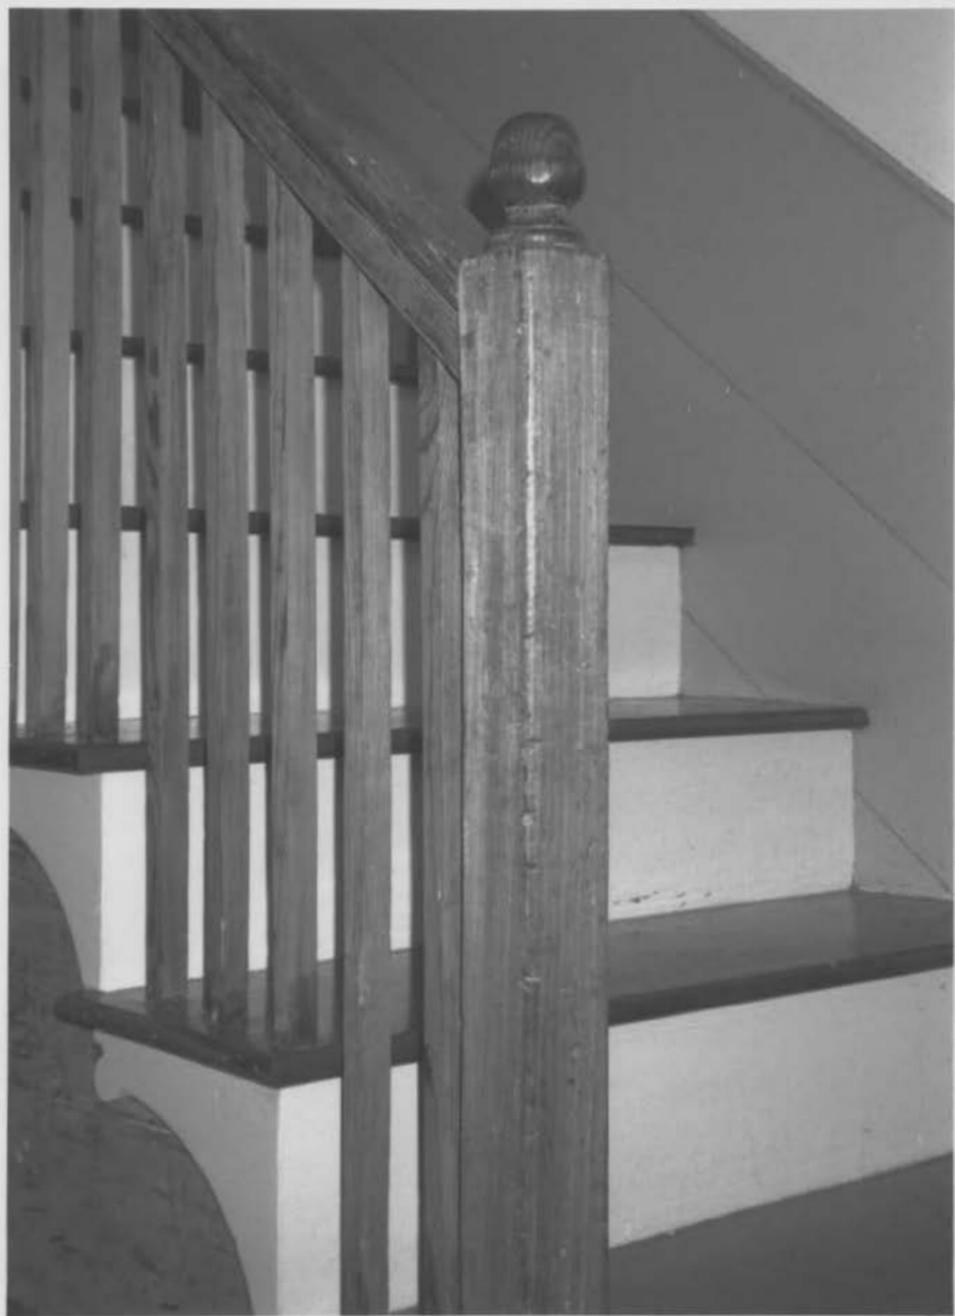
6 OF 8

=====
contemporary chair rail. The stair wall of the hall consists of wide beaded boards with their original 18th-century verdi-gris paint color exposed as part of the 1980s renovation. The stairs lead from the back of the hall up to the second floor. While the substructure of the stair has been reconstructed, the original stair rail and side wall remain. The stair rail consists of a square newel post with an acorn cap and three square balusters per tread. The interior stair wall consists of wide boards with a beaded cap. A door under the front of the stairs leads to the cellar via a ladder stair. This door appears to be an original exterior door that was cut down to size to fit the smaller cellar entry opening (originally eight-panelled, the top panels have been cut down).

STAIR DETAIL, MAIN NEWEL

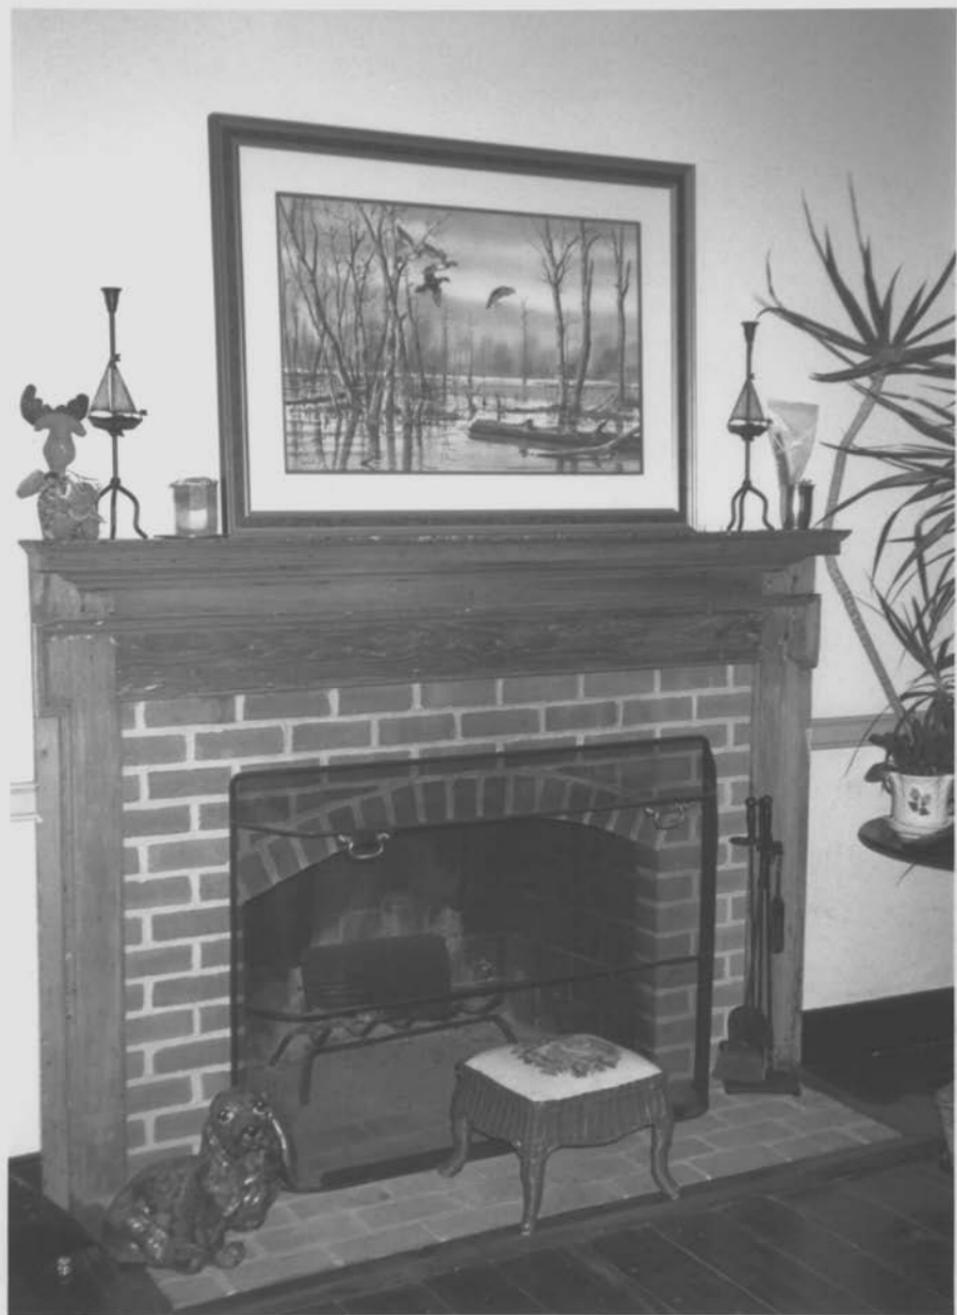
7 OF 8

The front parlor is entered directly from the hall through a single door opening with beaded casings. The room retains its original wide floorboards with some 1980s patching, original wide board wainscoting, and beaded casings. A chimney breast, located against the north wall, has a wood crossetted mantel framing a contemporary brick face. According to the present owners, the fireplace opening was made during the 1980s renovation, as the original opening was located above floor level.¹ A closet with beaded casings around the door is located next to the mantel; based upon the casings, and the owner's recollection, this was historically a passage between this front parlor and the rear dining room. The chair rail is a product of the renovation.

MANTEL, FRONT PARLOR

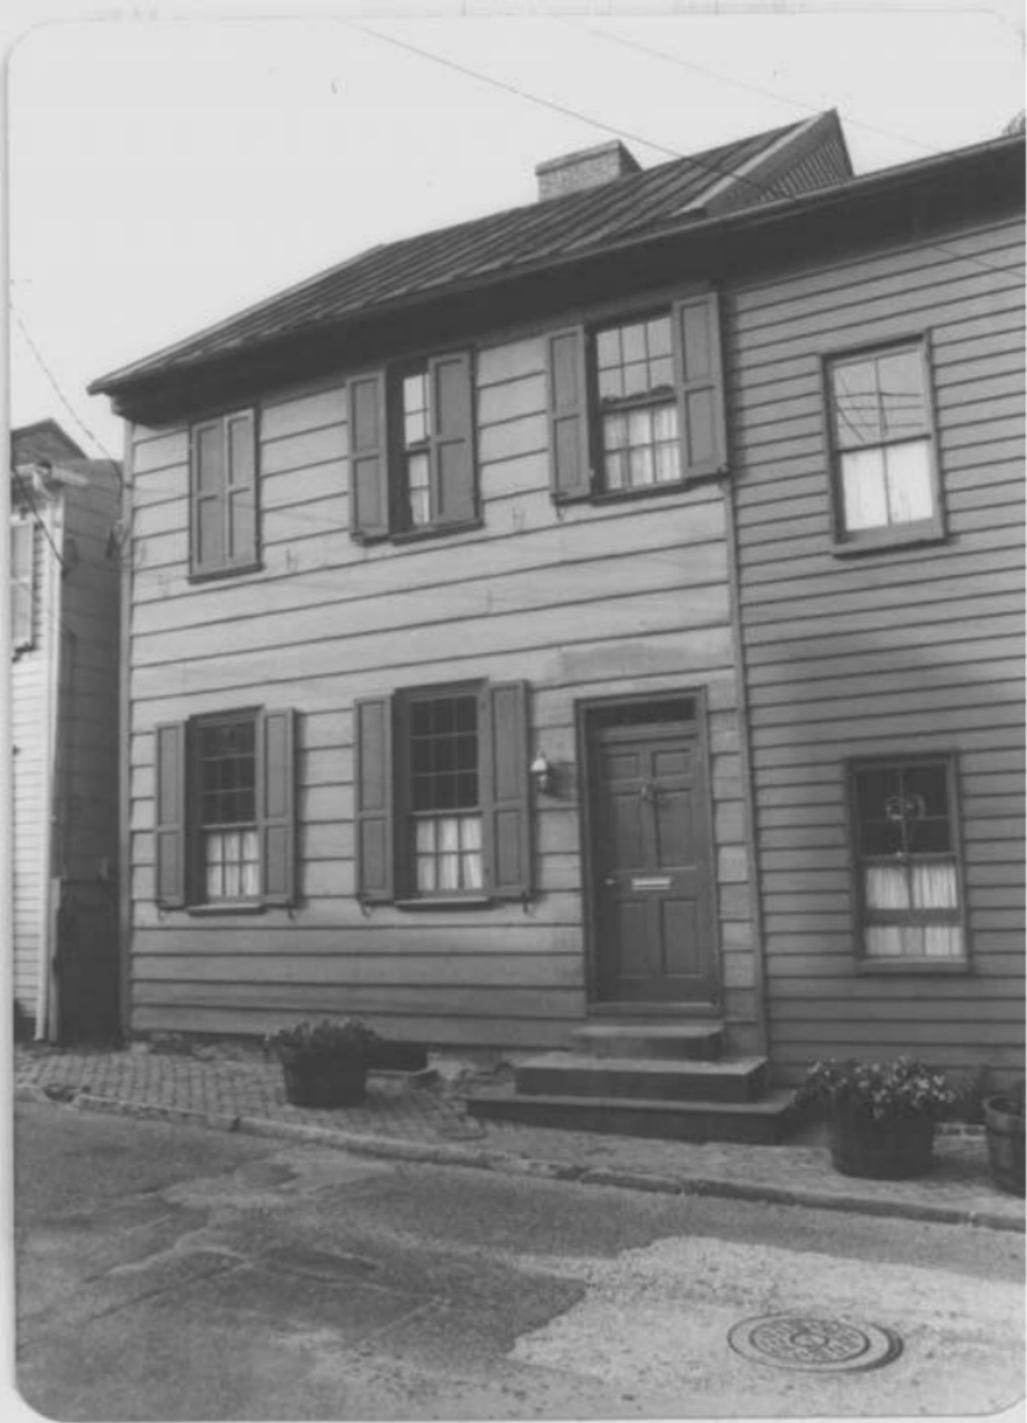
AA 443

SW Elevation/camera facing NE
