HISTORIC SITES SURVEY FIELD SHEET  
 Individual Structure Survey Form

SURVEY NUMBER: <u>AA 606</u>
NEGATIVE FILE NUMBER:
UTM REFERENCES: Zone/Easting/Northing
U.S.G.S. QUAD. MAP:
PRESENT FORMAL NAME:
ORIGINAL FORMAL NAME:
PRESENT USE: <u>single Family Residence</u>
ORIGINAL USE: " " "
ARCHITECT/ENGINEER:
BUILDER/CONTRACTOR:
PHYSICAL CONDITION OF STRUCTURE: Excellent ( ) Good (x) Fair ( ) Poor: ( )
THEME:
STYLE: <u>vernacular-Annapolis Federal</u>
DATE BUILT: <u>1891-1897</u>

COUNTY: <u>Anne Arundel</u>
TOWN: <u>Annapolis</u>
LOCATION: <u>122 Market</u>
COMMON NAME:
FUNCTIONAL TYPE: <u>Res Map 33 Par 42</u>
OWNER: <u>McConnaughay Norma E &amp; James</u>
ADDRESS: <u>1902 Carrollton Rd.</u> <u>Annapolis, MD 21401</u>
ACCESSIBILITY TO PUBLIC: Yes (x) No ( ) Restricted ( )
LEVEL OF SIGNIFICANCE: Local (x) State ( ) National ( ) <input checked="" type="radio"/>

<p>1. STATE <b>Annapolis, Maryland</b>          COUNTY          TOWN VICINITY          STREET NO. <b>122 Market Street</b></p> <p>ORIGINAL OWNER          ORIGINAL USE <b>residence</b>          PRESENT OWNER <b>Highland</b>          PRESENT USE <b>residence</b>          WALL CONSTRUCTION <b>stucco</b>          NO. OF STORIES <b>

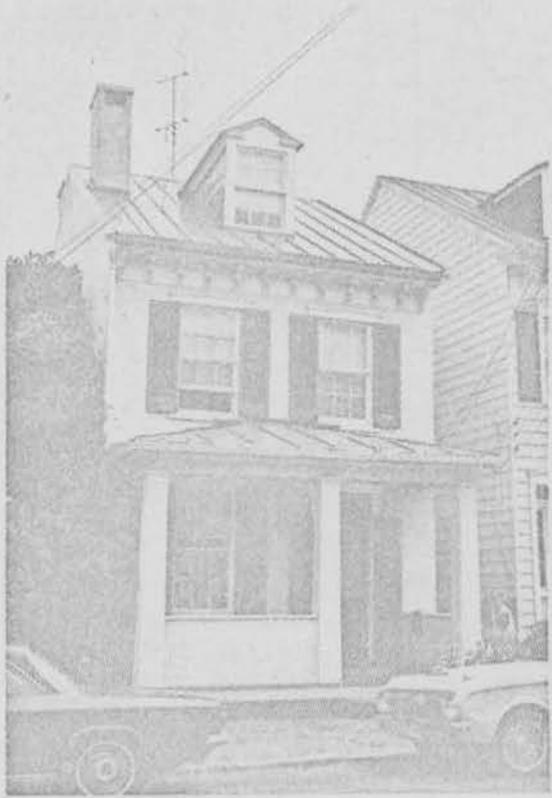
<p>5. PHYSICAL CONDITION OF STRUCTURE</p>	<p style="text-align: right;"><u>good</u></p>
<p>6. LOCATION MAP (Plan Optional)</p> <p>7. PUBLISHED SOURCES (Author, Title, Pages)          INTERVIEWS, RECORDS, PHOTOS, ETC.</p>	<p>7. PHOTOGRAPH</p> <p>8. NAME, ADDRESS AND TITLE OF RECORDER</p> <p><b>William D. Morgan</b>  <b>Columbia University</b>  <b>New York City</b></p> <p>DATE OF RECORD <b>July 21, 1967</b></p>

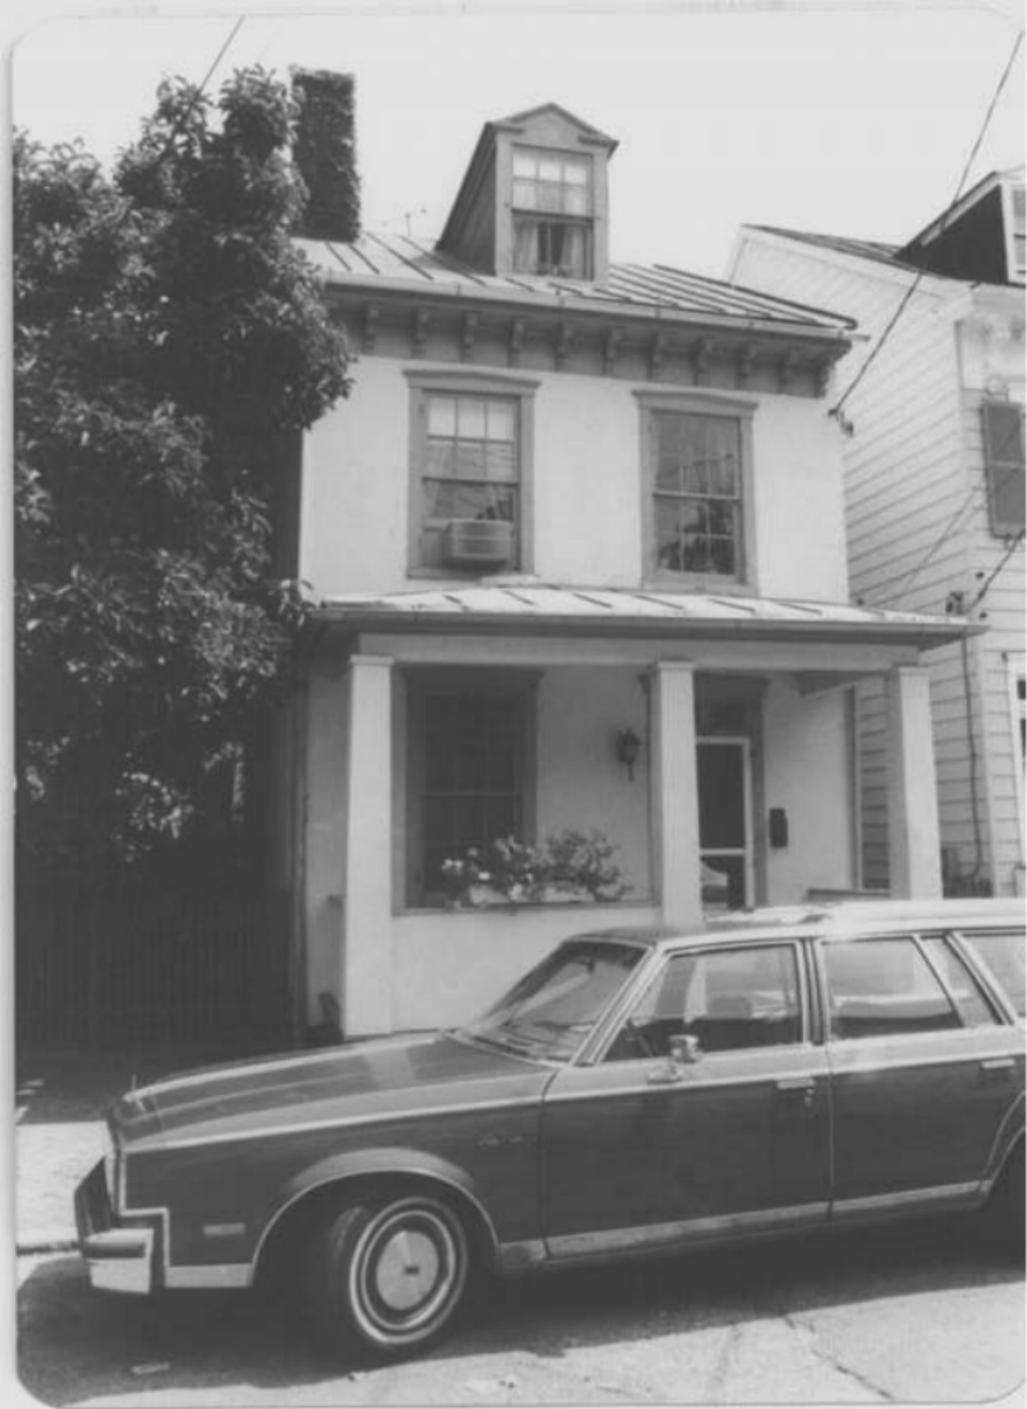
122 Mkt

Gabled dormer, heavy bracketed cornice with deep frieze; pedimented window and transom lit door caps; full width porch with later square pilasters, covered with stucco as is area below handrail.

Good example of late 19thC Vernacular with Italianate cornice, marred only by stucco and altered porch. Important to streetscape.

NE Elevation/camera facing SW
