HISTORIC SITES SURVEY FIELD SHEET  
 Individual Structure Survey Form

SURVEY NUMBER: <b>AA 696</b>
NEGATIVE FILE NUMBER:
UTM REFERENCES: Zone/Easting/Northing
U.S.G.S. QUAD. MAP:
PRESENT FORMAL NAME:
ORIGINAL FORMAL NAME:
PRESENT USE: Commercial/Apt
ORIGINAL USE: Commercial/Apt
ARCHITECT/ENGINEER:
BUILDER/CONTRACTOR:
PHYSICAL CONDITION OF STRUCTURE: Excellent ( ) Good (x) Fair ( ) Poor: ( )
THEME:
STYLE: Commercial
DATE BUILT: 1897-1903

COUNTY: Anne Arundel
TOWN: Annapolis
LOCATION: 8-10 West
COMMON NAME: Lucas Bros.
FUNCTIONAL TYPE: COMM Map 30 Par 110
OWNER: Horwitz Miriam A & Ann/% Marvin H ADDRESS: Achein/Auite 2001/One Charles Ctr Baltimore, MD 21201
ACCESSIBILITY TO PUBLIC: Yes (x) No ( ) Restricted ( )
LEVEL OF SIGNIFICANCE: Local (x) State ( ) National ( ) <input type="radio"/>

1. STATE <b>Annapolis, Maryland</b> COUNTY TOWN VICINITY STREET NO. <b>8 - 10 West Street</b>  ORIGINAL OWNER ORIGINAL USE <b>commercial</b> PRESENT OWNER PRESENT USE <b>commercial - vacant</b> WALL CONSTRUCTION <b>brick</b> NO. OF STORIES <b>two</b>	HISTORIC AMERICAN BUILDINGS SURVEY INVENTORY  2. NAME  DATE OR PERIOD <b>1890s</b> STYLE <b>Victorian</b> ARCHITECT BUILDER  3. FOR LIBRARY OF CONGRE

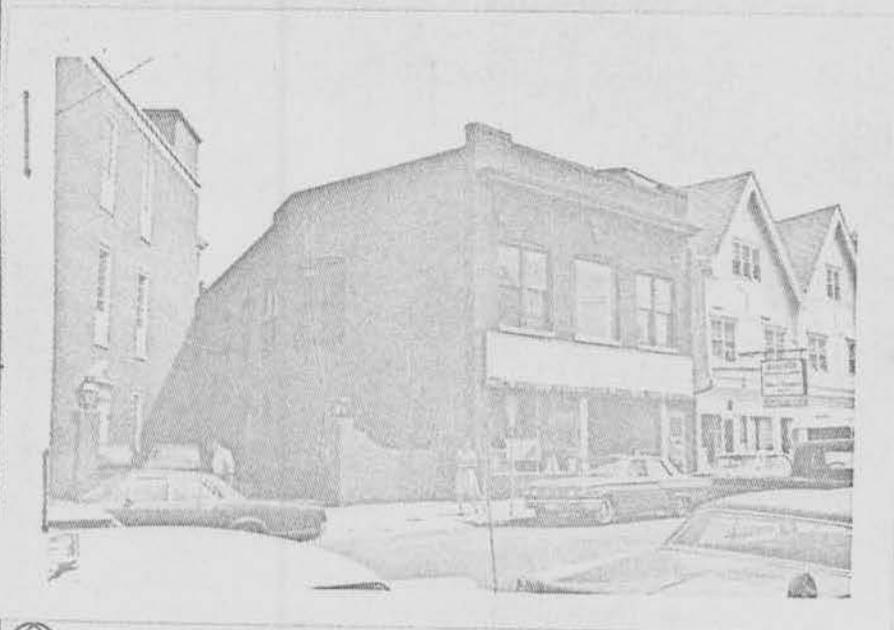
A fine, solid Victorian commercial building totally original except for 1st storey store front, and 1 sash removed from middle 2nd storey window. Three 2nd storey windows (originally 2 x 2/2 topped by triple arch of headers. Same window motif around the side. The mock cornice applied above the second storey windows is simple but with 3 very pronounced brackets of unusual design. The building is exposed on its West wall due to parking lot and meets Bell Tel. building at odd angle. This exposed wall is both aesthetically pleasing and compositionally important for the street. The 2nd storey windows on the side are echoed by smaller ones beneath. The common bond on the side is nicely set off by a row of darker headers every seventh course.

Exterior good

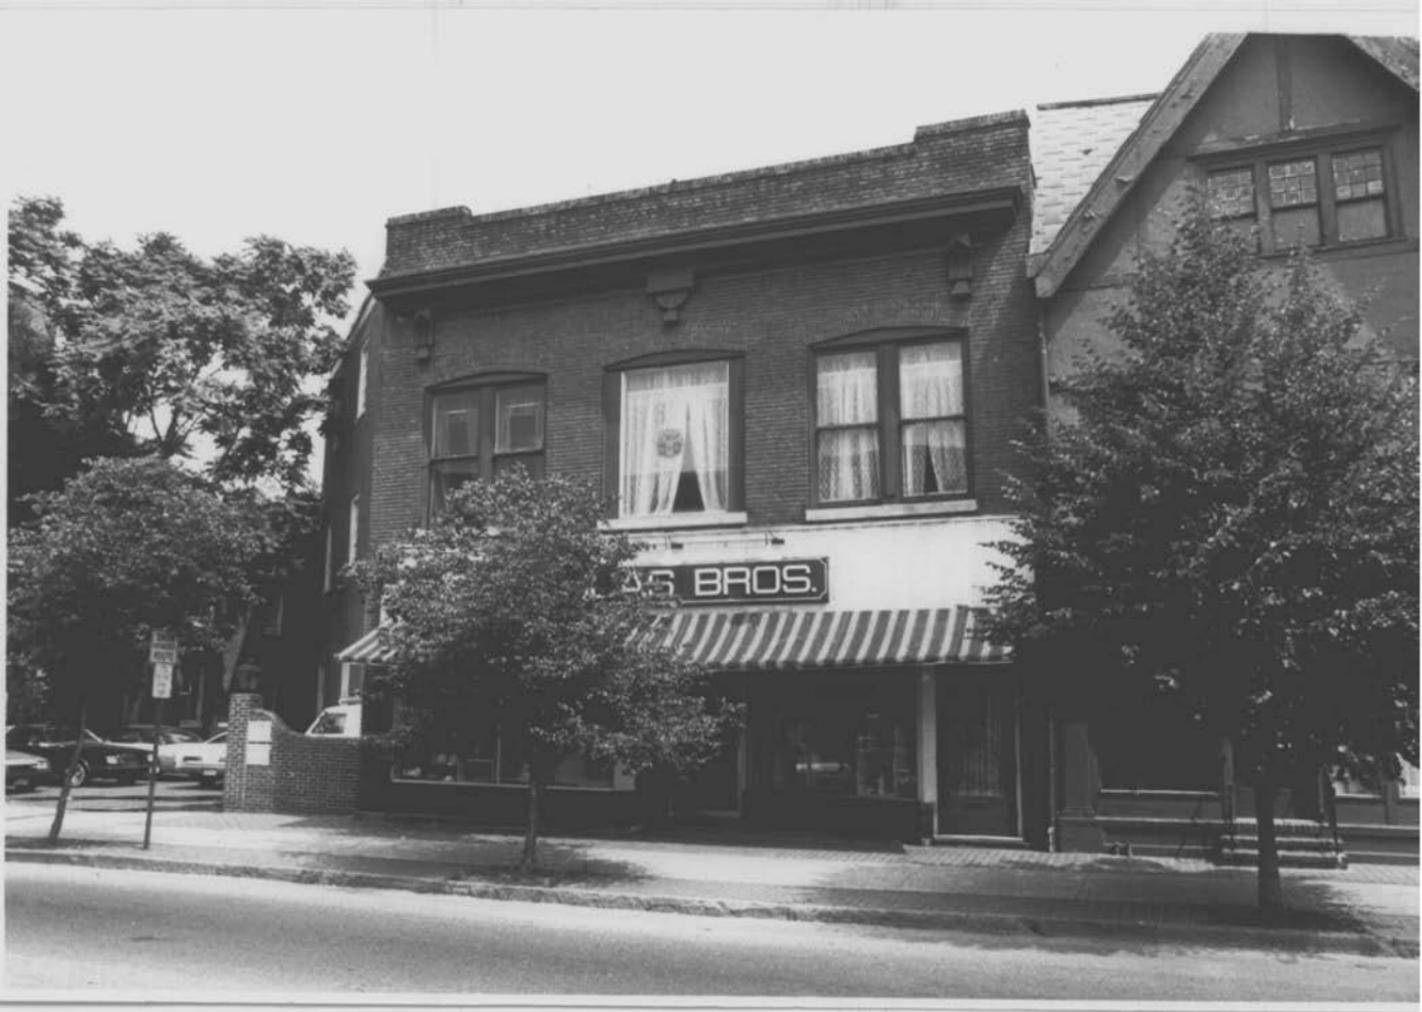
AA 696

sw Elevation/camera facing ne
